# WILDFIRE-ASSOCIATED LANDSLIDE EMERGENCY RESPONSE TEAM REPORT

## Nakia Creek Fire

Clark County, Washington

WASHINGTON  
GEOLOGICAL SURVEY  
WALERT Report  
January, 2023

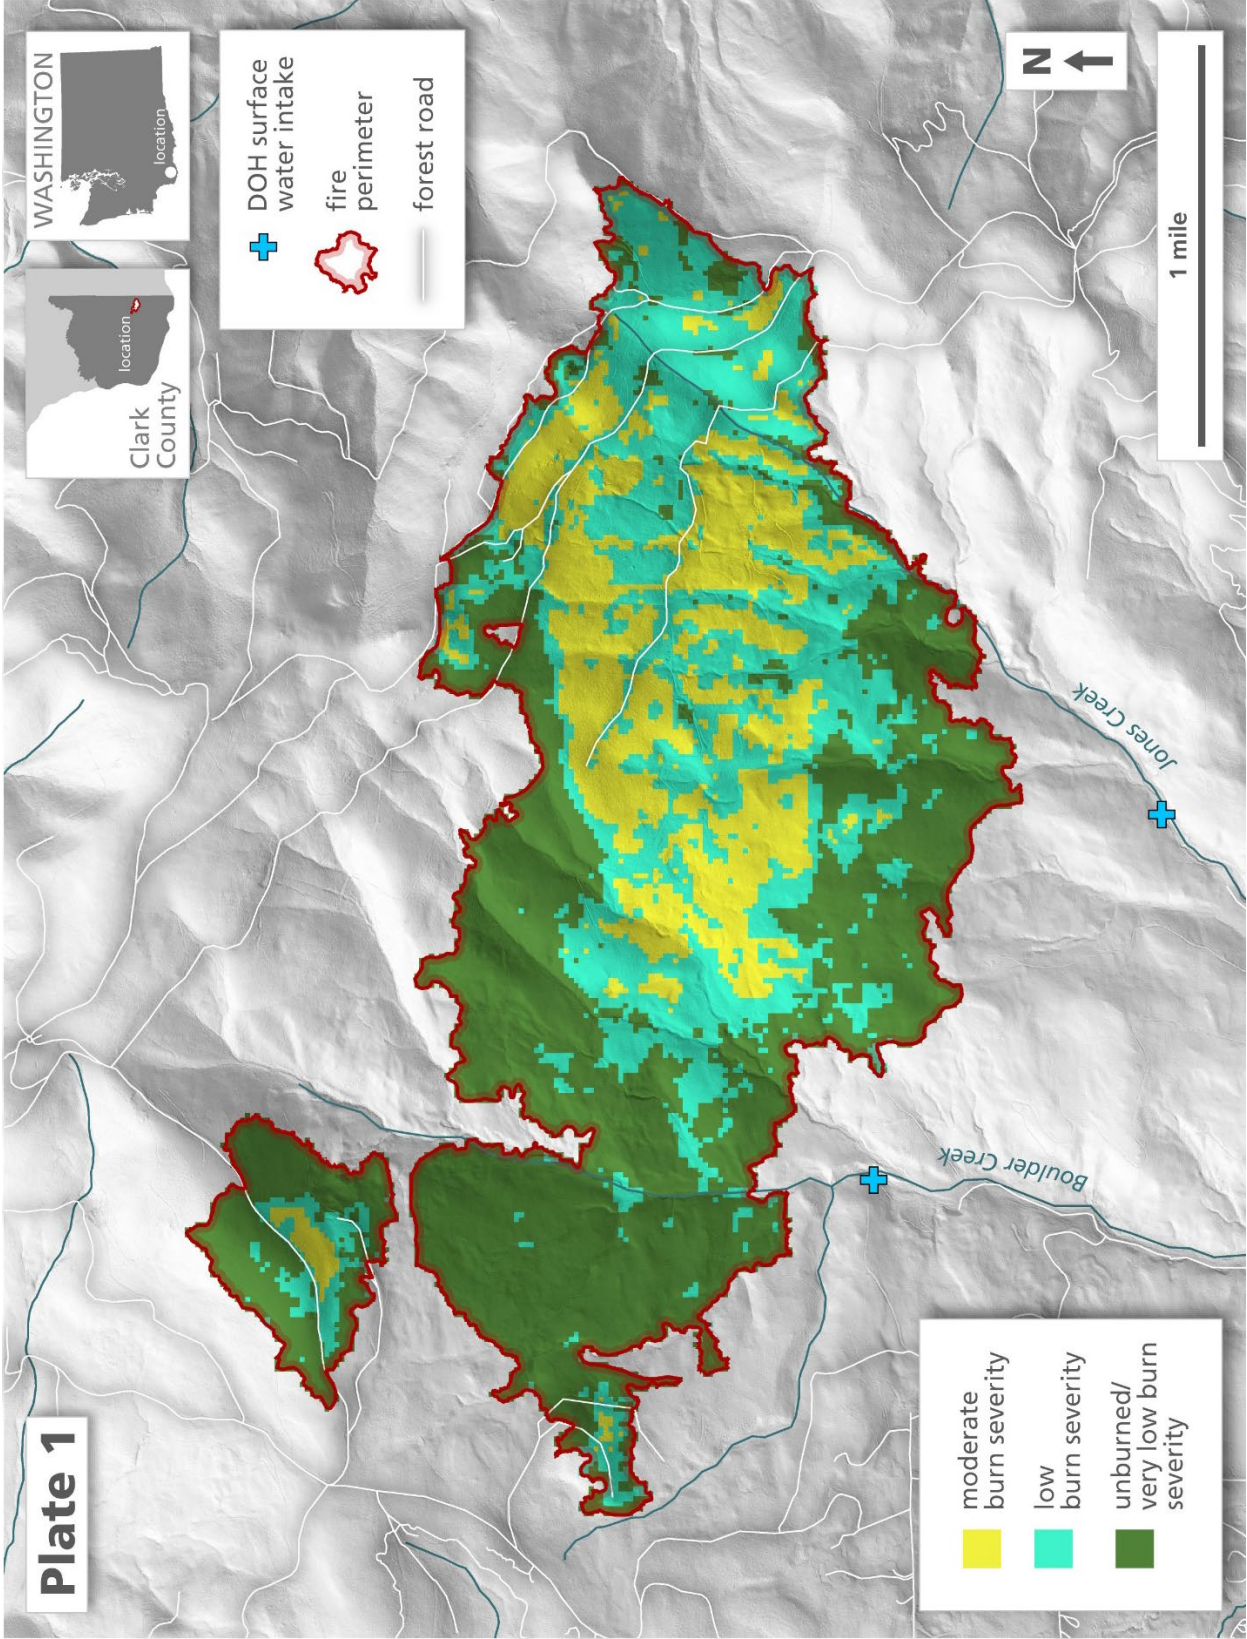
**Plate 1.** Map of Burned Area Reflectance Classification for the Nakia Creek Fire

Burned Area Reflectance Classification (BARC) data were used as a proxy for soil burn severity for this assessment. This is due to the BARC data not being verified by field observations for soil burn severity (Plate 1). The BARC data were generated by WALERT using the *Normalized Burn Ratio Vegetation Mortality Tool* made available on Google Earth Engine by the U.S. Forest Service.<sup>1</sup> In the absence of field observations of soil burn severity, default thresholds were used to remotely estimate soil burn severity (Table 1).

According to the BARC map (Plate 1), 914 acres or 48 percent of the area affected by the Nakia Creek Fire was either unburned or had very low soil burn severity. Approximately 626 acres (32%) experienced low soil burn severity, 378 acres (20%) were moderate in severity, and none of the area was shown to have experience high burn severity. Of note, the areas indicating the highest burn severity values within the fire perimeter are coincident with the slopes along the headwaters of Jones Creek that had been clearcut harvested in the last 20 years. If you need assistance accessing or analyzing the BARC data, please contact us and we can provide support.

Landowners and land managers may choose to take action to prevent excessive soil erosion, reduce flooding, and promote revegetation to meet their management and economic goals. Utilizing the BARC map, a proxy for soil burn severity, as a tool to find areas of moderate burn severity should assist in this evaluation. We are willing to help direct users to this map product, or to provide the data in various formats as needed.

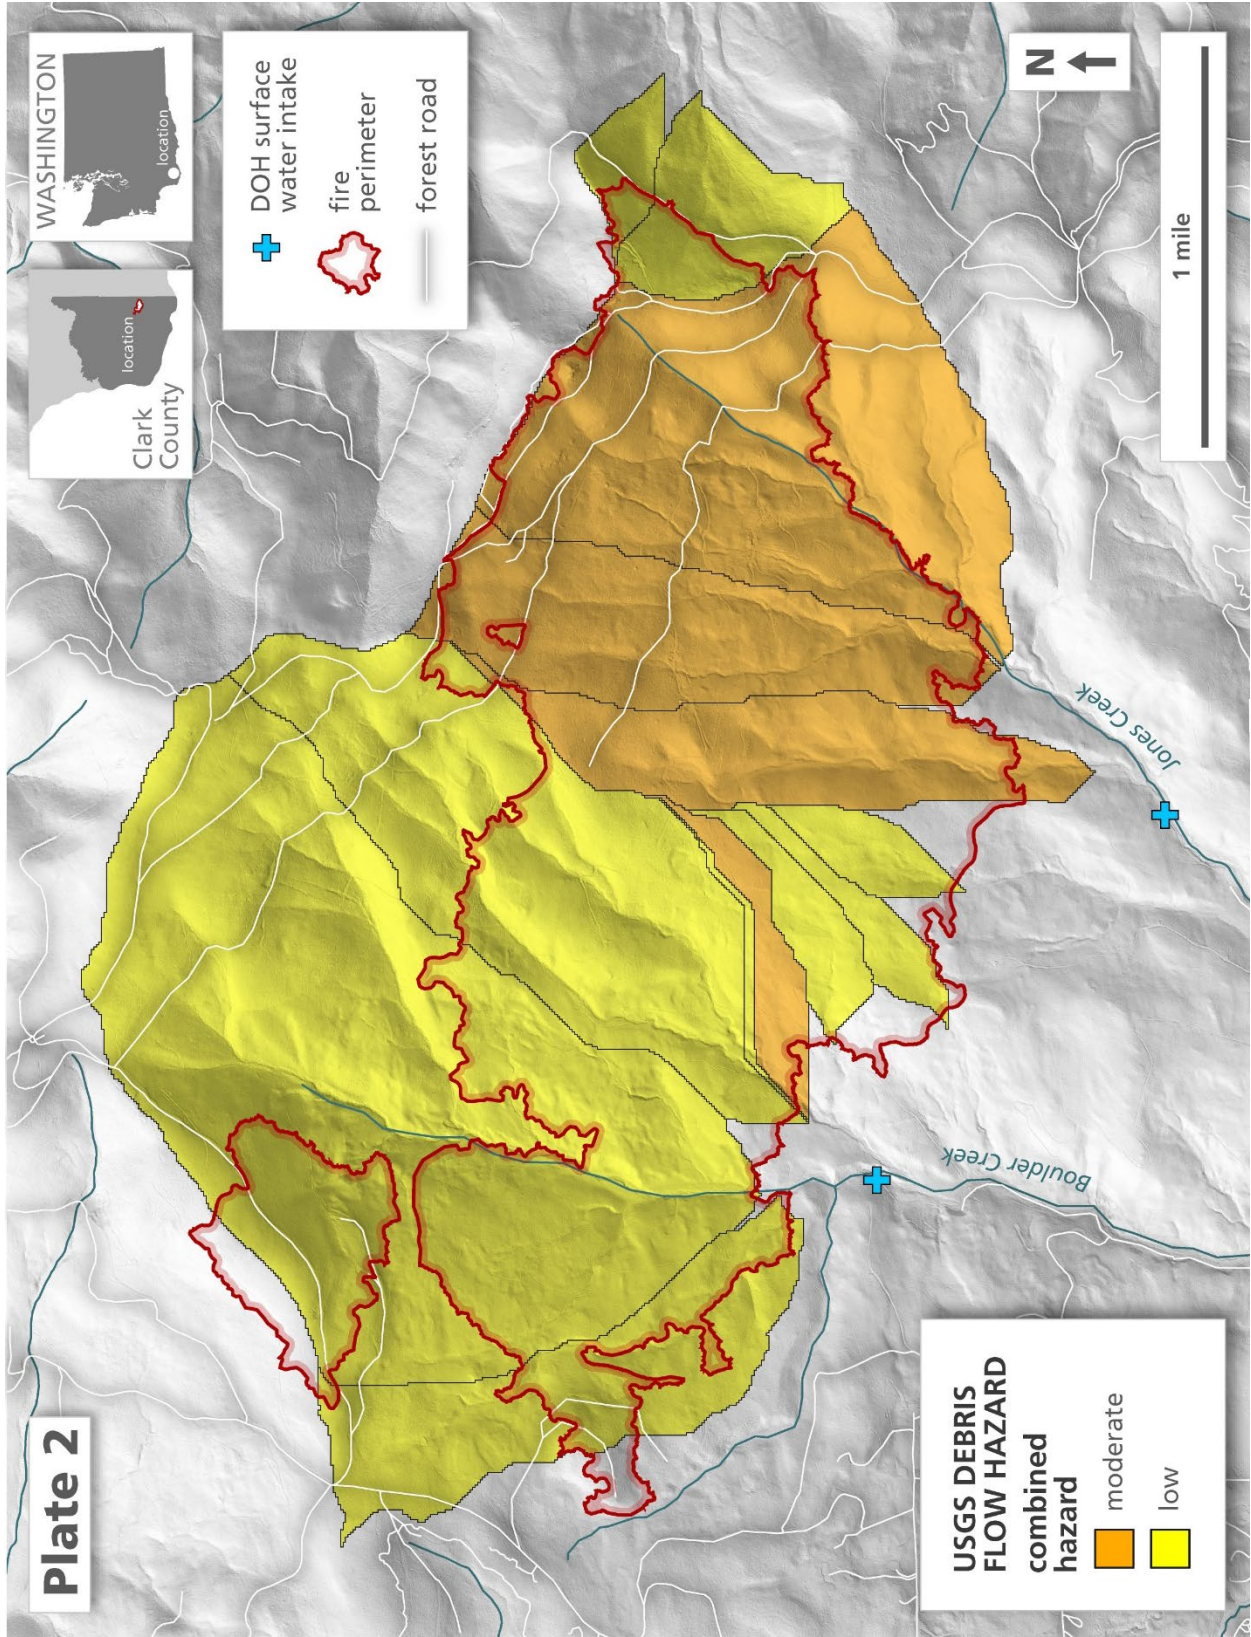
**Plate 2.** Map of Nakia Creek debris flow combined hazard

The USGS provided a debris flow assessment for the Nakia Creek Fire based on the non-field-validated BARC data provided by WALERT (Plate 2). There are various outputs and ways to view the data. Here we will discuss the combined relative debris flow hazard for basins, which uses both probability and volume from the USGS model to provide three different hazard ratings: Low, Moderate, and High. The USGS also models the combined relative debris flow hazard for channel segments within basins using the same hazard ratings. We focus on locations where public safety and infrastructure could be impacted. If you need assistance accessing or analyzing the debris flow assessment data, please contact us and we can provide support.

The USGS modeling suggests that there is Low and Moderate debris flow hazard in drainages throughout the burned area (Plate 2). Remote review of lidar and aerial imagery found little evidence to suggest a history of debris flow events in this area, based on limited channel scour and a lack of alluvial fans or other landforms built by accumulation of sediment deposited by channelized mass wasting events. However, the fire likely impacted the basin's hydrologic response to future storm events. Increased runoff and the potential for flash floods and debris

The Department of Health's (DOH) inventory of surface water intakes identifies two intakes that are owned by the City of Camas within Boulder Creek and Jones Creek downstream of the fire (Plate 2). All but one of the hydrologic basins associated with Boulder Creek and its tributaries were modeled as having a Low debris flow hazard, the one remaining basin has a Moderate hazard. All the hydrologic basins associated with Jones Creek and its tributaries were modeled as having a Moderate debris flow hazard. While debris flow hazards may be modeled as Low and Moderate, flash flooding, debris flows, and increased runoff could impact these surface water intakes during heavy precipitation or rain-on-snow events.

Forest road crossings and recreation trails exist within and downstream of the Nakia Creek Fire. Forest roads have been constructed in the headwaters of both Jones Creek and Boulder Creek (Plate 2). Northeast Boulder Creek Road crosses Boulder Creek roughly 1.5 miles downstream of the fire perimeter (south of the map plates), providing access to residential properties and recreation trails. While debris flow hazards may be modeled as Low and Moderate, flash flooding, debris flows, and increased runoff could impact this infrastructure during heavy precipitation or rain-on-snow events.

Managers of transportation networks, surface water intakes, and private landowners should be reminded of the increased likelihood of sediment transport, sediment deposition, and (or) erosion impacts to roads following wildfires, as well as potential issues with blocked culverts. We further recommend inspecting culverts within channels draining areas impacted by the fires both before and after storm events. Blocked culverts can cause additional flooding and damage, which could otherwise be minimized. For more information on how to stay safe when at risk from debris flows, please consult our Floods After Fire pamphlet and the USGS's fact sheet with safety tips relating to post-fire debris flows (links in the footnote at the bottom of this page).<sup>4</sup>
