Collision Between a Car Operating With
Automated Vehicle Control Systems
and a Tractor-Semitrailer Truck
Near Williston, Florida
May 7, 2016

NTSB/HAR-17/02
PB2017-102600

Highway Accident Report

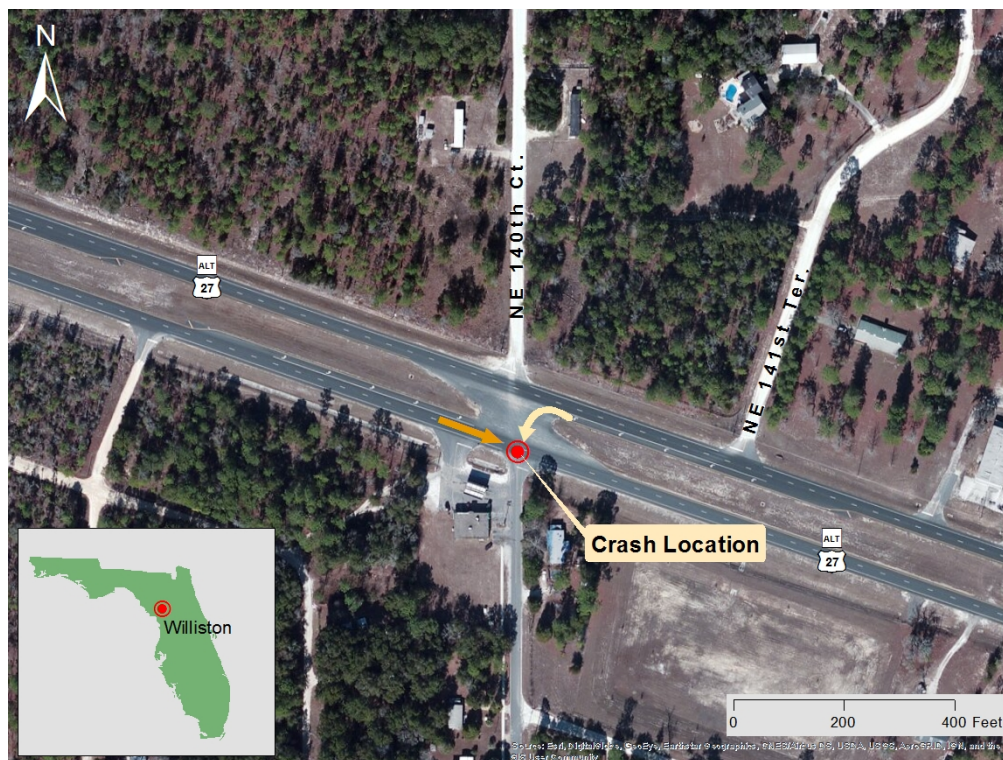
Figure 1. Overhead view of the crash intersection, showing the route of the eastbound car traveling toward the crash location with a straight arrow, and the route of the westbound truck, turning south, with a curved arrow. (Source: Google Earth [modified])

The crash occurred in the righthand eastbound travel lane of US-27A near mile marker 29, approximately 5 miles west of Williston in Levy County, Florida. Figure 1 provides an overhead view of the crash location.

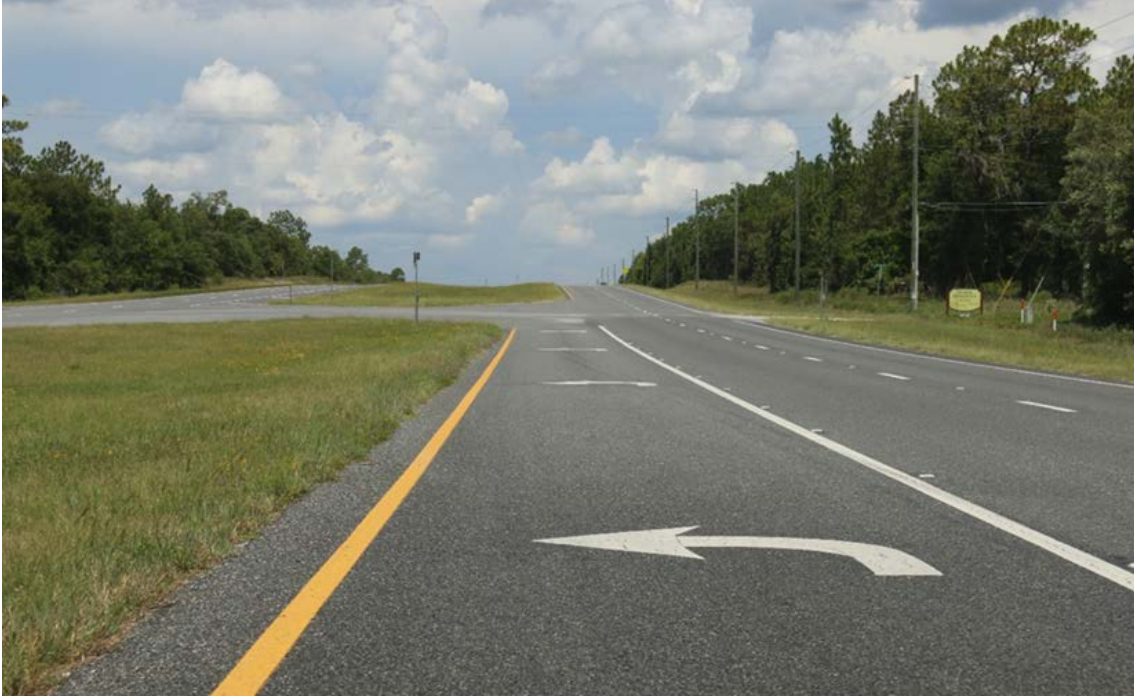
Figure 3. Approach to the crash scene from the US-27A westbound left turn lane, looking west as viewed from the truck's route of travel.

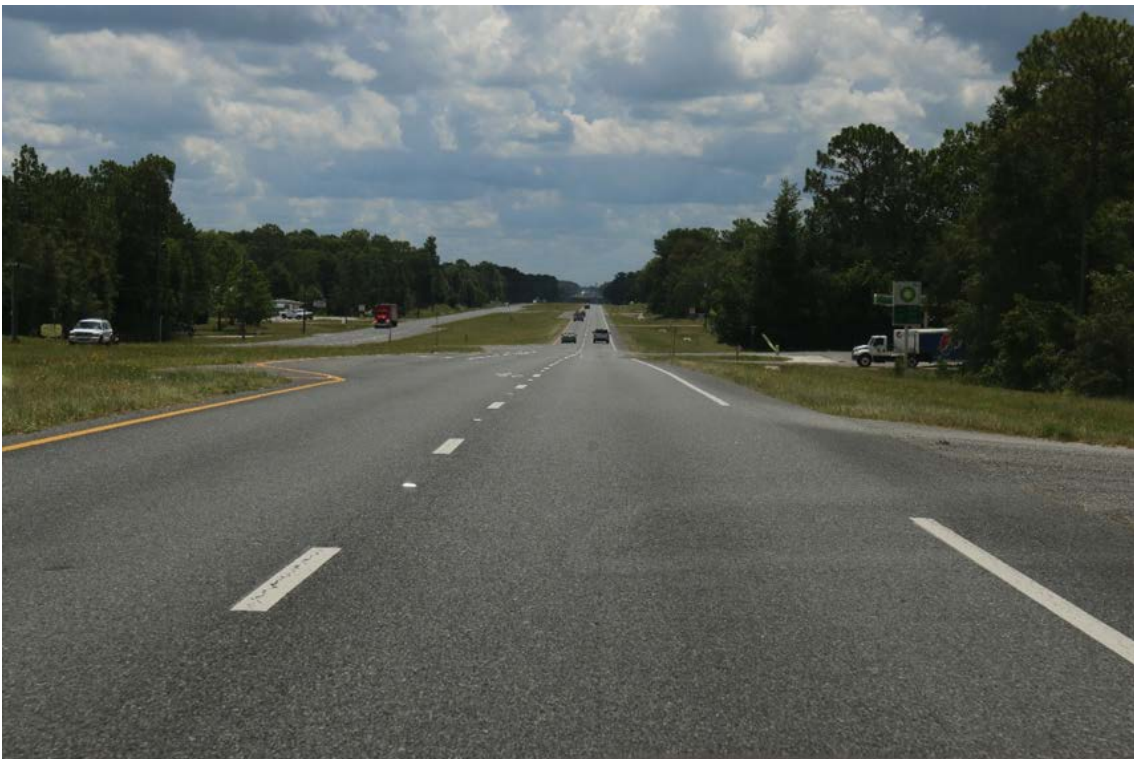
Figure 4. Approach to the crash scene from US-27A eastbound, looking east as viewed from the car's route in the righthand travel lane. (Based on the known length of the left turn lane, the distance to the intersection in this view is approximately 750 feet.)

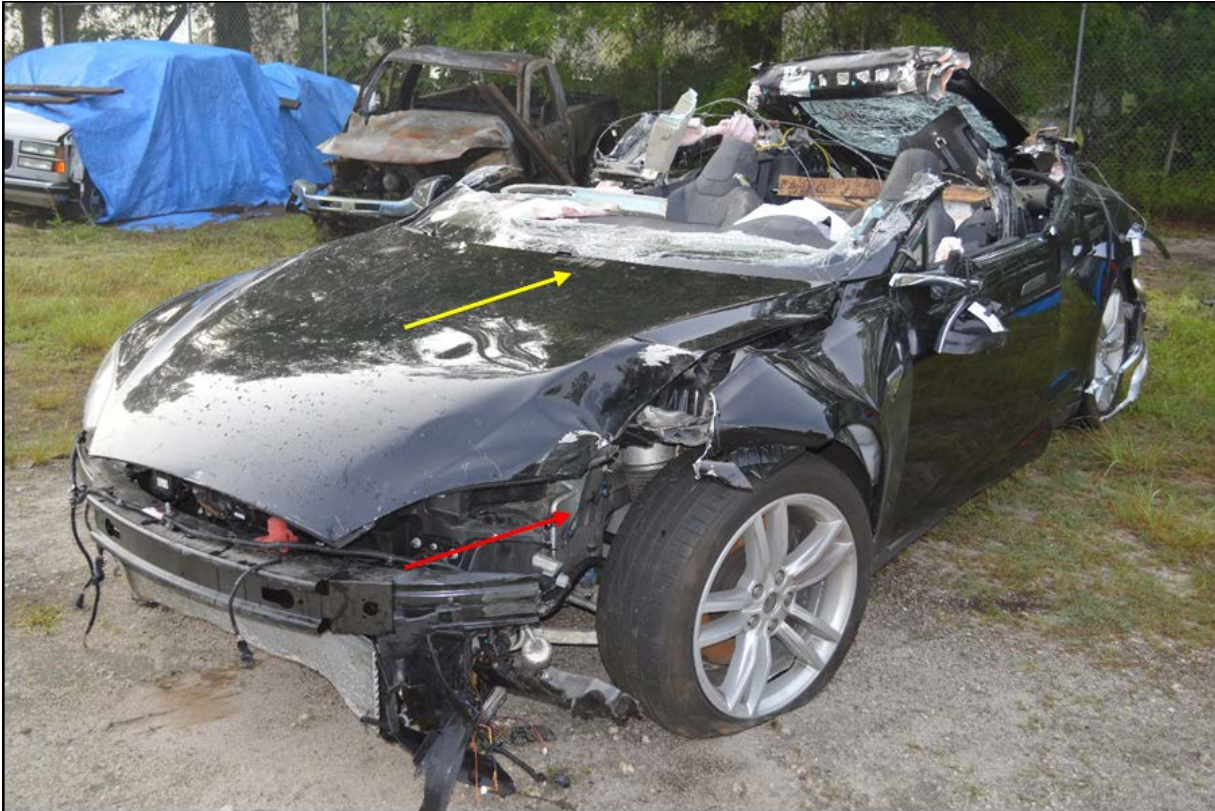
Damage to the car, as shown in figure 5, included separation of the roof panel, which exhibited fore-to-aft accordion-like compression. The forward-facing surfaces of the car's A-pillars were separated and deformed just below where the roof met the pillars. Additional impact evidence consisted of scrapes to the trailing edge of the hood just forward of the windshield. The scrapes were about 5 inches long and were located on the driver's side of the hood, about 5 inches from its longitudinal centerline (see figure 5, yellow arrow). The scrape widths were consistent with the length of the semitrailer's center side-marker lamp, which had been mounted below the side rail on the right side of the semitrailer. The static height of the trailing end of the hood was about 3 feet. Postcollision measurements indicated that the car's seatback headrests were at least 3.5 inches taller than the bottom edge of the semitrailer. The driver and front passenger seats were deformed rearward.

The damage to the car from the impact with the utility pole was centered 12.4 inches inboard of the left side in front of the wheel well. The impact of the front of the car with the utility pole displaced the left front fender and chassis structures (see figure 5, red arrow). Postcrash, the left (driver's) side wheelbase measured about 4 inches shorter than the right side. The battery pack of the electric car, located aft of the front axle, was not damaged.

Figure 5. Damaged car. Scrapes from the semitrailer's center side-marker lamp are indicated by the yellow arrow. Impact damage associated with the utility pole is indicated by the red arrow. (Source: Florida Highway Patrol)

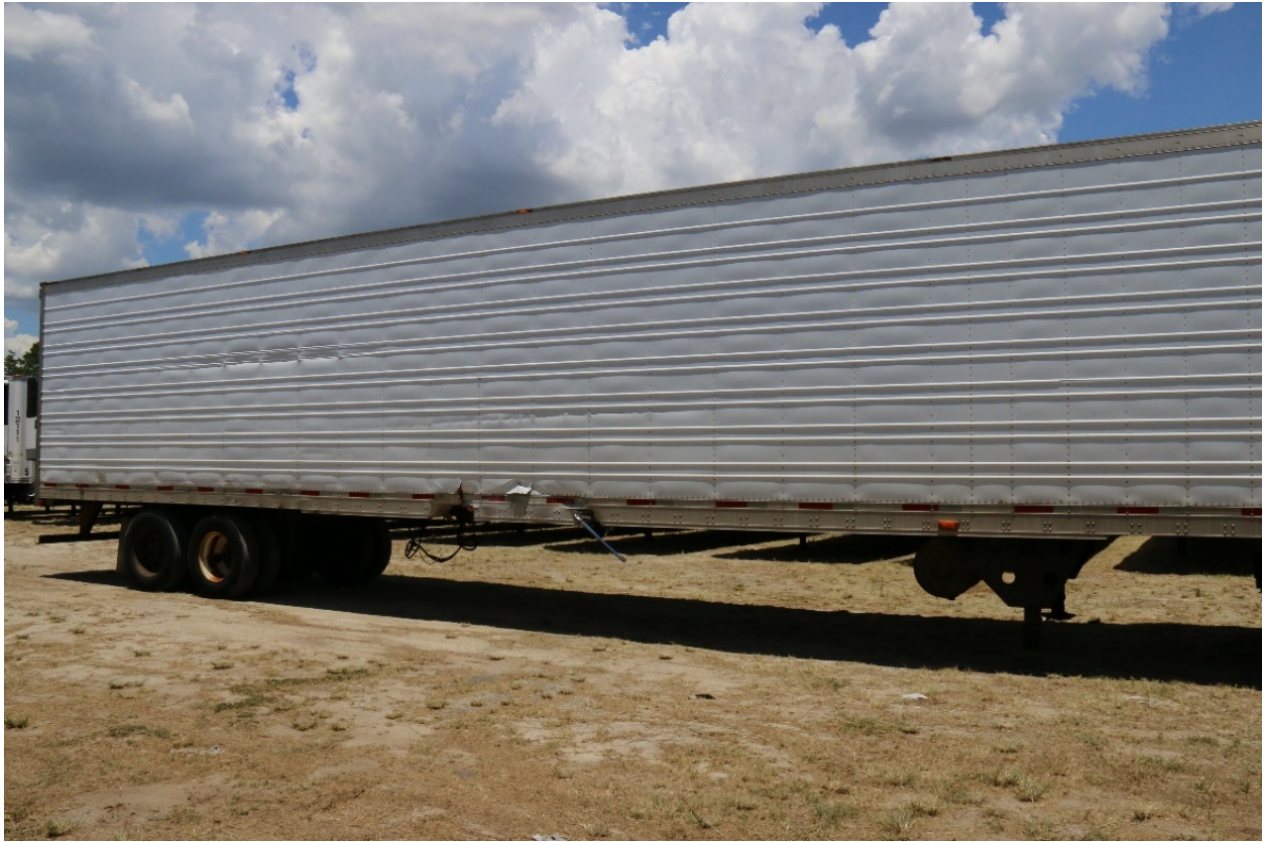
Investigators examined the involved semitrailer, which was a 2003 Utility VS2RA 3000R refrigerated van-body trailer. The investigators' comparison of the semitrailer with the photographs the FHP took at the crash scene showed that the external condition and appearance of the semitrailer had not changed since the crash. Collision evidence consisted of minor impact damage to the lower sidewall rails on both sides of the semitrailer and the undercarriage between the opposing damaged rails. Damage to the passenger (right) side exhibited inward intrusion, while damage on the driver (left) side exhibited outward deformation. The damage on both sides exhibited two distinct areas of contact. The undercarriage damage consisted of a displaced transverse floor support rail between the damaged areas on the two sides.⁶ A segment of windshield

trim from the car was found entangled within the forward-most area of contact damage on the semitrailer. Figure 6 shows a postcrash photograph of the semitrailer, and figure 7 focuses on the damage to the semitrailer.

Figure 6. Damaged right side of the Utility semitrailer.

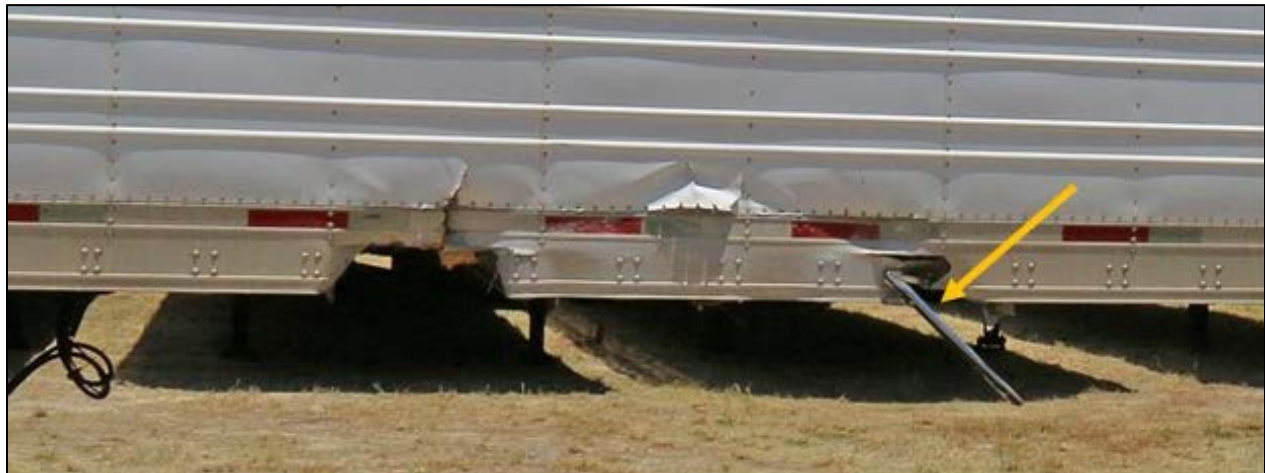
Figure 7. Closeup view of impact damage to the right side of the Utility semitrailer. The arrow indicates a segment of front windshield trim from the Tesla entangled in the forward-most area of damage.

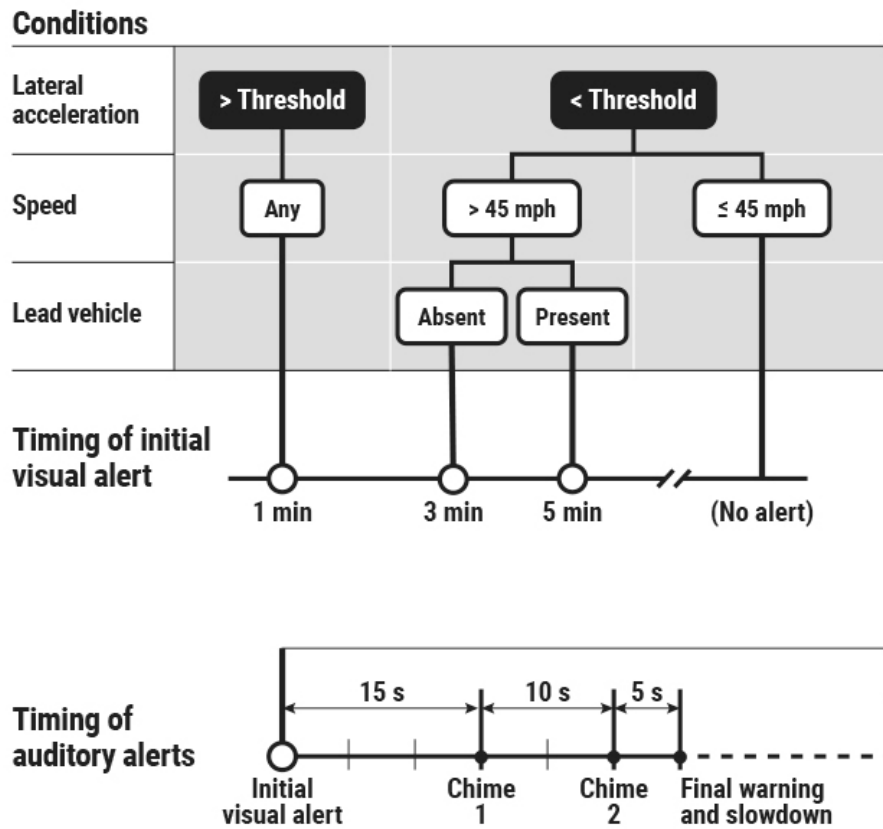
Figure 9. Autopilot system alert timing; top portion of figure provides timing of initial visual alert and bottom portion provides timing of auditory alerts. Following a visual alert, if the driver does not interact with the steering wheel, the Autopilot system proceeds to the auditory alert sequence as shown in the bottom portion of the figure (Tesla firmware version 7.1).

On the crash-involved car, the timing for the initial visual warning ranged from 1 to 5 minutes when traveling above 45 mph, depending on the system conditions. However, when traveling 45 mph and below, the warning for hands-off driving would not occur, unless the car exceeded the lateral acceleration threshold, such as when traveling on certain curves. When traveling above 45 mph, the initial warning would occur earlier when another vehicle was not detected ahead of the Tesla—and later when following another vehicle. The timing of the visual warning did not depend on the type of roadway being traveled. (See figure 9 for a graphic indicating the warning conditions and alert timing sequences for the Autopilot system firmware that was running on the Tesla at the time of the crash [firmware version 7.1].)

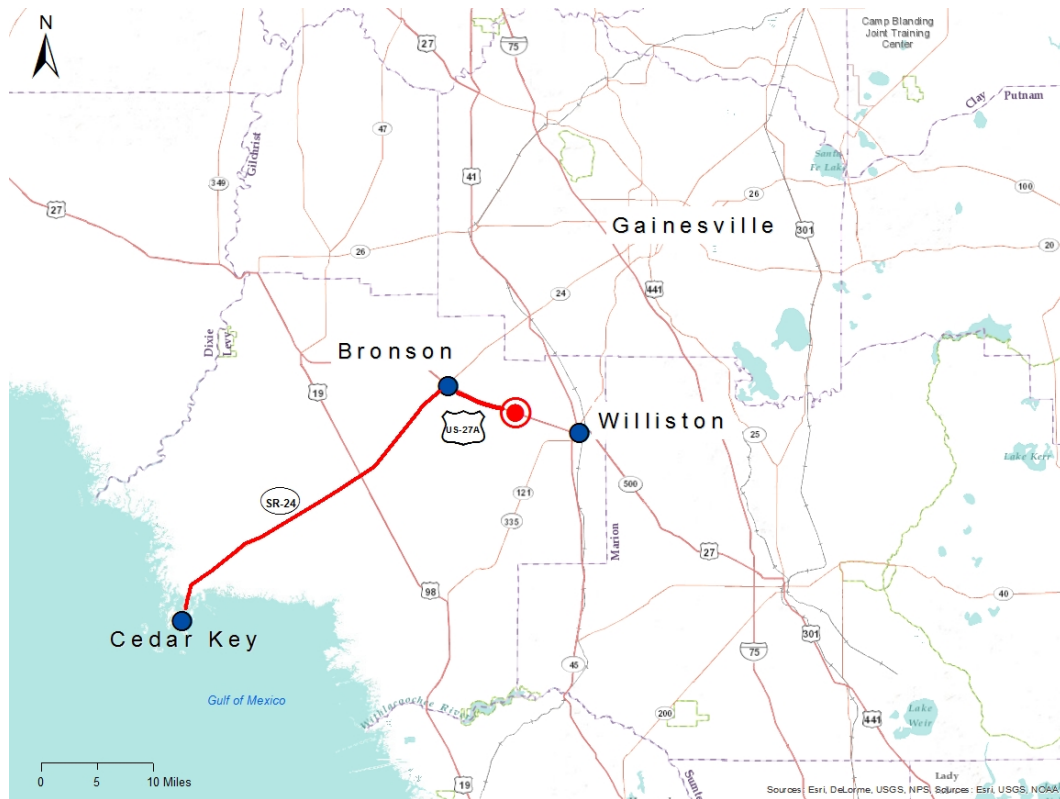
Figure 10. Route of the Williston car driver's final trip.

On the day of the crash, the Tesla driver was traveling from Cedar Key toward Ocala, Florida. (See figure 10 for route information.) He traveled along State Road 24 (SR-24) before turning eastbound onto US-27A, where the crash occurred.¹⁴ SR-24 is a two-lane roadway without a center divider, and it is not a limited-access roadway.¹⁵ Because it lacks a center divider, the Tesla’s automation system considered SR-24 a “non-preferred” roadway for the use of Autopilot. The system allowed the Tesla to travel 5 mph above the speed limit while on SR-24; the speed limit on SR-24 is 60 mph. The roadway on which the crash occurred, US-27A, is a four-lane road with an earthen center median, but it is not a limited-access roadway.¹⁶

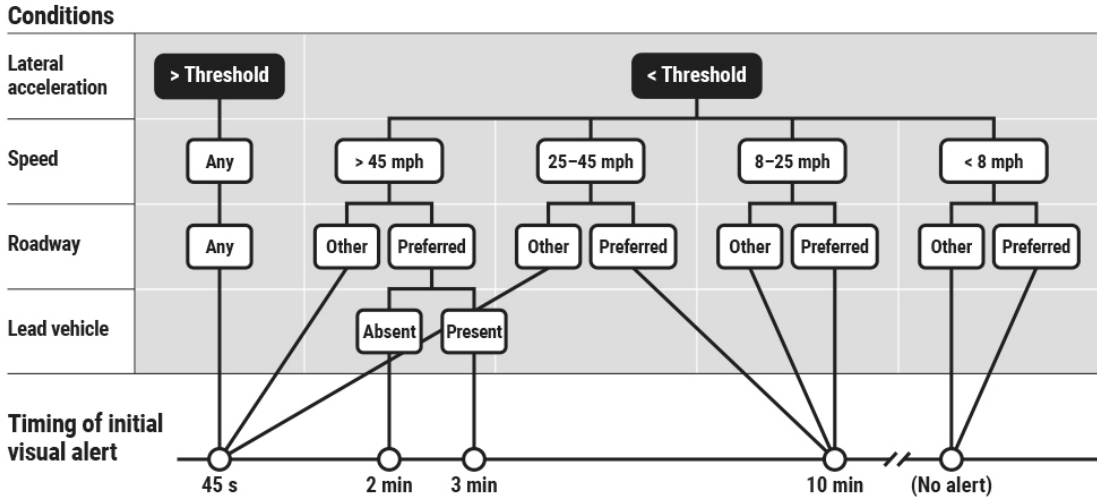
Figure C-1. Autopilot system alert timing sequence for version 8.

Since the crash, Tesla has implemented several changes to the Autopilot system, including reducing the allowed driver hands-off time. In addition, the timing of the initial visual warning is now dependent on the type of road and the speed at which the vehicle is traveling.
