NEW YORK CITY
HOUSING
AUTHORITY

2023

PNA TECHNICAL REPORT
**PHYSICAL NEEDS
ASSESSMENT**

Prepared By: NYCHA PNA 2023 JV
STV | AECOM
New York, NY 10003

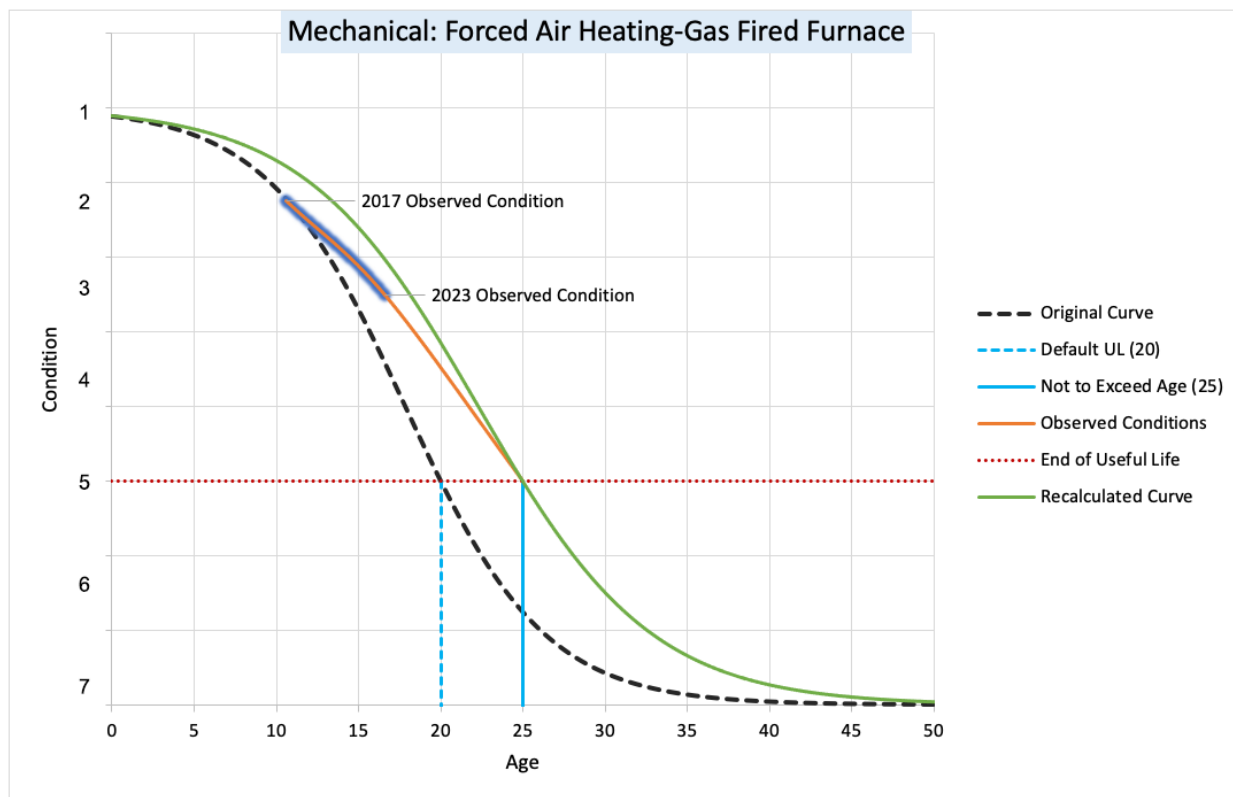
Figure 11 Example Deterioration Curve

The figure below is an example of how the 2017 and 2023 condition rating was used to refine the deterioration curve for a gas fired forced air heater. The original expected life was 20 years (shown when the condition rating reaches 5) based on the 2017 observed condition. When the unit was inspected in 2023, the furnace had not deteriorated as much as anticipated. Using the 2023 observed condition and a maximum not to exceed life of 25 years, a new deterioration curve (green) was calculated. Note that the graph includes ratings of six (6) and seven (7) while rating score above does not list these. There are several reasons for the additional scores. The additional ratings provide prioritization / scoring to assets which are past their useful life. Since assets with a rating of Poor (5) may continue to operate but will continue to deteriorate. This allows better deterioration into the future and prioritize spending across many assets with the "same" condition score.

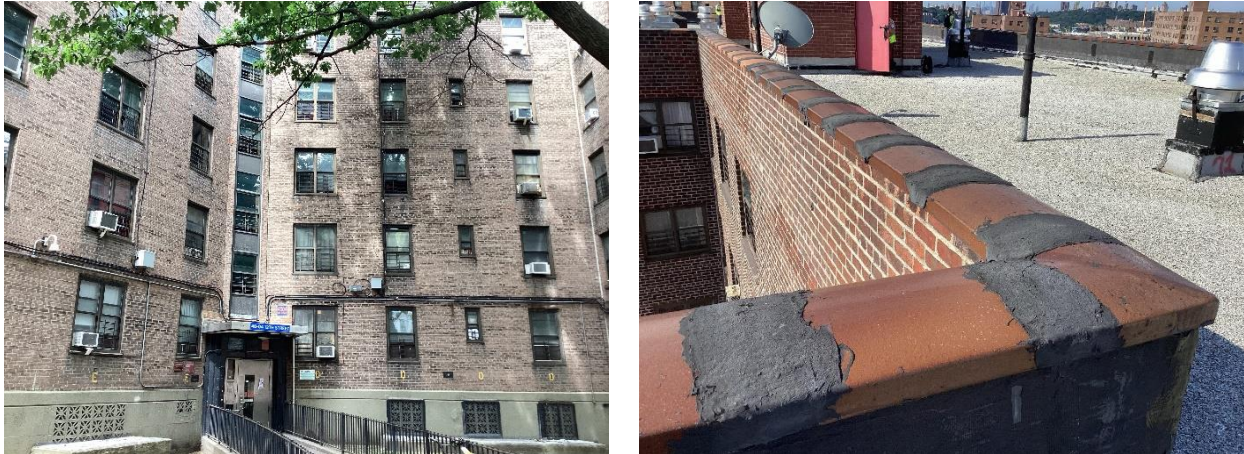
Figure 20 Typical Building Exterior (*left*), Parapet and Roof (*right*)

A key area of concern that was observed during the architectural inspections was damaged or missing child guard and AC brackets. Most building are in fair condition, with some buildings needing maintenance on the exterior walls and windows.

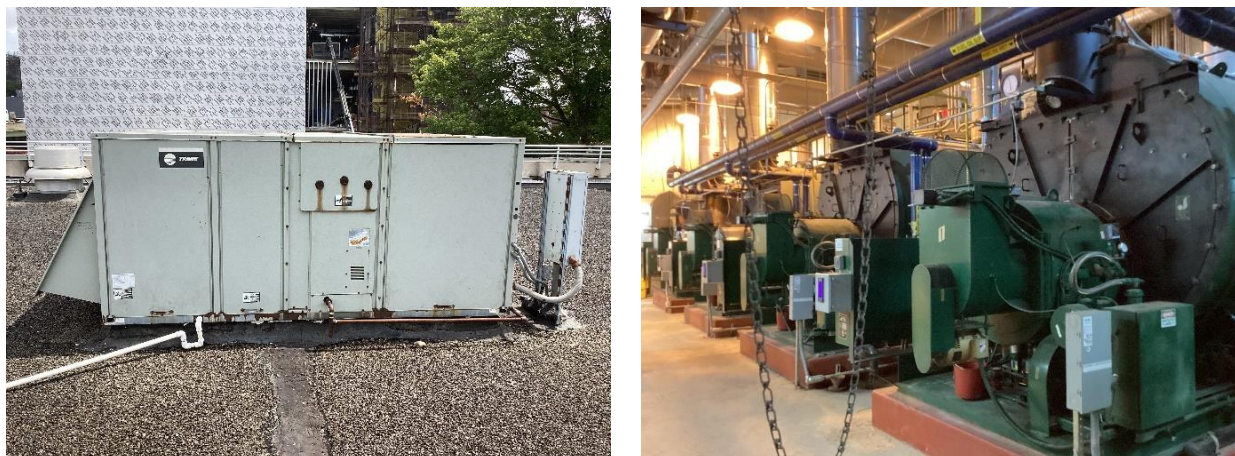
Figure 32 Typical Packaged Roof Top Unit (*left*) and Steam Boiler (*right*)

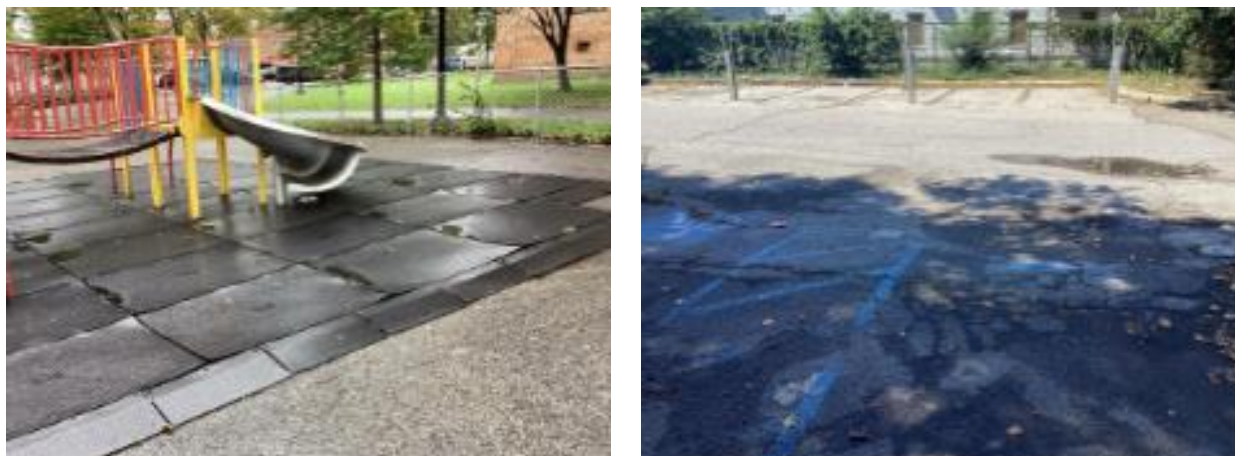
Figure 35 Playground Area (*left*) and Parking Lot (*right*)

The key areas of concern for site-architectural were parking areas, non-vehicular paved areas, sidewalks, curbs, playground safety matting, and fences. The most common observed deficiencies were asphalt cracks, concrete cracks and damaged fences. The deterioration of the items was due to normal use and the condition rating deteriorated as expected from the 2017 PNA to the 2023 PNA.

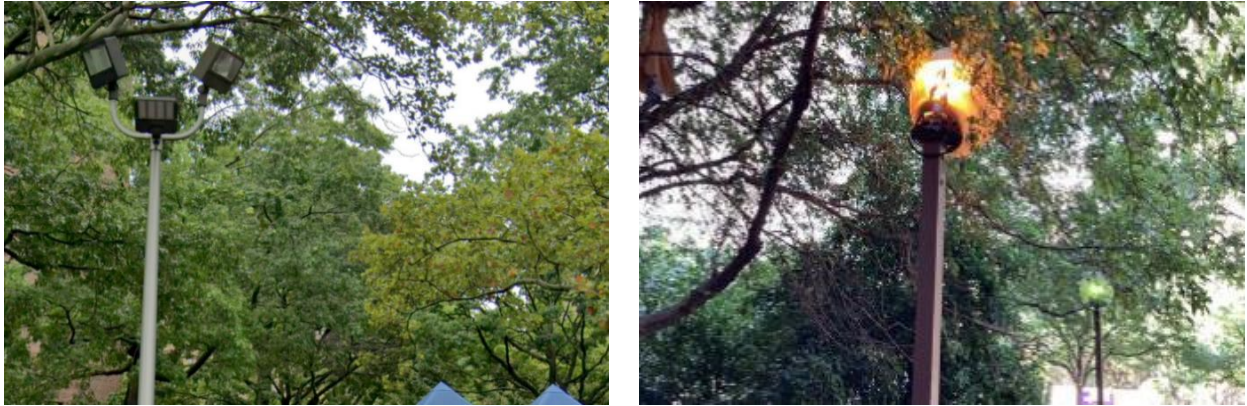
Figure 38 Typical Site Lighting

The site lighting varied from good (recently upgraded) to poor (non-functional). Many developments have had new area lighting installed. For the developments that have not been upgraded, some of the common deficiencies are time clock not operational, photocell not functional, and antique or obsolete lighting. For the lights that were not upgraded, the condition rating deteriorated as expected from the 2017 PNA to the 2023 PNA.

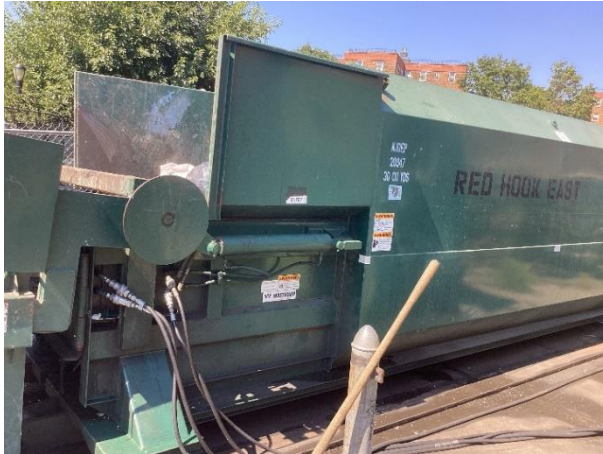
Figure 41 Typical Exterior Compactor

Most site-mechanical systems were in fair condition, with a key area of concern being defective steam piping and condensate return piping. Some developments had steam and steam condensate lines upgraded while other developments had active construction projects to replace the steam and steam condensate piping. Some developments had catch basins and fire hydrants with deficiencies. The most common upgrade was exterior compactors. Most items had very minor change in condition rating from the 2017 PNA to the 2023 PNA.

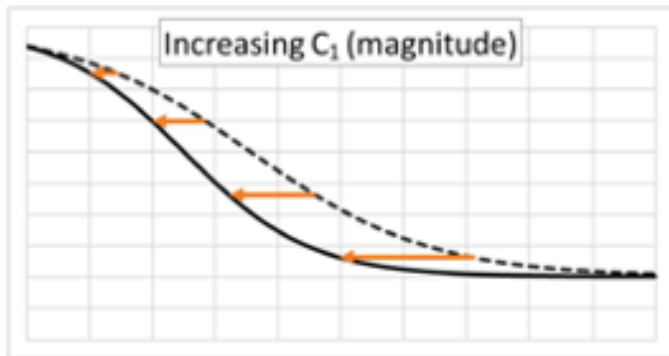
Figure 47 Increasing C_1 Changes the Slope of the Deterioration Curve

C_1 is an x-scalar parameter. Changes to this value affect how quickly an asset progresses through the curve as it ages. Negative values indicate the curve progresses from high to low; positive values indicate the curve progresses from low to high. Increasing the magnitude (away from zero) shrinks the curve.

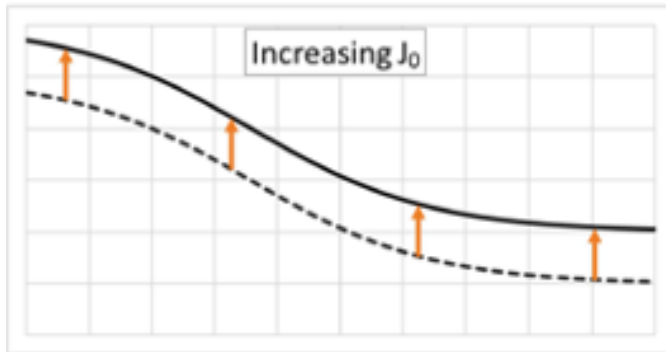
Figure 49 Increasing J_0 Shifts the Deterioration Curve Up

J_0 is a y-translational parameter. This represents the minimum value that the asset asymptotically approaches, either as it ages (when C_1 is negative) or near the beginning of its life (when C_1 is positive).
