FACILITIES ASSESSMENT REPORT

2019

CHAPTER ONE – PARK AND FACILITY ASSESSMENTS

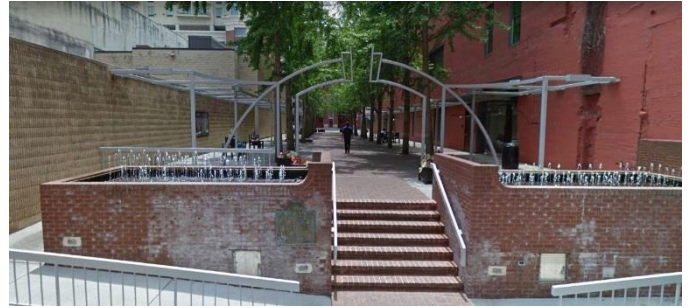
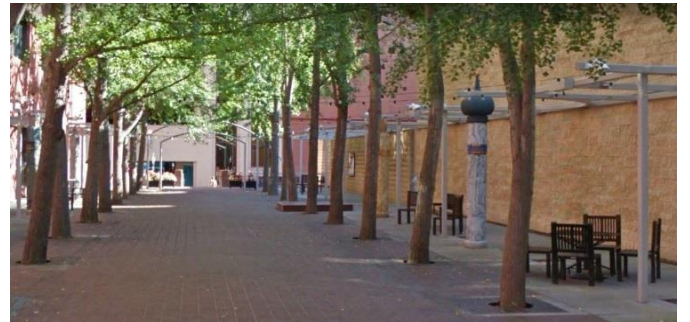
Century Plaza is a brick-paved pedestrian alley that connects Church and Kirk Avenues, between Market Street and Jefferson Street in downtown Roanoke. It features closely spaced trees, shrubs, and benches. The plaza is in overall good condition except there is discoloration on the brick walls of the fountain. The plaza is ADA accessible. The City should consider developing a master plan for this plaza in order to create a more engaging space for downtown employees and visitors.

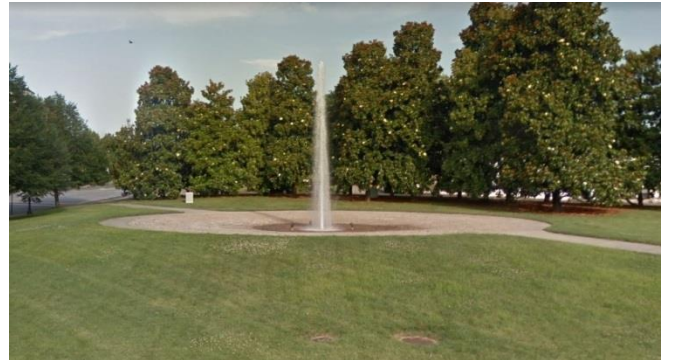
**Entranceway Park**

Entranceway Park is a lawn area containing a large fountain located in downtown Roanoke at the intersections of Williamson Road, Wells Avenue, and Commonwealth Avenue. The fountain area, walkways, and lawn are all in good condition, and the walkway leading to the fountain is ADA accessible. The park should have a master plan created to become more functional as a park.

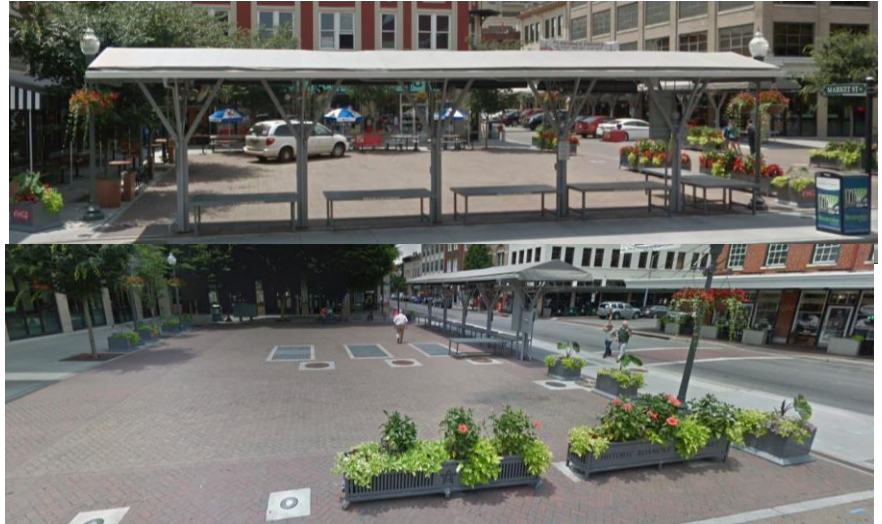
Market Square Park consist of two small brick-paved plazas, one on either side of Market Street, at the intersection of Market Street and Campbell Avenue in downtown Roanoke. The plazas are surrounded by shops, cafes and businesses, and are used regularly throughout the year for farmer's markets. There are two long shelters, one at each plaza,

with tables under them for use by vendors. The plaza is in good condition overall, and the entire plaza is ADA accessible. This park lacks the standard colors and visual branding typical of Roanoke parks. City should update the amenities, signage, and color palette to the Parks and Recreation standards.

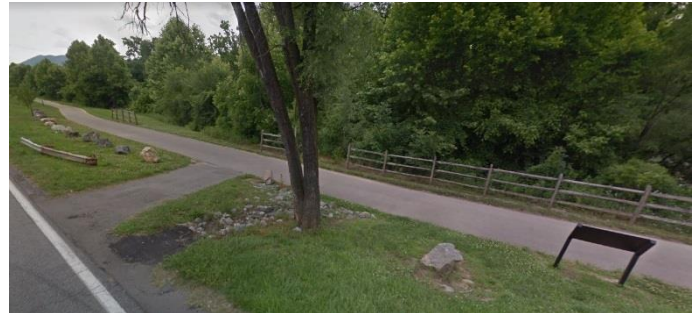
- Old rusty section of guardrail by the access path

- Remove the guardrail section.
- Develop a standard for trail bench locations
- Incorporate into the Roanoke River Greenway system.

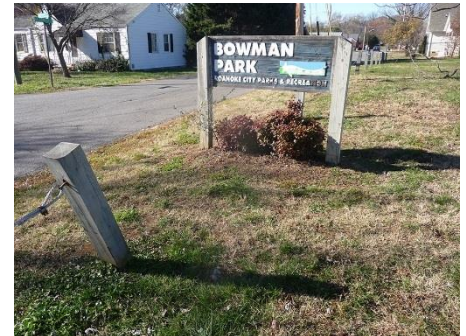
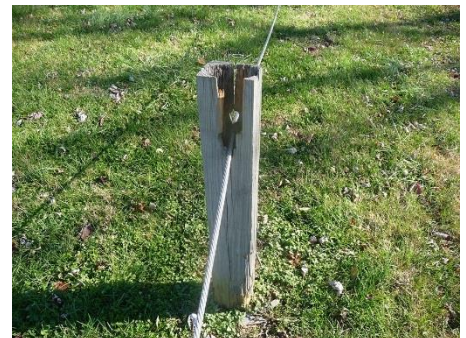
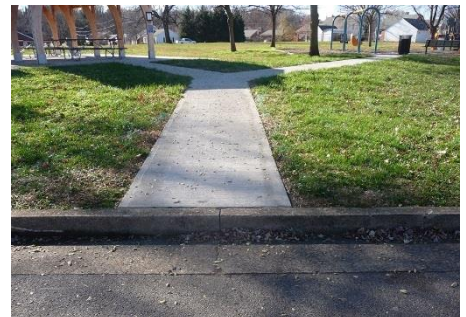
Bowman Park is located on Hillcrest Avenue, just east of Bowman Street within a large residential area in northwest Roanoke. It receives heavy use by young children. Most of the park space consists of an open mowed field that is not graded for organized sports. The park may benefit from adding an ADA accessible loop path with exercise equipment and planting more trees throughout the field and along the loop path for increased shade and visual appeal.

- Replace timber edging around playground
- Install ADA ramp into playground and some accessible pieces of play equipment
- Replace bollard posts around the park
- Install ADA curb ramp at the walkway leading into the park
- Construct an ADA accessible loop path around the open field. Plant trees throughout the field and along the path
- Add benches along the trail

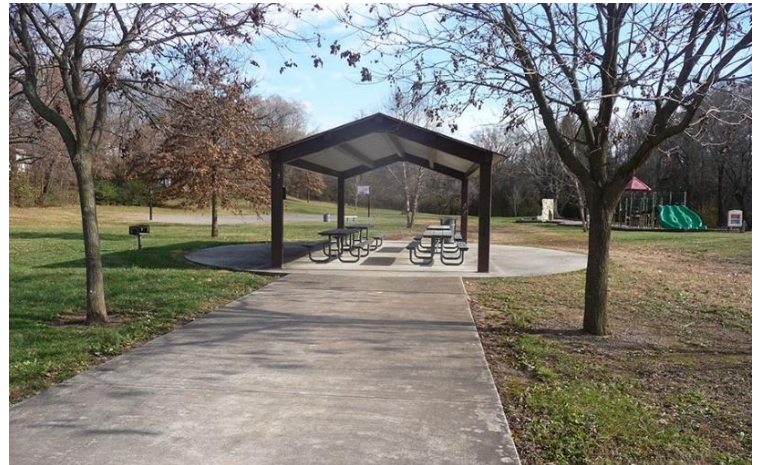
- There are no ADA walkways to park amenities
- While there is an ADA ramp leading into the playground, there is no walkway leading to it, and there are no accessible pieces of play equipment

Key deficiencies needing attention:

- Cracks in pavement of basketball court
- Large bare dirt area from the back of the park to the picnic shelter.
- No parking within the park and all park amenities are far back from the road.
- Park circulation and amenity locations are poorly designed

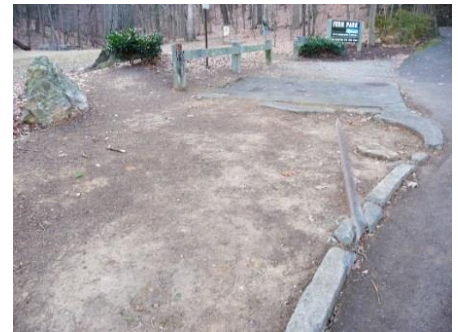
- There are no walkways within the park
- Playground is not ADA compliant. There is no walkway leading to it and there are no accessible pieces of play equipment.

- Park entrance in poor condition. Broken concrete pad and curb, wood posts are broken and rotting
- Bare dirt areas and erosion in front of trailhead and around playground
- Graffiti on playground equipment

- Enhance park entrance area. Repair or replace concrete pad and curb, replace wood posts
- Address erosion and reseed bare areas at trailhead and playground
- Clean graffiti off play equipment
- Construct an ADA accessible path to playground area

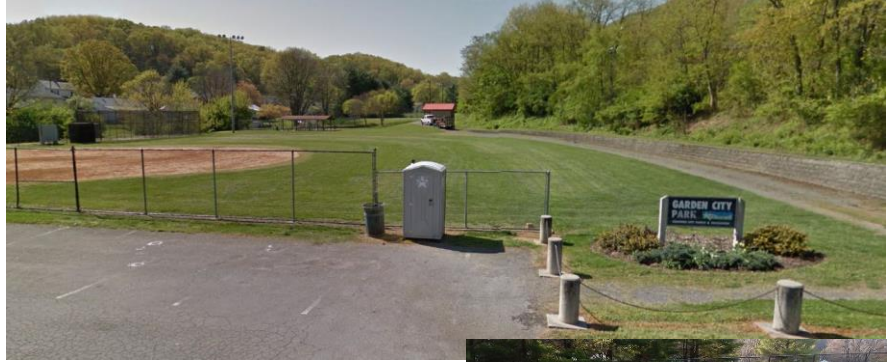
Garden City Park is an older neighborhood park located off Hillview Avenue just behind Garden City Elementary School. It has a softball field and playground that get a fair amount of use and a tennis court that is in very poor condition and doesn't get used at all.

- The paved walkway to the restroom and tennis courts is too steep to be compliant
- There is a step at the restroom concrete pad that compromises accessibility and presents a trip hazard
- Playground does not have any accessible pieces of play equipment.

Key deficiencies needing attention:

- Lawn drains onto softball field
- Picnic shelter very old and in poor condition
- Playground very old and in bad condition. Metal floor is broken and rusted making it unsafe for use.
- Tennis court very old and in poor condition; doesn't get used
- Multi-use field at back of park is very far from parking and not ADA accessible

Priority Recommendations

- Construct a drainage channel to keep water from draining from lawn onto softball field
- Replace picnic shelter
- Replace playground equipment
- Consider removing tennis court and repurposing that space
- Reroute path at restroom to be ADA compliant
- Install an ADA ramp into playground area
- Eliminate concrete step in front of restroom
- Extend paved pathway to multi-use field

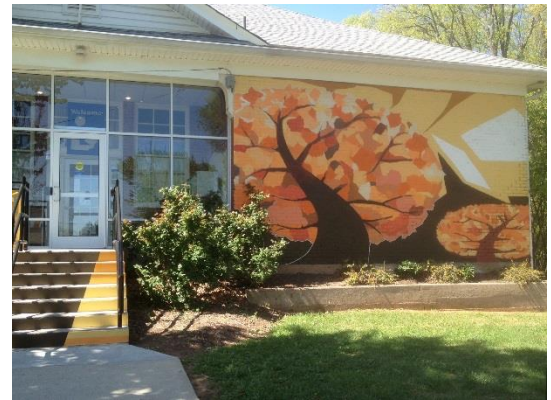
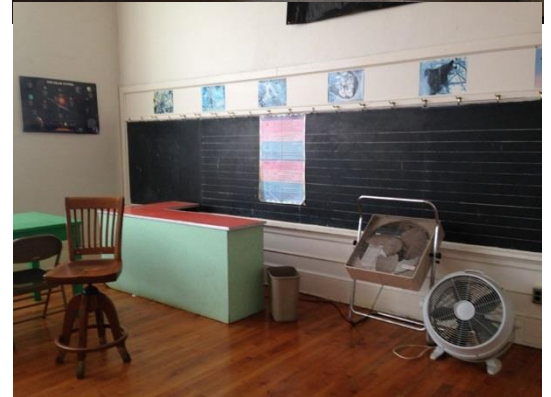
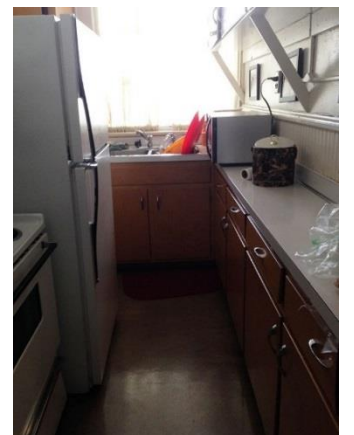
- Metal railing at the front door needs to be replaced
- Exterior and interior lighting is outdated and inadequate
- HVAC system is old and needs repair or replacement
- Kitchen is small and may need to be expanded for future use
- Cluttered and cramped in some areas due to personal items stored throughout the building
- Facility is not conducive to the needs of a modern community recreation center

- Replace metal railing at front door
- Replace exterior and interior lighting to meet modern standards
- Repair or replace HVAC system or components to meet facility needs

- Consider expanding kitchen to meet potential future needs
- Remove personal items to make additional space for increased uses
- City should revise the mission for the facility and renovate accordingly (consider an artisan center)
- Consider adding space for active recreation, amenities such as a small gym or multipurpose room larger than the current one.

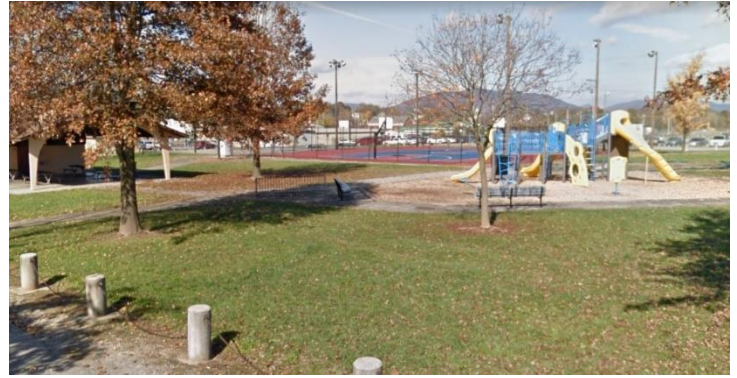
Golden Park is located in southeast Roanoke off Carlisle Avenue and Spruce Street. It is bordered by houses on one side and industrial use on the other three sides. The local neighborhood doesn't use the park very much, but people come from other areas on weekends to have cookouts and play soccer. The two old tennis courts were repurposed to new basketball courts which now get used, but the old basketball court does not get used and is in poor condition.

Key deficiencies needing attention:

- Old basketball court is in poor condition and doesn't get used
- Some of the walkways are in poor condition with large cracks, unevenness and grass growing through

Priority Recommendations:

- Confirm lack of use and remove old basketball court and return space to open park space
- Repair or repave walkways
- Install ADA ramp at playground
- Continue the Roanoke River Greenway trail through the park and remove bollards

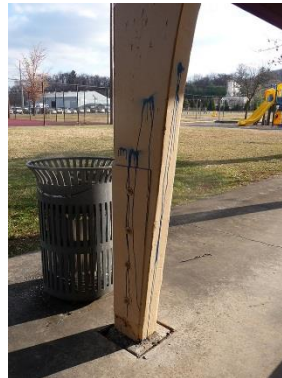
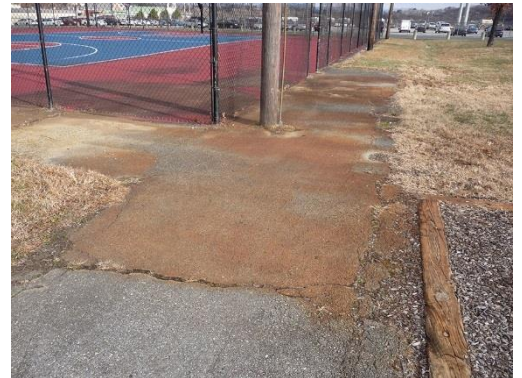
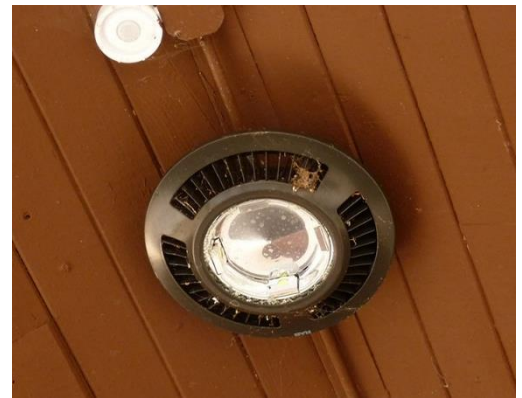
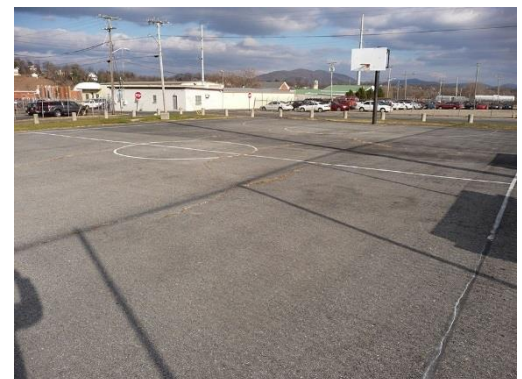
ADA issues:

- Playground is not ADA compliant because there is too much drop at the edge to the mulch surface.

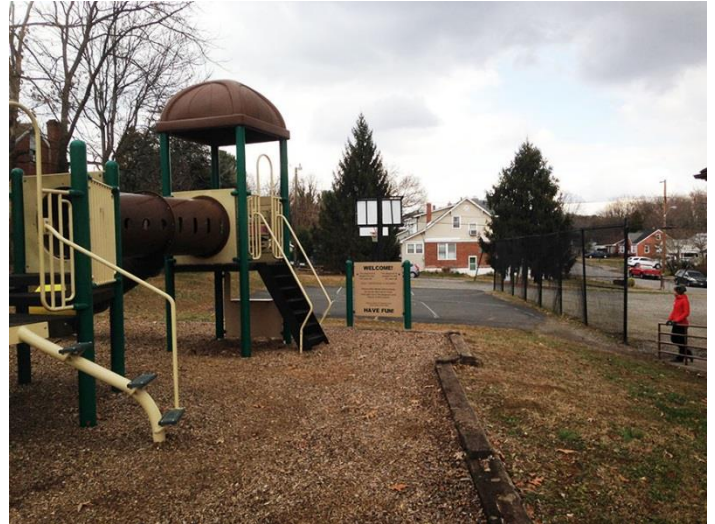
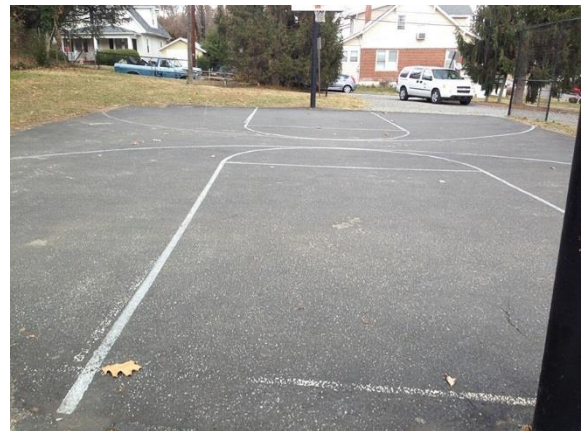
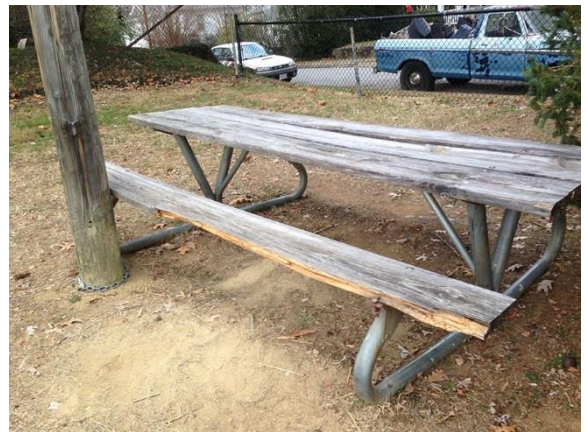
Key deficiencies needing attention:

- Basketball courts are in poor condition. Pavement is rough, has cracks, and there is discoloration
- Neighboring house to the north of the park is very close to the park and there is inadequate vegetative screening

Priority Recommendations:

- Rehabilitate basketball court to the City standard
- Provide a privacy hedge or vegetative screen between park and adjacent house
- Pave the ADA parking spaces and construct a paved walkway to the basketball court and playground
- Address drainage issues in parking area and surrounding the basketball court

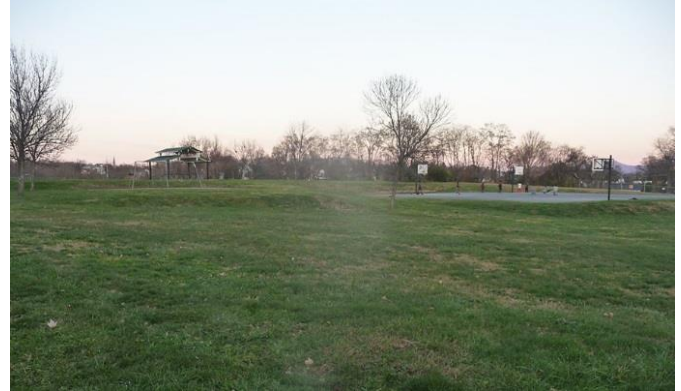
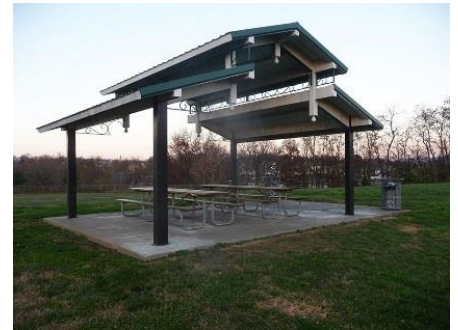
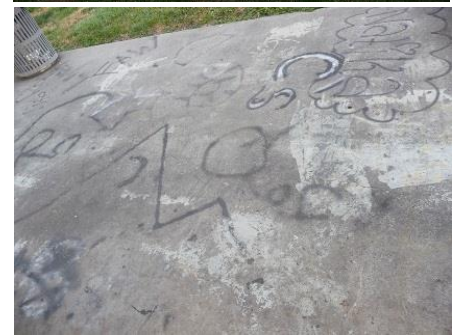
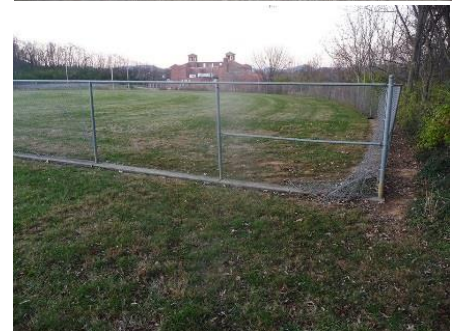
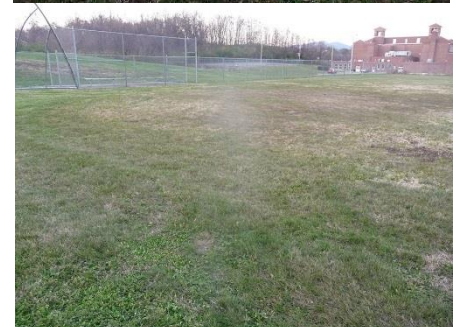
Horton Park

Key deficiencies needing attention:

- Softball field in poor condition. There is grass on the infield and the fence is badly damaged. It is not programmed and unused.
- Basketball court has some cracks in pavement and needs new striping
- Graffiti painted on the concrete floor of the picnic shelter and shelter itself is old and unused
- Drinking fountain is very old and appears non-functional

Priority Recommendations:

- If softball field doesn't get used, remove fence and repurpose this space. Otherwise, repair fence and restore the dirt infield.
- Rehabilitate basketball court to City's standard
- Remove or paint over graffiti on picnic shelter floor
- Replace drinking fountain
- Construct ADA compliant walkways leading to the picnic shelter, swings and basketball court and install an ADA swing
- Develop new Master Plan for the park to meet neighborhood park standards
- Develop safer street crossings to park

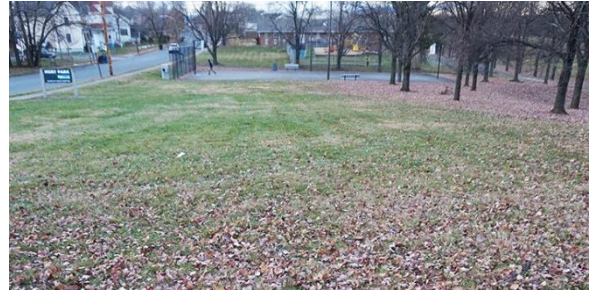
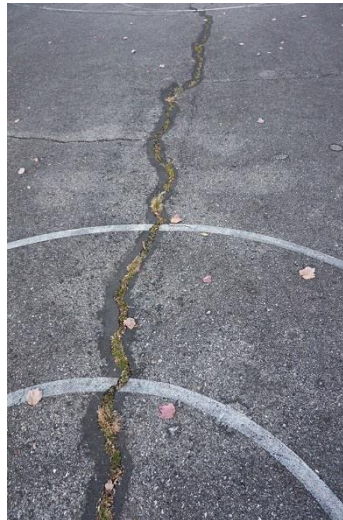
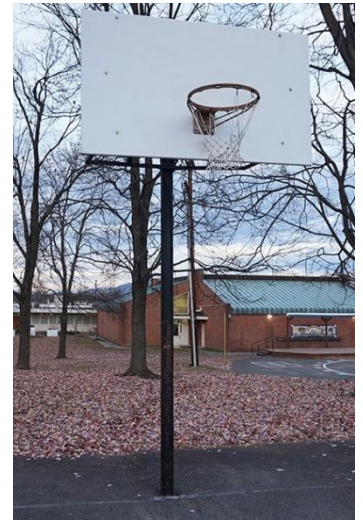
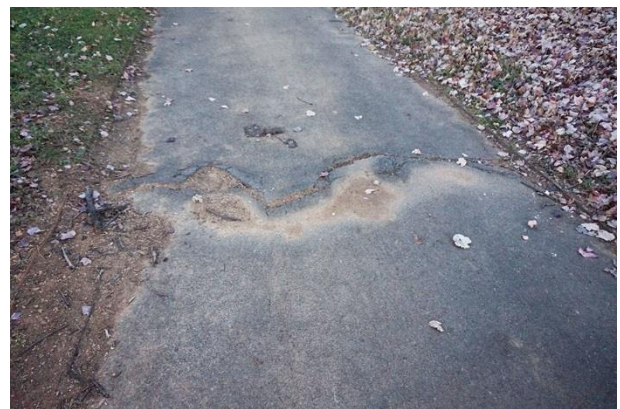
Key deficiencies needing attention:

- Basketball court in poor condition with large cracks

Priority Recommendations:

- Due to the proximity of Perry Park and the Hurt Park elementary school (and related open space), it is recommended that the basketball court be turned over to the school system while the Department concentrates its efforts on the neighborhood park two blocks away on Norfolk Avenue.

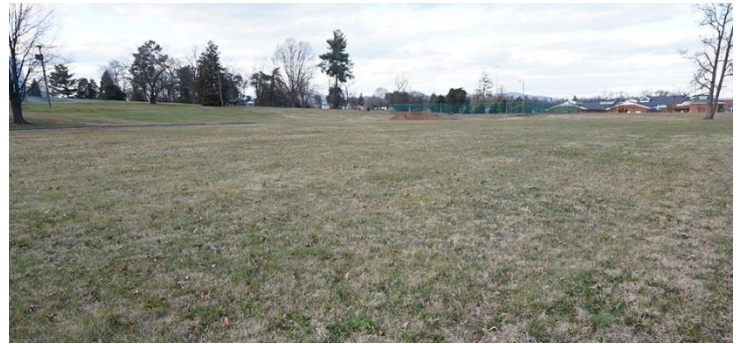
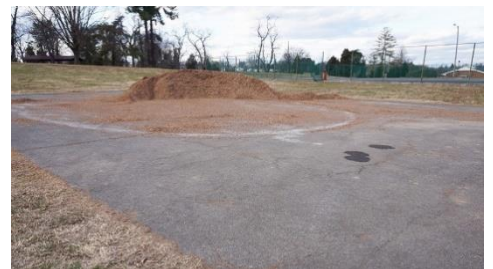
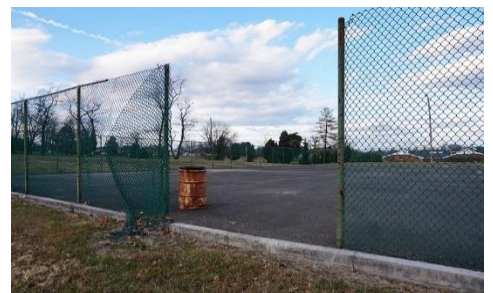
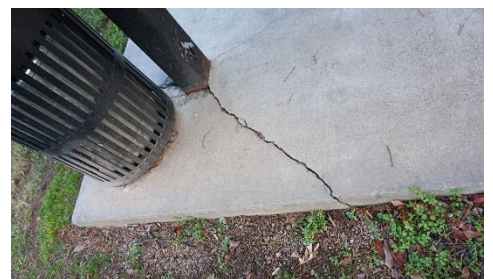
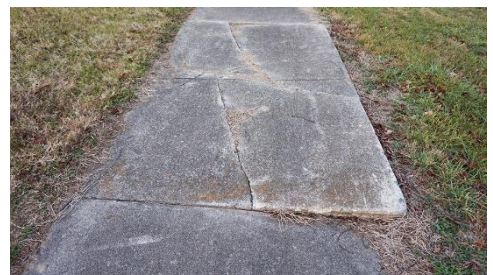
Kennedy Park

ADA issues:

- The picnic shelter and paved paths are accessible only from the church parking lot, not from within the park
- No other park amenities are connected to ADA paths

Key deficiencies needing attention:

- Asphalt court is in very poor condition and appears unused. There are large cracks in the pavement, the perimeter fence is damaged, and there is no equipment.
- One parking lot is being used for wood chip storage in view of park use
- Paved pathways and concrete walkways have cracks with grass growing through
- Concrete floor at picnic shelter is cracking
- Large amount of non-programmed mowed space

Priority Recommendations:

- Remove or repurpose unused hardcourt
- Patch/repair cracks in walkways
- Patch/repair cracks in concrete floor of picnic shelter
- Create additional program uses for the park's open space, such as disc golf, or consider establishing a wildflower meadow
- Screen or eliminate maintenance and storage areas

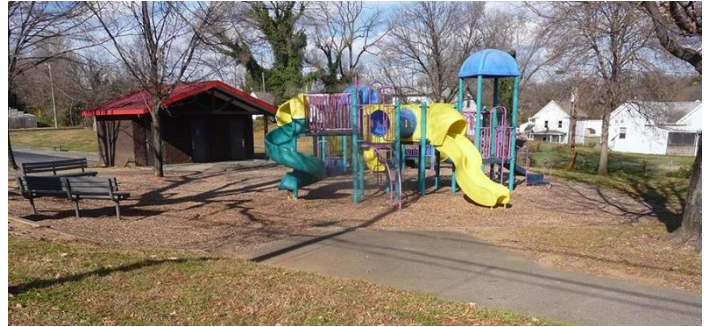
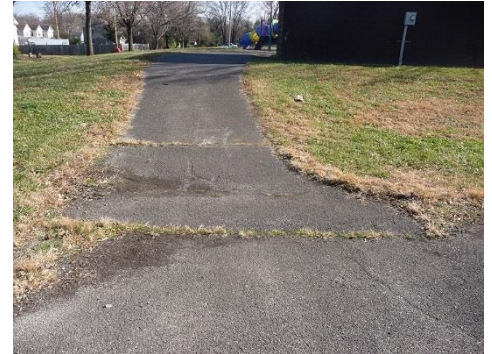
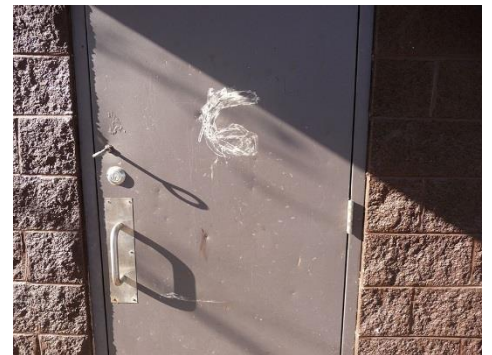
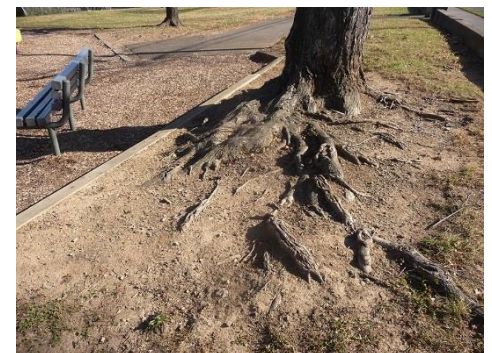
Loudon Park

ADA issues:

- The paved walkways throughout the park are not all stable and even
- There is too much drop at the edge of the playground to be ADA compliant and there are no accessible pieces of play equipment.

Key deficiencies needing attention:

- Basketball court pavement has large cracks and rough areas
- There is graffiti on the restroom doors and the concrete floor in front of the restroom
- There is erosion and bare dirt around the playground and restroom

Priority Recommendations:

- Repair cracks in pathways
- Replace and upgrade basketball court to the City standard
- Clean graffiti off restroom doors and floor
- Eliminate stand-alone picnic tables and design park to include City’s picnic platform standard with concrete pad, picnic table, grill, and trash receptacle
- Reseed bare area around playground and restroom

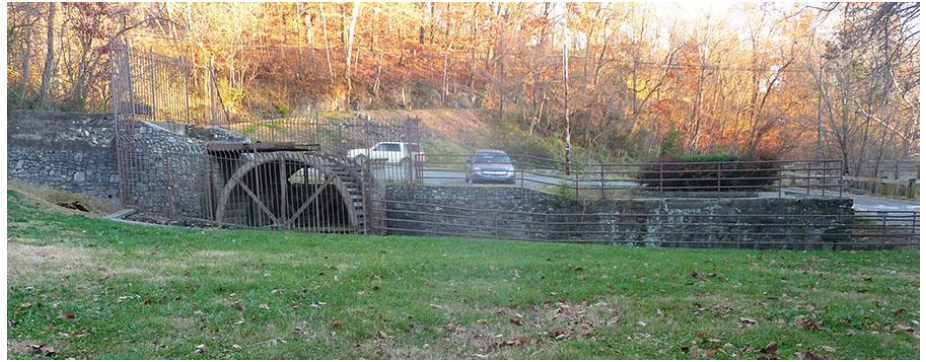
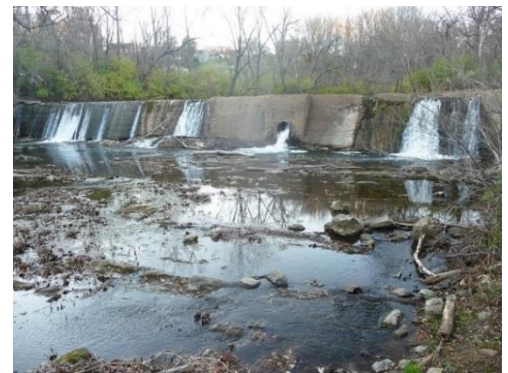
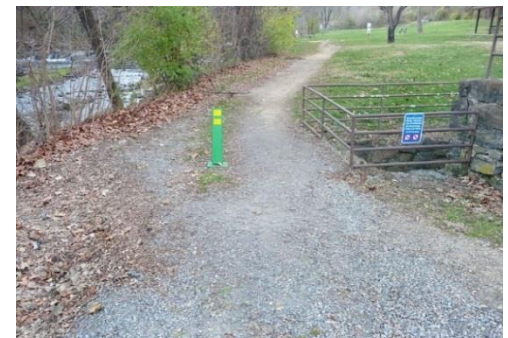
Mason Mill Park

ADA issues:

- None of the park is ADA accessible. The parking lot is paved, but the path along the river is rough dirt and there is no walkway to the picnic shelter.

Key deficiencies needing attention:

- Trail at the parking lot is rough with loose gravel and some erosion from parking lot drainage
- Parking lot drains down the path and directly into the creek, causing path and bank erosion.
- Trash receptacles, picnic tables, and historical interpretive plaque are in poor condition
- Flume is clogged with sediment and debris, which cause the mill wheel to be inoperative

Priority Recommendations:

- Install a trench drain where the path meets the edge of the parking lot to capture water runoff and pipe it to a BMP
- Upgrade and improve the trailhead via the future Tinker Creek Greenway Project that will come through the park. Use Tinker trail project to improve ADA accessibility and establish an ADA fishing boardwalk
- Establish individual picnic concrete pads with table, grill, and trash receptacle. Remove old single tables from the park.

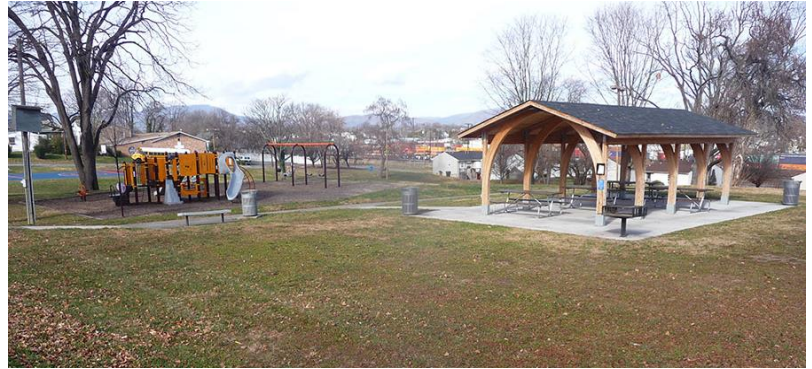
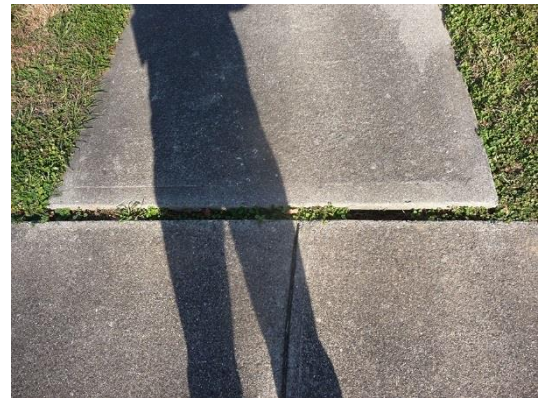
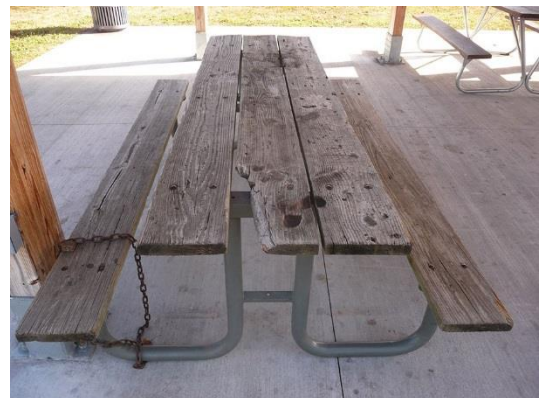
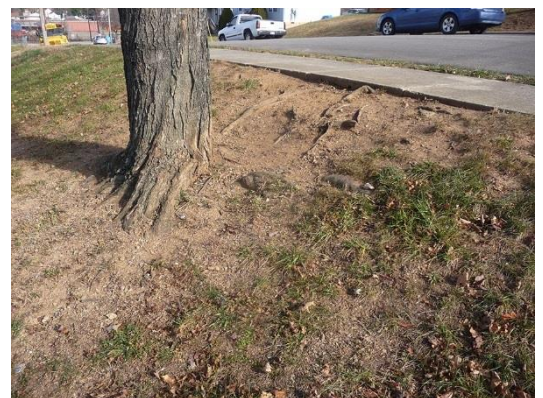
Perry Park is located in southwest Roanoke on Norfolk Avenue between 11th and 12th Streets several blocks east of Hurt Park and Elementary School. It has a new playground, picnic shelter and basketball courts, though some of the picnic tables are old and in poor condition.

- There are some large gaps in the walkways which would be problematic for wheelchairs
- The walkway does not extend to the playground and there are no accessible pieces of play equipment

- Some erosion and bare dirt along edge of park

- Repair gaps in walkways
- Extend walkway to playground, add ADA ramp and some accessible play equipment
- Reseed bare spot along park edge

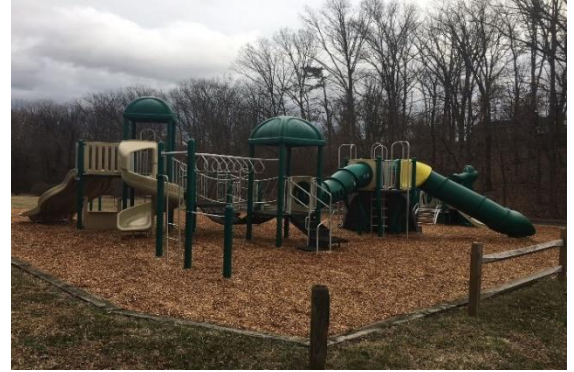
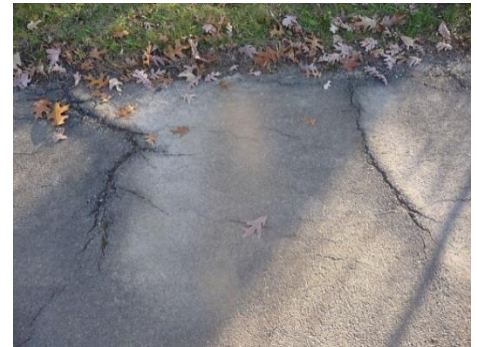
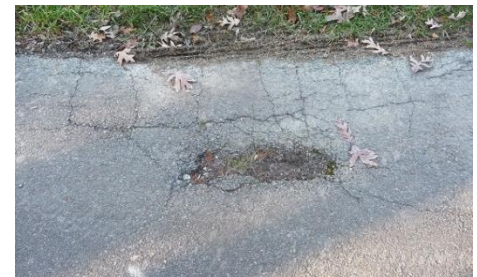
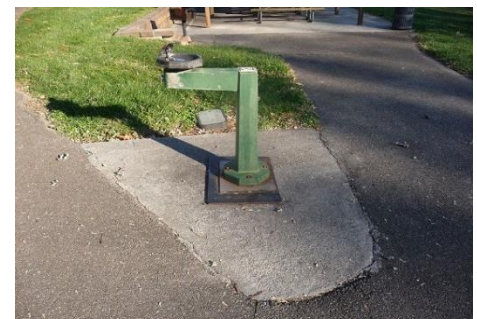
Ridgewood Park is located in a quiet residential area in northwest Roanoke on Hemlock Road across from the Ridgewood Baptist Church. It has a picnic shelter, playground, and a paved loop path around the park.

- The paved path provides ADA access to the entire park.
- There is too much drop at the edge of the playground to be ADA compliant, the mulch is in poor condition, and there are no accessible pieces of play equipment.

- Park sign is missing
- Several large cracks, holes, and rough spots in the asphalt path
- The shelter is not stable and will need to be replaced.

- Replace park sign
- Repair cracks, holes, and rough spots in asphalt path
- Repair outside lights
- Replace shelter

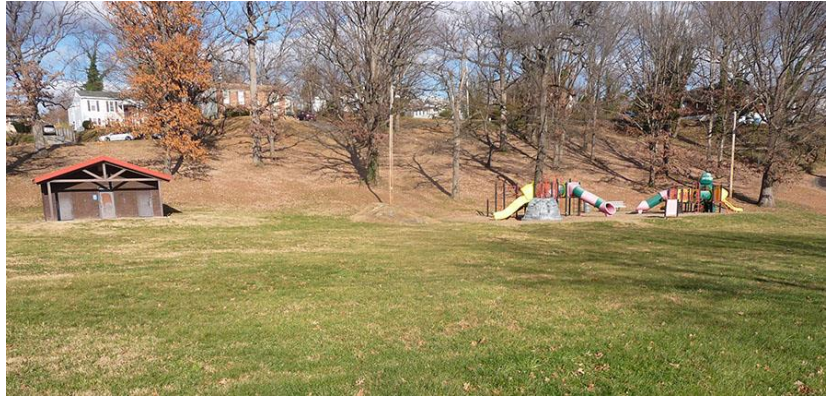
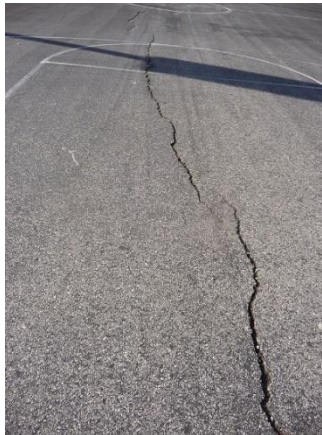
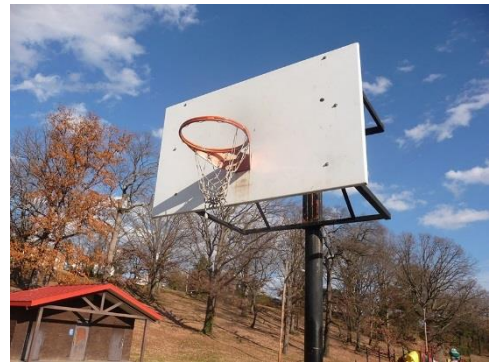
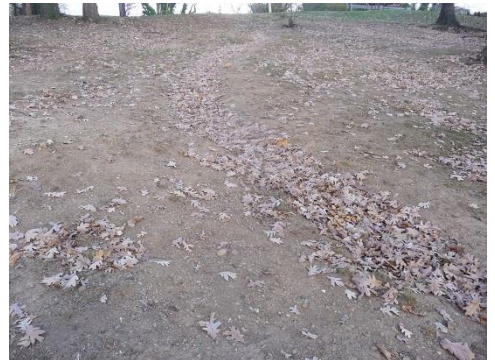
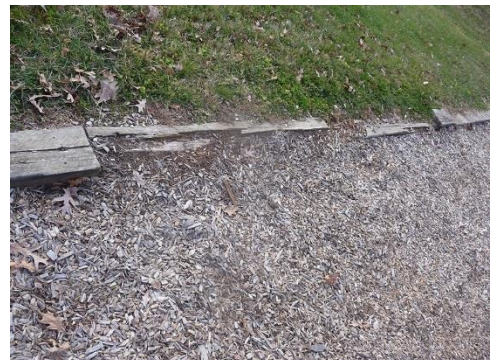
Staunton Park is in northwest Roanoke at Staunton Avenue and 23RD Street surrounded by residential communities. It contains a playground, one basketball court, restrooms and some open lawn space. The north side of the park is a steep hill covered with large trees.

- None of the park is ADA accessible and there are no walkways within the park
- There is no walkway leading to the playground and no accessible play equipment

- Basketball court pavement is badly cracked
- There is substantial erosion and bare dirt on the steep hill behind the park
- Some of the timber edging around the playground is rotting and broken

- Rehabilitate basketball court to City standard
- City Stormwater Division should address stormwater on Mercer Avenue to keep stormwater from running off the street and down the hill
- Replace timber edging around the playground
- Develop a master plan for the park that addresses the community's needs

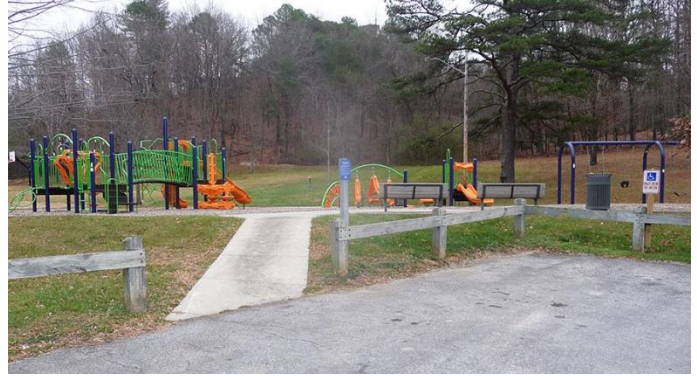
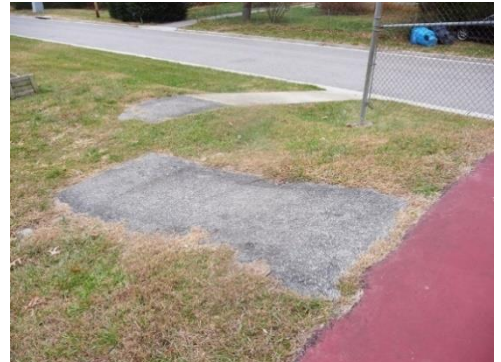
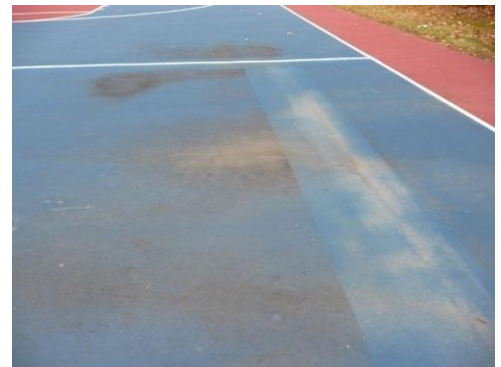
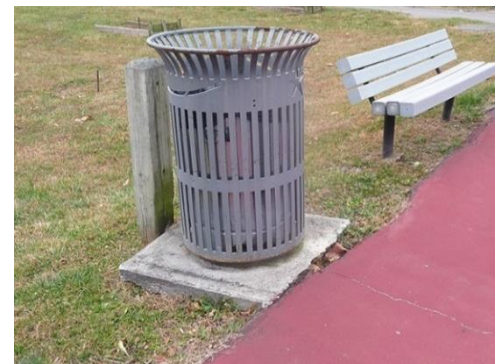
Sunrise Park is in south Roanoke on Southern Hills Drive, just east of Franklin Road. It is located within a small, low-density residential community and offers a small playground, one basketball court, and two horseshoe pits.

- The pathway leading from the street to the basketball court does not have an access ramp at the curb and the path is not continuous all the way to the court
- The walkway leading to the playground is too steep to be compliant, there is too much drop from the edge to the mulch surface, and there are no accessible pieces of play equipment.

- Walkways are very steep and walkway at basketball court is incomplete
- Basketball court pavement has cracks, discoloration, and chipping pavement
- Concrete pad under trash receptacle at the basketball court is uneven on top and separating from the edge of the court pavement
- Wooden frames around horseshoe pits are very old and have broken boards
- There are dislocated, and missing bumper stops in the parking lot
- The ADA parking signs are in the wrong place.

- Reconstruct walkways to be ADA compliant. Install new walkway and ADA curb ramp at basketball court.
- Make necessary repairs to basketball court pavement
- Repour the concrete pad under the trash receptacle, anchored properly into the ground
- Rebuild horseshoe pit frames

- Realign bumper stops and replace missing stops in parking lot
- Move the ADA parking signs to appropriate spaces

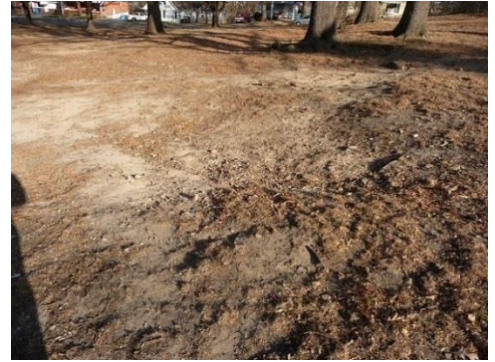
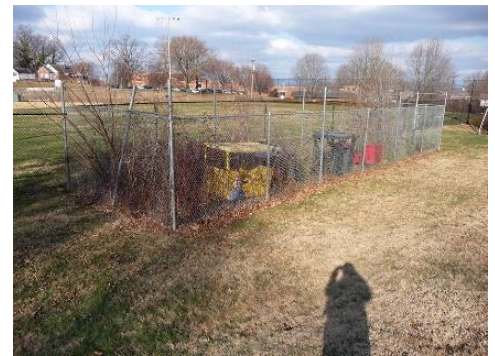
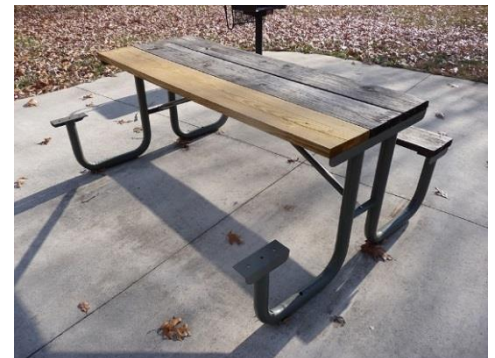
Belmont Park

- Erosion occurring on the banks by the baseball field and on the hill above the baseball field and bare dirt around playground and picnic shelter
- Parking is insufficient for the peak use at park. The west parking lot gets filled by users of the school and library across the street
- Old concession building and batting cage no longer in use. Batting cage is deteriorated
- Tennis courts have large cracks in pavement and are unplayable
- Retaining wall at baseball field has many broken blocks and concrete steps are old and outdated

- Address drainage issues causing erosion and reseed banks, hill, and area around playground.
- Post signs that parking lot is for park use only.
- Remove concession building and batting cage
- Rehabilitate or remove tennis courts
- Repair retaining wall and rebuild steps
- Construct an ADA compliant walkway connecting the playground to the paved path by the picnic shelter
- Improve lighting around interior park loop trail

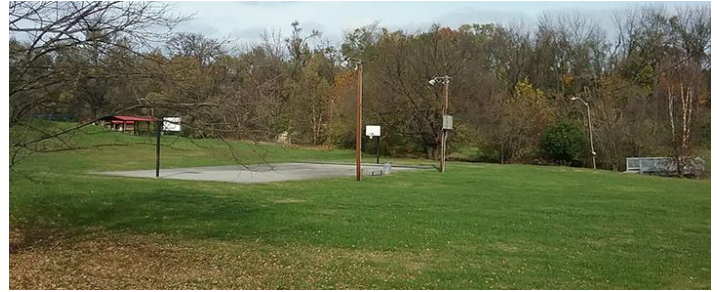
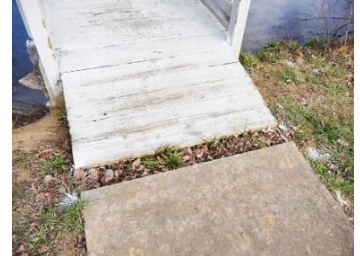
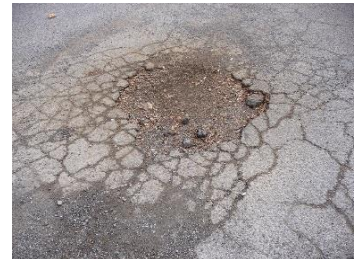
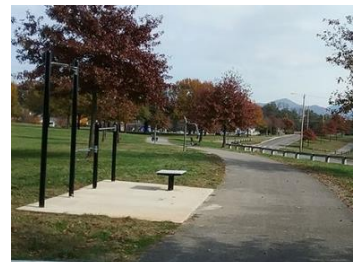
Booker T. Washington Park

- Upper playground equipment is old and in poor condition
- Tennis and basketball courts are old, in poor condition, and don't get used
- Old building at south end of park is abandoned and in unsafe condition

- Replace playground equipment
- Consider repurposing tennis and basketball courts
- Dismantle abandoned building or make it safe and presentable for interpretive use
- Pave the walkway from the lower parking lot to the restroom and picnic shelter and extend this paved path to the playground. Add an ADA ramp at the playground.

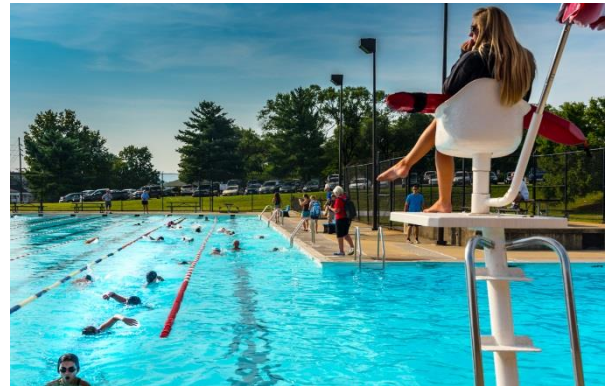
The Washington Pool facility is located along the east side of Washington Park on Burrell Street and accessed from Quarry Road. The facility receives heavy use throughout the summer and offers several recreation opportunities but does require some extensive maintenance and repair.

- Fix leak in wading pool or replace with a spray park
- Make necessary repairs to mechanical system
- Perform necessary updates, repairs and maintenance to improve the facility's appearance

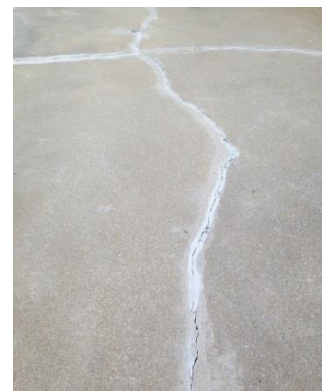
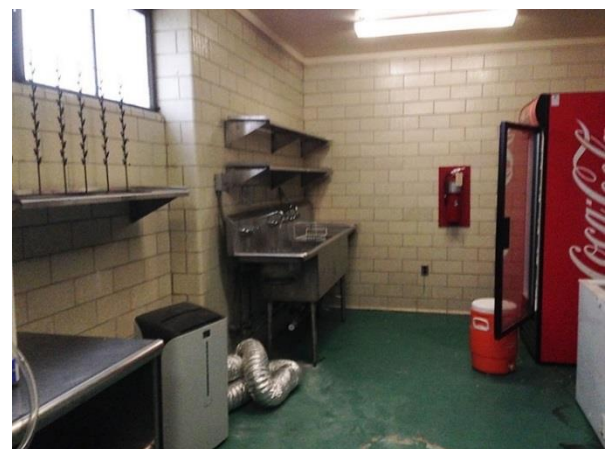
Booker T. Washington Pool

- Wading pool leaks
- Mechanical system has significant problems
- Facility is old and has numerous cosmetic issues, large cracks in pavement, graffiti, etc.

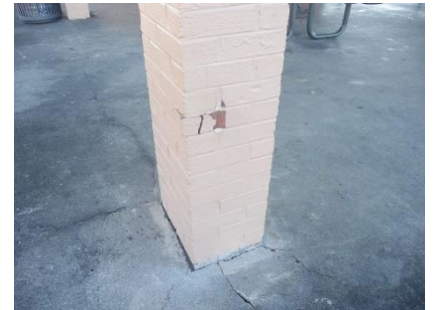
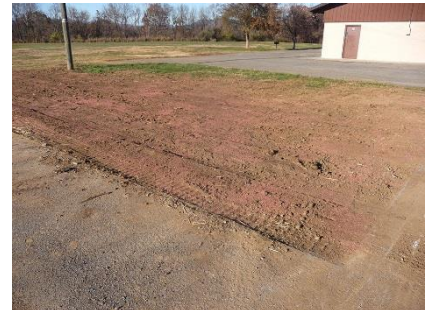
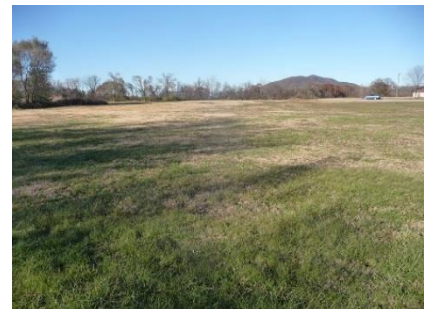
Eastgate Park

- Course gravel in parking lot is not ADA accessible
- Basketball court and picnic shelter are not ADA accessible due to rough or uneven surfaces
- Playground is not ADA compliant - there is no accessible route or accessible pieces of equipment.

- Parking lots are in poor condition with large potholes and uneven areas
- Broken bricks in the picnic shelter column and cracks in the concrete floor
- Bare dirt around the playground, picnic shelter, and parking area at the east entrance
- There is a large expanse of unused mowed lawn. Fields are rough and uneven and rocks and concrete blocks are protruding in places
- River access is steep and paths are narrow

- Pave parking area and provide ADA parking spaces
- Repair broken bricks in picnic shelter column and patch cracks in concrete floor

- Establish turf around playground, picnic shelter and parking
- Rehabilitate and reprogram large open areas
- Add picnic facilities
- Add hiking/biking trails with trailheads at the parking lots
- Construct safe and appropriate pathways leading down to the river

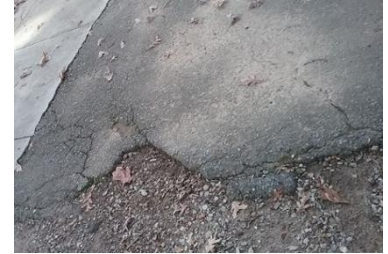
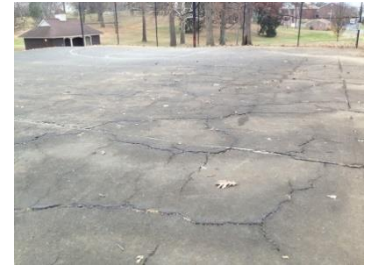
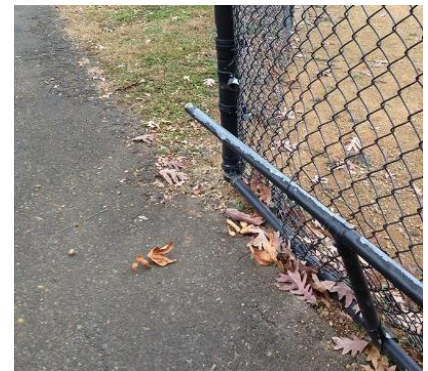
Eureka Park

- Basketball court does not have a walkway leading to it
- Paved walkways have rough spots that compromise access
- The playground edge drops too much to be ADA compliant, the mulch surface is in poor condition, and there are no accessible pieces of play equipment.

- Basketball court pavement has cracks and rough areas
- Area under shade trees is bare, with compacted dirt
- Softball field is not used
- Tennis court pavement has cracks and needs to be resurfaced
- Some areas on walkways have cracks and broken/rough spots
- Antiquated sports lighting is non-performing and inefficient

- Rehabilitate basketball court
- Improve ground cover under shade trees and consider installing picnic tables
- Repurpose the softball field area
- Repurpose or remove tennis court
- Make necessary repairs to asphalt walkways and connect all amenities with ADA pathways
- Install ADA ramp into playground area
- Upgrade all sports lighting
- Develop park master plan

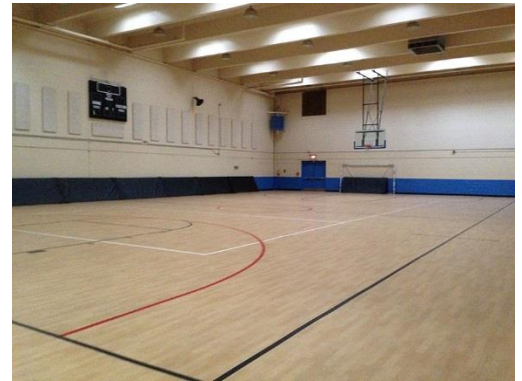
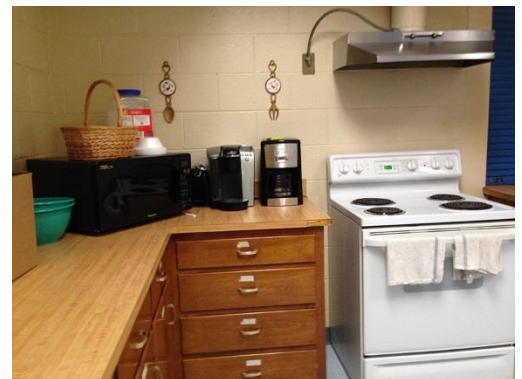
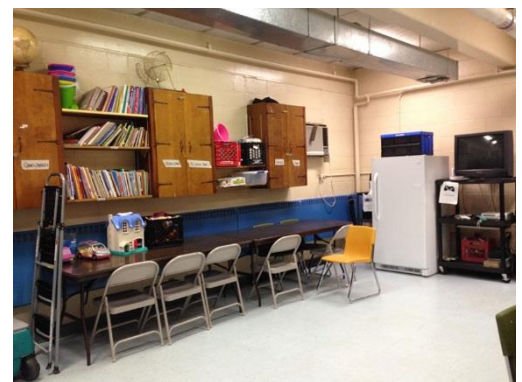
Eureka Park Recreation Center

- Exterior lighting around the building and parking lot is inadequate and does not meet code
- There are “dead” spots within the security camera range
- Not enough parking space for peak use
- Gymnasium floor should be replaced
- Skylights in the roof leak
- The boiler for heat is old and hard to control
- Ventilation system is outdated
- Not enough activity or storage space

- Install new exterior lights around building and parking
- Install additional security cameras or adjust positioning of existing cameras for better coverage
- Expand parking lot
- Replace gymnasium floor
- Repair skylights
- Replace the boiler system and old ventilation system with new HVAC
- Build extensions onto the building to expand activity and storage space. A separate storage shed apart from the main building is also an option to increase storage capacity.

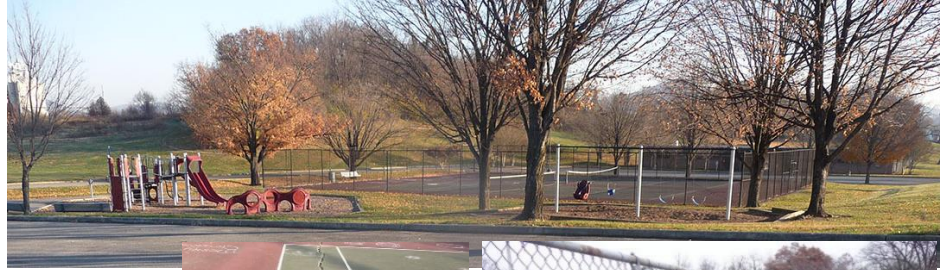
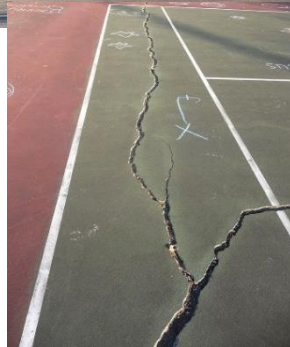
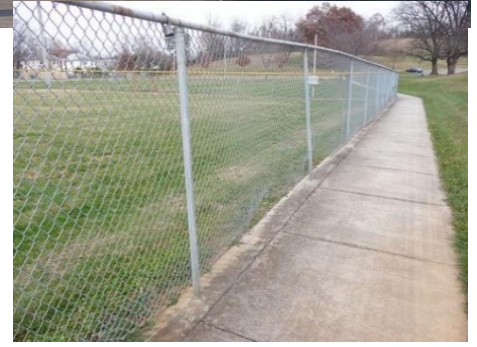
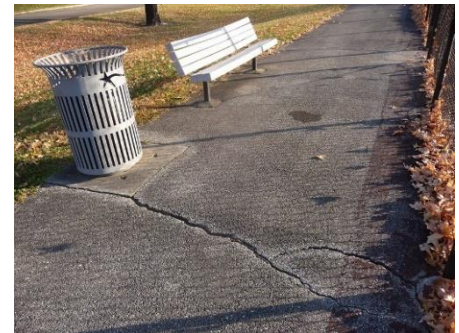
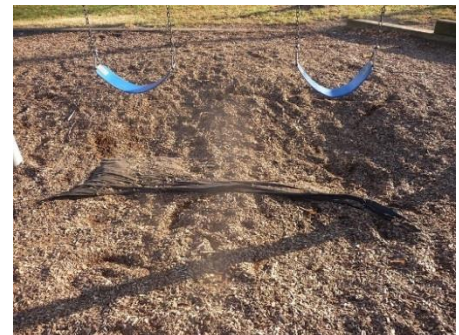
Fallon Park

- Tennis courts in poor condition with large cracks Fence around baseball field is damaged
- Large cracks in asphalt walkway and concrete floor around picnic shelter

- Repurpose the area where tennis courts and softball field are located
- Repair damaged fence around baseball field
- Repair cracks in walkways and floor at shelter
- Install an ADA ramp at the edge of the playground
- Designate ADA parking spaces with signage and markings
- Further develop the Tinker Creek Greenway
