FACILITIES ASSESSMENT REPORT

2019

CHAPTER ONE – PARK AND FACILITY ASSESSMENTS

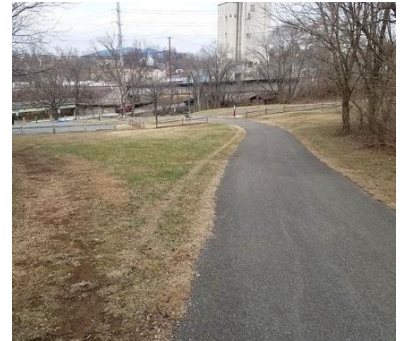
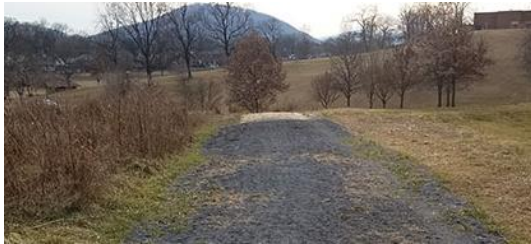
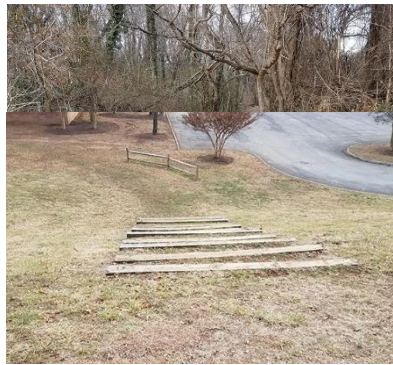
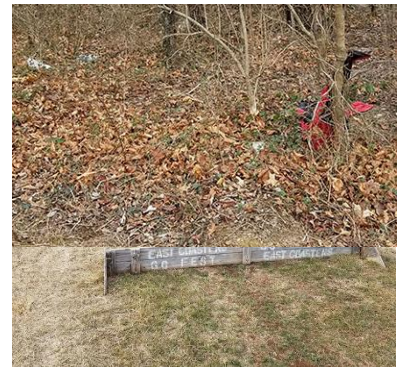
Fallon Park Trails

Cyclocross Course: This is a one-mile cycling course that offers varying rider experiences as its tread includes dirt, asphalt, gravel, sand, and grass, along with wooden steps and barriers. The paved portion of the course connects to the parking area and is ADA accessible; the non-paved portions of the trail are not ADA accessible. Overall the course is in good condition. The barriers could use minor repairs and the sand and gravel pit could use raking.

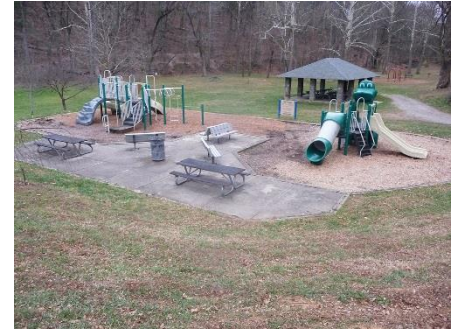
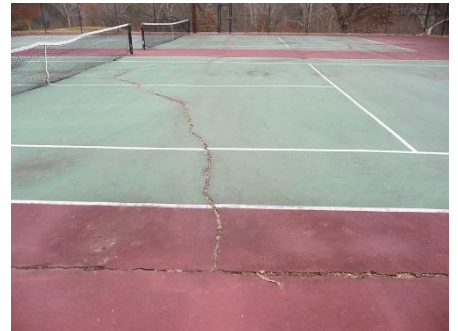
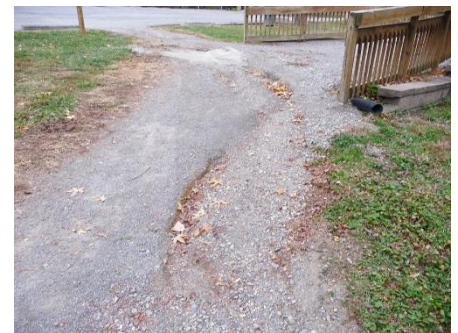
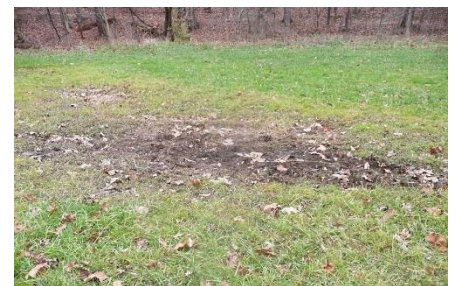
Fishburn Park

- Large potholes in the park access road and rough spots in the parking area; stormwater erosion is a problem
- Eroded and rough areas in the gravel walkway
- Tennis courts in poor condition

- Patch the potholes in the access road and pave the parking lot
- Address problem areas where water is draining across gravel walkways and then regrade and gravel the walkways; establish raingardens where appropriate
- Remove and repurpose the tennis courts
- Pave the ADA parking spaces and extend pavement to the restroom walkway
- Construct paved ADA parking spaces and walkways to the picnic shelter, playground, and lower section of park
- Remove old wooden light poles

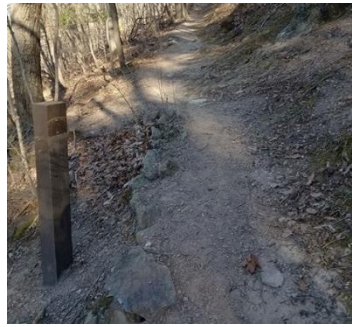
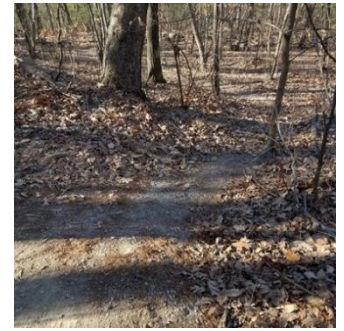
Hillside Trail: Hillside Trail is a 0.3-mile natural surface trail within Fishburn Park that connects the Murray Run Greenway to the Stream Trail in Fishburn Park. It received heavy use spring through fall and moderate use in winter and is not ADA accessible. The trail is in fair condition, mostly needing some water diverters to reduce trail drainage and erosion. The trail signage is outdated and should be replaced with usage and regulation signage that meets current

City standards, including adding a rules/regulation sign at the McNeil Drive trailhead. Also, the signpost at the Stream Trail intersection is missing its trail sign. There are numerous social trails along Hillside Trail which receive a bit of use, and these should be evaluated and either closed or easements should be acquired, and the trails improved and integrated into the City trails network.

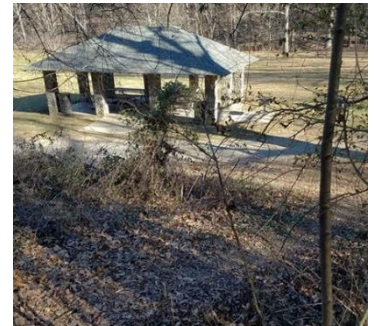
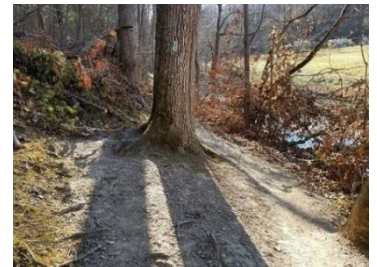
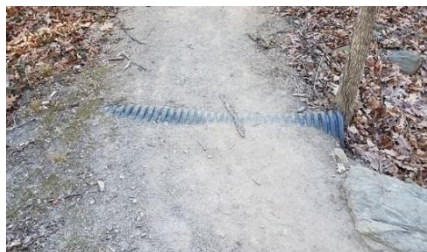
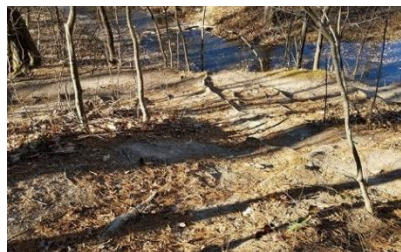
Stream Trail: This 0.7-mile natural surface trail follows the Murray Run creek for about half its length and receives heavy use spring through fall and moderate winter use. It is not ADA accessible and is in poor condition with several issues that need to be addressed. The portions of trail that are along the creek are too close to the creek and there are several places where the trail tread has fallen into the creek and the bank is deteriorated and eroded. Braiding occurs as users try to avoid these areas. The trail should be rerouted to higher ground away from the creek. Near the old spring there is a perennial mud spot that should be armored or have a culvert installed, and the culvert near the forest edge needs more dirt on the trail above it. There is a social trail by the stone shelter and numerous social trails that connect the Stream Trail to nearby neighborhoods. Options should be considered to reroute and/or formalize these. Additionally, the signpost at the Murray Run Greenway intersection is missing its sign and there should be a sign for the Murray Run Greenway posted at mile marker .05 on the Stream Trail.

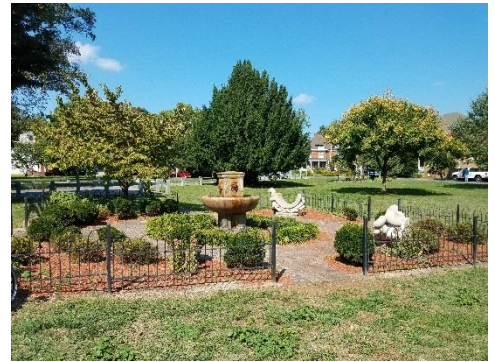
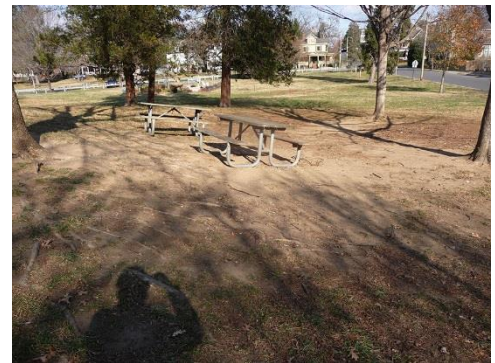
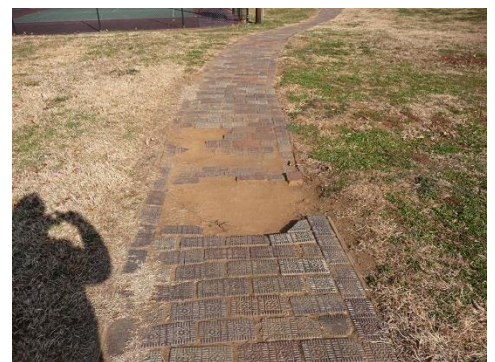
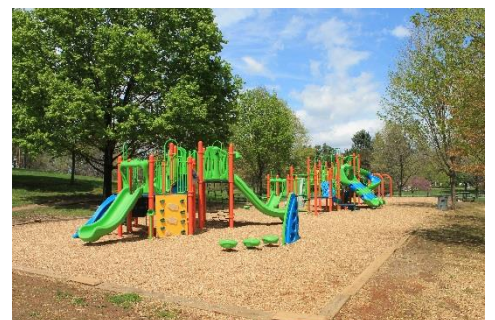
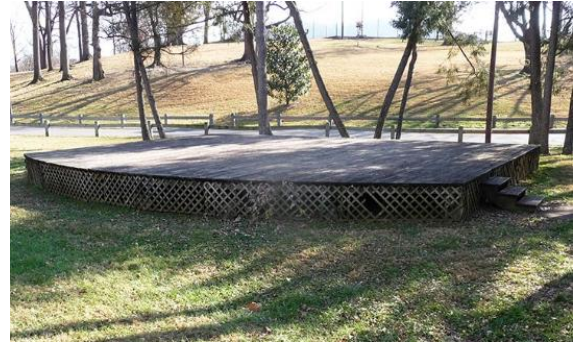
Highland Park

- Walkways are in poor condition. Numerous areas are damaged, with bricks broken or missing. Walkways are rough and uneven.
- Tennis courts are in poor condition and not being used. Pavement is cracked and heaving from tree roots underneath, fence is damaged, and nets are torn.
- Basketball court has cracks in the pavement with grass growing through
- Outdoor stage is very old, in poor condition with broken boards

- At a minimum repair all damaged and missing bricks on walkways and rebuild the rough uneven areas. Walkways will likely need to be entirely rebuilt to become ADA compliant.
- Pave an ADA parking space by the dog park and install a concrete walkway connecting to the entrance
- Remove tennis courts and repurpose the space
- Patch cracks in basketball court asphalt
- Replace broken boards on outdoor stage and paint or stain the wood
- Picnic facilities should be fully ADA-compliant with access from the nearest ADA parking space

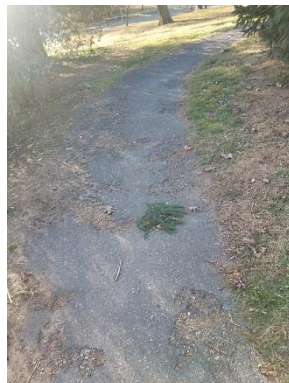
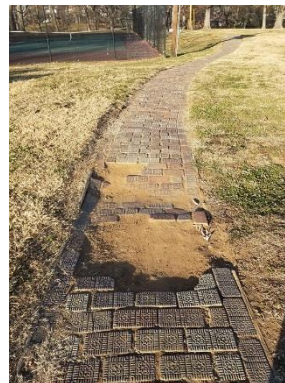
Highland Park Trails

The trails through Highland Park consist of brick pathways about 3 feet wide that cross through the park and connect to the streets around the park and to the amenities within the park. While the bricks are “historic Roanoke bricks” the paths are in poor condition due to many broken and missing bricks. The paths are too rough and steep to be ADA accessible and are not suitable for bicycle use. There is a short stretch of asphalt pathway near sixth street where the asphalt is badly deteriorating, and a section of path is missing. The asphalt and brick paths in Highland Park need to be substantially repaired and possibly new pathways installed to provide ADA accessible connections throughout the park. There is no wayfinding or trail use signage.

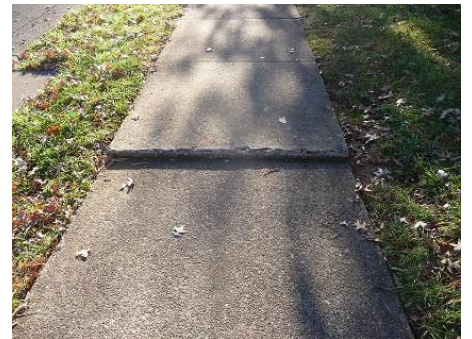
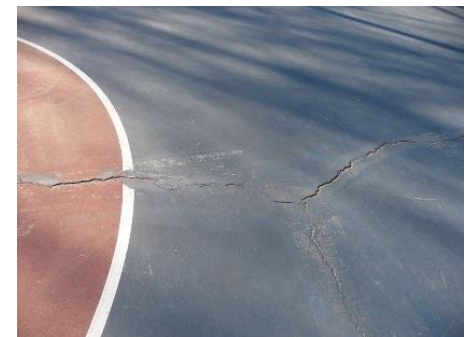
Huff Lane Park

- Hard courts have cracks in pavement and the tape from previous patching is deteriorating
- Sidewalk along Huff Lane in front of the park has a 2-inch high step from settling that presents a trip hazard
- There are unused power poles in the park that are unsightly and could be removed

- Repair cracks and taped areas on all hard courts
- Repair uneven sidewalk along the street in front of the park
- Install ADA access ramp into playground
- Construct a compliant walkway to the swings and add an ADA accessible swing
- Remove old power poles and utility boxes

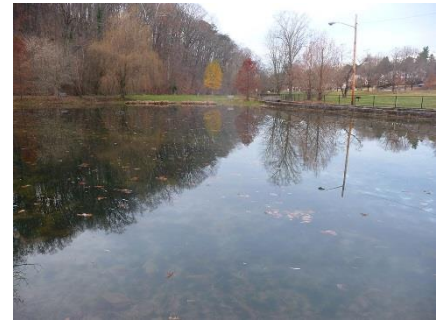
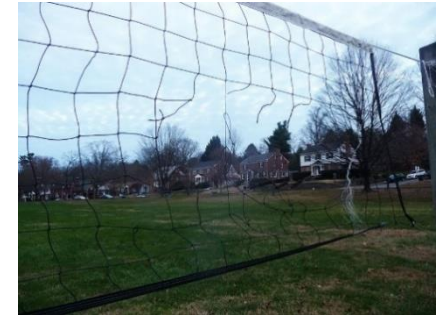
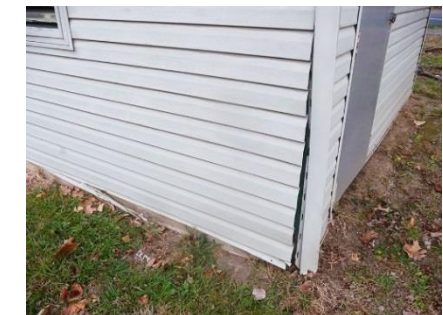
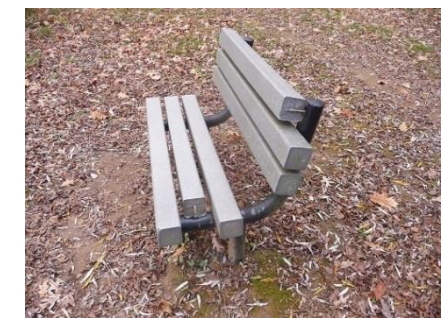
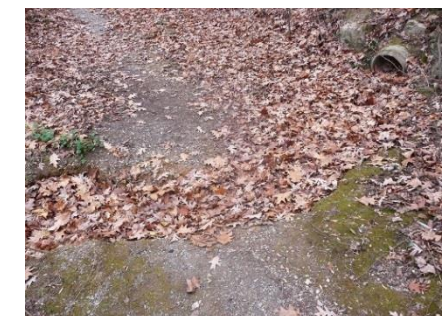
Lakewood Park

- Large cracks in basketball court pavement and rusted poles
- Timber edging around playground is rotting
- Benches and picnic tables are old and in poor condition
- Volleyball net is torn in several places
- Field is not graded for safe recreational sports use
- Drainage channel eroded across the path around the pond
- Pond is not sustainable

- Rehabilitate basketball court to City standards
- Replace timber edging around playground
- Replace benches and picnic tables
- If volleyball receives use, replace net and consider building a sand court
- Establish ADA paths to connect all amenities
- Develop ADA compliant picnic pads and shelter

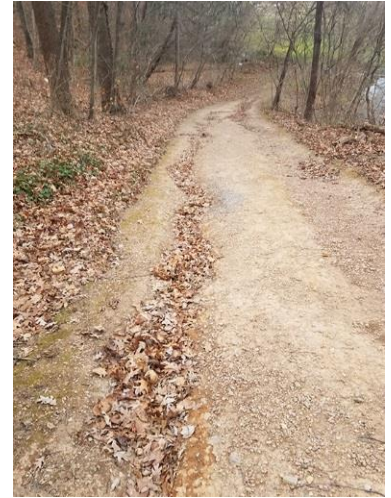
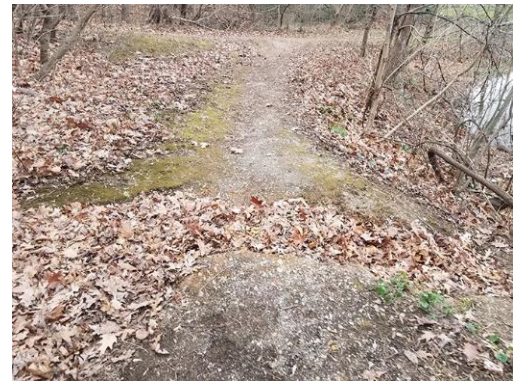
Lakewood Park Trails

The trail at Lakewood Park consists of a short section of old dirt road that leads from Lakewood Drive into the back of Lakewood Park and connects to a dirt trail that wraps around part of the lake inside the park. The entire trail is 0.1 miles long and receives heavy use spring through fall, moderate use in the winter, and is not ADA accessible.

The trail is in poor condition, with erosion down the road section, and the small culvert pipe is directing water onto the trail causing erosion on the trail. The culvert should be extended and buried under the trail. The trail does not connect to the bridge over the creek which is close by and connects to the front of the park, so this should be addressed as well. It would make sense to construct a new path around the perimeter of the park as many people use the field.

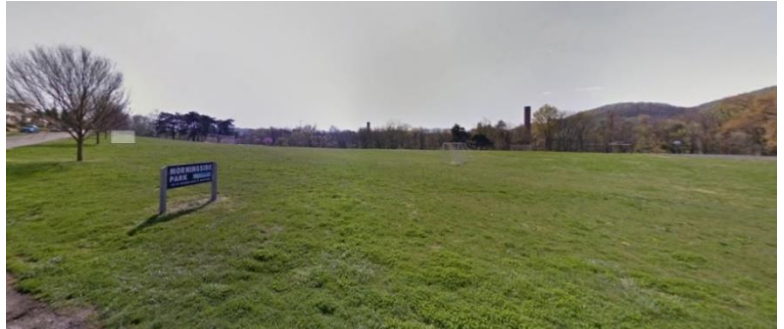
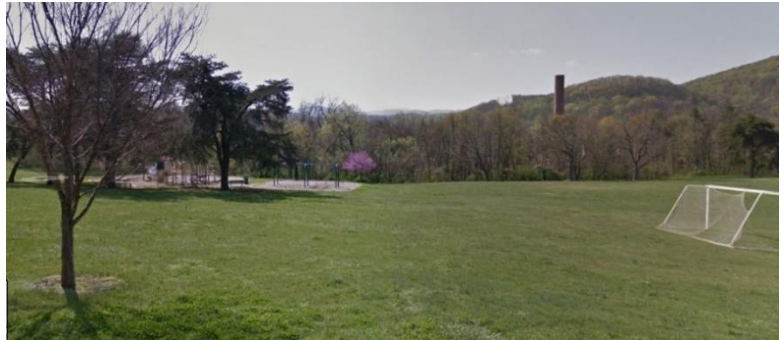
Morningside Park

- Tennis court is in poor condition
- Softball field not maintained and unused
- Basketball court has damaged pavement
- Playground is isolated from other amenities and parking, has no walkways to it, timber edging is rotted, and playground doesn't get much use
- Substantial areas of mowed grass with no trails or program

- Rehabilitate tennis courts and softball field
- Repair basketball court and install new goals
- Relocate playground closer to ball courts and parking. Replace timber edging
- Replace lawn with meadow or successional plantings to reduce park maintenance. Construct biking/hiking trails around/throughout open space with interpretive signage about ecological succession
- Establish curb-and-gutter along park edge and add on-street ADA parking

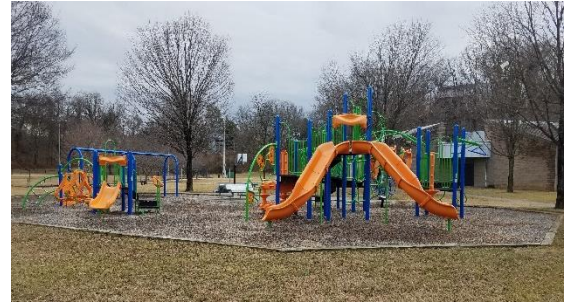
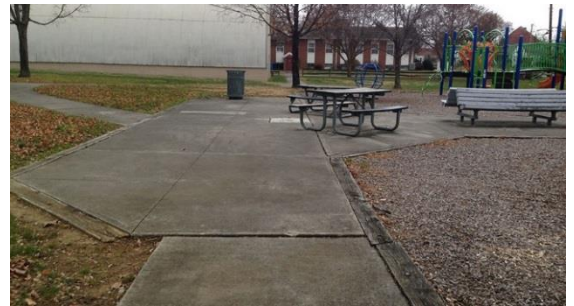
Norwich Park

- The on-street parking is not sufficient at peak times and is in poor condition
- There are cracks and uneven places in the walkways
- Baseball field in poor condition. There is poor drainage in the infield and bare spots in the outfield.

- Extend the gravel pull-off parking areas along Roanoke Avenue, or make them deeper to allow pull-in parking. Re-gravel the parking areas to fill in holes and rough areas.
- Repair cracks and uneven places in walkways
- Stabilize the ADA parking area
- Address drainage issues in baseball field and reseed grass

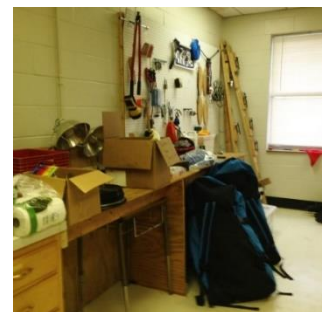
The recreation center at Norwich Park consists of two separate buildings. One building was built in the 1960's as a small recreation space and is currently used for storage, office space, and minimal programming; the other building is a small gymnasium that contains exercise equipment.

- The curb ramp at the ADA parking space on Rolfe Street is in poor condition with rough/broken concrete

- Lighting is inadequate in some areas
- There is not adequate storage space at the gym for current use

- Rehabilitate the old recreation building to a more modern neighborhood recreation center
- Remove old military hut (gymnasium)

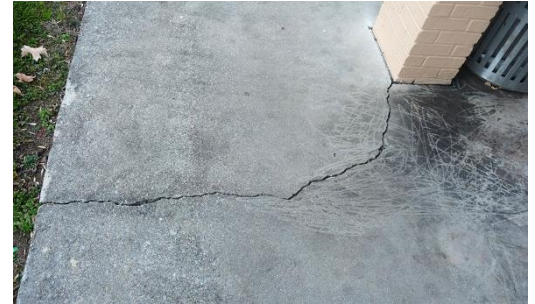
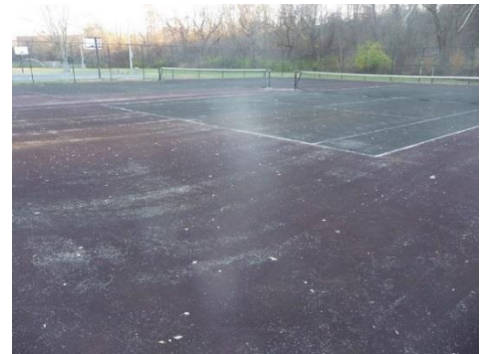
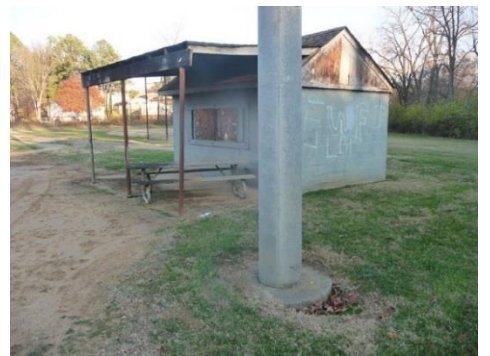
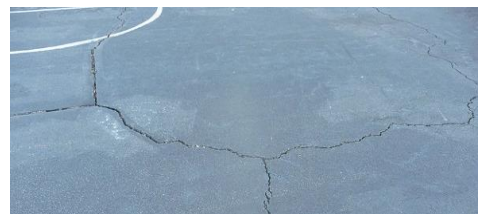
- Although most of the park amenities have paved paths leading to them, there are some large cracks and bulges in the asphalt
- The paved path does not extend to the swings
- The playground edge drops too much to the mulch surface to be ADA compliant and there are no accessible pieces of play equipment.

- Large cracks and uneven places in asphalt pathways
- The fence, concessions building, and drinking fountain at the softball field are in poor condition
- Tennis courts have large cracks and are not used
- Basketball court has large cracks in the pavement, the poles are rusted, and nets are torn
- Graffiti on the picnic shelter and cracks and markings in the concrete floor

- Repair damaged places and cracks in walkways and connect to all amenities
- Make necessary repairs to the softball fence, concessions building, and drinking fountain
- Repurpose or remove tennis courts
- Rehabilitate basketball courts
- Repaint picnic shelter, repair and clean concrete floor

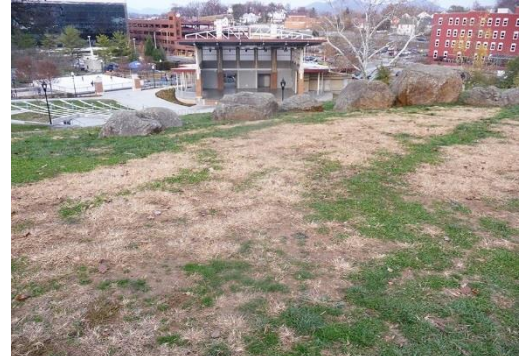
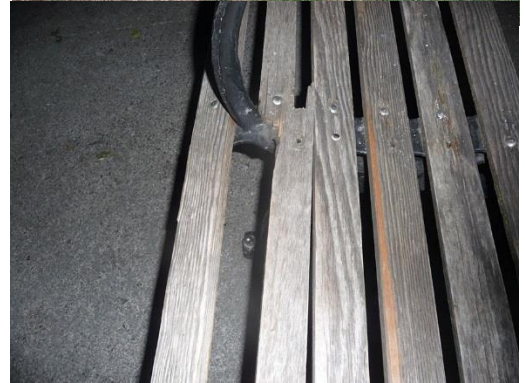
- Park benches are very old, and some have broken boards

- Replace all park benches with new matching benches

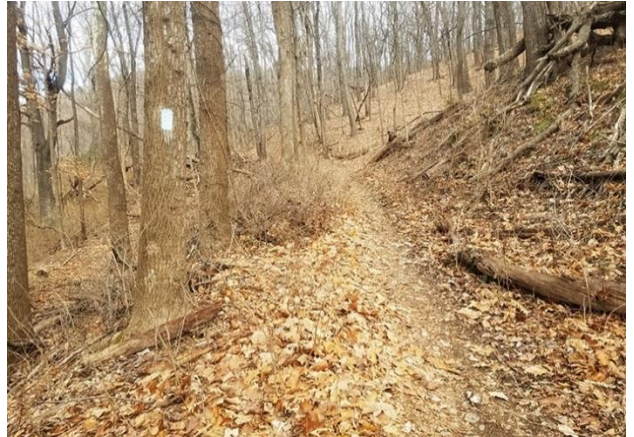
Big Sunny Trail: Big Sunny is a popular connector trail from the Mill Mountain Greenway to Riser and Robinhood Road. It is a natural surface trail that is 0.73 miles long, receives heavy use in the summer and fall, and moderate use in spring and light winter use. Overall, the trail is in good condition, but there are some erosion issues on the end near Robinhood. Reestablishing the ditch on the side of the trail and adding a grade reversal would help.

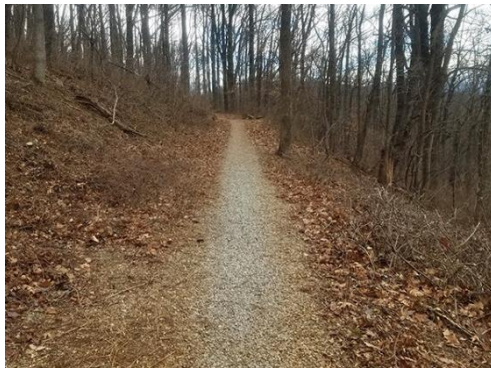
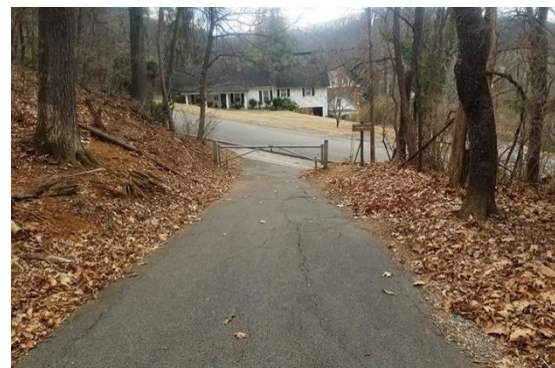
Crystal Spring Trail: This 0.61-mile gravel trail follows a sewer line cut and links Ivywood to Woodcliff on the lower end of Mill Mountain near the Hospital and is considered the easiest trail on Mill Mountain. It receives light use.

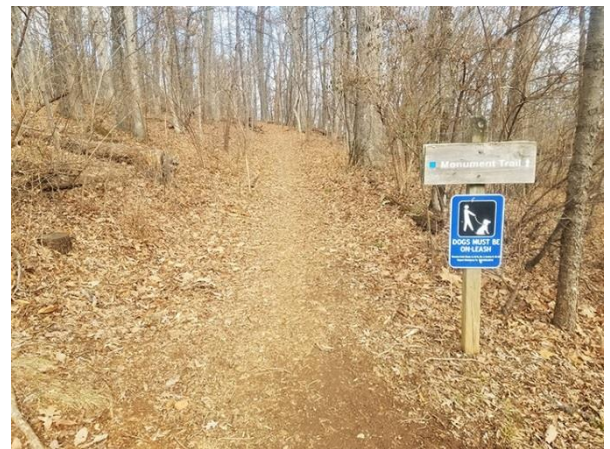
Monument Trail: This 1.55-mile natural surface trail is the most popular multi-use trail on Mill Mountain. It receives heavy use in the summer and moderate use the rest of the year. It is in good overall condition. There are spots near the top where there is tread creep, and re-benching would help reestablish the backslope and tread. There are two spots, one near the top and one at the very bottom, where invasive plants are needing to be trimmed back twice a year.

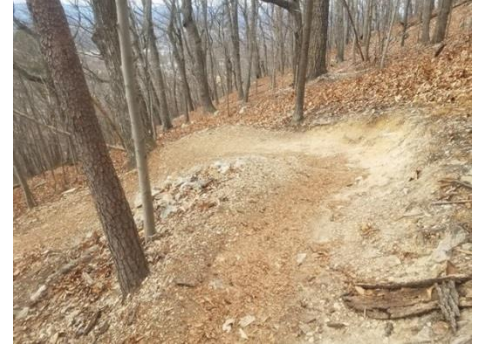
Ridgeline Trail: This 1.26-mile natural surface trail connects the Mill Mountain Greenway and Discovery Center to Understory and Riser trails as well as Yellow Mountain Road and the Chestnut Ridge Trail system. It receives heavy use summer and fall, and moderate spring use and light winter use. Overall, the trail is in good condition, however there are a few problem spots. The grass area near the Discovery Center has trail braiding and mud, there are some eroded areas near the switchback, and the section of trail on National Park Service property is braided as well. Staff should work with the park service to reroute this section of trail to make it more sustainable. There is also a row of invasives that need to be trimmed back near the top.

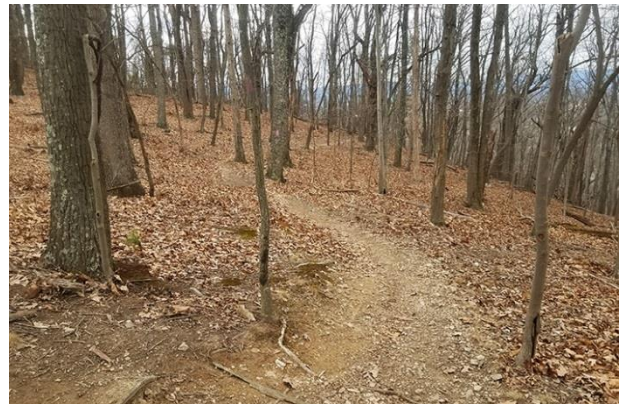
Riser Trail: Riser Trail is a 0.31-mile natural surface trail that serves as an important connection trail from Big Sunny to Ridgeline on the south side of the mountain. It receives heavy use spring and fall, moderate use in spring, and light use in winter. The trail is in good condition with no current issues that need to be addressed.

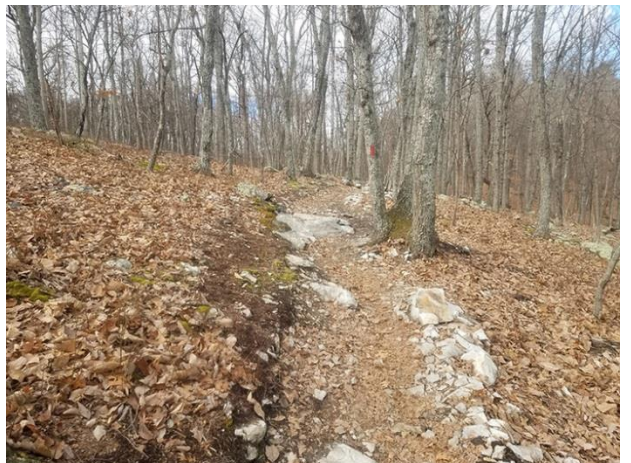
Star Trail: This 1.38-mile natural surface trail was the first official trail built in Mill Mountain Park and is also the most popular hiking trail in the Park. It receives heavy use spring through fall and light use in the winter. The trail is in poor condition, mostly because it receives so much use. There are several places where there is trail braiding, switchback cutting and erosion, and the steps between Fishburn Parkway and Monument have a step that is rotted. There is trash and bricks in the trail in the lower section from Woodthrush to Fishburn Parkway, and the crosswalk across Fishburn Parkway is faded and should be repainted.

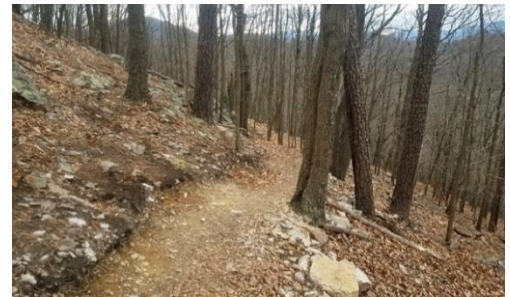
Understory Trail: This is a 0.38-mile natural surface trail that serves as a connector between Mill Mountain Greenway and Ridgeline Trail, providing a loop at the top of Mill Mountain. It receives moderate use spring through fall, light use in winter. The trail is in good condition and currently does not have any issues.

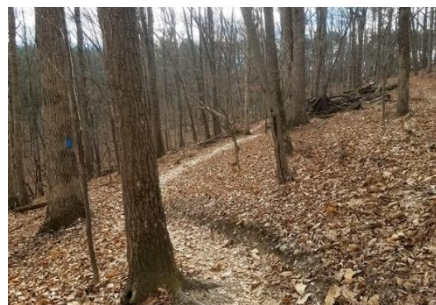
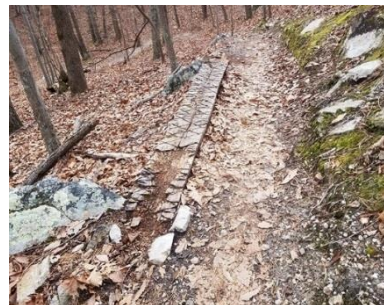
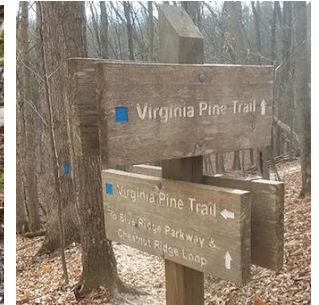
Virginia Pine Trail: This 0.75-mile natural surface trail starts at Woodthrush Trail and leads to Hartsook Road. It receives moderate use spring through fall and light winter use. The trail overall is in good condition, including its one bridge; however, the signage is inconsistent in its difficulty rating, being green circle in some places and blue square in others. Near the intersection with Woodthrush there is a rotten technical trail feature that should be removed or replaced.

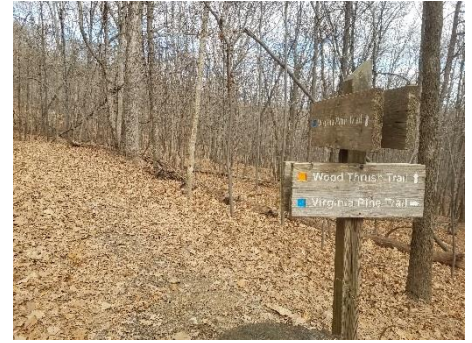
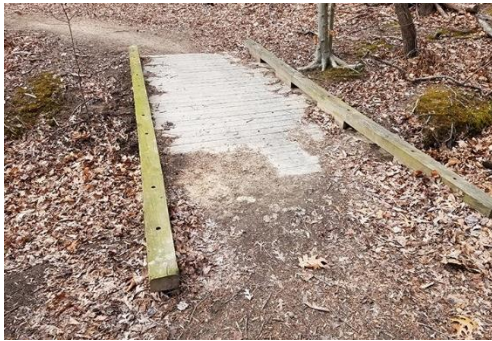
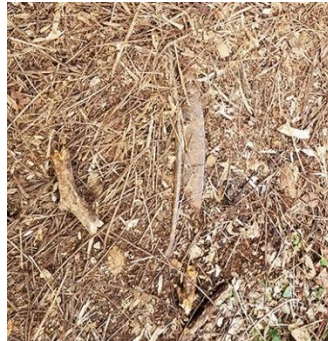
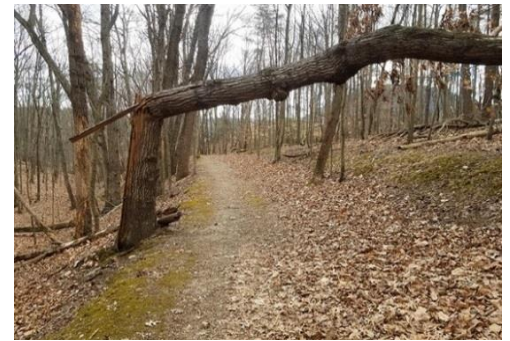
Woodthrush Trail: This is a 1.9-mile natural surface trail that connects Riverland Road and JB Fishburn Parkway, with several Mill Mountain trails branching off of it as well. The trail receives heavy use spring through fall and moderate winter use. The parking lot at Riverland Road is not large enough to accommodate use and needs improved stormwater control and grading. The sign there should be changed from “Star Trailhead” to” Riverland Road Parking” since the parking lot provides access to several trails, not just the Star Trail. It is confusing what the Star-Woodthrush connector is versus the Woodthrush Trail. Signage should be improved to clarify this. On the lower stretch of trail there is a large area of kudzu that should be removed and there is an area with protruding trash from the old landfill that should be covered with additional dirt. Near Sidewinder Trail there are social trails and a section that is very steep and braided and in need of repair. There is a leaner tree by one of the bridges that should be cut down, and the bridges should be cleaned.

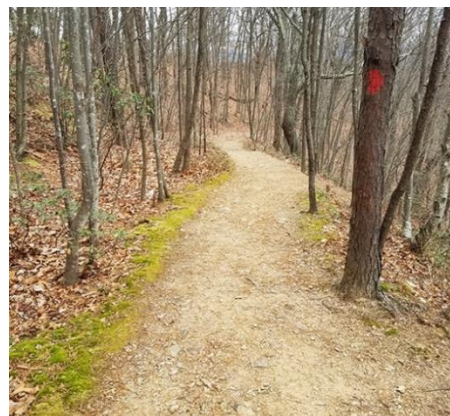
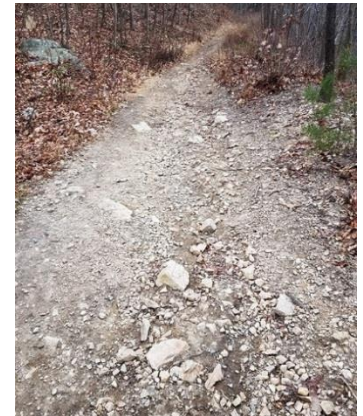
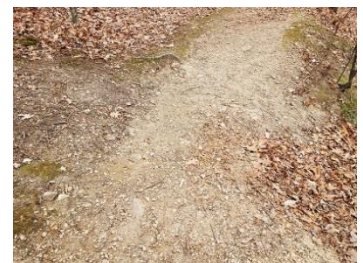
Watchtower Trail: This 0.2-mile natural surface trail provides good connectivity for Mill Mountain visitors looking for a short hike linking the star overlook and Mill Mountain Greenway. It receives heavy use in the spring and fall, and moderate use in summer and winter. The trail is in good overall condition except for a couple spots that are eroding from water running either down or across the trail.

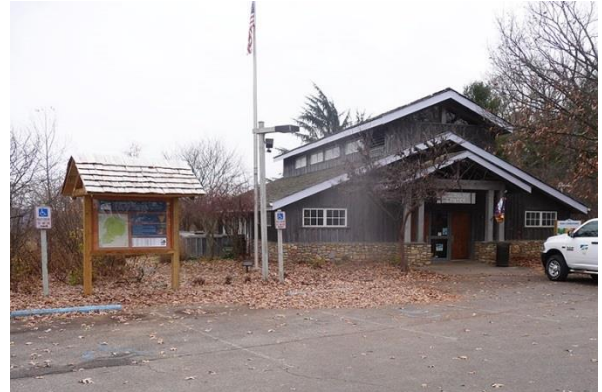
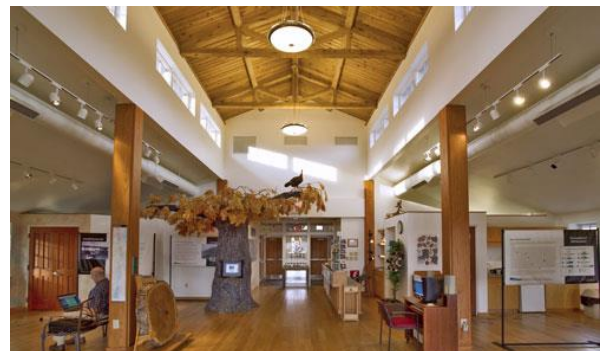
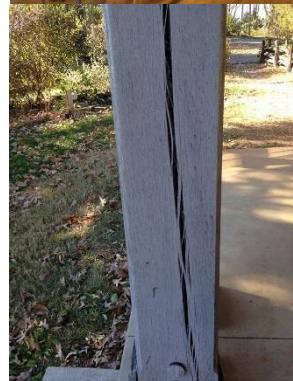
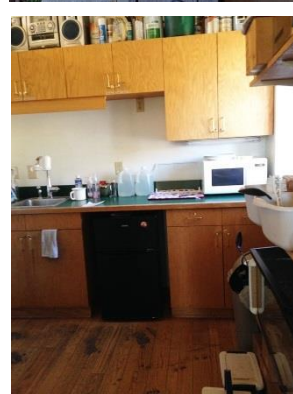
- Not enough parking space
- HVAC system is old, in poor condition and should be evaluated for replacement
- No heat in the bathrooms
- Storage space is inadequate

- Expand parking lot or consider a designated overflow parking area (in accordance with current plans and restrictions)
- Consider replacing HVAC system
- Install electric heaters in bathrooms
- Build an extension onto the building or a separate storage shed next to the building to provide adequate and accessible storage or reduce programming and storage needs.

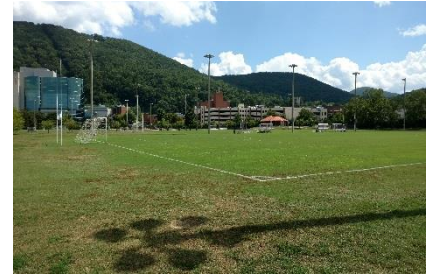
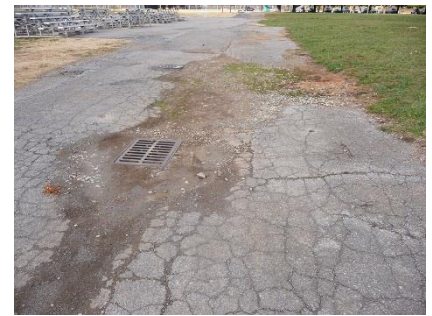
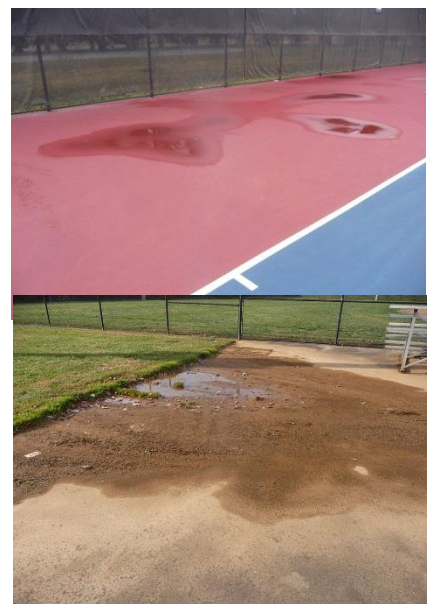
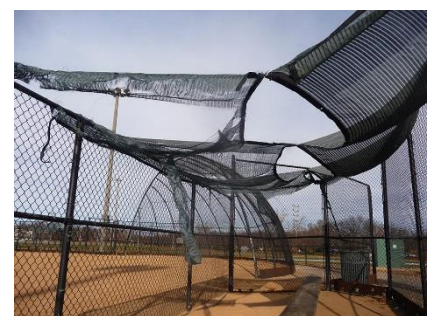
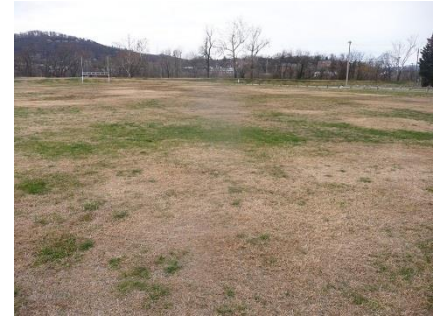
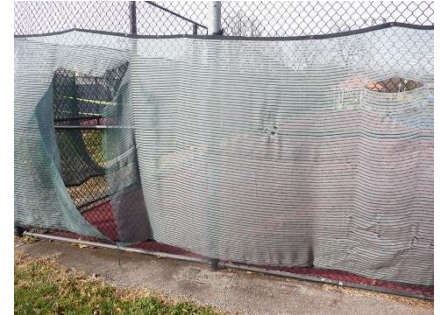
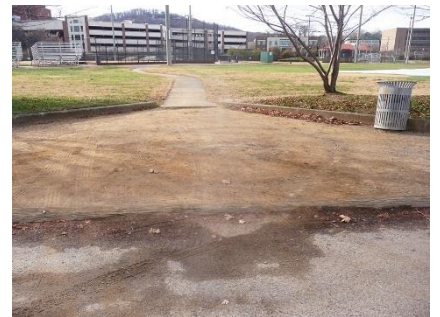
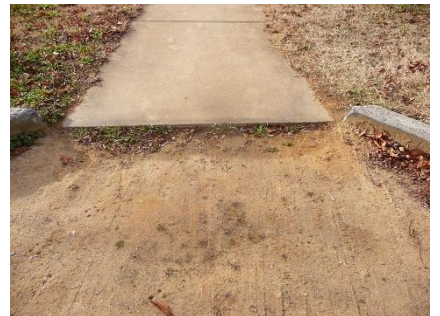
- Access road to multi-use fields at north end of park in poor condition - large holes, cracks and grass growing through
- Gravel parking lot at north end has large potholes
- Shade screens on baseball dugouts are torn
- Standing water behind bleachers at baseball fields
- Tennis court windscreen is torn along bottom of fence
- Areas of standing water on tennis court
- Football goals are old and rusting; picnic tables, benches, and drinking fountains are old; and one of the bleachers is damaged

- Repair and pave parking and access road at Rivers Edge North
- Pave ADA parking spaces to provide ADA access to the multi-use fields and tennis courts. Paving ADA spaces in the middle parking lot by the river would provide ADA access to the pedestrian bridge via the multi-use path and would also connect the north and south portions of the park with an accessible route. Install ADA parking signs to designate ADA parking spaces

- Remove grass growing on walkway
- Replace shade screens on baseball dugouts
- Continue necessary turf rehabilitation on multi-use fields
- Address drainage issue at baseball bleachers at Rivers Edge South

- Replace torn windscreens on tennis fence
- Patch low spots in tennis courts to ensure drainage off the court at Rivers Edge South
- Replace old football goals, picnic tables, benches, and drinking fountains and repair damaged bleachers at Rivers Edge South

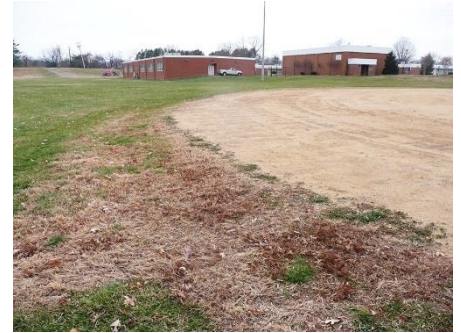
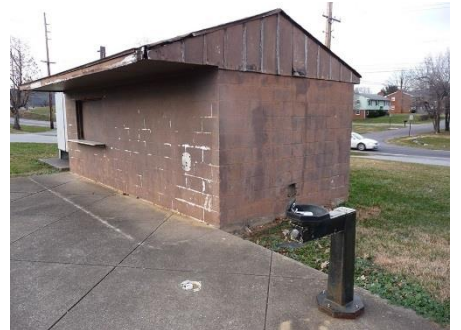
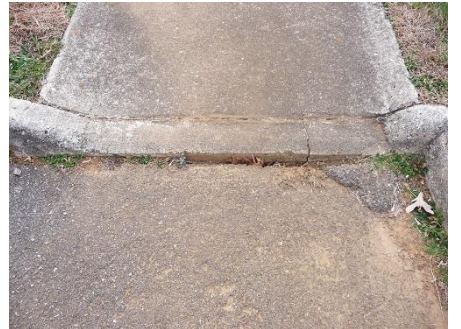
- Concessions building looks dilapidated
- Walkway from parking area is damaged
- Softball field looks unmaintained

- Renovate or rehabilitate concessions building
- Repair damaged walkway
- Repair and maintain softball field
- Consider transferring management to Roanoke City Public Schools

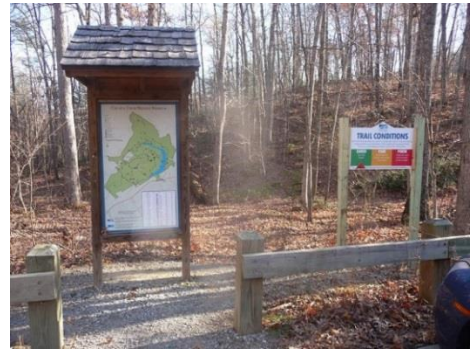
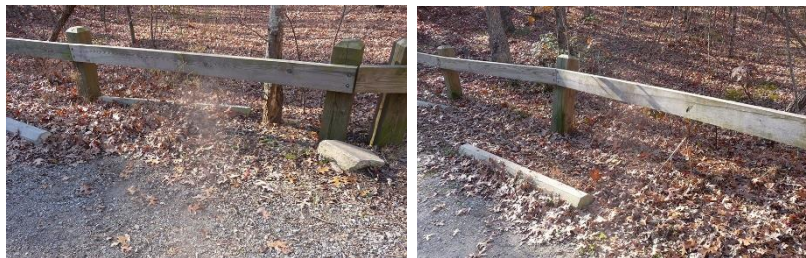
- Vehicle bumper stops missing or out of place
- Wood fence and post is leaning

- Replace missing bumper stops and align all stops in correct locations
- Repair wood fence and post

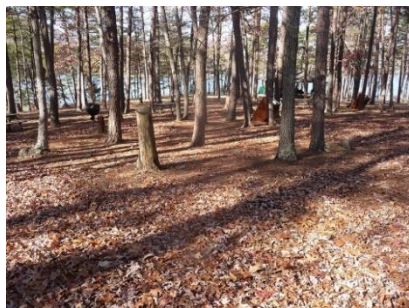
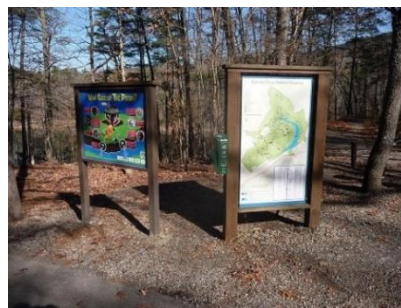
- Lack of ADA access routes to picnic facilities, restrooms and fishing areas

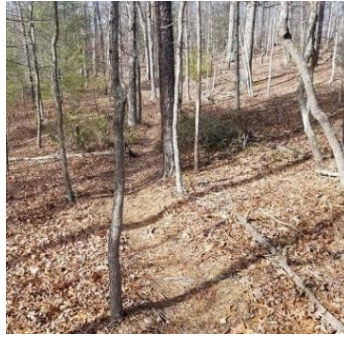
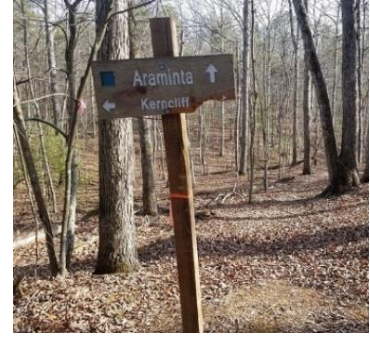
Araminta Trail: The Araminta trail is a natural surface trail that connects to the Hemlock Tunnel trail and the Kerncliff trail just above the reservoir. Araminta, which receives little use, is 0.71 miles long, and is in fair condition needing some minor repairs. The directional sign on the trail has some damage and should be replaced.

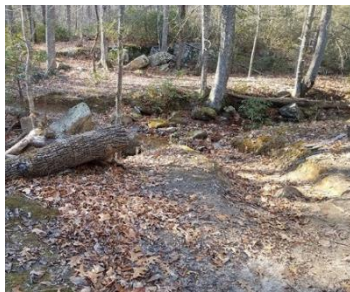
Arrowhead Trail: This is a 1.53-mile natural surface trail at the northwest end of the reservoir that receives moderate use spring, summer, and fall and little use in winter. The trail is in poor condition with erosion from poor drainage that needs to be addressed. There are several places where the trail is on a fall line and could be re-routed to reduce trail erosion. Water diverters that were put in 6-8 years ago have filled in and are overgrown. These need to be re-established to reduce erosion and prevent mud and water pools. The trail signs need repair as well, and the intersection with Sawmill Branch needs a sign added.

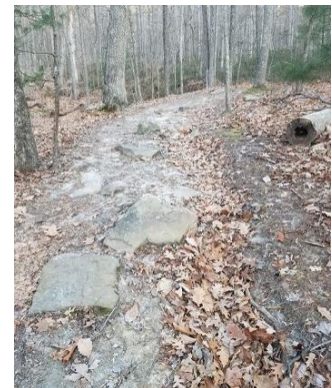
Bennett Springs Loop: This is a 0.83-mile loop trail at the Bennett Springs parking area that receives heavy use spring, summer, and fall and light use in the winter. It is a natural surface trail that is in good condition other than some erosion and saturation in places.

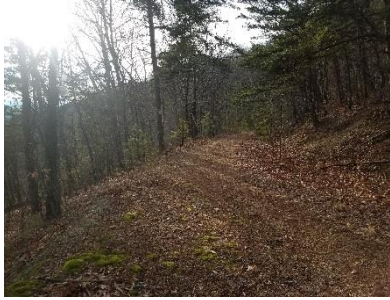
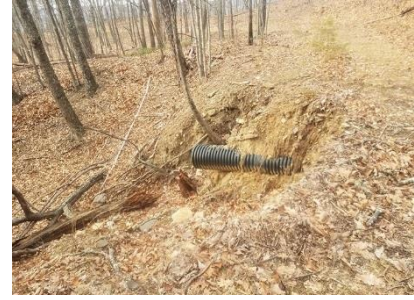
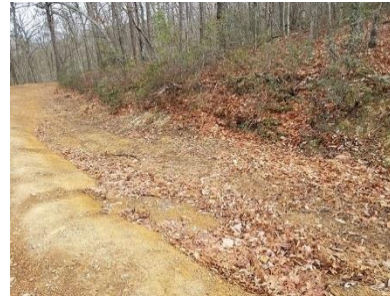
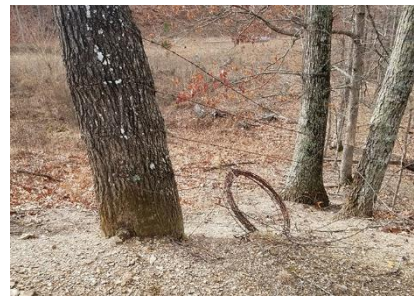
Brushy Mountain Trail: This trail is an old fire road that runs from the north end of Carvins Cove Road for 9.81 miles up and over Brushy Mountain. The trail is natural surface and receives moderate use spring through fall and light winter use. The side ditches and culverts should be reopened and the road re-graded to allow for better drainage. In many places the culverts are full of sediment, rock, deadfall and saplings, and the water is running down the trail causing erosion. There is substantial erosion along the sides of the trail as well,

particularly where there are steep banks. There are also some cosmetic issues such as barbed wire wrapped around trees and an old gate post alongside the trail.

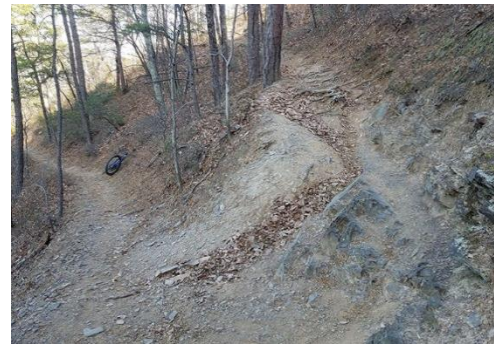
Buck Trail: Buck Trail is a 1.5-mile natural surface trail that is accessed from the Hotel Trail heading south from the Bennett Springs parking area. The trail receives heavy use in the fall, moderate use in the spring and summer, and light use during winter. The trail is in fair condition overall, but there are areas of bad

erosion that need to be addressed and water diverters that need to be cleaned out and new ones built to improve drainage.

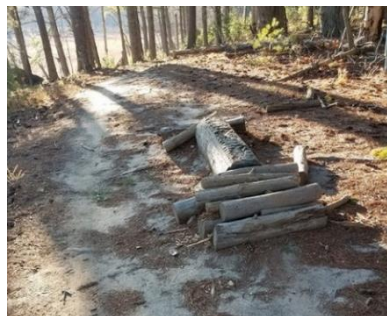
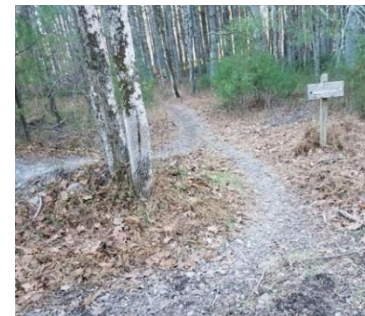
Enchanted Forest Trail: This 0.66-mile natural surface trail is located at the northwest end of the reservoir. It receives heavy use spring through fall and moderate use in winter. The trail is in good overall condition, other than some braiding at several intersections. The different trail intersections show two different trail difficulty markings while the kiosk just shows one. The trail signs should show the same as the kiosk for consistency. The trail is split into two separate segments,

which can be confusing, the technical mountain bike features should have signs, and the largest log stack should be rebuilt.

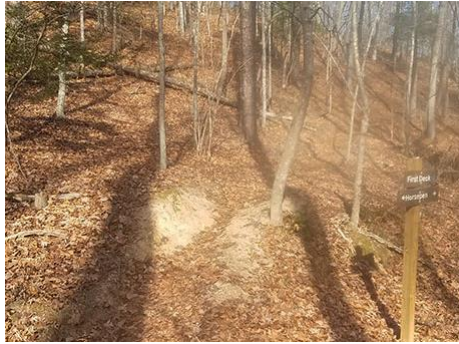
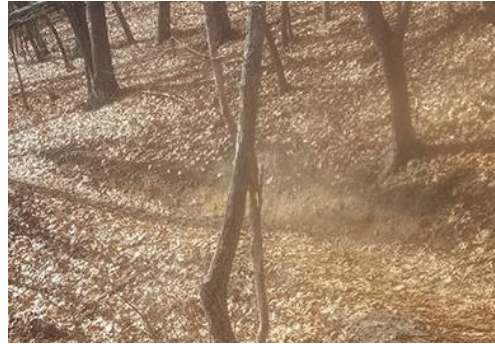
First Deck Trail: This is a 0.92-mile natural surface loop trail that begins and ends on Horsepen Trail between Trough and Gauntlet trails. It receives moderate use in summer and light use the rest of the year. The trail is in good condition other than some erosion in a couple spots and the trail sign needs repair.

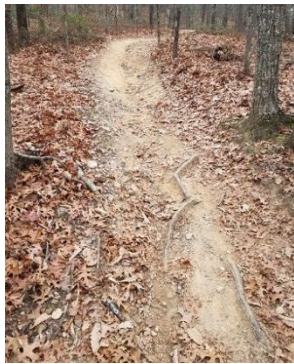
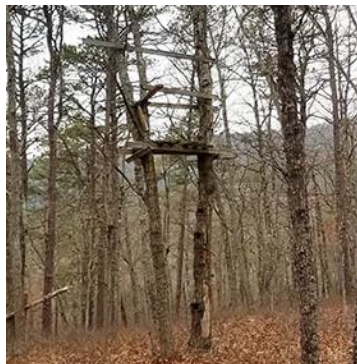
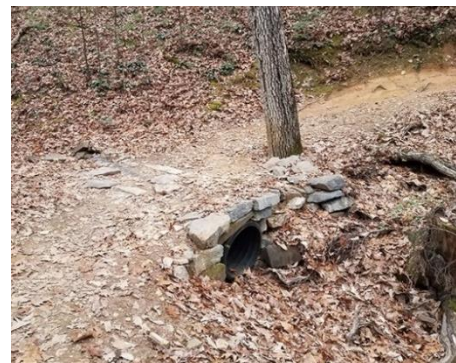
Four Gorge Trail: This 2.13-mile natural surface trail is accessed from the Bennett Springs parking area and is one of the most popular trails at Carvins Cove. It is in fair condition, receiving heavy use spring through fall and moderate use in winter. There is one spot of bad erosion, and many of the water diverters have washed out and need to be repaired. There is a social trail leading to a treestand and a “no trespassing” sign that is on City property. The social trail should be closed, the treestand and sign removed, and the culverts should be cleaned out and re-established. The bridge appears to be in good condition.

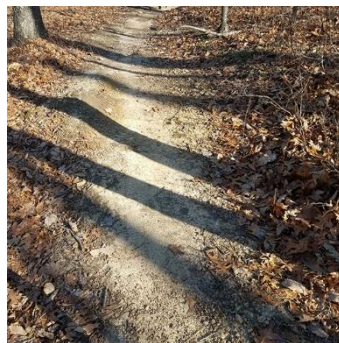
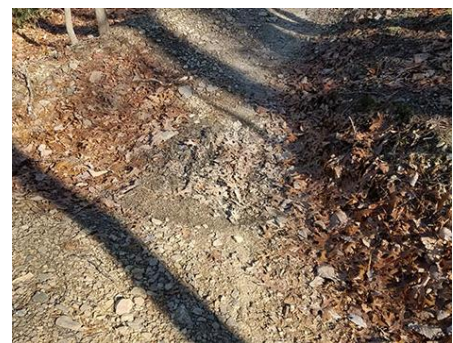
Four Gorge Extension: This 0.69-mile natural surface trail continues from the north end of the Four Gorge Trail and leads up to Tuck-a-Way and Kerncliff trails. It receives heavy use spring through fall and moderate winter use. It is in good condition except for some of the grade reversals and water diverters have eroded and filled in, causing muddy spots.

A sign needs to be placed at the trail intersection with Kerncliff Trail letting users know they are entering Kerncliff.

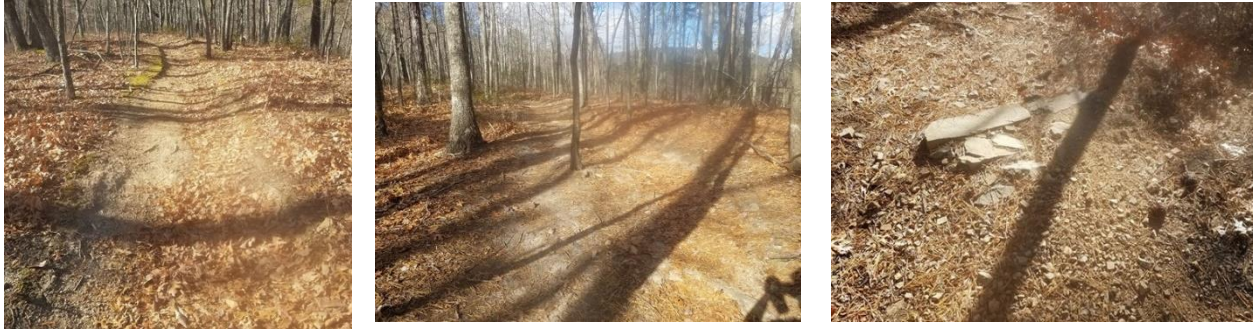
The Gauntlet: This is a steep 2.05-mile natural surface trail that goes over Brushy Mountain and connects Brushy Mountain and Horse Pen trails. It receives heavy use in the summer and fall, moderate use in spring, and light use in winter. The trail is in somewhat poor condition from erosion and water diverters that are not functioning. There is trail braiding at one place because of exposed roots from trail erosion, and there are a couple social trails that should be closed. Repairing the water diverters and placing new tread on eroded areas would greatly improve this trail.

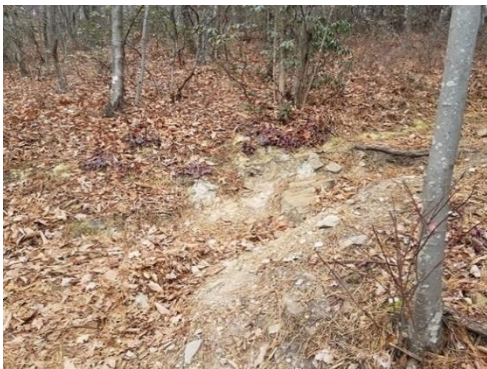
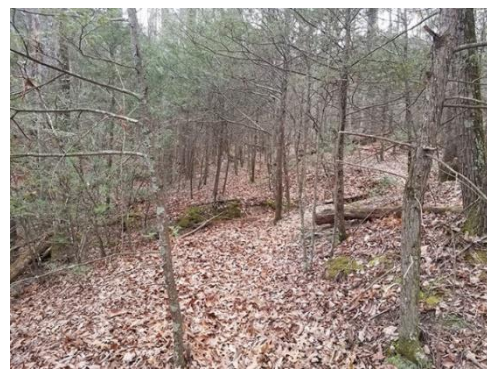
Hemlock Tunnel trail: This 1.87-mile natural surface trail is located at the north end of Brushy Mountain Trail and connects to Kerncliff Trail. It receives moderate use spring through fall and light winter use. The trail is in somewhat poor condition due to erosion and water diverters that need to be repaired and cleaned out. In some places the vegetation has grown into the trail corridor and needs to be trimmed back. There is a section of trail that is mostly in the creek, so alternate routes should be explored.
