FACILITIES ASSESSMENT REPORT

2019

CHAPTER ONE – PARK AND FACILITY ASSESSMENTS

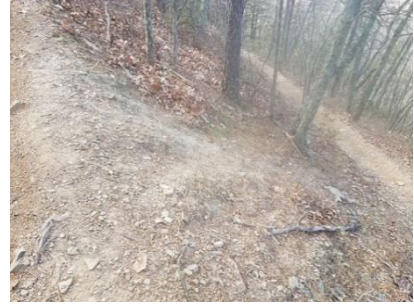
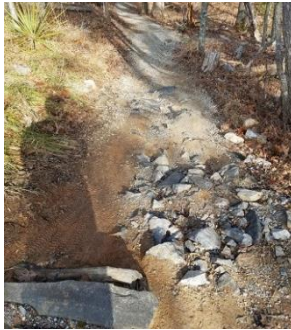
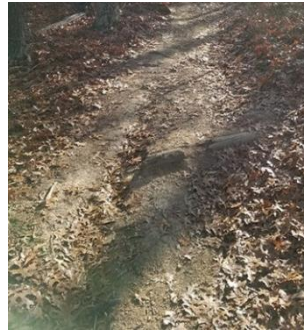
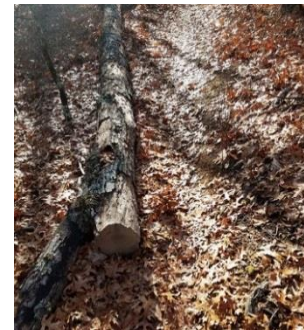
Hi Dee Hoe Trail: This is a 1.52-mile natural surface trail accessed from the Bennett Springs parking area. It receives moderate use spring through fall and light use in the winter, although the beginning of the trail gets heavy use because it provides access to the Four Gorge Trail. The trail is in fair condition, but there are some erosion and drainage issues. Several water diverters need to be repaired and other places along the trail need new ones built. Drainage from the parking lot is causing erosion at the beginning of the trail.

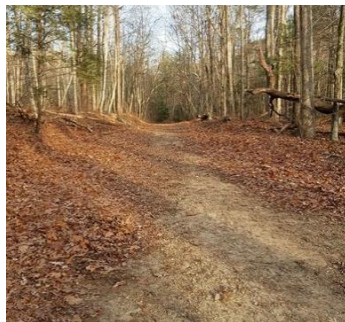
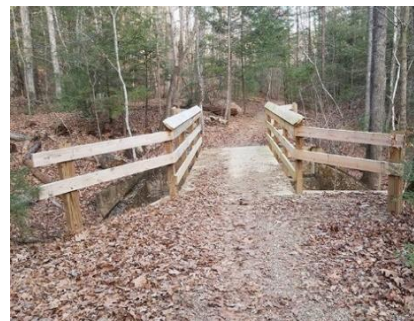
Horsepen Trail: This 1.24-mile natural surface trail is an old fire road that is accessed from the Timberview parking area and leads to the south tip of the reservoir. The trail is in fair condition and its two bridges are in good condition. Culverts should be cleaned out to improve drainage and improved and increased signage would be beneficial as well.

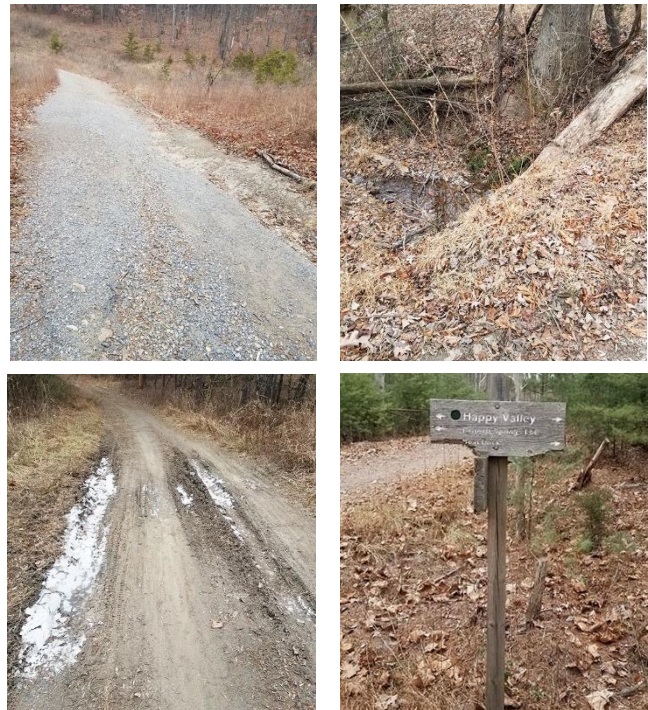
Happy Valley Trail: This is a 6.71- mile fire road that is dirt and gravel, located at the north terminus of Carvins Cove Road. It receives heavy use spring through fall and moderate winter use. The trail is in good overall condition, with a few areas of erosion and muddy spots, mostly near culverts. Most of the culverts are clogged with leaves or limbs and need to be reopened. There is an exposed culvert that needs tread placed above it, some metal posts with no signs, a damaged trail sign that needs replaced, and some of the intersections could use better signage.

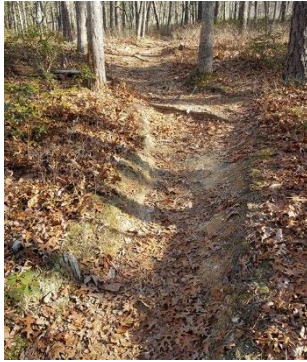
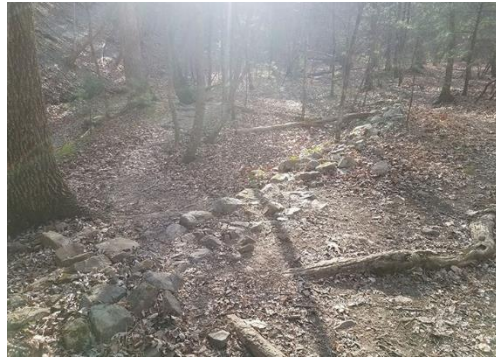
Hotel Trail: The Hotel Trail is a 1.14-mile natural surface trail that heads south from the Bennett Springs parking area. It receives heavy use spring through fall and light use in winter. The trail is in fair condition but needs maintenance and repair in several places. There are a couple spots with trail braiding and erosion and there are water diverters that have filled in and other places that could use new ones. Some of the armoring along the creek crossing needs the tread repaired, and the old fall line climb on the third reroute section should be permanently closed and revegetated.

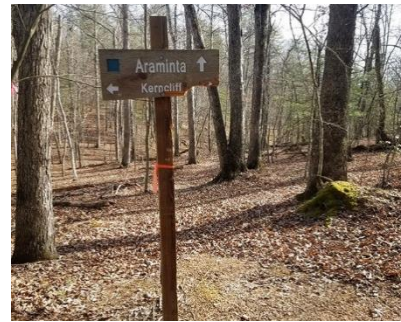
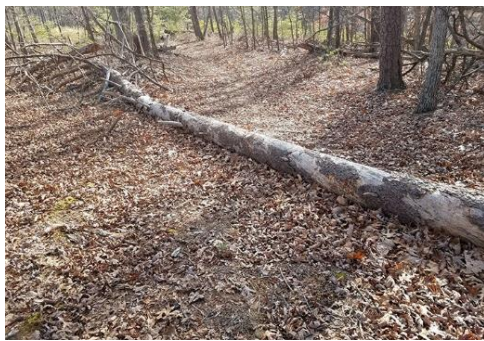
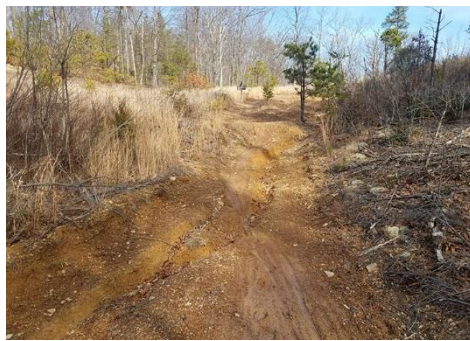
Kerncliff Trail: Kerncliff Trail is an old fire road that is 2.47 miles long and although it receives light use, it serves as an important connector for many of the mid-mountain trails. In many places it has become a single-track trail. The trail is in overall poor condition, with drainage issues that need to be addressed. One area needs a culvert installed to stop major drainage across the trail. Another place gets muddy and needs stone material added to the trail. Several culverts need to be cleaned out. There are seven trees down across the trail in various places, and several places need the vegetation cleared back away from the trail. Wayfinding signage could be improved along the trail as well, and some signs have been damaged and need to be replaced.

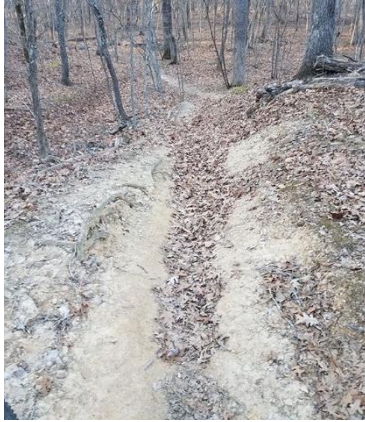
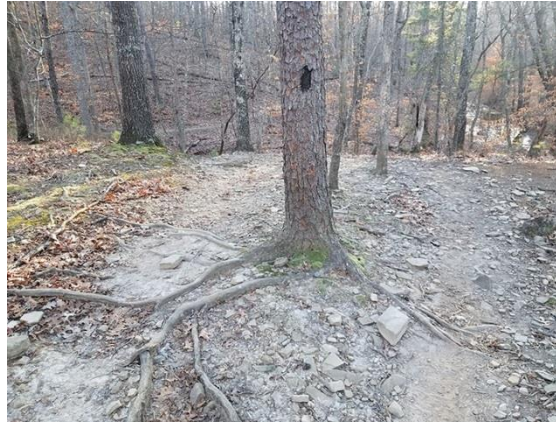
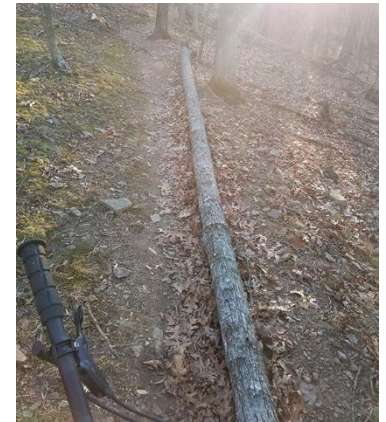
Lower Comet Trail: This is a 0.72-mile natural surface trail that runs north from the north end of Carvins Cove Road. It receives heavy use spring through fall and light winter use. The trail is in poor condition because of substantial erosion and braiding and needs tread repair and water diverters. A fallen tree alongside the trail has narrowed the trail and should be removed. There is a difference in trail difficulty between the lower and upper Comet Trails and a sign should be placed where Comet Trail intersects Happy Valley Trail and Tuckaway Trail to alert users to this.

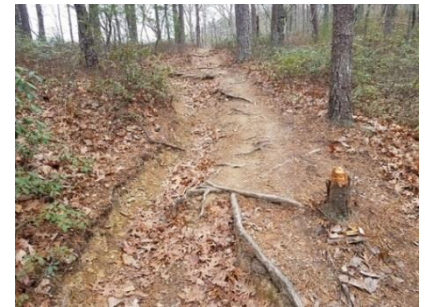
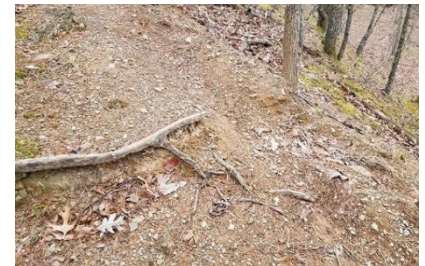
Upper Comet Trail: This portion of the Comet Trail continues north from the Lower Comet Trail and is considerably more difficult than the Lower Comet. This natural surface trail receives moderate use spring through fall and light winter use. The trail is mostly in poor condition due to bad erosion and braiding. The worst section is on the area called “the hill of despair,” which is so steep that bikers must push their bikes up the hill and the trail has widened to 10-12 feet. There is adequate space to construct an alternate route. There are several places along the trail where water is running down the steep hills to the trail causing erosion, so benches and water diverters should be constructed to improve drainage. Finally, there is a section where the vegetation should be trimmed back from the trail, and the sign at Tuckaway Trail should be changed to indicate the increased difficulty of Upper Comet Trail.

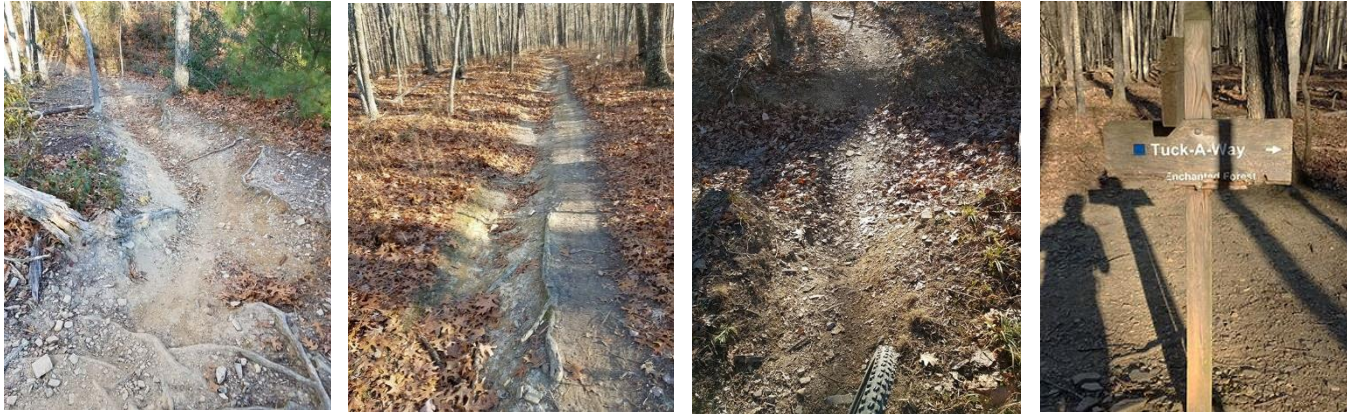
Tuckaway Trail: This natural surface trail is 0.97 miles long and connects the Happy Valley and Kerncliff trails. It receives heavy use spring through fall and moderate use during winter. The trail is in fair condition but has substantial drainage and erosion issues and braiding that need to be addressed. One section of trail passes through a steep narrow creek gorge and should probably be rerouted or have water diverters added along the top to protect the gorge. There is a perennial mud spot that needs to be armored or rerouted, and the sign at the Comet Trail intersection is damaged and should be replaced with a sign that includes better wayfinding.

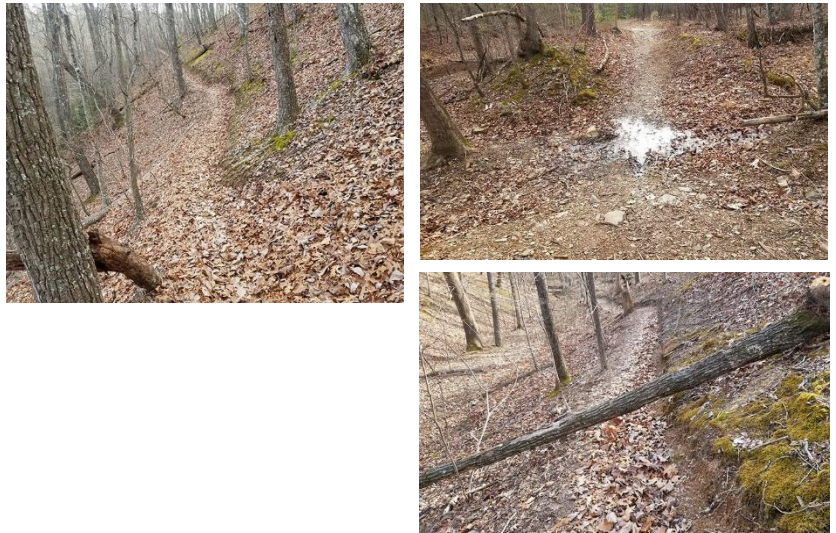
School House Trail: This 1.62-mile natural surface trail is a popular and easy hiking trail located at the northwest end of the reservoir. It receives heavy use spring through fall and moderate use in winter. The trail is in fair condition but has some drainage and erosion issues. Because it is flat and in a swampy area, it is prone to being muddy. Water diverters should be added in several places to reduce runoff on the trail, and there is significant erosion at the intersection of Happy Valley and Little Bell trails, so this area should be revegetated. The sign for the vista point needs to be replaced and wayfinding signs could be improved. There is a tree leaning across the trail that should be removed and the log stack area that needs to be restacked.

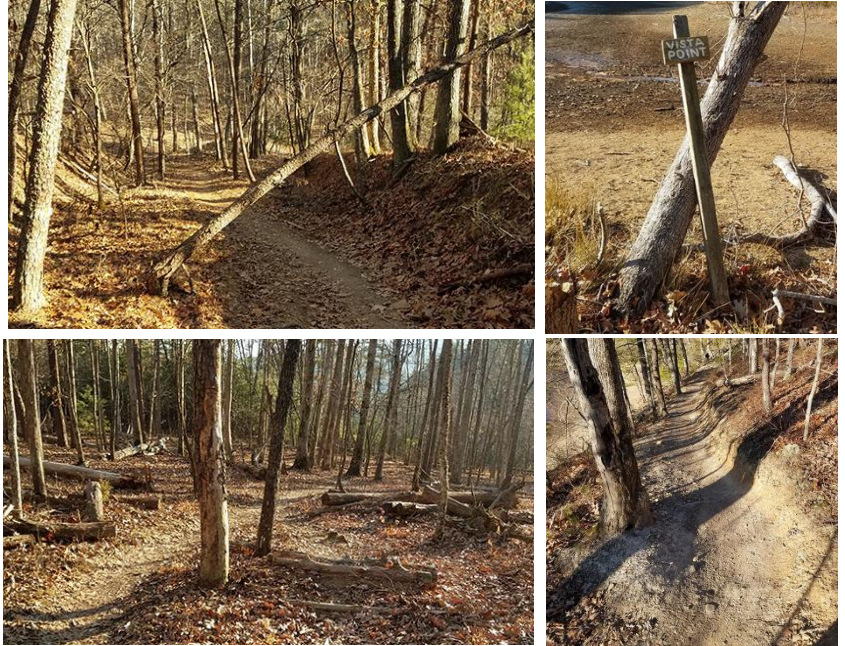
Little Bell Trail: This is a short 0.29-mile natural surface trail at the northwest end of the reservoir. It receives heavy use spring through fall and moderate winter use. The trail is in fair condition, but tends to be muddy because of its low, flat location. There is braiding at the Schoolhouse Trail intersection and better trail signage is needed there. Two muddy spots on the trail need armoring, and one needs the bricks removed from the trail because they get slick when wet. The old log stacks need to be either restacked or removed.

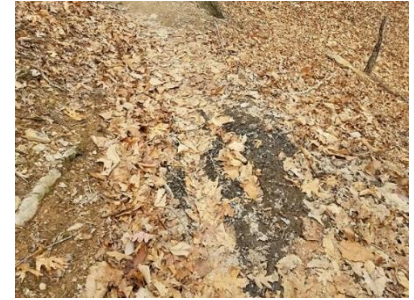
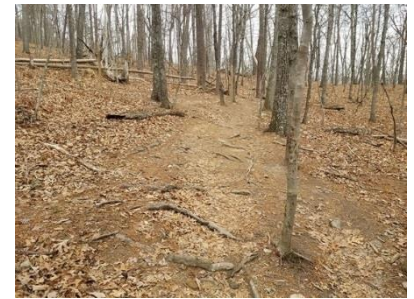
Songbird Trail: This 1.88-mile natural surface trail connects at both ends to the Happy Valley Trail and receives heavy use year-round. It is in fair condition with several areas of erosion, trail braiding, and muddy spots. The section of trail from Enchanted Forest to the Tunnel needs tread repair, dip repair, and water mitigation, and the sign at the south end of the trail needs to be reoriented to face the trail entrance.

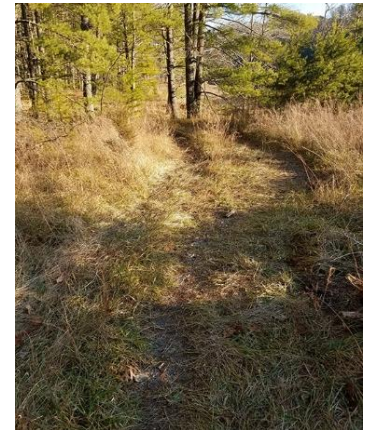
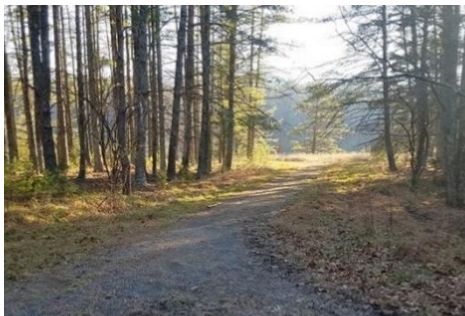
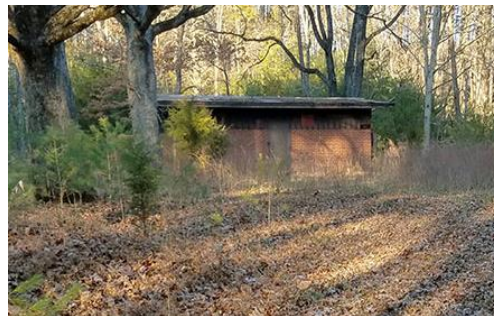
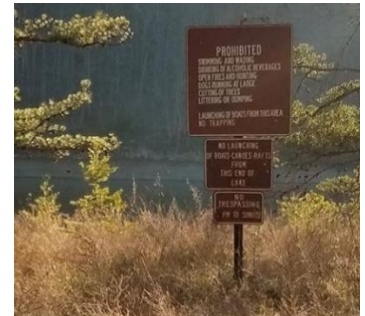
Riley's Loop Trail: Riley's Loop is a 0.34-mile stretch along the old fire road at the northwest end of the reservoir that leads to a picnic area with magnificent views of the lake. The trail and picnic area are rarely used. The trail is in fair condition with no significant issues, but the path leading to the lake has vegetation growing on it. Consider resurfacing with stone dust. Signage should be added at the Happy Valley intersection. Consider removing the old regulations sign and replacing with a more welcoming informational/ regulations sign. Removing the old restrooms and pump house and placing some picnic tables and lounging chairs would help to make this a destination picnic area.

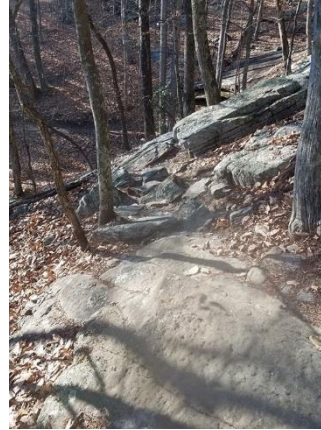
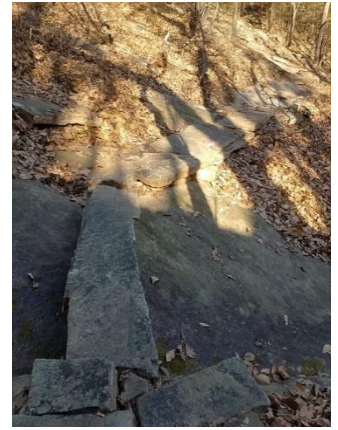
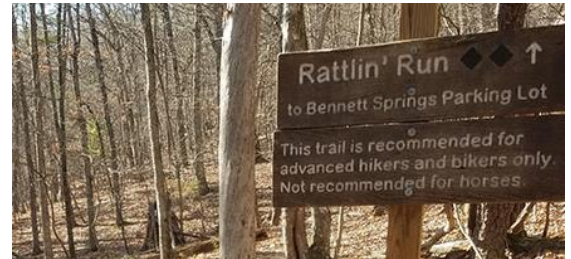
Rattlin' Run Trail: This 2.28-mile natural surface trail, which heads northwest from the Bennett Springs parking area, is the most difficult and technical trail at Carvins Cove because of its challenging rock features. While it receives only light use, it attracts mountain bikers from all over due to its technical challenge. The trail is in good condition with no erosion or drainage issues thanks to all the rocks and well-drained soils, but there is some braiding from bikers going around the technical features. Leaves on the rocky trail make it more hazardous and further encourage users to skirt around difficult areas, so blowing the leaves off in late fall should help reduce braiding. The sign at the Bennett Springs loop intersection needs to be changed from “not recommended for horses” to “no horses allowed.”

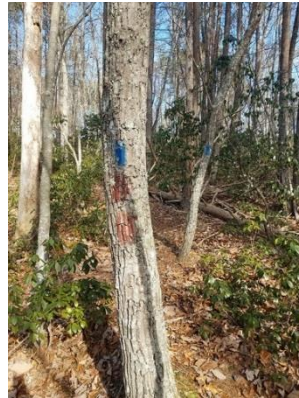
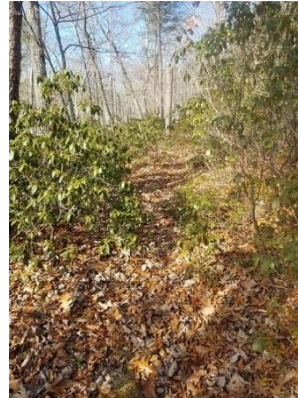
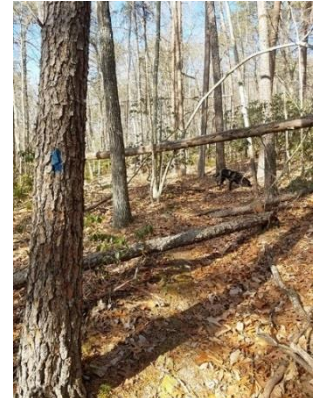
Sawmill Branch Trail: This 1.17-mile natural surface trail is the northern-most trail within Carvins Cove and is the only Cove trail that connects to the Appalachian Trail. It gets very little use and is in poor condition and in need of maintenance. The middle section of the trail is steep and has erosion from water

drainage. Water diverters should be installed to reduce this. There is significant deadfall and vegetation covering the trail, the trail blazes are two different colors and hard to follow, and there is no signage at the Arrowhead or AT intersections. The deadfall and vegetation need to be removed, the trail should be re-marked in both directions with consistent color blazes, and wayfinding signs need to be installed at the Arrowhead and AT intersections. New signage should be added at the Carvins Cove boundary to alert AT hikers that they are entering Carvins Cove and stating the regulations that apply.

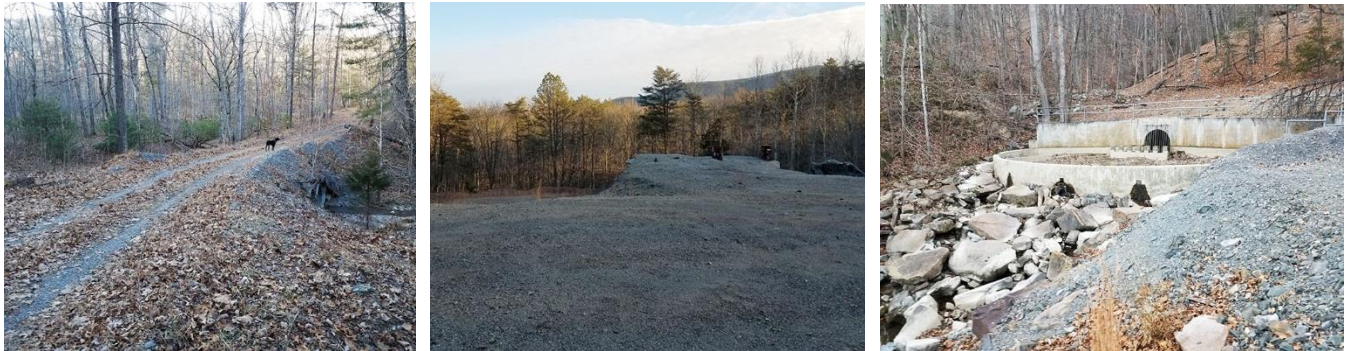
Tunnel Trail: The Tunnel Trail is a vehicle access road for the Western Virginia Water Authority that leads through Catawba Mountain to Catawba Creek. It is 0.43 miles long, 8-10-foot-wide, dirt and crushed stone, and is open to hikers, bikers and horses, though it receives little use. The road is in good overall condition with minor drainage issues. The trail ends at the tunnel, which is gated, and there is a large gravel field and old signs from when the tunnel was built. This area could be improved and made safer by removing the old signs, fencing off an area for viewing the tunnel, and installing interpretive signs informing trail users about the site.

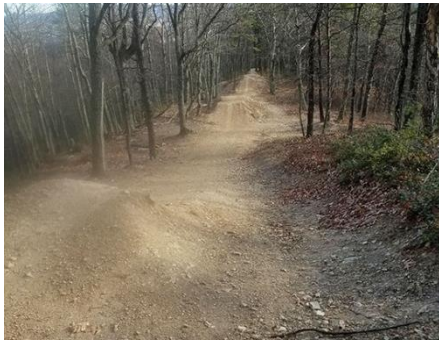
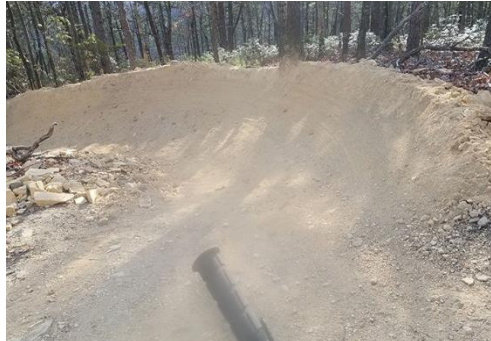
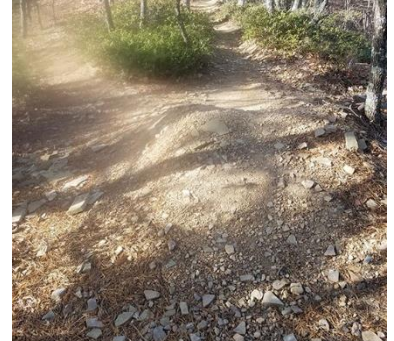
OG Trail: This was originally an old social trail near The Gauntlet Trail that has been converted to a gravity jump line for mountain bikes. It is 0.55 miles long and is a popular trail because of its unique technical features. The top and bottom portions of the trail are in good condition with well built and maintained features, but the middle portion has old hand-built features that should be rehabilitated. There are two drops along the trail that are very big and may need signage. There are also some minor drainage issues that should be addressed and an old social trail that should be closed off.

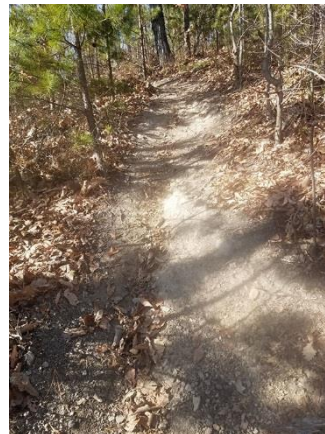
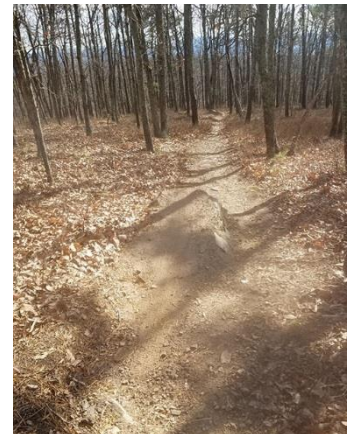
Royalty Trail: This 0.80-mile mountain bike trail was an old social trail that has been gradually getting developed as an official technical bike route. It receives moderate use and is in fair condition, mostly needing better water diversion to reduce erosion on the trail. There are three free-ride features that are either on short side trails or on the main trail with ride-arounds. These should have signs and lip marks to notify trail riders about them.

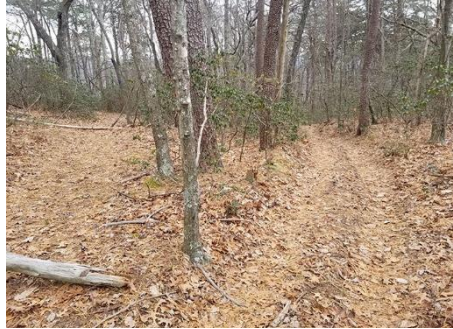
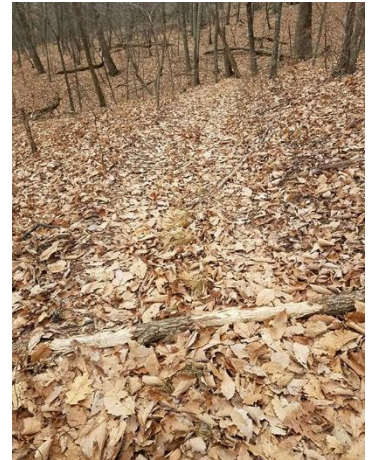
Old Blue Blaze Trail: This is a 1.7-mile natural surface trail that is mostly within the Carvins Cove property, but its northeastern intersection is on Appalachian Trail Conservancy (ATC) land near Lambert’s Meadow and its southwestern intersection is on private property. It receives very little use and is not currently shown on the Carvins Cove trail map. The trail is in poor condition and there is significant ATV use and social trails. The trail should be added to Carvins Cove trail map and be marked and maintained as an official hiking trail. Wayfinding and use restriction signs as well as increased hiker use would help to discourage ATV use. Staff should work with the Virginia Outdoors Foundation and DCR to get an exemption to reroute the trail back toward the rest of the Cove system near the tunnel through a Natural Heritage Area of the park.

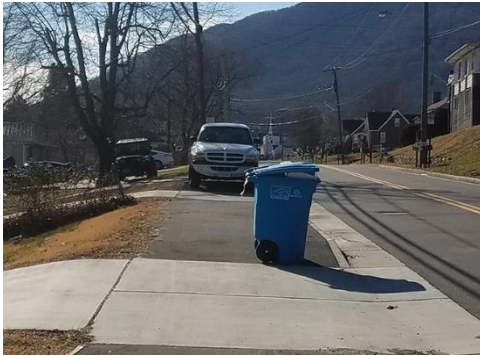
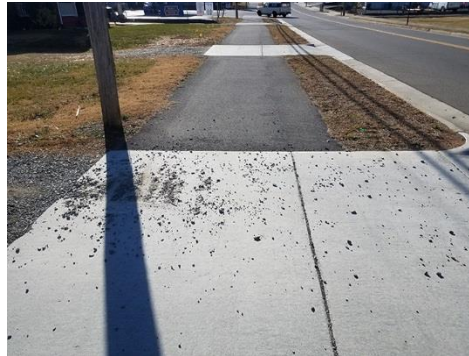
The Garden City Greenway is a 3.43-mile paved trail located within the Garden City neighborhood that runs from the Garden City Rec Center to Roanoke River Greenway. It is somewhat accessible, but not to the standards as per ADA for Outdoor Developed Areas at residential driveway entrances. The trail was recently developed and in very good condition; however, it is greatly lacking in signage, the City's standard 10-foot-wide trail width, clear zones, and definition at commercial entrances. Gravel washes from driveways onto the trail in places and poses a potential hazard to trail users.

There are no mile markers along the trail, and no kiosk or trail information signage at either end of the trail. It is recommended that utility poles be removed from within the asphalt trail sections; paint the trail section across commercial entrances and find opportunity to locate park benches and drinking fountains as feasible.

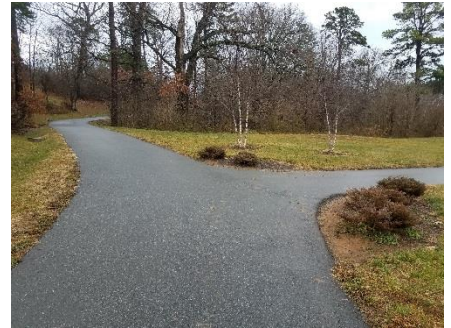
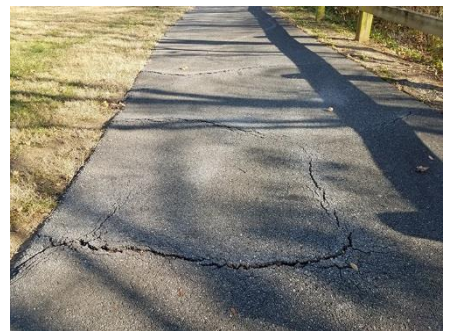
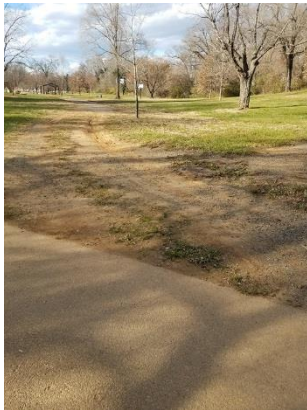
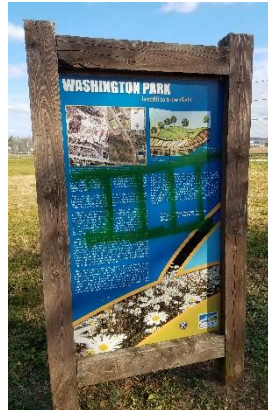
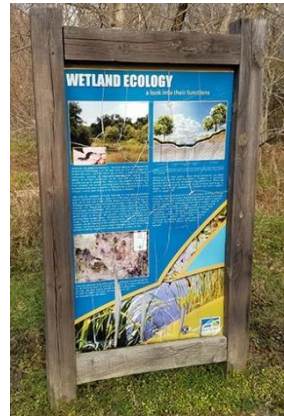
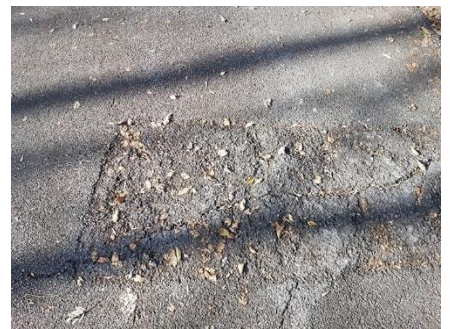
The Lick Run Greenway is a 4.5-mile asphalt paved trail that provides neighborhood connections via Countryside, Brown-Robertson, and Booker T. Washington Parks and offers amazing views of downtown Roanoke and Mill Mountain as well as solace within an urban environment. It also features interpretive signage. The trail receives moderate usage spring through fall and light winter use, and is ADA accessible, although there is a rough edge transition at the ADA ramp at Lucy Addison. Most of the trail is in good condition except for several places with cracking and upheaving in the asphalt; however, there are several other issues along the greenway that should be addressed. Wayfinding signage is very limited and should be increased, there are no trailhead kiosks or maps, and there are five commercial entrances that cross the greenway which have no safety signage and limited crosswalk markings. Many of the interpretive signs have cracked and peeling panels and some have been vandalized, and there is graffiti along the trail in Brown Robertson Park. There are several missing bollards along the greenway and evidence of vehicles driving on the greenway.

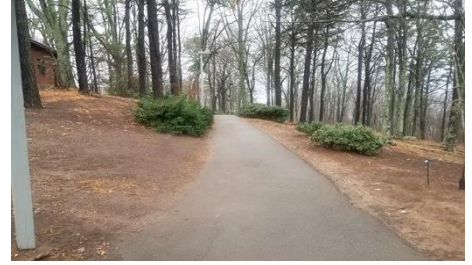
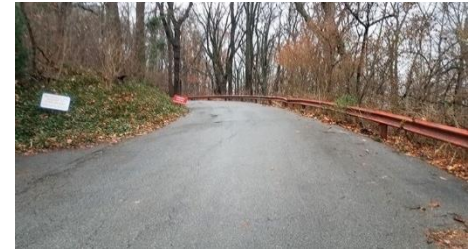
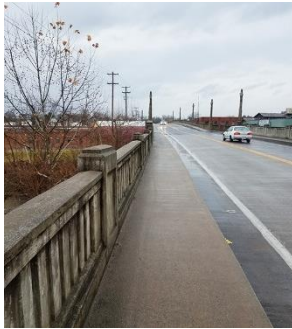
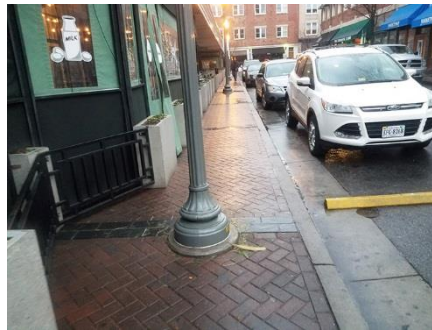
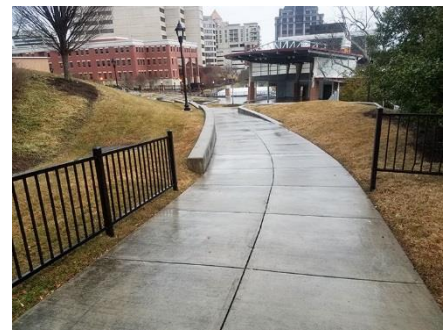
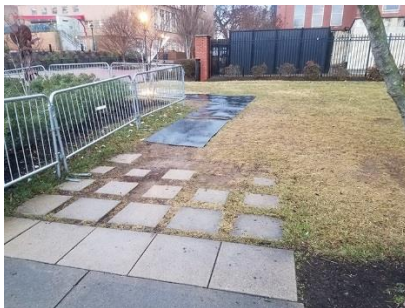
The Mill Mountain Greenway is a 3.4-mile paved trail that begins at the Star on top of Mill Mountain Park and terminates at Wells Fargo Plaza in downtown Roanoke. Portions of it are shared with roads or sidewalks, and ADA accessibility varies along the trail. The greenway receives moderate use spring through fall and light winter use. It is in good condition but needs significant improvements and upgrades with its wayfinding signage, mile markers, and amenities such as benches and trash receptacles. The culverts and stone wall on Prospect Road could use repair.

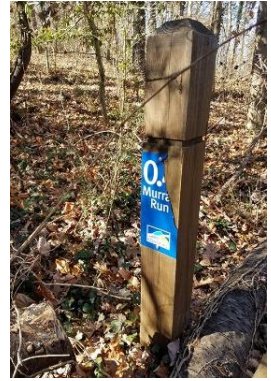
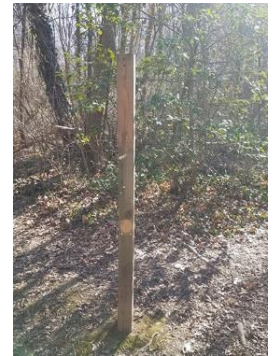
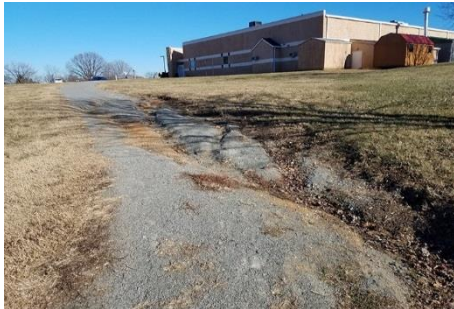
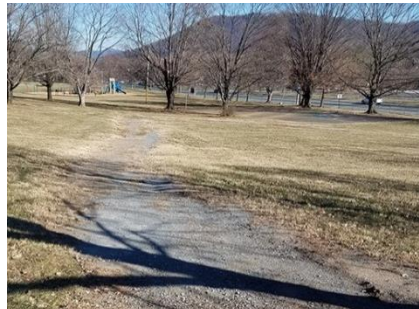
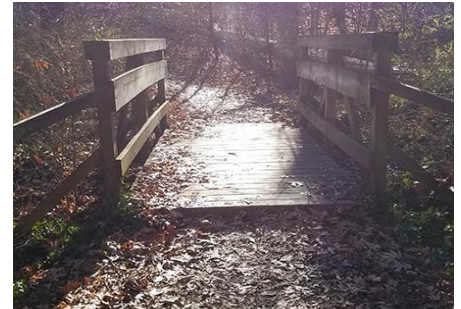
Murray Run Greenway is a 1.61-mile trail that starts in Shrine Hill Park on Grandin Ave SW and travels through City school property to Woodlawn Park, Fishburn Park, and terminates at McNeil Drive SW. Portions of the trail are natural surface dirt and other sections are crushed stone/cinder path and receives heavy use spring through fall and moderate winter use. The City's most natural greenway trail, Murray Run was created to follow the terrain via Fishburn, Woodlawn, and Shrine Hill Parks; therefore, ADA accessibility is not achievable due to the natural terrain. Several issues exist along this greenway that should be addressed. There are places where the trail is eroding, rutted and/or grass is growing through. The parking lot at Fishburn park is draining directly onto the trail causing erosion. This portion of trail is too steep for gravel as it keeps washing out, so it should be either paved or rerouted. One of the bridges has a large step up to it that should be eliminated and the sign on the other side of the bridge labels the social trail there rather than the greenway. There are several social trails along the greenway that should be managed. Some of the wayfinding signs along the greenway are damaged, old and faded, missing or in the wrong place, and many of the mile marker posts have cracked or missing placards.

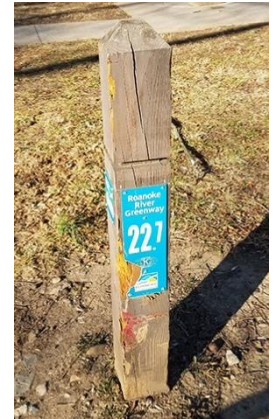
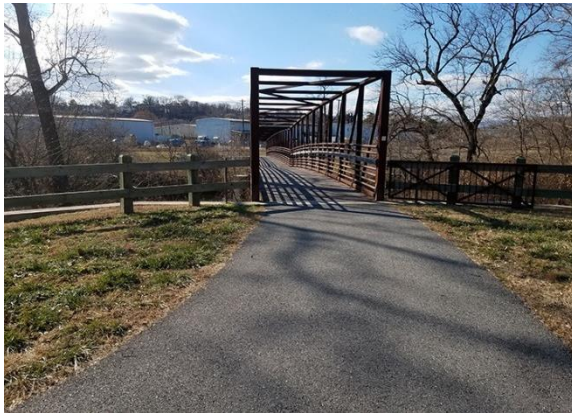
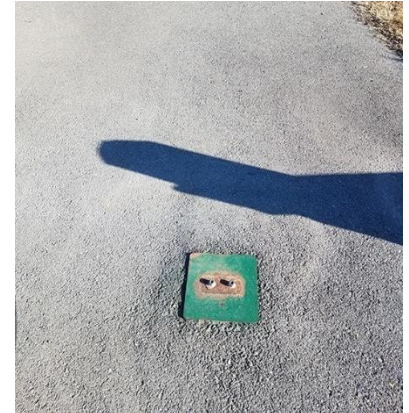
Bridge Street to Smith Park: This 3-mile stretch of the Roanoke River Greenway is one of the busiest sections of trail in Roanoke, receiving very heavy use year-round. It is asphalt paved and fully ADA accessible, and has abundant amenities such as benches, trash receptacles, fitness equipment, art sculptures, and wayfinding/regulation signage. The trail is in very good condition, but with some minor issues. The 22.5-mile marker post is rotted and post 22.7 is cracked, the crosswalk at the access road to Richardson needs to be repainted, the kiosk maps need to be updated to show the new Greenway expansions, and there is a bollard missing near the bridge between Vic Thomas and Wasena Parks and another bollard missing near the Green Goat. Additional wayfinding and trail-use signage would be helpful through Wasena and Smith Parks and along Memorial Bridge. While Parking is an issue, better wayfinding would provide information as to where larger parking opportunities are.

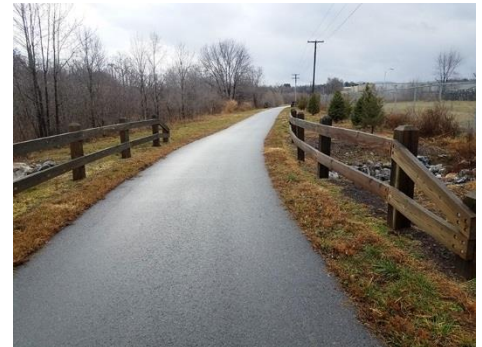
Blue Ridge Drive to Aerial Way: The section of Roanoke River Greenway from Blue Ridge Drive to Aerial Way is the newest stretch of Roanoke River Greenway. It is 1 mile long, asphalt paved and fully ADA accessible, although it receives little use. The tread surface is in great shape, but it has almost no amenities and no signage. A signage plan needs to be implemented along with mile markers, kiosks, benches, trash cans, and bike racks. There are also no public parking areas for this stretch of trail.

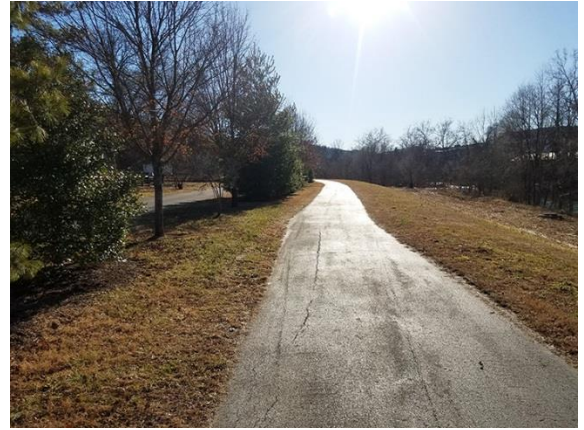
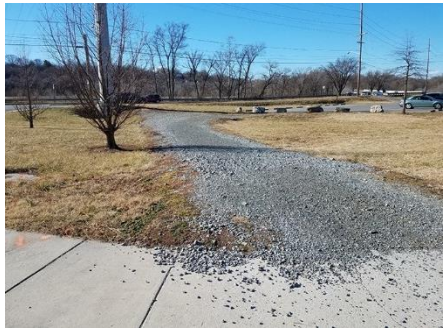
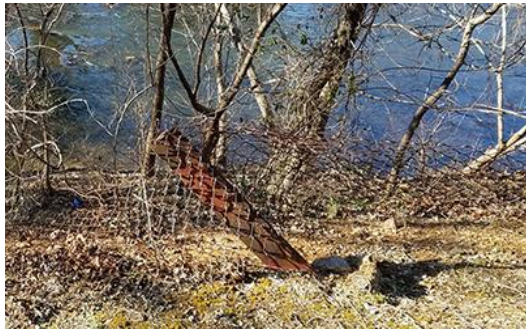
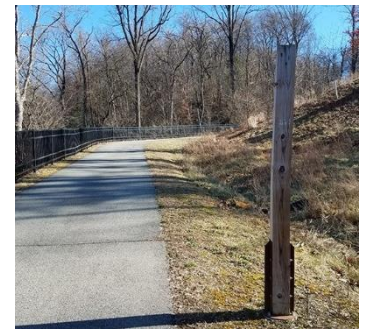
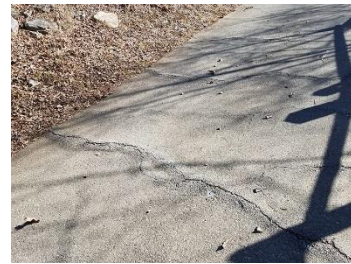
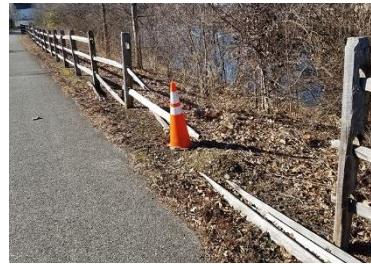
13th St. Trailhead at Bennington to Smith Park: This 6.3-mile stretch of the Roanoke River Greenway is mostly a 10-foot wide asphalt path. The paved portion of the trail is ADA accessible. The trail receives heavy use spring through fall and moderate use in winter and is in good condition except for a couple areas where there are cracks in the asphalt or missing asphalt edge from erosion. There are 13 missing mile markers and several missing bollards along this stretch of the greenway and two signposts with no signs. Certain areas along the trail could use additional signage as well. Near the hospital there is a section of fence that is falling down, and a section of wood fence is damaged near the intersection with Garden City Trail. Graffiti is present on signs and posts near the water treatment plant. While mapped, there is an off-road gap between the Bennington trailhead and the connection to the upper portion of the trail uphill from the Western Virginia Water Authority Treatment Facility. The on-road gap is very steep so it is recommended that the trail gap be developed and signed appropriately.

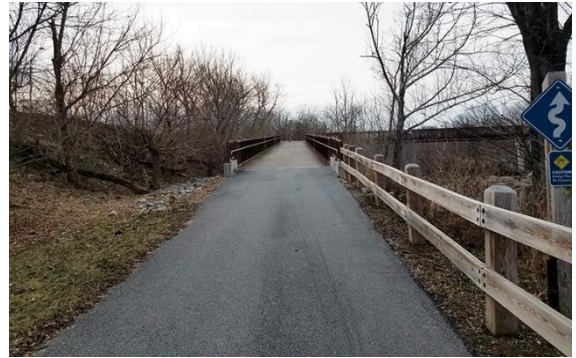
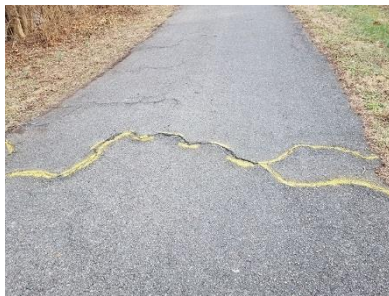
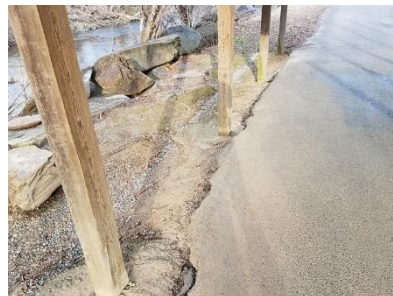
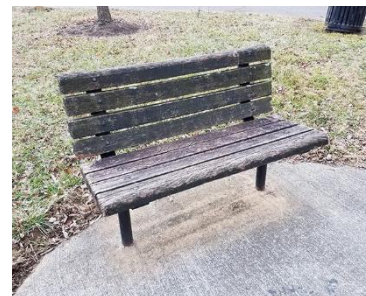
Tinker Creek Greenway Trail: This 1.1-mile portion of the Tinker Creek Greenway runs from the Roanoke River Greenway to Wise Avenue. It is a 10-foot wide asphalt path that is fully ADA accessible and receives moderate use spring through fall and light use during the winter. Overall, the trail is in good condition, except for some cracks in the asphalt between mile markers 0.8 and 0.9, and there is high water damage to the trail under the railroad underpass near Wise Avenue. There is considerable trash in this area on the ground and in the trees and bushes, likely deposited during high water events. There is only one kiosk and its map panels are peeling and the map is incorrect as to where Tinker Creek Greenway starts and ends. Kiosks are needed at the Wise Avenue and Dale Avenue trailheads, and signage placed at the Fallon and Kenwood trail connections. A bollard is missing at the Kenwood connector and the benches along the trail have rotting planks and need to be replaced. The second phase of the greenway trail is currently under design from the Wise Avenue trailhead north to Masons Mill Park.

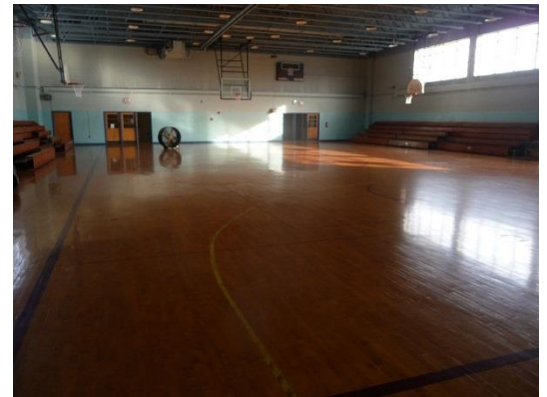
Once the Booker T. Washington School, this facility is now used as an administrative building by the City's school system and the indoor gymnasium is used for basketball practice during the week and occasionally for games. The facility is located in northwest Roanoke on Burrell Street, just north of Orange Avenue and across the street from Booker T. Washington Park.

- None of the facility is ADA accessible. All the walkways leading into the main building and the gymnasium building have steps and there is no ramp access.

- There is a damaged and uneven spot in the gym floor
- Gym lighting is outdated
- Restrooms are downstairs from the gymnasium- no ADA access
- There is no air conditioning in the gymnasium

- The entire gymnasium floor needs to be replaced or repaired

- Replace gymnasium lights with modern lighting
- Due to the structural and site issues with the facility, and since this facility is not managed by Parks and Recreation, it is recommended that the City halt all Parks and Recreation programming at this location.

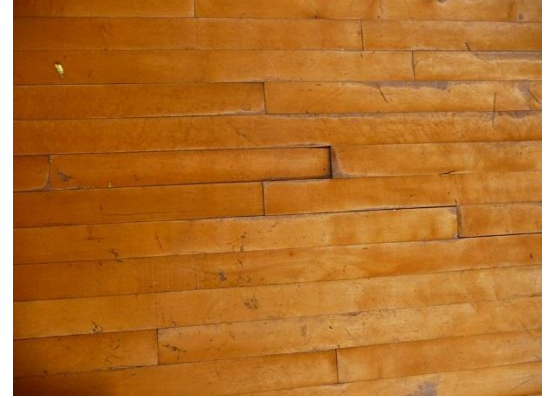
Breckinridge Middle School gymnasium

Breckinridge Middle school is located on Williamson Road between Trinkle and Fleming Avenues, just south of Preston Park. The City uses the gymnasium for basketball practice and games. The gymnasium is in pretty good condition but requires HVAC work, does not have AC, and needs a divider to separate the two sides of the gym.

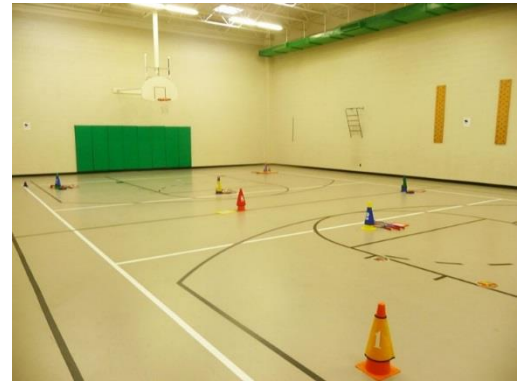
Highland Park Elementary School gymnasium

Highland Park Elementary School is located in southwest Roanoke on 5th Street between Albemarle and Walnut Avenues. The City uses the gymnasium heavily throughout the winter. The school building is very old, and the gymnasium is in fair condition with a few cosmetic issues. The basketball hoops are 11 feet high and unable to be adjusted to the proper 10-foot height, so the school is planning to replace them. Items belonging to the school are being stored along the walls inside the gym because there is not adequate storage space within the school. The gym is ADA accessible.

- Relocate non-athletic items to elsewhere in the building and add storage for athletic items

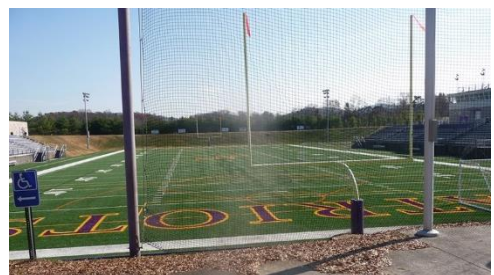
Preston Park Elementary School sports fields and gymnasium

Preston Park Elementary School is located on Preston Avenue just east of Williamson Road. The gym is used only for basketball practice since there are no bleachers in the gym. The gymnasium is in very good condition other than two places on the outside wall where the vinyl has been cut and taped.
