Carvins Cove
Natural Reserve
Park Management Plan

**Adopted
The Council of the City of Roanoke, Virginia**

**As Submitted by:
Roanoke Parks and Recreation**

December 17, 2007

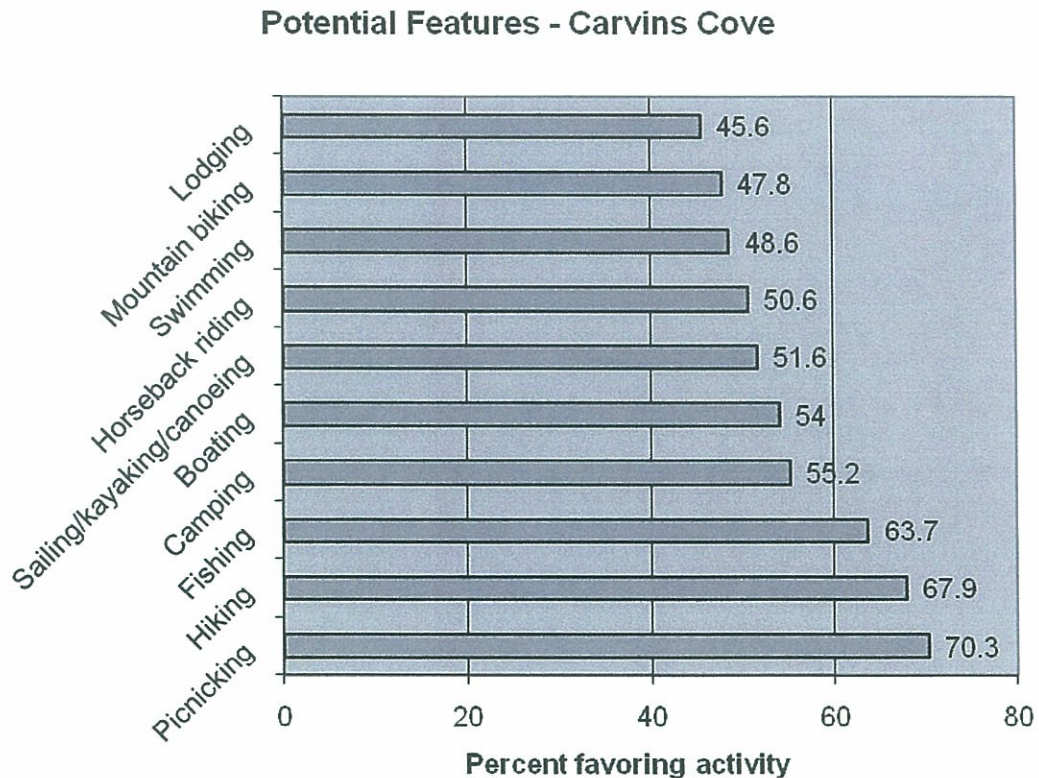
Figure 3. Telephone survey results for possible future recreational development at Carvins Cove

The survey also included a question about the types of recreational facilities that should be developed at Carvins Cove. Figure 3 shows a graph of the responses.

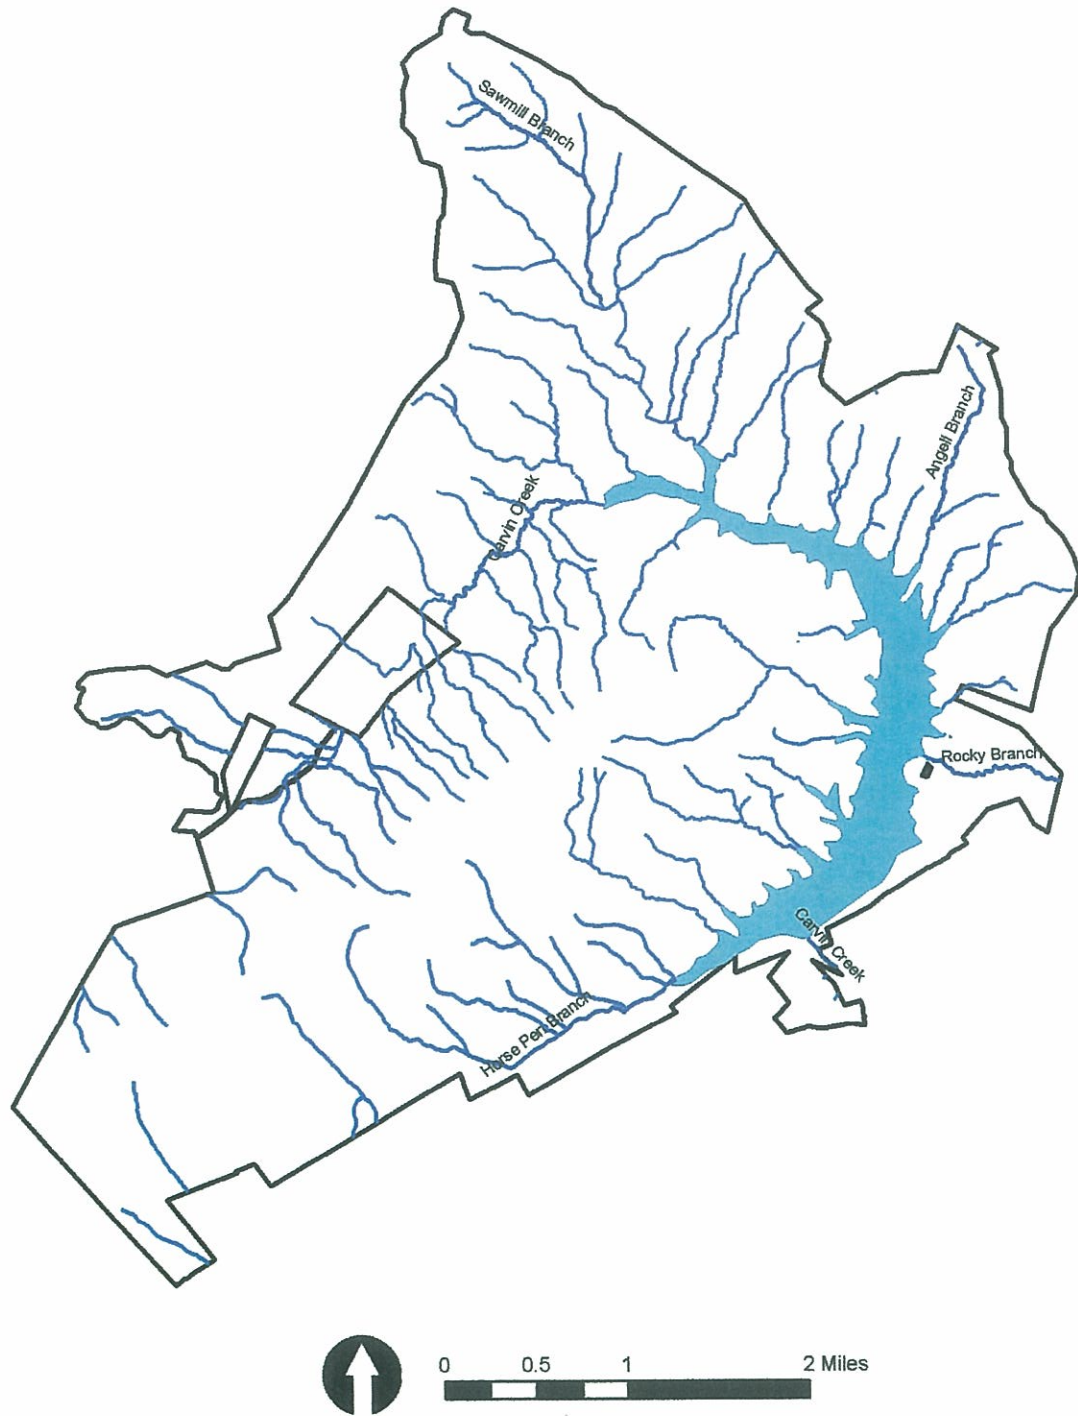
Figure 12. Hydrology

Hydrology of the Carvins Cove Natural Reserve is shown in Figure 12. The main tributaries into the Cove are Carvin Creek, Horse Pen Branch, and Sawmill Branch. Angell Branch, Rocky Branch, and many unnamed tributaries flow into the main streams and the reservoir itself. The 1999 Team Environmental Quality Resources (EQR) report titled "Carvins Cove Natural Resource Assessment" (Appendix A) states the following about the main tributaries:

of these [in-stream] features indicates that the reach is presently in the midst of substantial channel adjustments. ...The absence of significant riffle sections is an indication of degraded habitat conditions.
