# Hurricane Ike

Nature's Force vs. Structural Strength

**Institute for  
Business &  
Home Safety®**

September 2009

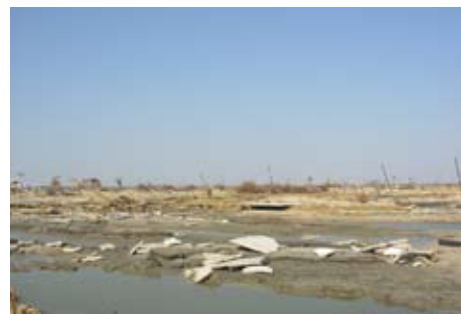
When the vast majority of buildings are built at or slightly above the 1 percent annual probability of exceedance base flood elevation (BFE), all it takes is an event (i.e., Hurricanes Ike, Ivan, Katrina or Rita) with surge levels a few feet above the BFE to wipe out the entire community.

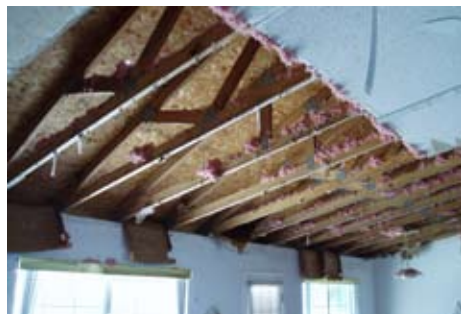
When you build in an area where water is likely to get inside, the choice of building materials can make all the difference.

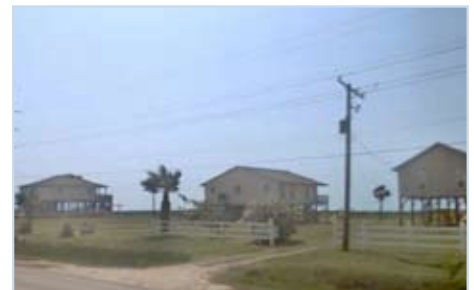
**Figure 2** Older traditionally built homes before Hurricane Ike. These houses, located directly south of some of the **Fortified** homes in Figure 4, were on the narrow strip of land on the Gulf side of the highway before being destroyed by Ike.

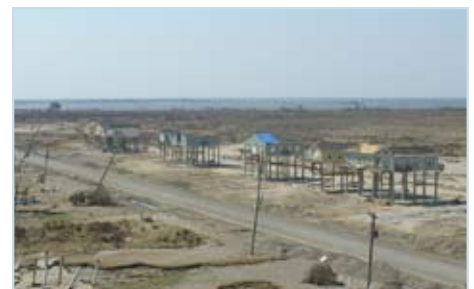
While **Fortified** homes performed exceedingly well compared to the more than 270 other surrounding homes on Bolivar Peninsula that were completely destroyed by Ike (Figure 3), they did sustain some damage. The key findings and recommendations contained here were formulated after IBHS compared and contrasted the performance of the **Fortified** homes with the conventional construction surrounding them, as well as examined relevant building code and other construction-related performance requirements. These research results can significantly improve the performance of both existing and new structures in hurricane-exposed areas.

**Figure 3** An aerial view of nine of the 10 **Fortified** homes still standing following Hurricane Ike amid the rubble of other traditionally built houses that did not survive.

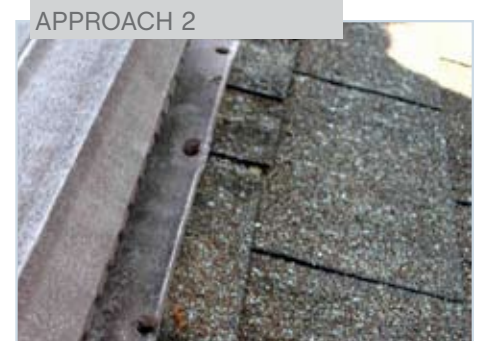
Poorly attached ridge vent covers can easily be replaced or the anchorage can be strengthened, since these are the last items to be installed on a shingle roof.

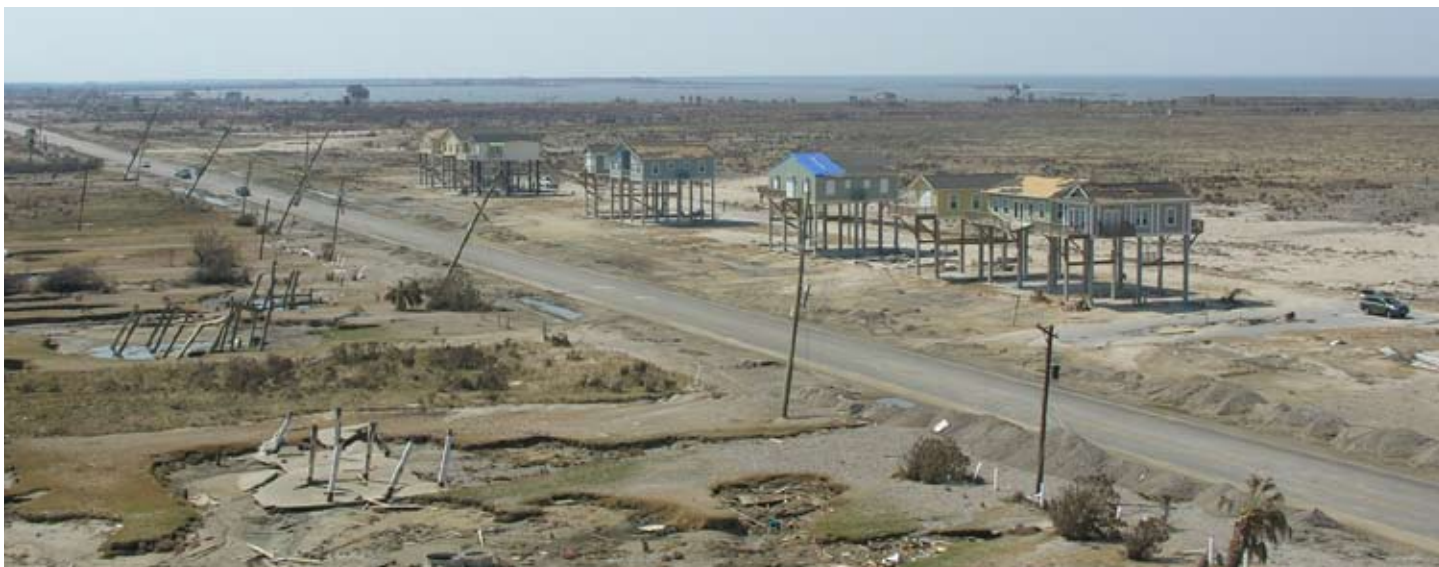
**Fortified** homes that survived Hurricane Ike on the Bolivar Peninsula, Texas.
