Surviving Nature's Fury: Performance of Asphalt Shingle Roofs in the Real World

Zhuzhao Liu, Research Engineer, Institute for Business & Home Safety, 4775 E. Fowler Ave., Tampa, FL 33617, zliu@ibhs.org

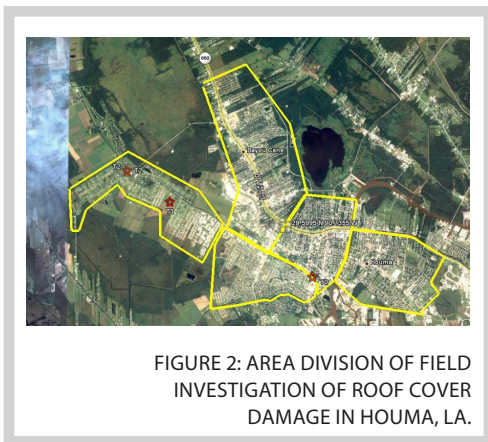
FIGURE 2: AREA DIVISION OF FIELD INVESTIGATION OF ROOF COVER DAMAGE IN HOUMA, LA.

After the storm, the UF faculty and students, who deployed the towers, split up into five teams and investigated damage to a total of 933 houses spread among the five yellow areas of Houma shown in Figure 2. The information collected included address, type of roof cover, roof shape, roof pitch, wall type and estimated average amount of roof damage as a percentage of the visible roof area. The data on the extent of the roof cover damage was generally recorded in 5 percent increments of the visible roof surface area.

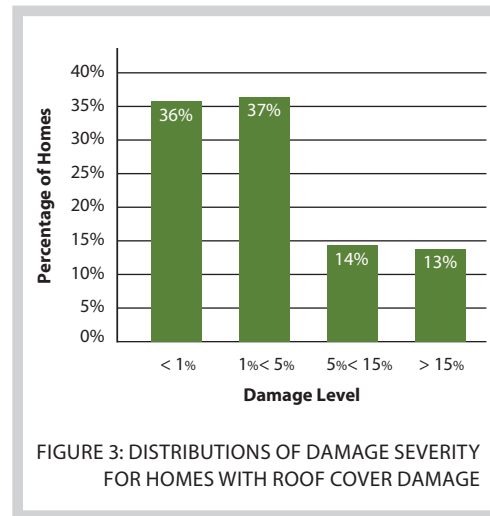
Summary data for damage frequency and severity obtained from the ground survey are listed in Table 2 and shown in Figure 3. Of the 933 houses investigated, 602 (65 percent) suffered some level of roof cover damage. The average roof

FIGURE 3: DISTRIBUTIONS OF DAMAGE SEVERITY FOR HOMES WITH ROOF COVER DAMAGE

cover damage per home was 7.7 percent. Of the 602 homes with roof cover damage, the average roof cover damage was 11.9 percent.

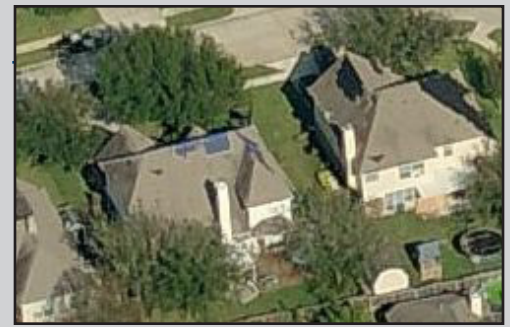
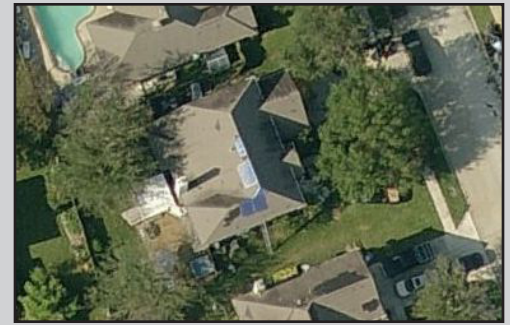
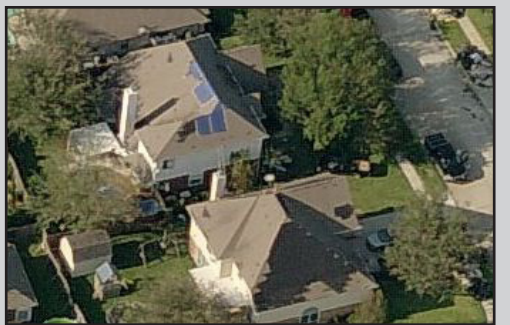
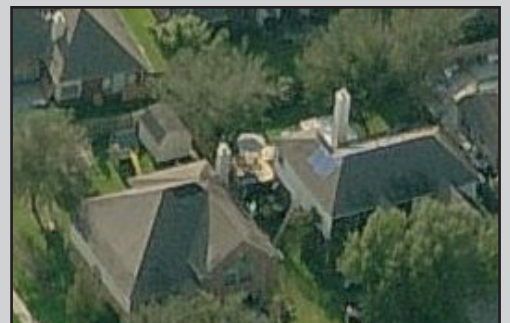
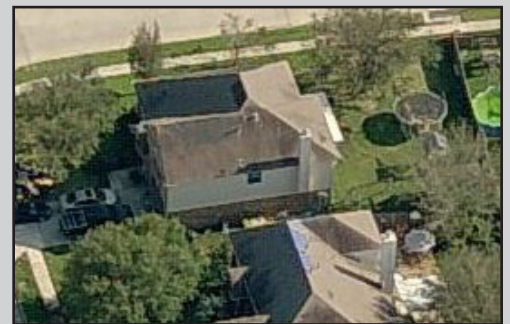
A more comprehensive assessment of the roof cover damage was conducted using high resolution aerial photographs. The photographs made it possible to more accurately locate the areas where damage occurred, relative to both typical roof wind pressure zones defined in modern building codes and to compass orientation. For Hurricane Gustav, IBHS purchased post-hurricane high definition oblique aerial photographs of Houma, La., from AirReldan, Inc. The view restrictions of the oblique aerial photographs made it possible to view all of the necessary orientations for only 388 single-family houses with shingle roofs. For Hurricane Ike, the research was enhanced through the IBHS partnership with FEMA and its contractors, through which IBHS was able to obtain access to 6-inch GSD imagery acquired by FEMA and Pictometry International Corp.⁶ following the storm. The images afforded researchers vertical as well as oblique photography views [Figure 7], including but not limited to the sides of buildings, which fostered the capability of performing accurate measurements of building features. Additionally, Pictometry provided researchers a program and a web application that could be used to locate, view, measure, and save Pictometry images. This program was used to assess the roof cover damage from Hurricane Ike.

FIGURE 7: HIGH DEFINITION AERIAL PHOTOGRAPHS PROVIDED BY FEMA/ PICTOMETRY INTERNATIONAL CORP.

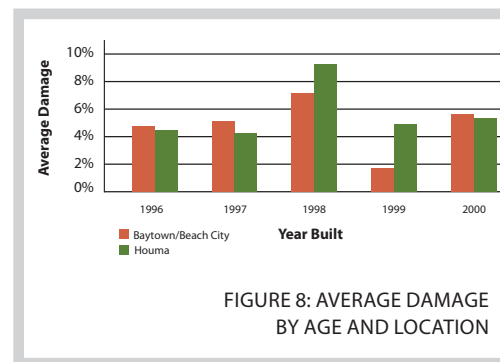
The average damage per exposure for homes in the Houma data set is similar to that of the combined Baytown and Beach City data sets, when comparing homes of the same age. This is illustrated in Figure 8.

FIGURE 8: AVERAGE DAMAGE BY AGE AND LOCATION

The majority of homes in the Hurricane Ike data set were constructed after 2001, and they received considerably less damage on average as compared to older homes. Unfortunately, because none of the Houma homes were constructed after 2000, it was not possible to determine if newer homes in that area experienced the same reduction in damage.

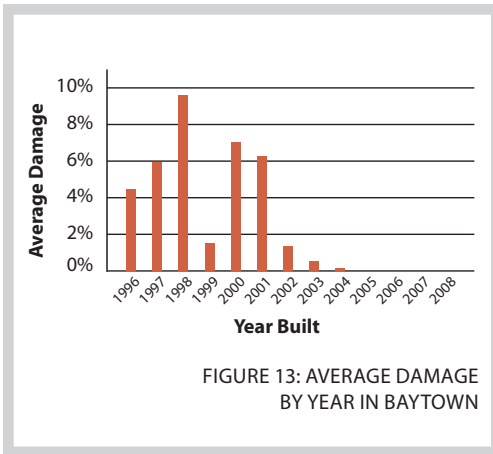
The age of the homes in this study that were affected by Hurricane Ike in Texas range from 1 to 12 years, and therefore the age of the home is more likely to reflect the age of the roof. Figures 13 and 14 represent the average damage per exposure by year individually for the Baytown and Beach City communities. Each graph shows a sudden increase in average damage for homes constructed

FIGURE 13: AVERAGE DAMAGE BY YEAR IN BAYTOWN

in 2001, followed by a general trend of increasing damage for homes built in prior years.

One interesting trend was that the average damage per exposure peaks for Baytown homes built in 1998, but declines for those constructed in 1997 and 1996. Aerial photography analysis showed this decline may be due more to the location of the homes and the density of the tree cover surrounding them than their age. These homes are located at the west side of the community and are surrounded by other houses and high density woods, which may have shielded them from the high winds.

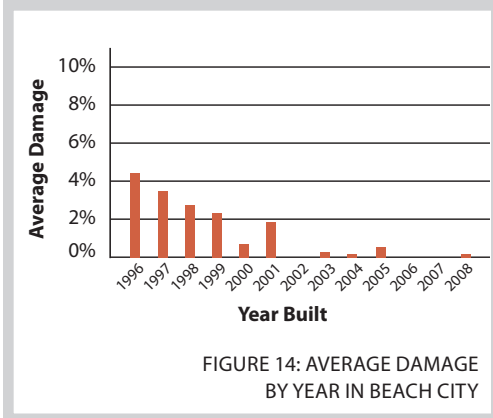
FIGURE 14: AVERAGE DAMAGE BY YEAR IN BEACH CITY

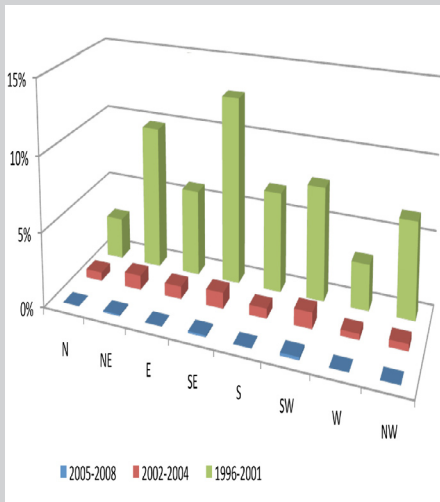
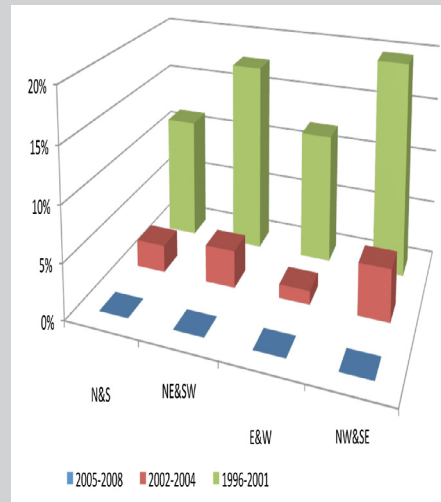
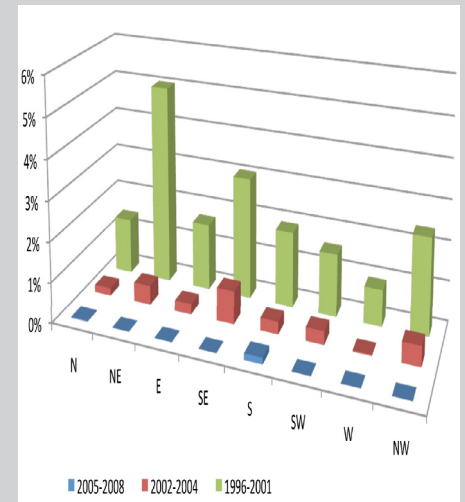
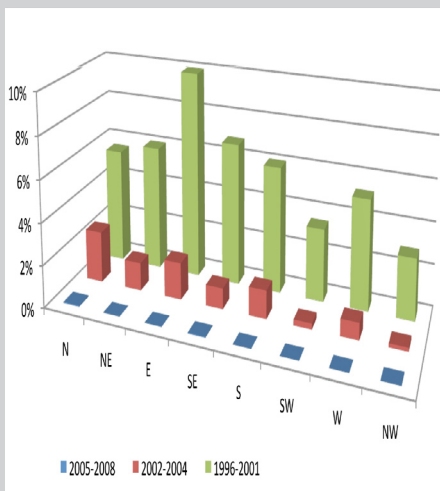
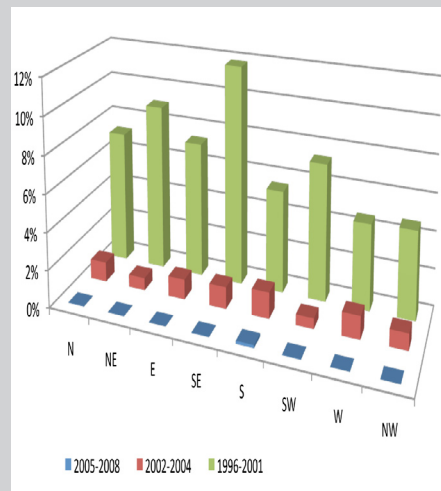
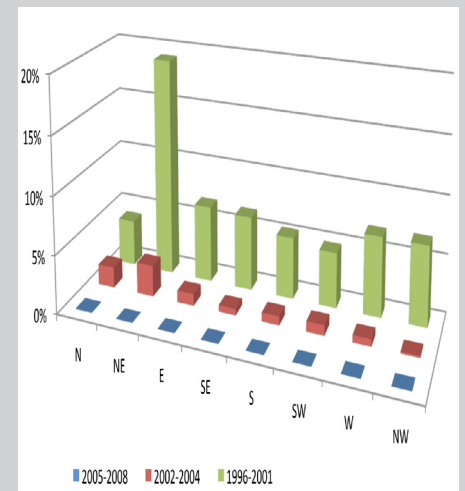
The Baytown data set was divided into three groups based on year of construction: homes built in 2005 or later; homes built from 2002 to 2004; and homes built prior to 2001. The average damage on different roof areas of each group was calculated for eight directions and results are shown in Figure 15. The high wind speeds recorded by mobile towers in Hurricane Ike for Baytown homes were concentrated

FIGURE 15: AVERAGE DAMAGE ON DIFFERENT ROOF AREAS OF BAYTOWN HOMES IN DIFFERENT DIRECTIONS

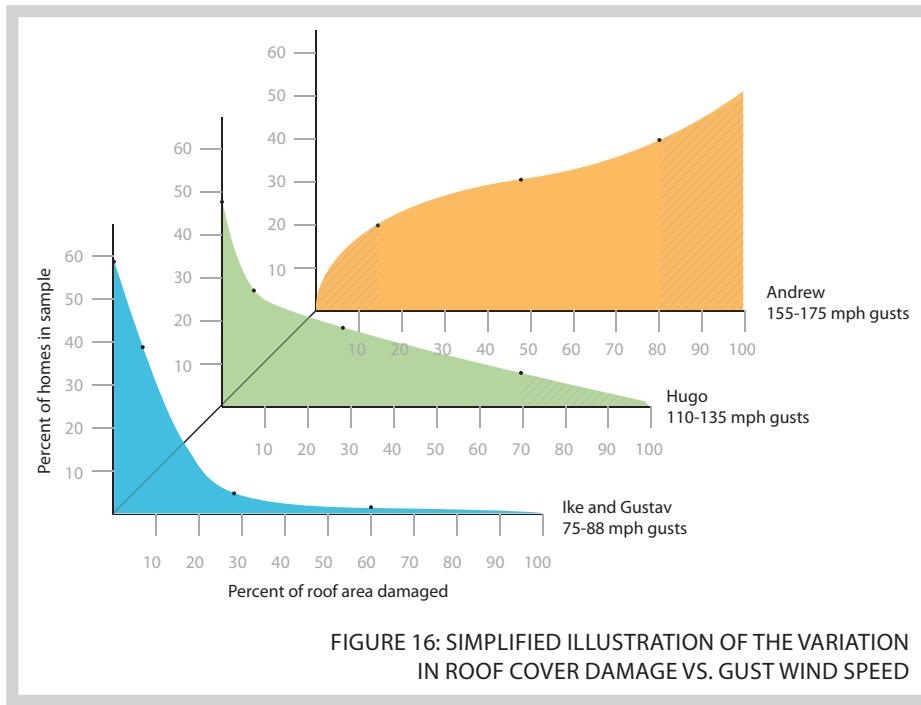
It should be emphasized that the data obtained in this study corresponded to relatively low wind speeds with the measured peak gusts in the area ranging between 75 and 88 mph. As wind speeds increase, so does the frequency and severity of the damage. The analysis of damage presented in this study used a fairly fine breakdown of damage levels into smaller area increments in part because the winds were relatively low. The change in roof damage area statistics associated with increased wind speeds is illustrated in Figure 16.

FIGURE 16: SIMPLIFIED ILLUSTRATION OF THE VARIATION IN ROOF COVER DAMAGE VS. GUST WIND SPEED
