U.S. CHEMICAL SAFETY AND HAZARD INVESTIGATION BOARD

INVESTIGATION REPORT

REFINERY EXPLOSION AND FIRE

REPORT NO. 2005-04-I-TX

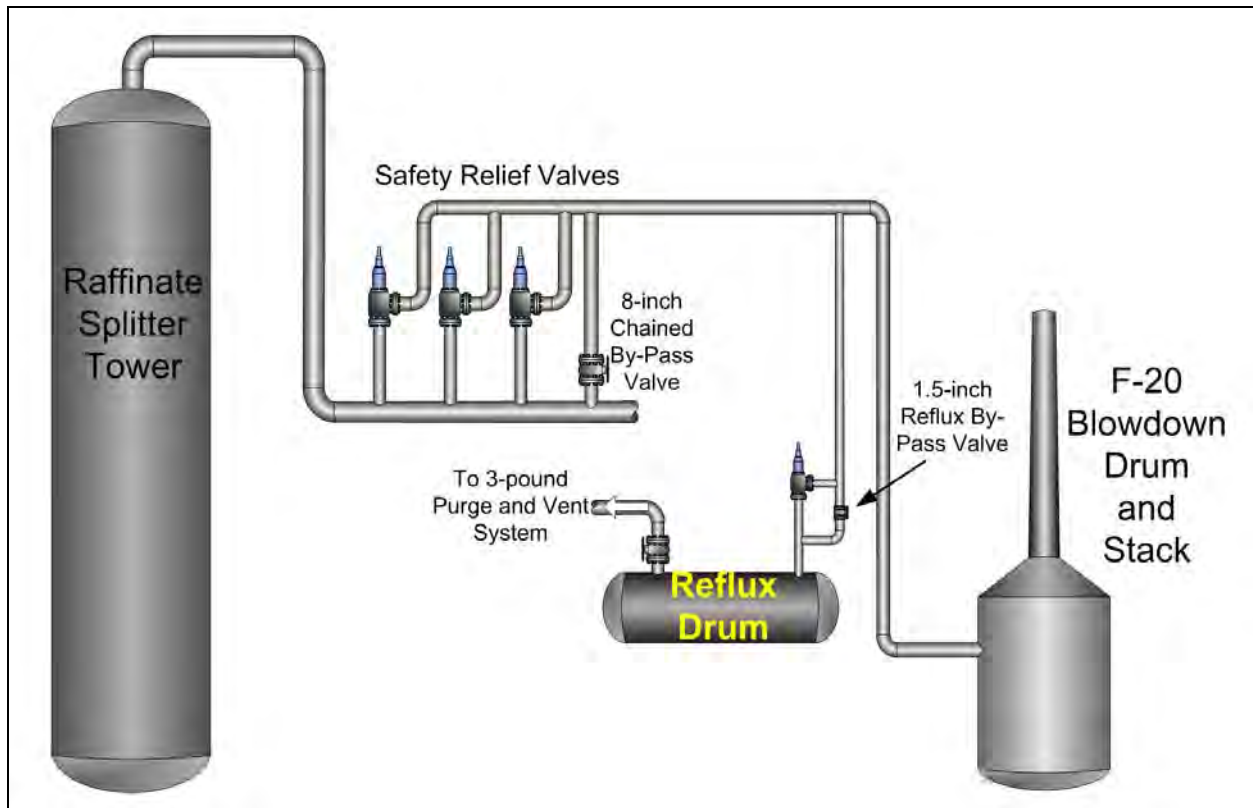
Figure 2. Disposal collection header system

To protect the raffinate splitter tower from overpressure, three parallel safety relief valves (Figure 2) were located in the overhead vapor line 148 feet (45 m) below the top of the tower. The outlet of the relief valves was piped to a disposal header collection system that discharged into a blowdown drum fitted with a vent stack.

The disposal header collection system received liquid and/or vapor hydrocarbons from venting relief and blowdown valves from equipment in the ISOM unit and discharged them to the blowdown drum. The header collection system included a 14-inch NPS (35.6 cm outer diameter) elevated pipe about 885 feet (270 m) long from the raffinate splitter tower (Figure 2). Other sections of the ISOM unit also discharged from two additional collection headers into the blowdown drum.

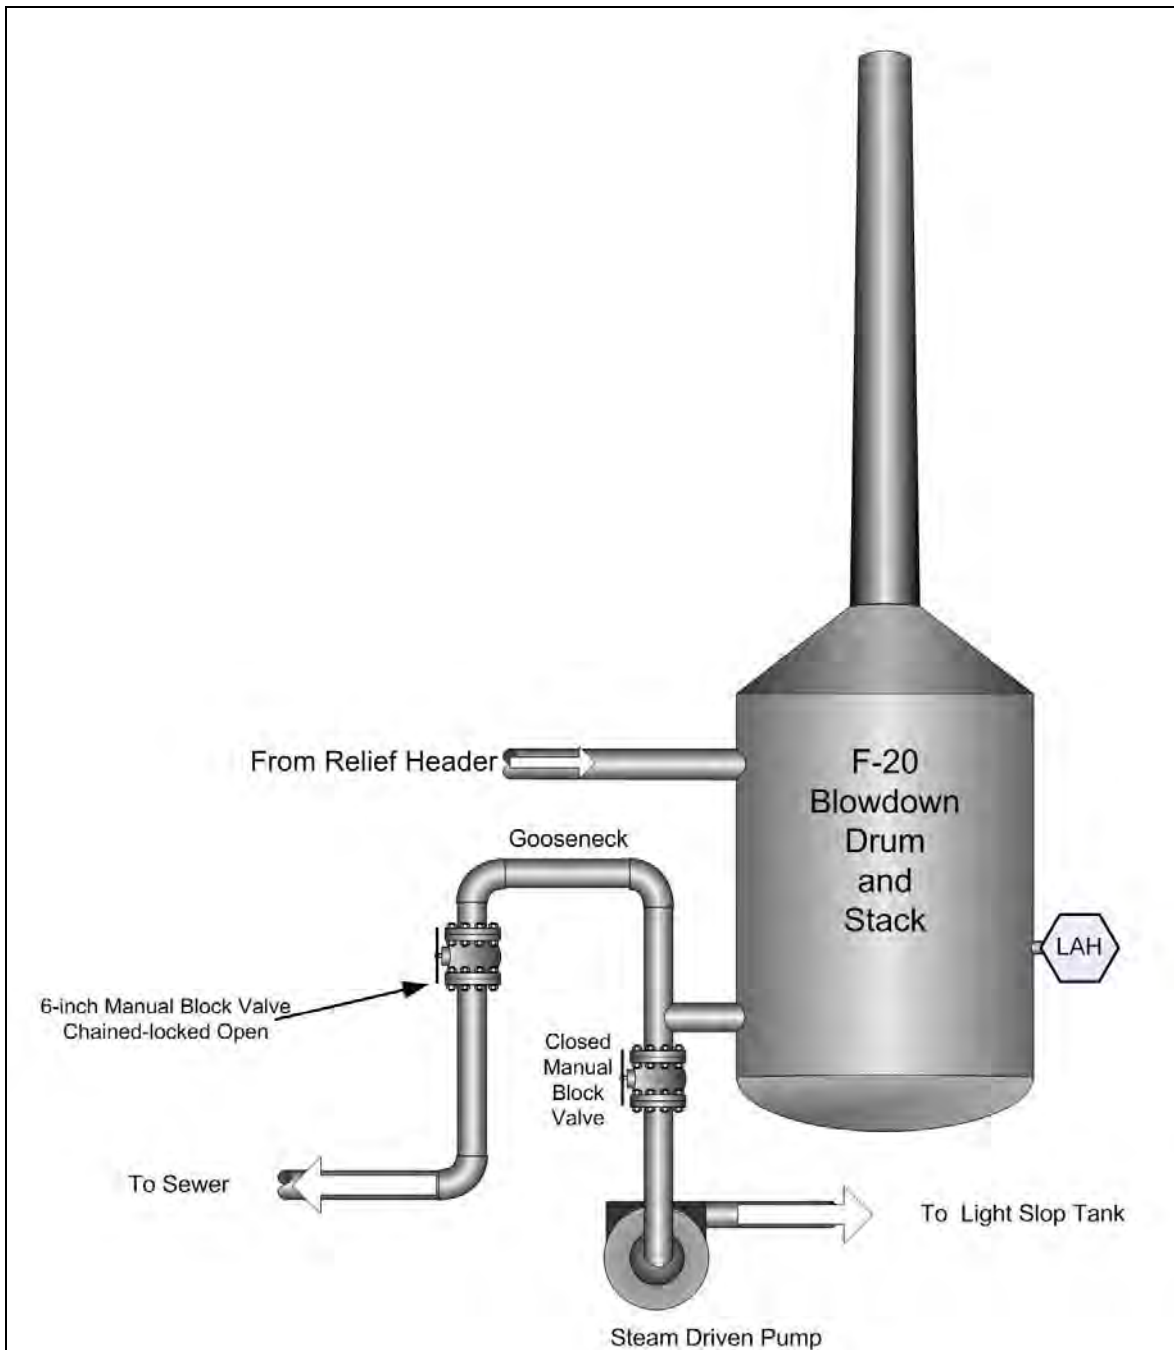
Figure 3. Blowdown drum and gooseneck

A liquid level, normally water, was maintained in the bottom of the blowdown drum. The height of this level was controlled by a "gooseneck" seal leg piped to a closed drain (Figure 3 and 4).

As the blowdown drum and stack filled, some of the flammable liquid flowed into the ISOM unit process sewer system through the chained-open 6-inch NPS manual block valve (Figures 3 and 4) and the other safety relief valve discharge pipe headers. As explained in section 2.2.5, this practice of discharging to the sewer was unsafe.

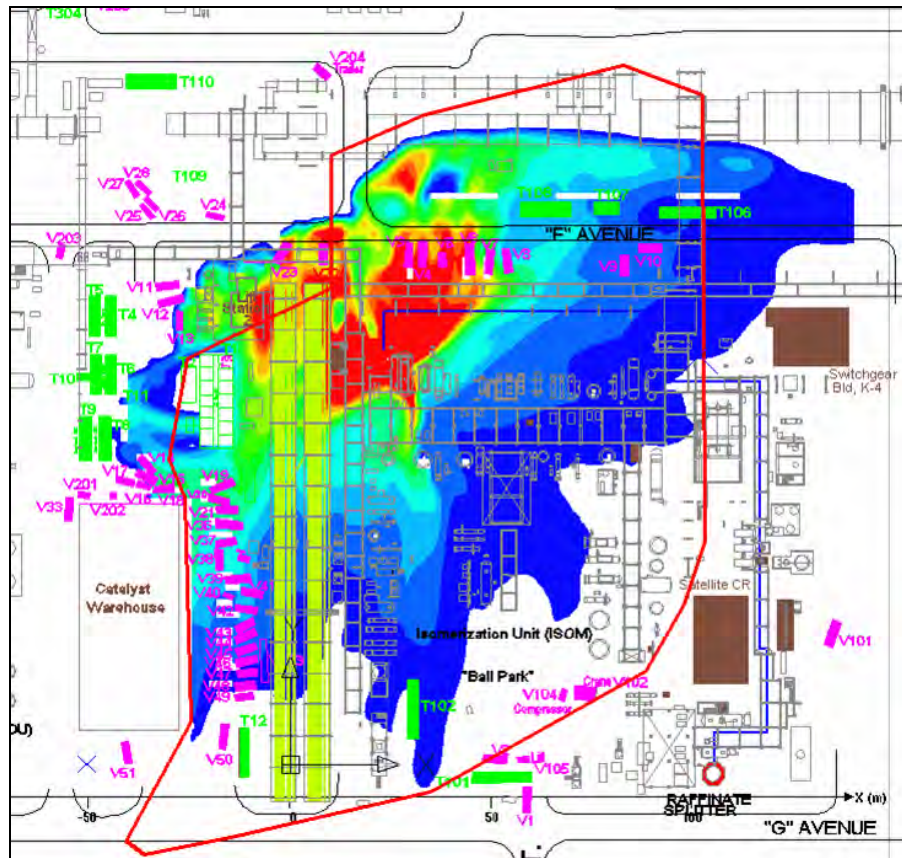
Figure H- 3. Cloud extent comparing field observations (red line) to dispersion modeling

A large domain was chosen that exceeded the expected extent of the flammable dispersion. The domain was also large enough to address sizeable objects around the perimeter of the ISOM unit that would affect wind patterns and ultimately dispersion of flammables. Steady-state wind conditions, as described, were established prior to beginning the dispersion of flammable materials. The dispersion grid was set at 1 meter in the X, Y, and Z directions for the bulk of the model. A tighter grid was chosen at low elevations where the heavy flammable vapor cloud was expected to settle. The CFD modeling attempted to simulate the release conditions and source terms described previously. The CFD model included several vapor source terms that represent vapor generated from evaporation of falling liquid, vapor generated through evaporation when liquid interacted with elevated equipment, and vapor generated by evaporation from liquid pooled on the ground. The numerically discrete nature of CFD allows specifications of definite leak locations; therefore, vapor sources were placed in the model at various locations to represent potential sources. A total of 16 discrete “leak” locations were selected that would be vapor sources in the model, including four sets, placed at various elevations, of four leaks located about the perimeter of blowdown drum. A parameter study that varied the rate of vapor generation for the source terms was then conducted and comparisons made against field data and observations. A comparison (Figure H-3) shows reasonable agreement.
