Mitigation Assessment Team Compendium Report

2017 Hurricane Season

Building Performance Observations, Recommendations,
and Technical Guidance

FEMA P-2054 / September 2019

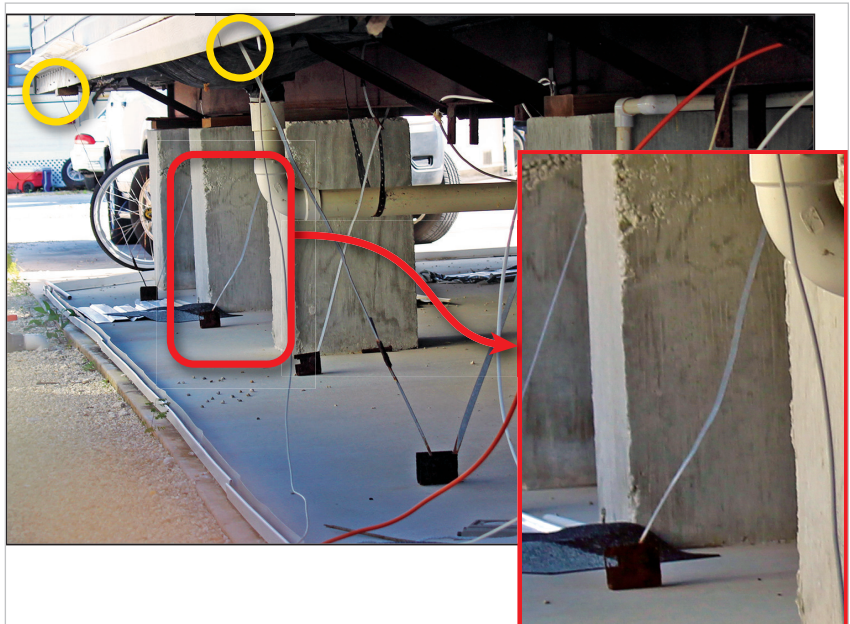
On this MHU installation, only the first and fourth straps are attached to the exterior wall base.

Yellow circles show where straps are attached to the base of the unit wall. The inset shows close-up of loose strap inside red outline.

Wind damage to MHUs frequently is initiated when improperly attached appurtenances are blown off or damaged. Specifically, when carports and covered porches—which are particularly vulnerable to wind loads—break away from the MHU, they leave openings at failed connections in the remaining roof and/or wall that allow wind and rain to enter the MHU envelope. In some cases, damage progresses from the initial point of failure. The MAT observations confirm this progressive failure pattern occurred in Florida during Hurricane Irma.

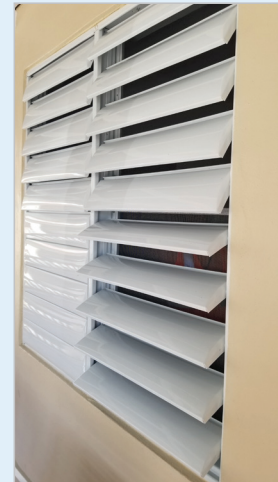
Jalousie windows are the most common window system observed in residential buildings in Puerto Rico and the USVI. Jalousie window systems contain panels (louvers) made of metal, glass, or wood that typically are opened or closed by turning a handle to allow natural ventilation to help control the temperature inside the building while limiting sunlight into the building and providing visual privacy. Because they are inherently “open,” non-sealed systems, they allow the passage of wind-driven rain, water, and air into buildings. Wind pressures allowed in through jalousie windows can overload the roof and cause failure. The common use of metal panel jalousie window systems in informally constructed homes contributed to the failure of many roof systems in the residential buildings the MAT observed. The photo above shows a close-up of a jalousie window with metal louvers on a residential building in Puerto Rico.

Impact-resistant shutters cannot prevent water intrusion through jalousie windows, however, which are inherently unable to prevent water from seeping between their operable louvers.

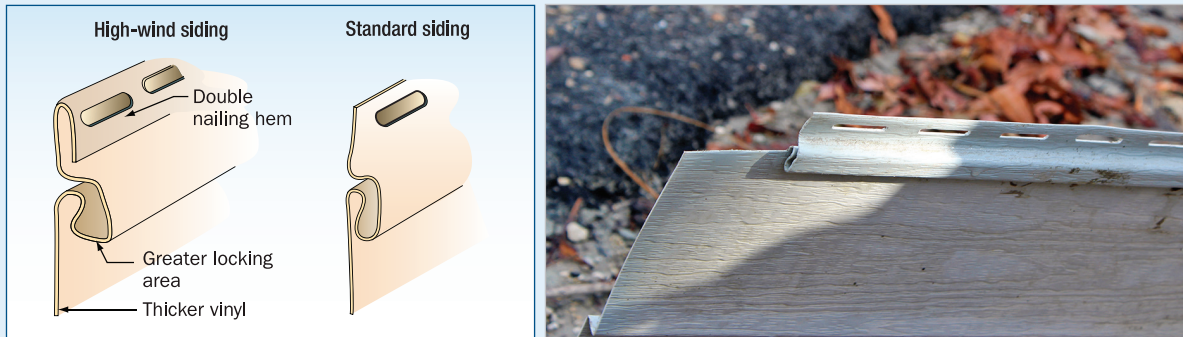
HIGH WIND-RATED VINYL SIDING VS. STANDARD VINYL SIDING

Much of the failed vinyl siding that the Irma MAT observed in Florida did not appear to be rated for high-wind regions. Technical Fact Sheet 5.3, “Siding Installation in High-Wind Regions,” in FEMA P-499, *Homebuilders Guide to Coastal Construction* (2010), includes guidance on vinyl siding installation. The left-side graphic below from Technical Fact Sheet 5.3 demonstrates the basic differences between vinyl siding rated for high-wind regions and standard vinyl siding. The right-side image is siding from one of the damaged houses in Goodland. Note how the detached siding has a standard (single) hem and locking area depicted in the left image (rather than the high-wind siding required by the FBC in the area).
