MULTIDISCIPLINARY ACCIDENT INVESTIGATION TEAM NARRATIVE/DIAGRAM

NL-020-18

MAIT SUPPLEMENTAL

- A mechanical inspection of the Forest River to determine if there were any pre-existing conditions that caused or contributed to the cause of the mechanical failure, which potentially caused the fire

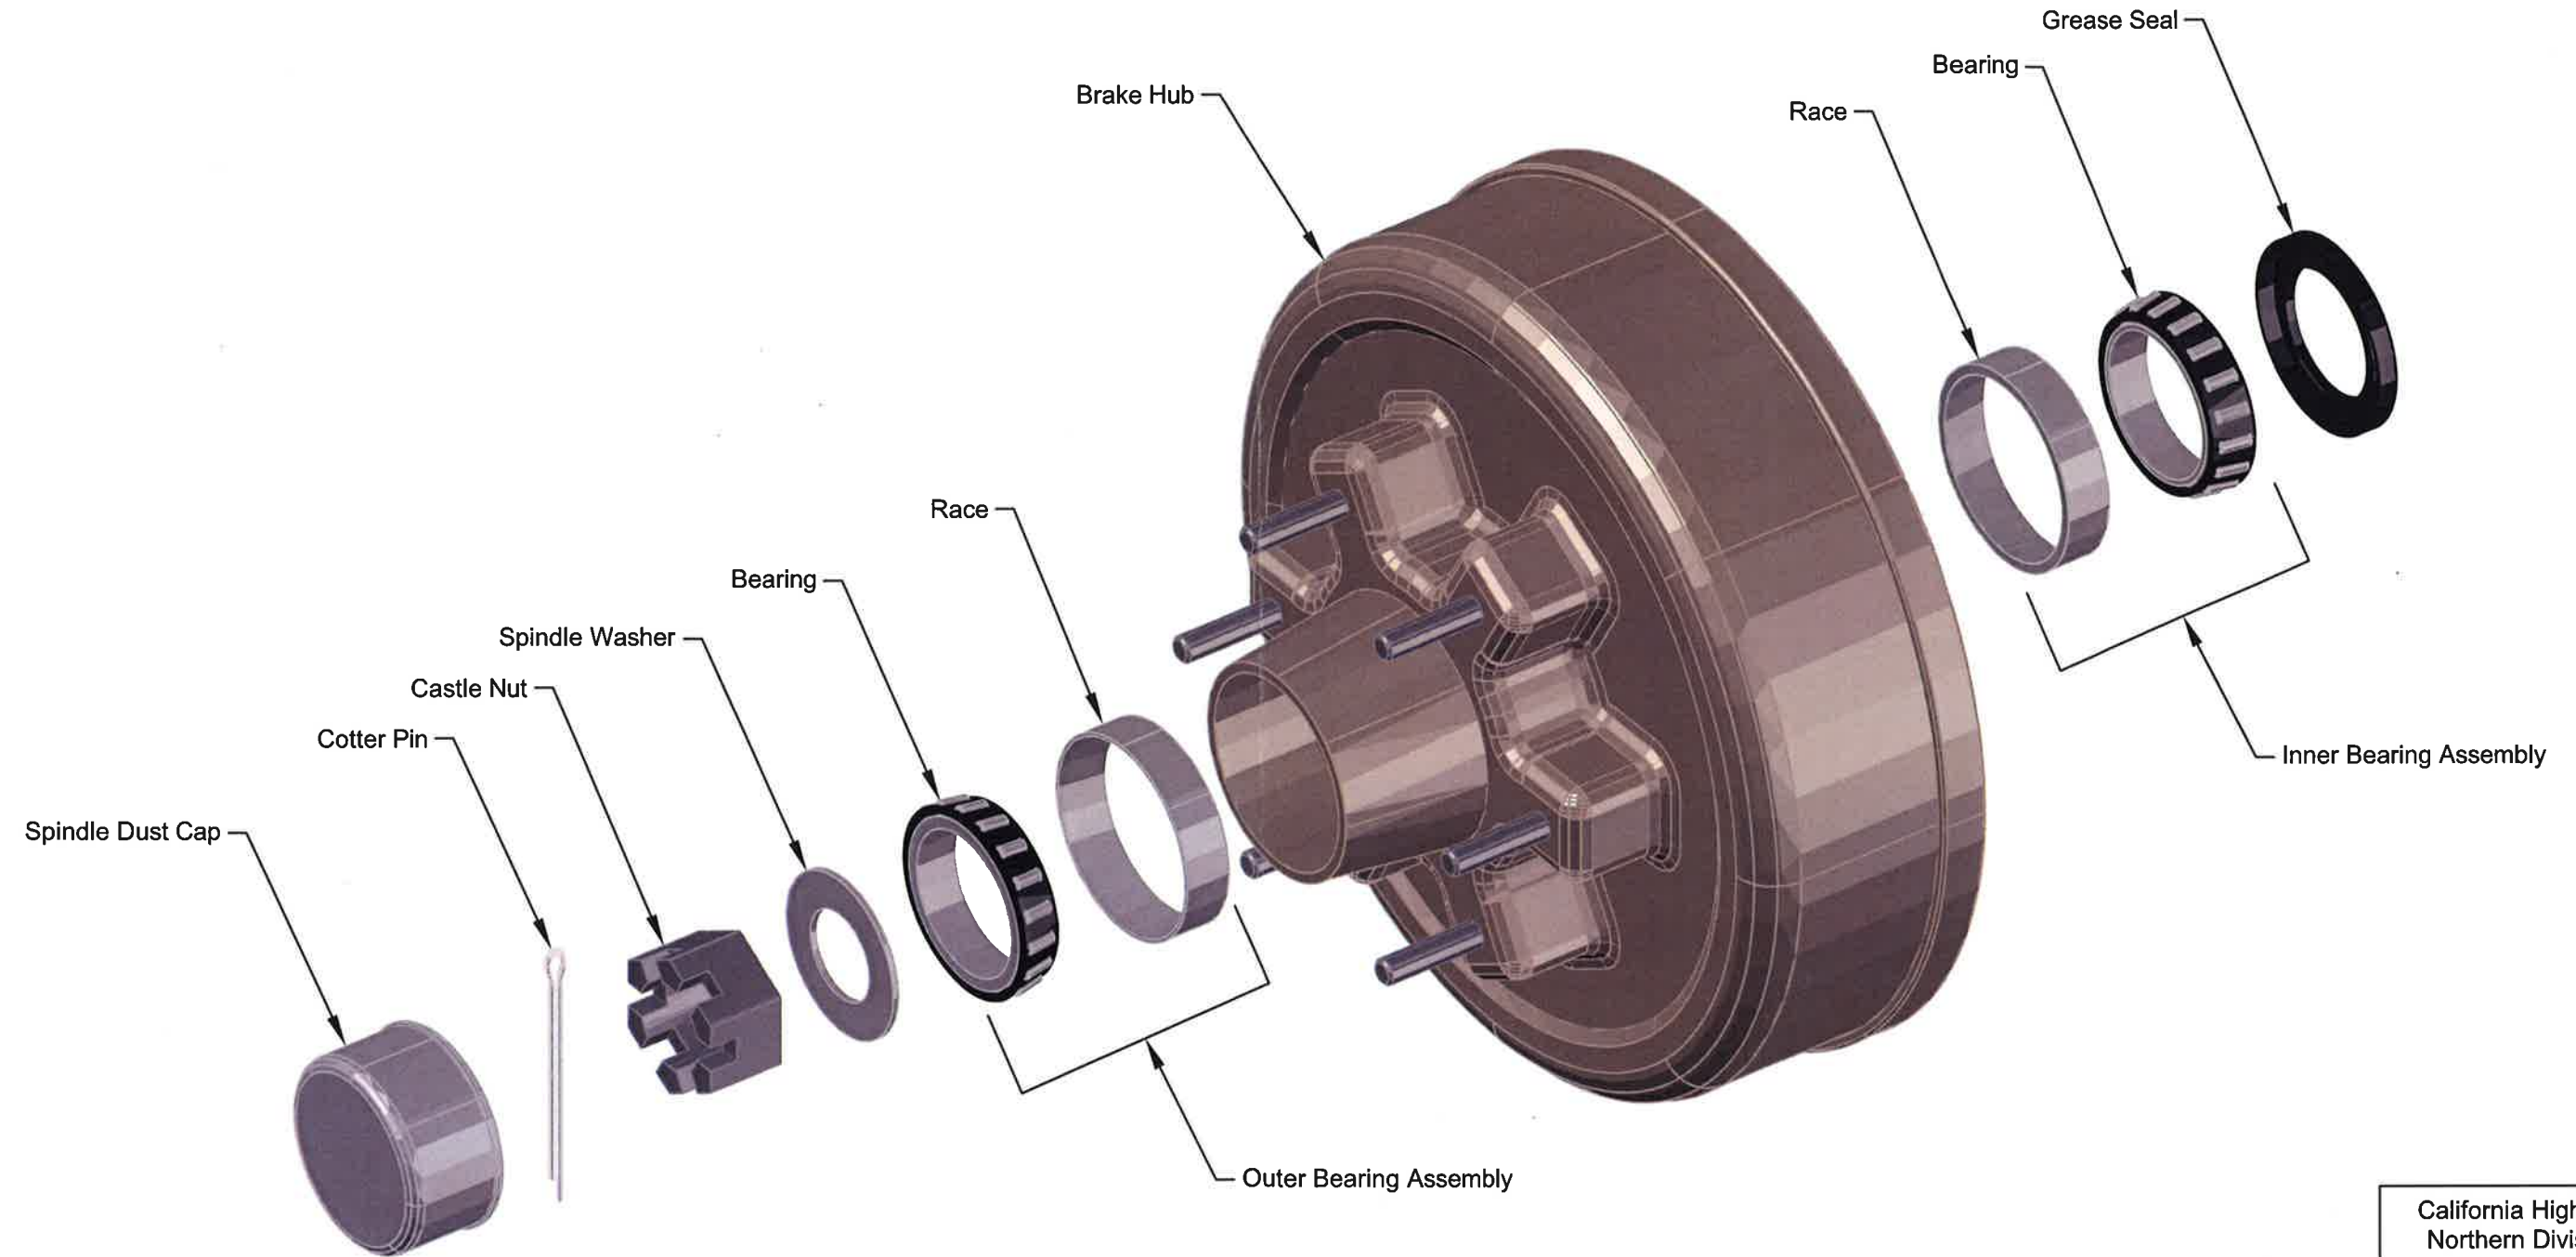
Brake Hub Assembly

On the following page, an exploded diagram depicting components discussed in this report was prepared for a visual reference and is not to scale.
