**National Park Service**

**Repair and Upgrade Washington Monument Elevator –  
Washington, DC**

**NAMA-224923**

**Pre-Design Report  
Final Submission**

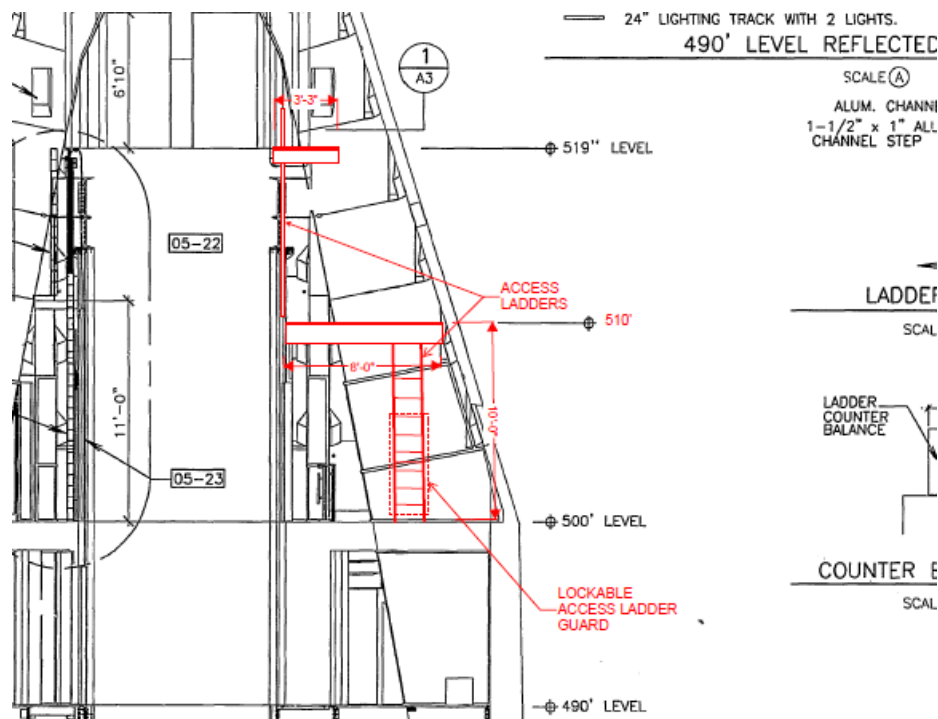
Figure 4: Draft Section of Proposed Ladder Access

- Permanent access to the elevator machine room should be provided from the 500-foot level to the 519-foot level. This would be accomplished by providing a fixed ladder and a hung platform at the entrance to the elevator machine room on the south side of the elevator shaft. The new permanent access would meet current Occupational Safety and Health Administration (OSHA) requirements for a fixed ladder and access platform; a section and partial plan layout of a proposed method for the platform and ladder to access the elevator machine room at the 519-foot level are provided on **Figures 4 and 5**. Alternate layouts will be considered during the Schematic Design phase.

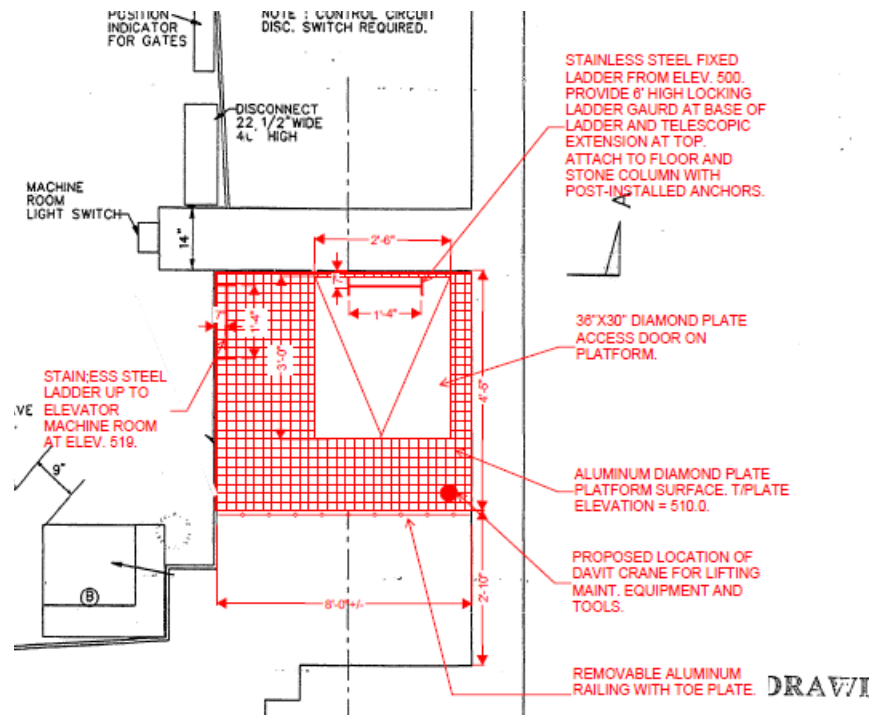
**Figure 5: Draft Partial Plan of Proposed Platform for Access to the Elevator Machine Room**

- To control access to the elevator machine room from the 500-foot level, a 6-foot high lockable access cover should be provided over the ladder to cover the ladder rungs.
- The proposed access platform provided at the elevator machine room should include an access hatch above the ladder and aluminum diamond-plate flooring. Provisions for a lift or davit crane system to assist in raising tools and maintenance equipment up to the elevator machine room is also recommended. A removable code compliant aluminum guardrail should be provided on all open edges of the platform.

Because of the limited amount of available open space, a fixed ladder would not meet the access requirements of ASME 17.1, Section 2.7.3.3, which requires provisions for a permanent stair to elevator machine rooms with controllers and motor generators. It is likely a variance from compliance of elevator code requirements from the local Authority Having Jurisdiction will be necessary to provide the proposed ladder and platform.

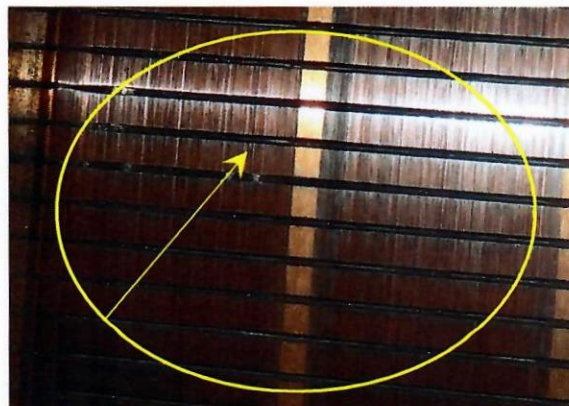
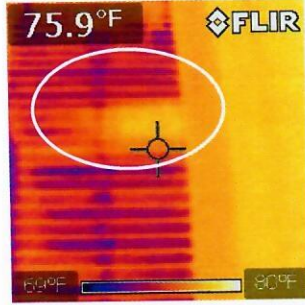
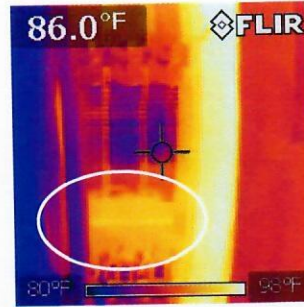
The armature should be blown out, vacuumed and sprayed with black air-dry varnish. The brush holders/insulators should be sand blasted or cleaned thoroughly to clear the insulation material of static electricity. There is capacitance between the bars caused by carbon deposits. This carbon should be removed by undercutting the commutator bars. (See Pictures).

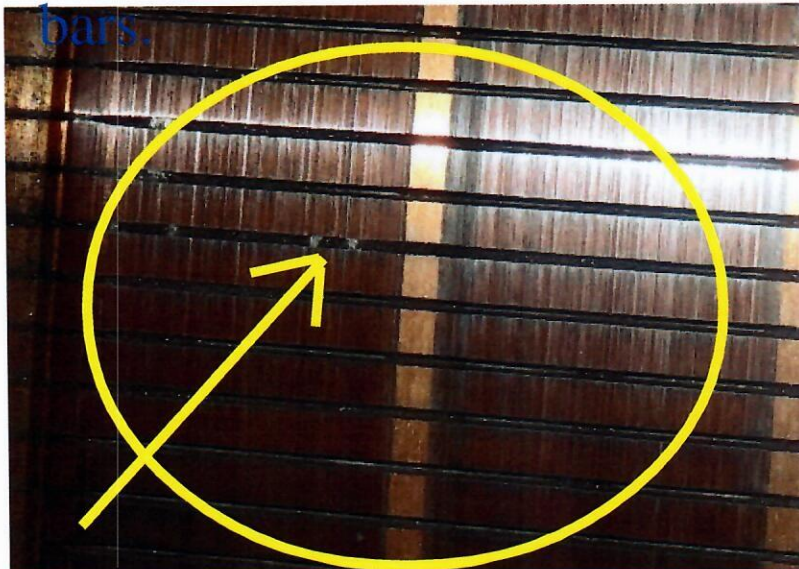
Close up of commutator which  
needs to be cleaned between  
bars.

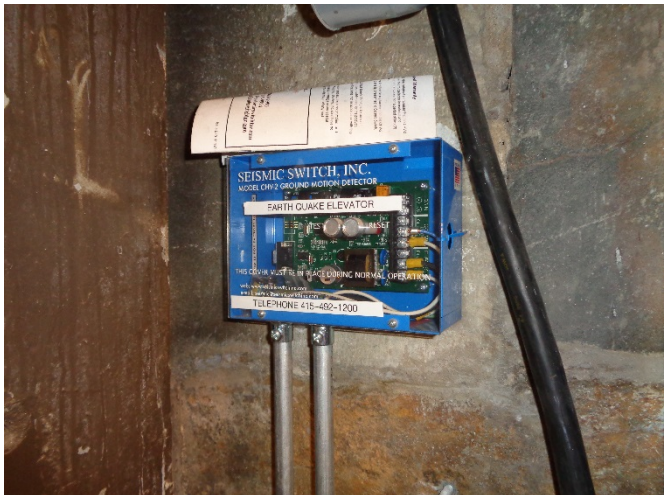
11. Existing seismic monitor to be retained.
