# **CBP Needs to Improve Its Video and Audio Coverage at Land Ports of Entry**

**September 25, 2023**

**OIG-23-54**

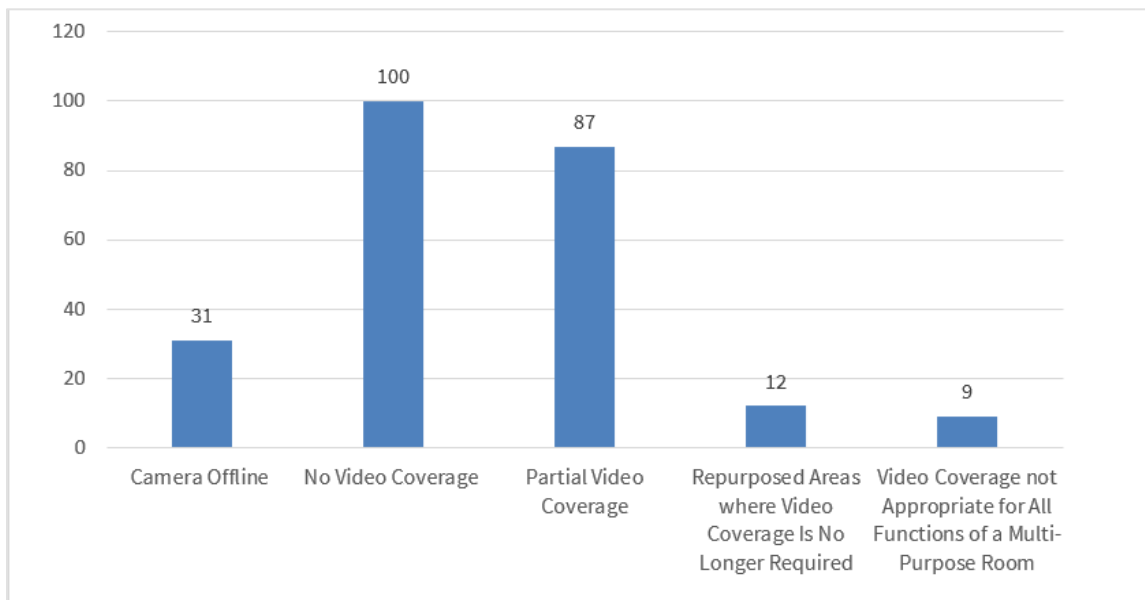
**Figure 6. Video Coverage Issues Observed at 18 LPOEs**

We observed 239 instances of video coverage issues at 18 LPOEs, as shown in Figure 6.

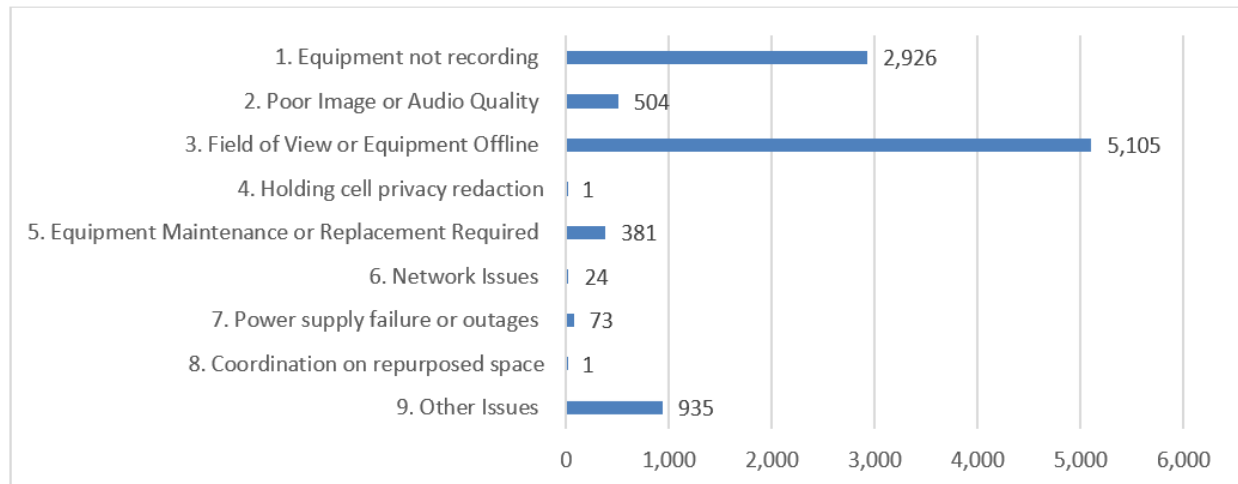
**Figure 9. CAVSS Issues Reported by LPOE Personnel from April 2022 through April 2023**

BSDP PMO provided information on 9,950 outage work tickets for CAVSS issues reported by LPOEs from April 2022 through April 2023, as presented in Figure 9.

Overall, inadequate video coverage primarily resulted from:

- Office of Facilities and Asset Management facility projects resulting in the addition or removal of cameras without BSDP PMO and Office of Information and Technology coordination;
- a lack of coordination among LPOEs, OFO personnel, and BSDP PMO when repurposing rooms or adding cameras for additional coverage at LPOEs;
- inadequate network infrastructure;
- field of view and gaps in coverage issues being reported but not fixed in a timely manner due to funding and network infrastructure constraints; and
- CAVSS operators not always identifying or reporting field of view and coverage issues and offline cameras because of inadequate training.

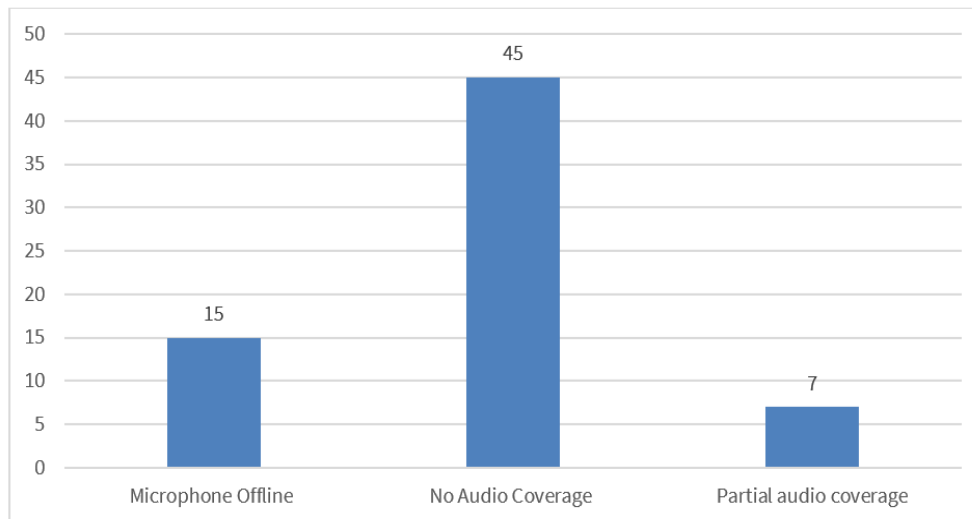
**Figure 10. Audio Coverage Issues Observed at 12 LPOEs**

LPOEs do not have any audio coverage and the remaining 101 LPOEs are covered by a total of approximately 2,600 audio feeds. BSDP PMO is aware that these LPOEs do not have audio coverage and considers it an unfunded CAVSS requirement. We observed 67 audio coverage issues at 12 LPOEs (see Figure 10).

Field personnel at 15 of 49 LPOEs responded to our questionnaire that their location had issues with audio coverage. Ten of 15 respondents said not all areas have audio coverage; other respondents mentioned unclear audio quality due to microphone placements and inconsistent audio.

Overall, inadequate audio coverage primarily resulted from funding and network infrastructure constraints, as well as from CAVSS operators at LPOEs not consistently reporting audio coverage issues.

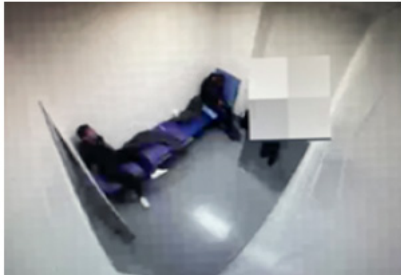
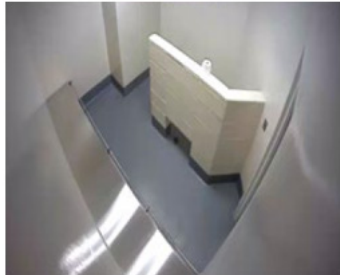
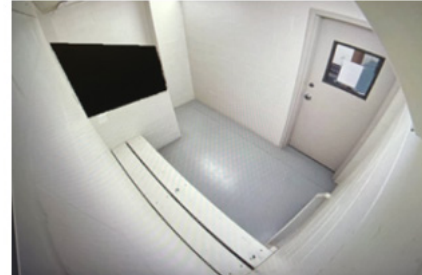
**Figure 11. Examples of Adequate Privacy Protections for Detainees in Hold Rooms with Toilets at Three LPOEs**

LPOE design standards require video for hold rooms to capture the entire area except for a detainee’s body while using the lavatory (i.e., toilet). To protect the detainee’s privacy, LPOE design standards state, “The entire room must be viewable, except for the body of the detainee when using the toilet. The head and feet of the detainee shall be visible by the camera and/or vision panel in the door when the detainee is using the toilet. The privacy panel shall be used to block the rest of the detainee’s body from view.” When privacy panels are not available or sufficient to provide adequate privacy, the detainee’s body must be masked or blurred when using the toilet. Figure 11 shows examples of adequate privacy protections for detainees in hold rooms with toilets.
