# Independent Engineering Report Costa Sur Steam Plant

**Puerto Rico Electric Power Authority**

**Report SL-015976.CS**

**October 8, 2021**

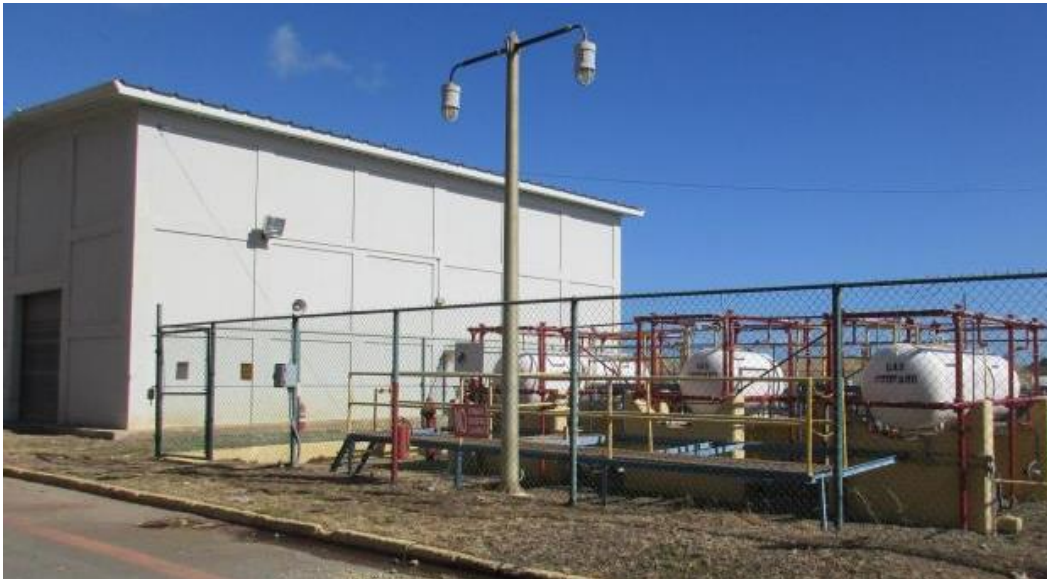
**Figure 5-1 — Storage Building**

The Plant stores spares in a climate-controlled building, non-conditioned enclosures, and outdoors as shown in the figure below.

Temperature- and humidity-controlled storage building on the left for spare motors and other parts.  
Propane tanks on the right.

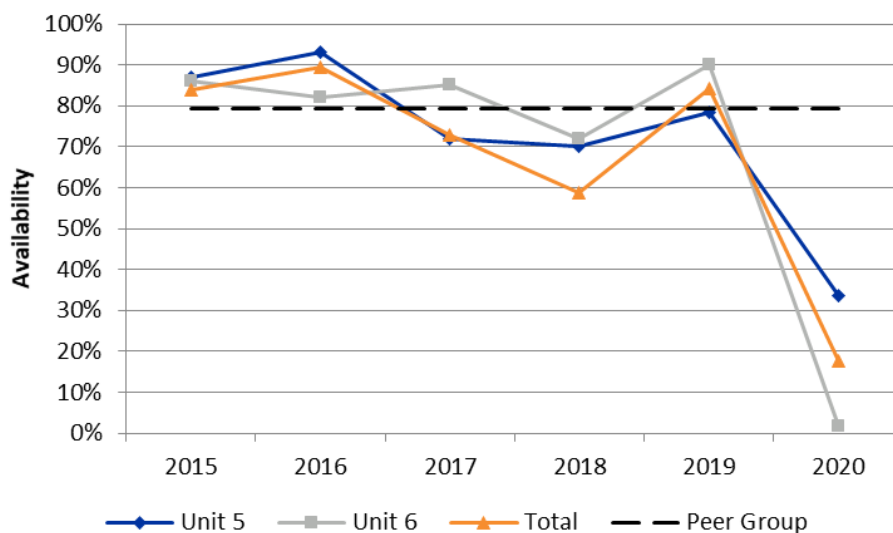
**Figure 6-3 — Costa Sur Steam Units Equivalent Availability Factor**

Units 5 and 6 exhibited decreases in availability in 2017 and 2018, but recovered as expected in 2019 after planned work was completed as discussed in their condition assessment Sections 3.4 and 3.5. Availability of the units in 2021 was also expected to recover since being brought back online later in 2020. The availability of Units 5 and 6 are also similar to that of their peers (except for 2020).

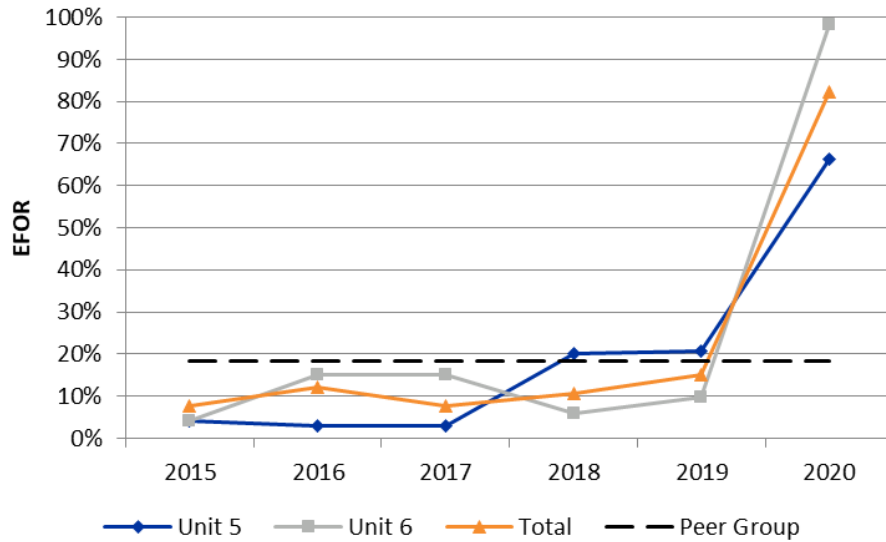
**Figure 6-5 — Costa Sur Steam Units Equivalent Forced Outage Rate**

The EFOR of the steam units has remained generally below the peer group average; however, the forced outages after the January 7, 2020 earthquake has significantly impacted the Units 5 and 6 EFOR. Unit 5 increased EFOR in 2018 was due to a latent defect from Hurricane Maria in the main power transformer’s connection to the grid.

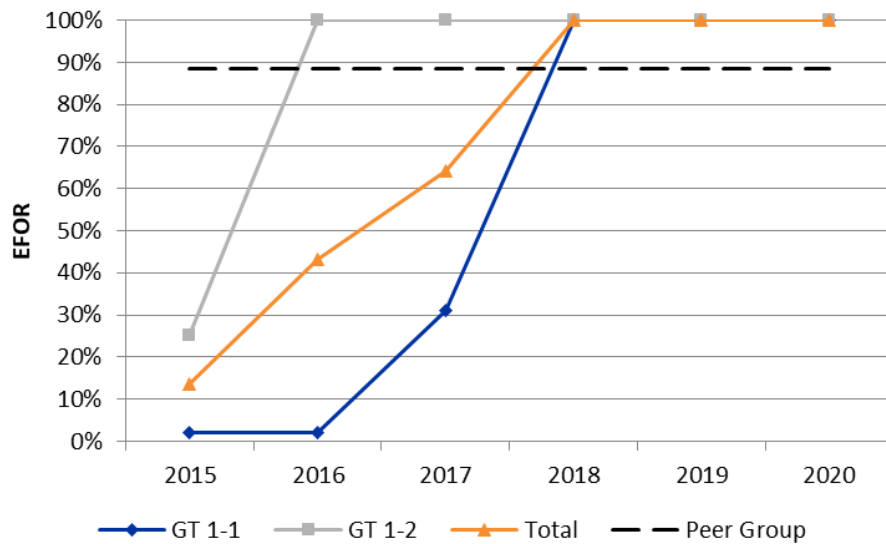
**Figure 6-6 — Costa Sur Gas Turbine Equivalent Forced Outage Rate**

Figure 6-6 depicts the black start GT EFORs. Recall that GT #1.1 began an extended outage in 2017 and GT #1.2 began one in 2015. Refer to Section 3.6 for additional information. Although high, the GTs in the peer group have also experienced high EFOR, nearing 90% on average.

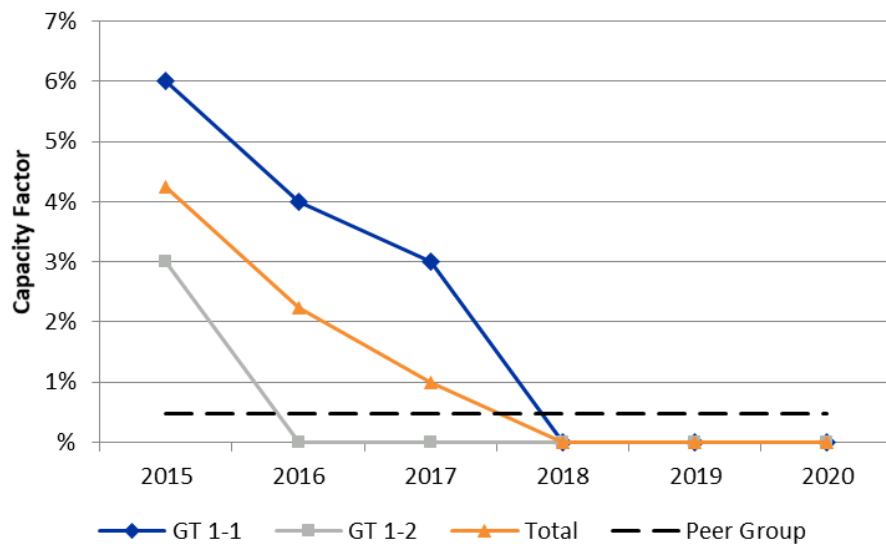
**Figure 6-8 — Costa Sur Gas Turbine Capacity Factor**

The black start units' capacity factors are shown in the figure below. Due to their small size and primary role as emergency generators, the capacity factors of the black start GTs are an order of magnitude less than the steam units. GT #1.1 had high availability in 2016 (see Section 6.2), but the demand for its power

was low from central dispatch; hence its drop in capacity factor in 2016. In 2017, GT #1.1's generator was damaged by Hurricane Maria and has not returned to service due to the repair order being suspended. In 2015, the GT #1.2 rotor and compressor section were removed for servicing, which has not been completed by the Hidro Gas division due to reported budgetary constraints. Instead, a decommissioned turbine from the Central Hidro Gas Mayagüez Plant was installed in the GT #1.2 enclosure and is being restored for service in its place. This restoration work is expected to be completed for unit testing in January 2022. Section 3.6 contains additional detail.

Although the capacity factor has been low for the black start units, when they have operated, they have shown capacity factors higher than other similar units, showing that the units are used for peaking capacity when available, in addition to their black start capabilities.

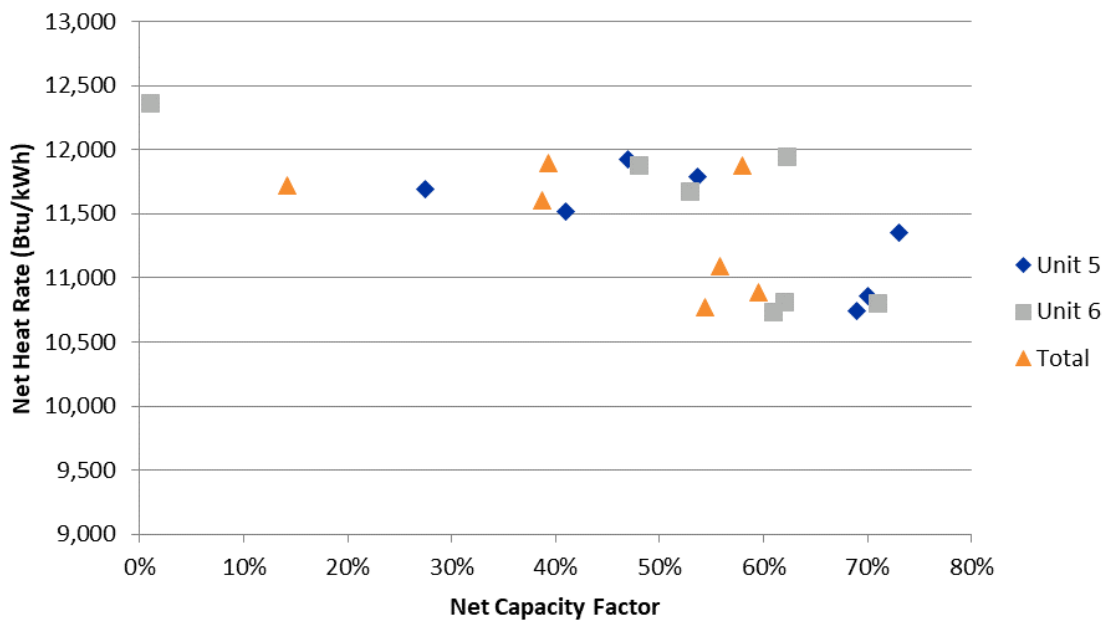
**Figure 6-9 — Costa Sur Steam Units Heat Rate v. Capacity Factor**

The heat rates of Units 5 and 6 are increasing, signaling a decrease in their efficiencies. Their gas conversions were completed in late 2010 and early 2011. In 2014, their heat rates were both about 10,800 Btu/kWh, and by 2019 they had increased to 11,900 Btu/kWh. Figure 6-9 below shows the heat rate on

Other natural gas units of their age and size have heat rates in the range of 10,600–12,400 Btu/kWh. While Units 5 and 6 have heat rates in the middle of this comparative range, they have been closer to the forefront in recent years. Sargent & Lundy recommends a detailed study be completed to identify efficiency improvements and estimate their installed cost, resulting fuel savings, and payback period.

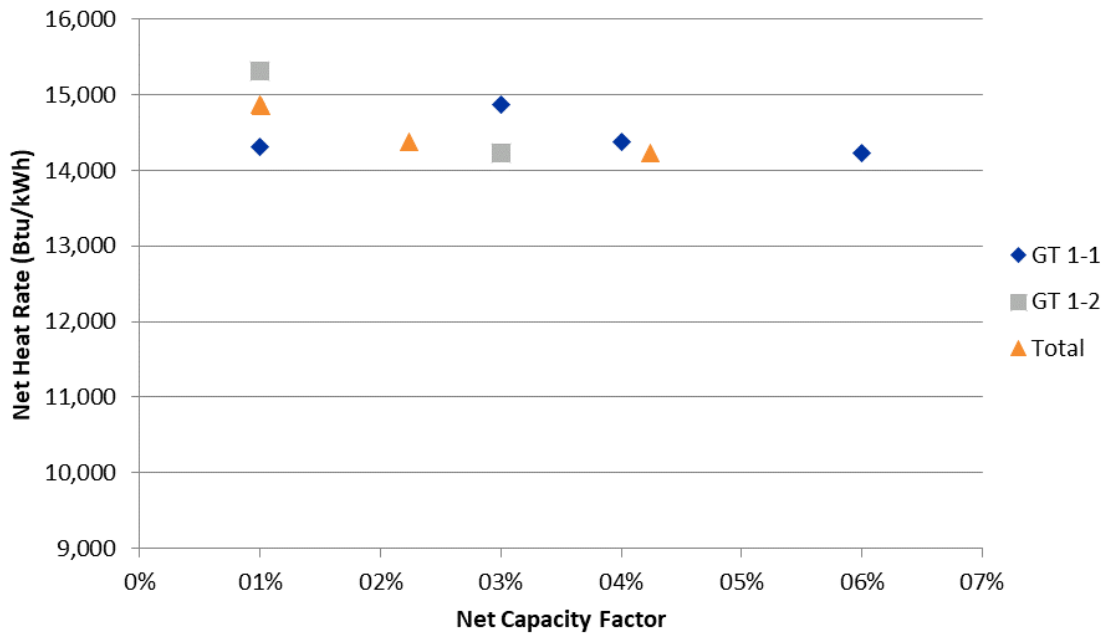
**Figure 6-10 — Costa Sur Gas Turbine Heat Rate v. Capacity Factor**

The net heat rates of the black start GTs have been fairly consistent when they've been operated over the past six years. They have high heat rates, but that is not as important as their availability and reliability for their role as emergency generators. Unfortunately, both units have been out of service for several years. Heat rate for the GT units are provided in Figure 6-10.
