SEISMIC ASSESSMENT REPORT

School Seismic Safety Assessments Project

June 2019

SEISMIC ASSESSMENT REPORT VOLUME 1 of 4

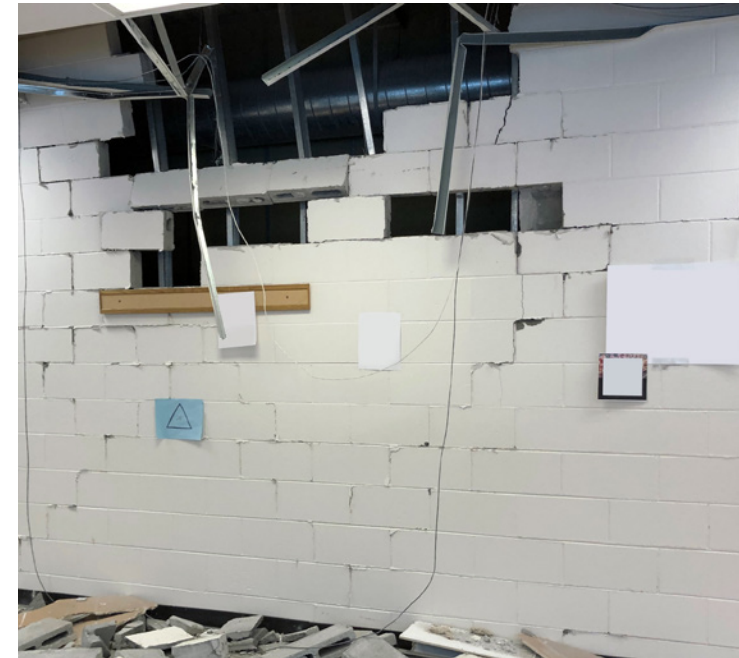
Considerable cracking and damage in CMU bearing and partition walls. – High School CMU Partition Wall Damage. Credit: David Stierwalt, Reid Middleton, Inc.

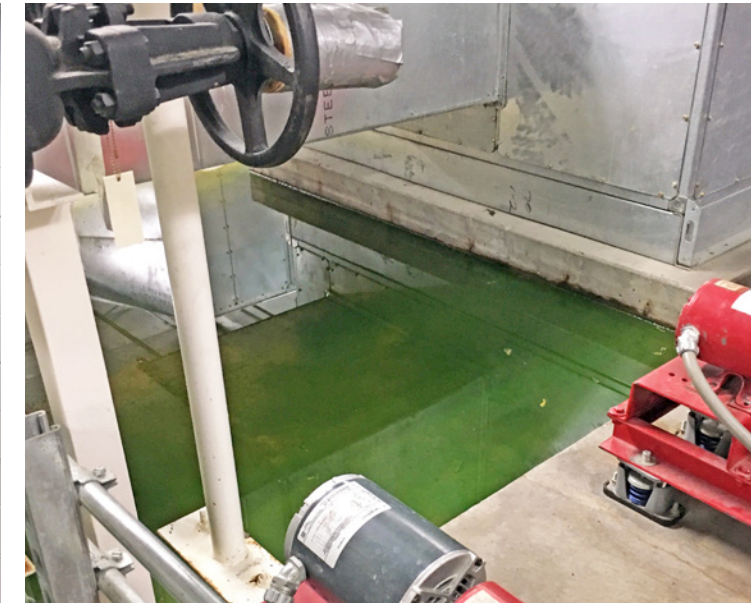
Some suspended and ground supported HVAC and mechanical equipment sustained damage and sheared their support structural bolts causing unsafe conditions and chemical leaks. – Elementary School Leaking Glycol in Fan Room. Credit: David Stierwalt, Reid Middleton, Inc.

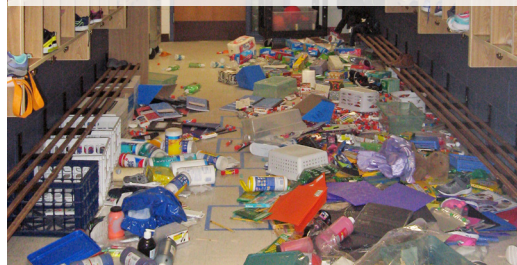
Elementary school unreinforced concrete masonry partition wall collapse

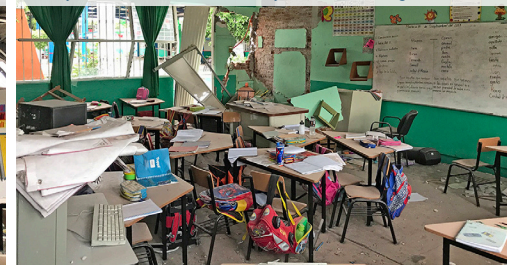
Primary school wall failure due to diagonal tension in unreinforced masonry bearing wall
