Washington State School Seismic Safety Assessments Project

SEISMIC UPGRADES CONCEPT DESIGN REPORT

Lake Roosevelt Jr/Sr High, Lake Roosevelt
Elementary – CTE/Gym Building
Grand Coulee Dam School District

June 2019

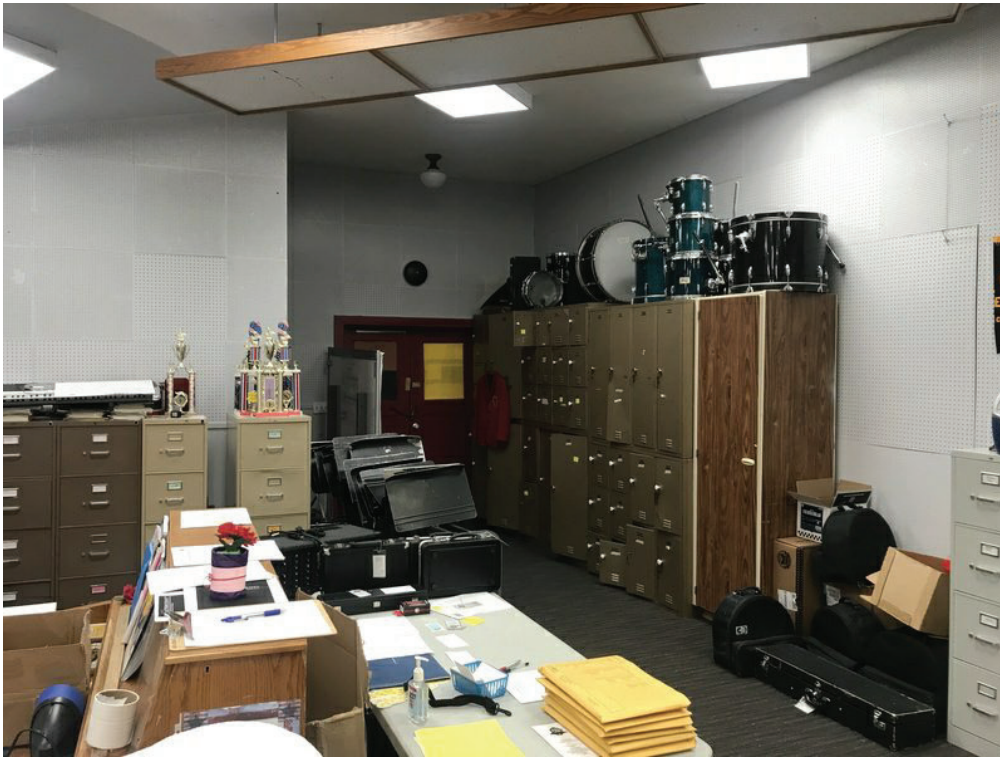
Figure 1-3. Band room with unsecured storage units and heavy instruments stored on top of units.

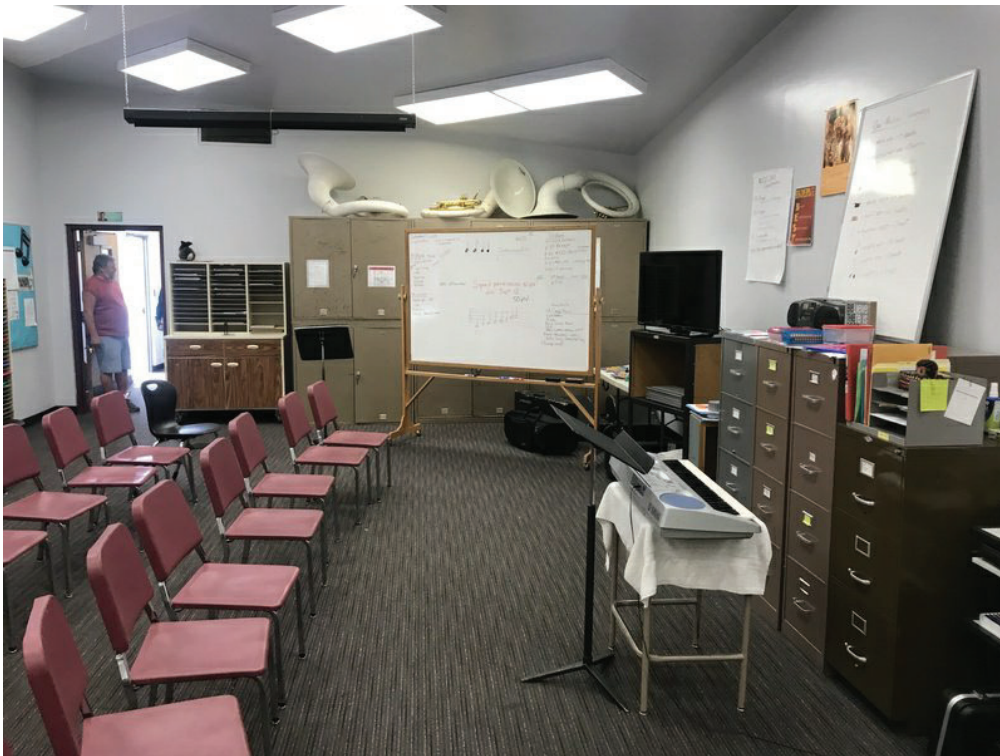
Figure 1-4. Band room with unsecured storage units and heavy instruments stored on top of units.

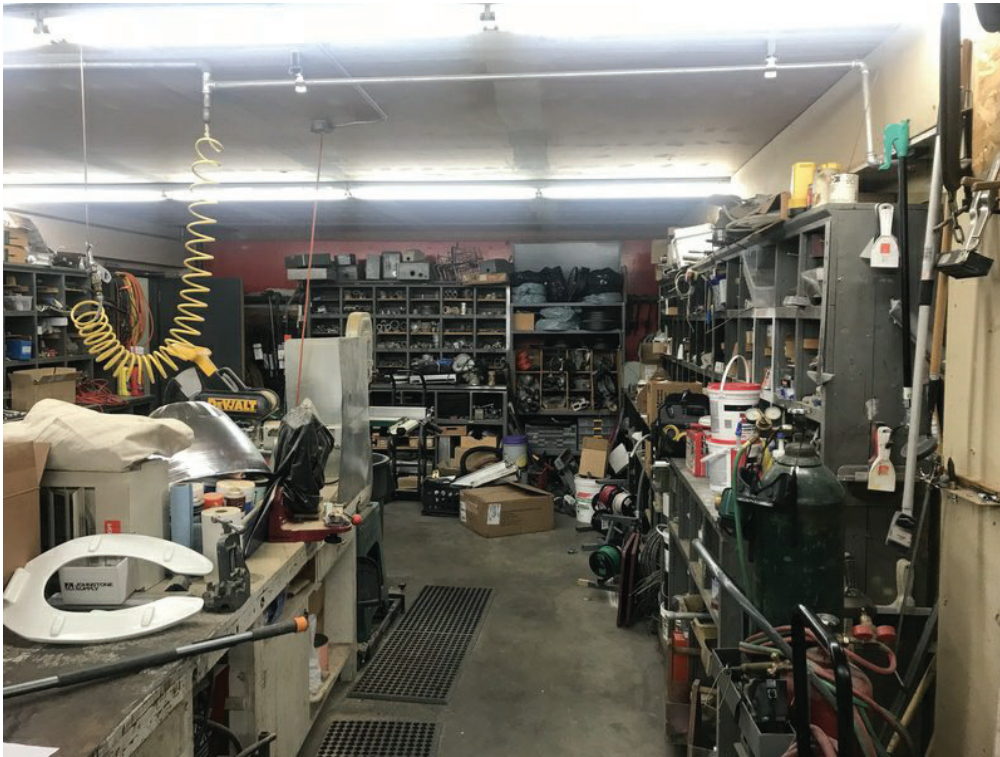
Figure 1-5. Maintenance room with unsecured shelving units.

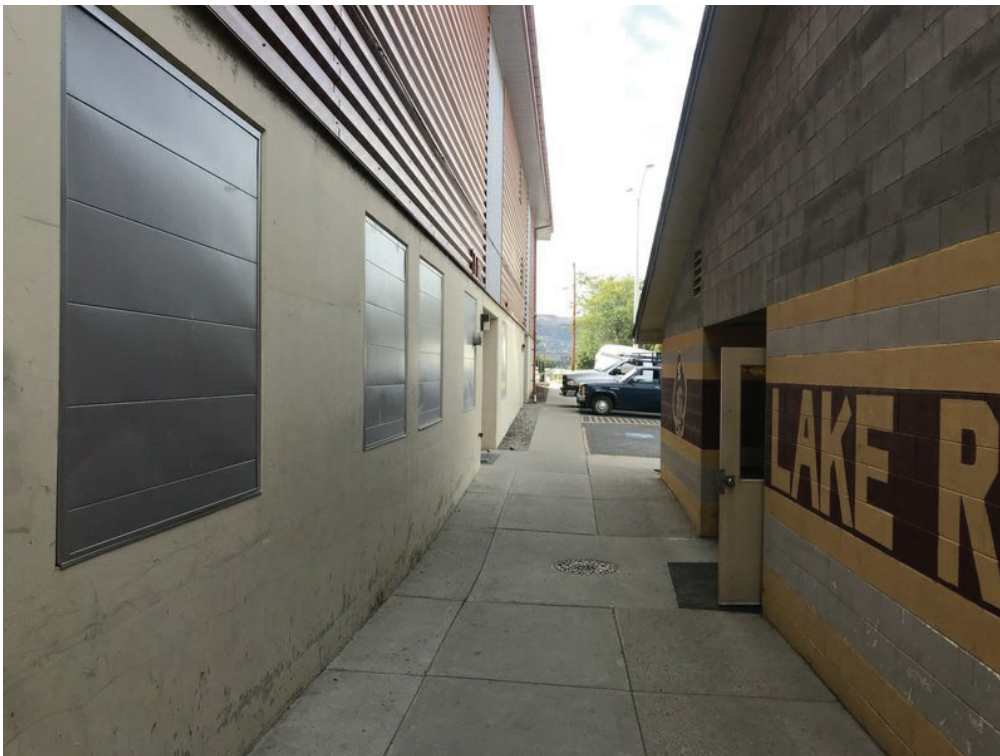
Figure 1-6. Separation between gymnasium building (on the left) and the wood shop (on the right).
