Washington State
School Seismic Safety Assessments Project

MARY M. KNIGHT SCHOOL ELEMENTARY SCHOOL BUILDING Mary M. Knight School District 311

SEISMIC UPGRADES CONCEPT DESIGN REPORT

June 2021

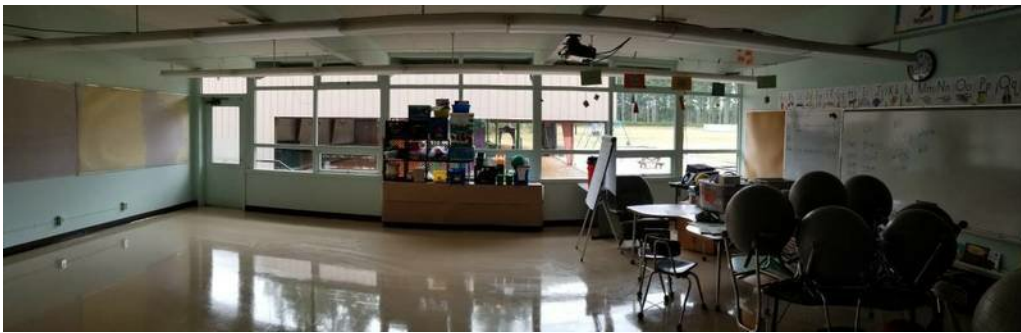
Figure 1-4. Panoramic view of classroom.

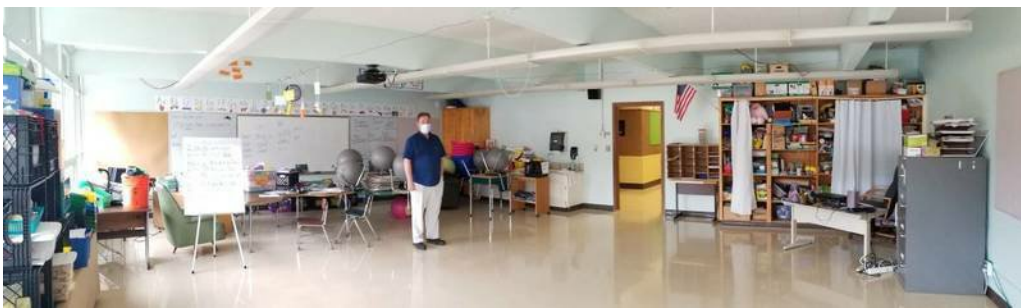
Figure 1-5. Panoramic view of classroom.

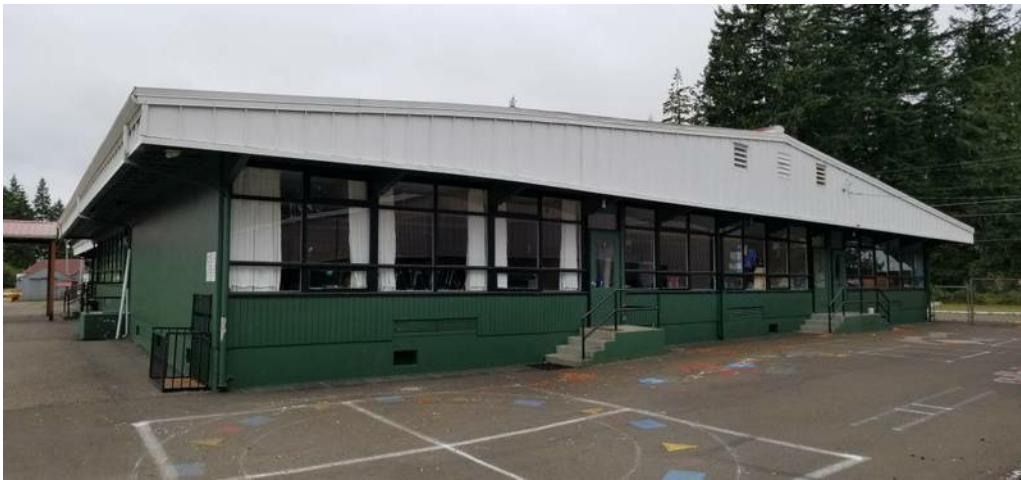
Figure 1-8. North façade of building.

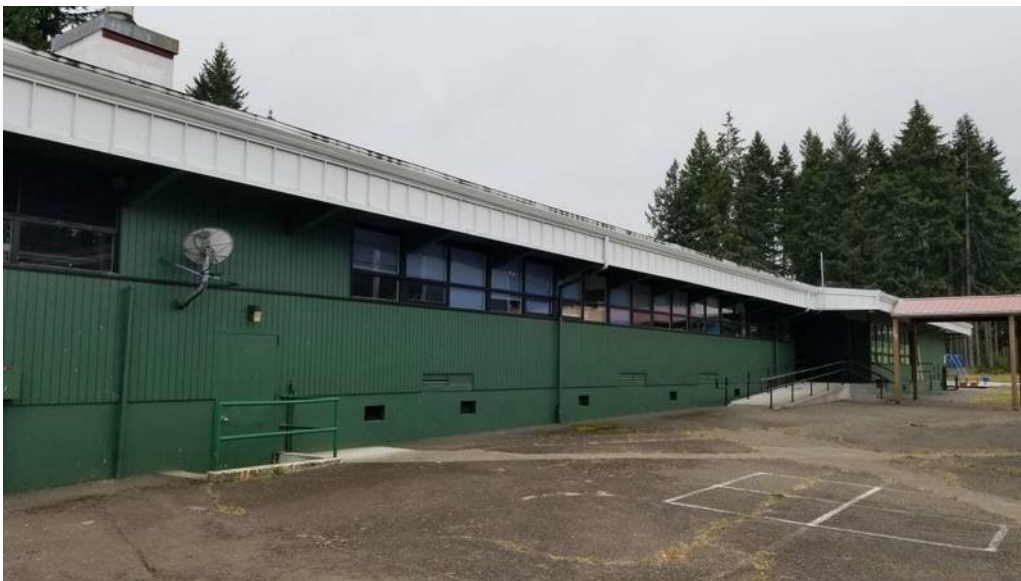
Figure 1-9. East façade of building.

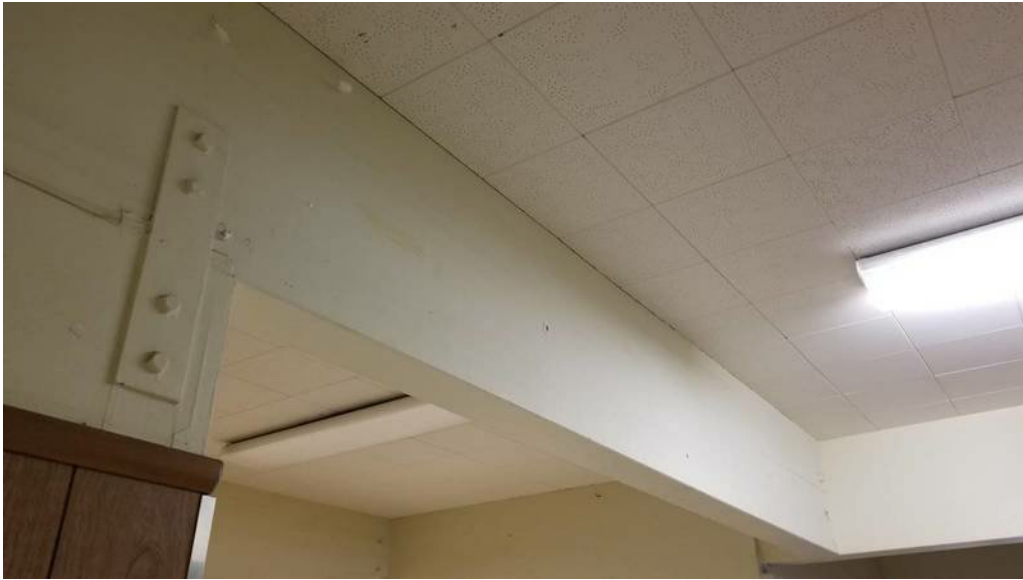
Figure 1-10. Exposed roof framing at interior.
