Washington State  
School Seismic Safety Assessments Project

# QUILCENE HIGH SCHOOL MAIN BUILDING Quilcene School District #48

SEISMIC UPGRADES CONCEPT DESIGN REPORT

June 2021

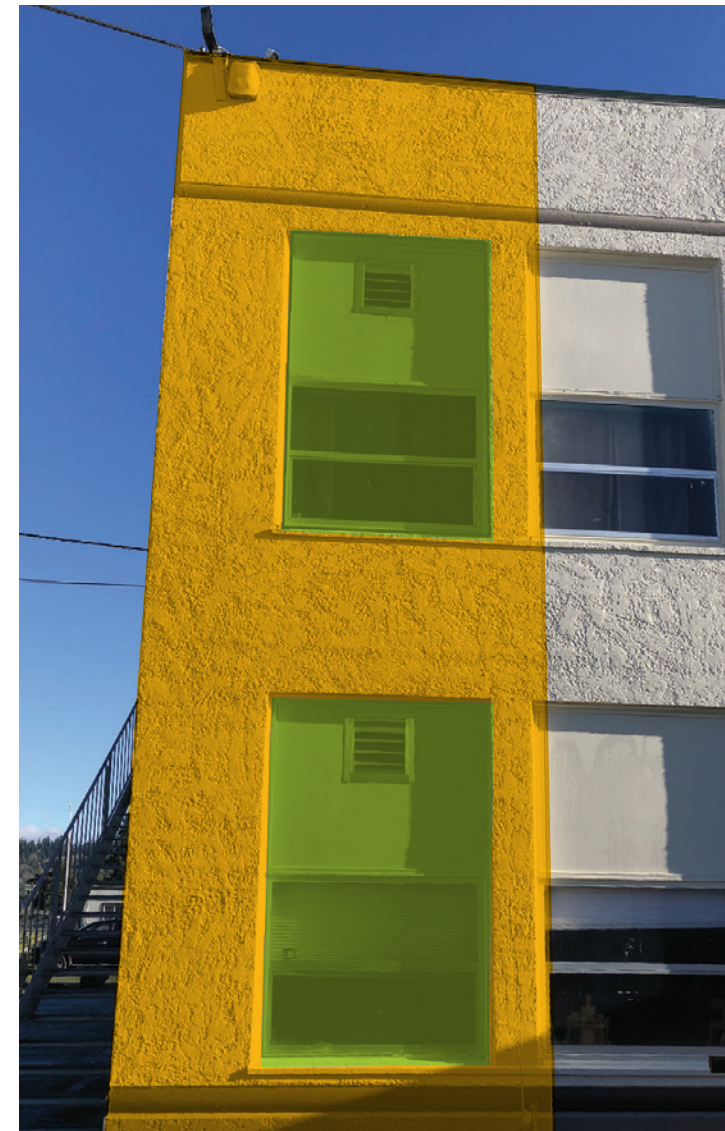
**CONCRETE WALL ELEVATION**

The east and west exterior concrete walls that laterally support the building in the north-south direction have insufficient shear strength for a current code level event. It is recommended that these existing shear wall lines be strengthened with new concrete shear walls at each end as shown in Figure 1 in Appendix B. These new concrete shear walls would require the infill of the end bay window openings at each floor and will need to be supported on strengthened foundations.

recommended that the existing concrete walls on each side of the building be anchored to the diaphragms at the second floor, second floor ceiling, and roof with Simpson LTT or HTT tension ties. See Figures 1 through 3 of Appendix B for the recommended spacing of the anchors. The LTT/HTT tension ties would fasten directly to the incoming wood floor, ceiling, or roof framing and would be anchored to the existing concrete wall with epoxy-grouted anchor rods.
