Washington State
School Seismic Safety Assessments Project

TACOMA SCHOOL OF THE ARTS PACIFIC AVENUE BUILDING Tacoma Public Schools

SEISMIC UPGRADES CONCEPT DESIGN REPORT

June 2021

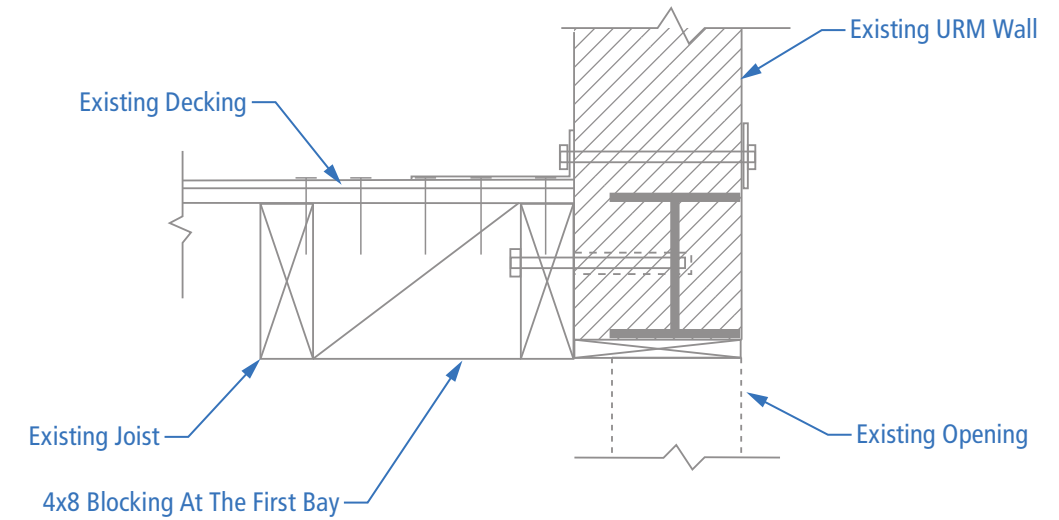
2a WALL ANCHORAGE FOR JOISTS PERPENDICULAR TO WALL AT WINDOW OPENINGS

1. Based on visual observation, it is assumed that there is a steel header element above window openings. However, the size and shape of the beam is unknown. Further investigation should be done prior to retrofit. Similar assumptions were made at door openings.
2. Spacing of joists is assumed to be ~48" OC. LTT straps to match the joist spacing. Further investigation should be done prior to retrofit.

1. Refer to detail (2a) for additional details.
