Canyon Fire Shelter Deployment and Entrapment Incident Review

CA-AFV-003151
Vandenberg Air Force Base, California
September 19, 2016

1. Executive Summary

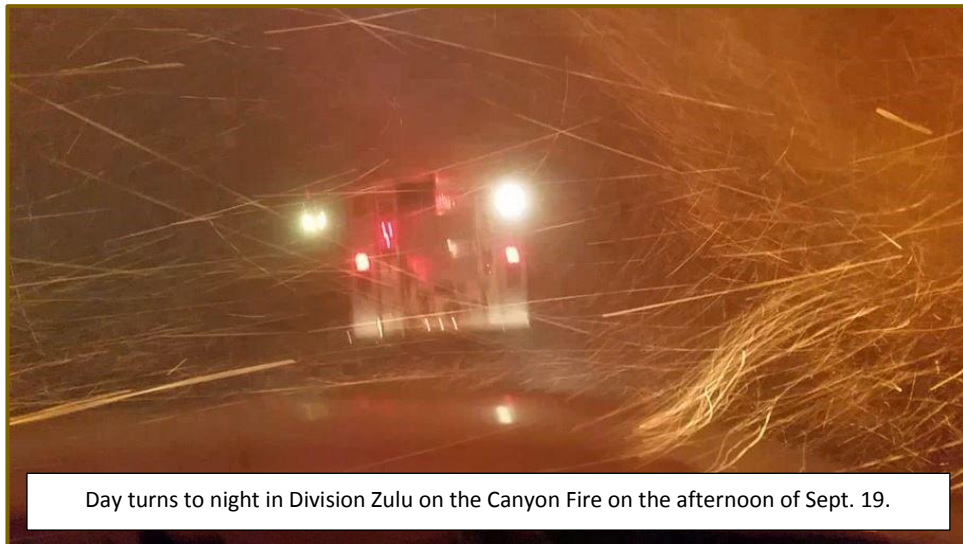
Day turns to night in Division Zulu on the Canyon Fire on the afternoon of Sept. 19.

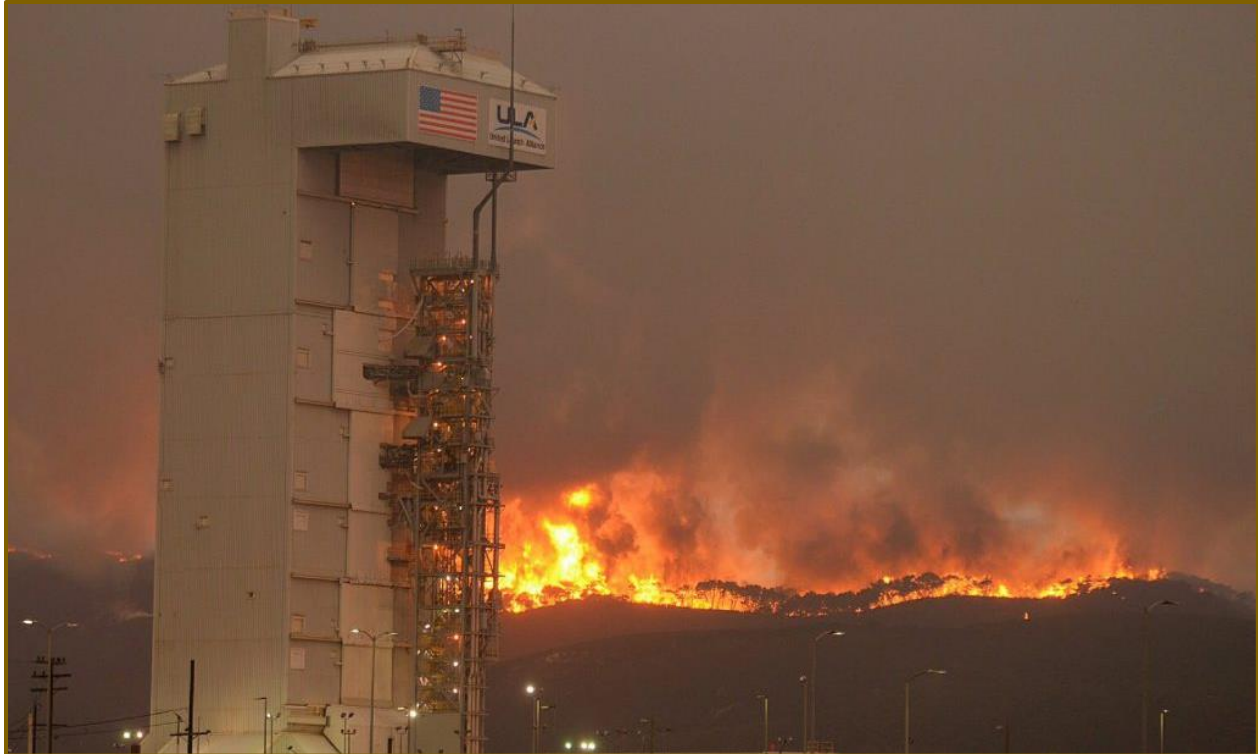
The Canyon Fire burning behind the Atlas 5 Rocket Pad on Vandenberg Air Force Base on Monday, Sept. 18, the day before the entrapment incident. Photo courtesy Santa Barbara County Fire Department.

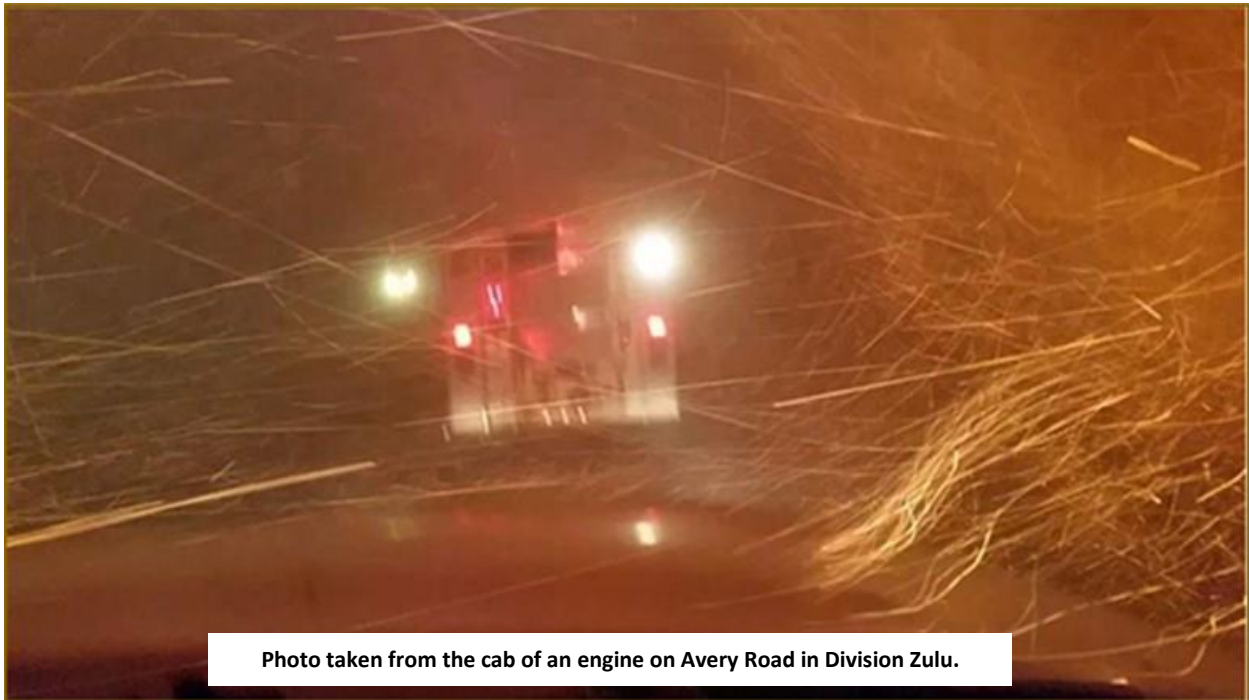
Photo taken from the cab of an engine on Avery Road in Division Zulu.

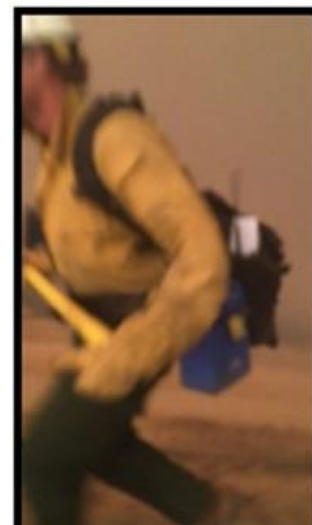
Screen grab from a firefighter’s video of a Helitack Module Crewmember running during the Division Zulu personnel’s escape to safety.
