BEACHAM/WILLIAMS STREET CORRIDOR STUDY

CITY OF CHELSEA,
MASSACHUSETTS

JUNE 26 2018

ROAD SAFETY AUDIT (RSA)
FINAL REPORT

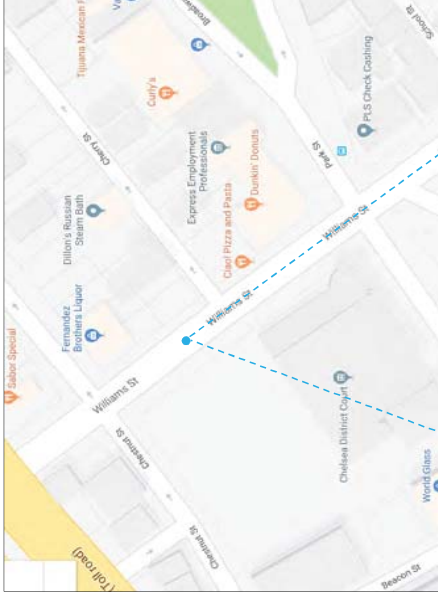
CORE 15
 140' S of Chestnut St.; 5' off E curb

CORE	DEPTH	CLASSIFICATION
15	3.75	Bit Conc
	5"	Cobblestone
		Bituminous Concrete
