NCHRP Report 350 Test 3-71
Of the Multi-Barrier Model MB-42x72 JSS LCB
Longitudinal Channelizing Barricade System
TRC Inc. Test Number: 061221

Prepared by:
Transportation Research Center Inc.
10820 State Route 347
East Liberty, OH 43319

Final Report
December 2006 - January 2007

Prepared for:
Off the Wall Products, LLC
180 South 300 West, Suite 314
Salt Lake City, UT 84101

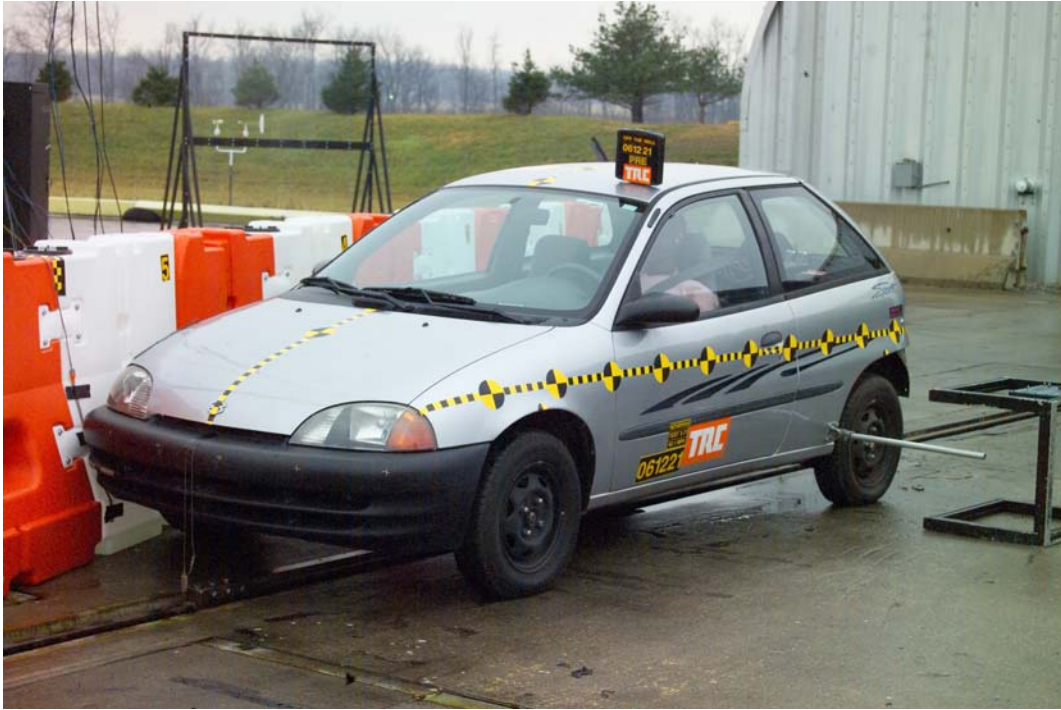
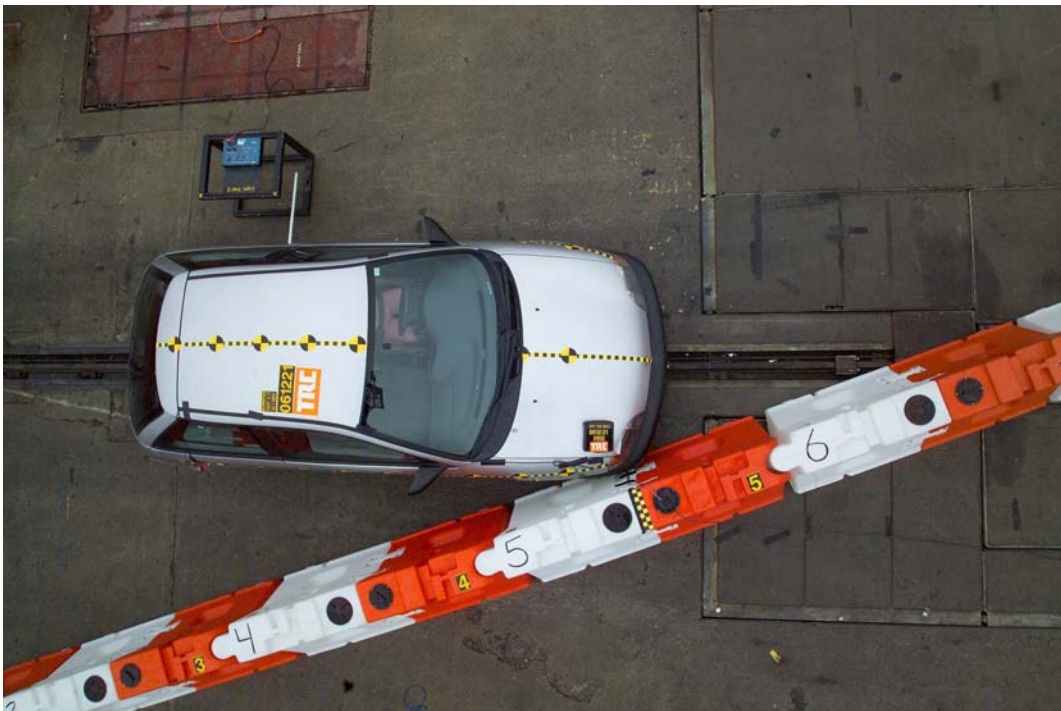
The vehicle, traveling at 100.5 km/h, impacted the center of barricade 5 of the Multi-Barrier Model MB-42x72 JSS LCB channelizing barricade system at 20° with the vehicle's right front fender (see Figure 3). The vehicle continued in a forward direction and remained in momentary contact with barricade 5. At approximately 40 milliseconds after time zero barricade 6 was pushed to the right and backwards slightly, as the vehicle, remaining in contact with barricade 5, continued in a forward direction. At approximately 54 milliseconds after time zero, barricade 5 started to become disconnected from barricades 4 and 6. At approximately 68 milliseconds after time zero the vehicle's right front fender impacted the center of barricade 6, while barricade 5 was pushed slightly to the right and parallel to the vehicle's forward direction. At approximately 90 milliseconds after time zero the vehicle

Figure 3. Impacting vehicle/ MB-42x72 JSS LCB channelizing barricade system geometrics for test 061221.

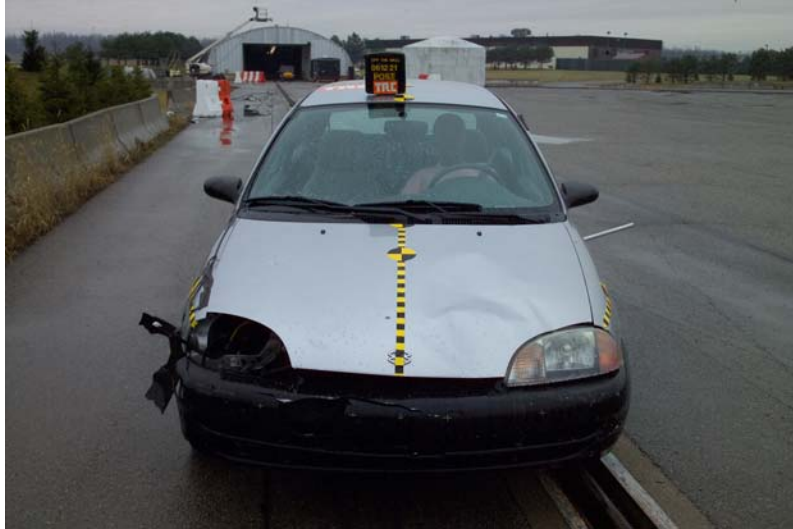
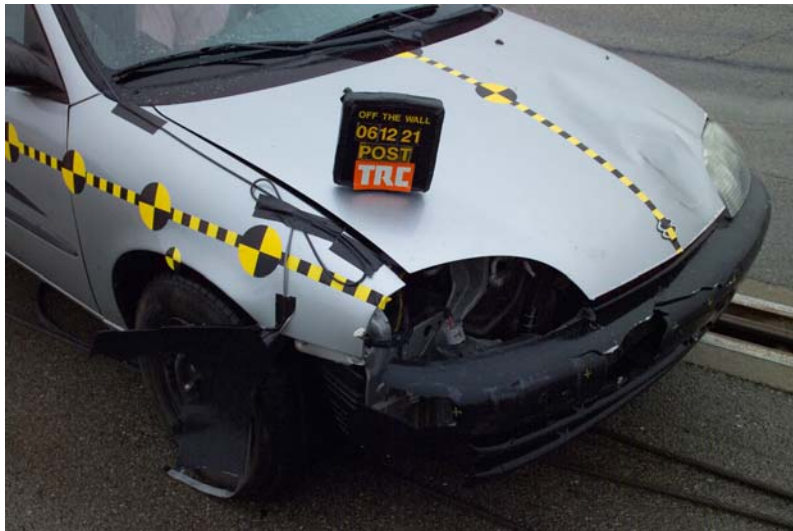
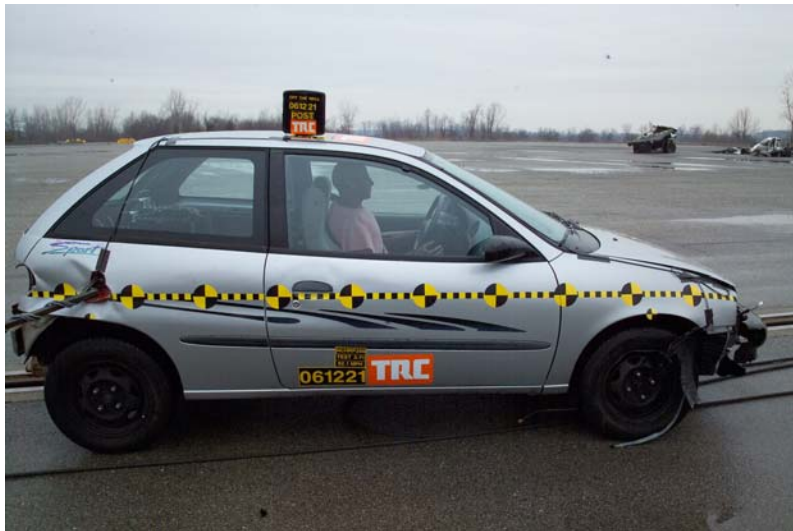
Most of the damage to the vehicle was to the front and right front sides as shown in Appendix A, Figures A-2, A-14, A-16, A-17 and A-18. The bumper, hood and right fender were moderately damaged. Maximum crush to the exterior of the vehicle was 280 mm. No measurable crush was evident to the occupant compartment of the vehicle.

Figure 8. Impacting vehicle after test 061221.

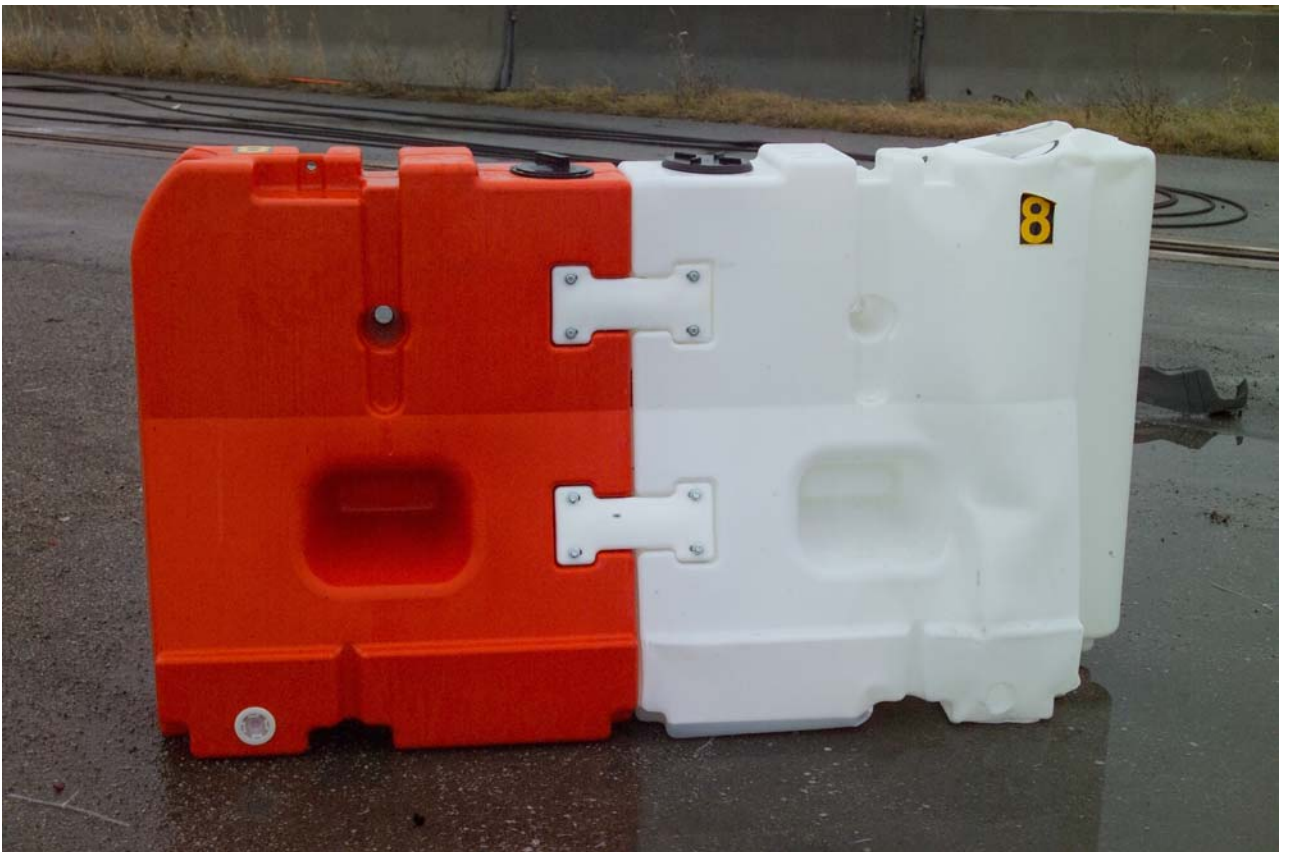
Figure A-58 Post-Test Barricade 8 View

Individual barricade sections 5, 6, 7, and 8 incurred damage to their overall outer shell sidewalls, being scored or ruptured, as shown in Appendix A, Figures A-57, A-58, A-61, A-62, A-63, A-64, and A-65.

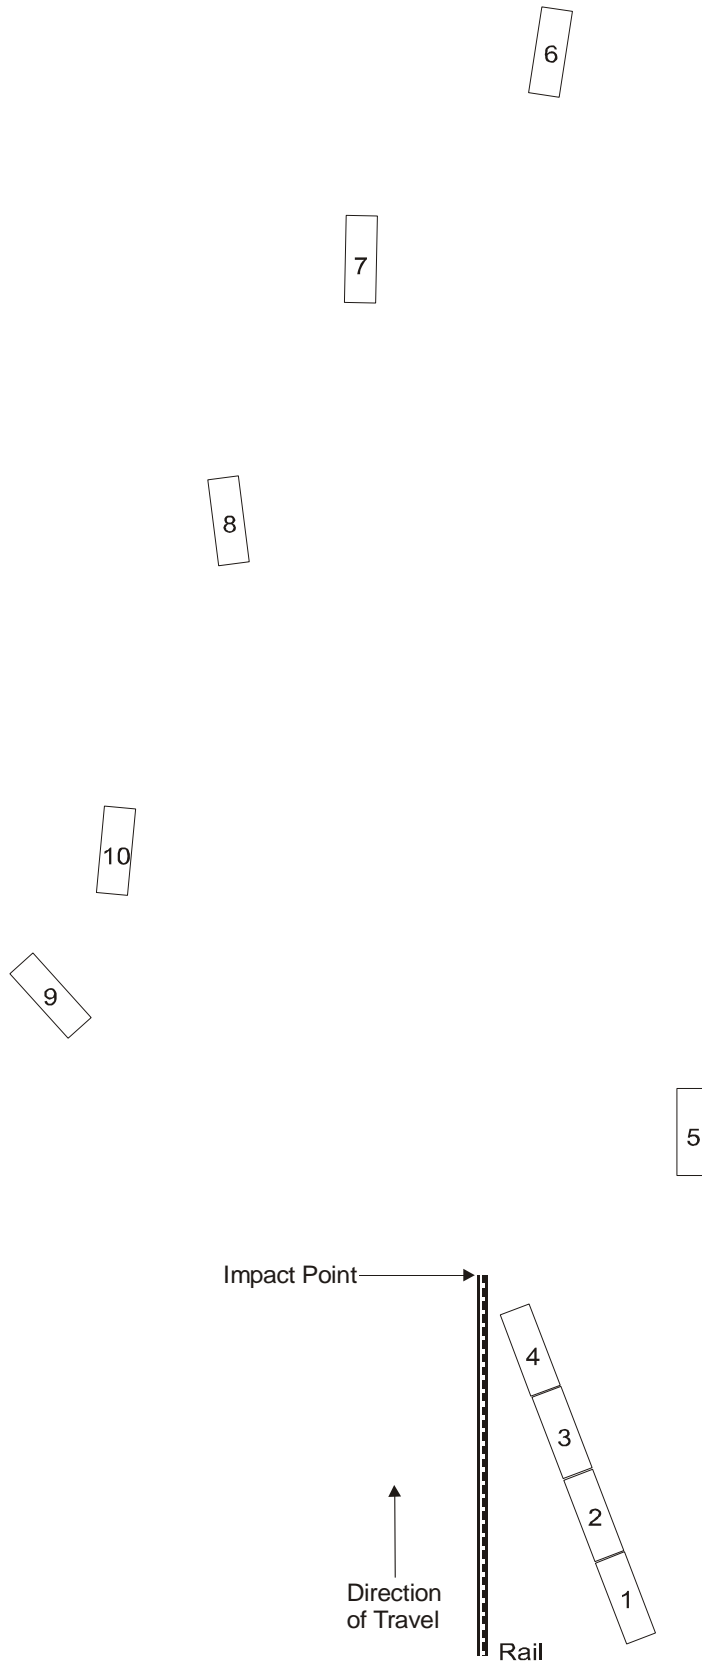
Post-Test Barrier Diagram

During test 061221 (NCHRP Report 350 TL 3-71), there were six detached individual barricades, and four individual barricades that exhibited damage from the Multi-Barrier Model MB-42x72 JSS LCB channelizing barricade system, with each individual barricade weighing less than 45 kg empty. There were no detached elements from the impacting vehicle or barricade system to penetrate the occupant compartment of the impacting vehicle or to present hazards to others in the area. There was no measurable deformation into the occupant compartment. The ridedown accelerations were within the recommended limits for the impacting vehicle. The occupant impact velocity was within the stated limits when evaluating the Multi-Barrier Model MB-42x72 JSS LCB channelizing barricade system to the longitudinal barrier criteria for velocity. The Multi-Barrier Model MB-42x72 JSS LCB channelizing barricade system performed acceptably per current NCHRP Report 350 TL 3-71 test standards, which require the test article to activate in a predictable manner by breaking away, fracturing, or yielding in response to the test vehicle. The channelizing barricade system, used as a work zone traffic control device, allowed the test vehicle to penetrate the barrier system. The impacting vehicle's final resting place intruded into the adjacent pedestrian area to the right of the barricade's initial pre-test placement location.

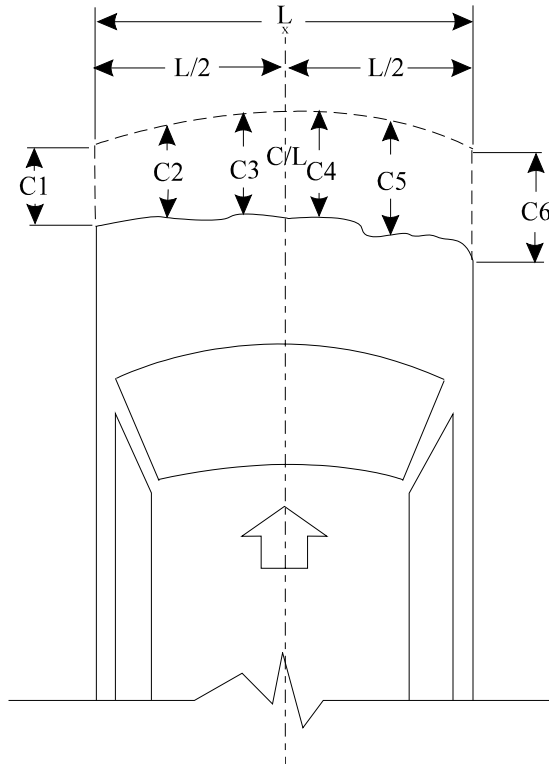
Impacting Vehicle Crush Data

Dynamic	13.3
Permanent	13.3
Vehicle Damage	
Exterior	
VDS	N/A
CDC	01FZEW1
Interior	
OCDI	FS0000000
Maximum Exterior	
Vehicle Crush (mm)	280
Max. Occ. Compart.	
Deformation (mm)	0
Post-Impact Vehicular Behavior	
Maximum Roll Angle (deg)	-23.2
Maximum Pitch Angle (deg)	6.2
Maximum Yaw Angle (deg)	-22.1
