Macondo

T H E G U L F O I L D I S A S T E R

Chief Counsel's Report | 2011

National Commission on the BP Deepwater Horizon Oil Spill and Offshore Drilling

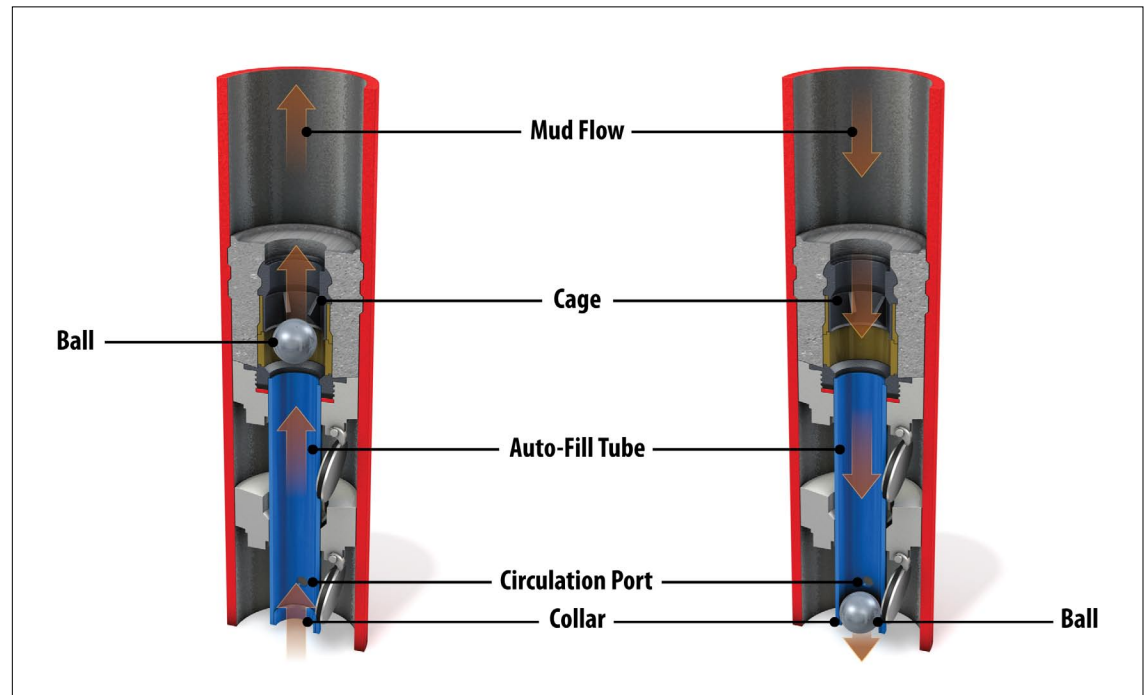
Figure 4.3.17. Auto-fill float collar.

The float collar's auto-fill tube contains a 2-inch weighted ball, which is free to move within the tube but not out of it. At the top of the float assembly is a plastic cage that prevents the ball from escaping but allows mud to flow through. At the bottom is a phenolic resin collar that is less than 2 inches in diameter, which also allows mud, but not the ball, to flow through. When casing is being run, mud flowing up through the tube pushes the ball against the inside of the cage. When the casing lands, the ball falls to and plugs the bottom of the tube, leaving two small holes on the side of the tube as the only path through the tube for mud circulated down through the well.¹⁴⁵

Flow while casing is being lowered (left) and flow during conversion (right).

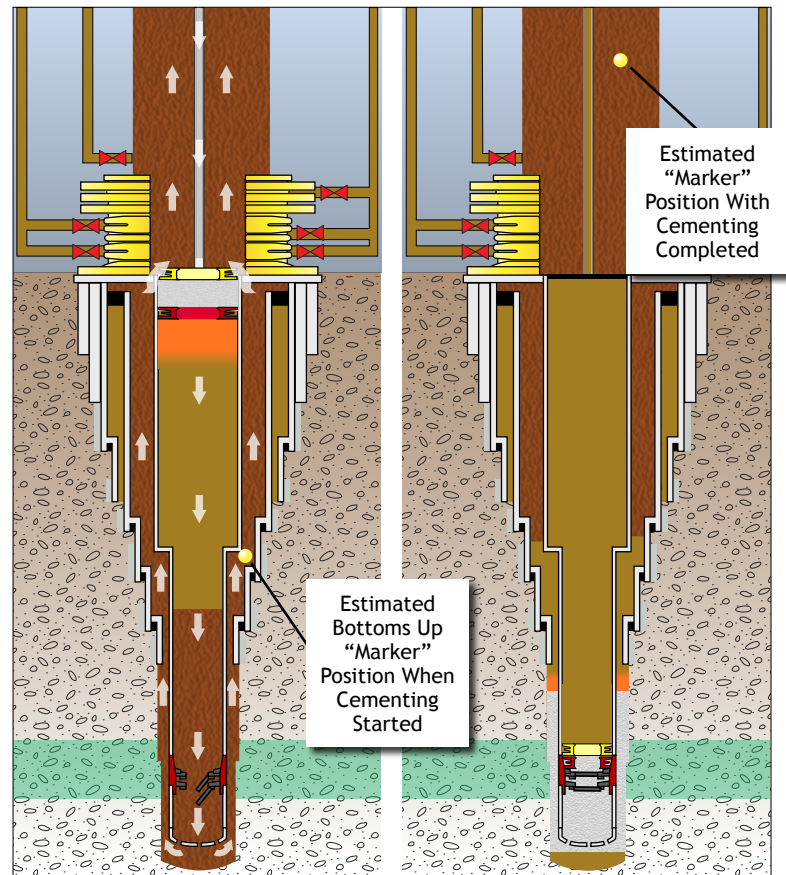
Figure 4.3.18. BP's pre-cementing mud circulation.

At approximately 4:18 p.m. on April 19, the rig crew re-established mud circulation after running the long string.¹⁹⁹ The rig crew then circulated a total of approximately 350 barrels of mud at rates up to 4 bpm before beginning the cementing process.²⁰⁰ This figure exceeds the 261 bbl called for in the April 18 Halliburton cement job procedure²⁰¹ but is significantly lower than the 2,760 bbl required for a full bottoms up.²⁰²

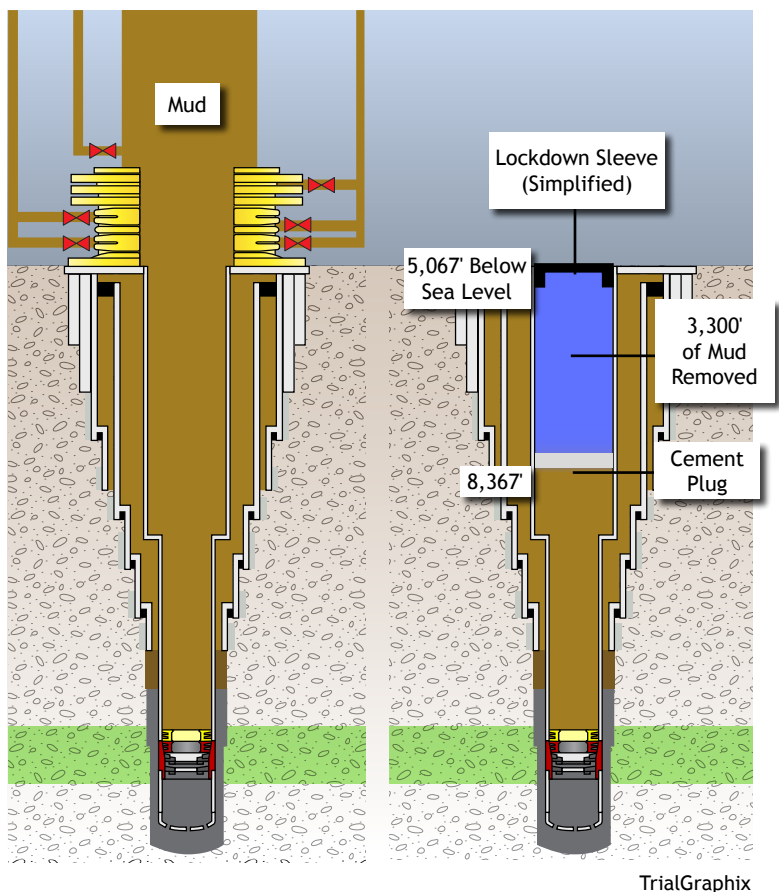
Figure 4.5.1. Planned configuration after temporary abandonment.

After finishing cementing the production casing (left), the rig crew began temporary abandonment procedures that would have allowed the *Deepwater Horizon* to remove its riser and BOP from the well and move on to another job (right). The blowout occurred before the rig crew set the cement plug and lockdown sleeve.

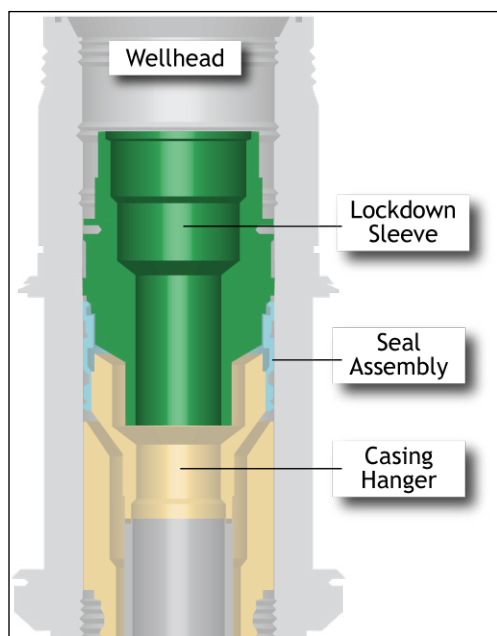
Figure 4.5.2. Lockdown sleeve.

BP's desire to set a lockdown sleeve during temporary abandonment drove the development of its temporary abandonment procedure. The lockdown sleeve locks down the casing hanger and seal assembly.

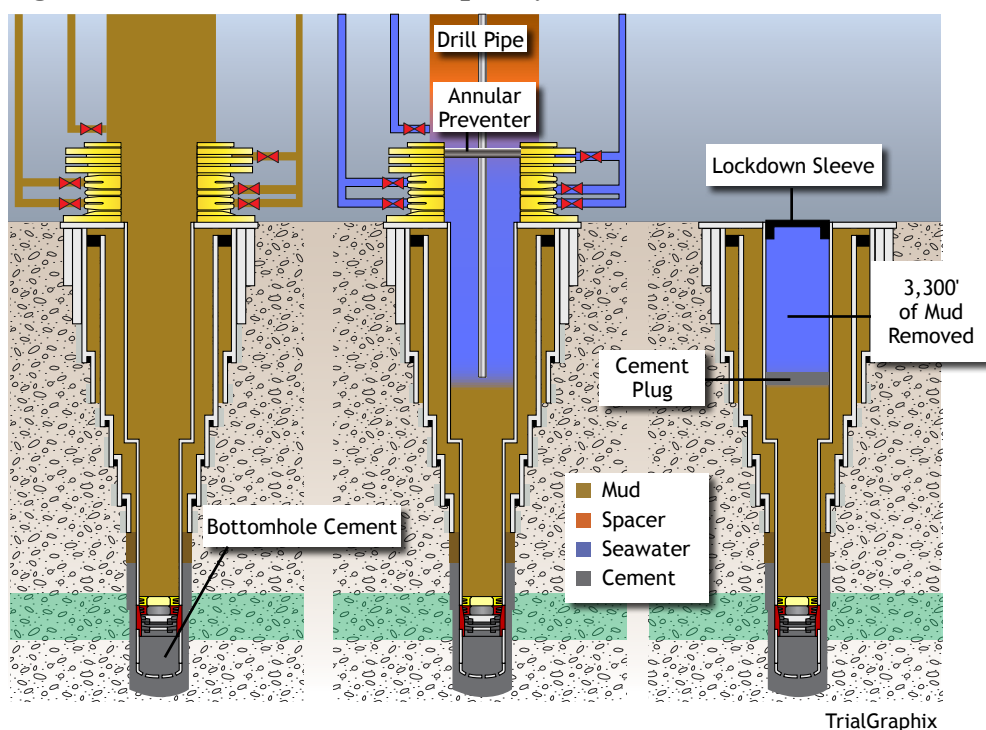
Figure 4.6.5. End of cement to temporary abandonment.

After the final casing string was cemented, heavy drilling mud filled the riser and the well (left). After the temporary abandonment planned for Macondo, the riser and its drilling mud would be removed. The drilling mud in the final casing string would be replaced with lighter seawater to a depth of over 8,000 feet below sea level (right). The removal of the hydrostatic pressure this drilling mud applied to the bottom of the well would increase the stress on the casing, seals, and cement. The negative pressure test simulated the conditions of temporary abandonment to confirm the integrity of the well in a controlled environment (middle).

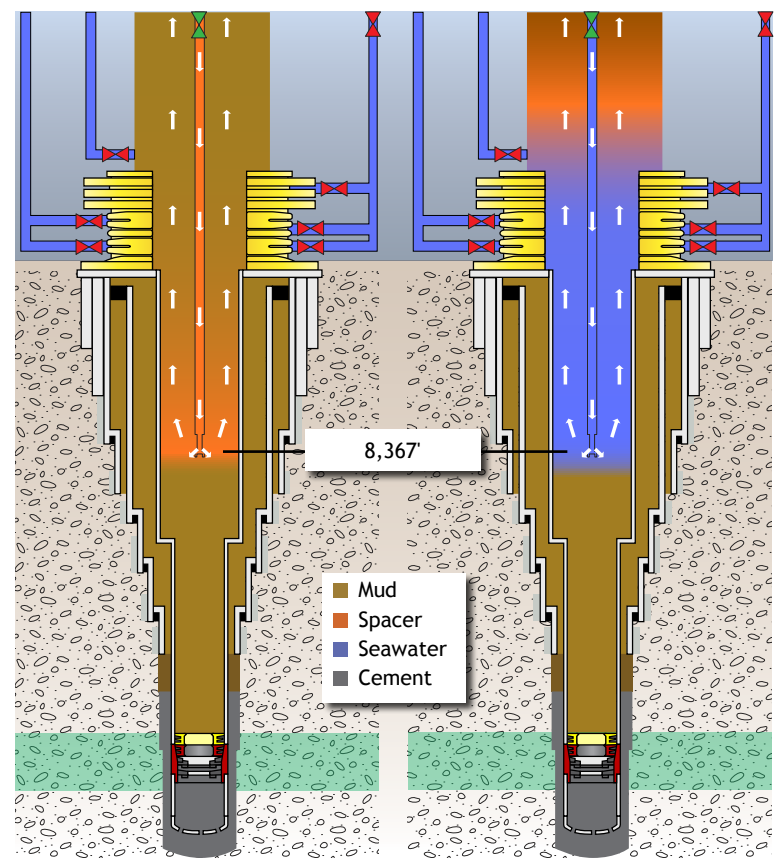
Figure 4.6.6. Preparations for the negative pressure test.

To prepare for the negative pressure test, the rig crew needed to displace the mud in the drill pipe and casing string from a depth of 8,367 feet to above the BOP. The crew did so by pumping spacer fluid (left) and then seawater (right) down the drill pipe until the mud was above the BOP.

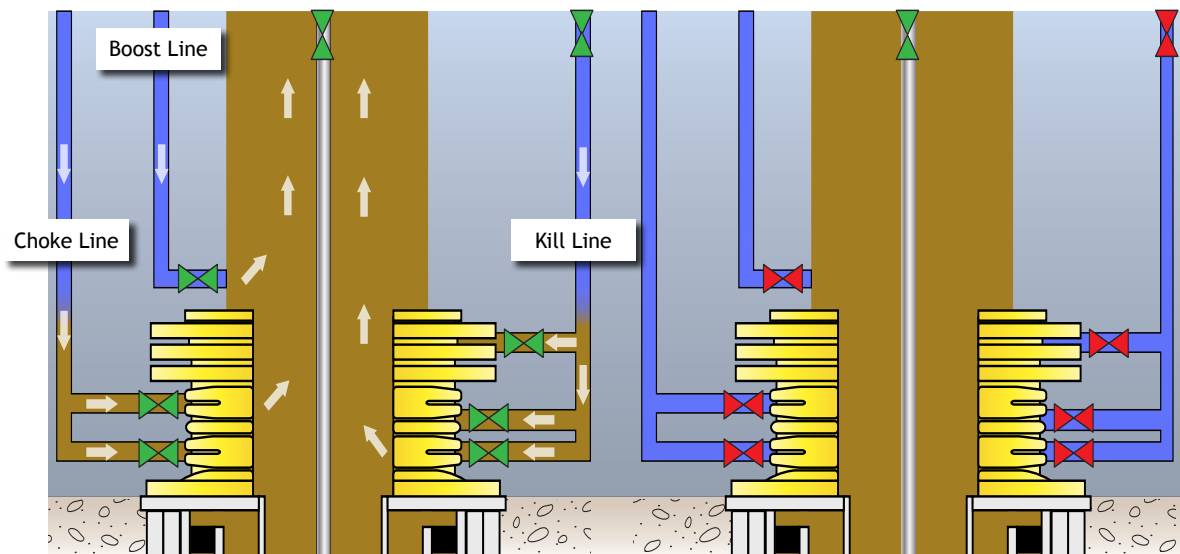
Figure 4.6.9. Negative pressure test progress, 3 p.m. on April 20, 2010.

To begin preparations for the negative pressure test, the rig crew displaced the boost, choke, and kill lines with seawater. Seawater was pumped into the lines on the rig, forcing mud into and up the riser (left). After the lines were displaced, the crew closed the valves connecting them to the riser and BOP (right).

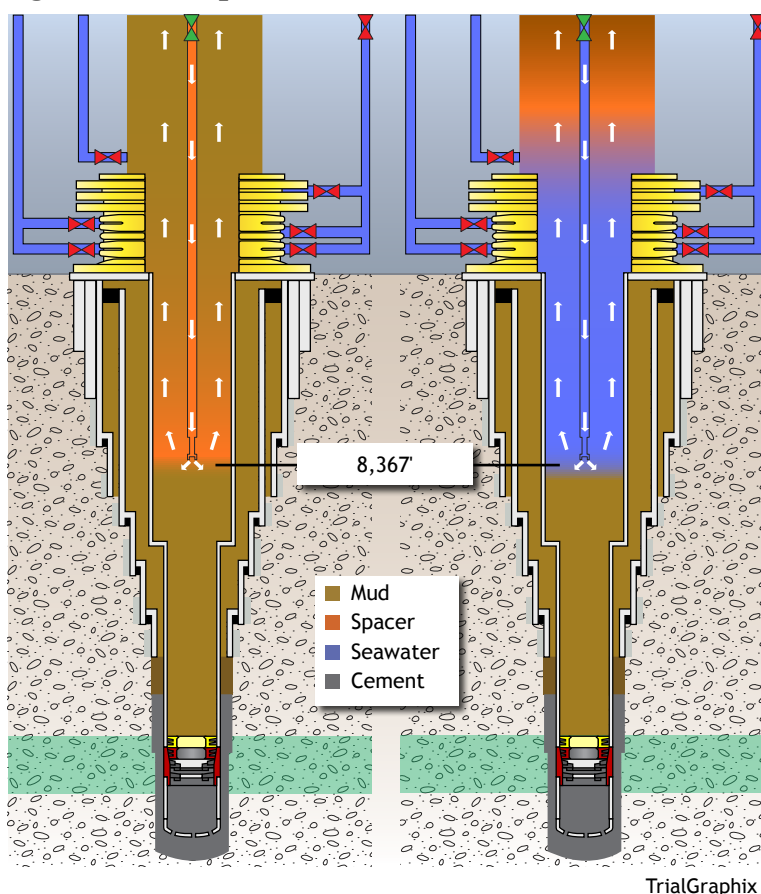
Figure 4.6.10. 4 p.m.

The crew displaced the mud in the drill pipe and in the casing from 8,367 feet to above the BOP. The crew first pumped a spacer fluid down the drill pipe, which forced the mud out and up the casing and the riser (left). Following the spacer, the crew pumped seawater into the drill pipe. This forced the spacer and the mud up the casing. The crew’s intent was to pump enough seawater to displace the spacer and mud above the BOP (right).

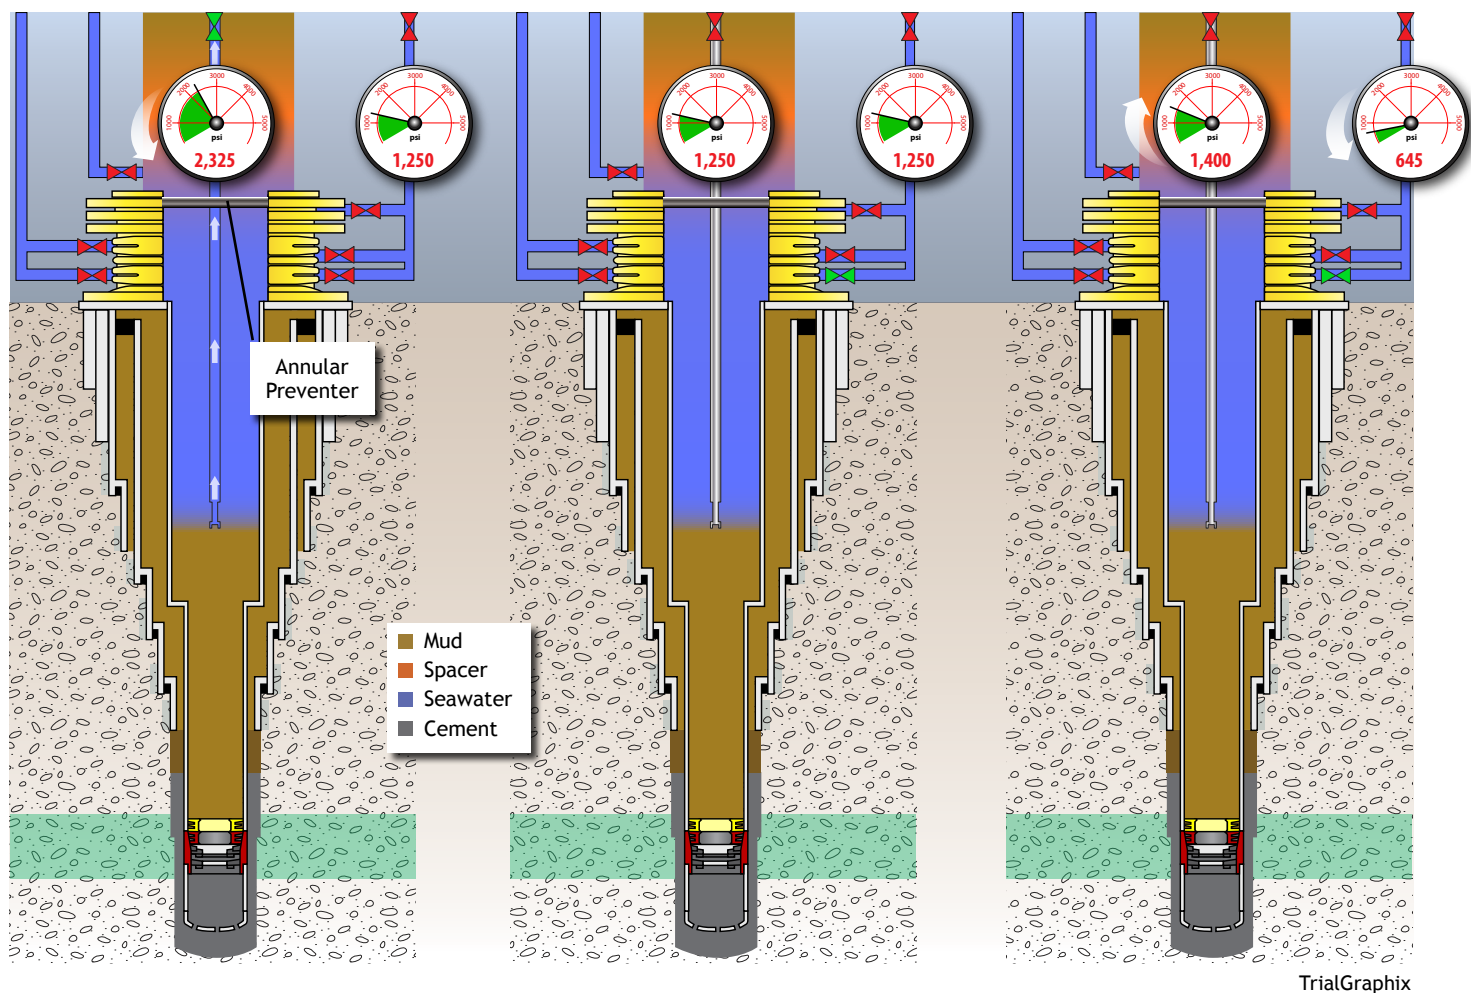
Figure 4.6.12. 4:55 p.m.

After the annular preventer was closed (left) the crew bled down the pressure in the drill pipe to equalize its pressure with the pressure in the kill line. Because both the drill pipe and the kill line go to the same vessel, when the valve connecting the kill line to the BOP is opened, the pressures should remain equal (middle). Instead, when the valve was opened, the pressures diverged (right).

The rig crew next bled the drill pipe to 1,250 psi, in an effort to equalize pressure on the drill pipe with pressure on the kill line (which was 1,250 psi at the time, as shown in Figure 4.6.12).³⁰ Once the crew had bled the drill pipe pressure down to 1,250 psi, it opened a valve on the kill line at the BOP so that both the drill pipe and kill line were open to the well. At this point, the drill pipe and kill line should have behaved like two straws in the same glass of water: The pressure in both should have been a steady 1,250 psi. Instead, when rig personnel opened the valve, the drill pipe pressure jumped, and the kill line pressure dropped.³¹

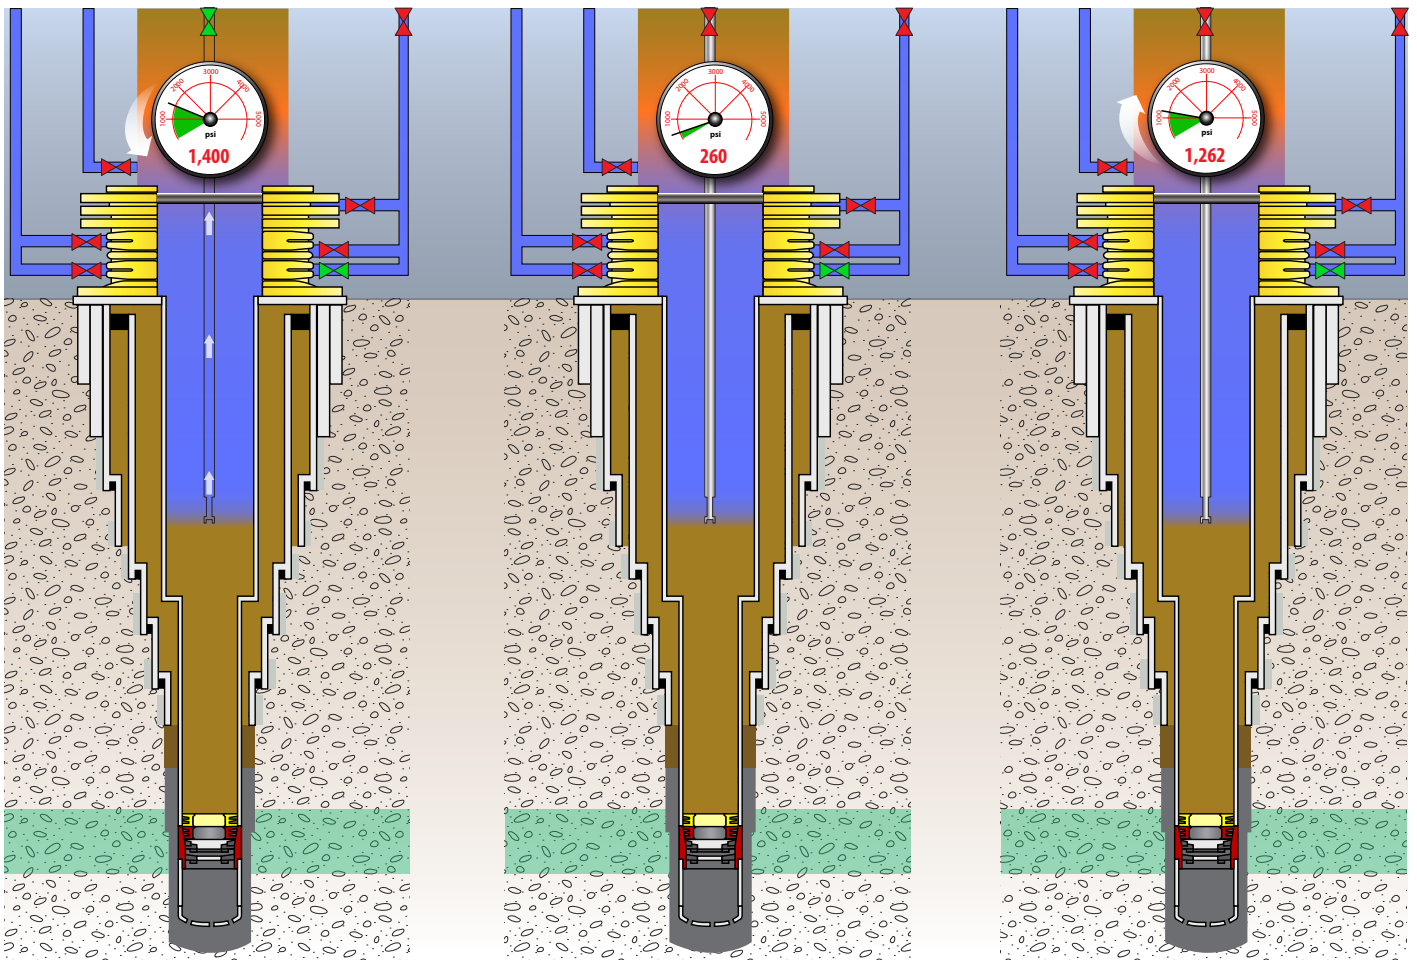
Figure 4.6.13. 4:58 p.m.

The crew began the negative pressure test by attempting to bleed the drill pipe pressure to 0 psi (left). However, the crew was unable to reduce pressure to below 260 psi (middle). This bleed returned an unknown amount of water to the rig. The crew shut in the drill pipe, and the pressure built up to 1,262 psi (right). In a successful negative pressure test, pressure does not build up.

The uncertainty over how much fluid flowed from the well during the bleed-off suggests that the well site leaders and crew failed to monitor the bleed-off volumes with requisite rigor. It does not appear that anyone had calculated ahead of time how many barrels should have flowed from the

well during the bleed, even though such calculations would have been relatively straightforward.³⁷ After failing to bleed the pressure down to 0 psi, the crew closed the valve on the drill pipe, and the pressure built back up to 1,262 psi.³⁸

As one independent expert has pointed out, this series of events actually constituted a failed negative pressure test, although the crew did not recognize that fact.⁴⁰

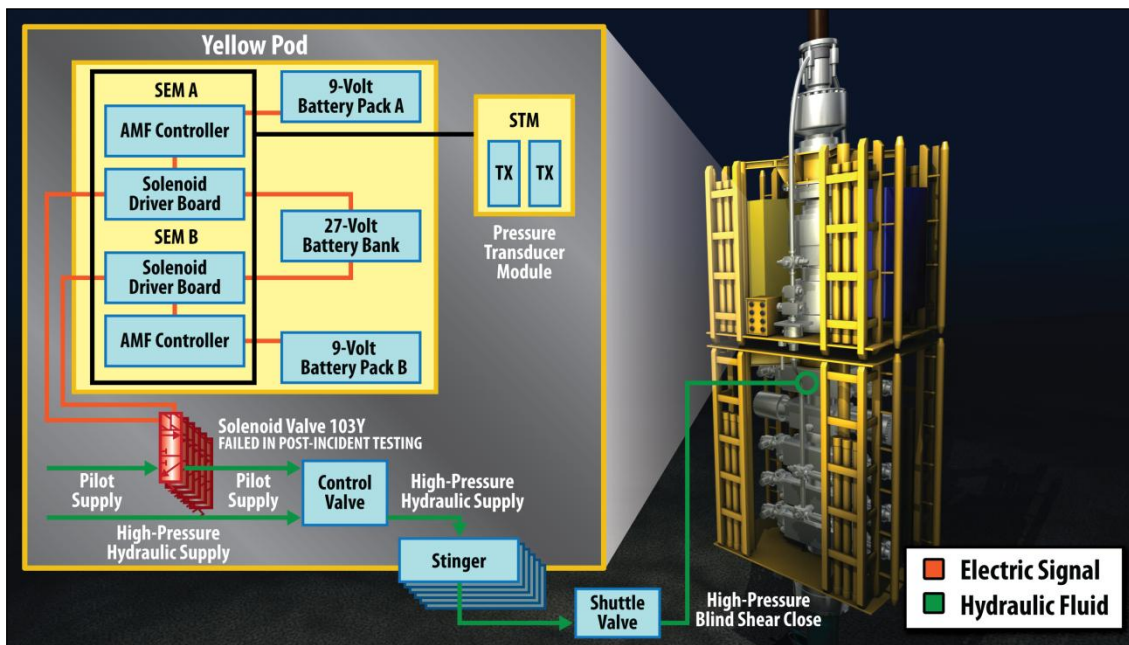
Figure 4.9.8. BOP’s electrical schematic.

Control pods also rely on functioning solenoid valves (diagrammed in Figure 4.9.8). The solenoid valves open and close in response to electrical signals and thereby send hydraulic pilot signals from the pods to the BOP elements.⁸⁹ The pilot signals in turn open hydraulic valves, which then deliver pressurized hydraulic fluid into BOP rams to close them.⁹⁰ Each solenoid activates when electric signals energize one of two redundant coils in the solenoid.⁹¹

Tests on the *Deepwater Horizon*’s yellow pod revealed that the solenoid valve used to close the blind shear ram was inoperable.
