Burned Area Emergency Response (BAER)

Cougar Creek Fire

Geology: Entiat River Road Debris Flow Evaluation

Okanogan-Wenatchee Ranger District, Washington

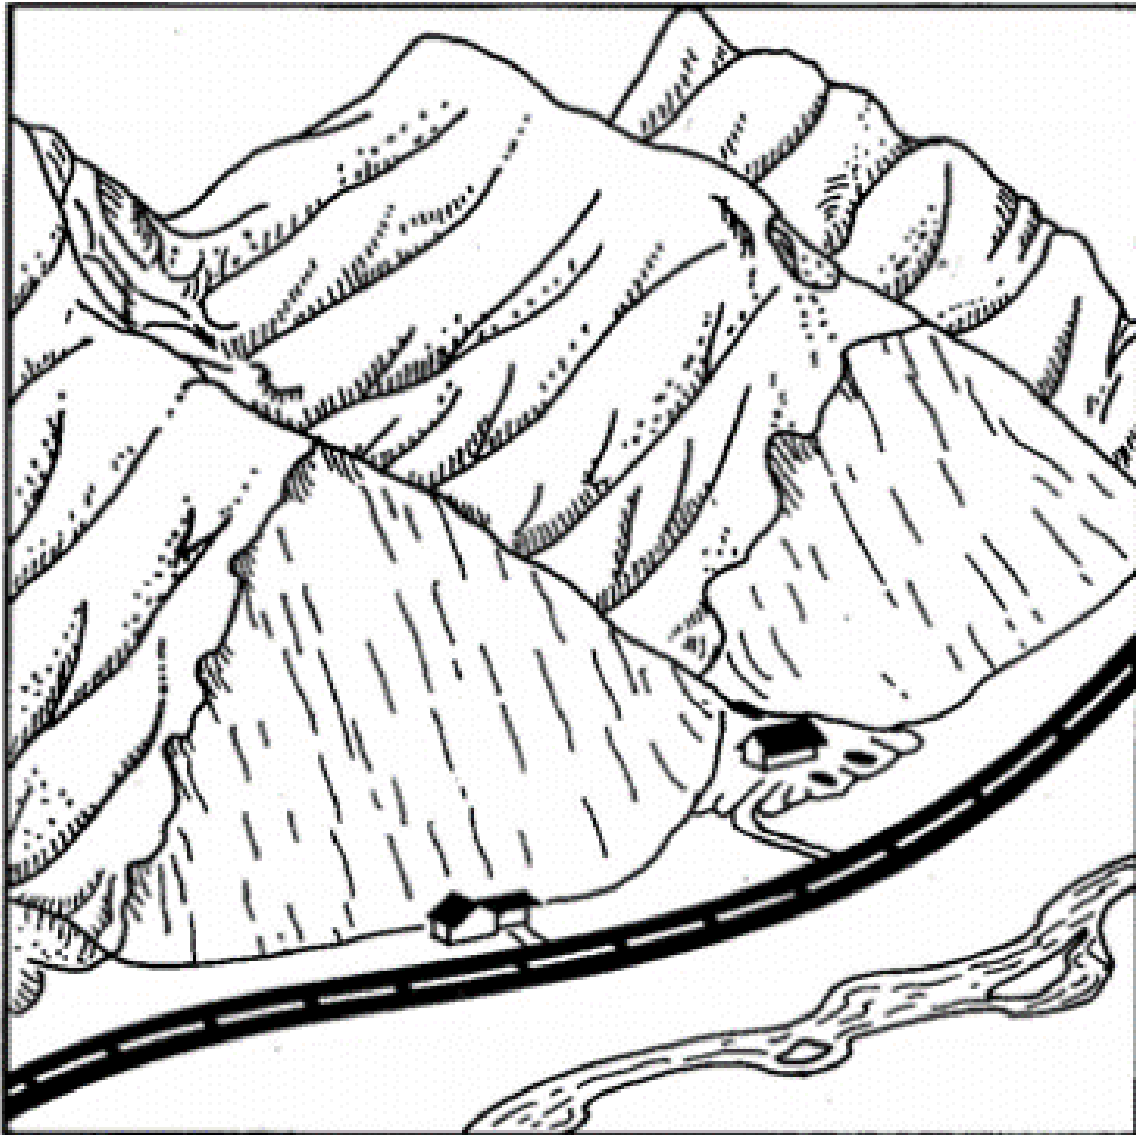
Fans are attractive locations to build cabins and homes due to the slight elevation above river floodplains and (or) the occasion to have a view of the floodplain (Figure 1). However, fans are there because they are active depositional areas that accumulate sediment over time. The sediment can be deposited both slowly, such as during a spring melt when high streamflow during spring runoff transports and deposits fine sediment on the fan or quickly, when a flash flood, HCF, or debris flow transports sediment and debris to the fan. As stated previously, both flash floods and HCF can inundate areas not typically wetted by regular streamflow, so channel-adjacent roads, trails, building, and other infrastructure can still be damaged by impact from debris, sedimentation, water erosion, and (or) water inundation. In addition, a debris flow can be very destructive due to the ability of a debris flow to buoy cobbles, boulders, and woody debris at the front of the moving mass. Debris flows are extremely dangerous to public safety and infrastructure.

Figure 1. Homes and road in debris flow-prone locations on fans. Courtesy of Oregon Dept. of Forestry.
