Crescent Mountain Fire

Twisp River Debris Flow Evaluation

Washington Geological Survey

Okanogan-Wenatchee Ranger District, Washington

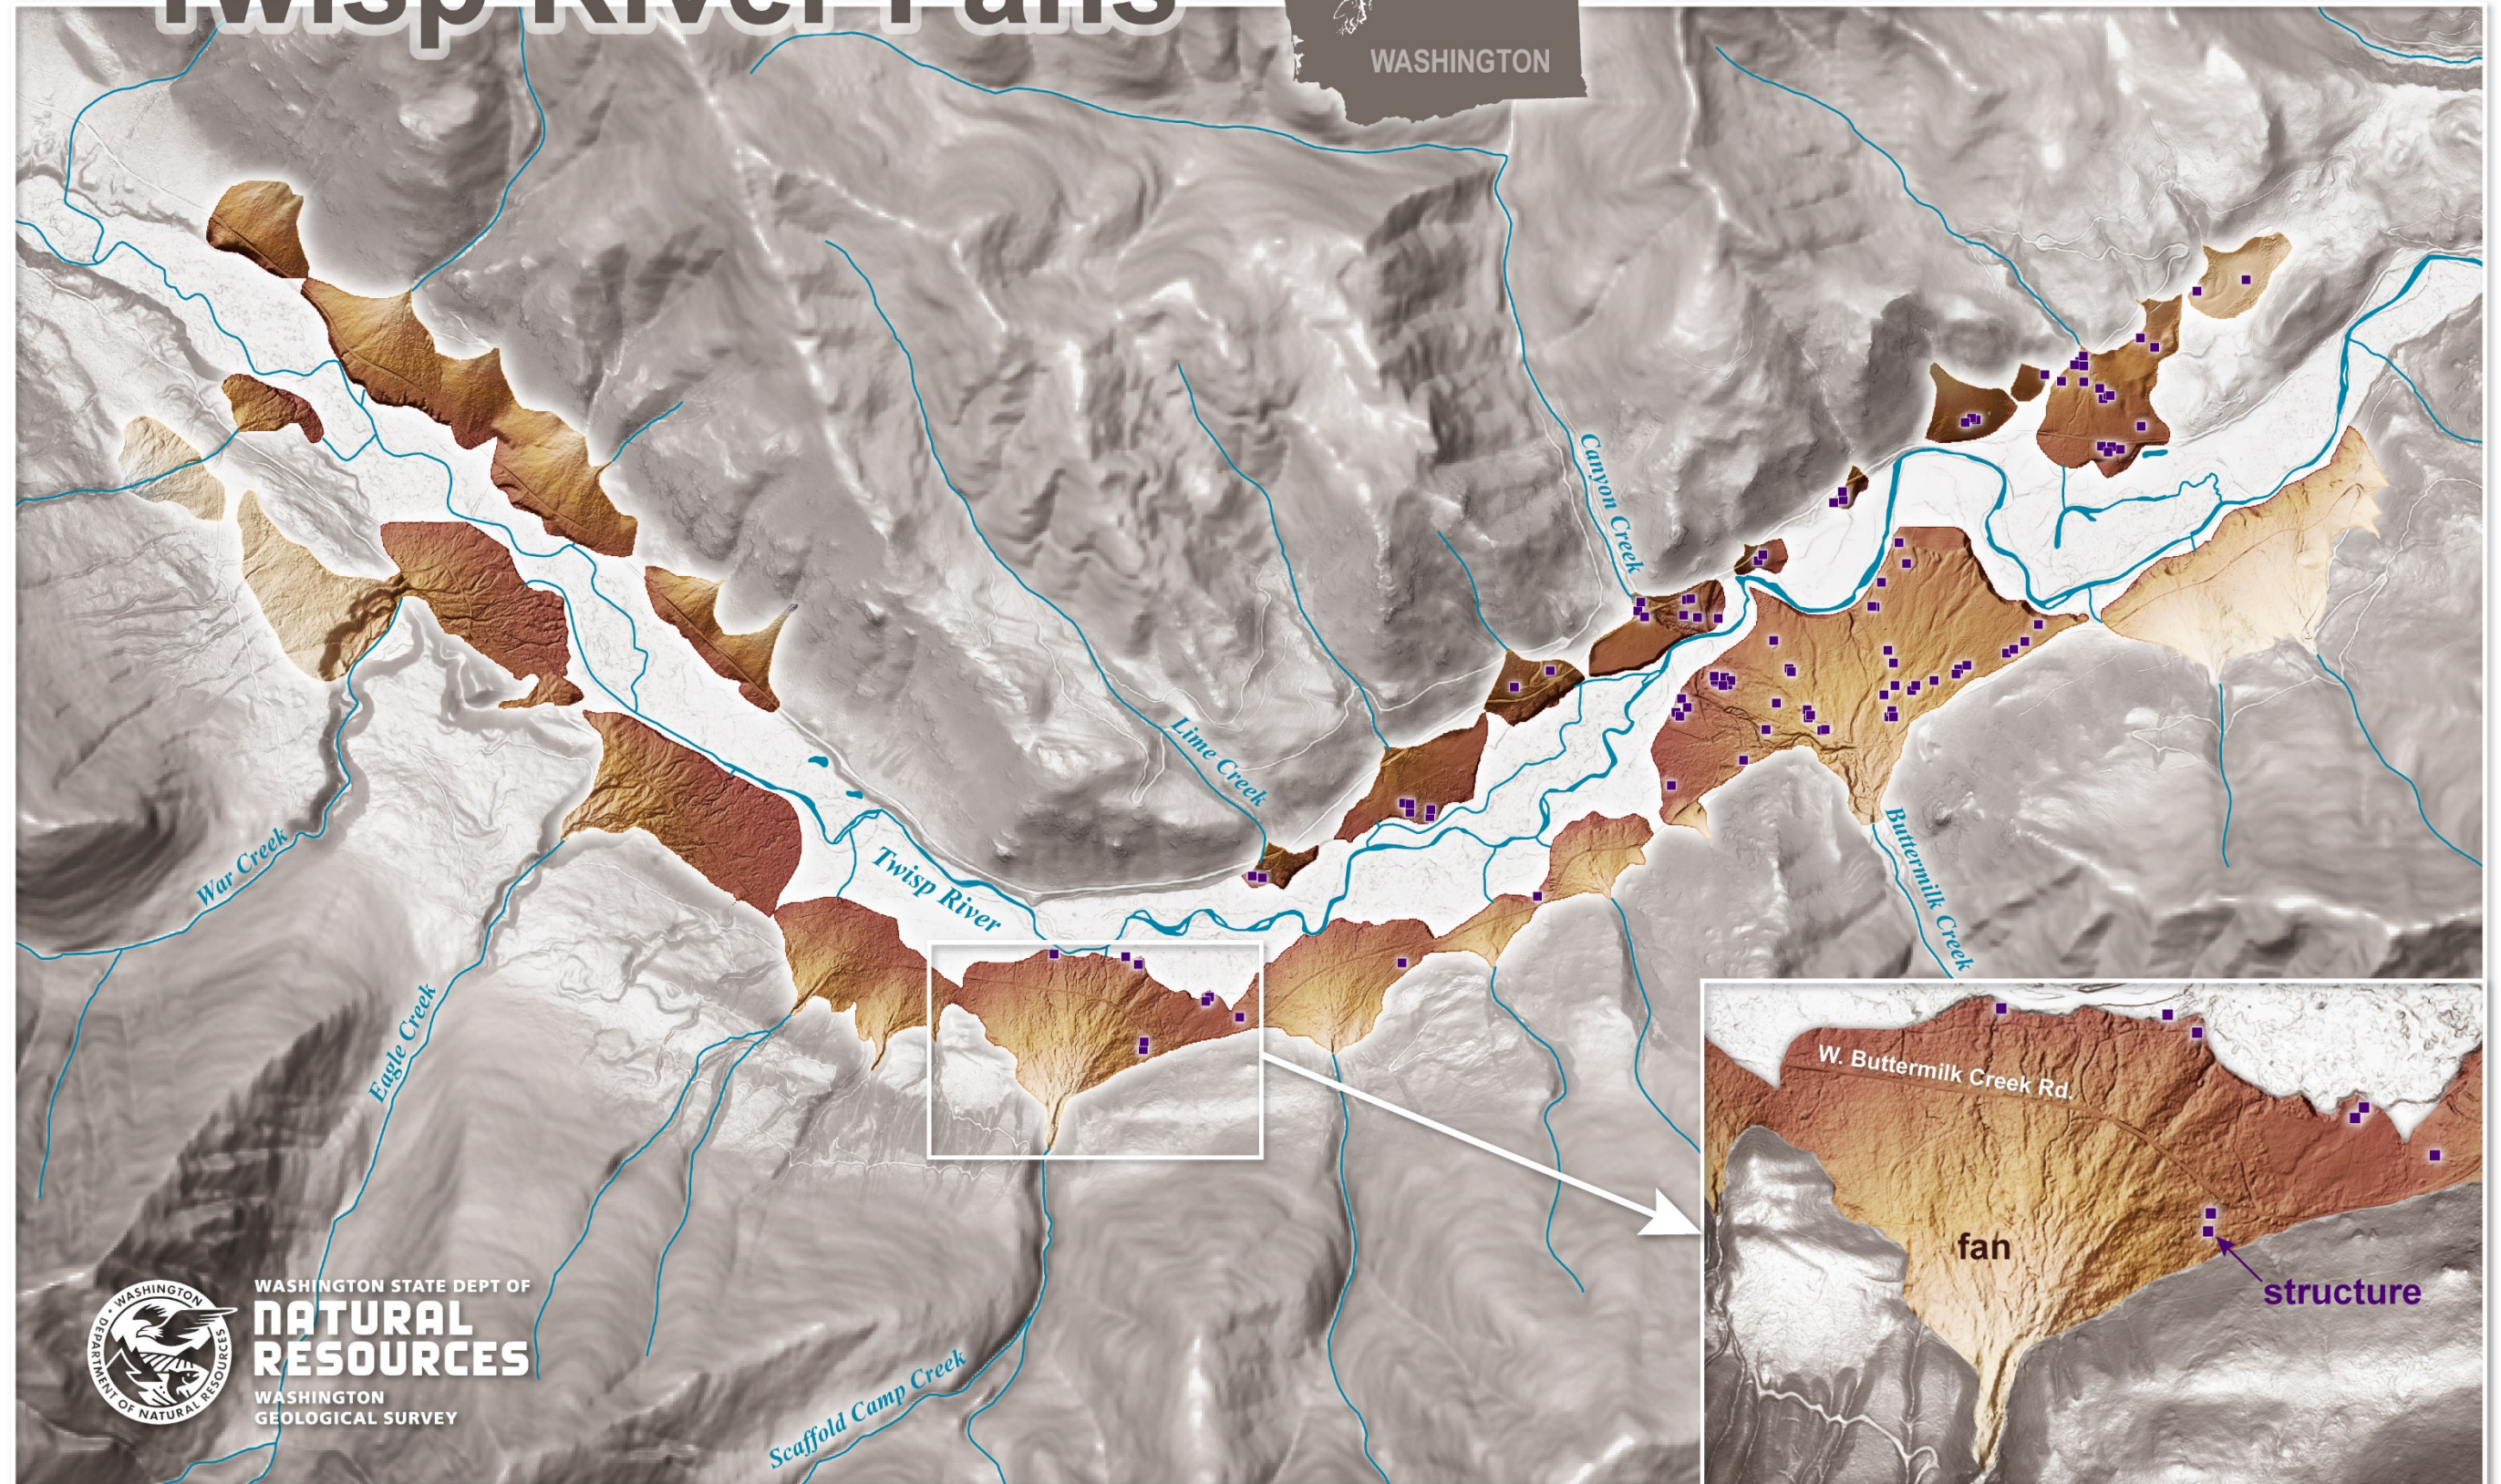
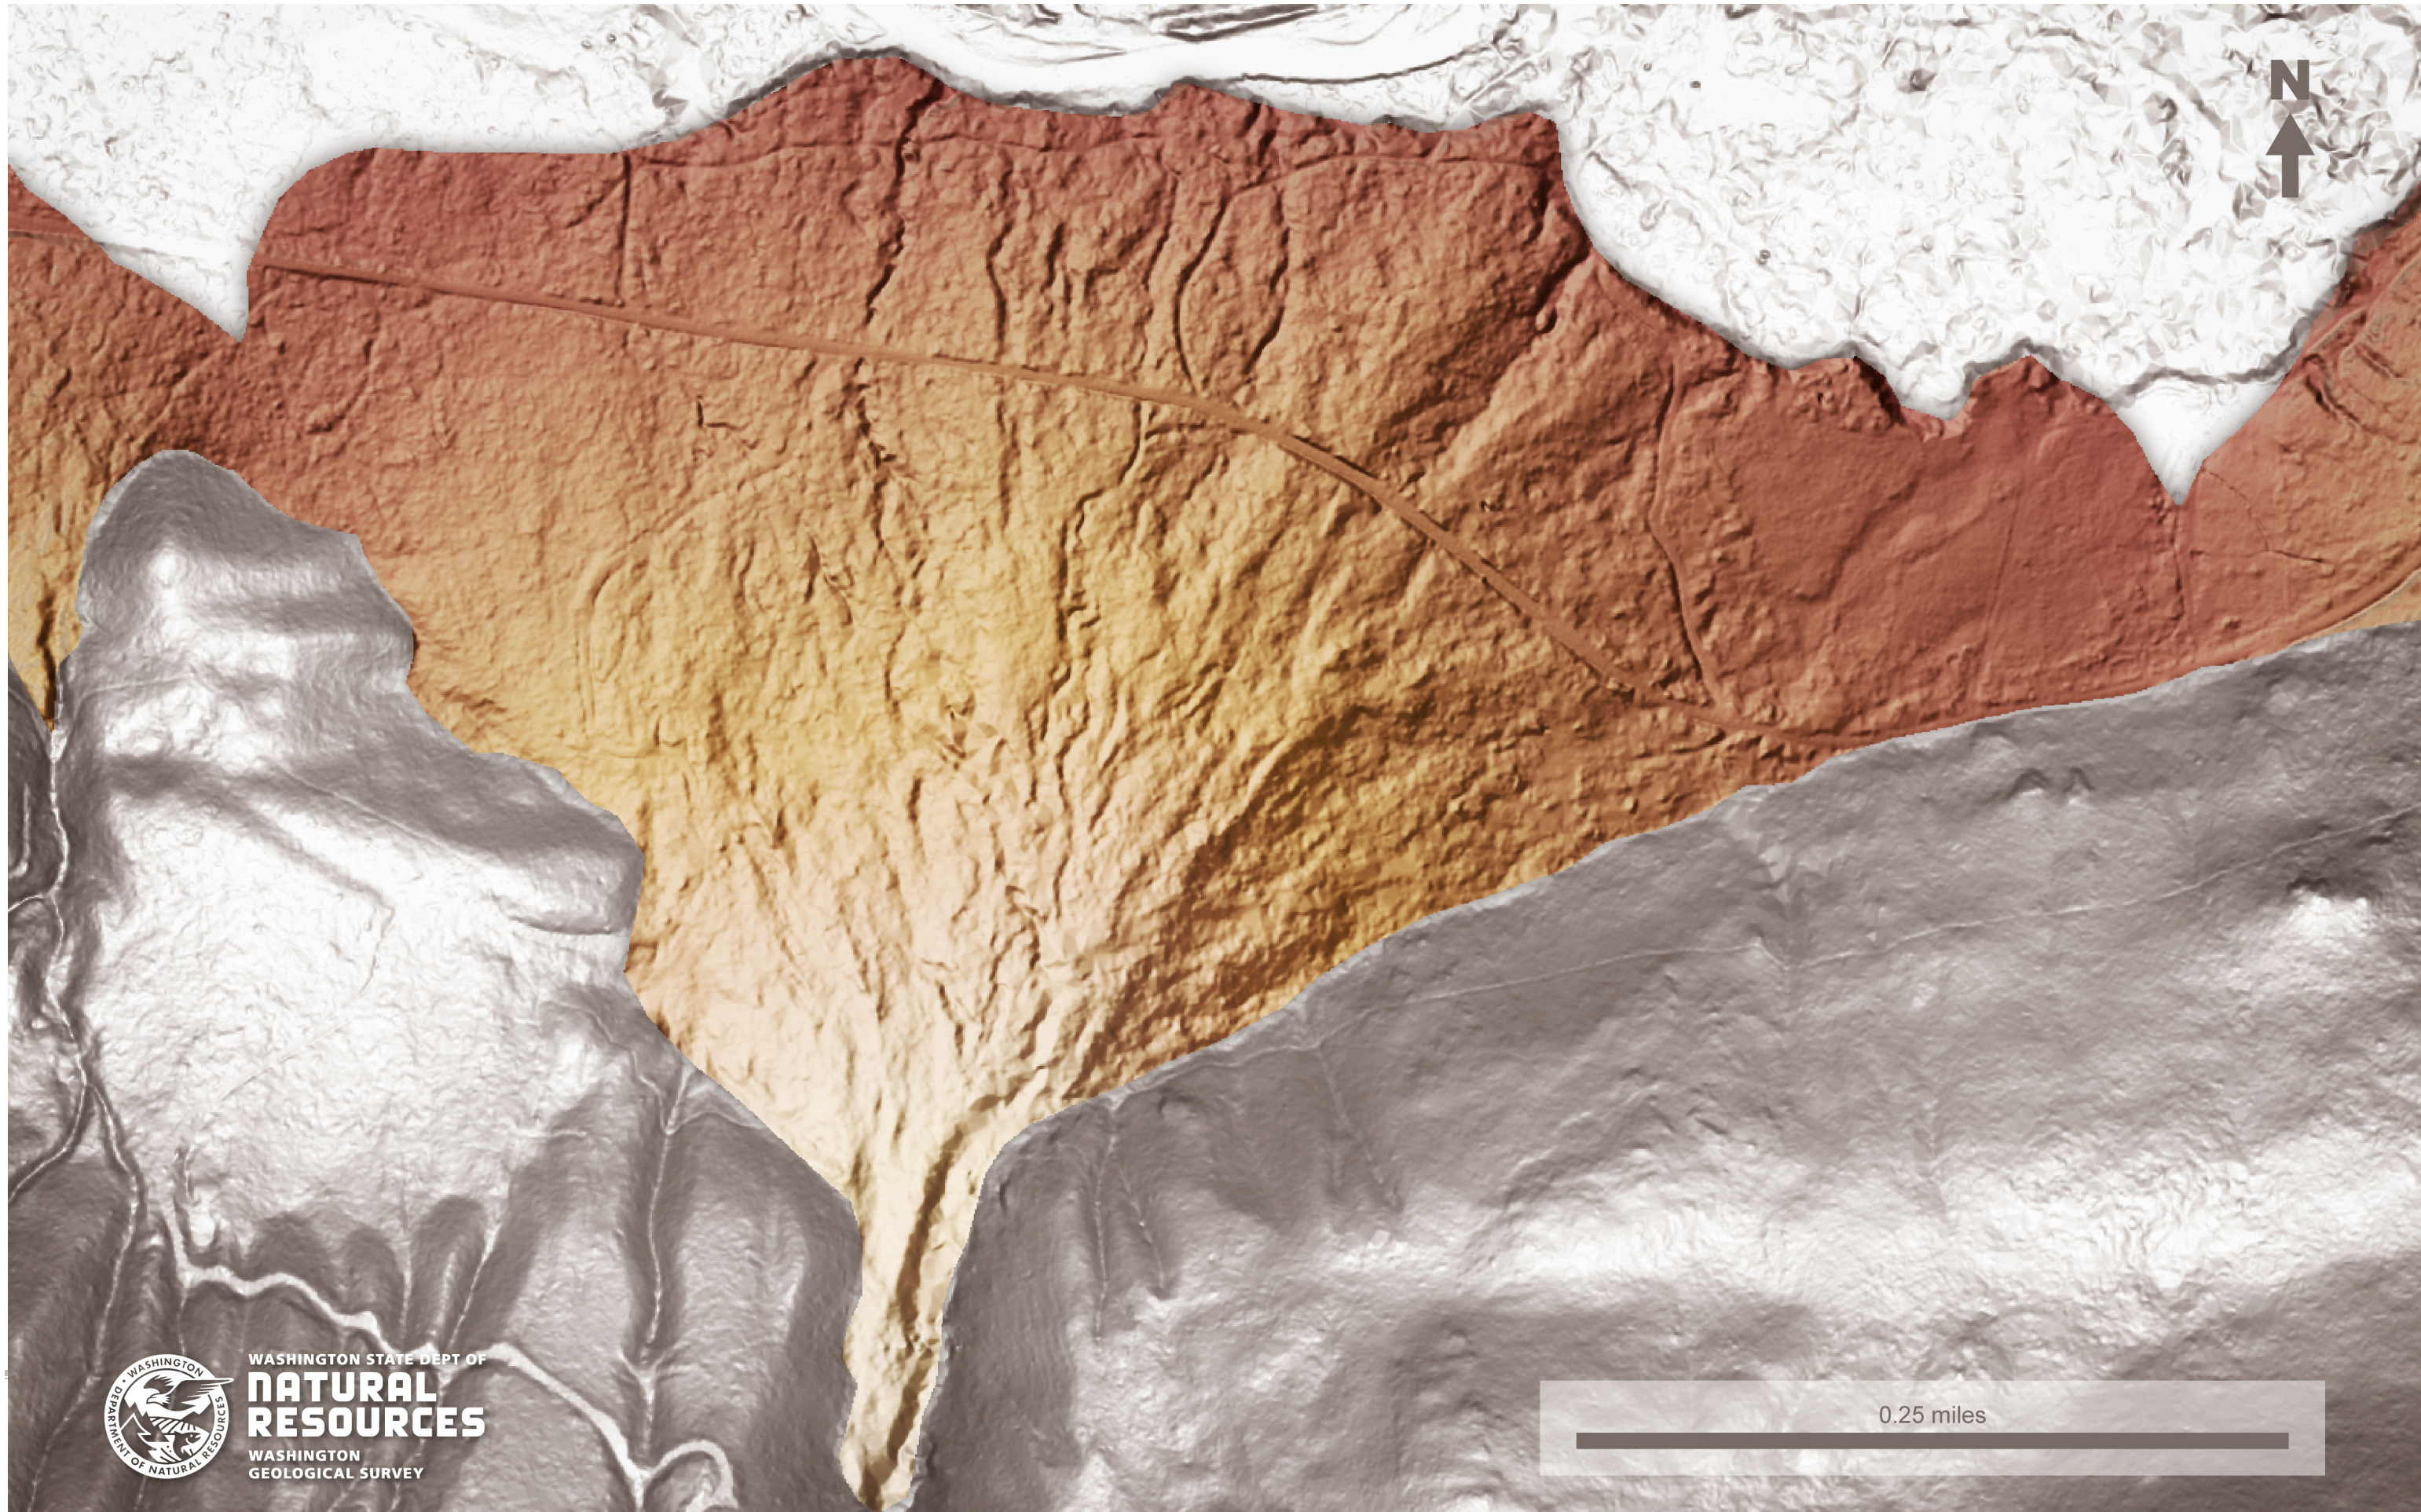
Twisp River Fans

During the site visit of the fan, we observed multiple dry channels typically 10 to 12 feet wide and 4 to 5 feet deep. We also observed lobes and levees of boulders and cobbles oriented north south. These lobes show various ages of activity based on the varying thickness of soil formation on the deposits. Some deposits appear to have occurred in the past 20 to 30 years based on trees that have cobble deposits piled up against them (Fig. 3). The photo on the front of this report shows smaller boulders stacked up between two large boulders. The largest is approximately 8 feet in the longest axis. These boulders are approximately 1275 feet from the apex of the fan, about 285 feet from the road, and 550 feet west of the home at 211 West Buttermilk Creek Rd. Boulders were also noted 200 feet west of the home. These boulder and cobble deposits are interpreted as evidence for debris flows and flood events on the fan.

Given the distance from the apex of the fan and the mostly intact forest on the fan body, a debris-flow hazard is low for the two structures. However, flooding and debris may be an issue, as well as safe evacuation routes if debris flows or flooding events impact the fan. It is more likely that flooding events might impact these structures by taking advantage of existing channel network from the apex of the fan. That said, large debris flow events may be possible that could impact this distal area of the fan.

The road may be impacted by flooding and debris where flood waters cross the road. These hazards are possible anywhere the road crosses a fan, and are more likely where channels currently exist along the fans. Many of these channel networks can be observed in lidar data. The culverts at these locations are unlikely to pass the quantity of water and debris that a significant event could produce. The worst flooding and debris would be expected along the current channels, and new channels could form or abandoned channels could be reoccupied.

Residents on the fans should consider flood insurance coverage if possible, consult the [Post Wildfire Flash Flood and Debris Flow guide](#), and prepare for potential flooding and debris flows. Anyone who lives on these fans should be notified of the risk to personal safety and develop emergency evacuation plans noting locations of high ground outside of the flood and debris flow hazard areas. It should be noted that flooding and debris flows hazards on fans can occur at any time, not just after a wildfire.

All parties should work together to minimize flood damage to homes and roads, and identify evacuation routes and areas that may be impacted during flooding events. Mitigation measures to protect homes from flood damage may be helpful in reducing damage to structures on the fans. Protecting homes from the impacts of large debris flows should be explored but may need additional design resources and consultation with engineers that is outside the scope of this evaluation. See discussions on design and implementation in [Prochaska and others \(2008\)](#) and [VanDine \(1996\)](#).
