Burned Area Emergency Response (BAER)

Jolly Mountain Fire

Geology: Landslides

Okanogan-Wenatchee National Forest, Washington

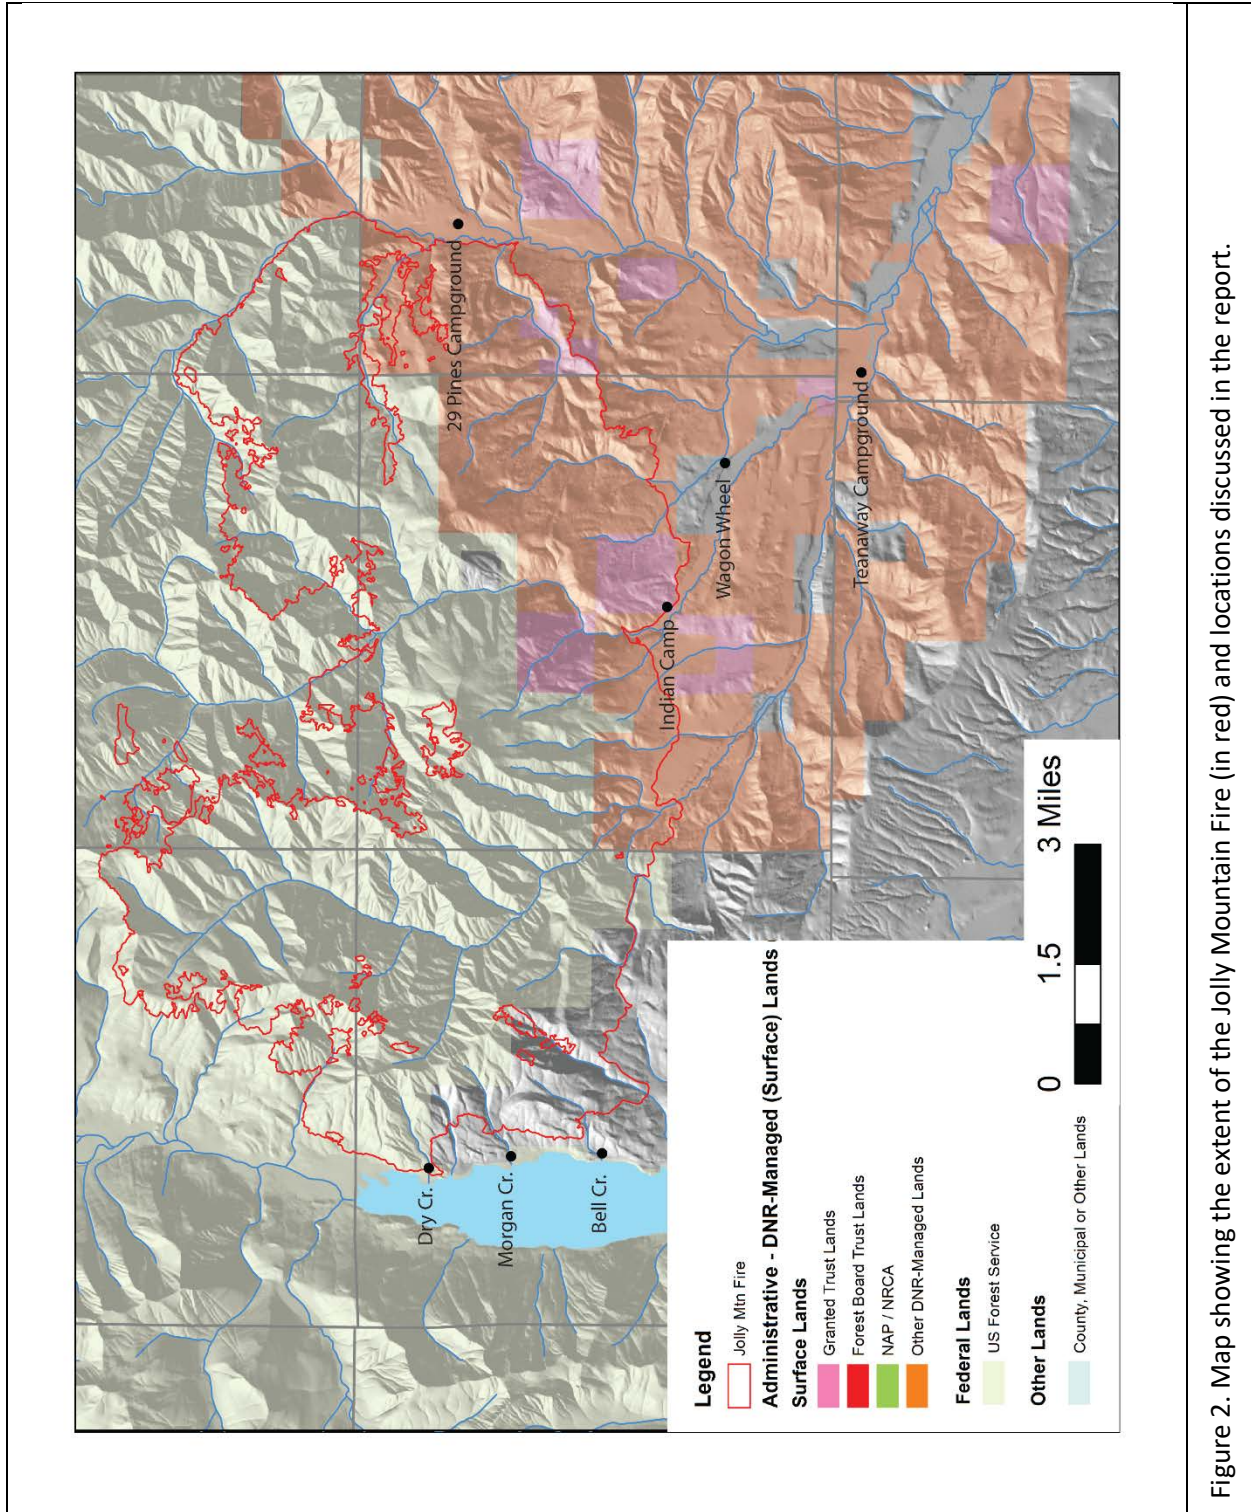
Indian Camp is on the Middle Fork (MF) Teanaway River (Figure 2) and the upper portion of the basin northeast of the camp experienced high burn severity and soils displayed hydrophobic conditions to depths of 2 cm. The basin revealed no evidence of past debris flows; however, the concern in this basin is flash flood and (or) HCF that could impact Indian Camp. The camp is on a small alluvial fan with several sites potentially exposed to a flash flood. Particularly exposed is the horse camp adjacent to the creek (east of the T5000 road) where a flash flood would likely inundate the camp site. In addition, camp 3 in the main portion of the campground is on a low terrace of the Middle Fork Teanaway River, near the current mouth of the creek, and may be impacted by flooding. It is recommended that the campground remain closed to allow for recovery of herbaceous growth and breakdown of hydrophobic soil conditions in the upper basin. The USGS combined relative debris flow hazard model indicated the basin above Indian Camp has a “moderate” rating during a 12mm (0.47in) in 15-minute storm event. This is the only DNR-managed campground close enough to the wildfire perimeter to have USGS modeling.

There are numerous structures built in the Teanaway River watershed and many are adjacent to the various forks of the Teanaway River, including the Wagon Wheel development (Figure 2) at Lick Creek. There is an extremely low likelihood of a debris flow from the burn area directly impacting any of the structures along the three forks of the Teanaway River. Flooding is likely the most significant post-wildfire hazard and both flash floods and HCF can mobilize large volumes of woody debris and HCF can transport large volumes of coarse sediment. Both flash floods and HCF can inundate areas not typically wetted by regular flows, so channel-adjacent roads, trails, building, and other infrastructure can still be damaged by impact from debris, sedimentation, water erosion, and (or) water inundation. To determine the post-wildfire downstream flooding hazards to cabins along the river, further hydrologic analysis is recommended.

There was no obvious evidence of historic debris flow(s) at the mouth of Morgan Creek at the Salmon La Sac Road (Figure 2). The stream channel shows evidence of flooding and transport of gravel and cobbles. The alluvial fan at the mouth of the creek suggests a history of sediment transport and deposition from the above basin. Flooding is likely the most significant post-wildfire hazard and both flash floods and HCF can mobilize large volumes of woody debris and HCF can transport large volumes of coarse sediment and impact the Salmon La Sac Road. In addition, when Cle Elum Reservoir is low, dispersed camping is common on the Morgan Creek alluvial fan and this location should be assessed for potential flood hazards and possible closures.

There was no evidence of historic debris flow(s) at the mouth of Dry Creek at the Salmon La Sac Road (Figure 2). The stream channel shows evidence of flooding and transport of gravel and cobbles. The alluvial fan at the mouth of the creek suggests a history of sediment transport and deposition from the above basin. The Dry Creek drainage basin was primarily low burn severity and unburned, reducing the likelihood of post-wildfire flooding. However, during low reservoir levels, there is dispersed camping on the Dry Creek alluvial fan and this location should be assessed for potential flood hazards.

There was no evidence of historic debris flow(s) at the mouth of Bell Creek at the Salmon La Sac Road (Figure 2). A WDFW boat launch site at the mouth of Bell Creek (Annabelle or Bell Creek Water Access?) contains a vault toilet and is day-use only. If there is a flood in Bell Creek and the culvert under Salmon la Sac Road is blocked or overwhelmed, flood water will likely flow south in the Salmon la Sac Road ditch to a culvert that drains into the boat launch site. If flood water were to flow to this culvert, the assets at risk is Salmon La Sac Road and the WDFW access road to the site. We do not believe that the vault toilet is at risk of impact by flooding. Also, much of the Bell Creek drainage basin wasn't burned or experience primarily low burn severity, reducing the likelihood of post-wildfire flooding.

Figure 2. Map showing the extent of the Jolly Mountain Fire (in red) and locations discussed in the report.
