Hope Island Atlantic Salmon Net Pens Engineering Assessment

January 29, 2018

State of Washington
Department of Natural
Resources
1111 Washington Street SE
Olympia Washington 98504

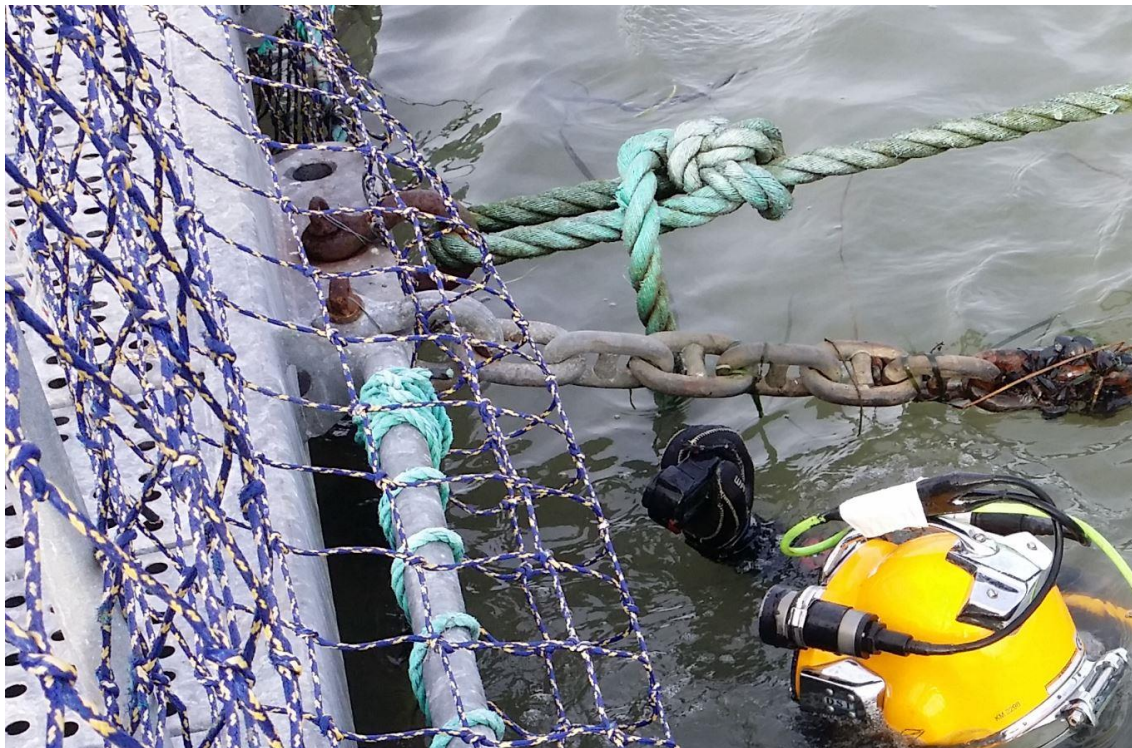
Figure 8: Mooring Bracket at Hope Island Net Pens

The mooring lines are connected by steel shackles to steel plate mooring brackets. The mooring brackets are also known as “tabs” or “padeyes”. At Hope Island the brackets were not hinged. A typical bracket is shown in **Figure 8**. Most anchor mooring lines had a single point of attachment, rather than a “bridle” or “hen’s foot” arrangement where the mooring line is divided near the net pen into two lines that attach to two different points on the net pen structure. The synthetic line in the photo below appeared to be used to moor a buoy and was not part of the mooring line system connected to the anchor.

- Mooring brackets are attached to the walkway structure frame near the walking surface. The brackets are evenly distributed around the net pen facility, located at walkway intersections. Details of the connection are shown below in **Figure 10** and in **Figure 8**, and on sheet 4 of the drawings in Appendix A. The mooring brackets are not hinged, unlike mooring connections at other net pens observed in Washington waters, and typically have three holes for connecting three mooring lines. Typically, only one mooring line was connected to each bracket, typically the middle hole, but not always.
- Mooring brackets were observed during our site visit to be in good to satisfactory condition. Minor corrosion was observed in places but the galvanizing was generally intact.

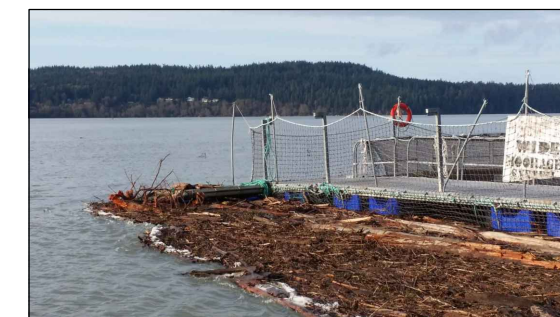
PHOTO 5
DEBRIS BUILDUP ON SOUTH END OF FACILITY

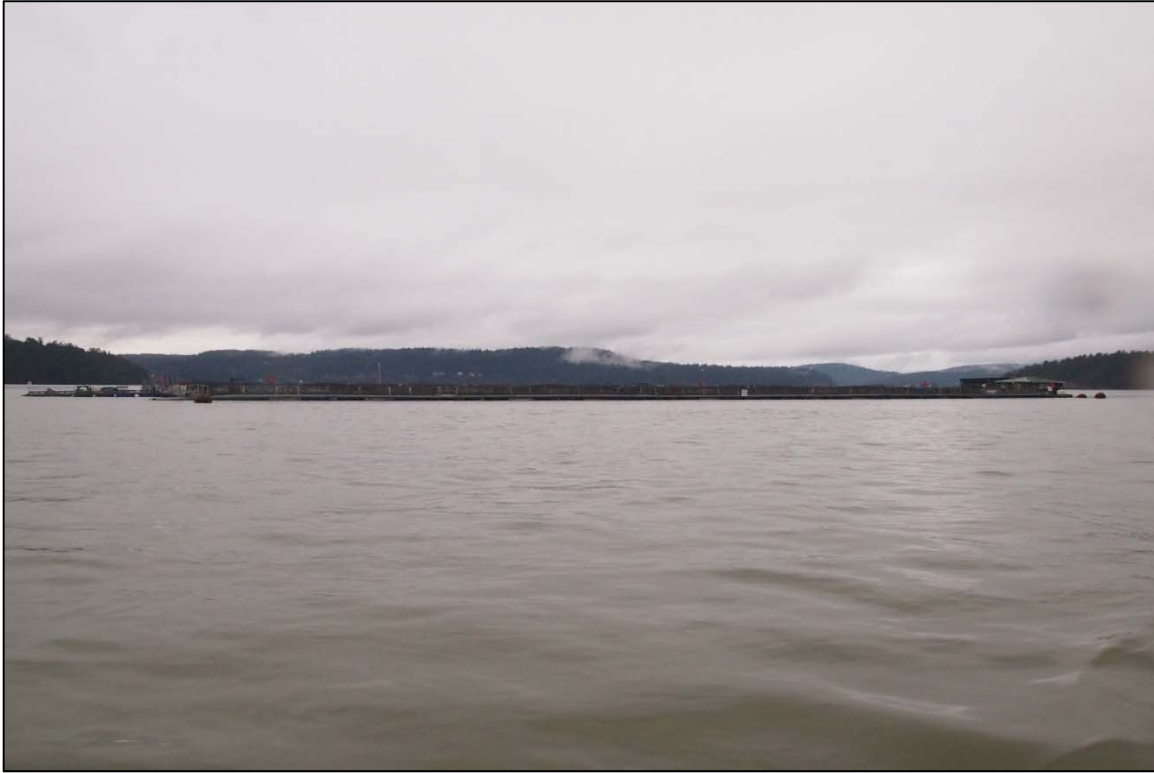
Photograph 1: Overall View of the Fish Net Pen System, Looking West.

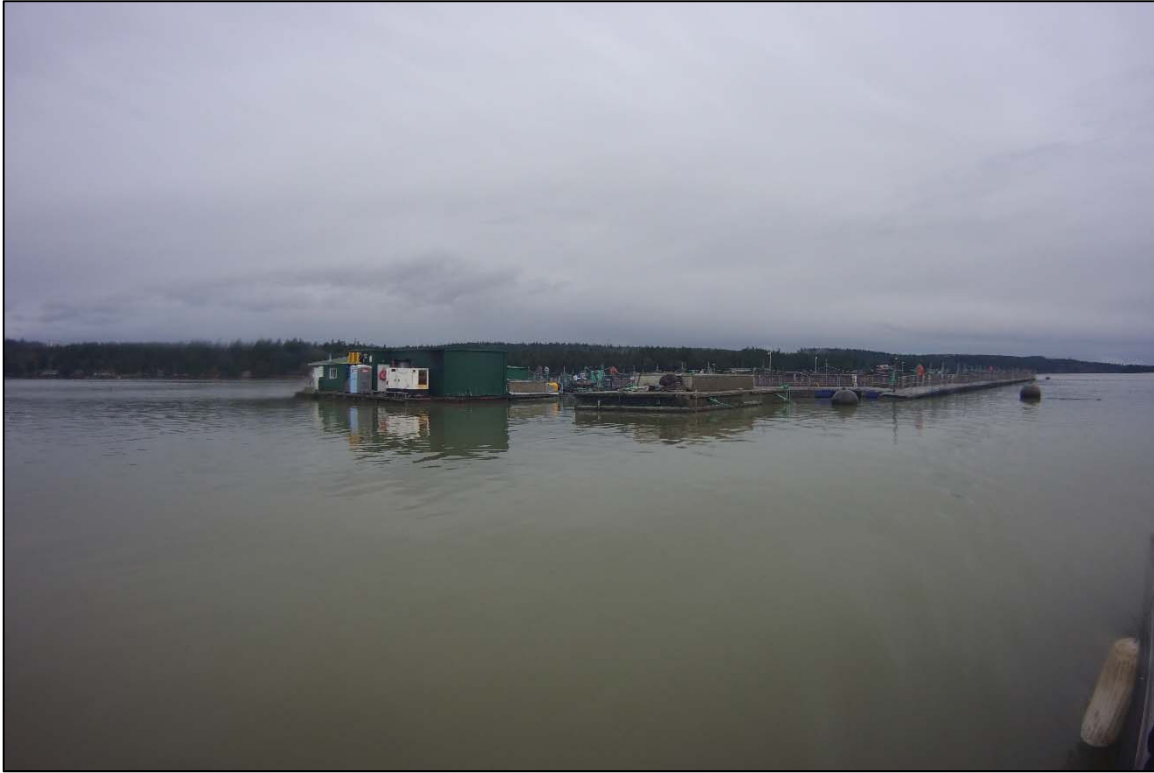
Photograph 3: Overall View of the Fish Net Pen System, Looking Southeast.

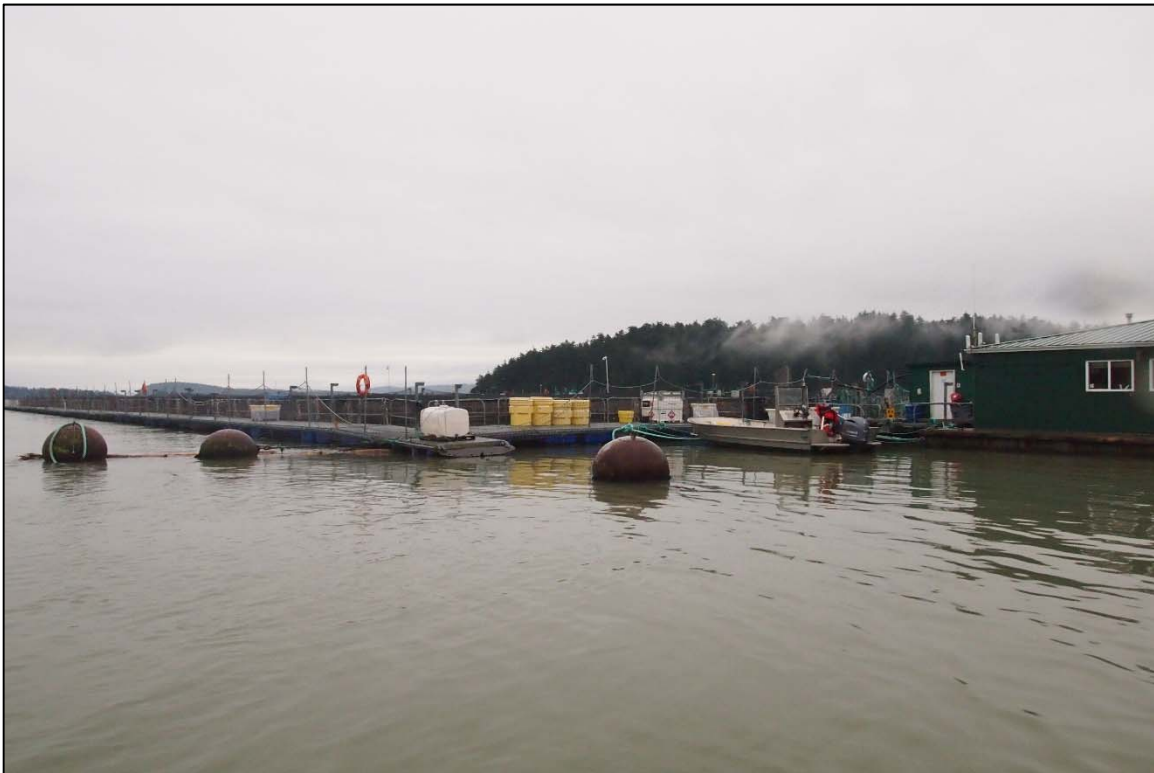
Photograph 4: Overall View of the Fish Net Pen System, Looking Southwest.

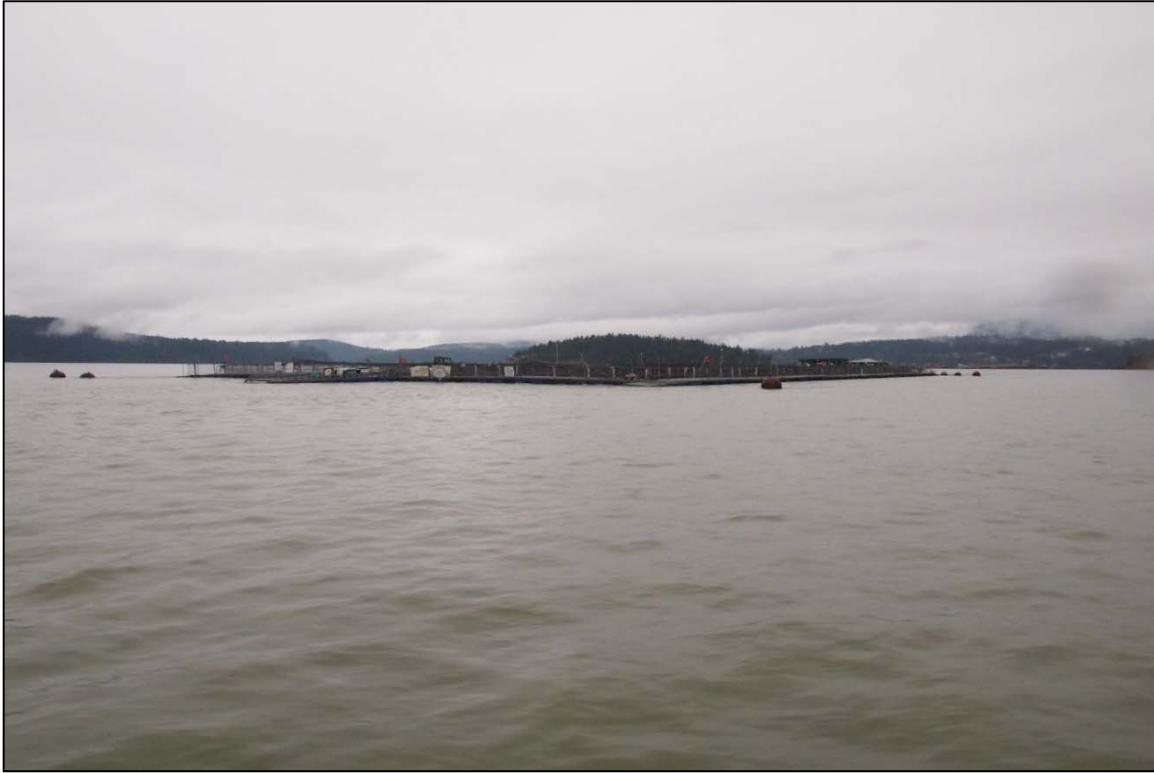
Photograph 5: Overall View of the Fish Net Pen System, Looking Northwest.

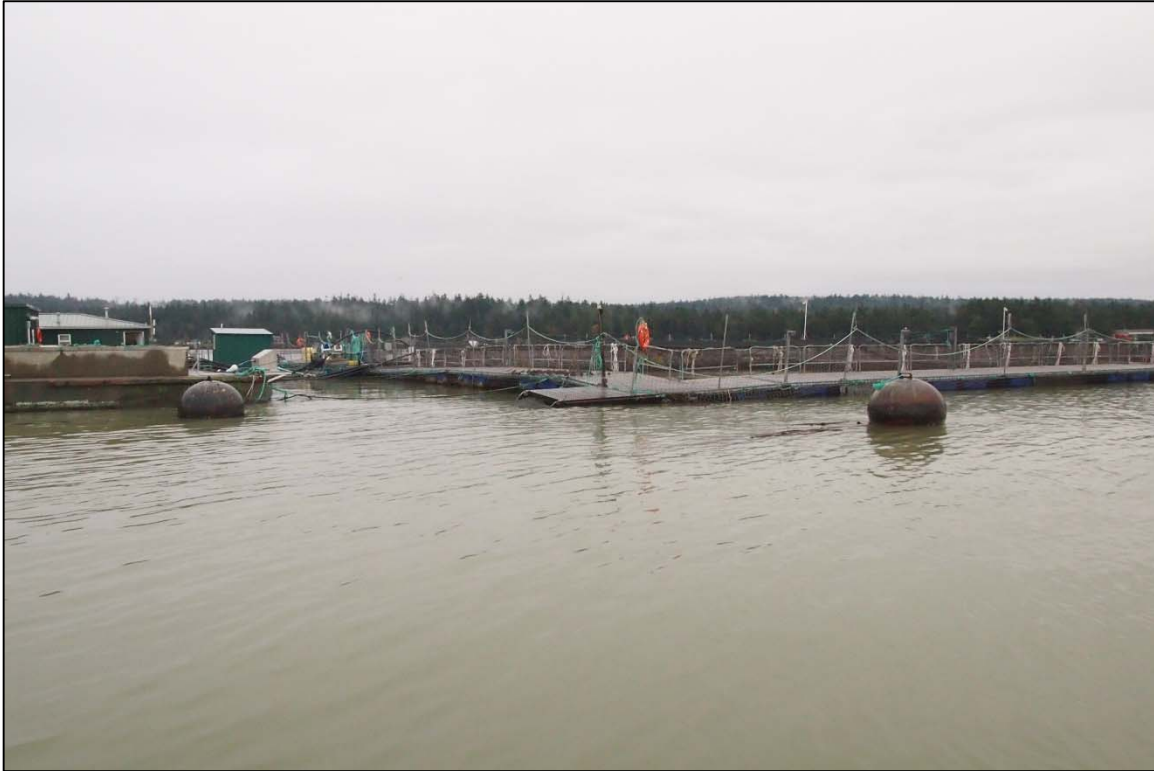
Photograph 7: View of the Anchor Line Buoys in the Northwest Corner, Looking Southeast.

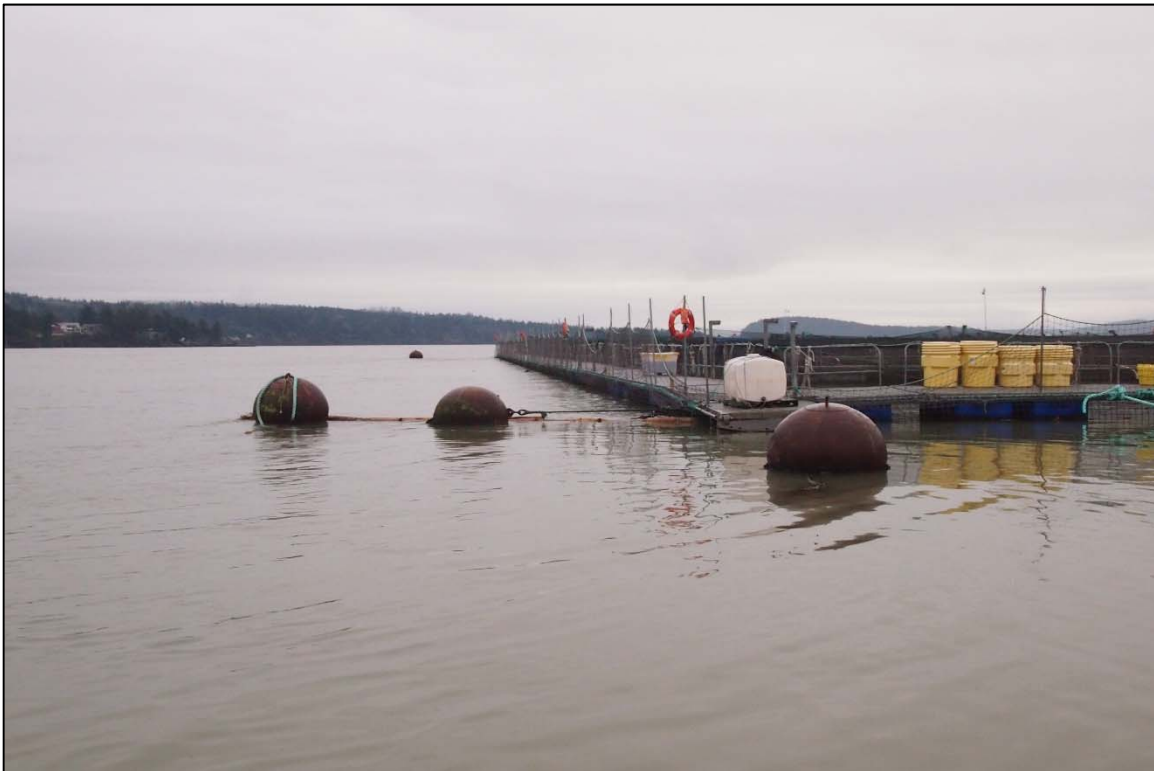
Photograph 8: View of the Anchor Line Buoys in the Northeast Corner, Looking Southwest.

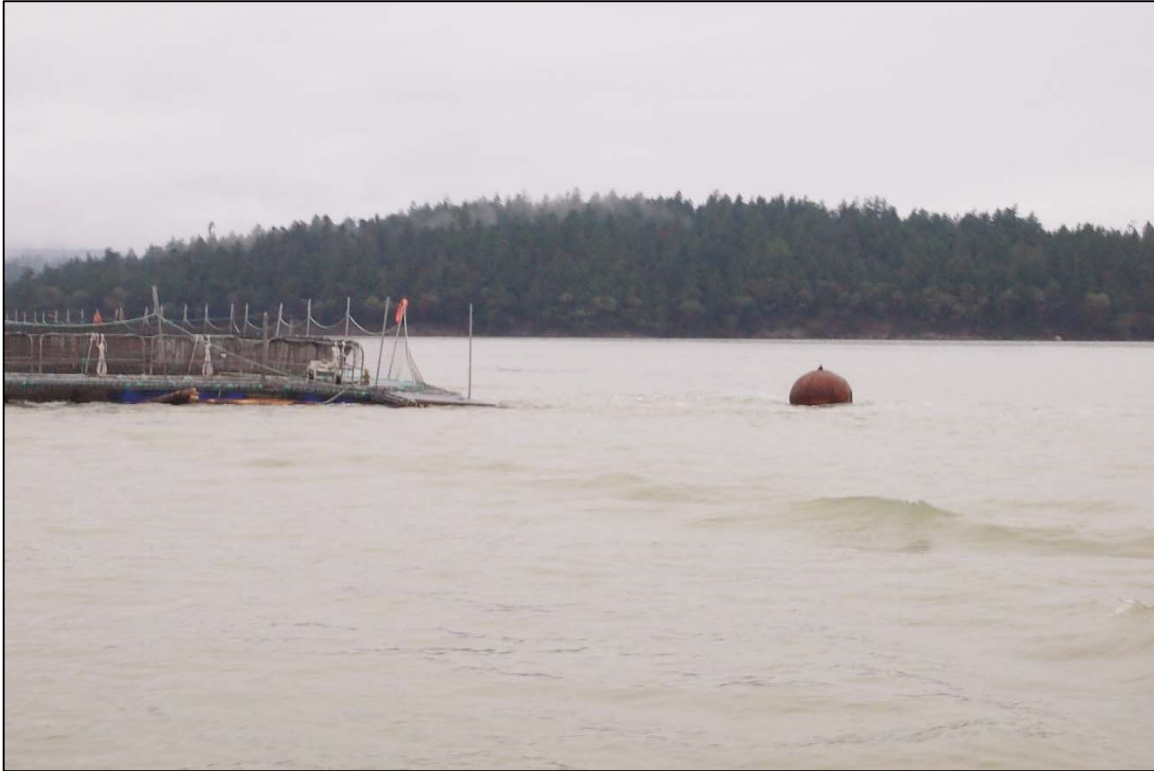
Photograph 9: View of the Anchor Line Buoy in the Southeast Corner, Looking East.

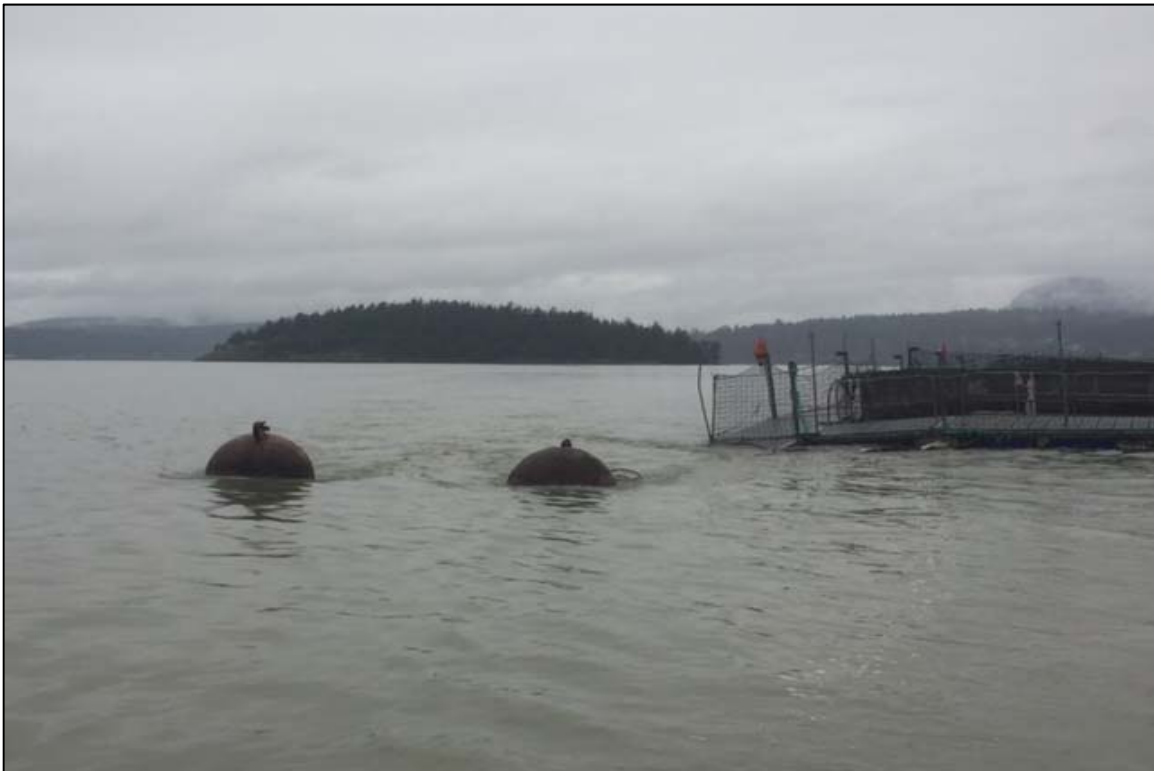
Photograph 10: View of the Anchor Line Buoys in the Southwest Corner, Looking Northwest.

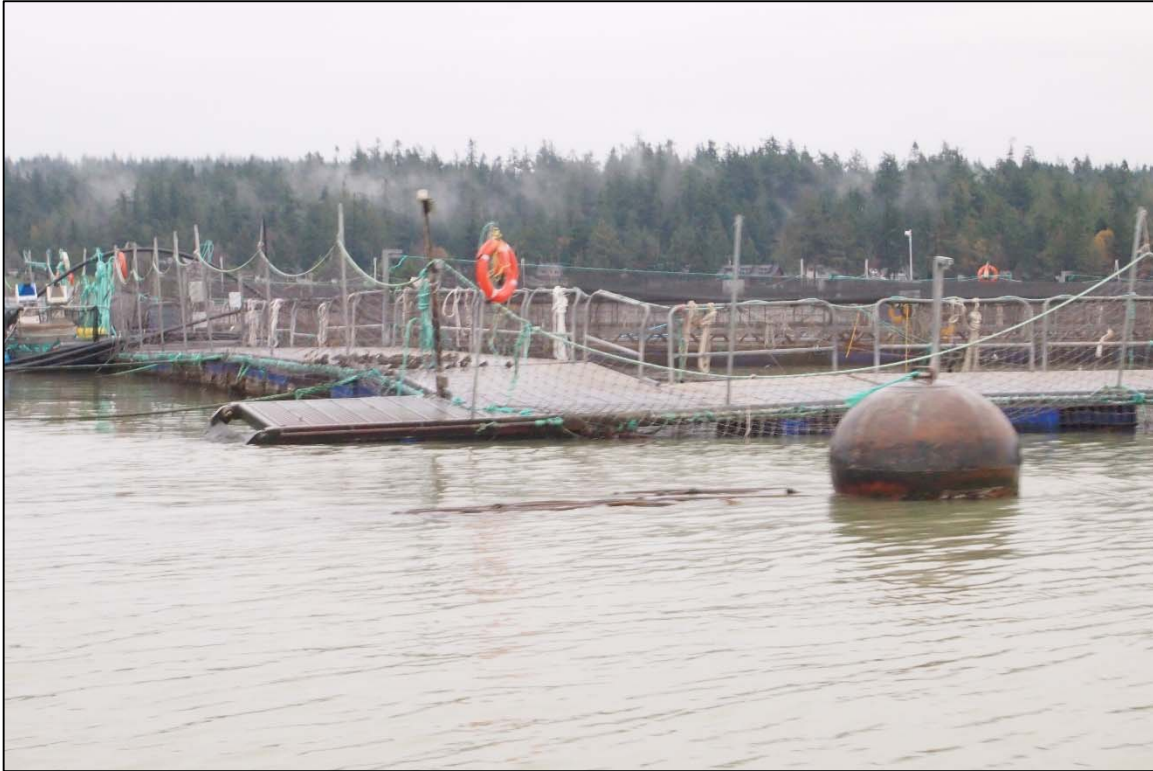
Photograph 11: View of the Depressed Pen Support Float at the Northwest Corner, Looking Southeast.

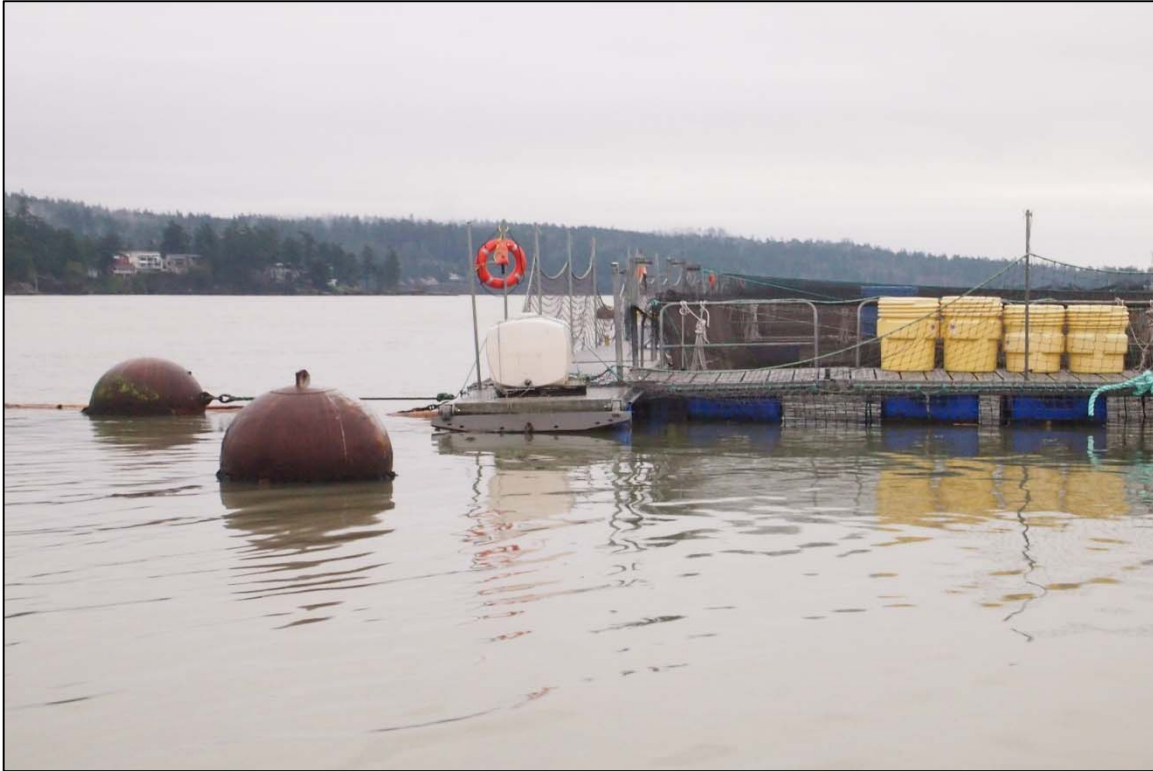
The building and pen support floats were typically found to be in good to satisfactory condition with no appreciable deficiencies or deterioration. All four corners of the fish net pen system, however, were depressed due to concentrated loading from the weight of the anchor line assemblies. This loading was partially relieved by the addition of extra float modules and chain buoys in the corners; however, the buoys also likely add to the loading and consequently further depress the southeast and southwest corner floats during high ebb tidal flows. In that regard, the southerly walkway ends were observed to extend below water somewhat during a strong combined ebb (northerly) tidal flow and northerly wave action. The moderate to heavy marine growth on the south end ropes (Anchors 7 through 12) also likely adds to the loading and south end float downward displacement during high ebb tidal flows. Although the downward displacements don't currently compromise the stability of the fish net pen system, they should be evaluated to see if they can be eliminated or reduced by adding additional float modules and/or buoys or by changing out the corner float assemblies for a more stable float assembly type.

Photograph 13: View of the Depressed Pen Support Float at the Northeast Corner, Looking South.

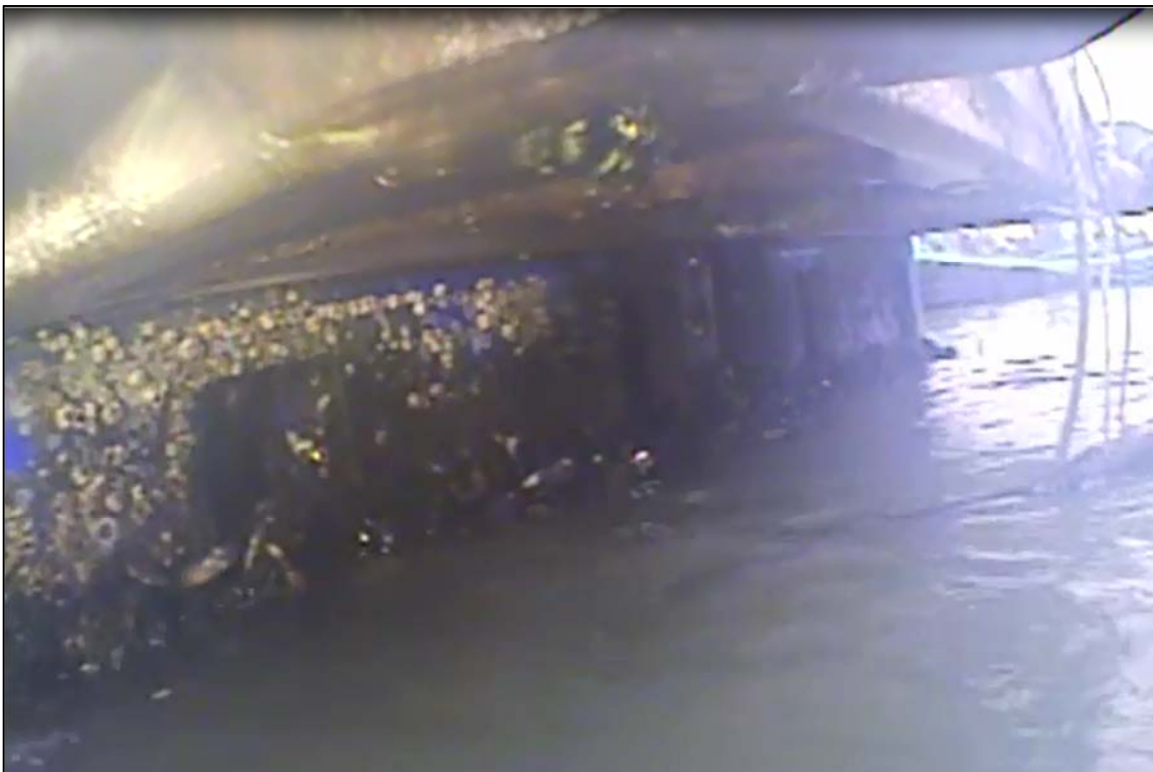
Photograph 14: View of the Northeast Corner Pen Support Float, Looking Southwest.

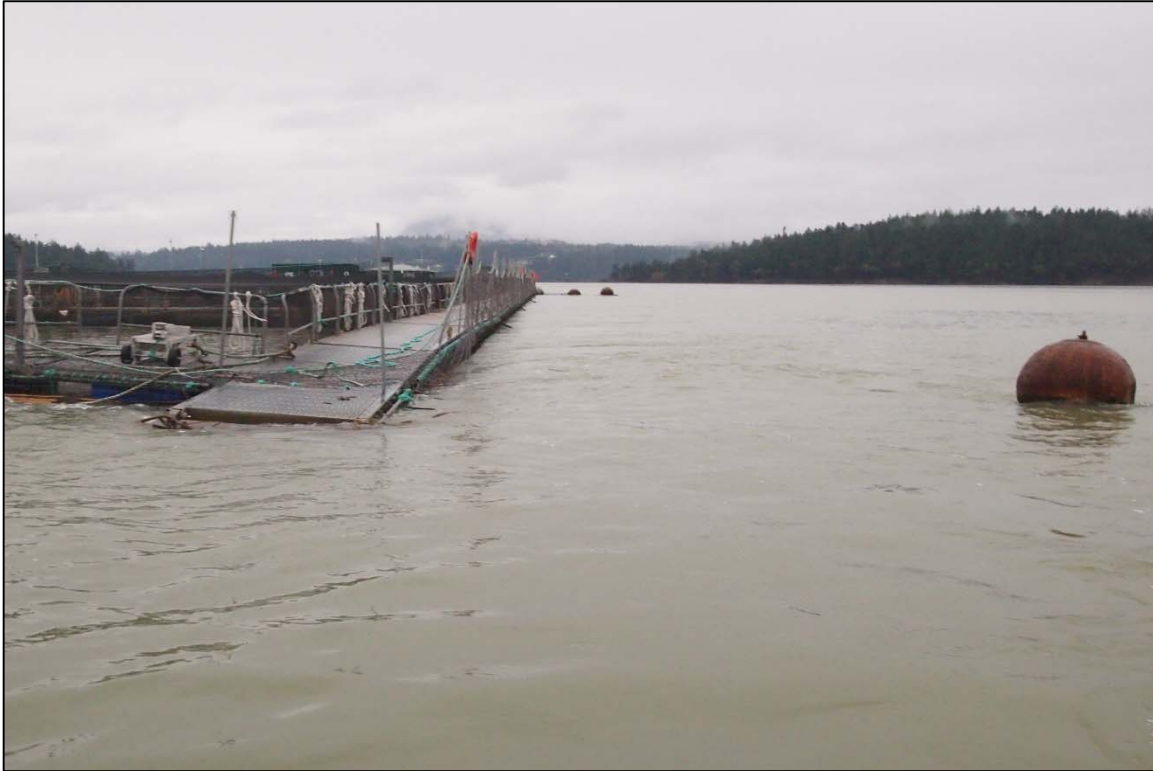
Photograph 15: View of the Depressed Pen Support Float (During High Ebb Tidal Flow) at the Southeast Corner, Looking North.

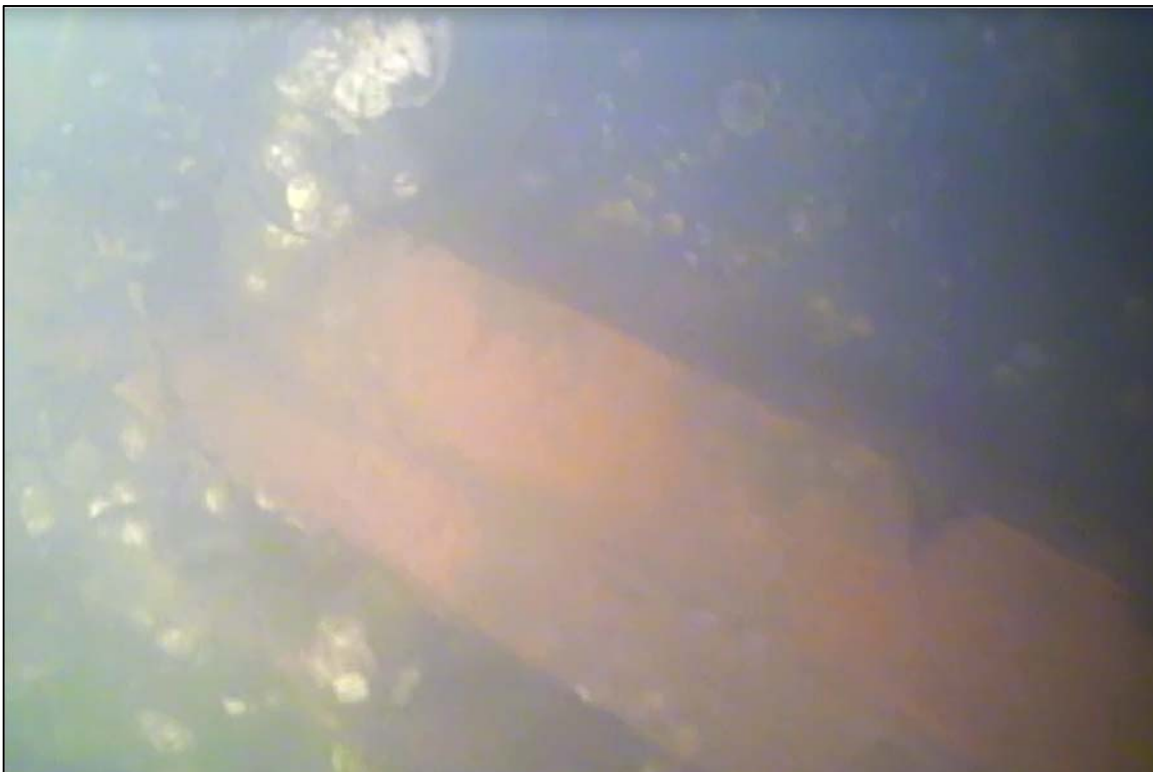
Photograph 16: View of the Southeast Corner Pen Support Float and Bracing Below Water, Looking Southeast.

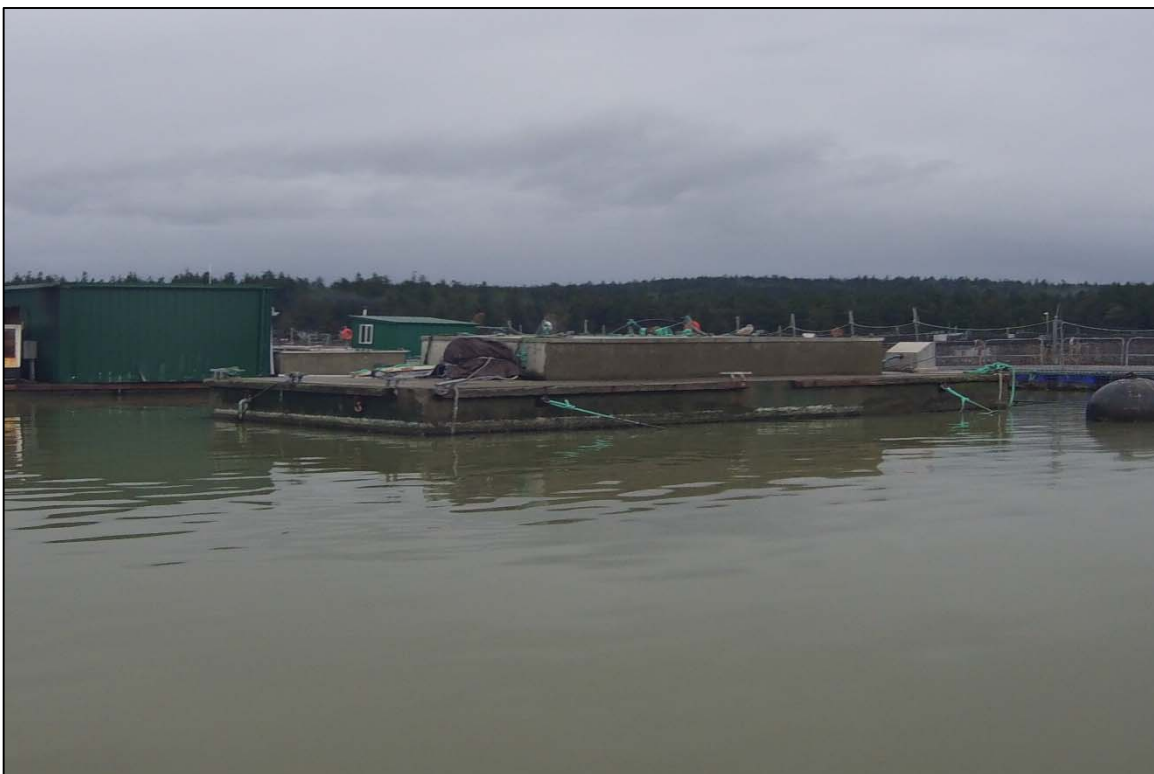
Photograph 22: View of the Abandoned Float Located on the North End, Looking Southeast.

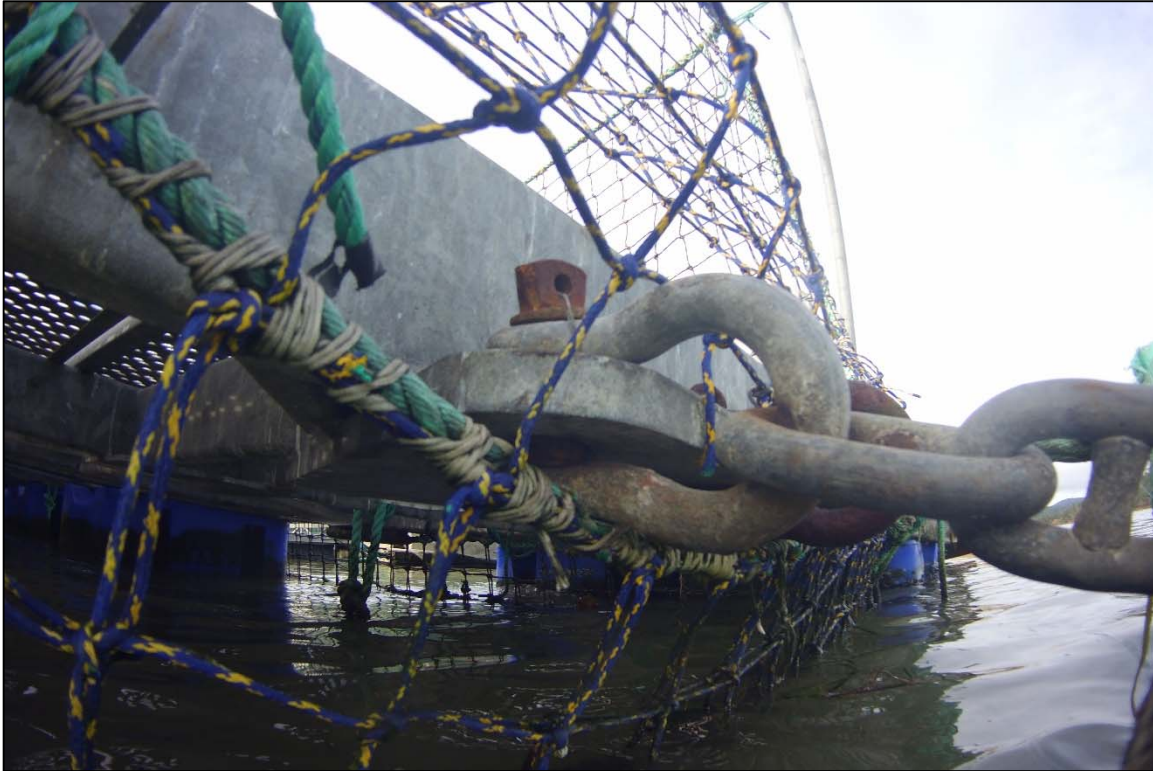
The building/pen support float to upper anchor chain connections were typically found to be fully intact, secure, and in good to satisfactory condition. The steel shackles typically exhibited little, if any, deterioration, and in many instances appeared to be relatively new. The shackles were also found to be properly aligned and secure, with the restraining wires for the shackle pins typically in place and properly installed. The accessible portions of the steel framing that provide the connection between the aforementioned shackles and the pen support floats and perimeter walkway were also observed to be sound and secure with no concerns for instability.

Photograph 23: View of Pen Support Float to Upper Anchor Chain Connection at Anchor 18 (Typical), Looking Northwest.

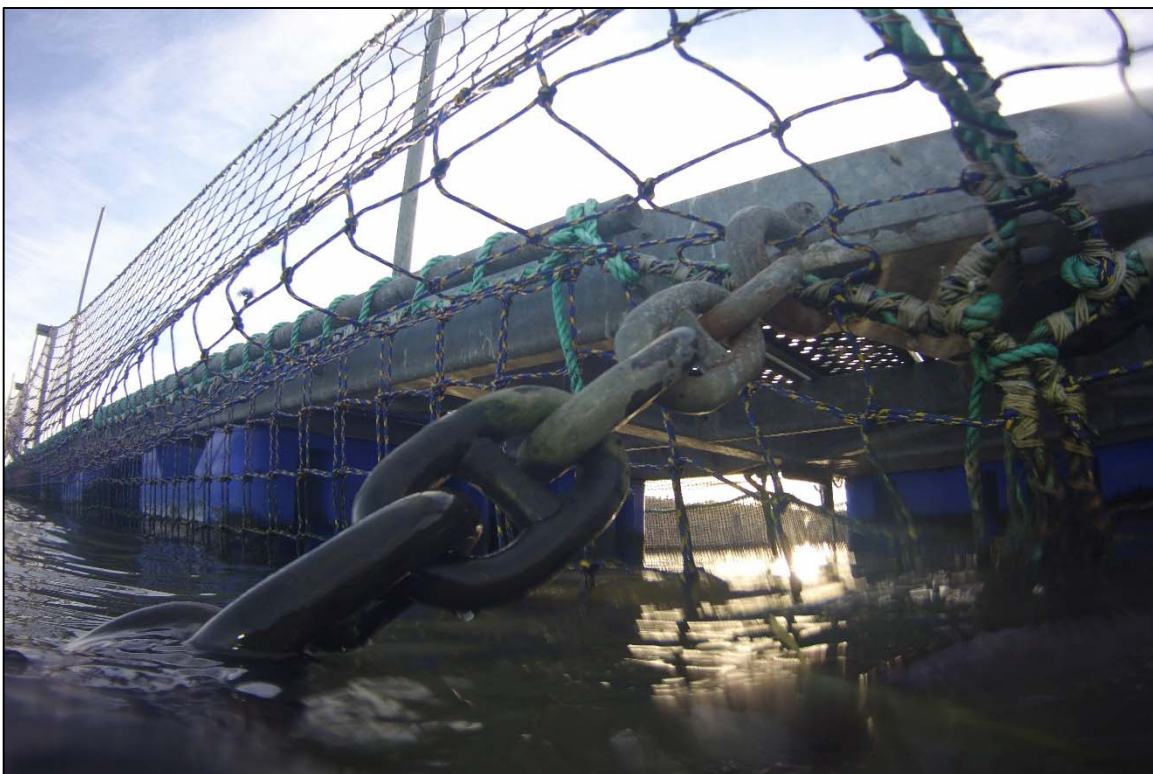
The ± 30 ft long upper anchor chains were typically found to be in good to satisfactory condition with minimal deterioration (less than 15% section loss). The below water portions of the upper anchor chains typically exhibited moderate (1 to 3 in. thick) marine growth. Steel buoys were attached to the upper anchor chains at Anchors 1, 7, 8, 13, 18 (two buoys), 19 and 24. The buoys, which were most likely installed to help to lessen the concentrated loading from the weight of the anchor line assemblies, were typically found to be fully intact, secure and in good to satisfactory condition.

Photograph 24: View of Upper Anchor Chain at Anchor 16 (Typical), Looking Southwest.

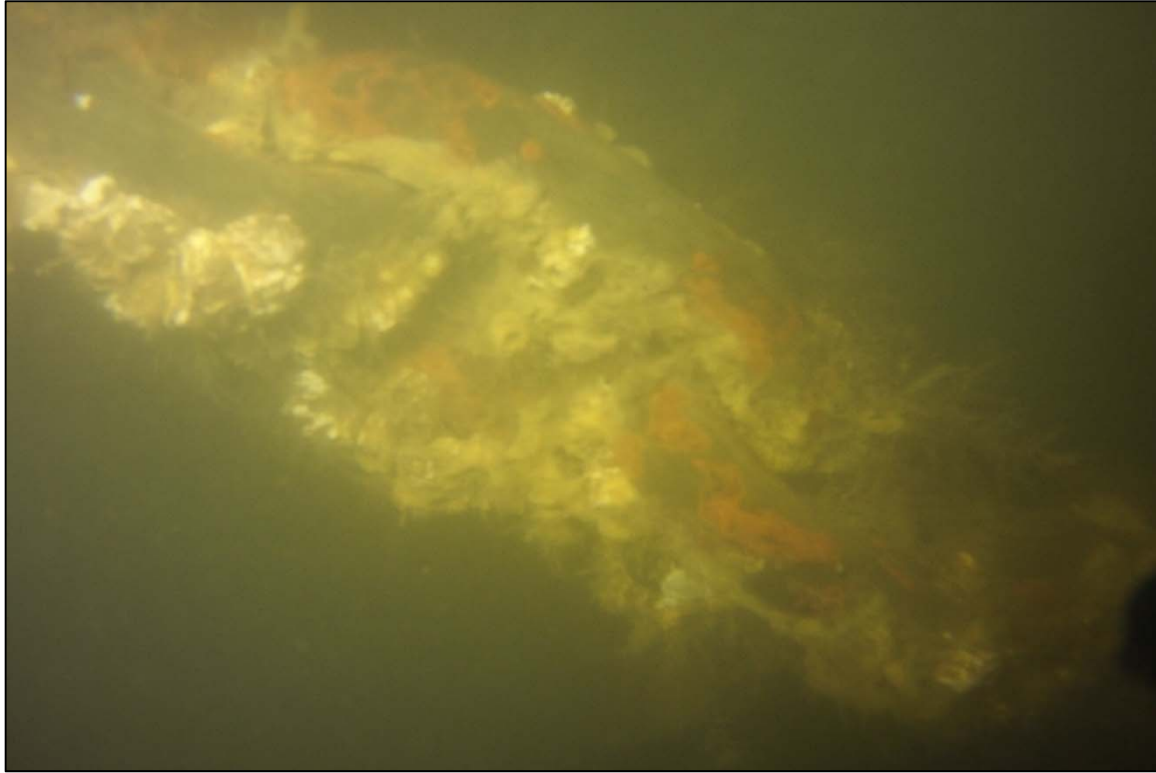
Photograph 25: View of Upper Anchor Chain Below Water at Anchor 21 (Typical), Looking West.

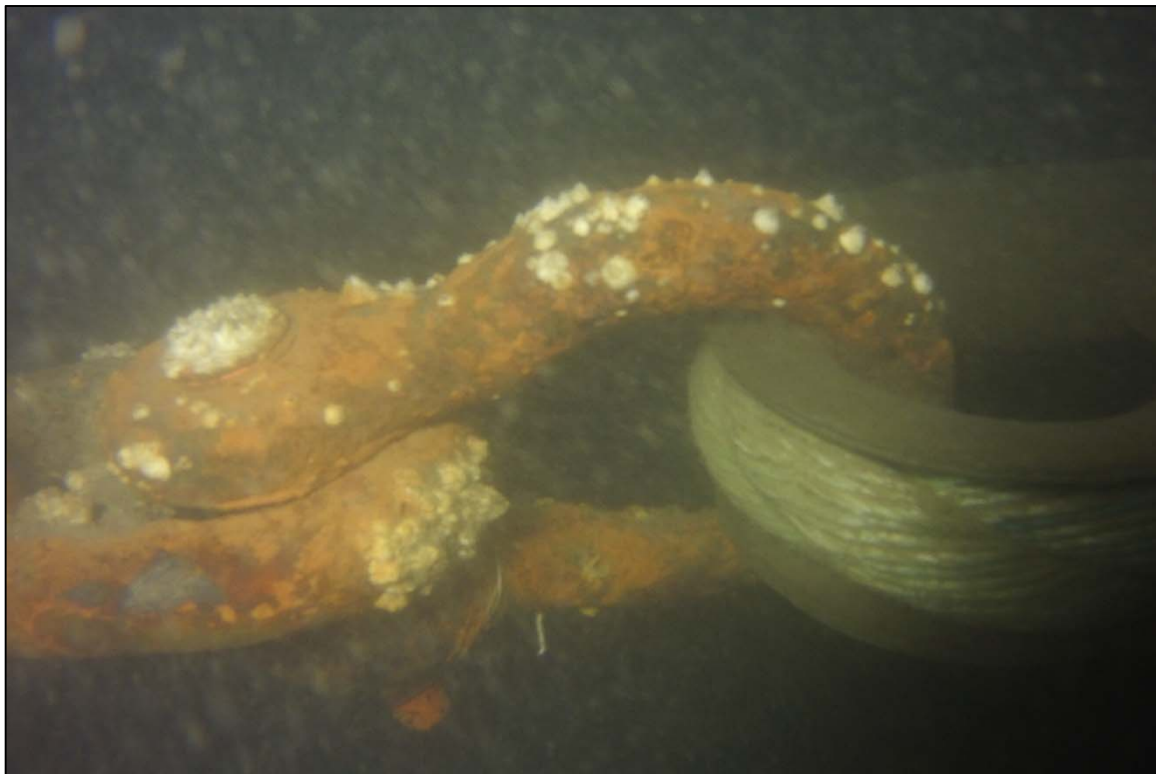
The upper and lower anchor chain to rope connections (thimble and shackle) were also typically found to be fully intact, secure, and in good to satisfactory condition. The steel thimbles typically exhibited minimal deterioration, and the ropes were typically secured beyond the thimble with a bowline knot at the upper connection and eye splice at the lower connection. The steel shackles also typically exhibited minimal deterioration, and were found to be properly aligned and secure, with the restraining wires for the shackle pins typically in place and properly installed.

Photograph 26: View of Upper Anchor Chain to Rope Connection (Thimble and Shackle) at Anchor 18 (Typical), Looking North.

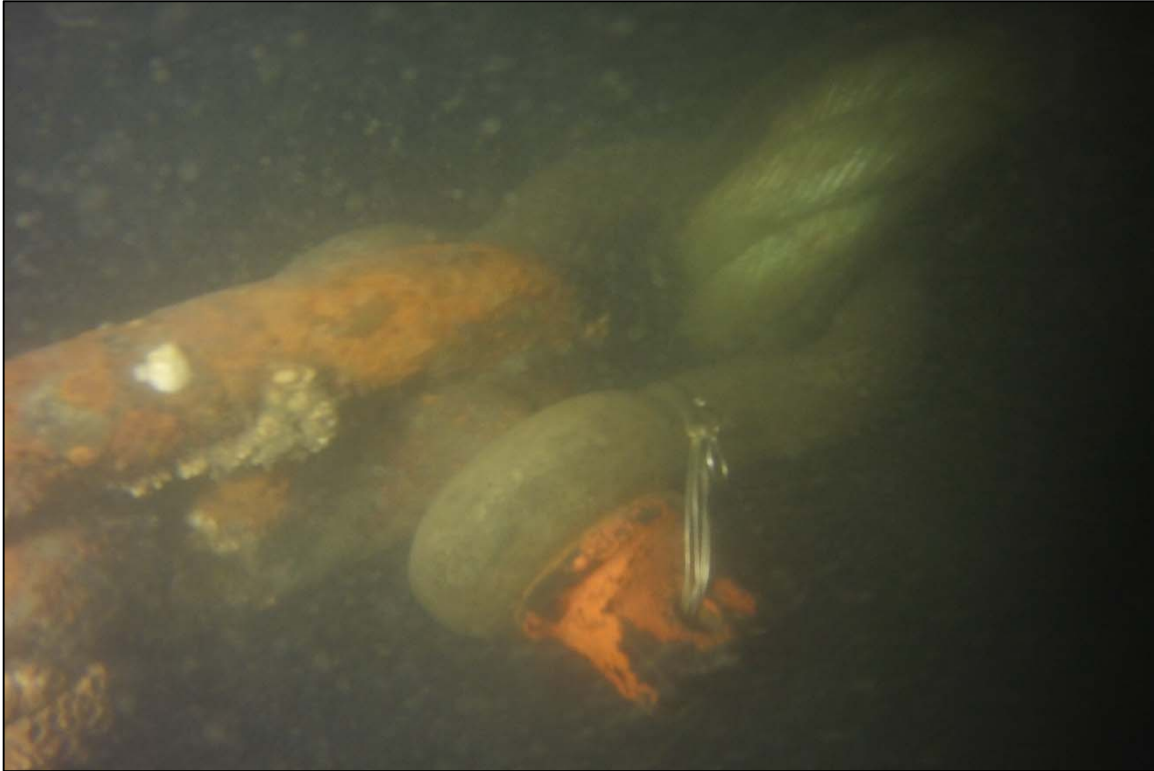
Photograph 27: View of Safety Wire Located on Upper Anchor Chain to Rope Connection (Thimble and Shackle) at Anchor 14 (Typical), Looking Northeast.

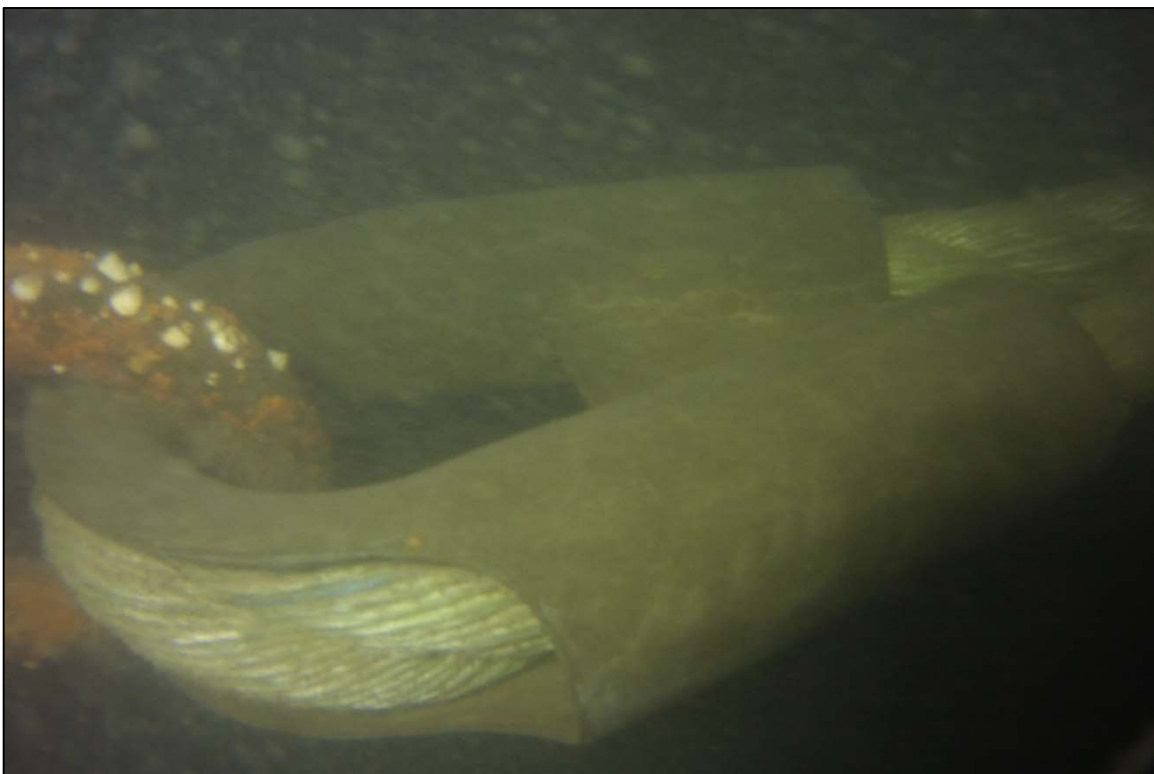
Photograph 28: View of Upper Thimble at Anchor 18 (Typical), Looking North.

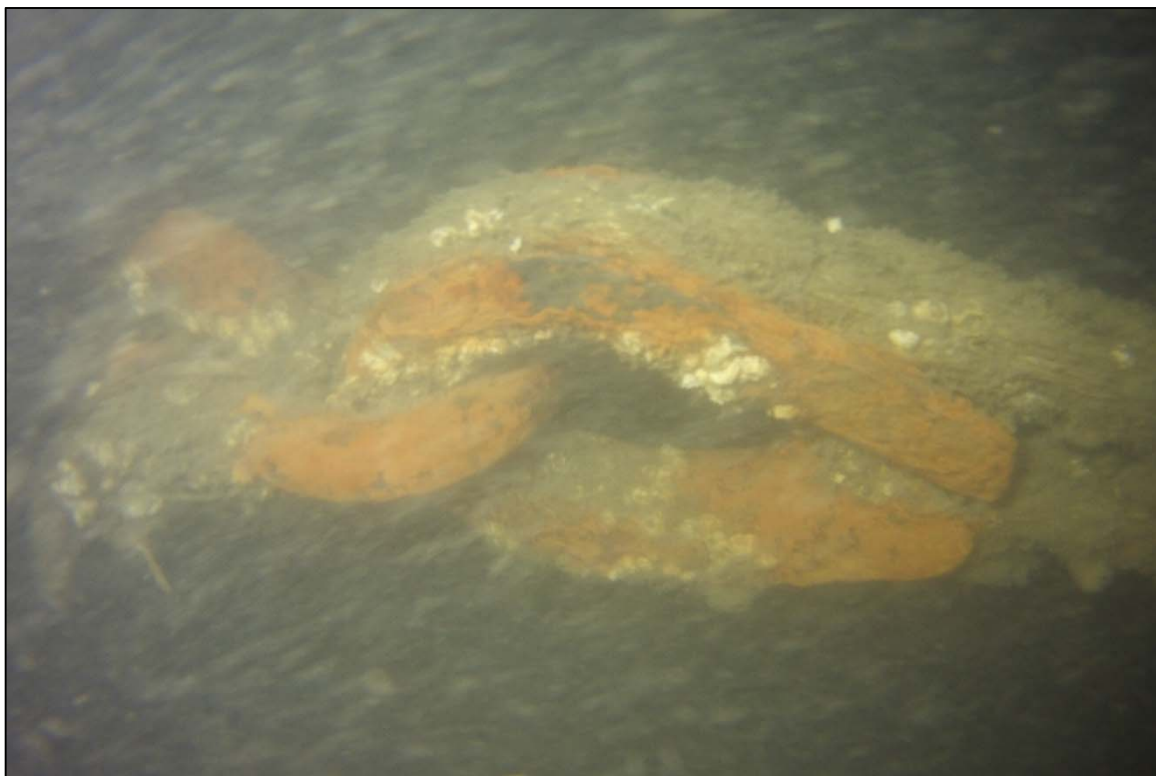
Photograph 32: View of Lower Anchor Chain to Rope Connection (Thimble and Shackle) at Anchor 21 (Typical), Looking East.

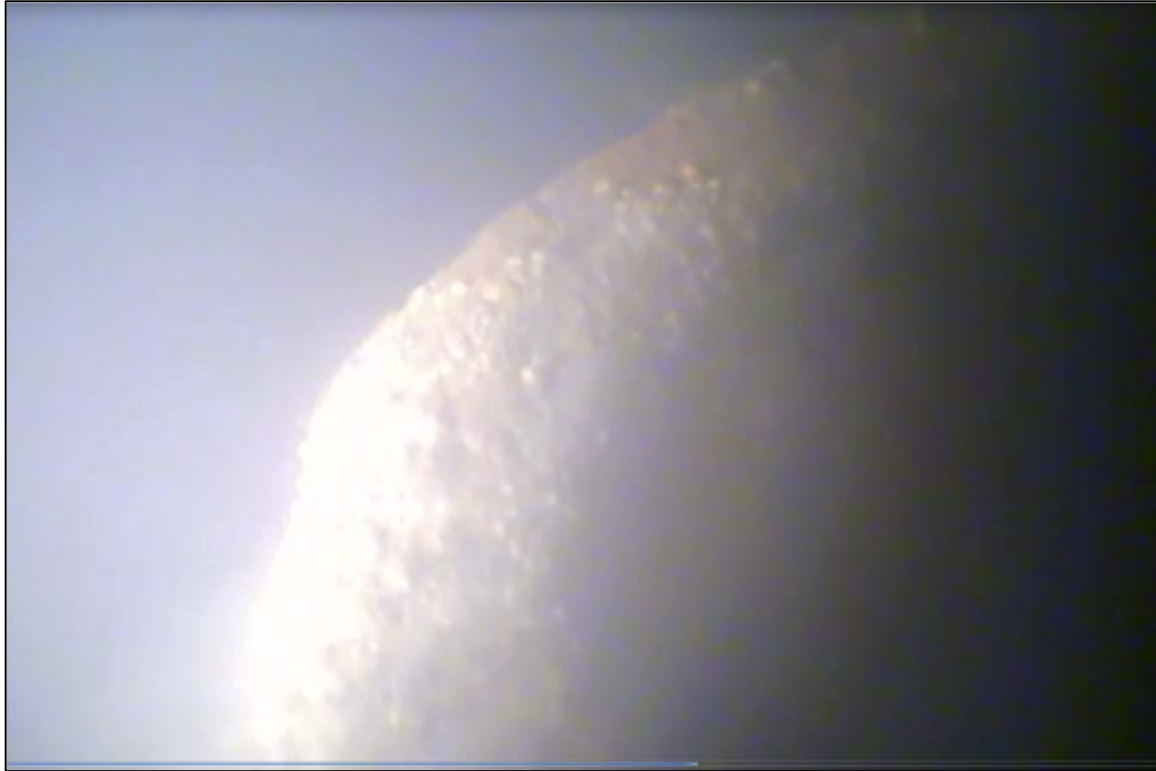
Photograph 35: View of Anchor Fluke Located on the Channel Bottom at Anchor 11, Looking Southeast.
