Hope Island Atlantic Salmon Net Pens Engineering Assessment

January 29, 2018

State of Washington
Department of Natural
Resources
1111 Washington Street SE
Olympia Washington 98504

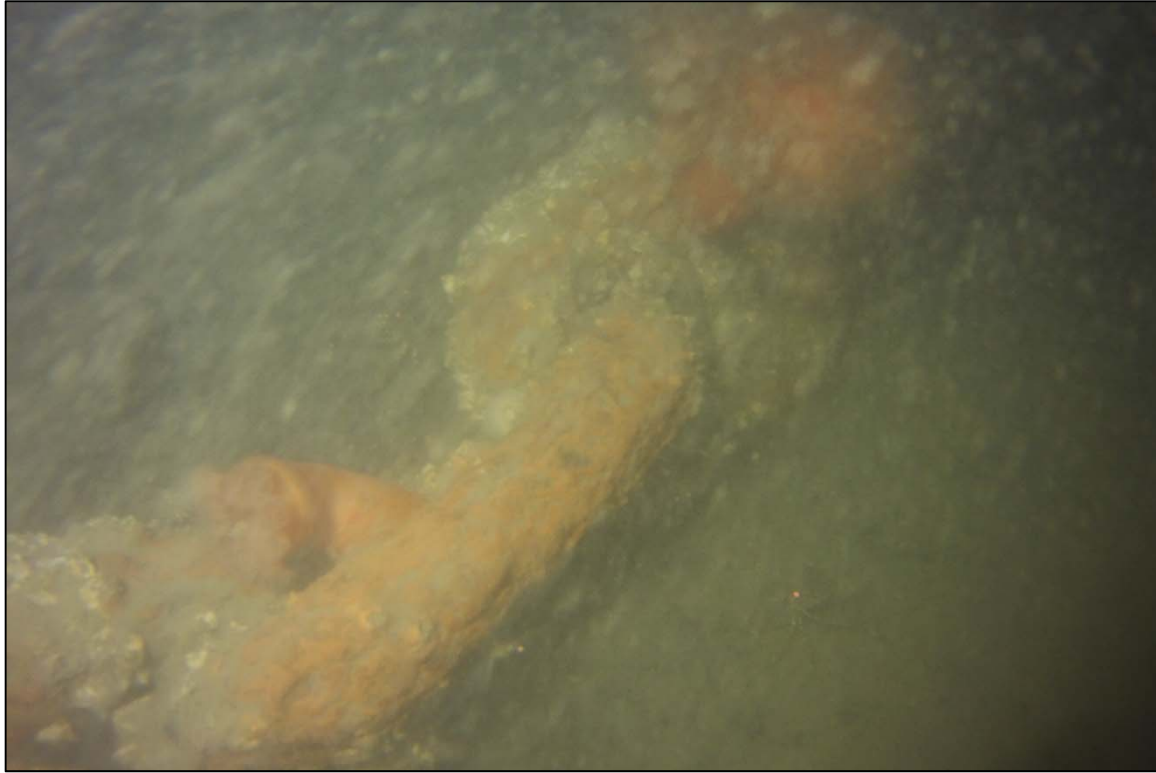
Photograph 41: View of Lower Anchor Chain on Channel Bottom at Anchor 22, Looking Northwest.

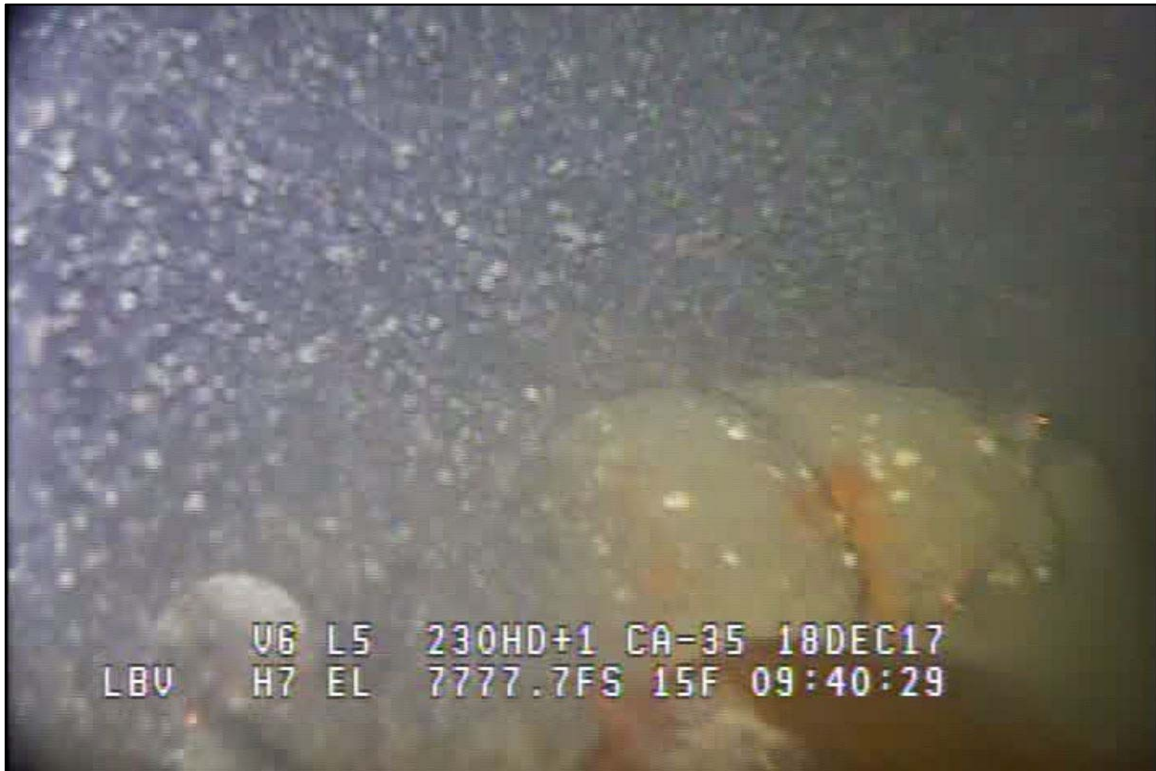
As previously indicated, due to being located in water depths greater than 100 fsw, it became necessary to inspect the lower portions of Anchor Lines 1, 2, 3, 24 and 25 with the use of an ROV. Ultimately, the ROV inspection of those anchor lines revealed the existing conditions in general to be very comparable to those observed from the diving inspections at the other Hope Island anchor lines. In particular, the lower rope to chain connections were always secure, with a proper rope eye splice and with a thimble and shackle that exhibited minimal deterioration. Regarding the lower anchor chains, they were typically resting on or embedded to some degree in the seabed for an approximate length ranging between only 20 ft, on the low end, and up to 90 ft (one shot of chain) at the most, with the chain exhibiting minimal deterioration and marine growth. The anchor chains also always appeared to be well-established with regard to their position on or in the seabed, with no notable rutting of the seabed, suggesting that the anchor chains are not displacing appreciably, and that their alignment is conducive to promoting proper setting and subsequent grip of their respective anchors. As for the anchors of the anchor lines inspected with the ROV, anchor exposure was only encountered at Anchor Line 3 and the extent of exposure was very minimal (essentially just a short length of the anchor stem exposed). Otherwise, there was no other anchor exposure encountered, and for all for all of the anchor lines inspected by ROV, the existing channel

Photograph 42: View of the Exposed Anchor Stem at Anchor 3, Looking Southwest. Photo taken from an ROV.

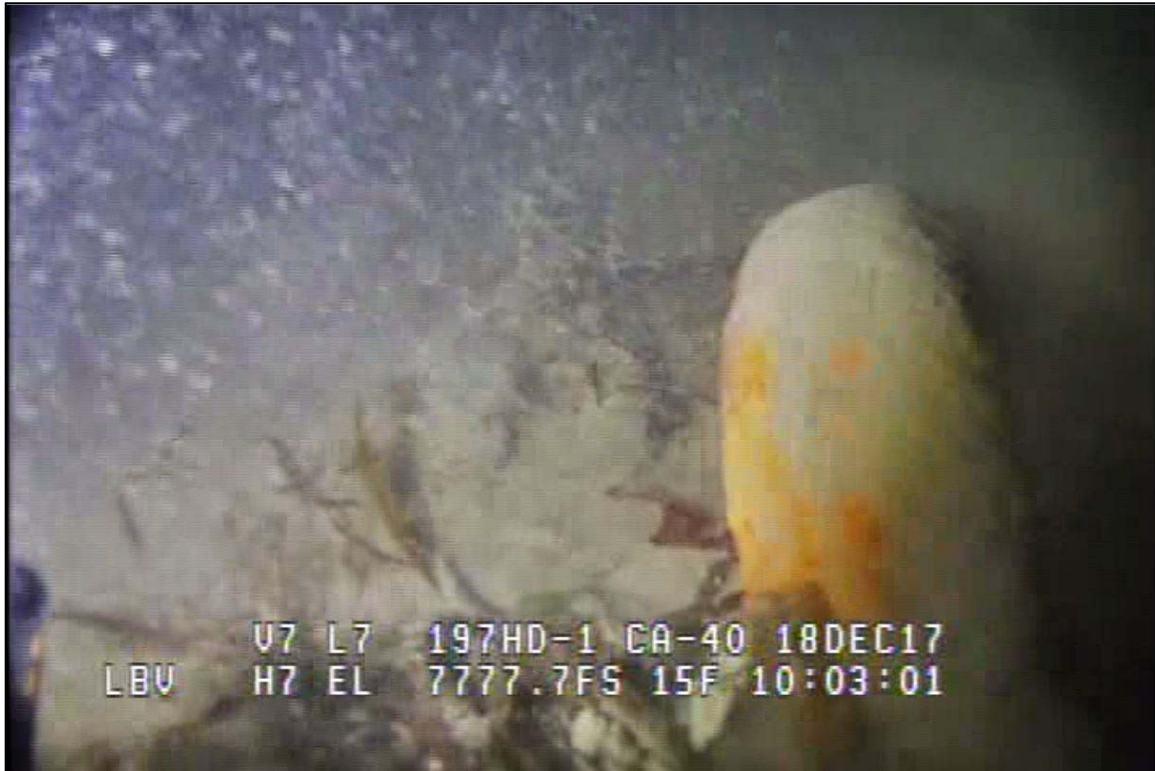
Photograph 43: View of half-buried Shackle at the Lower Anchor Line to Anchor Connection at Anchor 2, Looking West. Photo taken from an ROV.

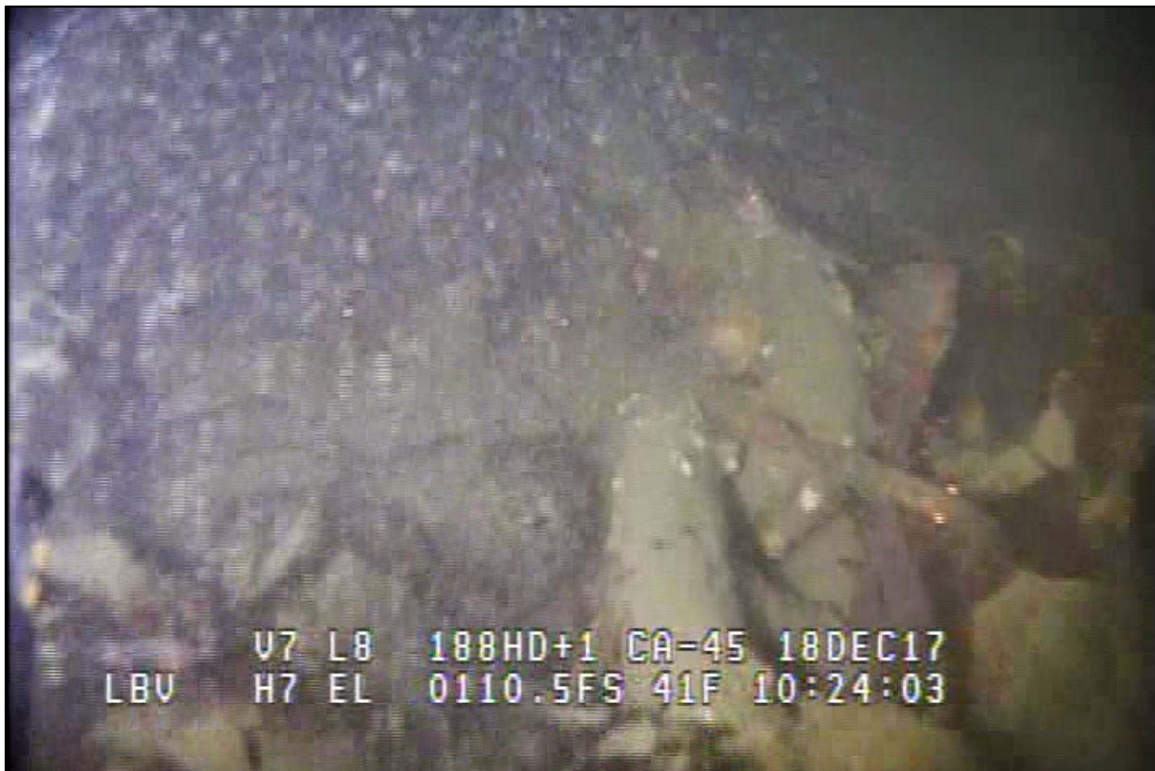
Photograph 44: View of the Lower Anchor Chain on the Channel Bottom at Anchor 1, Looking Southwest. Photo taken from an ROV.

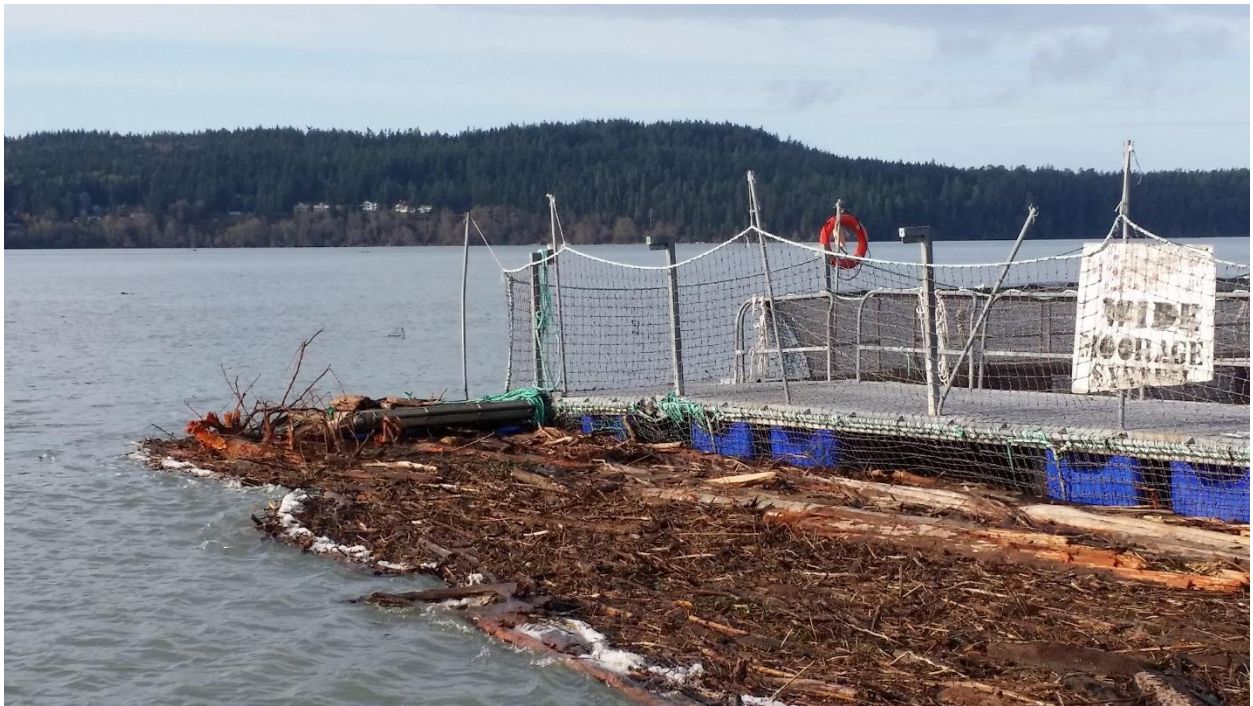
Figure C-15: Hope Island Net Pens - Debris Buildup on South End, Looking West

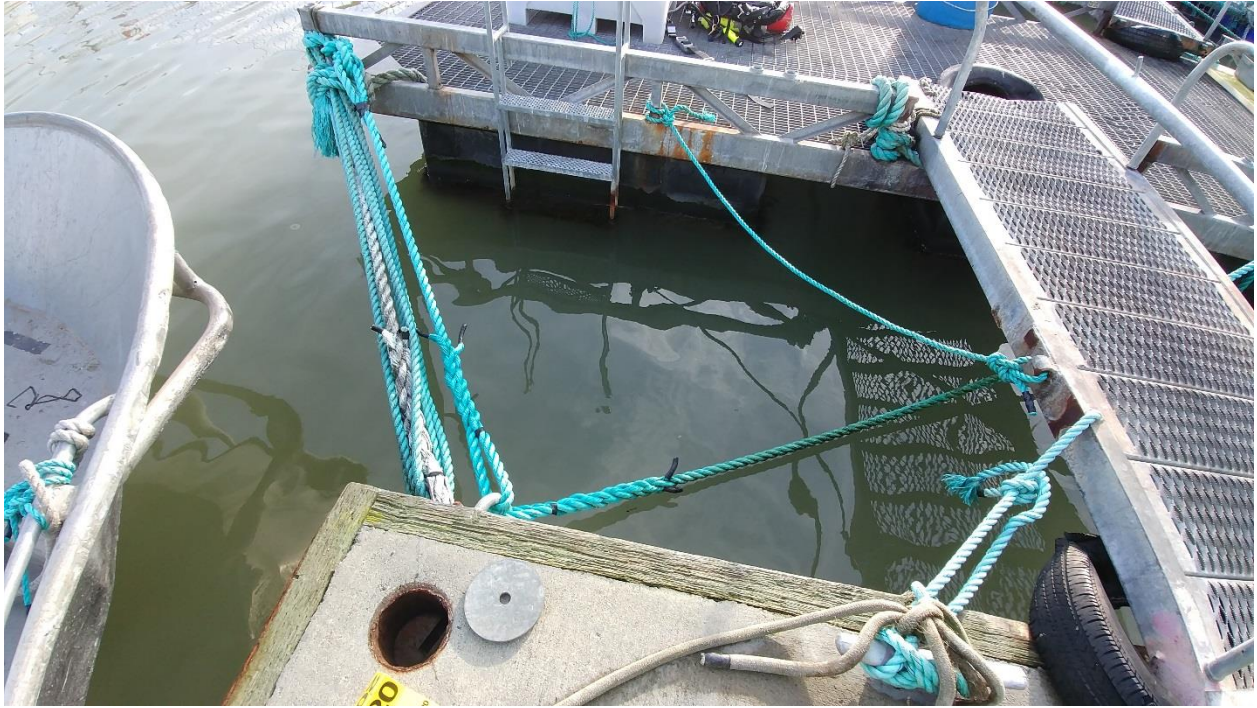
primarily minor and not compromising the integrity of the affected component. Except for the middle chain section at Anchor 20, the lengths of chain inspected exhibited only very minor deterioration, with just light surface corrosion being present that had no appreciable loss of original chain section associated with it. With respect to the ropes running between the upper and lower anchor chains, they were found to be in good, full original section condition, with no evidence of fraying or abrasion related damage. The exception to this was at Anchor 11 where minor abrasion damage was observed in the rope where it passed by and was in contact with a large concrete block located on the seabed. The thimbles and related rope knots and splices, which were used to connect the ropes to the upper and lower chain shackles, were also found to be sound and secure with no evidence of any condition that would compromise the connections. The moderate marine growth on all of the upper chains and the moderate to heavy marine growth on 12 of the 25 ropes relate to the age of the components, and did not appear to be detrimental to the facility at this time. The remaining 13 ropes, which exhibited essentially no growth, were relatively new (likely installed within the last 1 to 2 years).

Figure C-57: Anchor #20, SE Corner of the Main Barge. Part of an Anchor Bridle System.

Except for the anchor line assembly at Anchor 20, which should be replaced, the underwater inspection of the Hope Island Fish Net Pen System did not reveal any significant deterioration or other notable deficiencies that would suggest any appreciable reduction in the inherently designed integrity or stability of the system. In that regard, the components inspected below water were typically found to be in sound condition with no indication that a reduction in the originally intended capacity of a component or connection could be expected.

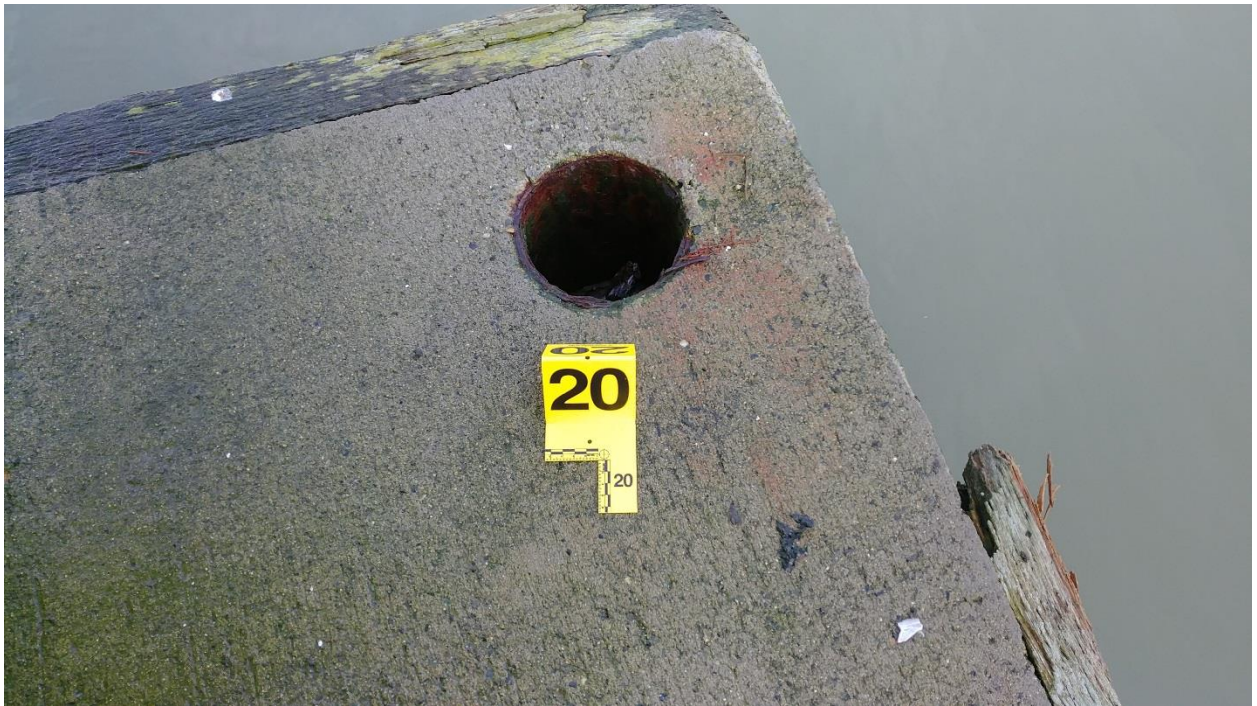
Figure C-58: Anchor #20, SE Corner of the Main Barge. Part of an Anchor Bridle System.

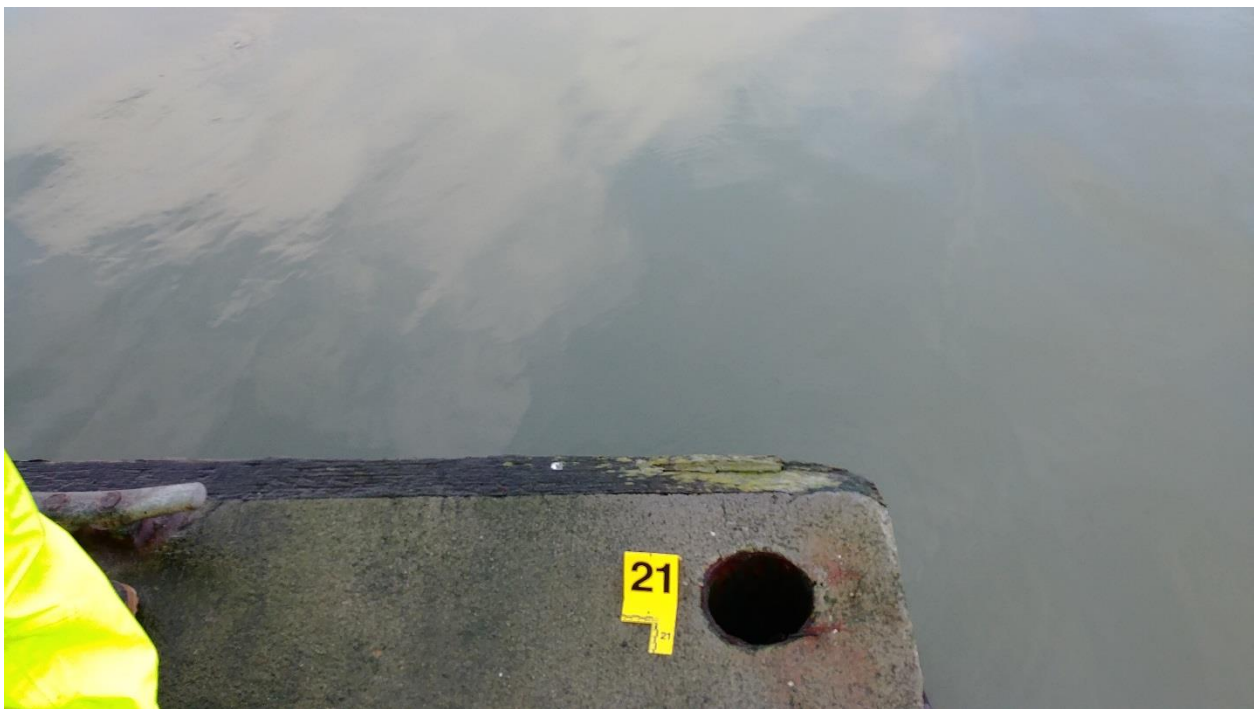
Figure C-60: Anchor #21, NE Corner of the Main Barge. Part of an Anchor Bridle System.

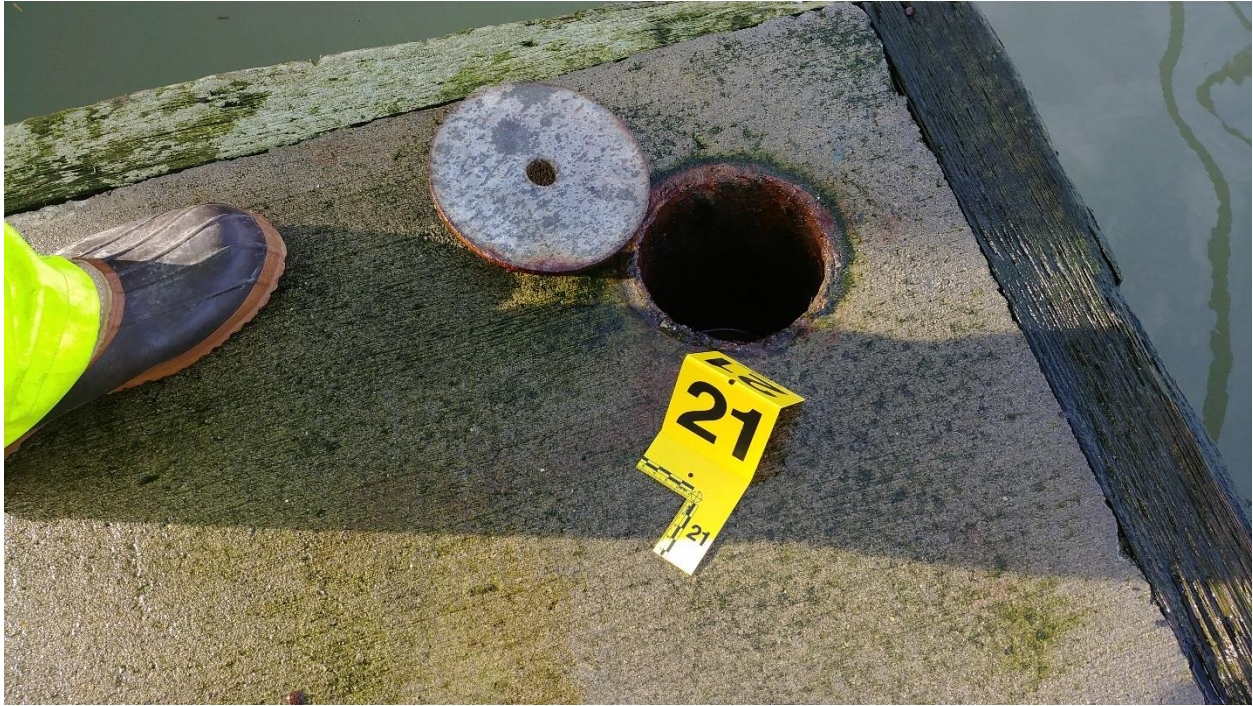
Figure C-61: Anchor #21, NE Corner of the Main Barge. Connection Point Shared with Anchor #21..

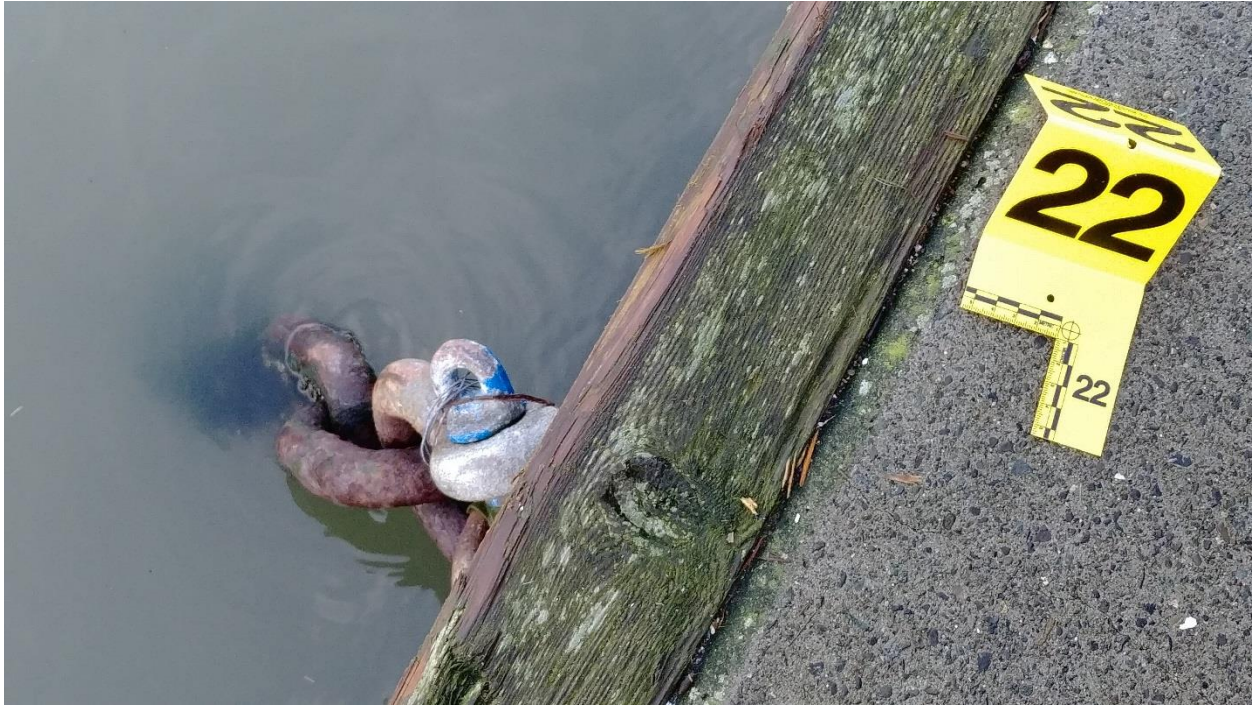
Figure C-63: Anchor #21, NW Corner of the Main Barge. Part of an Anchor Bridle System.

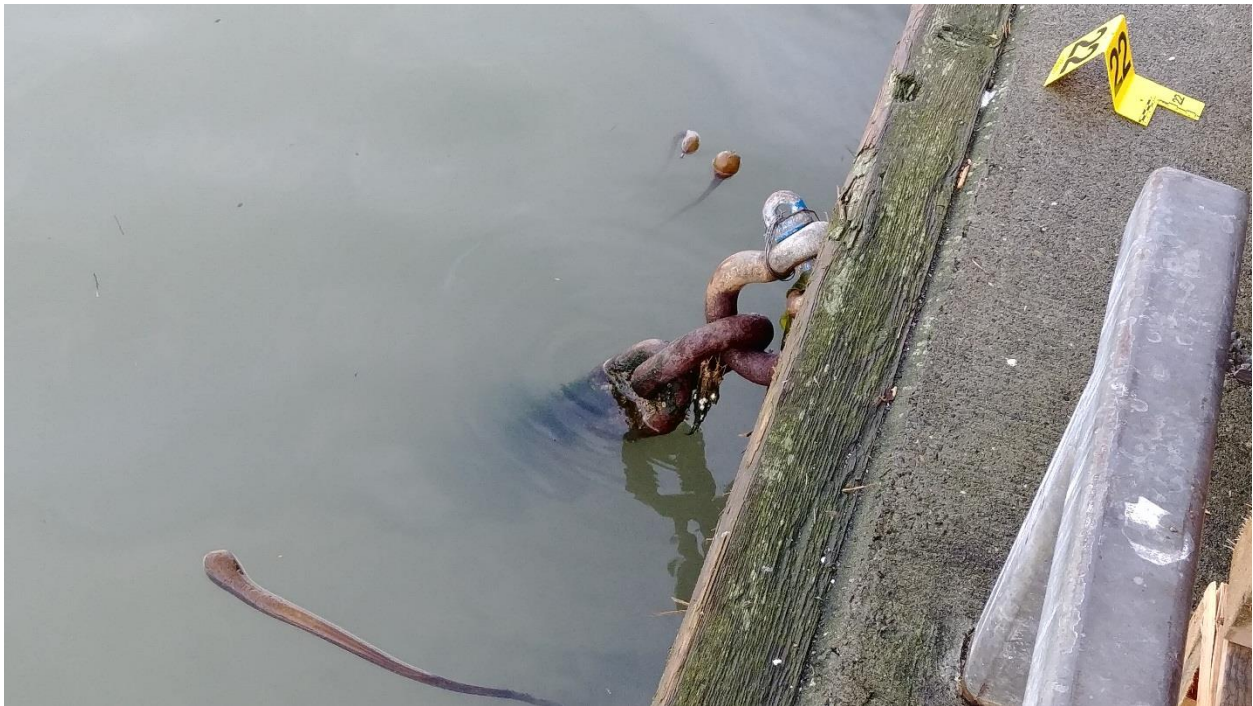
Figure C-64: Anchor #22, North Side of the Feed Barge, East of Centerline.

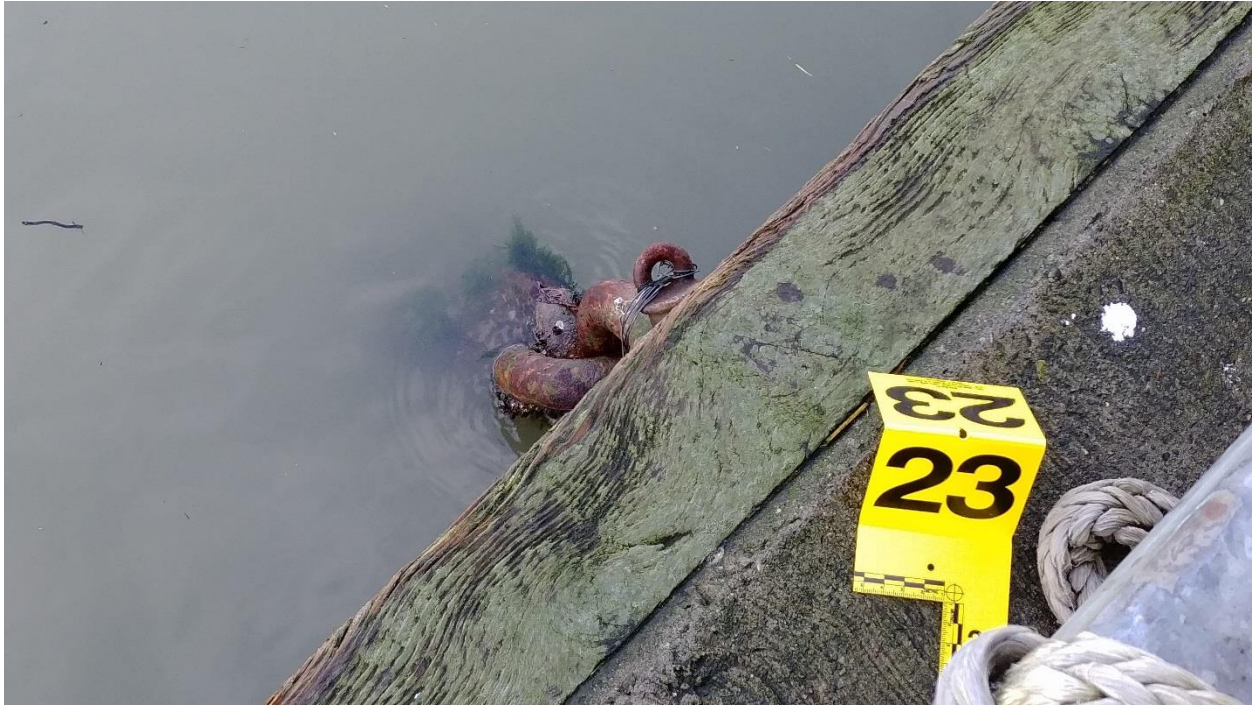
Figure C-65: Anchor #22, North Side of the Feed Barge, East of Centerline.

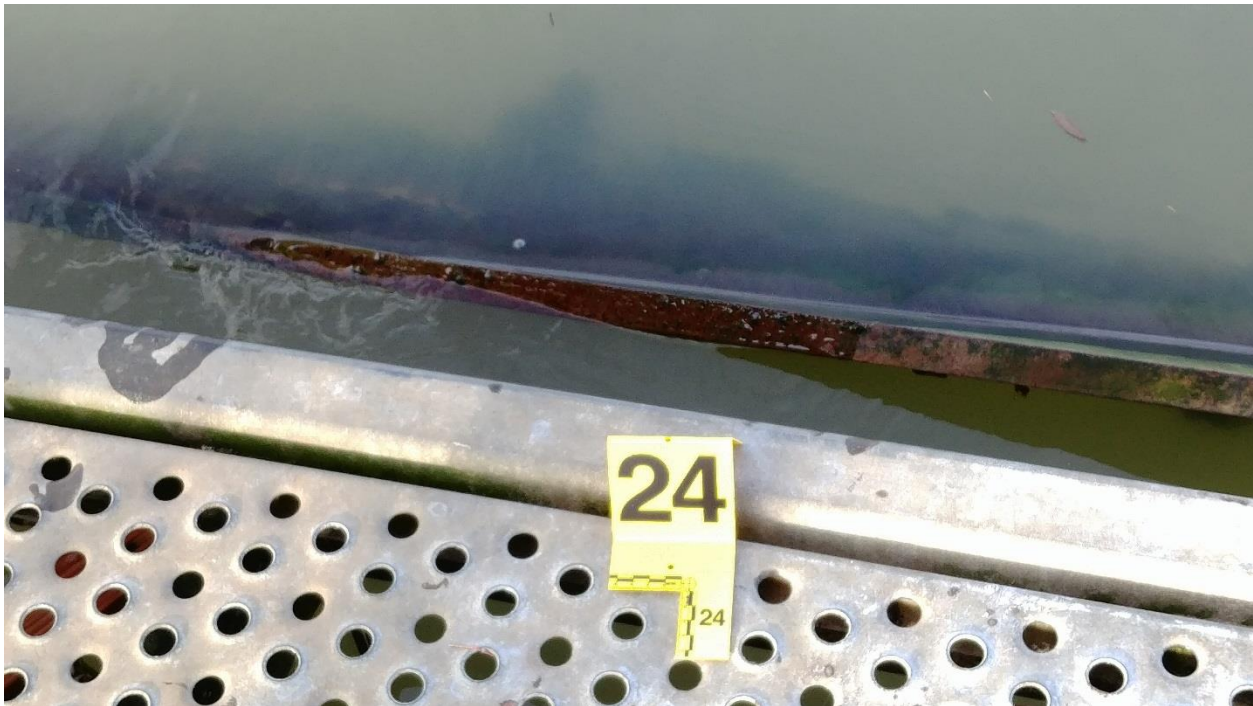
Figure C-66: Anchor #23, North Side of the Feed Barge, West of Centerline.

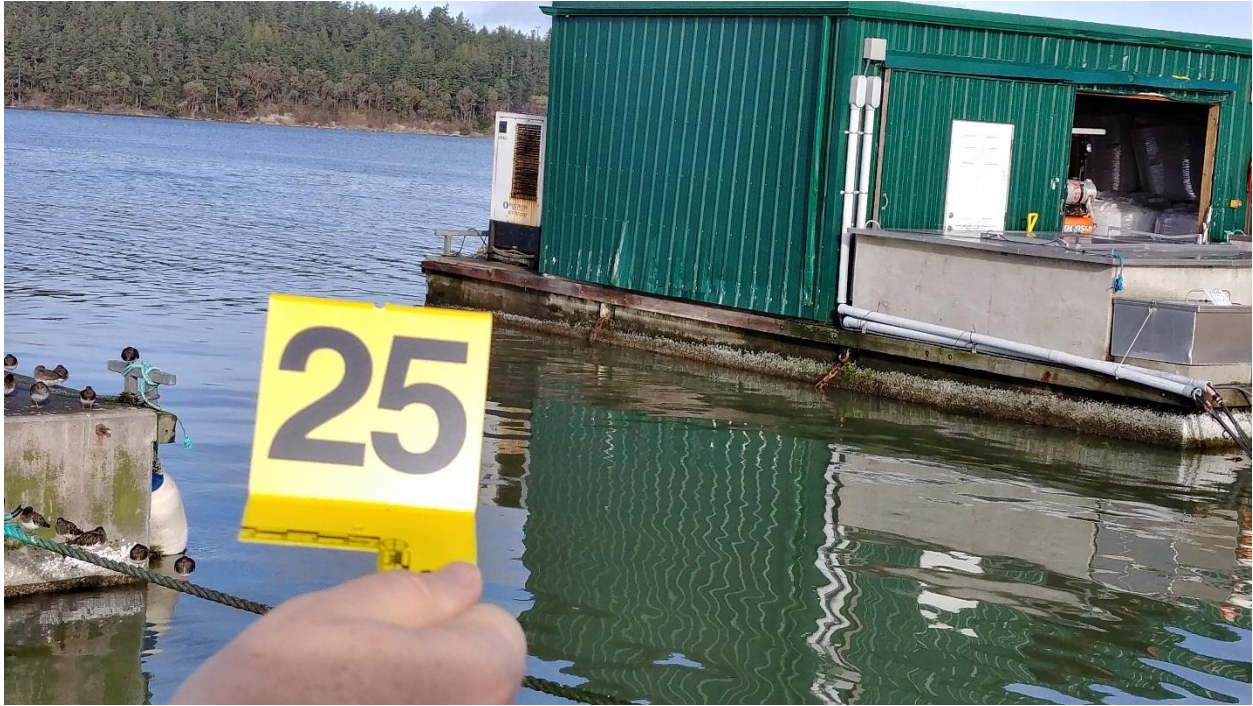
Figure C-67: Anchor #24, NW Corner of the Net Pens, Near Anchor #1

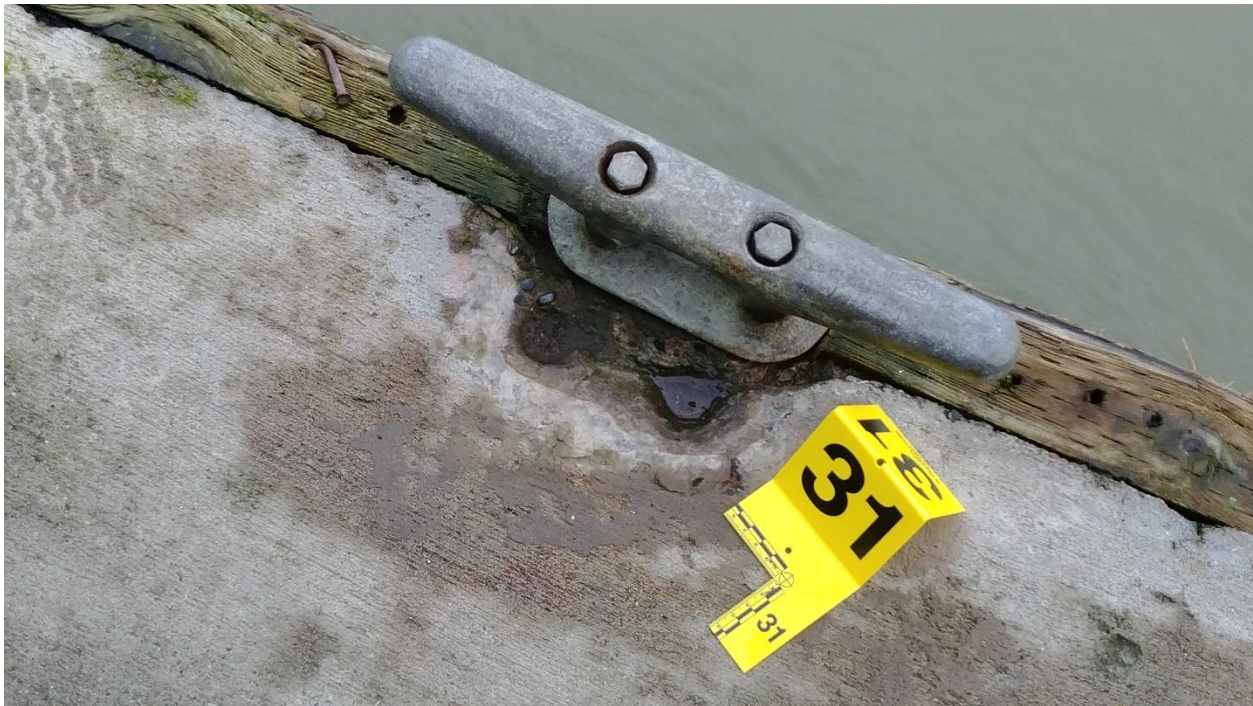
Figure C-76: Horn on Mooring Cleat Has Sheared Off at the Bolt

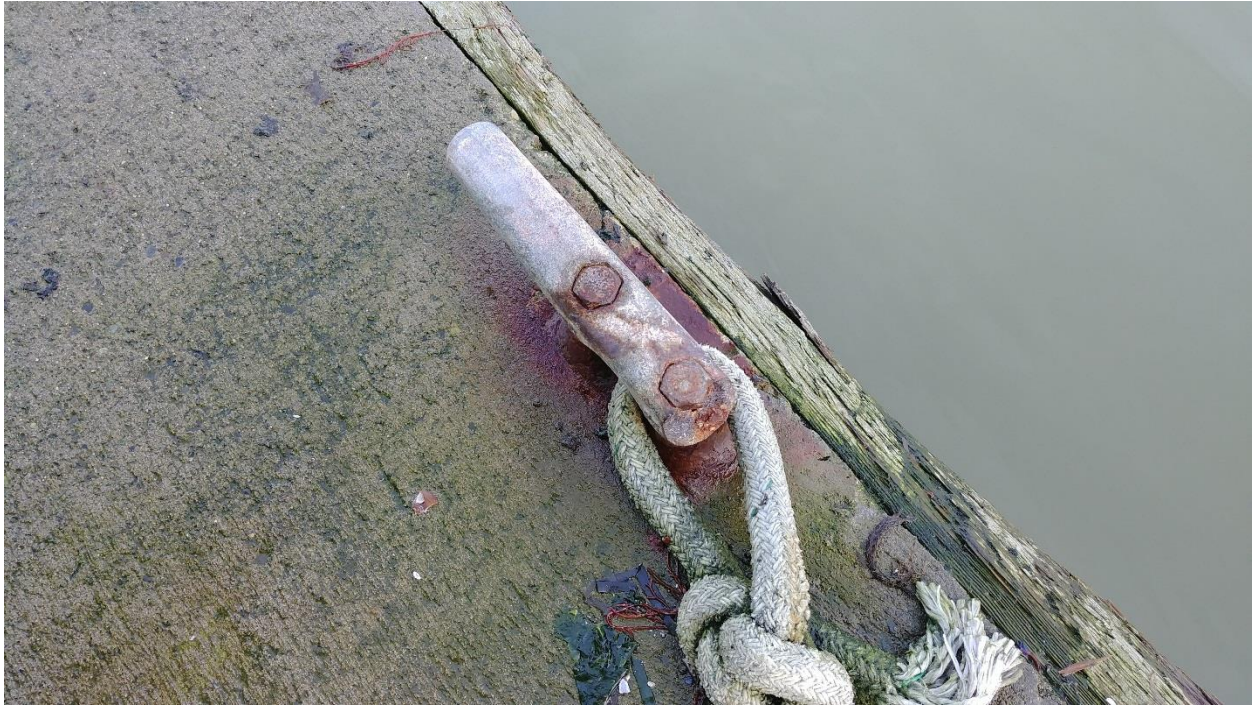
Figure C-77: Mooring Cleat Removed from its Original Location and Reattached into the Timber Waler

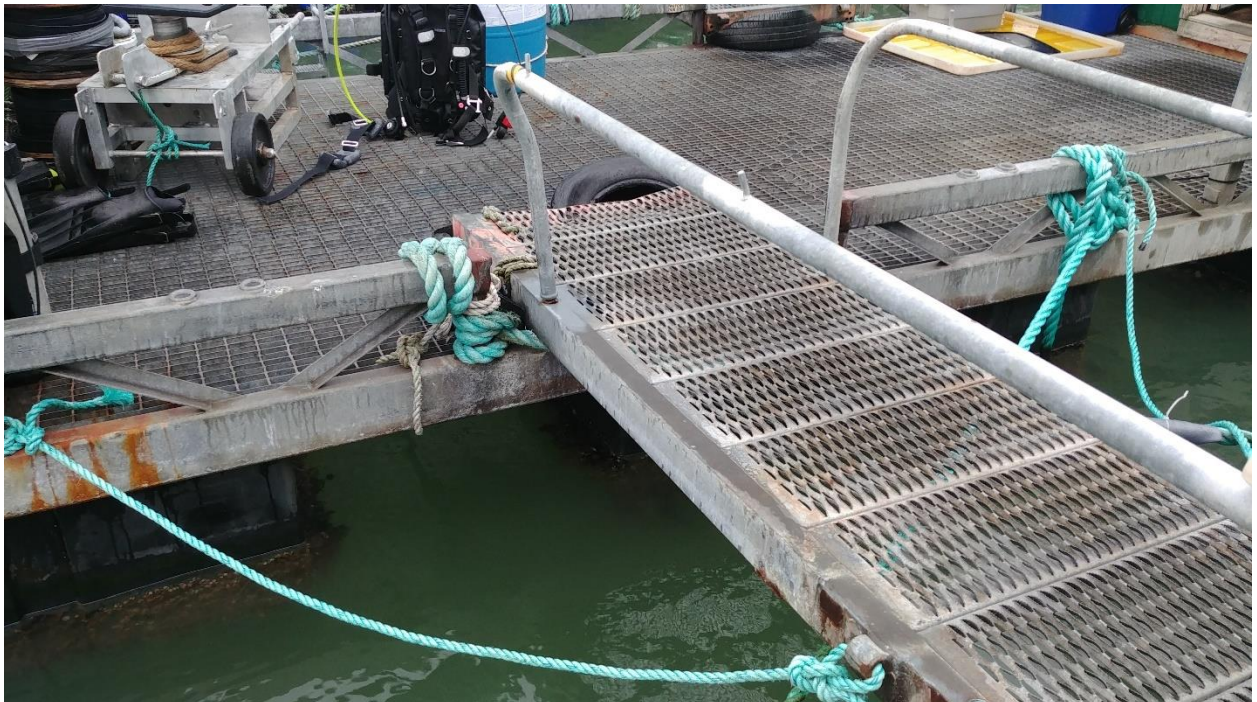
Figure C-84: Gangway Connecting Net Pens to Dive Float. Note Low Overhead Clearance.

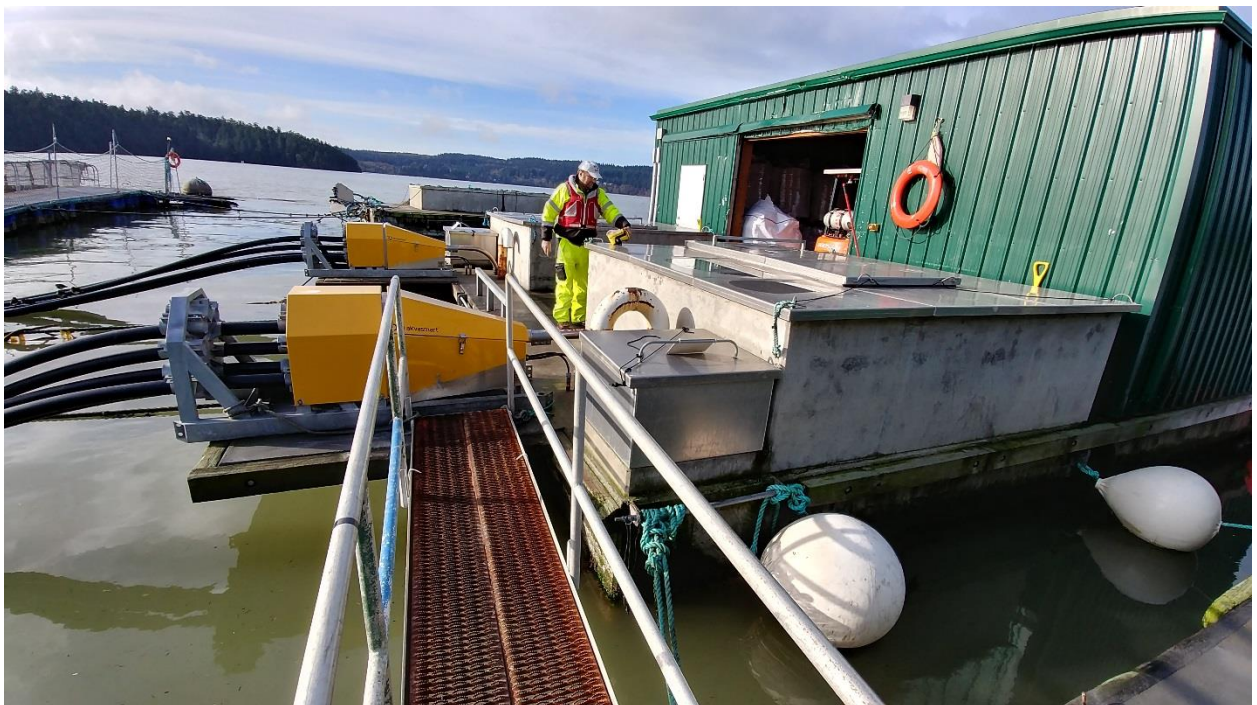
Figure C-86: South Side of Main Barge, Showing rafting of Intermediate Barge.

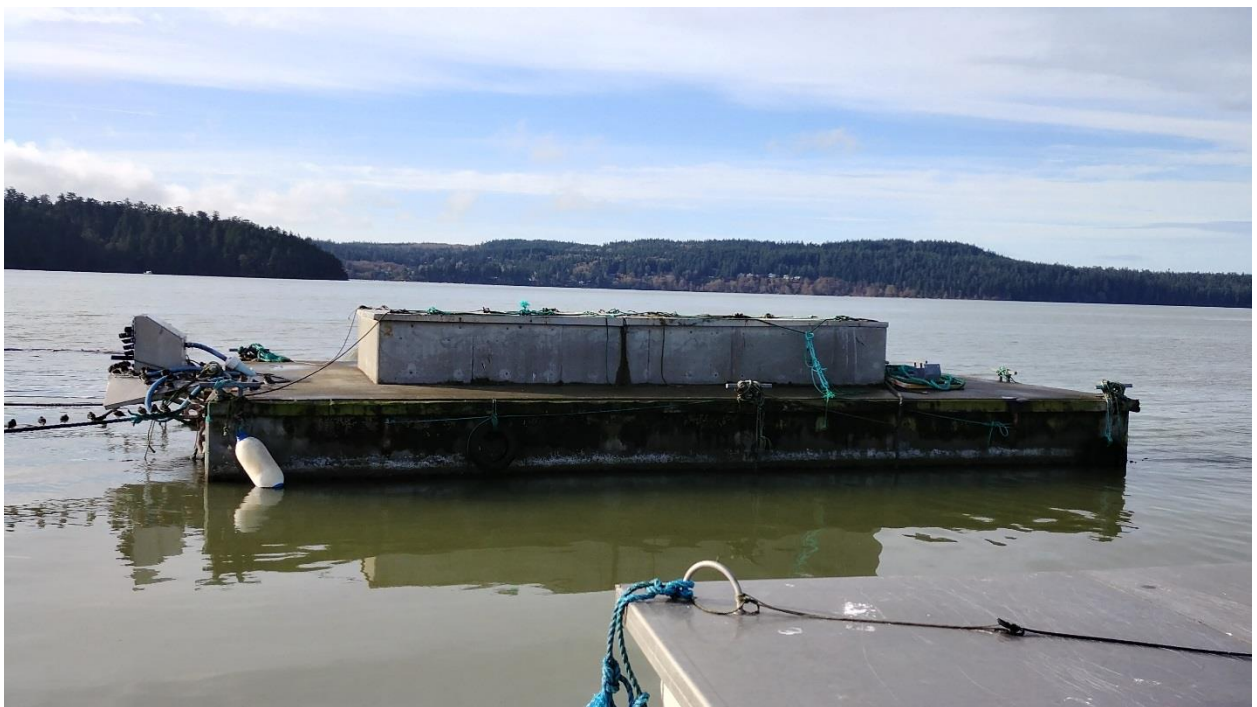
Figure C-92: Additional Feed Barge Tethered to Net Pens.

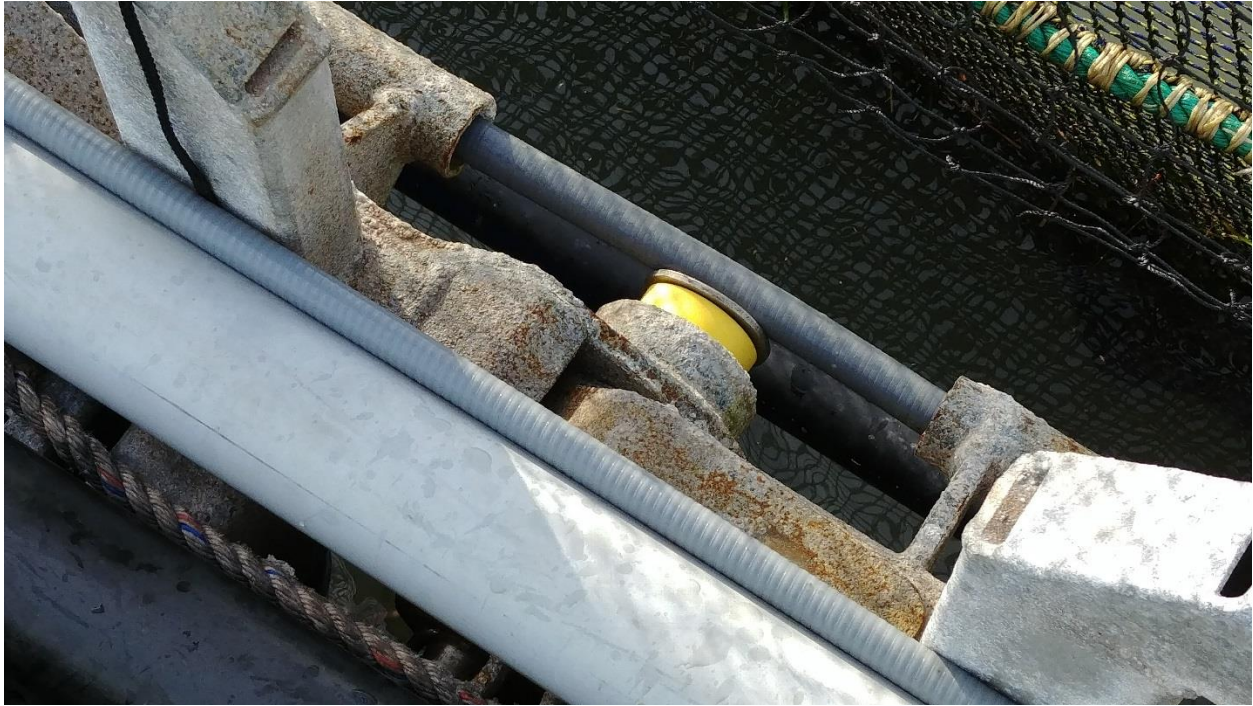
Figure C-99: Cantilevered Transition Plates between Main Walkway Segments - Removed

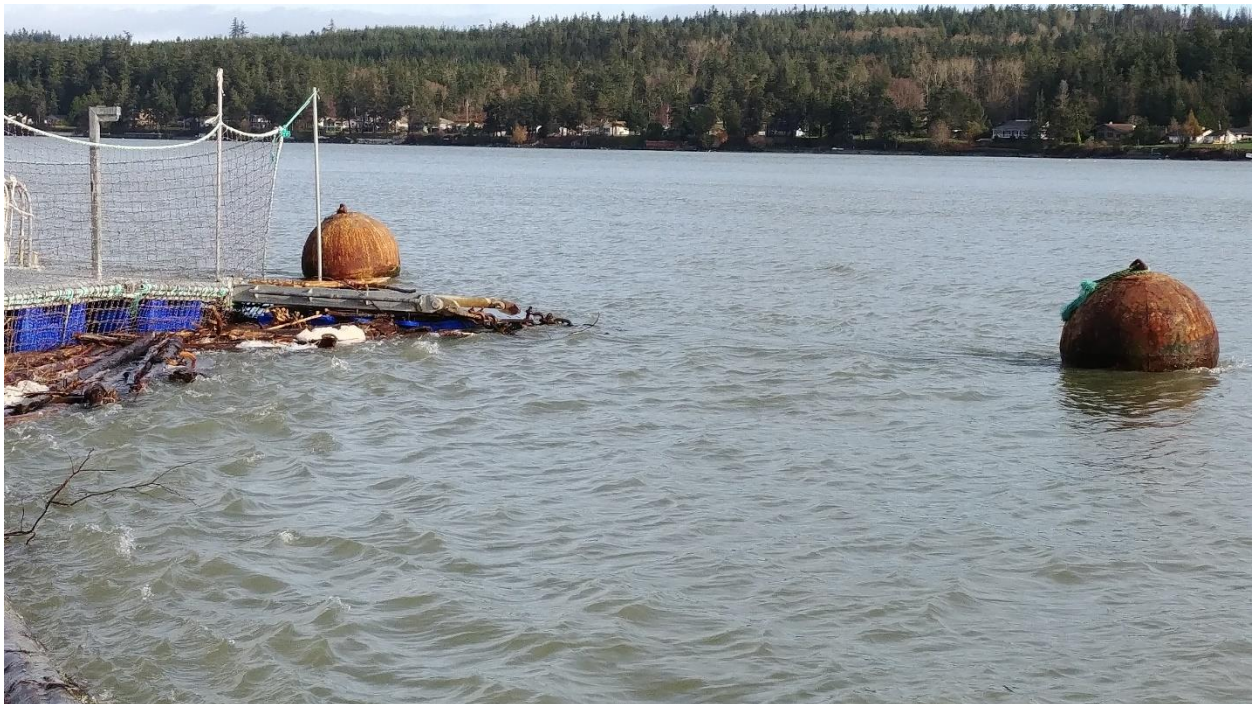
Figure C-102: Mooring Buoys, NE Corner. The Far-Right Buoy is not a part of the anchoring system.
