# **Cypress Island Site 1 Atlantic Salmon Net Pens Engineering Assessment**

January 29, 2018

**Document reference:** 391980 | 6 | b

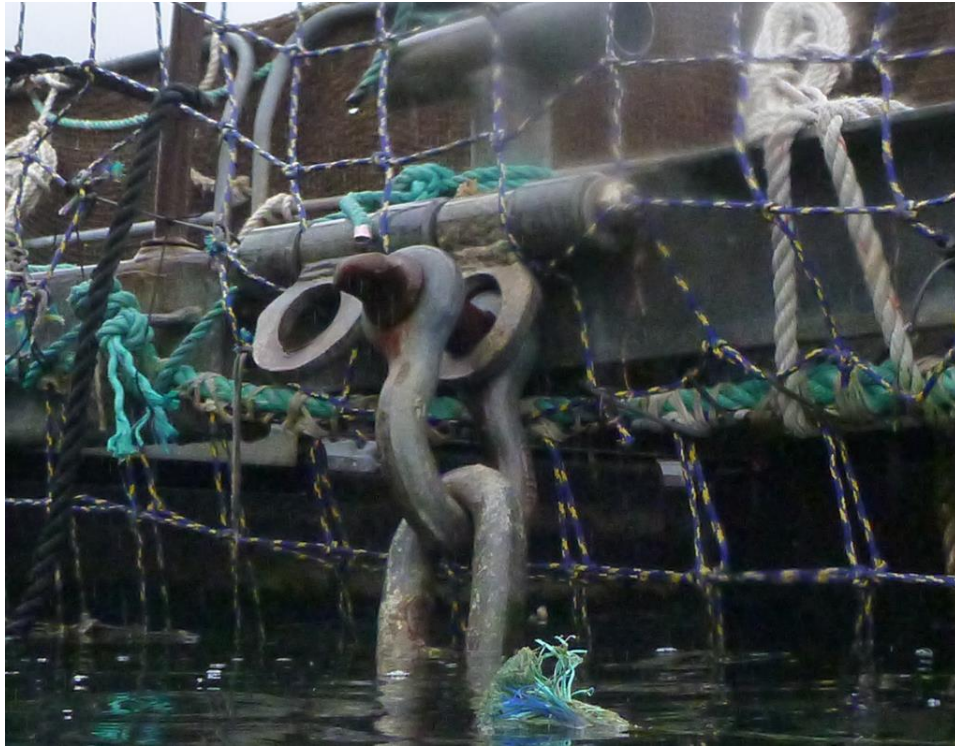
**Figure 6: Cypress Island Site 1 - Mooring Bracket at Line 20**

The mooring lines are connected by shackles to mooring brackets on the floats. The mooring brackets consist of two pad-eyes attached to a hinge welded to the floats a few inches below the walking surface. A stainless-steel bolt acts as the pin in the hinge. Typically, the mooring lines were found to be attached to only one pad-eye at each connection point. **Figure 6** shows a typical mooring bracket. Most anchor mooring lines had a single point of attachment, rather than a “bridle” or “hen’s foot” arrangement as shown on the plan provided by the owner. A bridle connection divides the mooring line near the net pen into two lines that attach to two different points on the net pen structure.

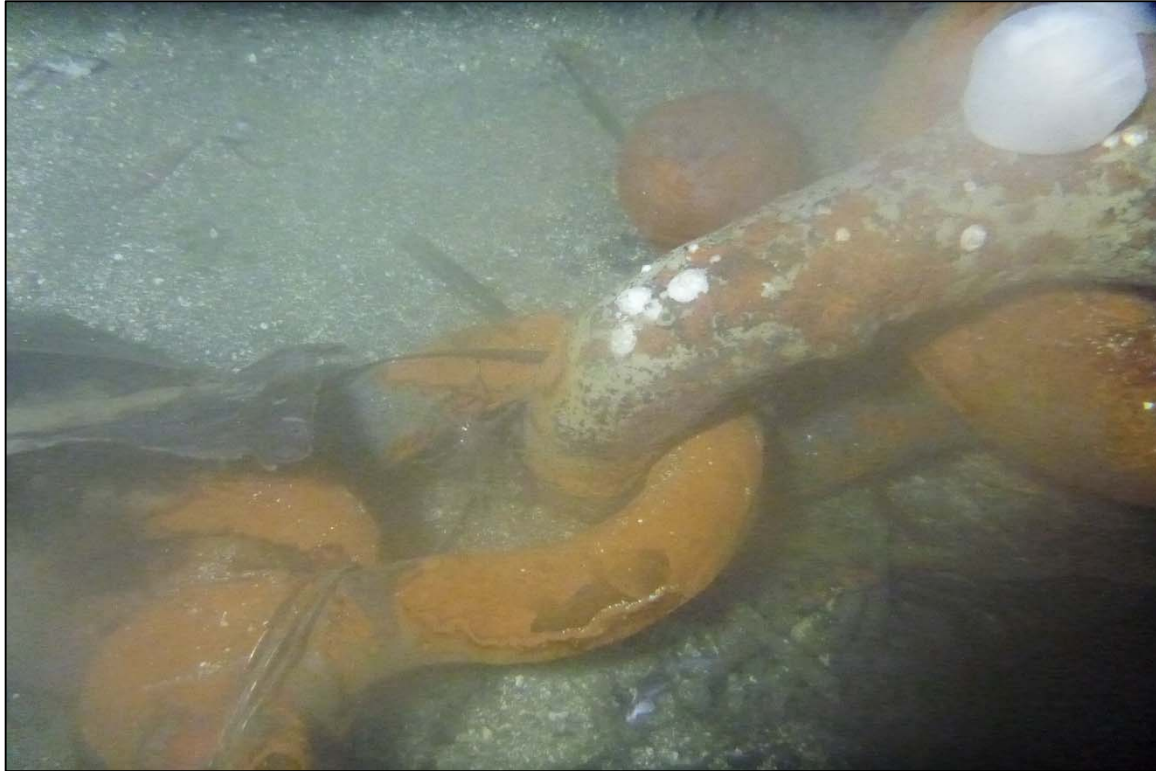
Photograph 11: View of the Lower Anchor Chain to Anchor Connection (Shackle) at Site 1 Feed Barge North Anchor Line, Looking West.

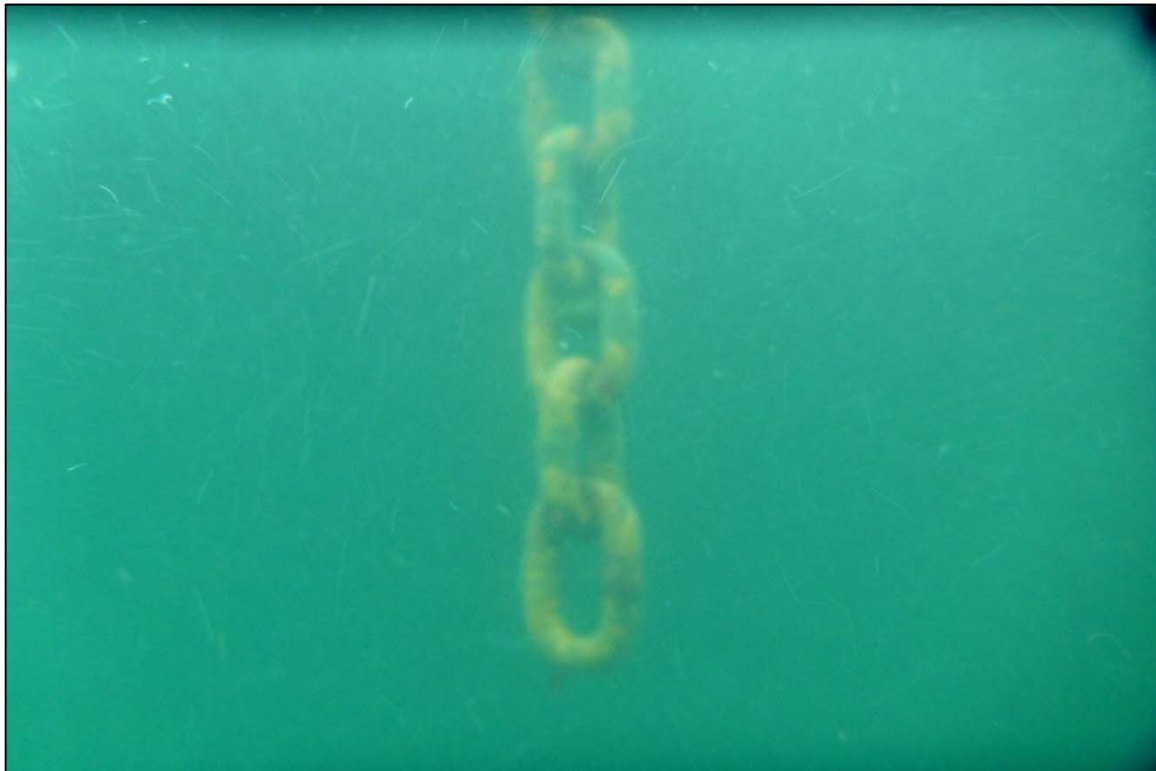
Photograph 12: View of the Termination of the Upper Anchor Chain at Site 1 Feed Barge South Anchor Line, Looking North.

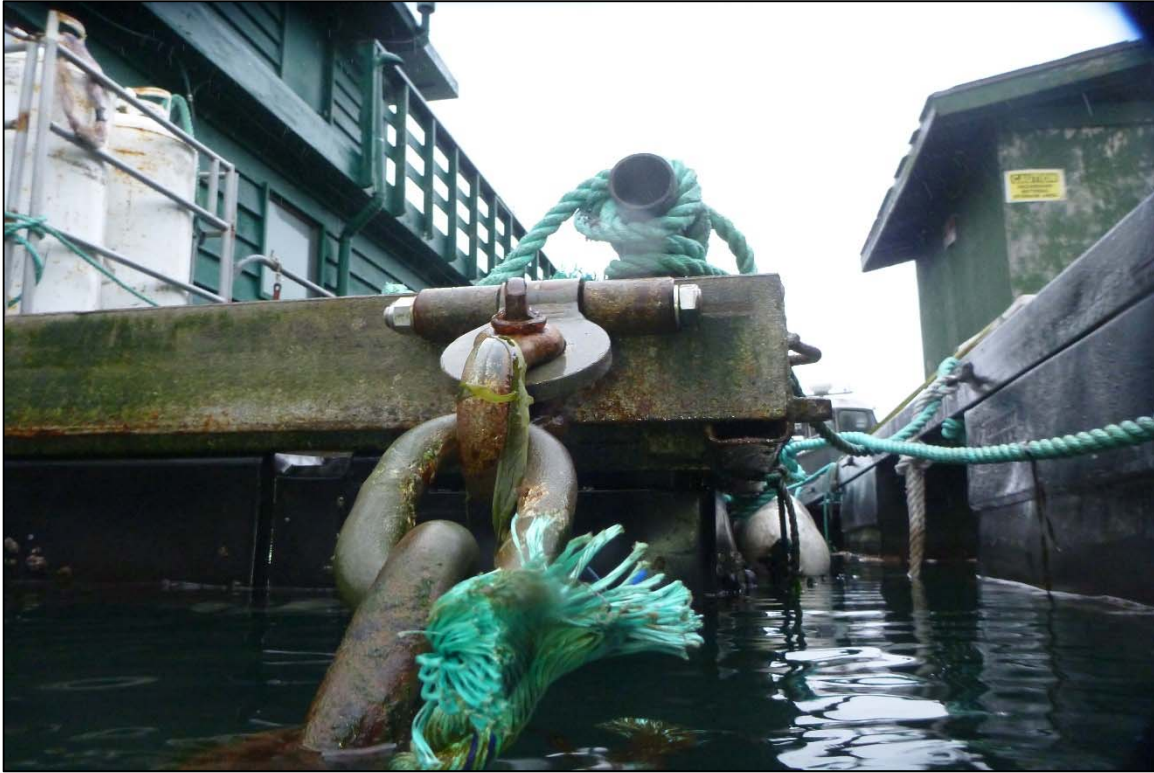
Photograph 13: View of the Float to Upper Anchor Chain Connection at Site 1 Anchor Line 1, Looking East.

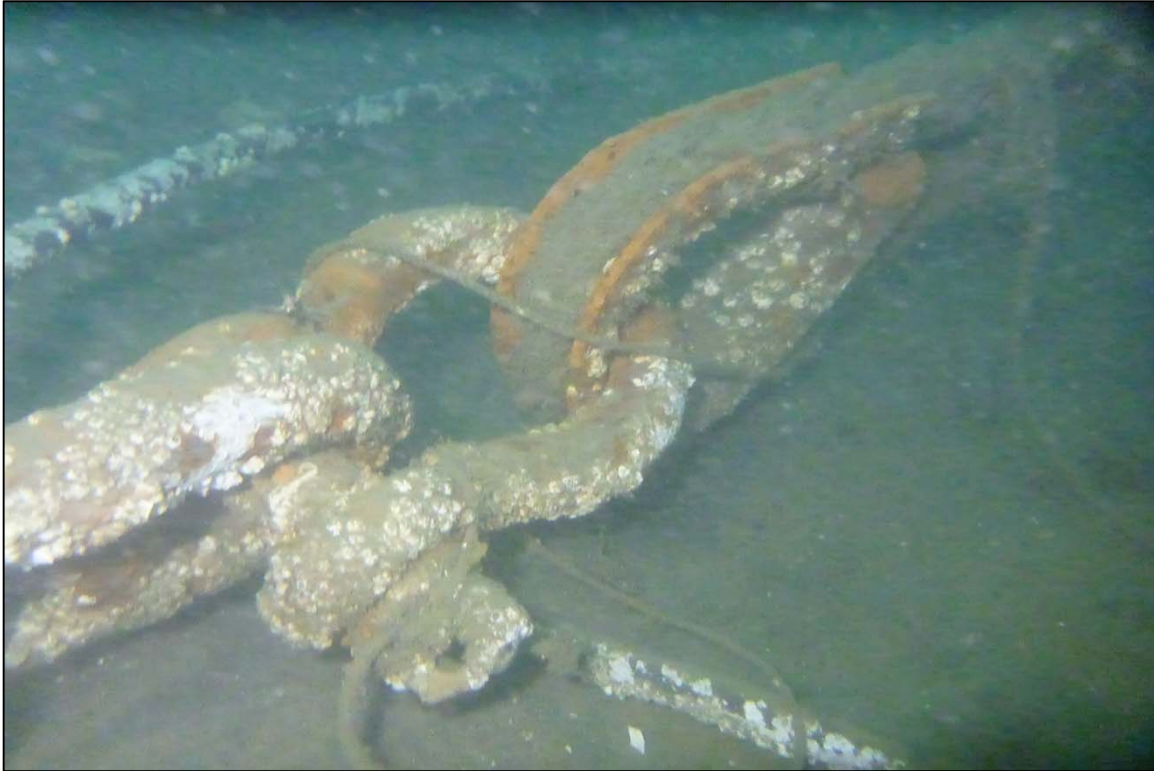
Photograph 15: View of the Rope to Anchor Chain Connection (Sleeve, Shackle and Thimble) and Random Piping at Site 1 Anchor Line 1, Looking North.

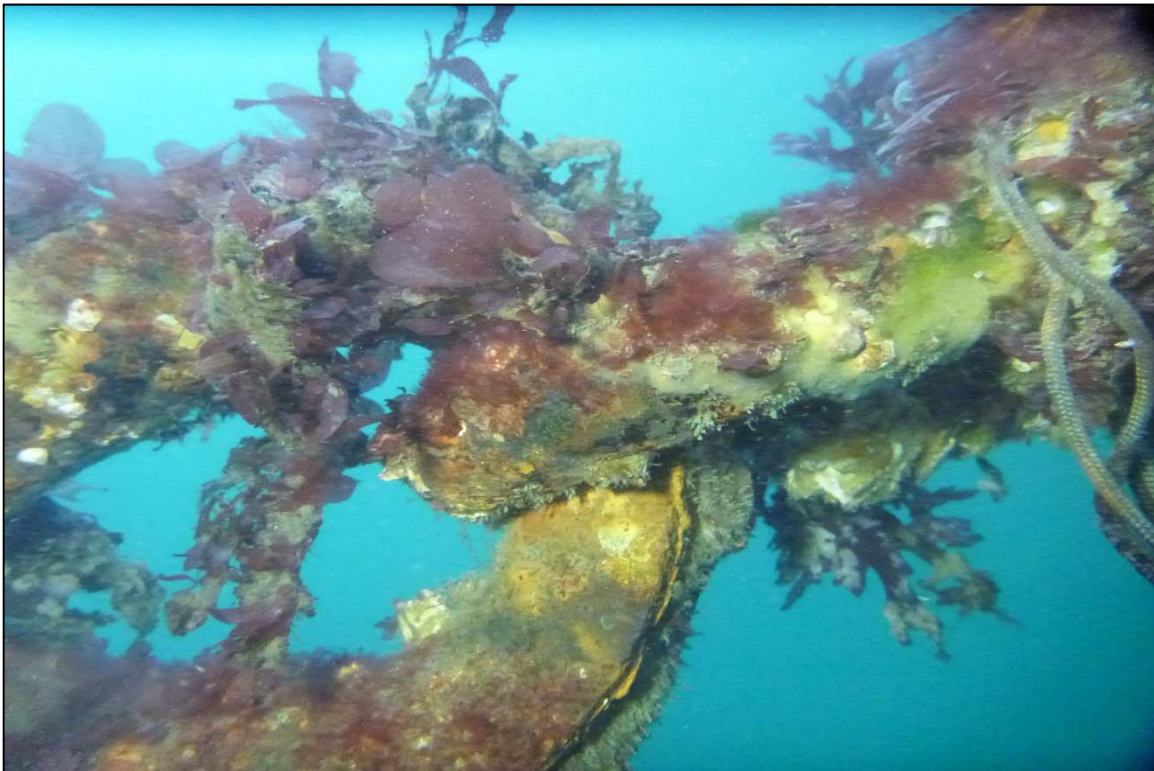
Photograph 16: View of the Upper Anchor Chain to Rope Connection (Thimble) at Site 1 Anchor Line 2, Looking North.

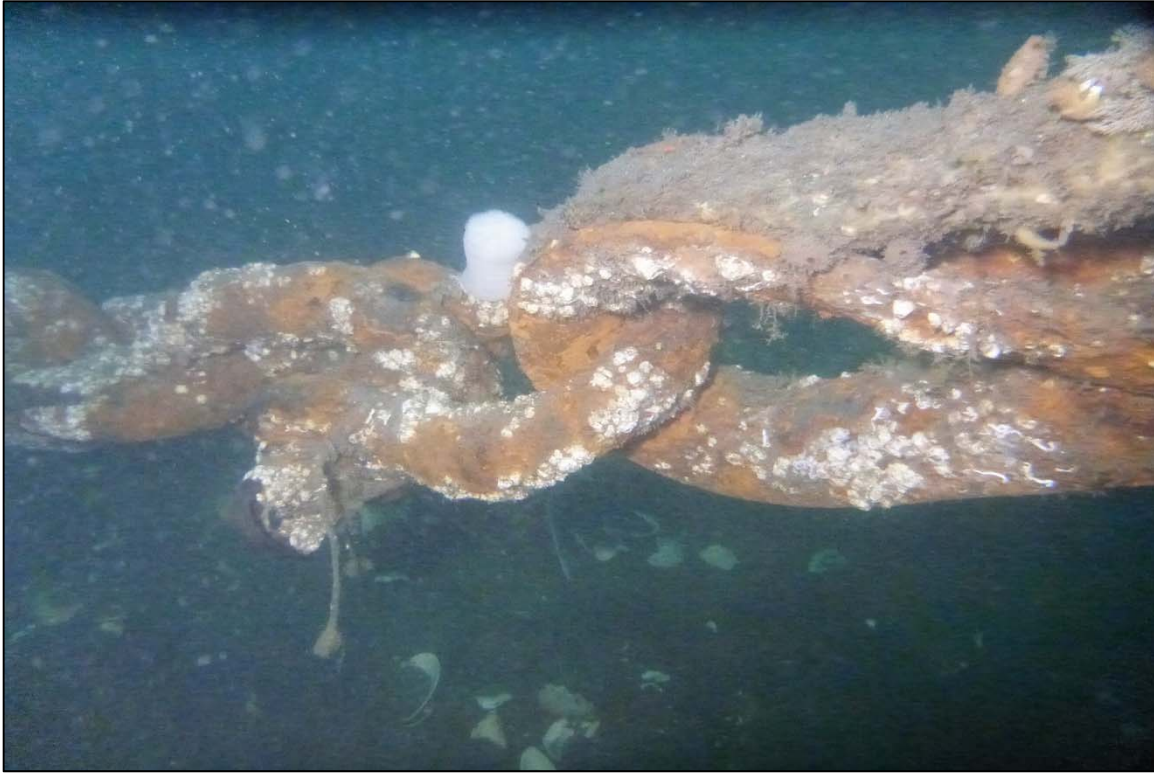
Photograph 17: View of the Rope to Anchor Chain Connection (Shackle and Thimble) at Site 1 Anchor Line 2, Looking Northwest.

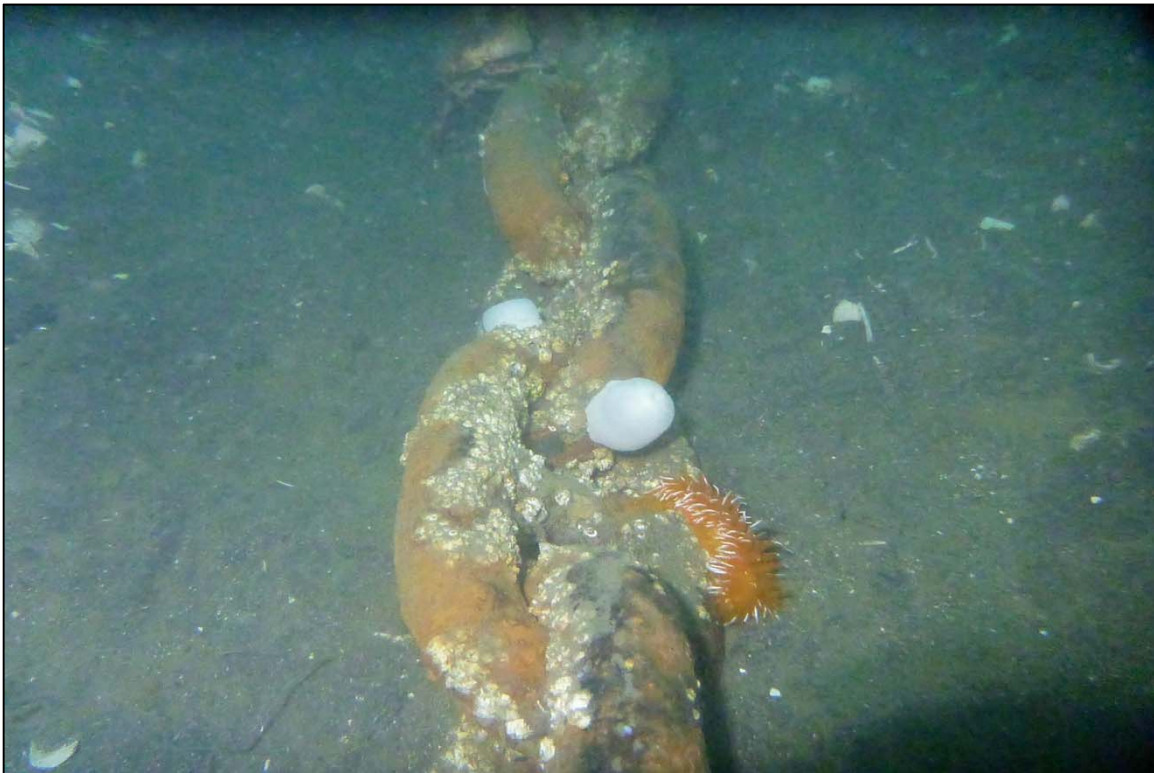
Photograph 18: View of the Lower Anchor Chain on the Channel Bottom at Site 1 Anchor Line 2, Looking West.

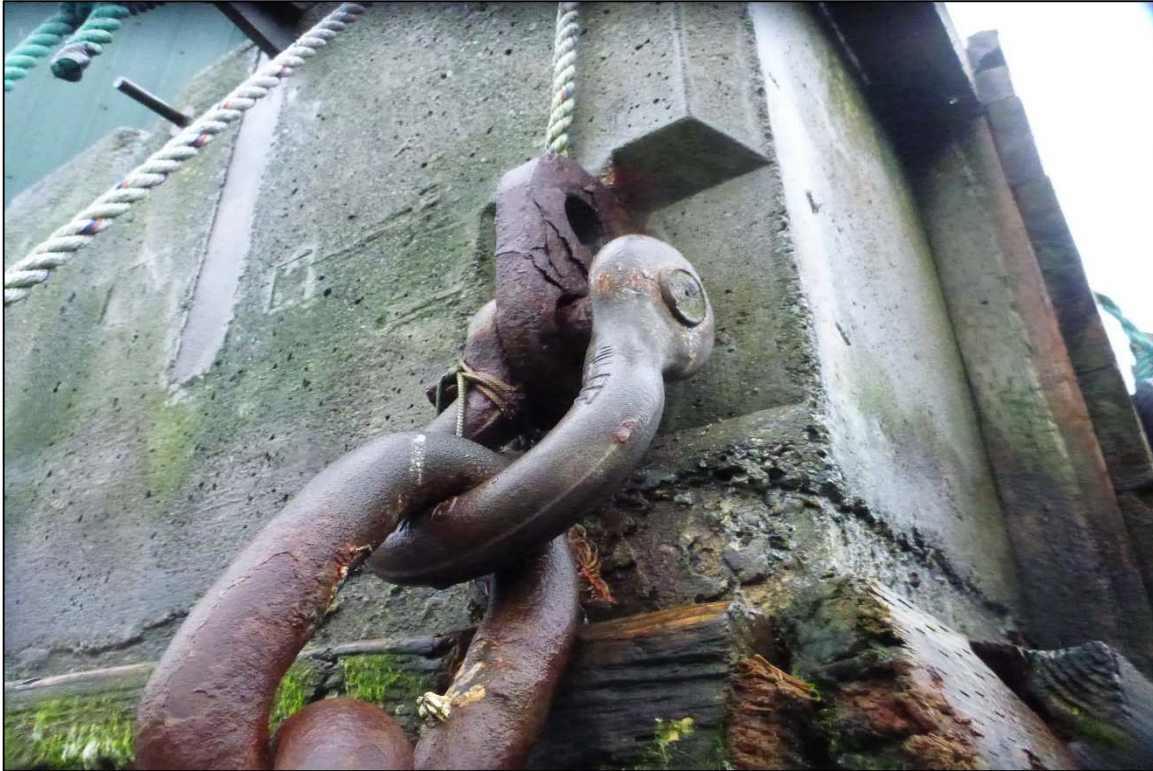
Photograph 19: View of the Feed Barge to Upper Anchor Chain Connection at Site 1 Anchor Line 3, Looking East.

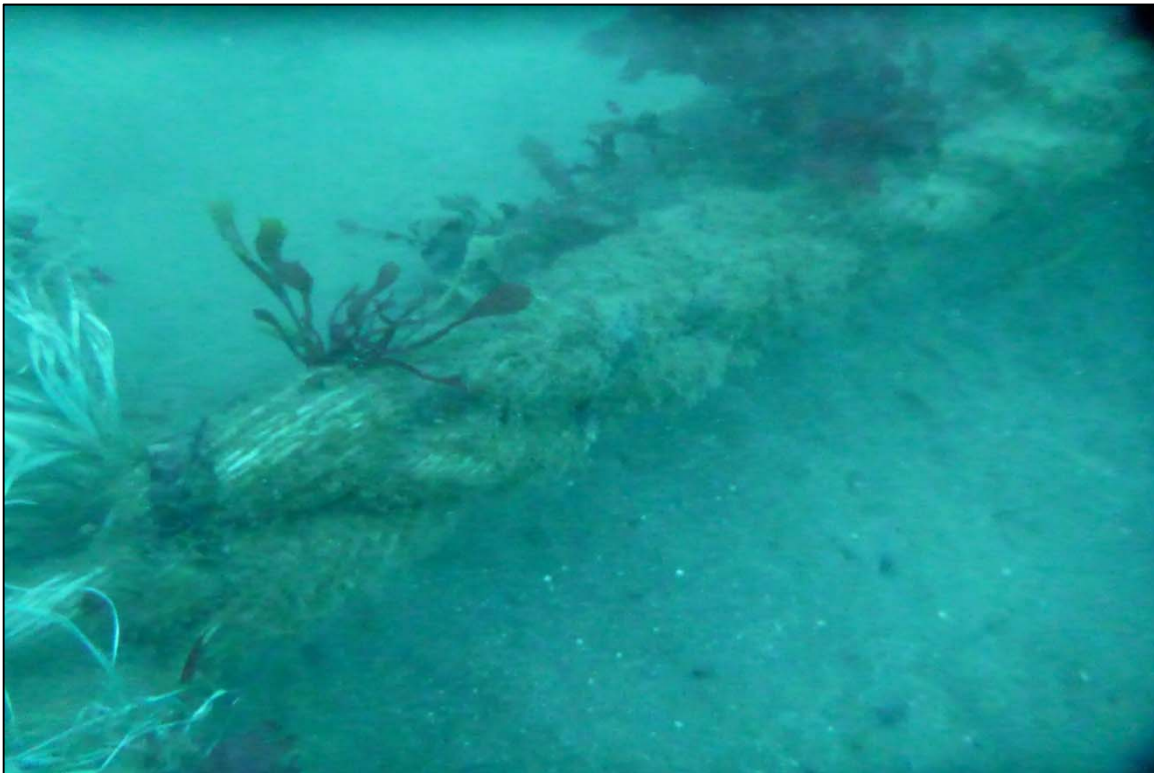
Photograph 25: View of Upper Anchor Chain Condition at Site 1 Anchor Line 5, Looking South.

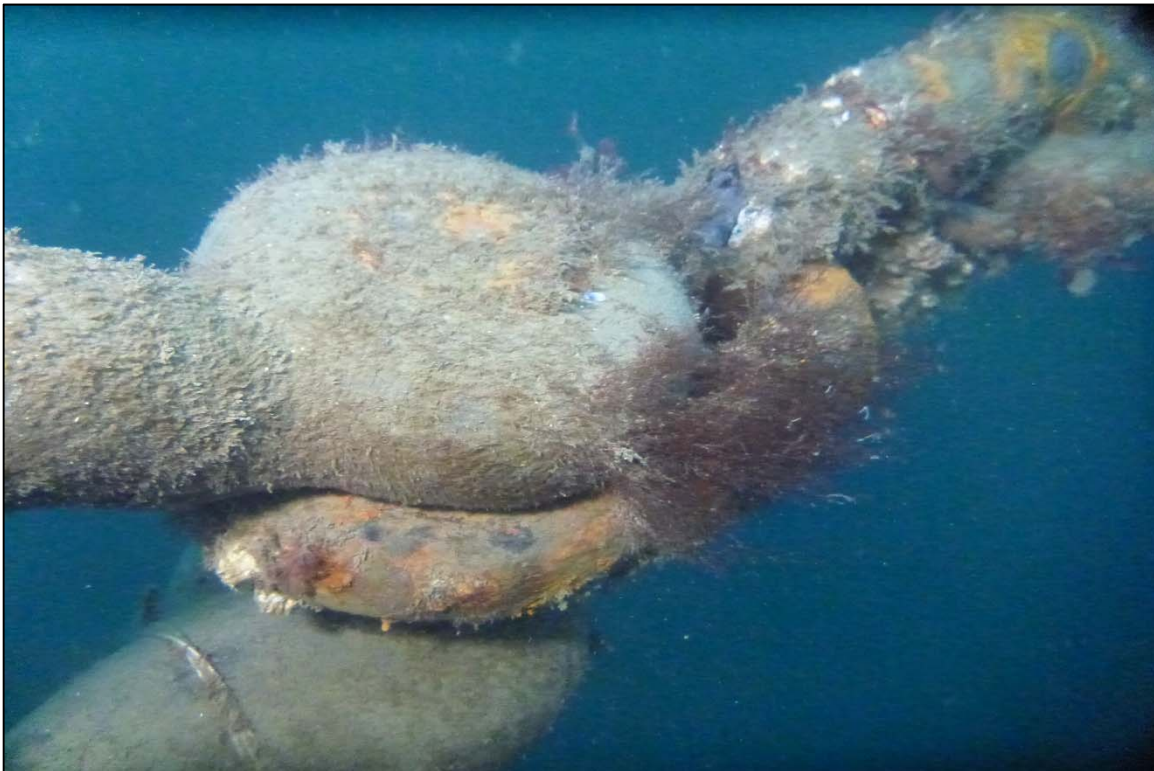
Photograph 27: View of the Rope to Lower Anchor Chain Connection (Thimble and Shackle) at Site 1 Anchor Line 5, Looking South.

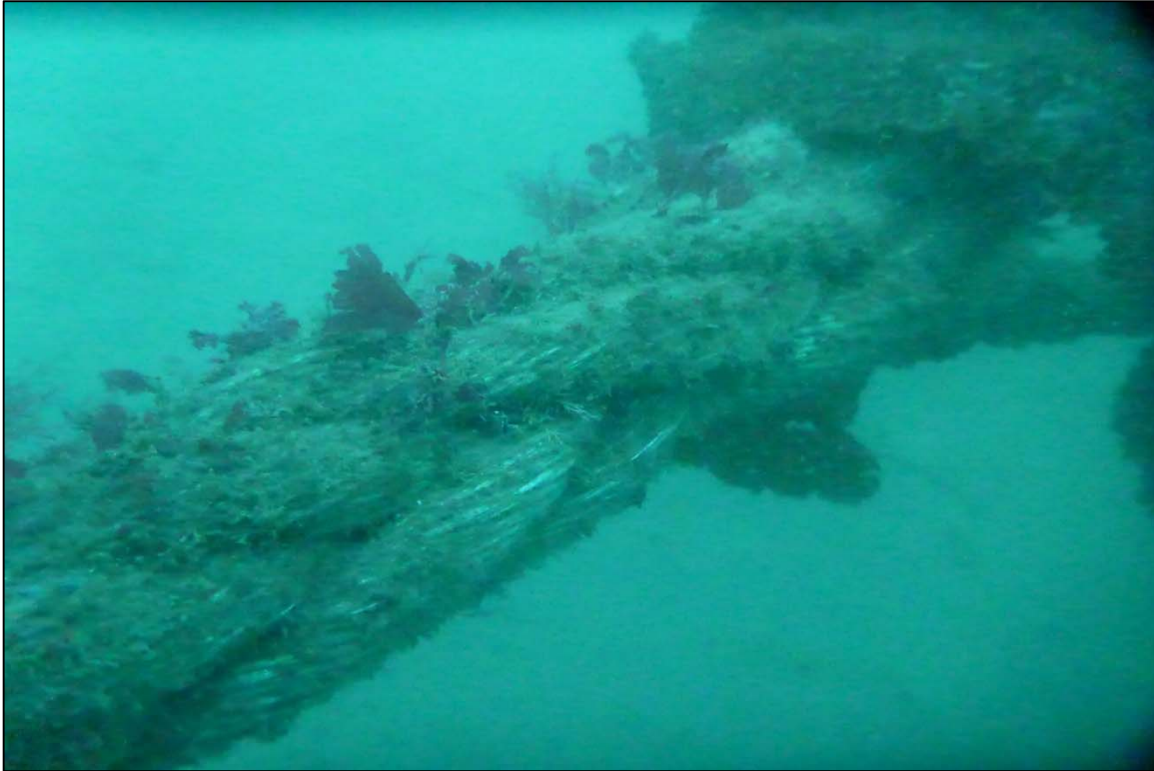
Photograph 28: View of the Upper Anchor Chain to Rope Connection (Shackle) at Site 1 Anchor Line 6, Looking North.

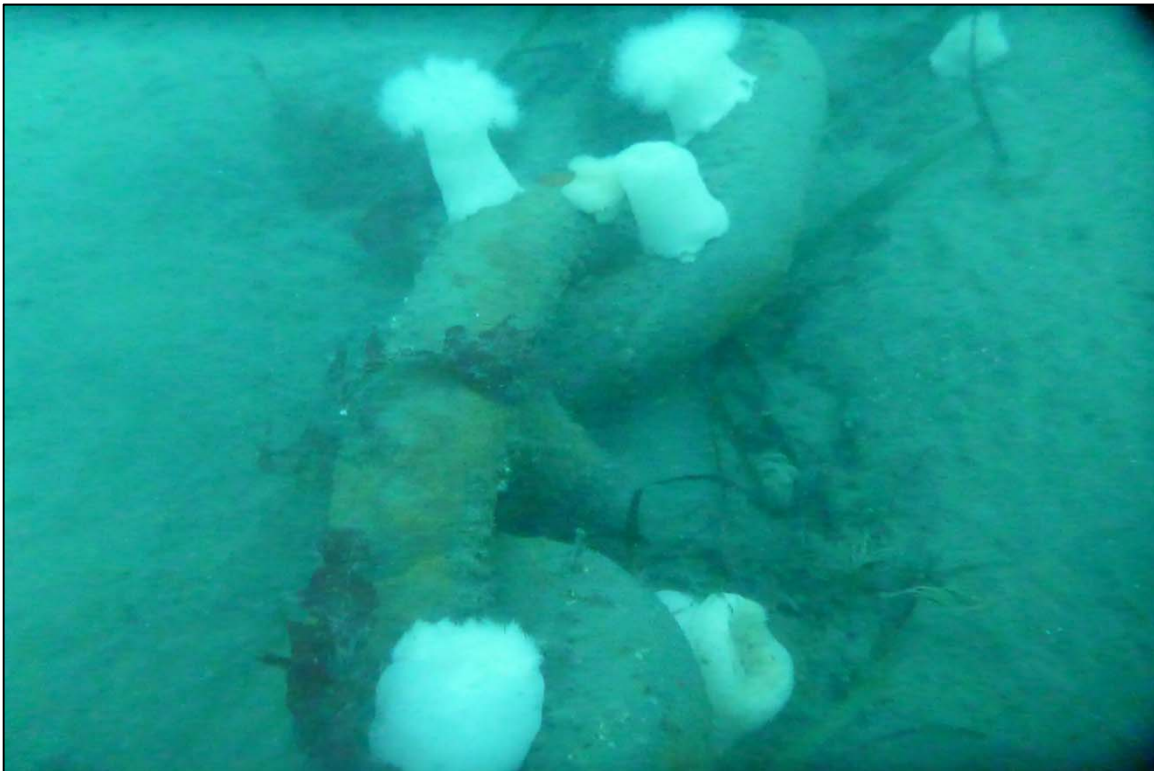
Photograph 29: View of Light Marine Growth on the Rope (Typical) at Site 1 Anchor Line 6, Looking North.

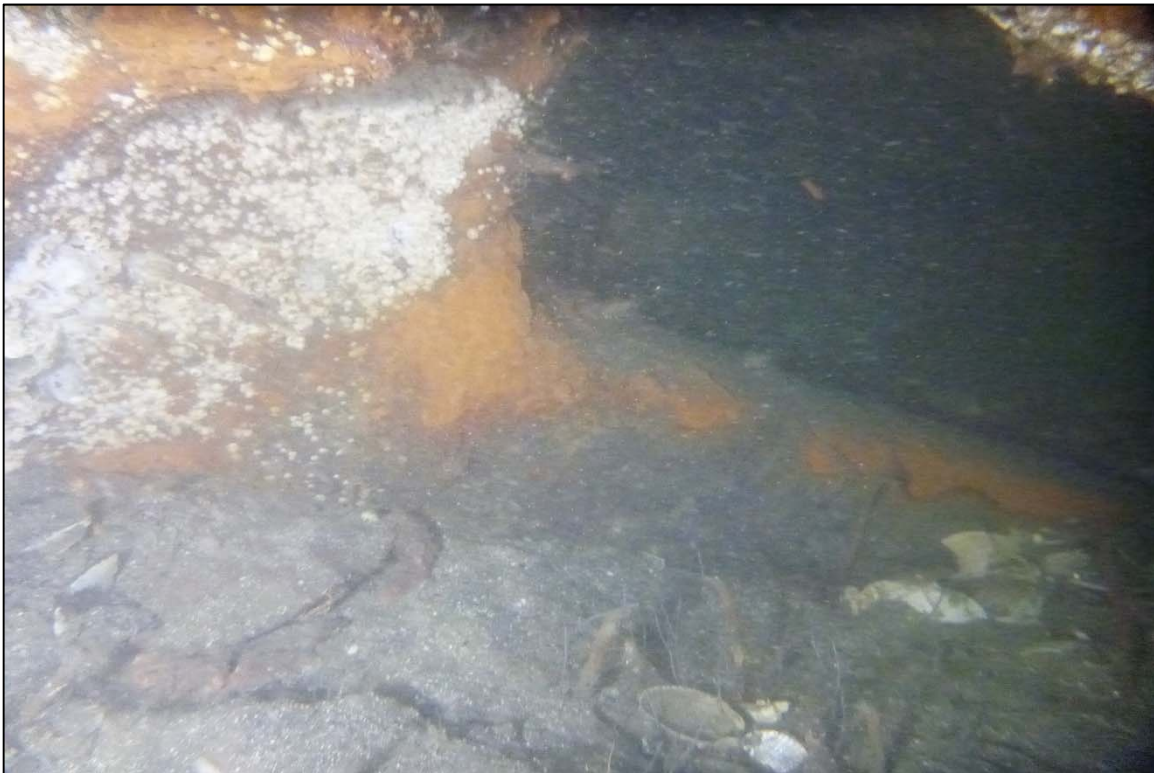
Photograph 33: View of the Lower Anchor Chain Embedment in the Channel Bottom at Site 1 Anchor Chain 7, Looking North.

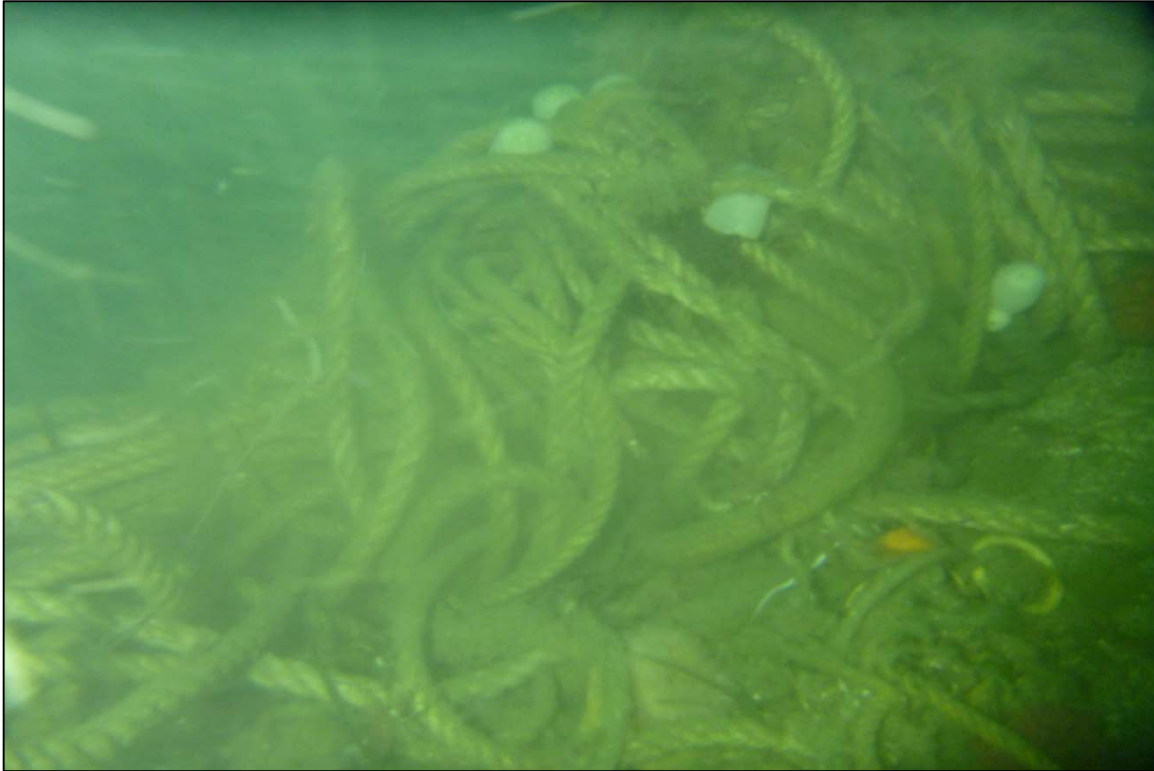
Photograph 36: View of the Rope to Lower Anchor Chain Connection at Site 1 Anchor Line 8, Looking Northwest.

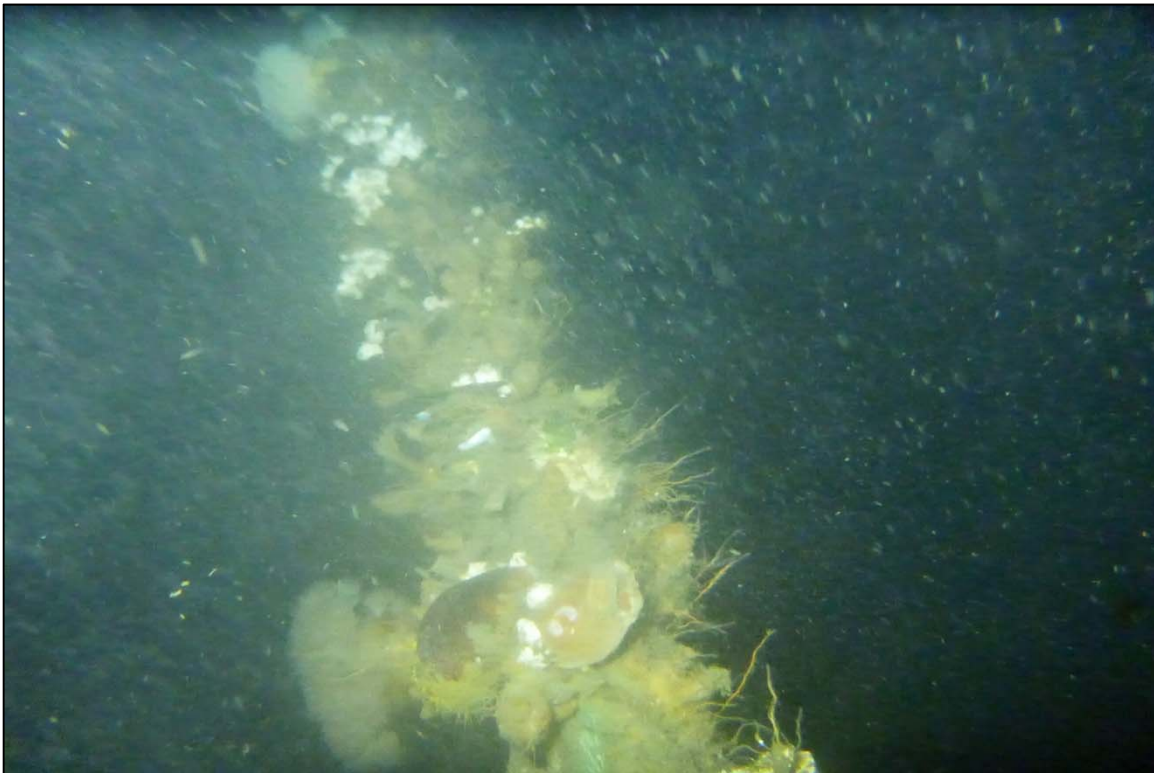
Photograph 41: View of Float to Upper Anchor Chain Connection at Site 1 Anchor Chain 10, Looking Southeast.

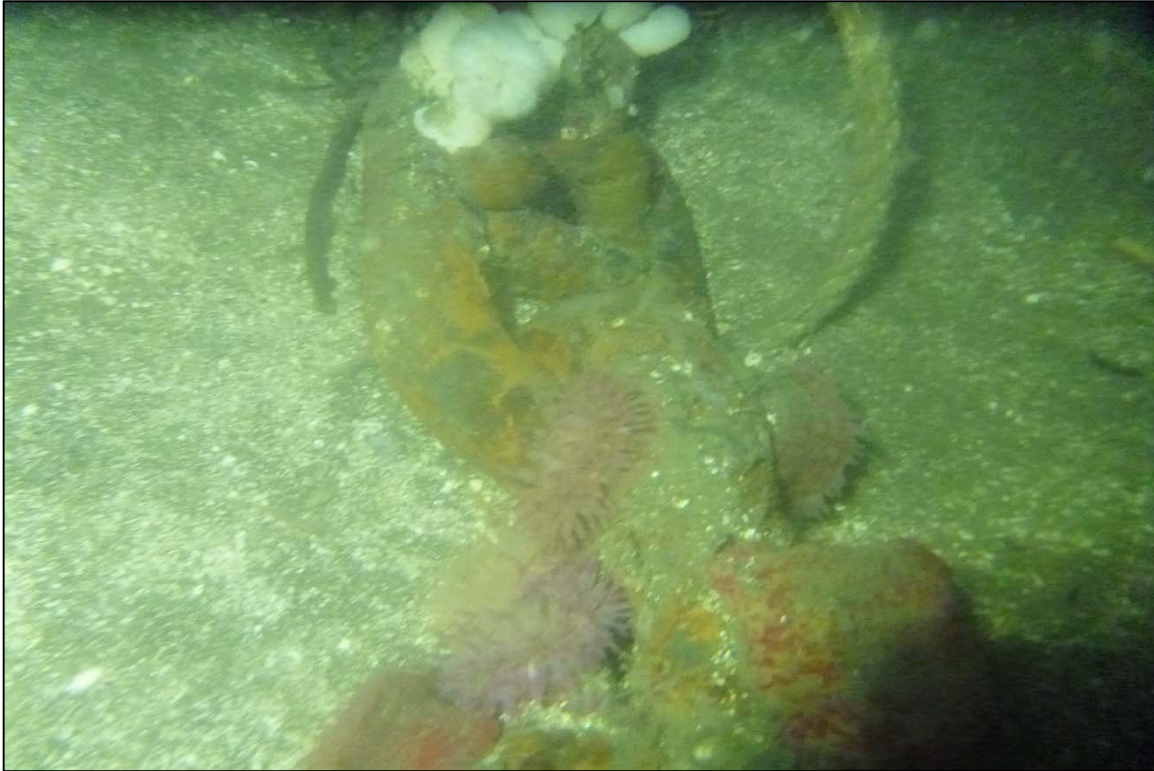
Photograph 42: View of Moderate Marine Growth on the Rope at Site 1 Anchor Line 10, Looking North.

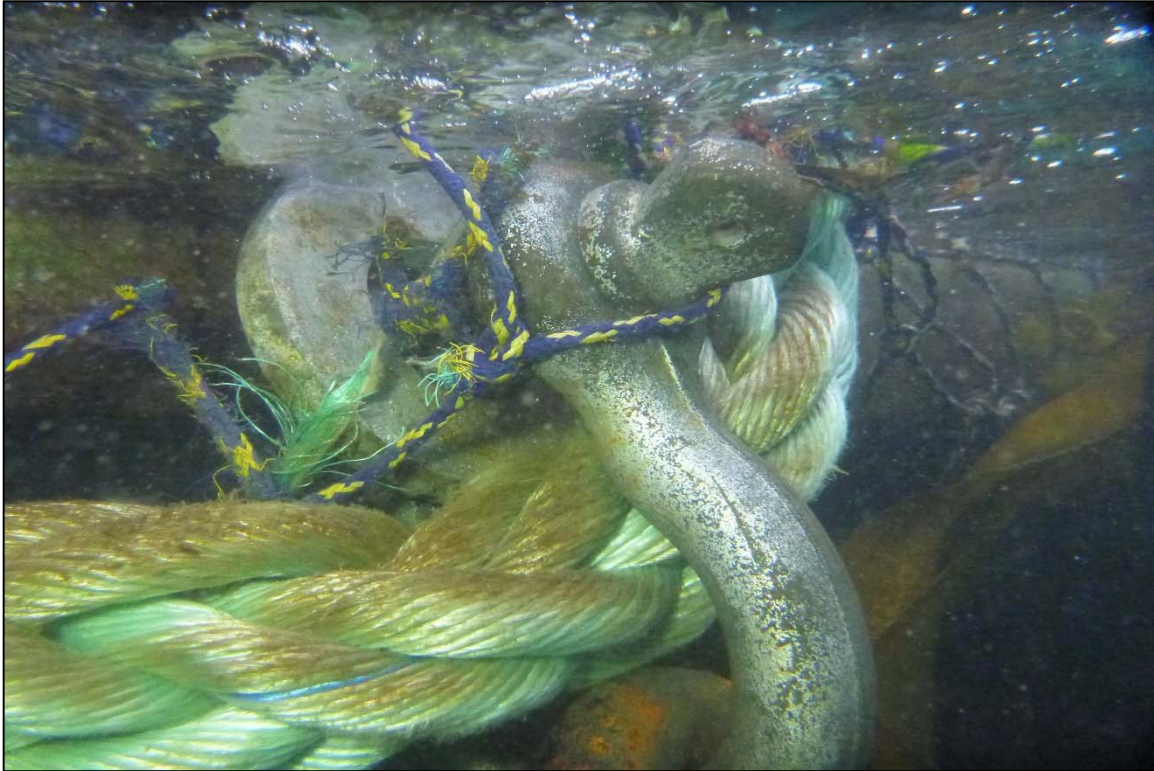
Photograph 48: View of Light Marine Growth on the Rope at Site 1 Anchor Line 12, Looking East.

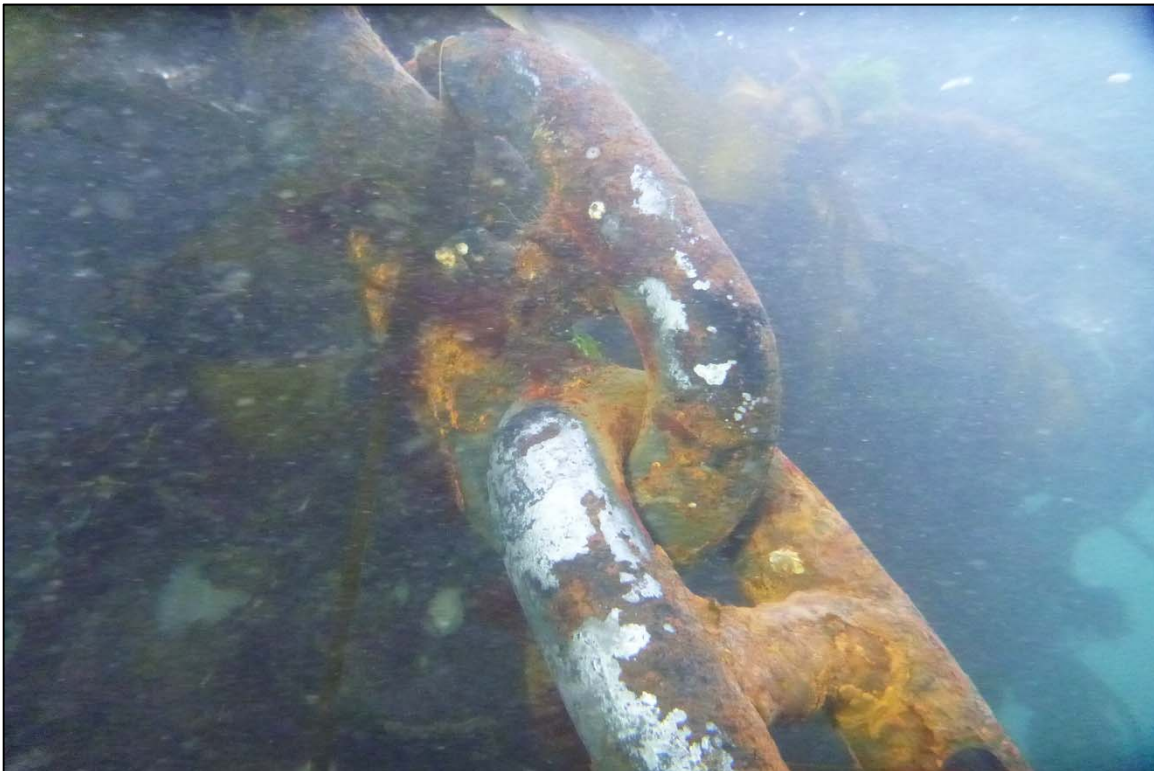
Photograph 49: View of the Float to Upper Anchor Chain Connection at Site 1 Anchor Chain 13, Looking Northwest.

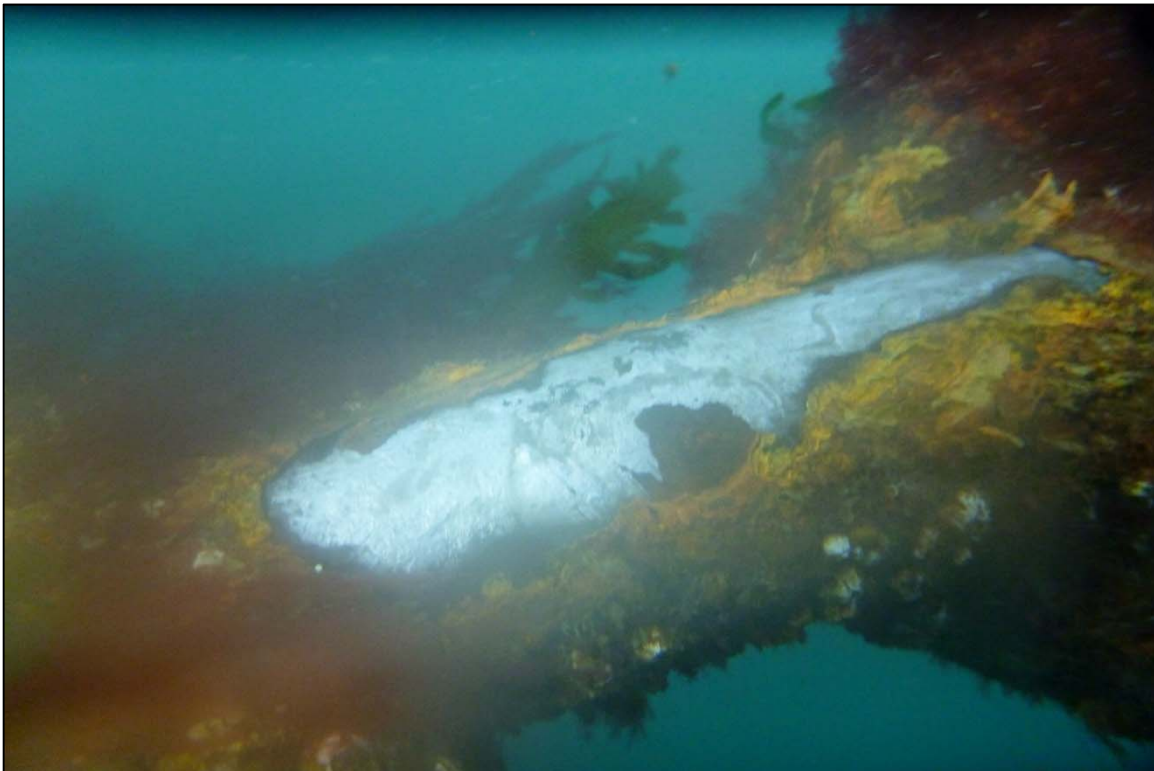
Photograph 53: View of the Upper Anchor Chain to Rope Connection (Shackle and Thimble) at Site 1 Anchor Line 14, Looking South.

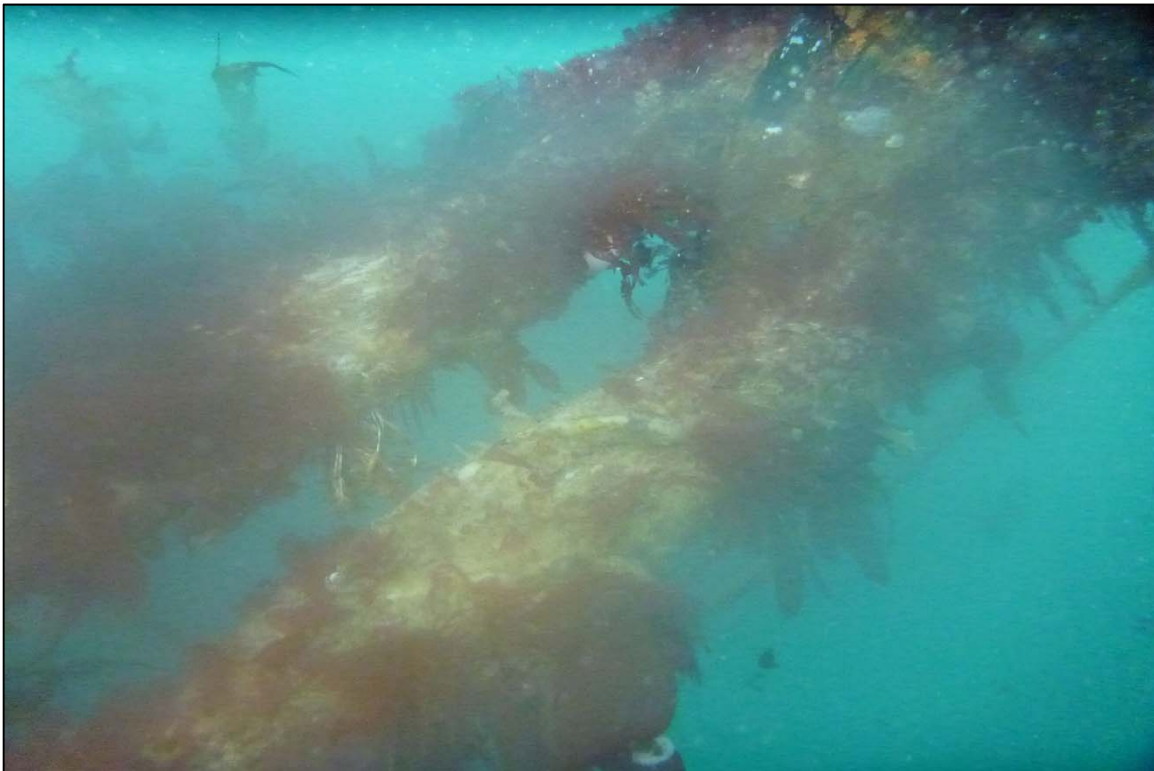
Photograph 55: View of the Upper Anchor Chain at Site 1 Anchor Line 16, Looking Southwest.

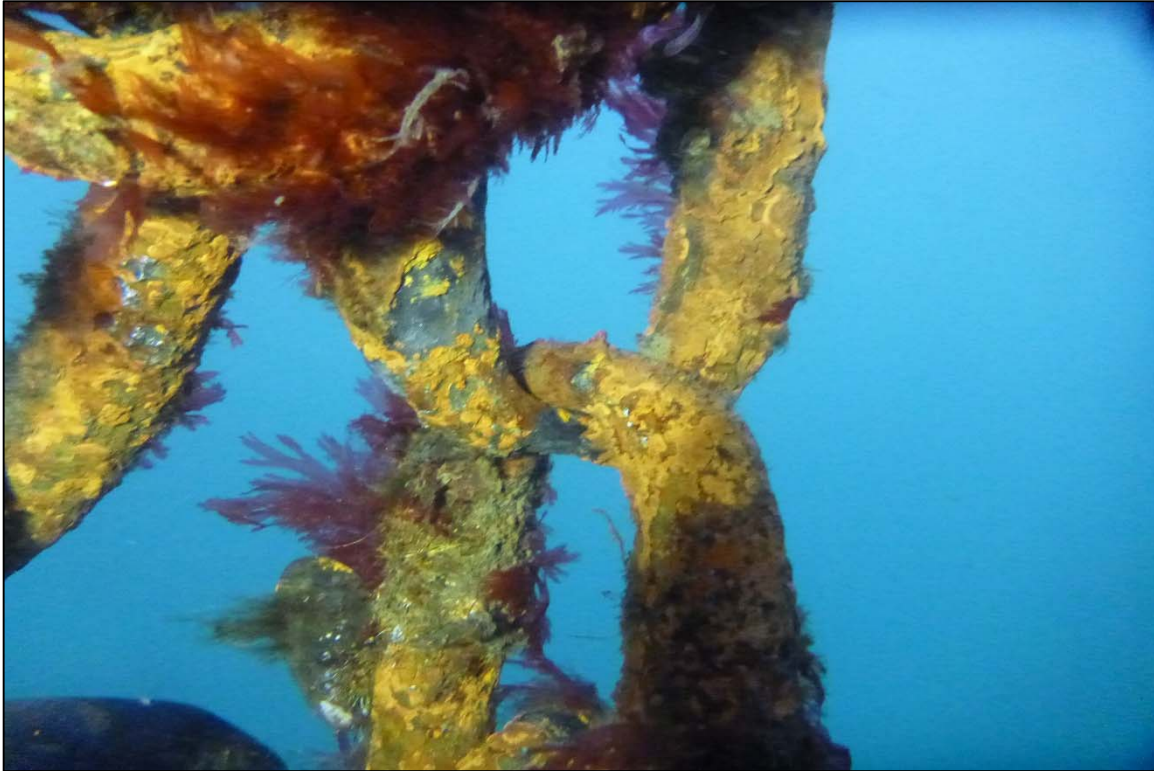
Photograph 56: View of Light Marine Growth on the Rope at Site 1 Anchor Chain 16, Looking South.

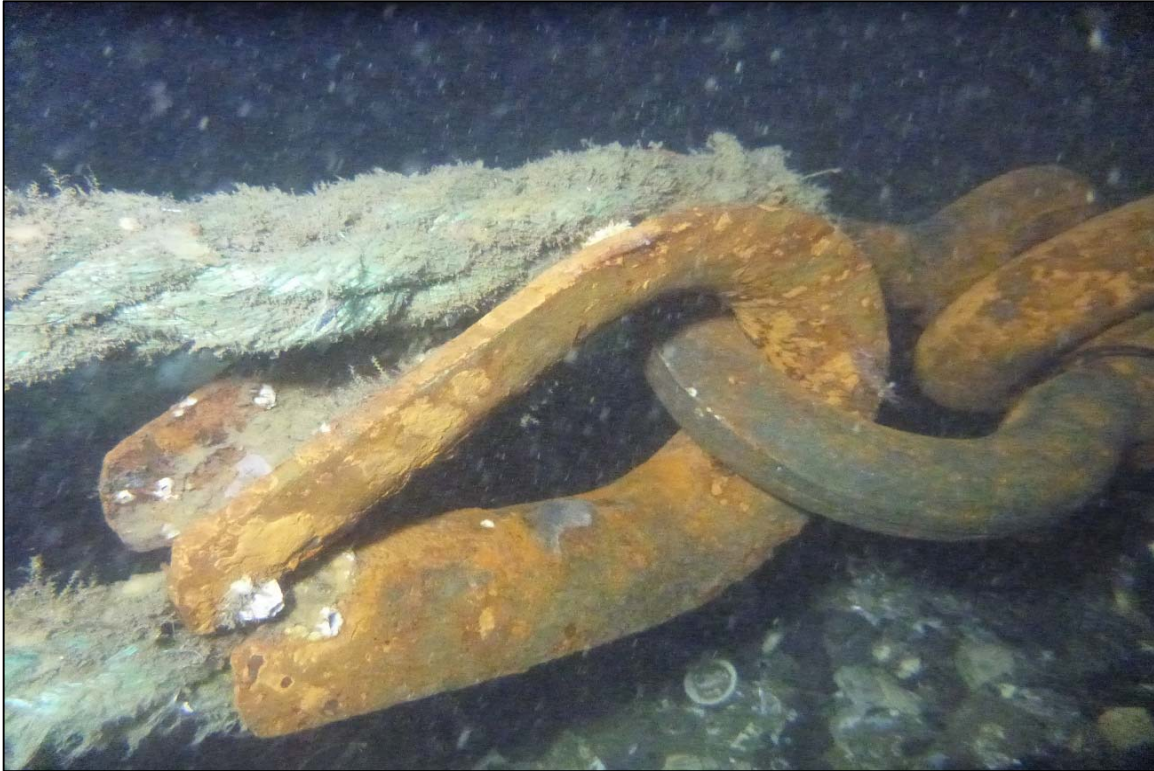
Photograph 58: View of Bowline Knot in the Rope at the Connection to the Lower Anchor Chain at Site 1 Anchor Chain 17, Looking Northeast.

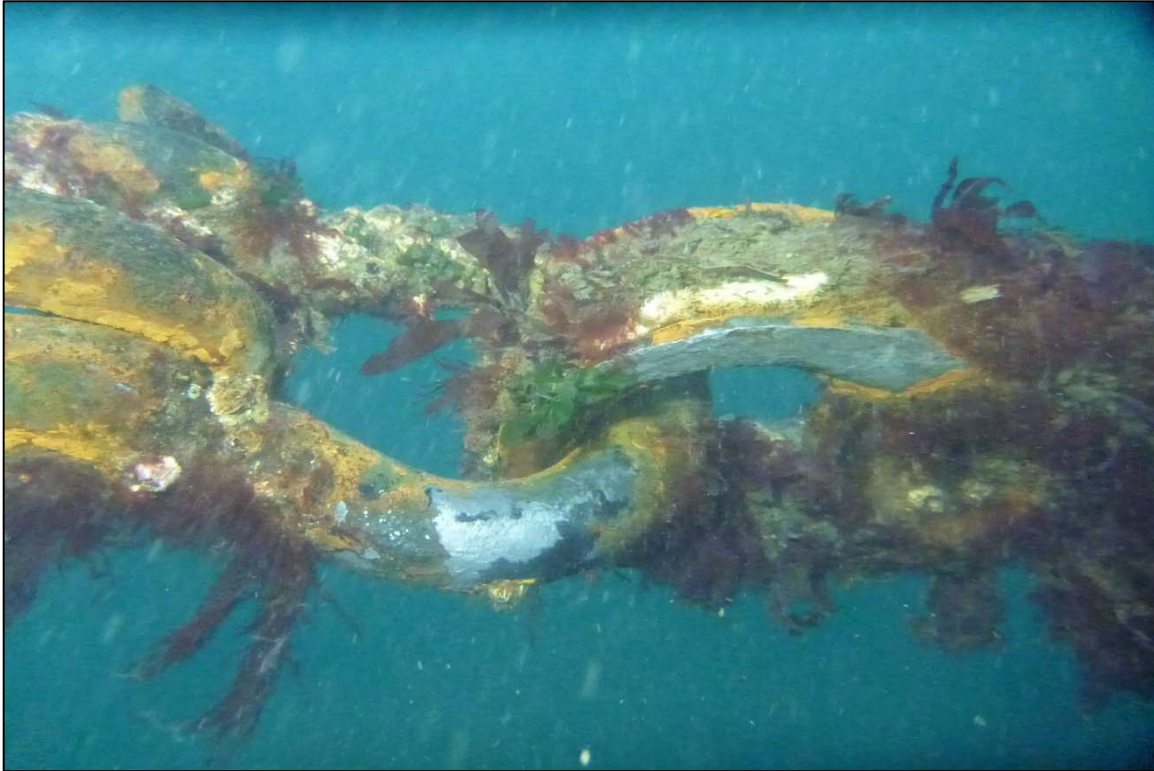
Photograph 60: View of the Upper Anchor Chain to Float Connection (Shackle) at Site 1 Anchor Line 18, Looking Northeast.

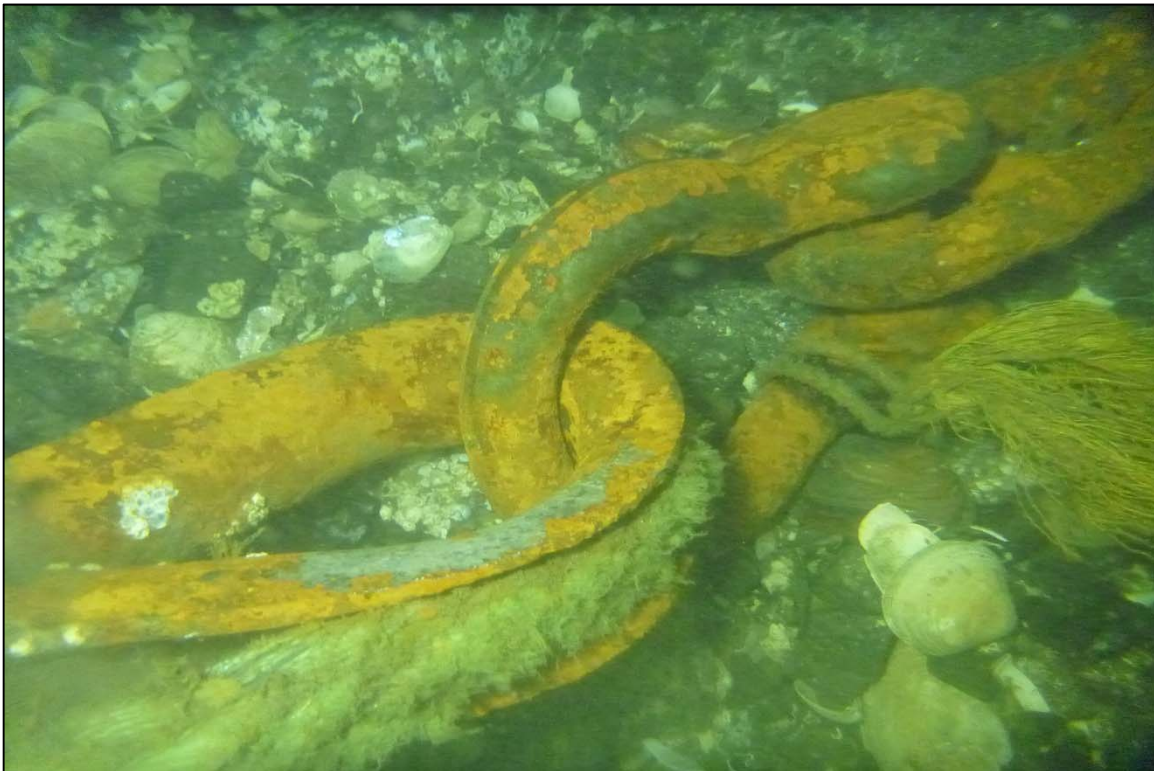
Photograph 61: View of the Upper Anchor Chain to Rope Connection (Shackle and Thimble) at Site 1 Anchor Chain 18, Looking North.
