# **Cypress Island Site 1 Atlantic Salmon Net Pens Engineering Assessment**

January 29, 2018

**Document reference:** 391980 | 6 | b

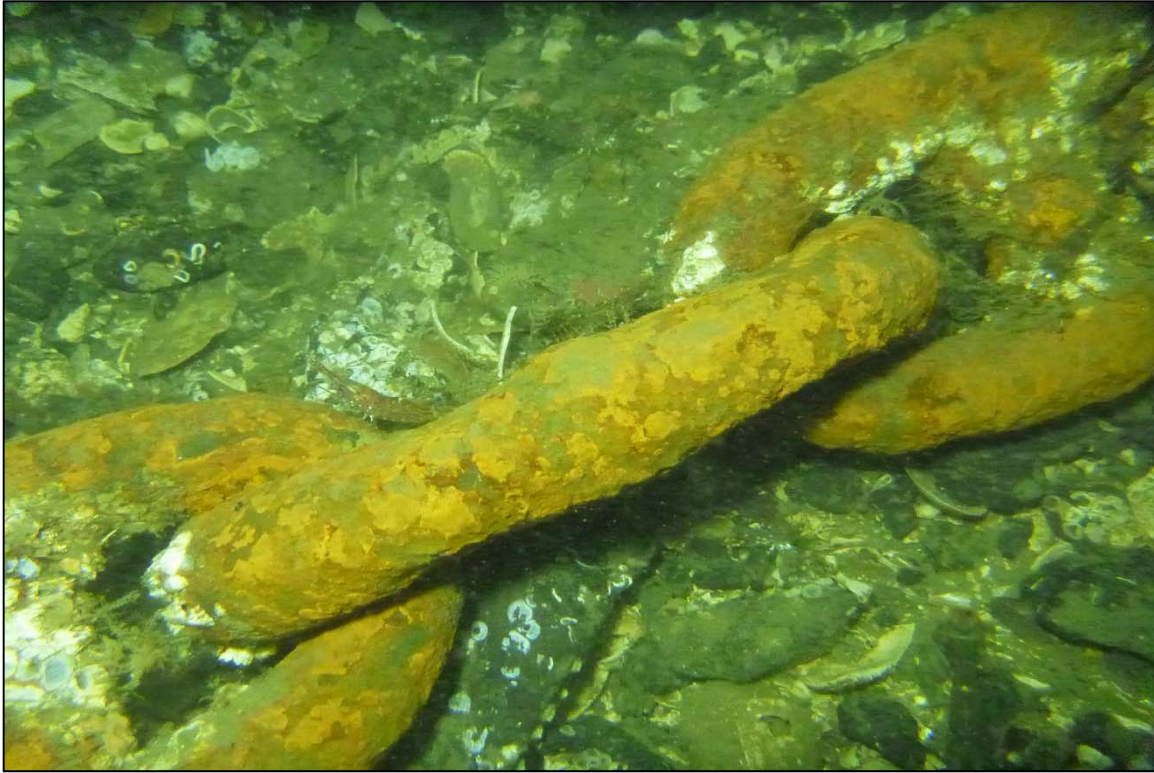
Photograph 62: View of the Rope to Lower Anchor Chain Connection (Thimble and Shackle) at Site 1 Anchor Line 18, Looking Northeast.

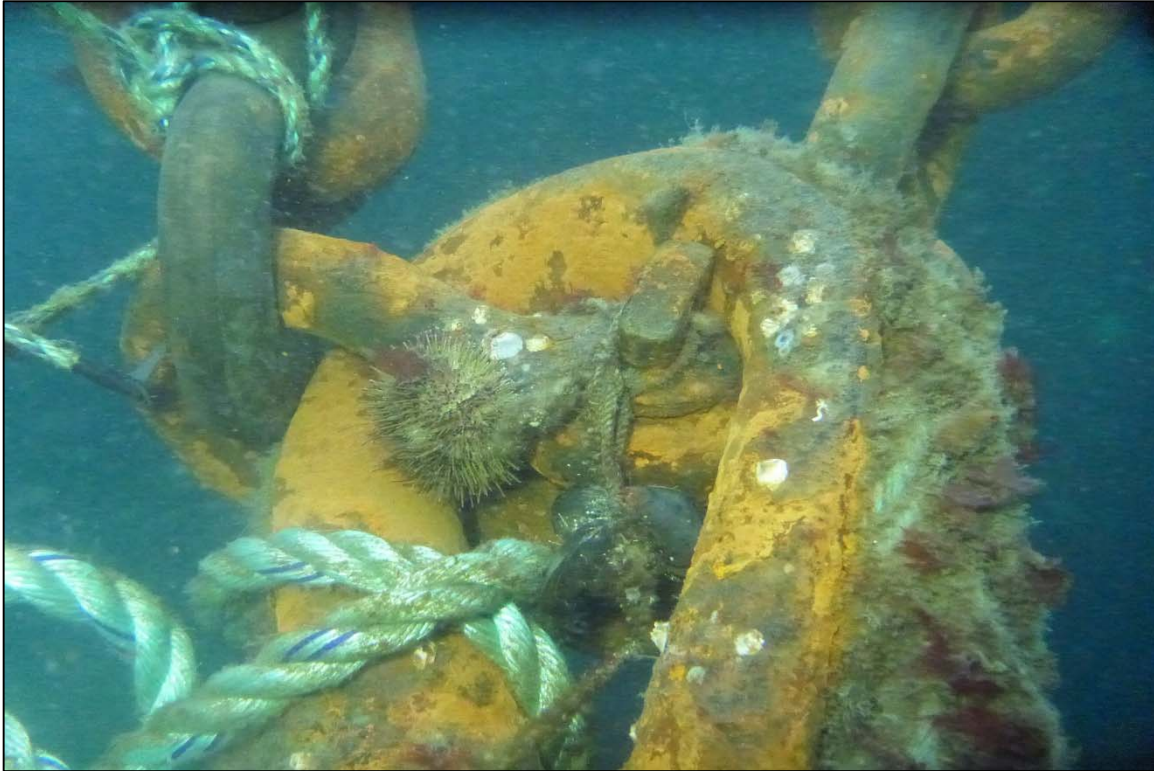
Photograph 64: View of the Pipe Anchor and Lower Anchor Chain at Site 1 Anchor Chain 18, Looking Southwest.

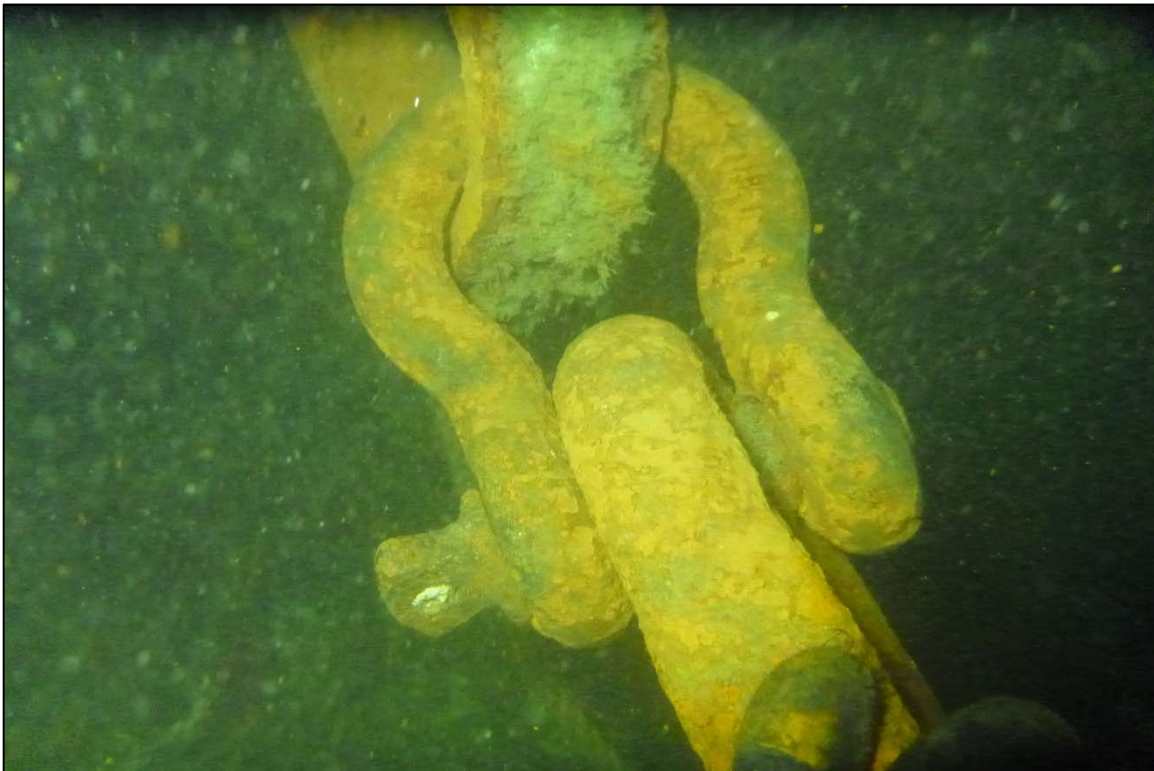
Photograph 65: View of the Upper Anchor Chain to Rope Connection (Thimble and Shackle) at Site 1 Anchor Line 19, Looking North.

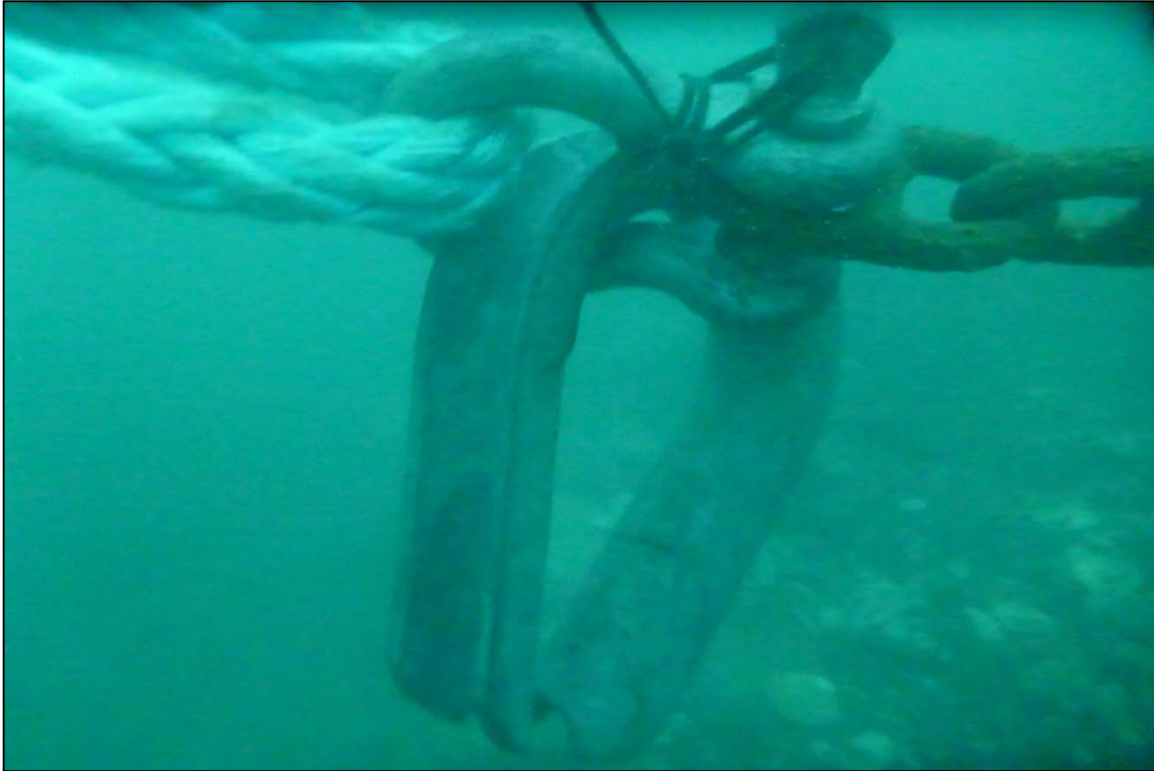
Photograph 68: View of the Upper Anchor Chain to Rope Connection (Thimble and Shackle) with a Bowline Knot at Site 1 Anchor Chain 20, Looking Northwest.

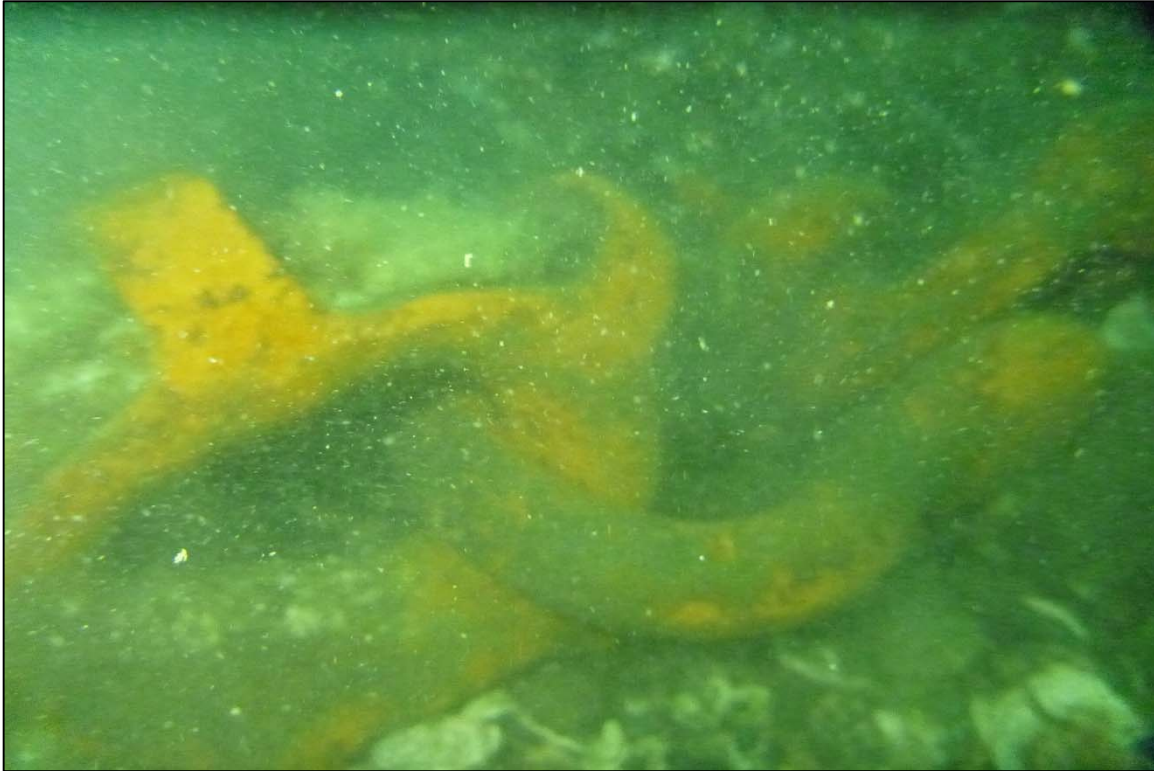
Photograph 72: View of the Upper Anchor Chain to Rope Connection (Shackle) with a Bowline Knot at Site 1 Anchor Chain 21, Looking Northwest.

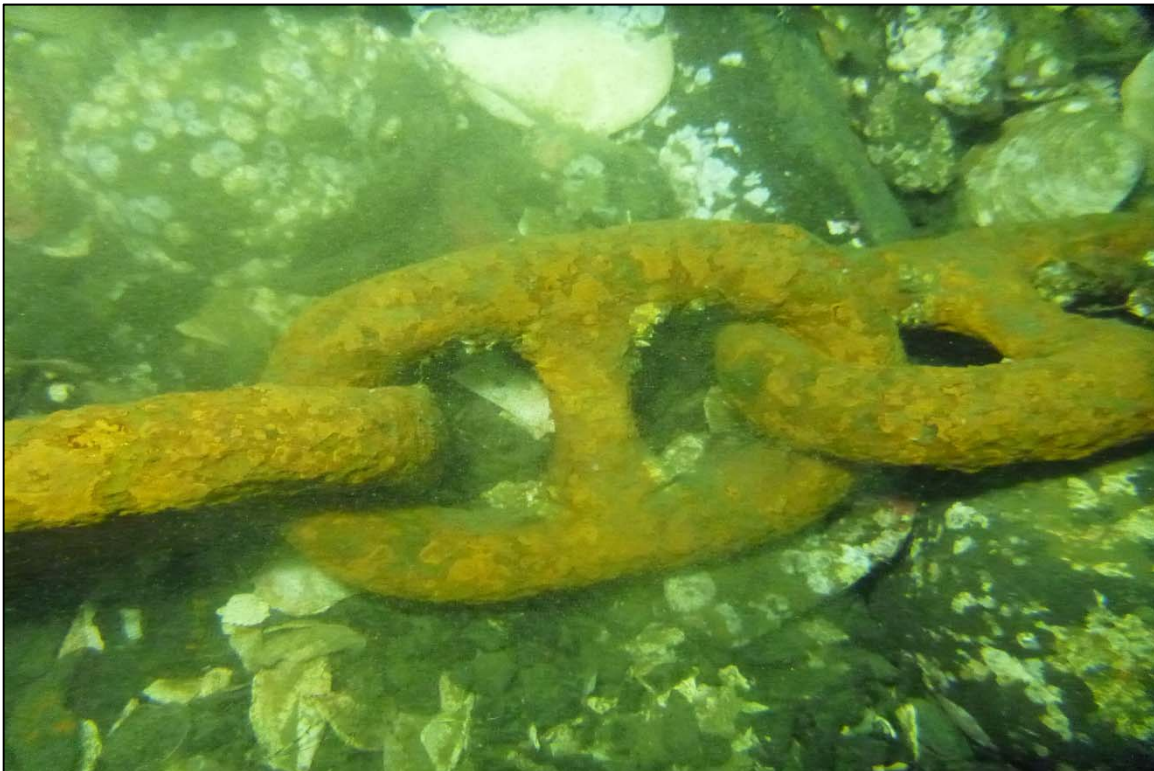
Photograph 73: View of the Rope to Lower Anchor Chain Connection (Thimble and Shackle) at Site 1 Anchor Line 21, Looking East.

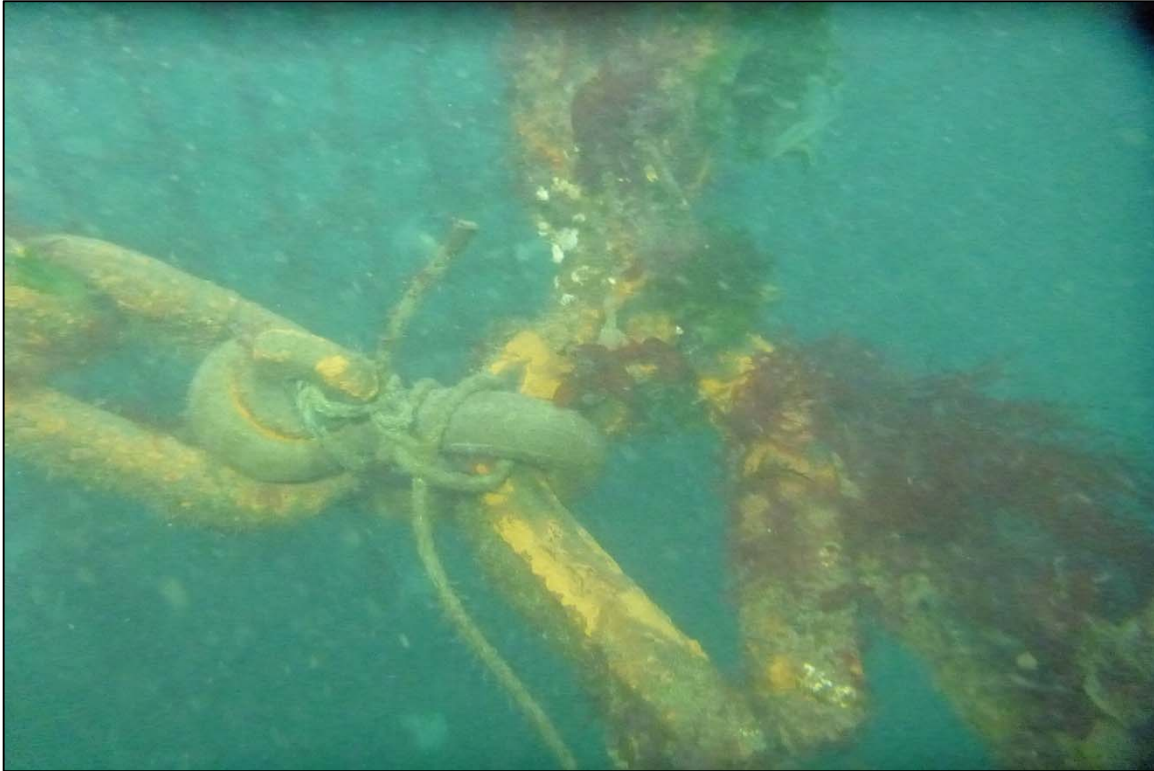
Anchor Lines 18, 20 and 21, the various lengths of chain and related shackles inspected along the anchor lines exhibited only minor deterioration, with just minor to moderate corrosion being present that had no appreciable loss of original section associated with it. With respect to the ropes running between the upper and lower anchor chains, they were always found to be in a satisfactory, full original section condition, with no evidence of notable fraying or abrasion related damage, with the exception of minor strand damage at Anchor Line 7. The thimbles and related rope knots or splices, which were used to connect the ropes to the upper and lower chain shackles, were also typically found to be sound and secure with no evidence of any conditions that would compromise the connections. Presently, all of the anchor line anchors, whether it be the Danforth or Navy type anchor or the driven pipe type, and including the four anchors that were minimally embedded in the seabed, were observed to be stable and affording what appeared to be sufficient anchorage for the net pens system. As for the barges/floats supporting the operations and feed house building, they were overall in good to satisfactory condition, with negligible deficiencies and affording what appeared to be the necessary floatation for the building structures. Currently, the only items of possible concern noted were the instances of heavier section loss due to deterioration and wear on the smaller chains connecting the steel buoys to the upper anchor chains of Anchor Lines 9 and 17. In particular, if these conditions were to progress, they could result in the failure of the buoy chain, which in turn could allow for change in anchor line configuration and greater loading on the net pens system.

Photograph 74: View of Section Loss in the Lower Anchor Chain at Site 1 Anchor Chain 21, Looking East.

In conclusion, the underwater inspection of the Site 1 Cypress Island Fish Net Pens System did not reveal any structurally significant deterioration or other notable deficiencies that would suggest any appreciable reduction in the inherent integrity or stability of the overall system. In that regard, the components inspected below water were typically found to be in sound condition with no indication that an appreciable reduction in the originally intended capacity of a component or connection could be expected. It should again be noted, however, that while the aforementioned deficient buoy attachments do not affect the capacity of the anchor lines per se, if they were to fail, that could disrupt the equilibrium of the overall net pens system, and therefore, consideration should be given to renewing the heavily deteriorated items.

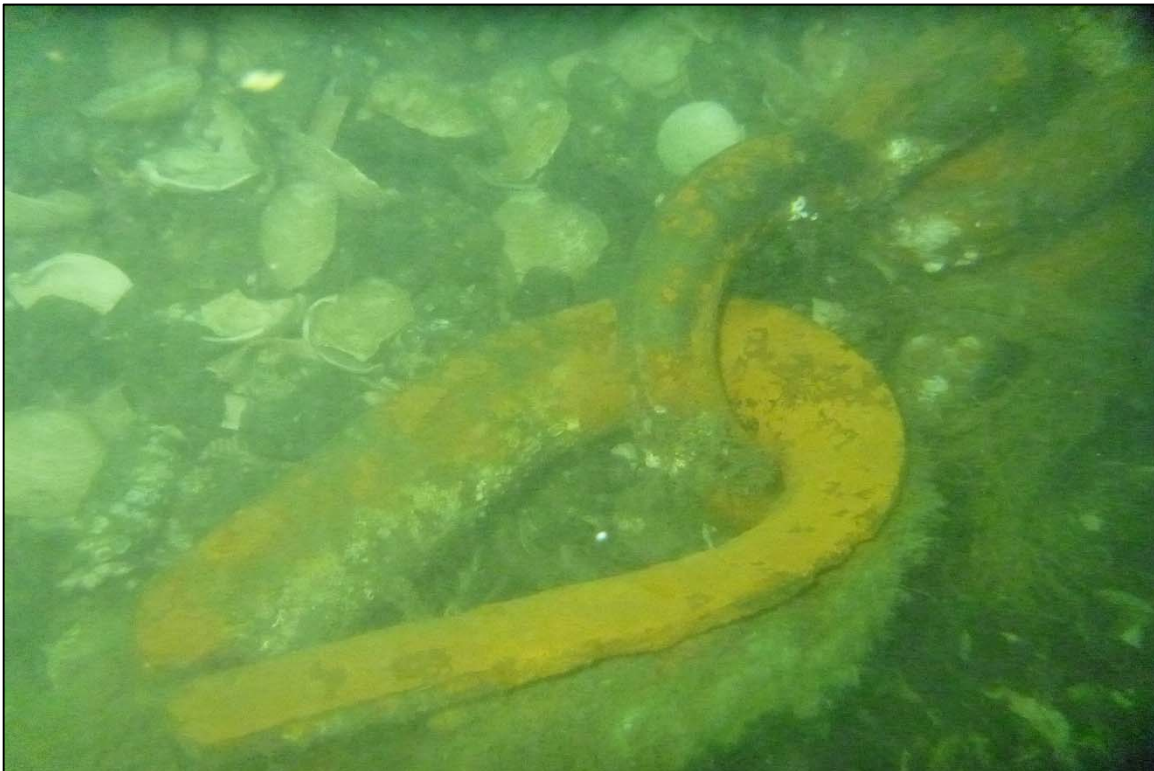
Photograph 75: View of the Upper Anchor Chain to Rope Connection (Thimble and Shackles) at Site 1 Anchor Chain 22, Looking North.

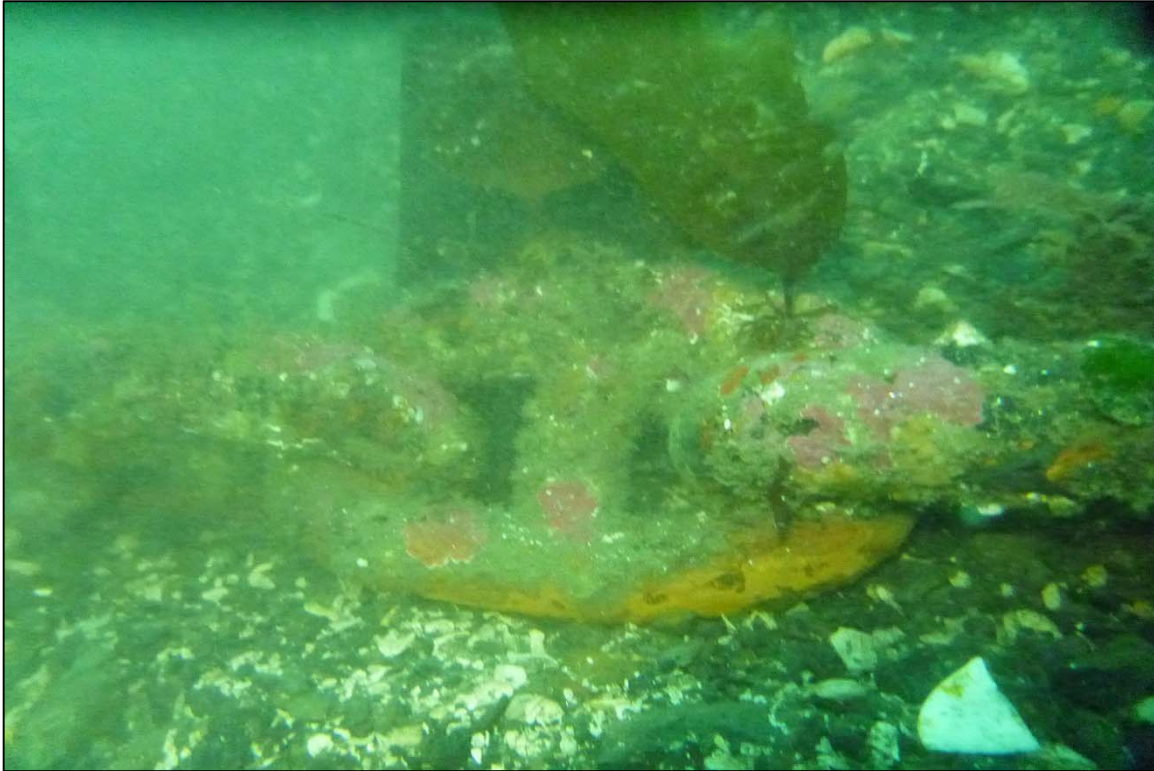
Photograph 76: View of the Rope to Lower Anchor Chain Connection (Thimble and Shackle) at Site 1 Anchor Line 22, Looking East.

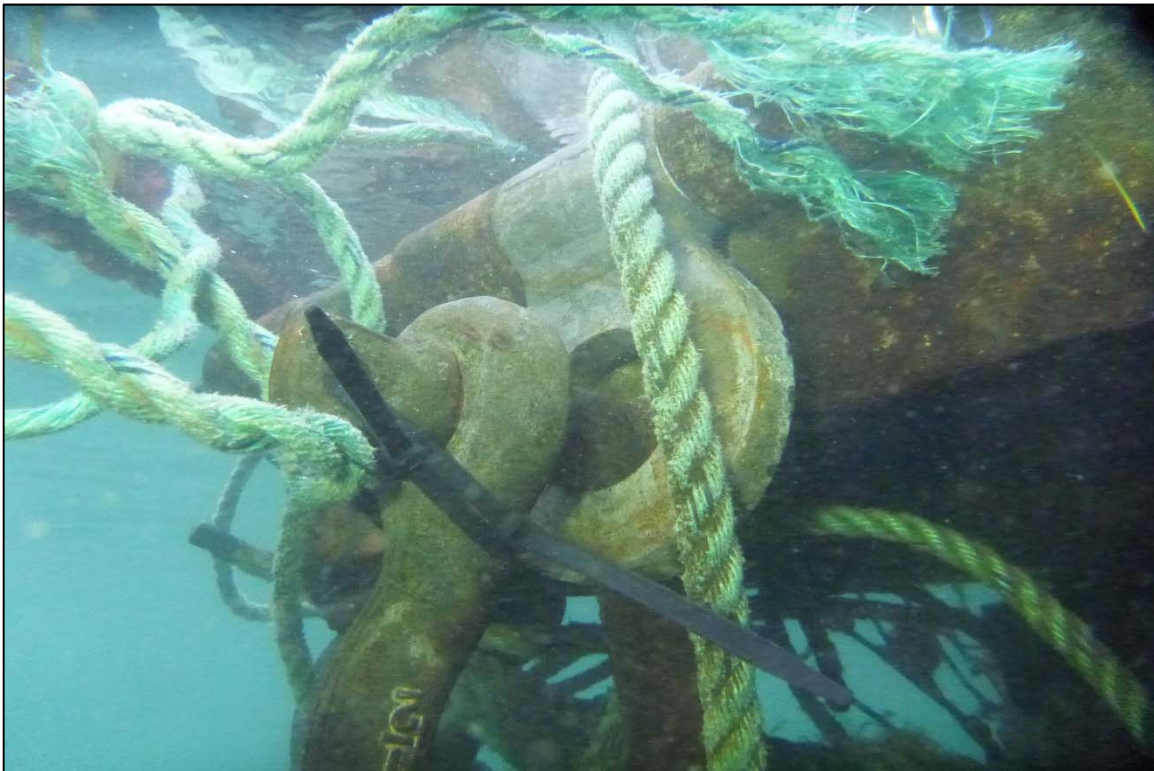
Photograph 77: View of the Lower Anchor Chain on the Channel Bottom at Site 1 Anchor Line 22, Looking East.

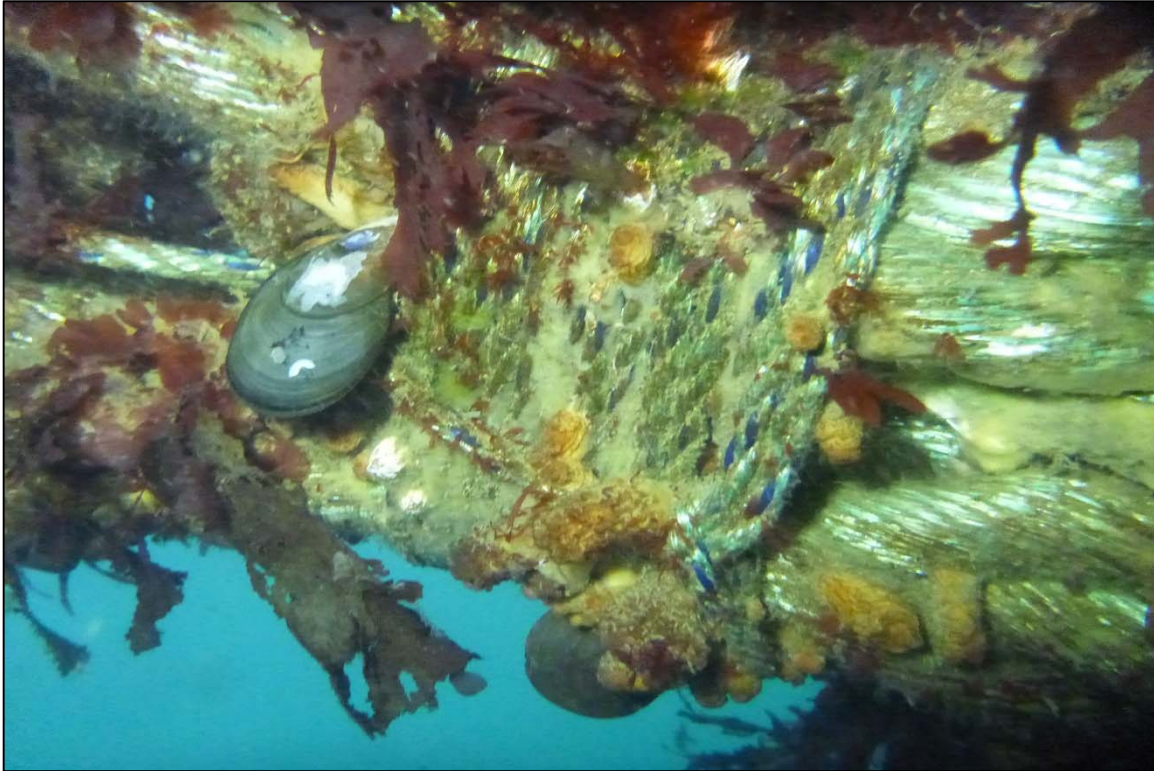
Photograph 78: View of the Float to Upper Anchor Chain Connection at Site 1 Anchor Line 23, Looking Southeast.

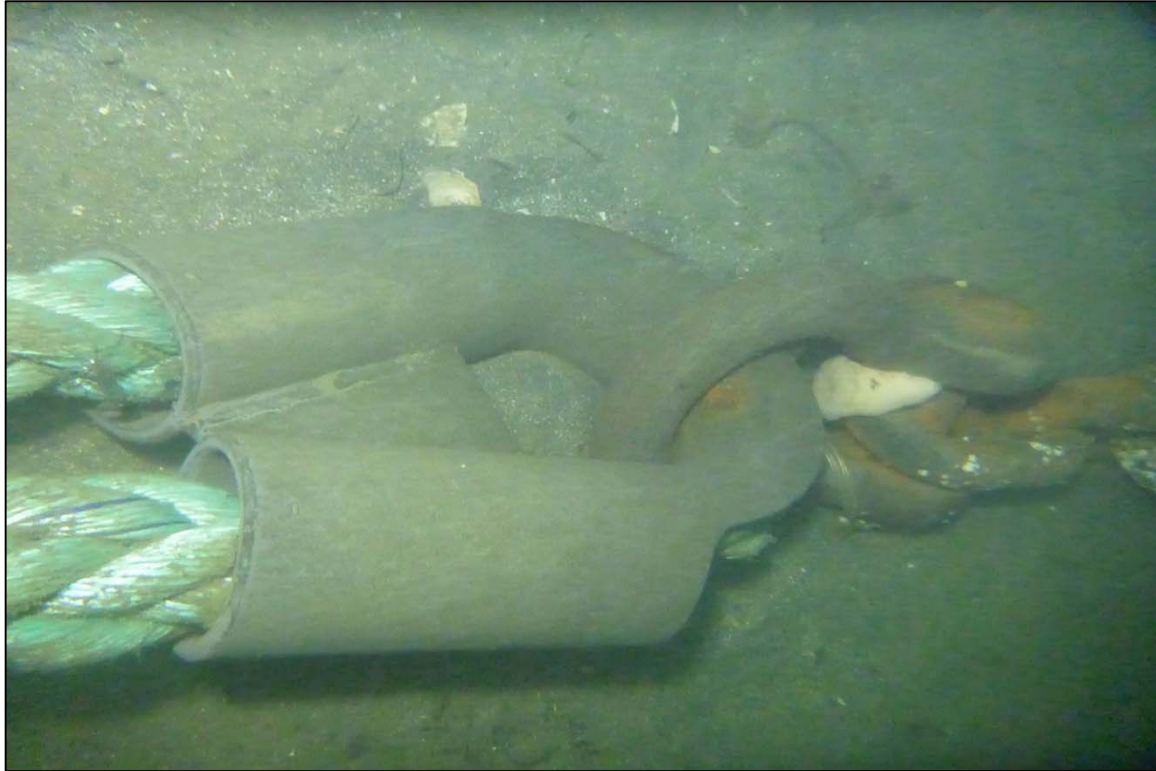
Photograph 80: View of the Upper Anchor Chain to Rope Connection (Shackle) at Site 1 Anchor Line 24, Looking West.

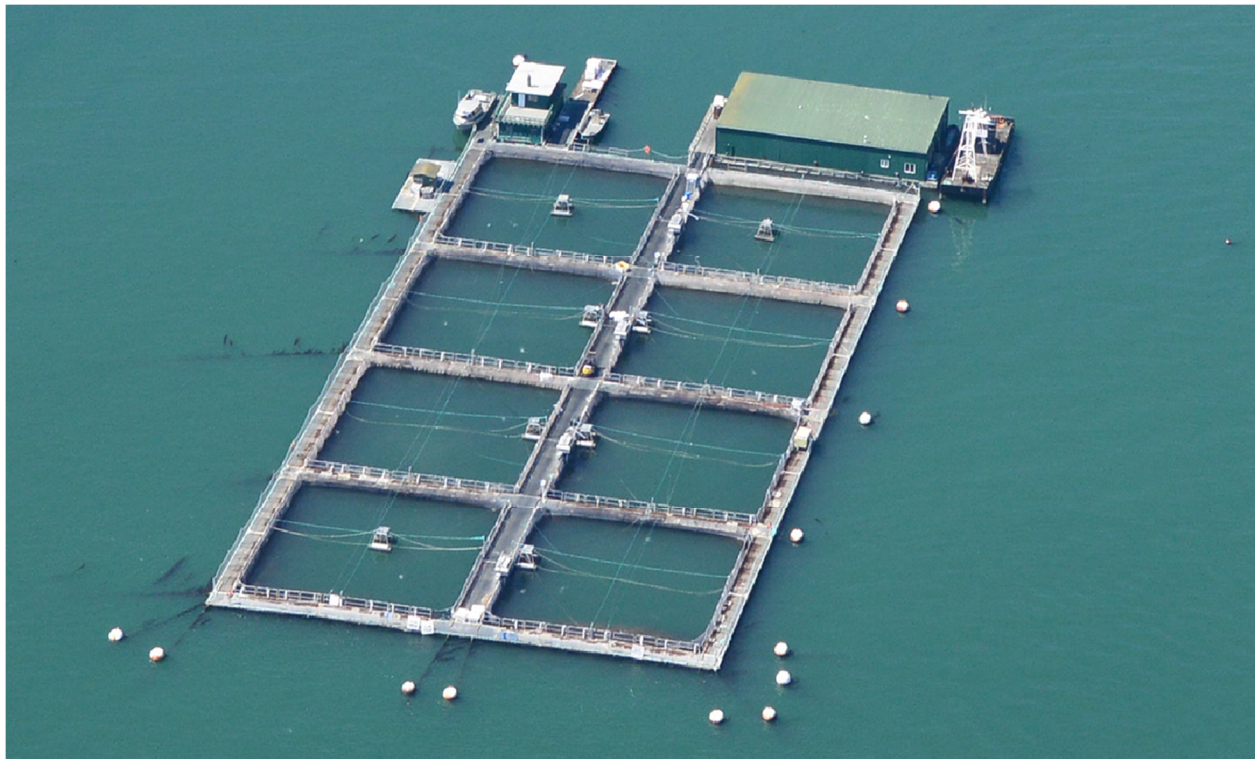
Figure C-1: Cypress Island Net Pen Site 1 – Oblique Aerial from NorthEast

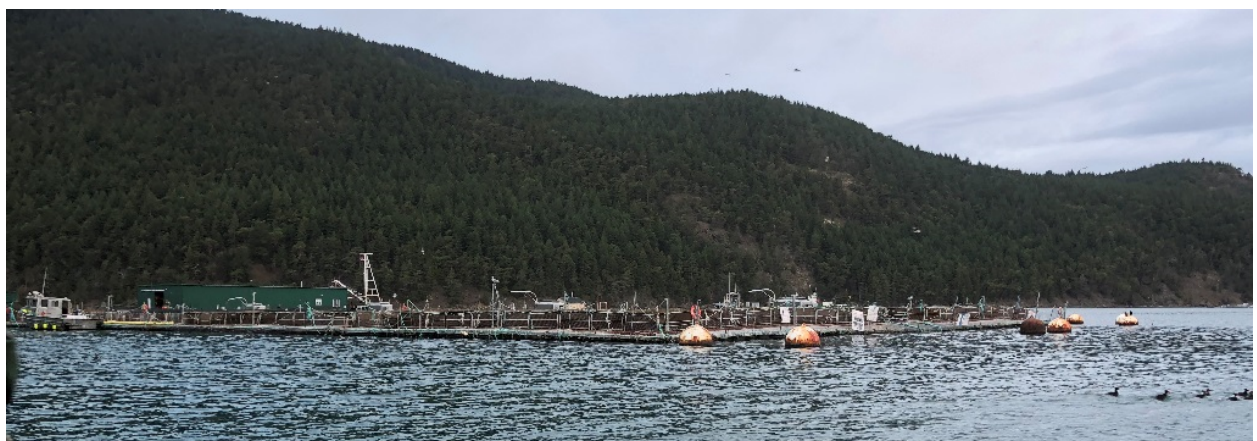
Figure C-2: Cypress Island Net Pen Site 1 – Overview from southeast

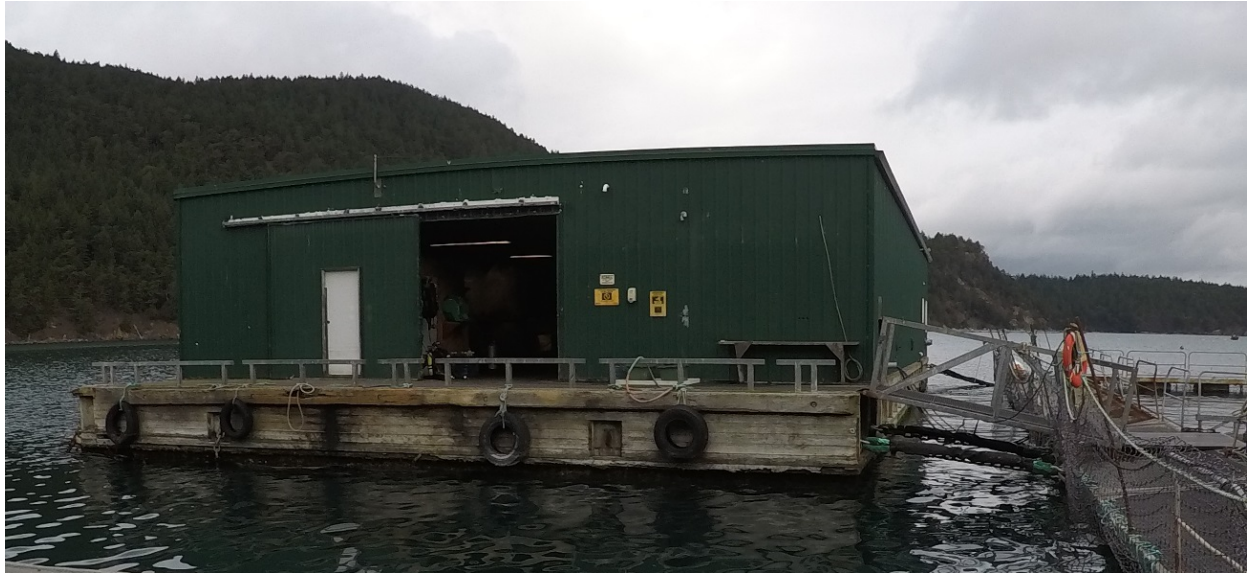
Figure C-3: Cypress Island Net Pen Site 1 – Storage Shed on Concrete Float

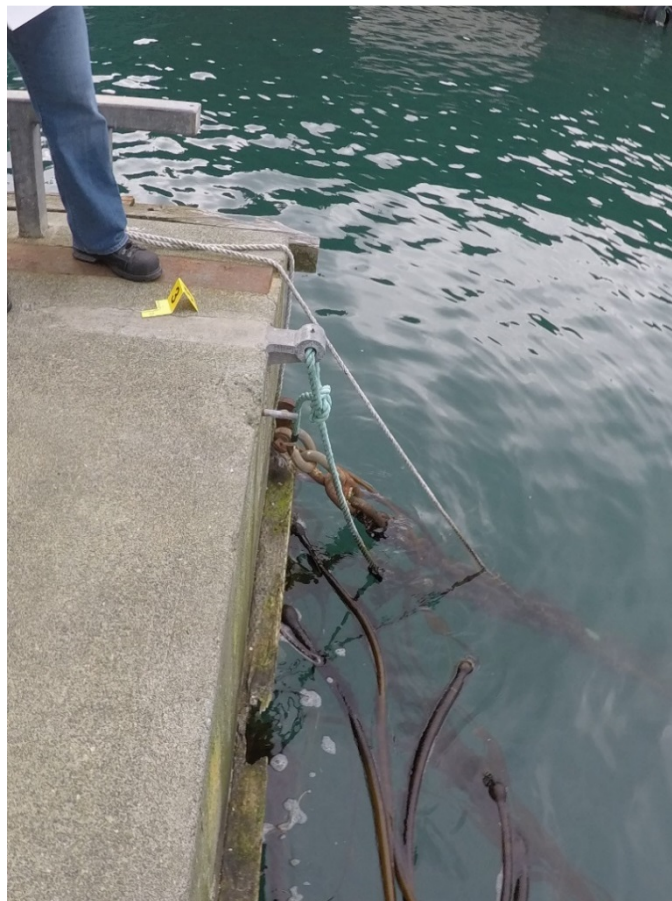
Figure C-6: Cypress Island Net Pen Site 1 – Anchor Line 3  
at Concrete Barge

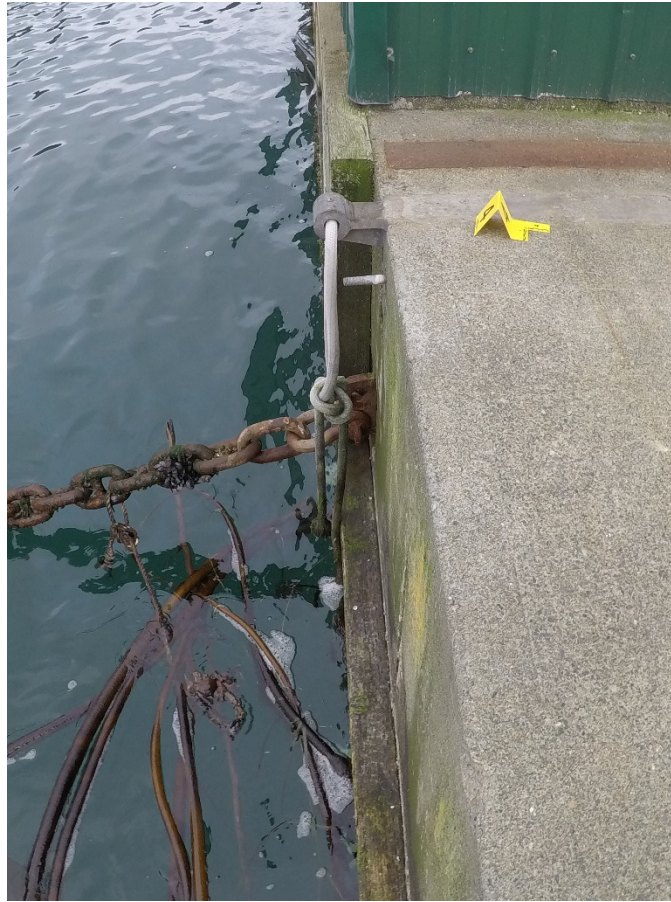
Figure C-7: Cypress Island Net Pen Site 1 – Anchor Line 4 at Concrete Barge

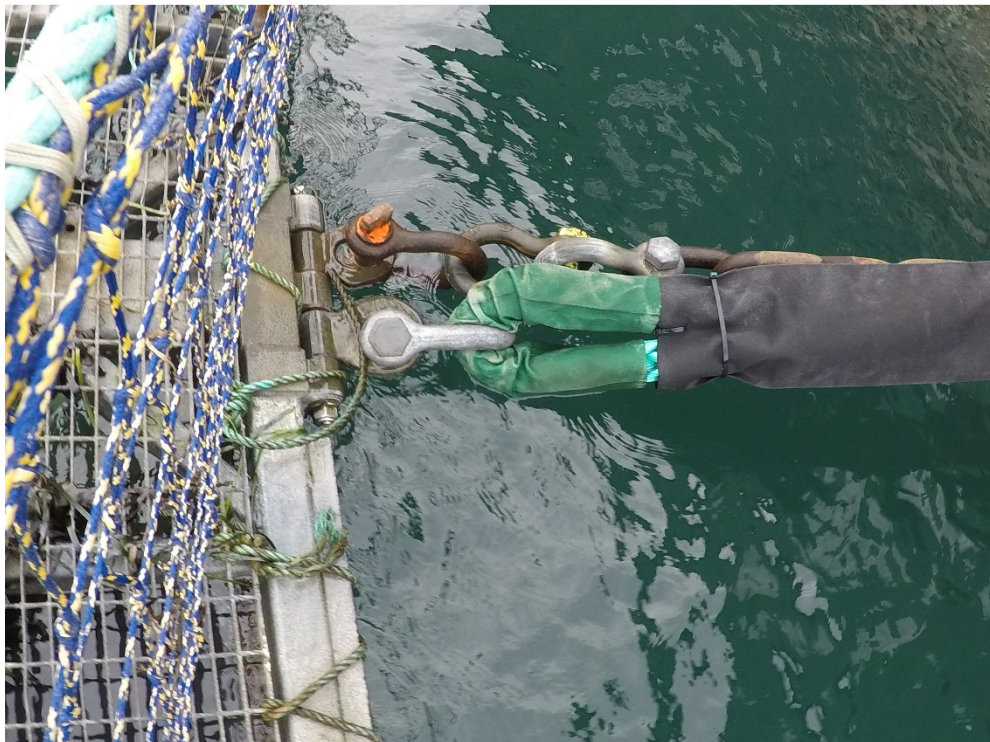
Figure C-8: Cypress Island Net Pen Site 1 – Connection between Concrete Barge and Net Pen

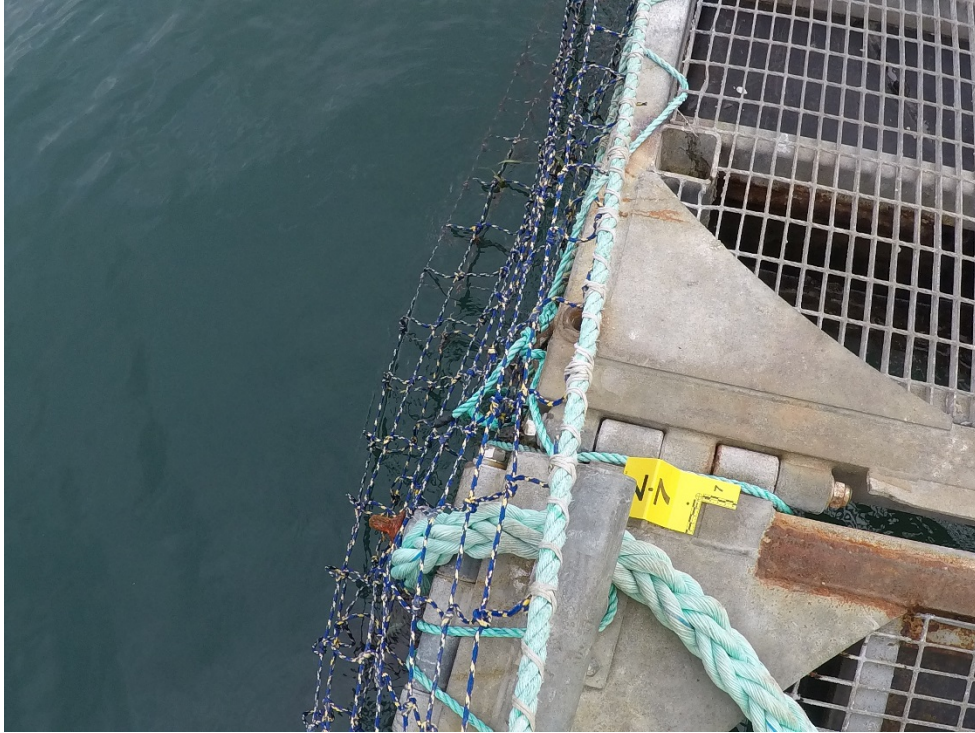
Figure C-9: Cypress Island Net Pen Site 1 – Connection at Anchor Line 7 and typical float-to-float hinge connection

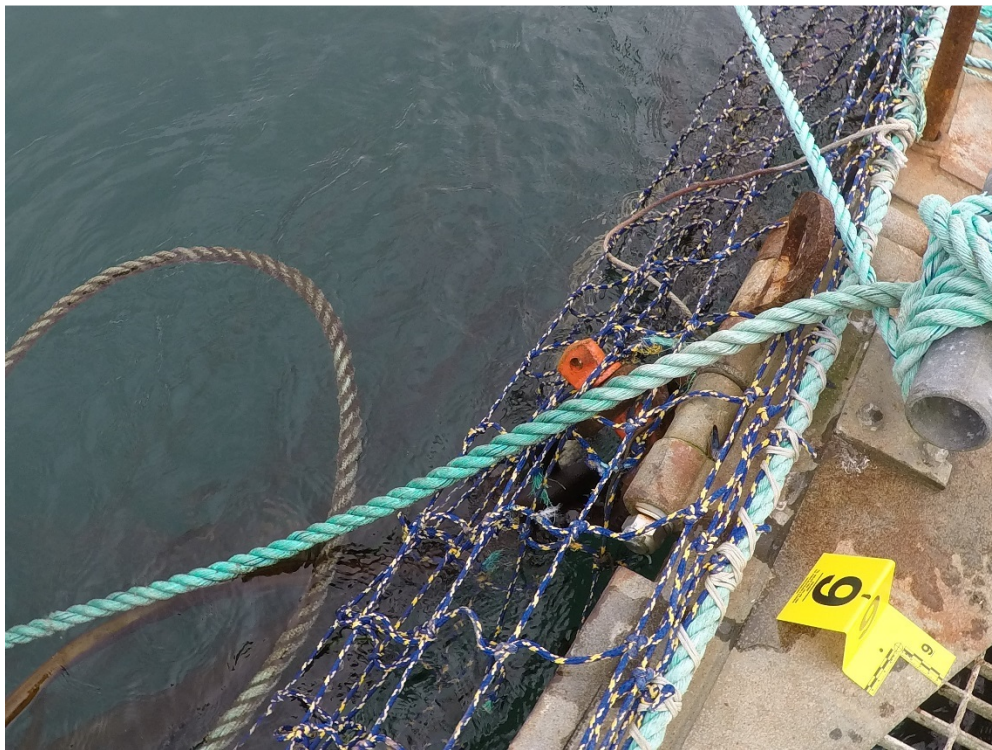
Figure C-10: Cypress Island Net Pen Site 1 – Connection at Anchor Line 9

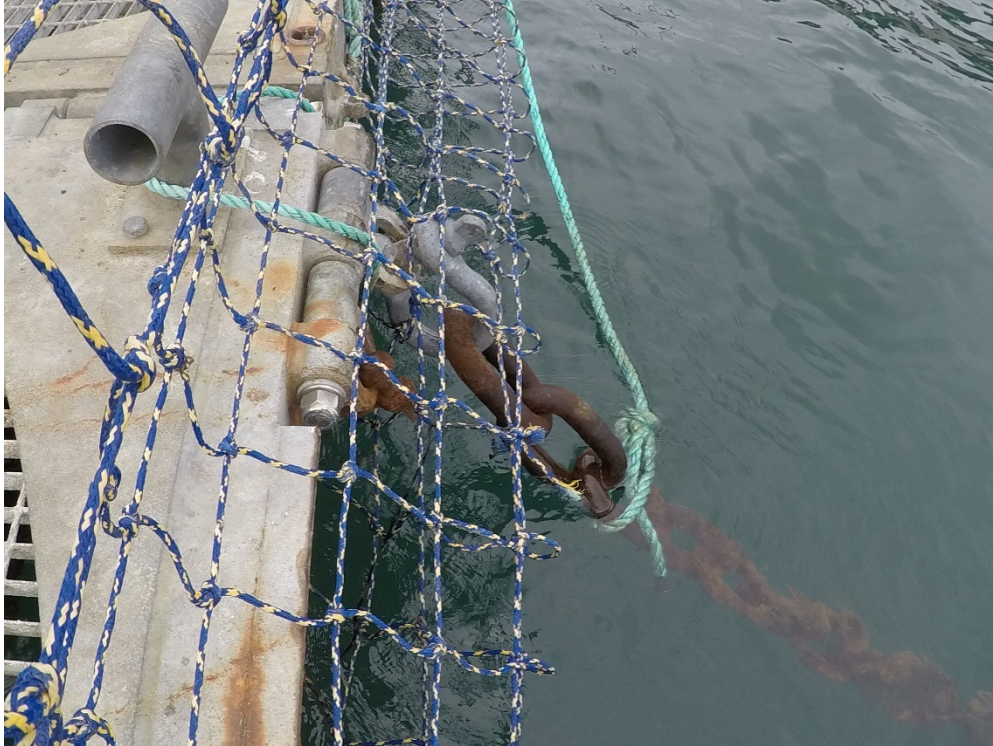
Figure C-11: Cypress Island Net Pen Site 1 – Connection at Anchor Line 10

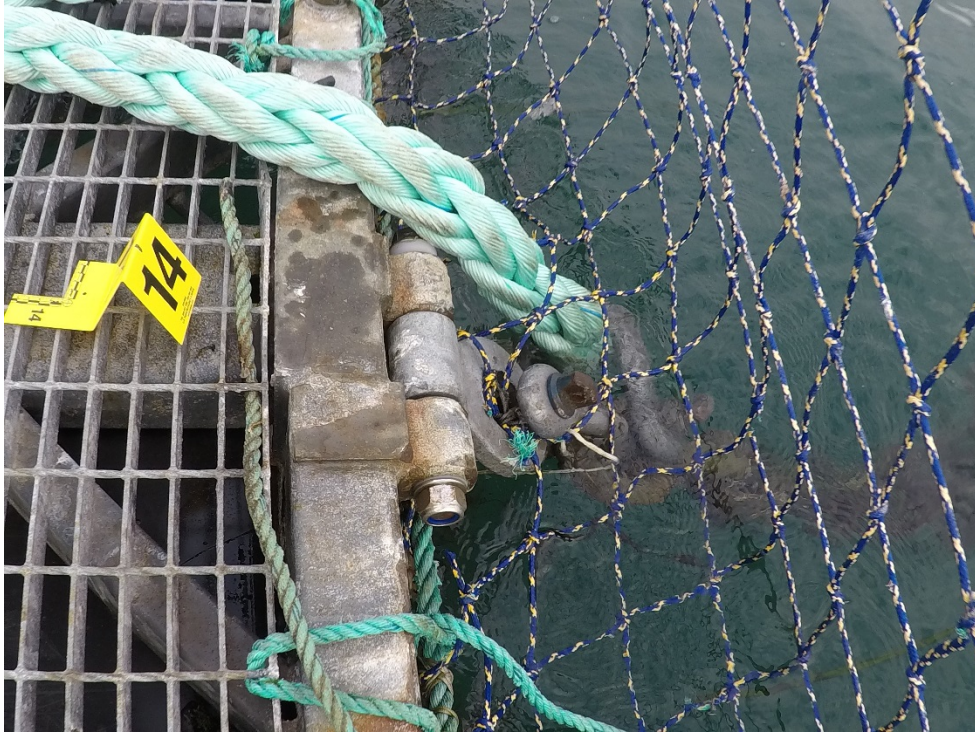
Figure C-13: Cypress Island Net Pen Site 1 – Connection at Anchor Line 14

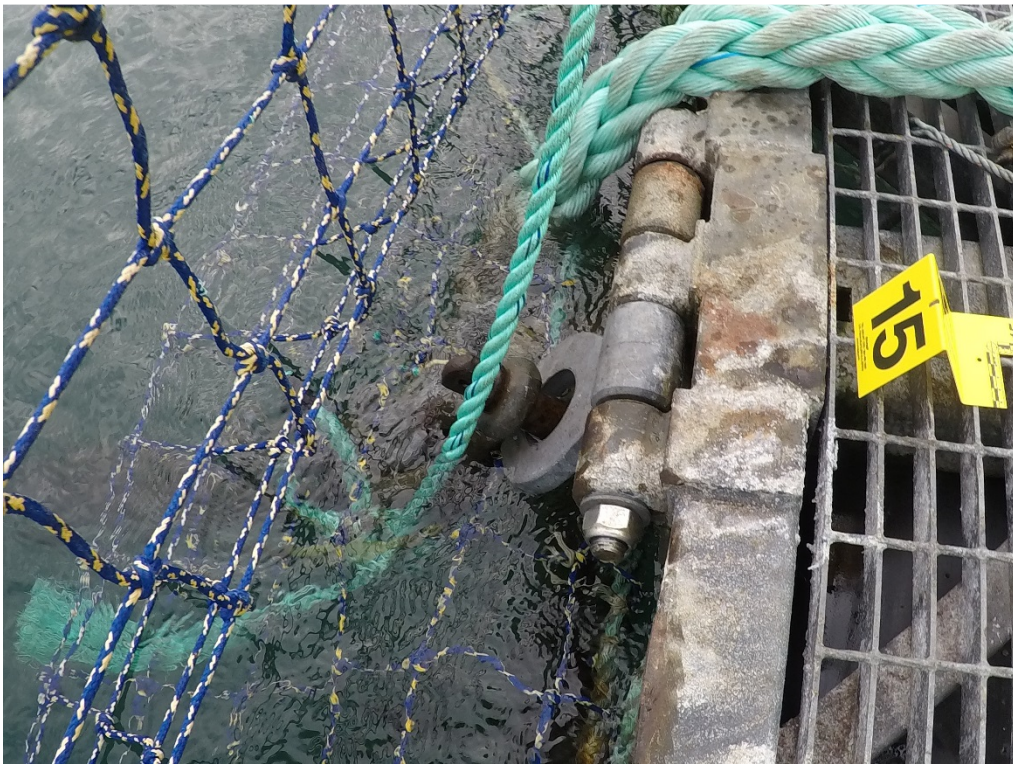
Figure C-14: Cypress Island Net Pen Site 1 – Connection at Anchor Line 15

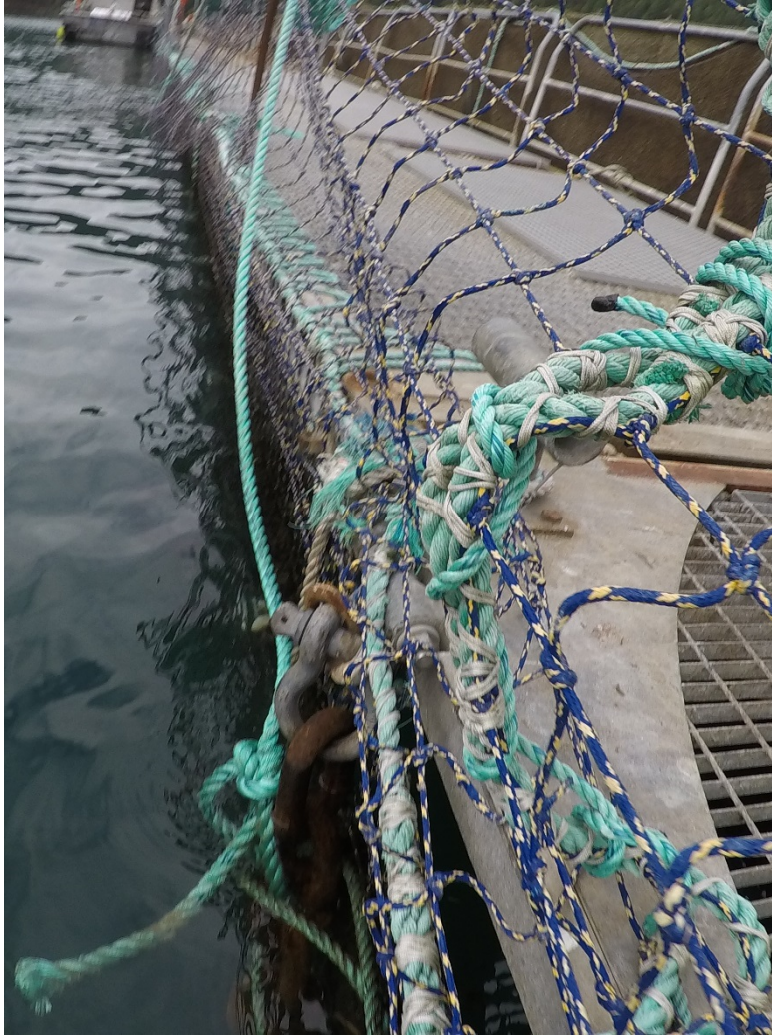
Figure C-16: Cypress Island Net Pen Site 1 – Connection at Anchor Line 19

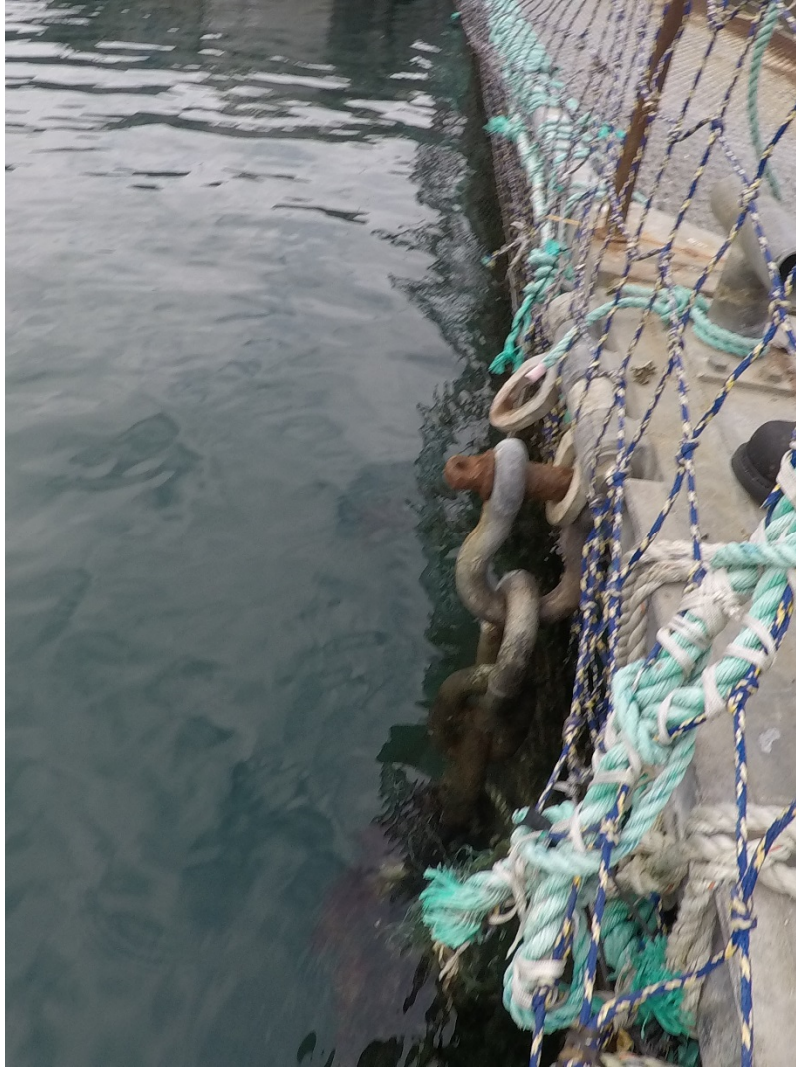
Figure C-17: Cypress Island Net Pen Site 1 – Connection at Anchor Line 20

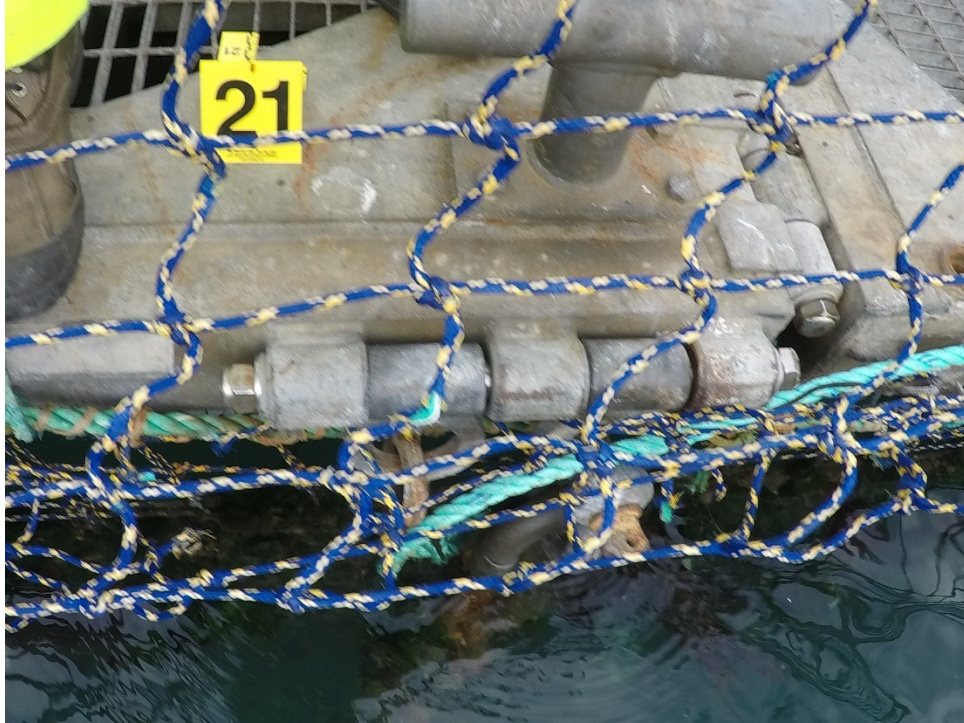
Figure C-18: Cypress Island Net Pen Site 1 – Connection at Anchor Line 21

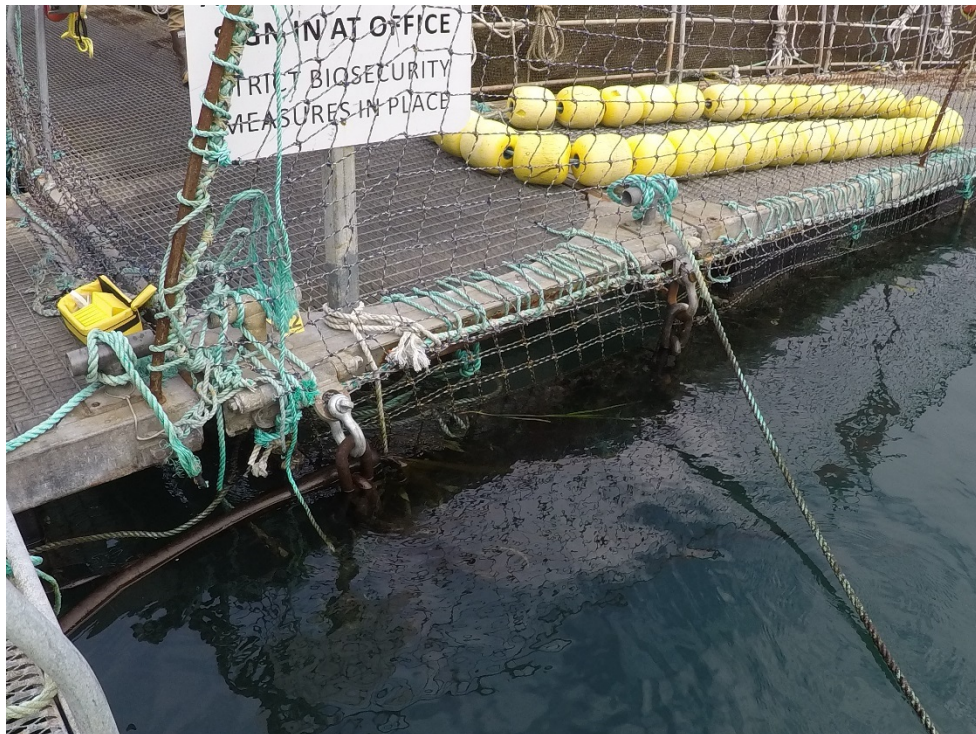
Figure C-19: Cypress Island Net Pen Site 1 – Connection at Anchor Line 22
