# **Cypress Island Site 1 Atlantic Salmon Net Pens Engineering Assessment**

January 29, 2018

**Document reference:** 391980 | 6 | b

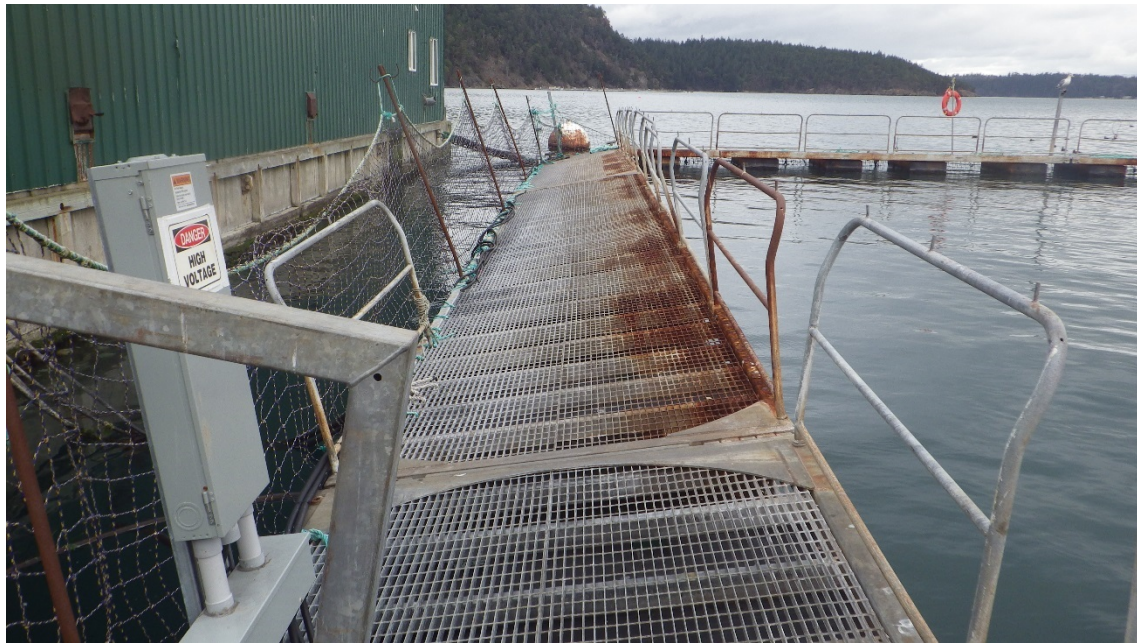
Figure C-20: Cypress Island Net Pen Site 1 – Severe listing of floats along west walkway
