Cypress Island Site 3 Atlantic Salmon Net Pens Engineering Assessment

January 29, 2018

State of Washington
Department of Natural
Resources
1111 Washington Street SE
Olympia Washington 98504

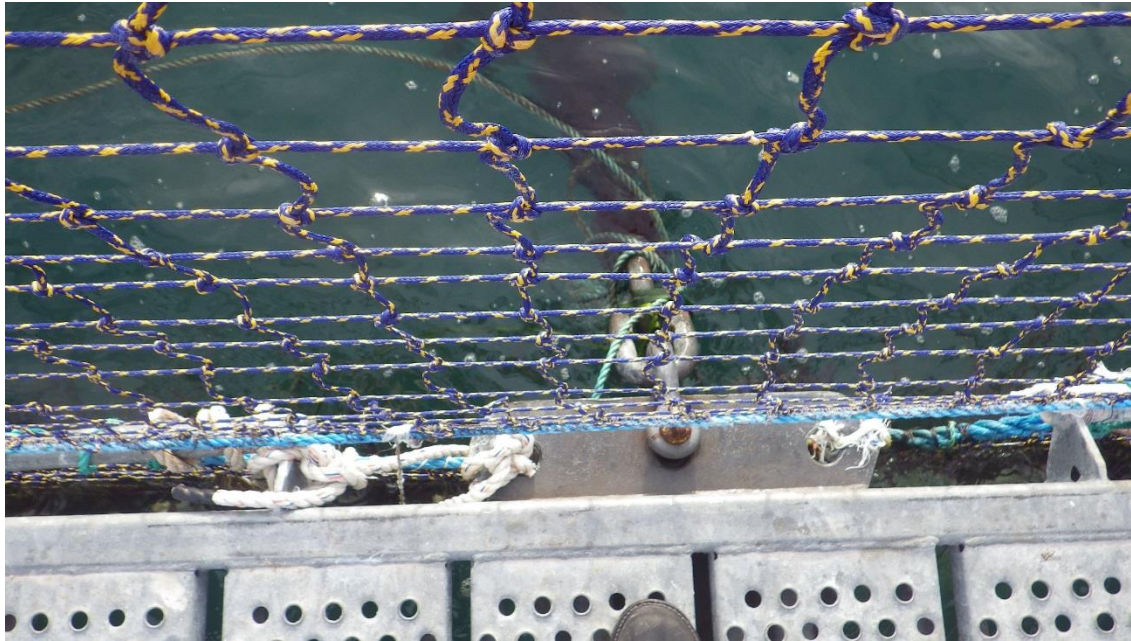
Figure 6: Cypress Island Site 3 Typical Mooring Bracket

The mooring lines are connected by steel shackles to steel plate mooring brackets. These brackets were welded to the float framing and were not hinged, unlike at Site 1 which were hinged. A typical bracket is shown in **Figure 6**. Most anchor mooring lines had a single point of attachment, rather than a “bridle” or “hen’s foot” arrangement as shown on the plan provided by the owner. A bridle connection divides the mooring line near the net pen into two lines that attach to two different points on the net pen structure.

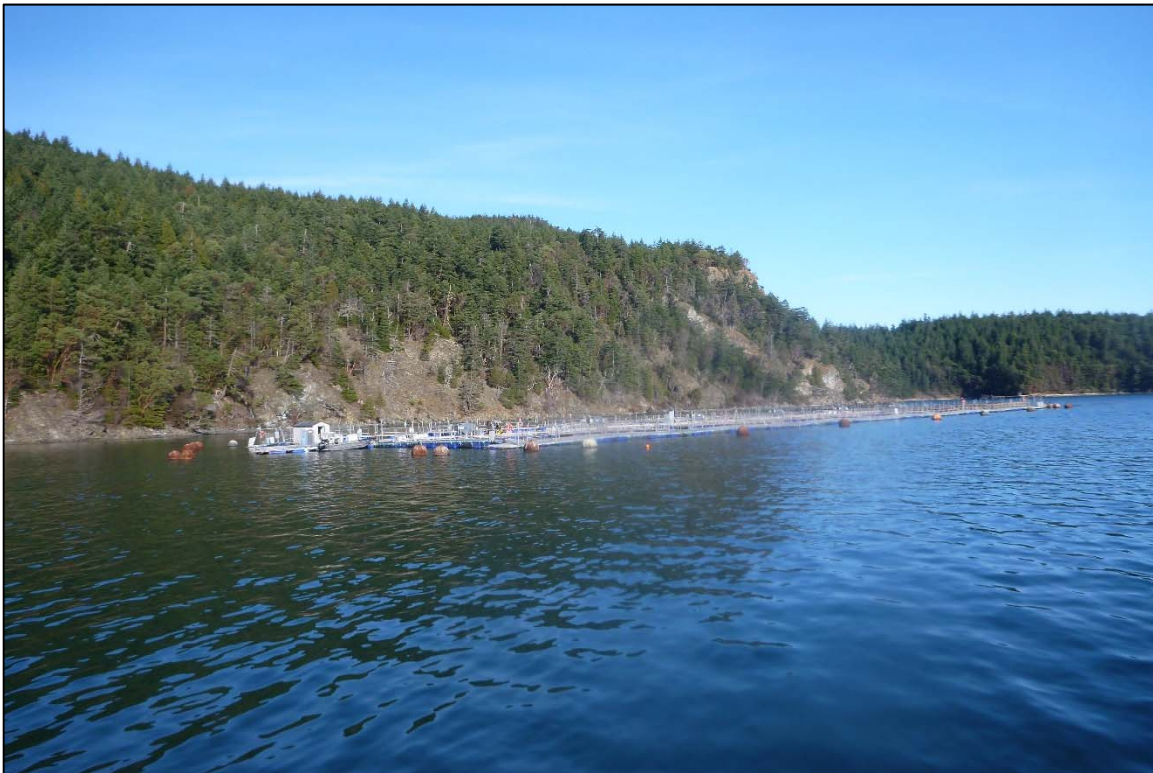
Photograph 2: Overall View of the Site 3 Fish Net Pens System, Looking North.

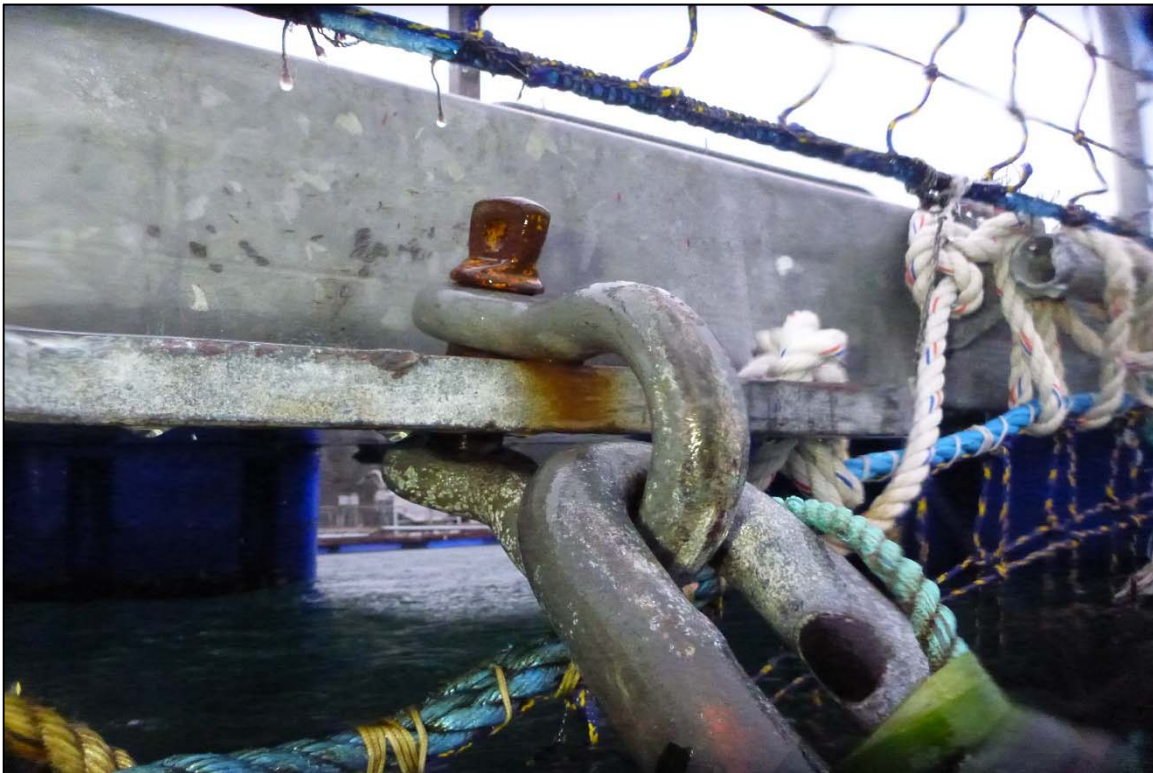
Photograph 10: View of Upper Anchor Chain to Float Connection at Site 3 Anchor Line 10, Looking North.

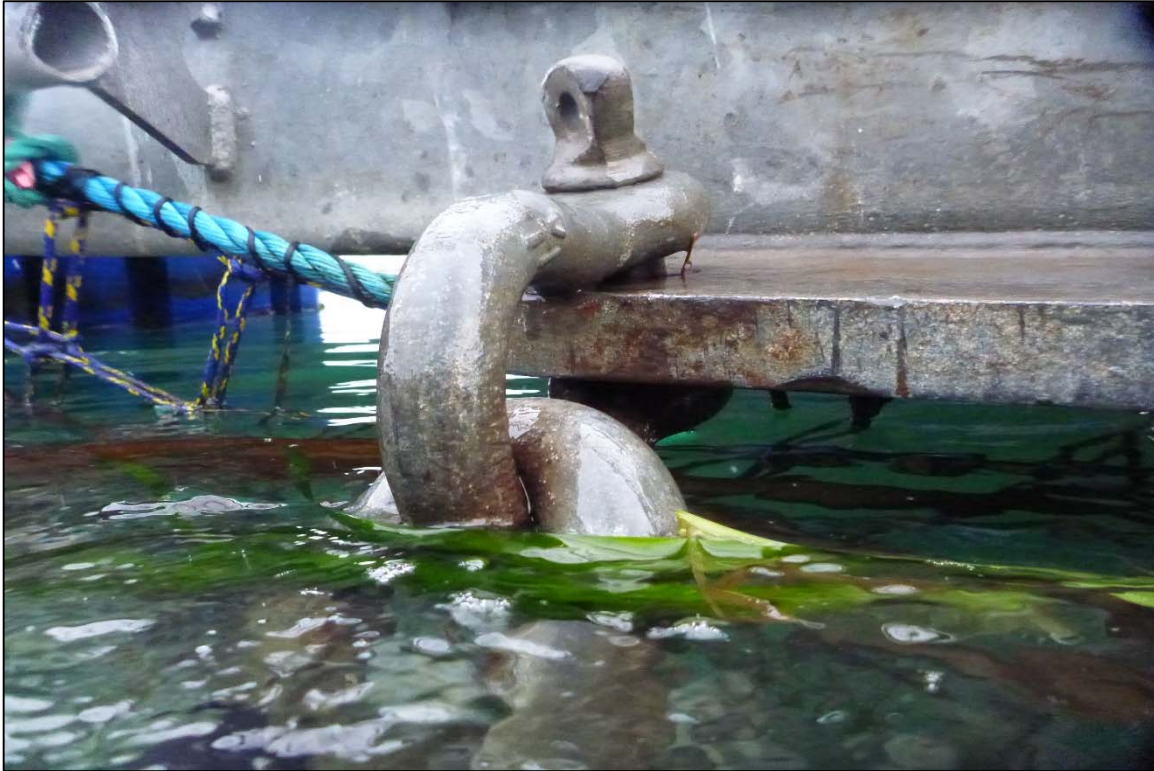
Photograph 11: View of Upper Anchor Chain to Float Connection at Site 3 Anchor Line 21, Looking Southwest.

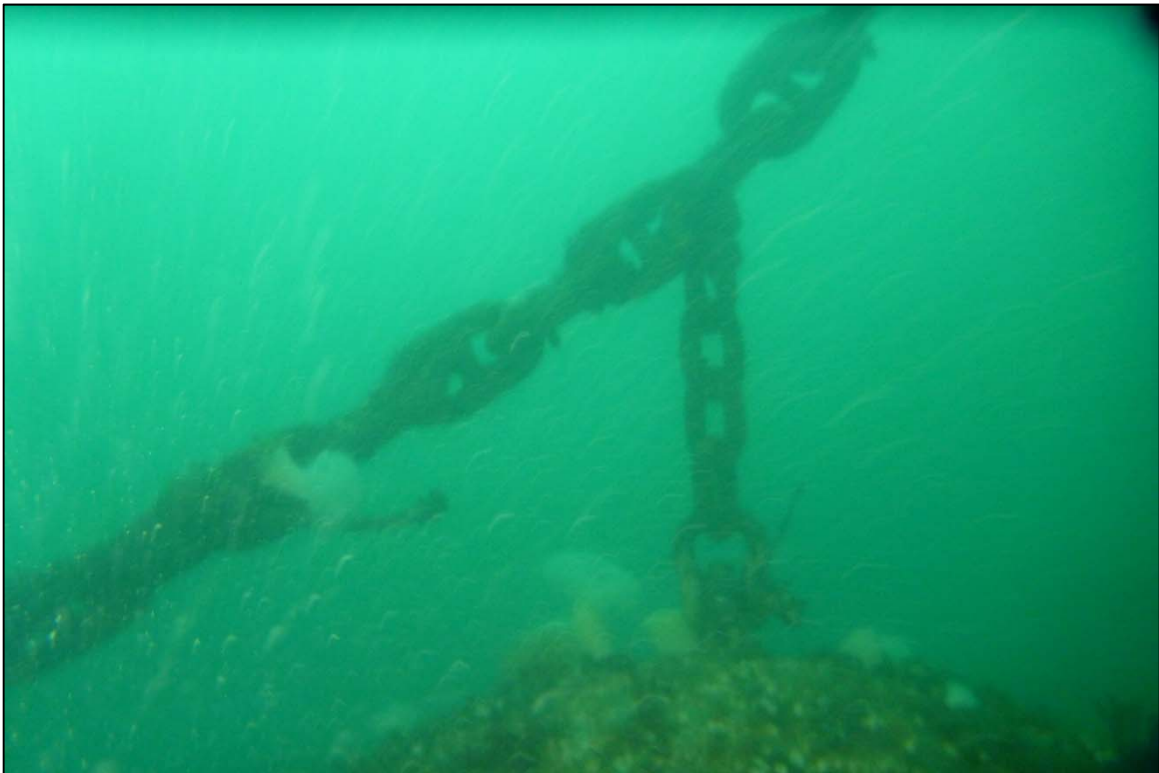
Photograph 14: View of Submerged Steel Buoy at Site 3 Anchor Line 2, Looking Northwest.

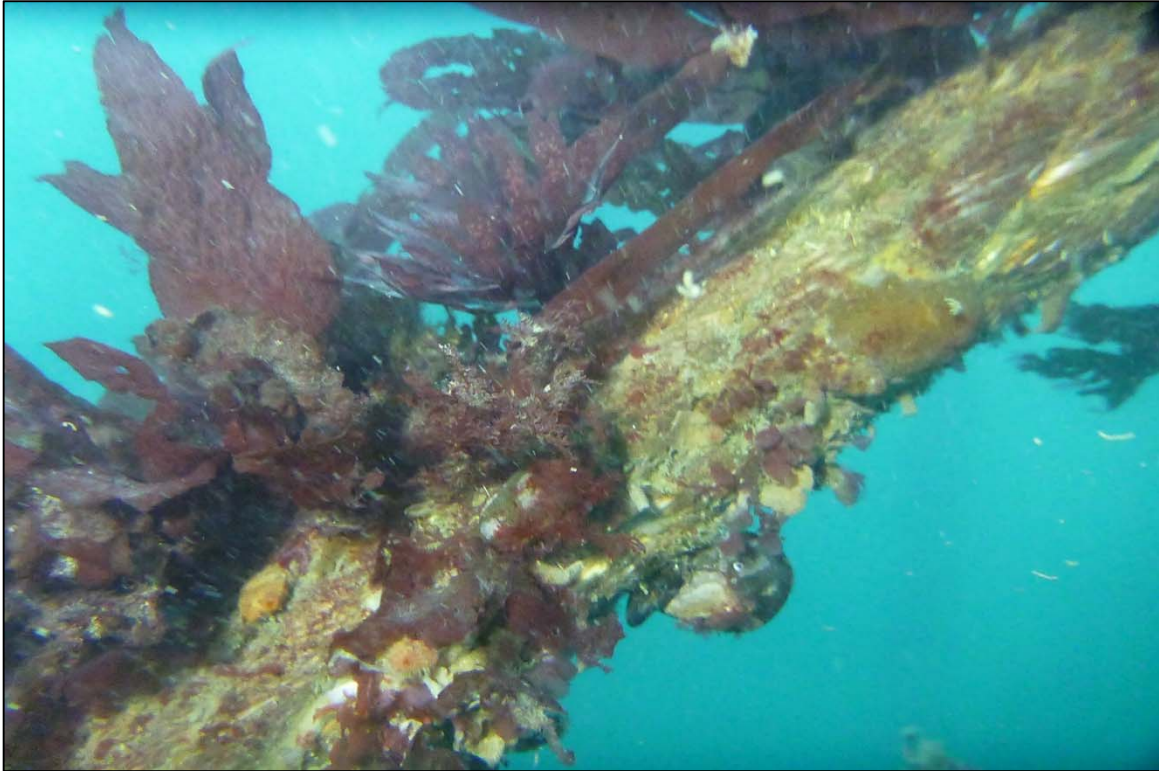
Photograph 19: View of Heavy Marine Growth on the Anchor Rope at Site 3 Anchor Line 3, Looking North.

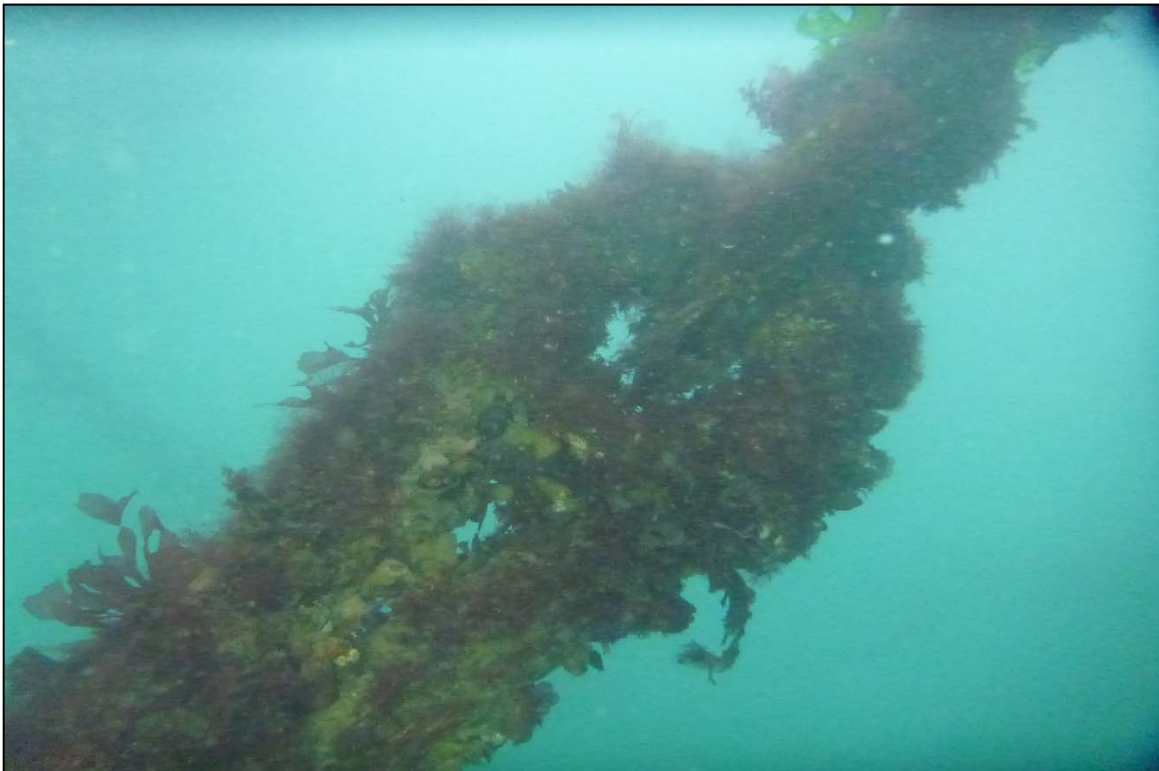
Photograph 20: View of Upper Anchor Chain to Rope Connection (Thimble) at Site 3 Anchor Line 3, Looking North.

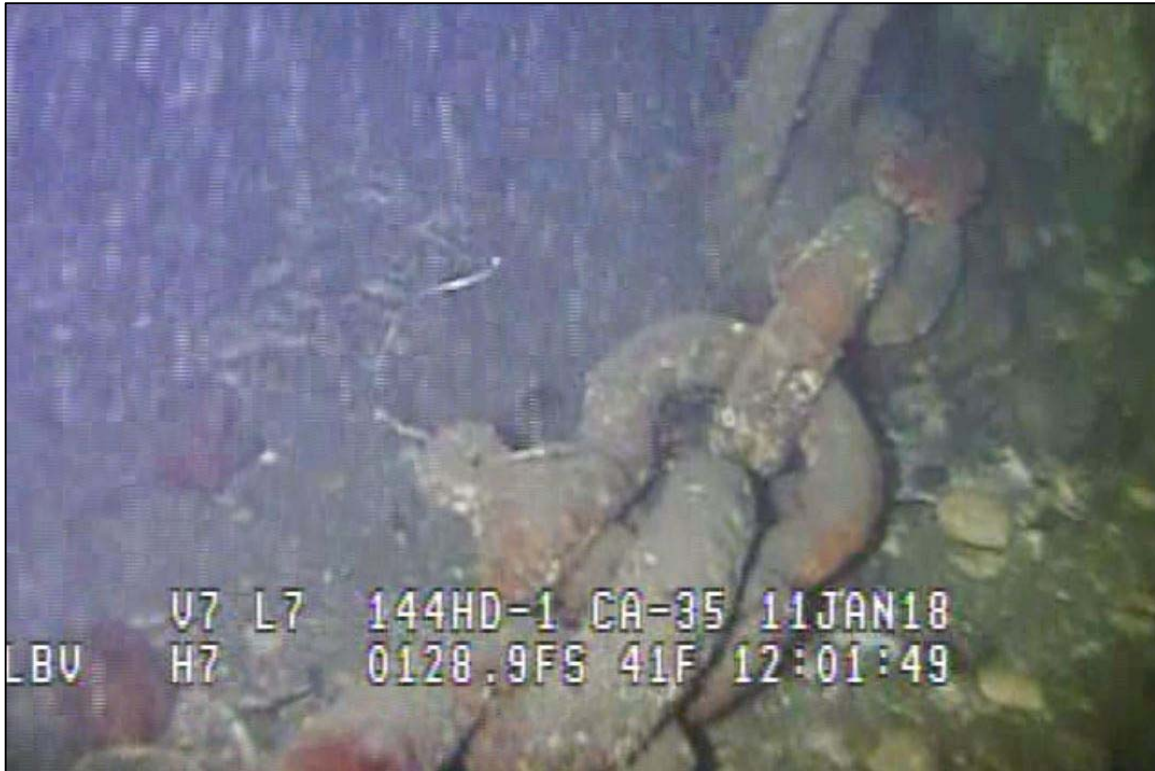
Photograph 23: View of Lower Chain to Chain Connection (Shackle) at Site 3 Anchor Line 4, Looking North.

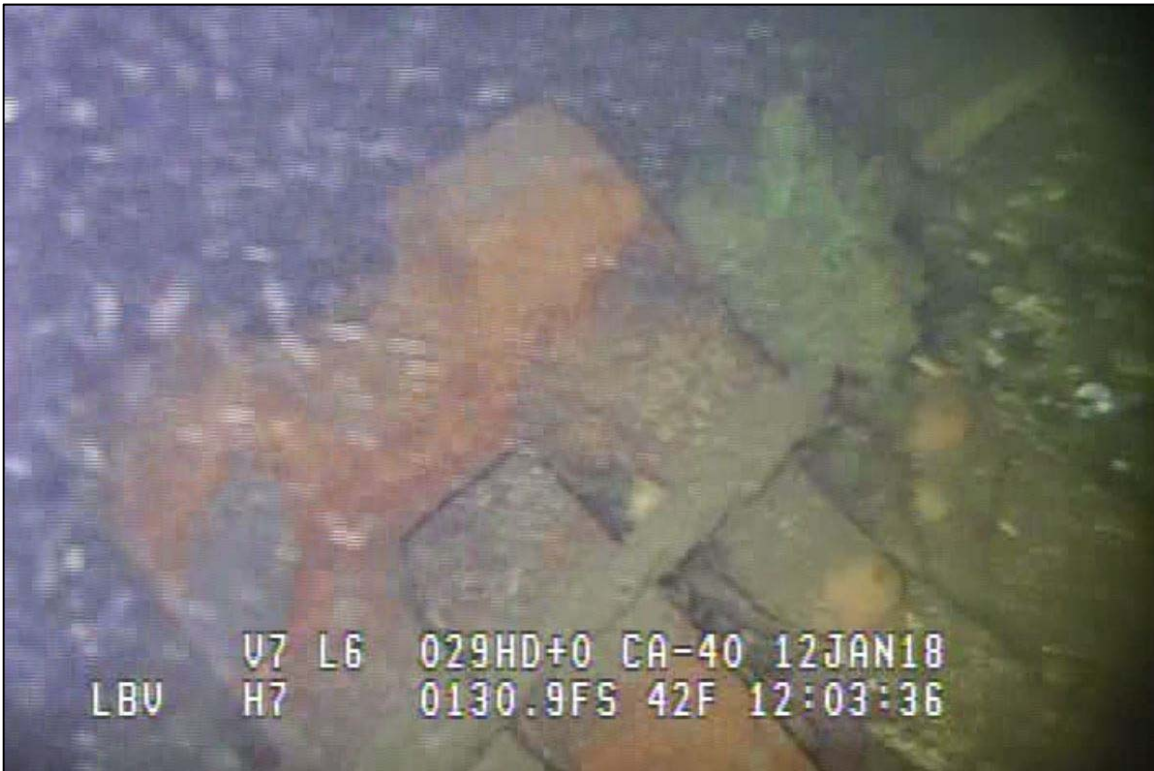
Photograph 28: View of Top of Anchor with Fluke Exposure at Site 3 Anchor Line 6, Looking North.

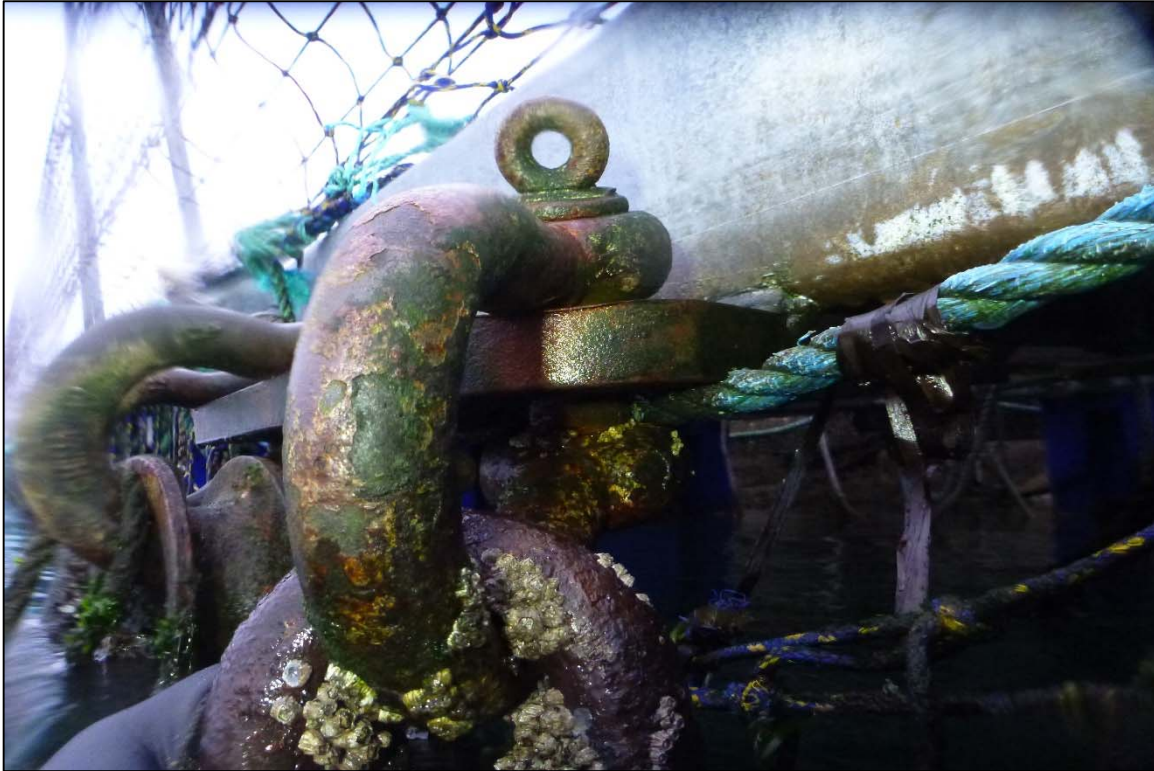
Photograph 29: View of Upper Chain to Float Connection (Shackle) at Site 3 Anchor Line 6A, Looking West.

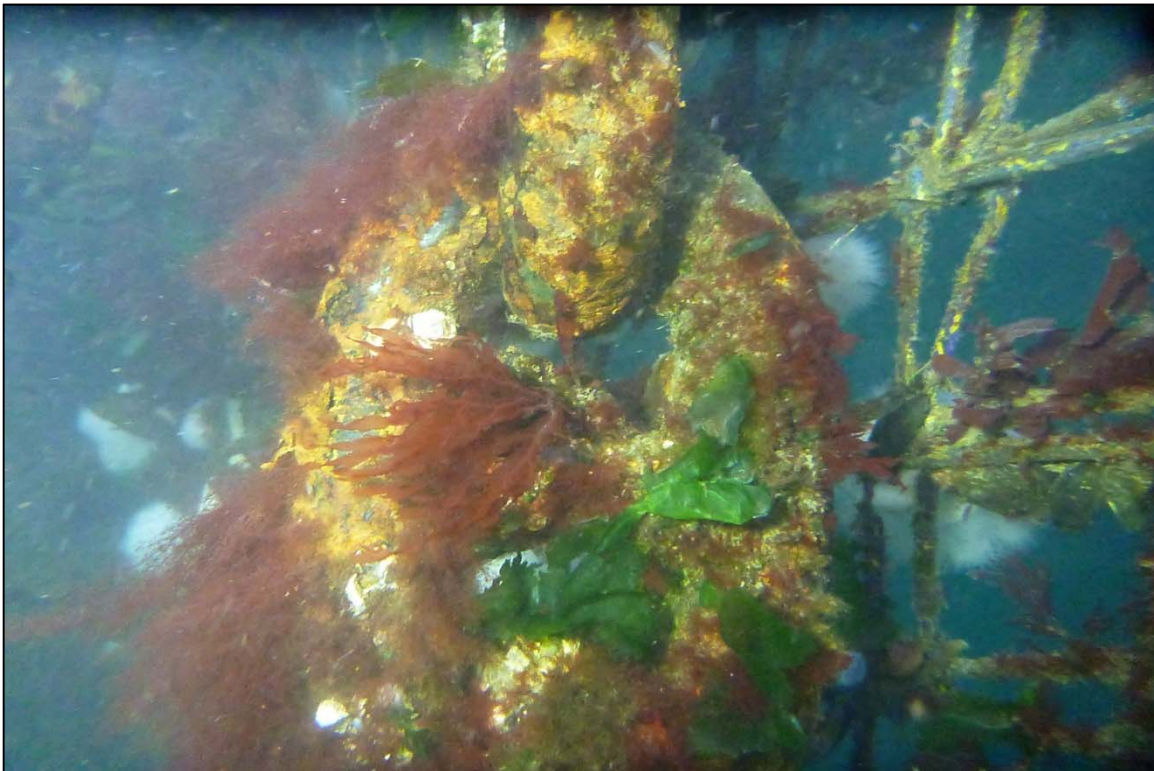
Photograph 30: View of Upper Anchor Chain at Site 3 Anchor Line 6A, Looking West.

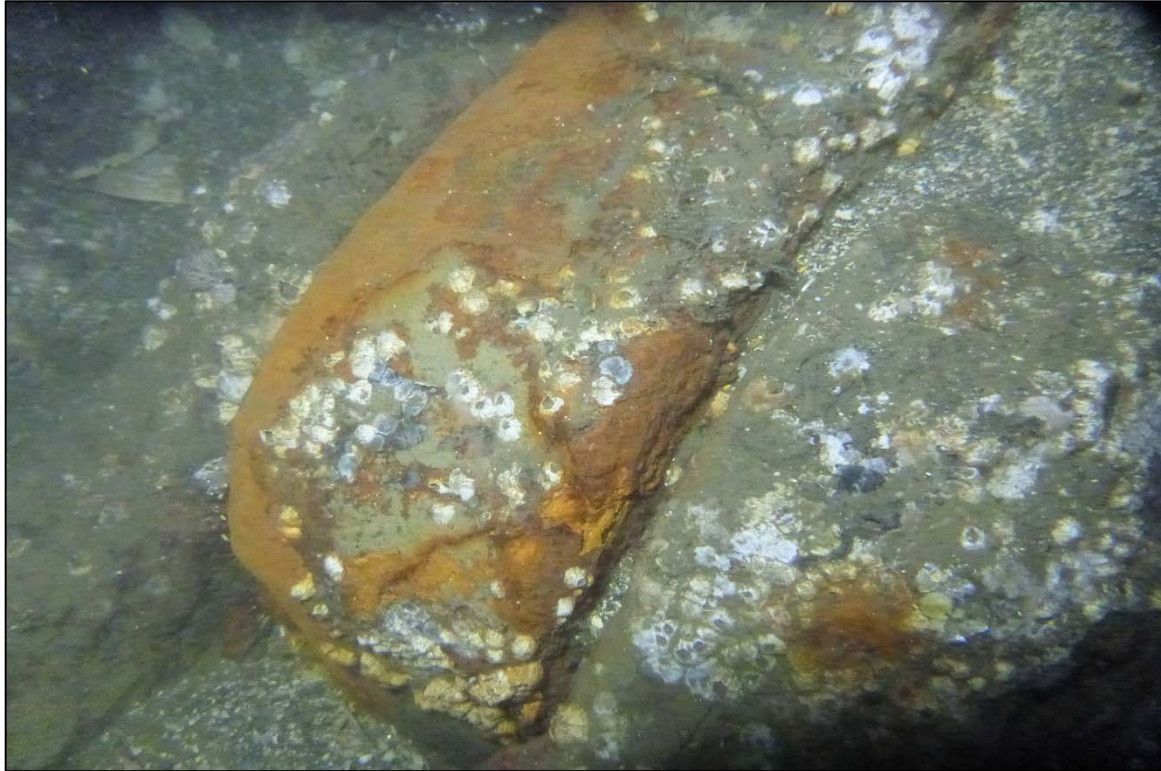
Photograph 33: View of Top of Exposed Anchor at Site 3 Anchor Line 6A, Looking East.

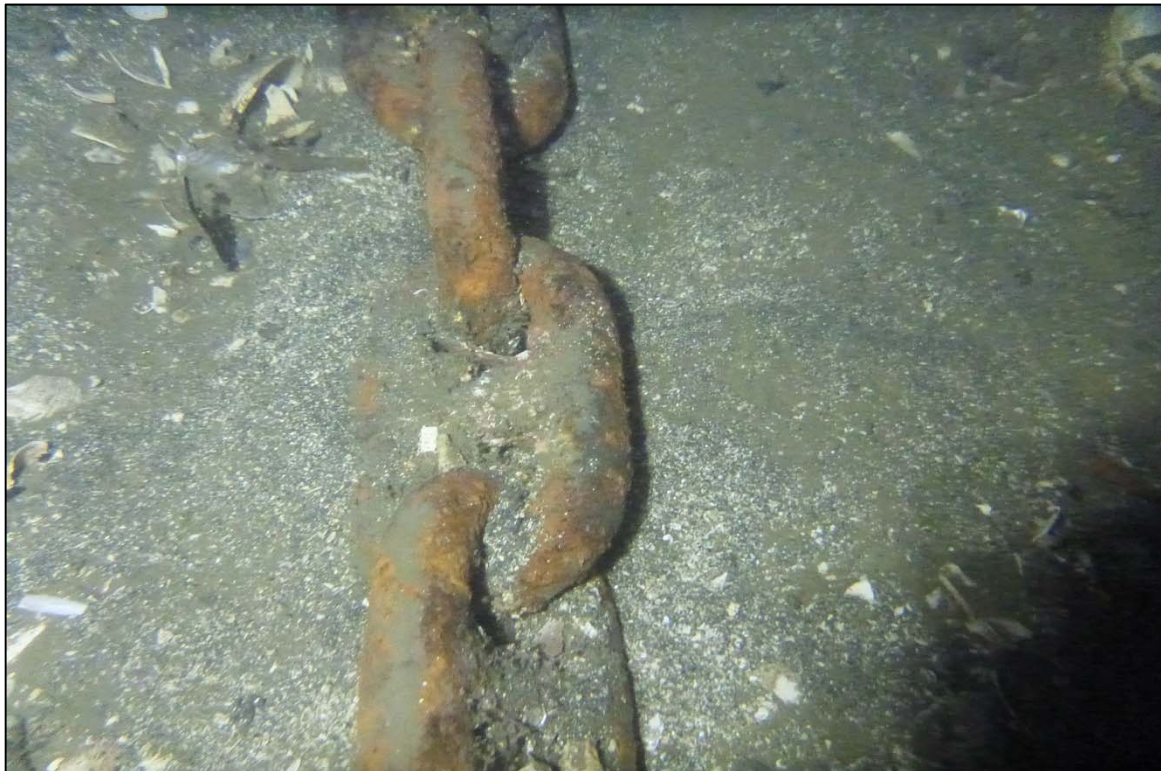
Photograph 36: View of Lower Anchor Chain laying on the Channel Bottom at Site 3 Anchor Line 7, Looking Southeast.

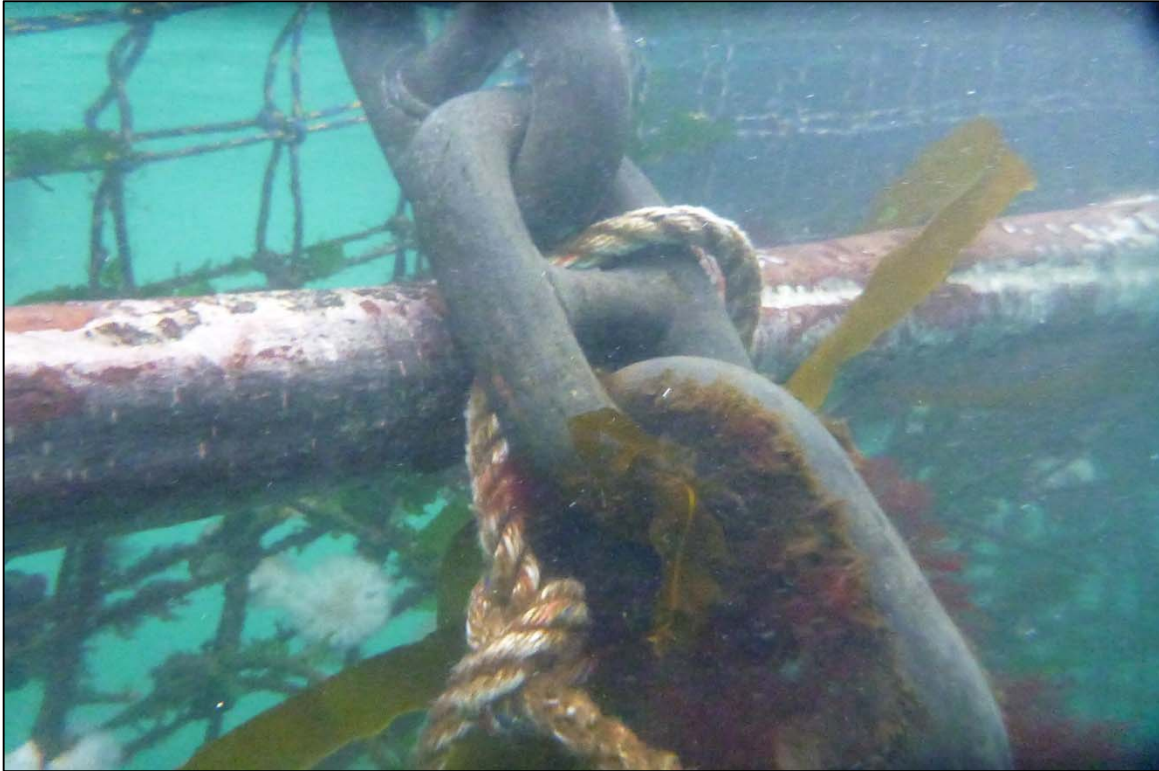
Photograph 41: View of Upper Chain with Trapped Timber Debris between Predator Net and Anchor Chain at Site 3 Anchor Line 9, Looking Northwest.

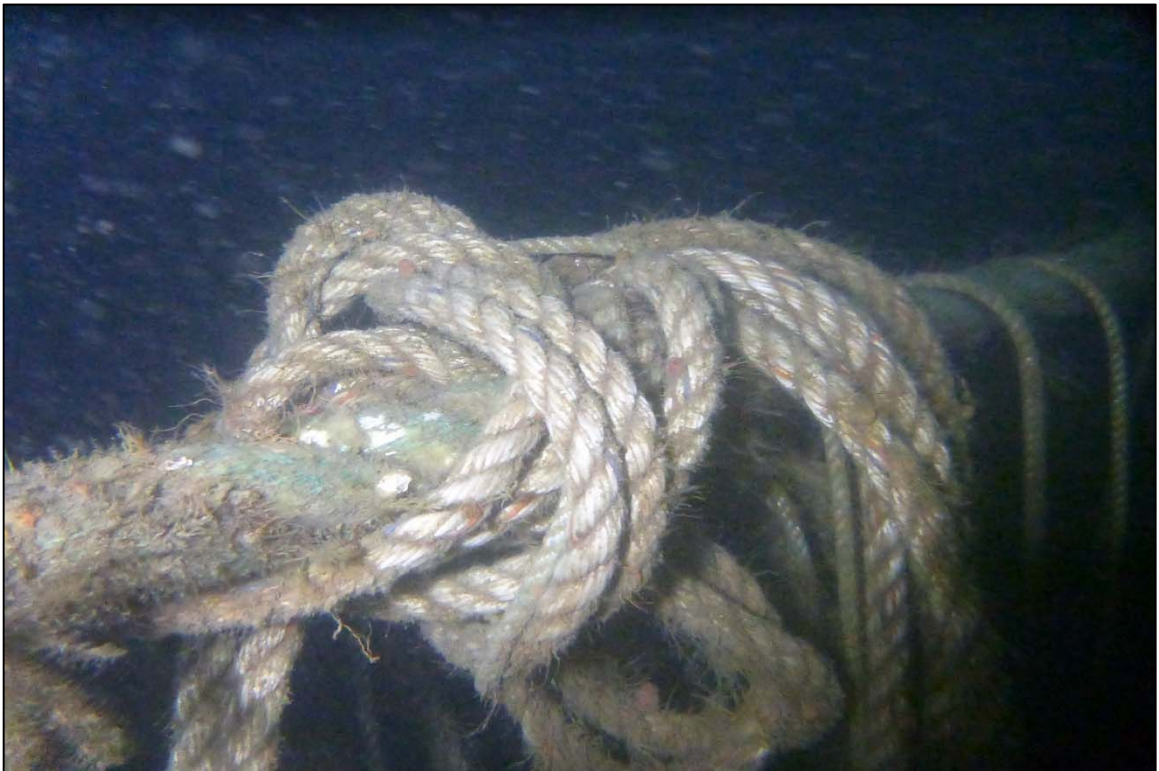
Photograph 42: View of Rope, Possibly Debris, on the Anchor Rope at Site 3 Anchor Line 9, Looking North.

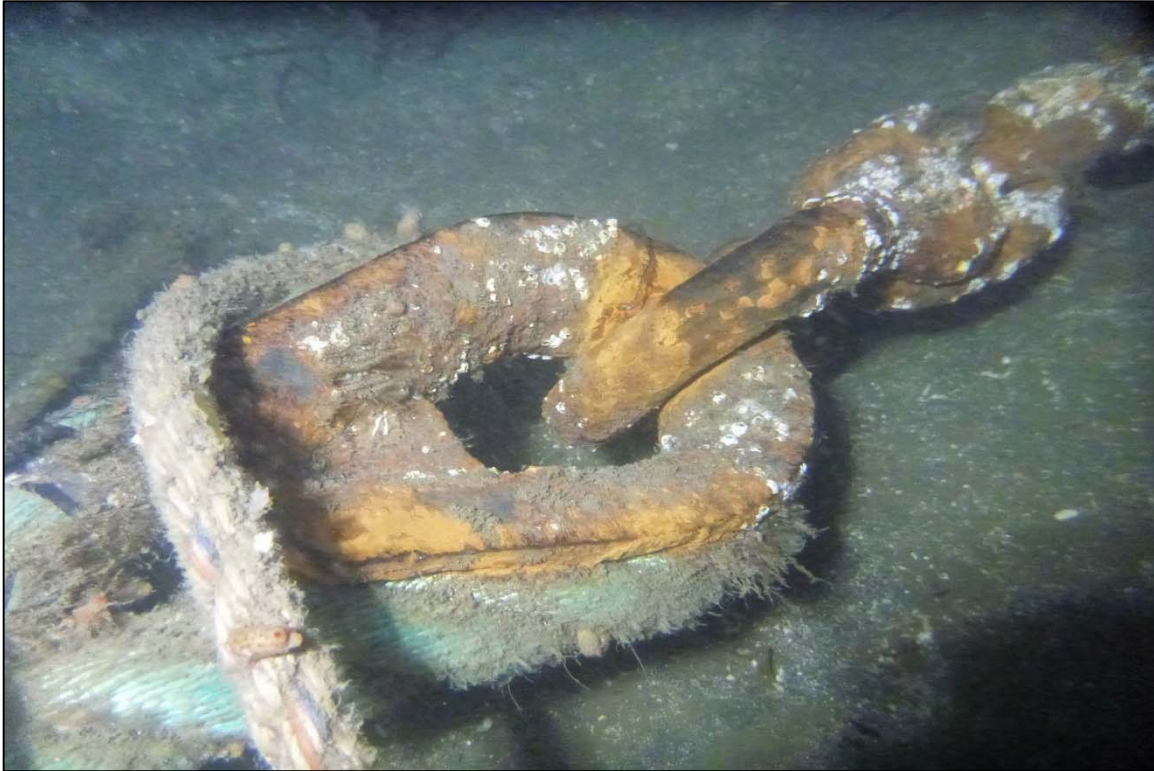
Photograph 43: View of Lower Anchor Chain to Anchor Rope Connection (Shackle and Thimble) at Site 3 Anchor Line 9, Looking East.

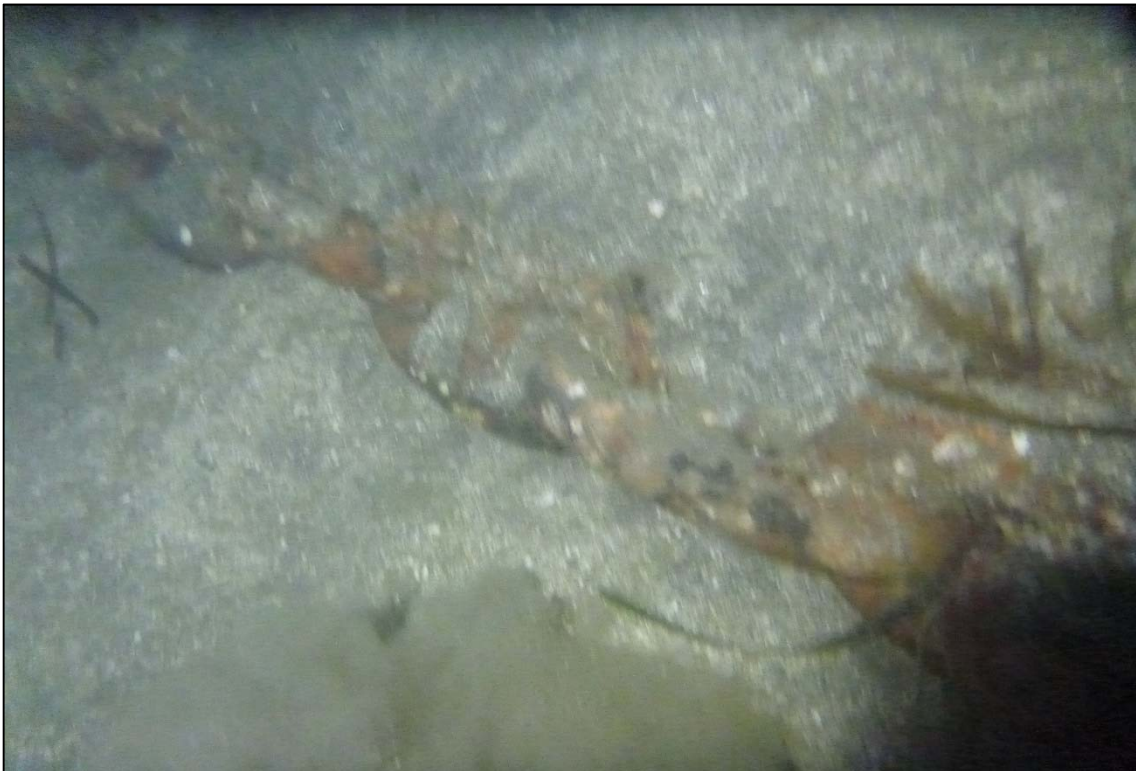
Photograph 44: View of Lower Anchor Chain Mostly Buried at the Channel Bottom Anchor Line 9, Looking North.

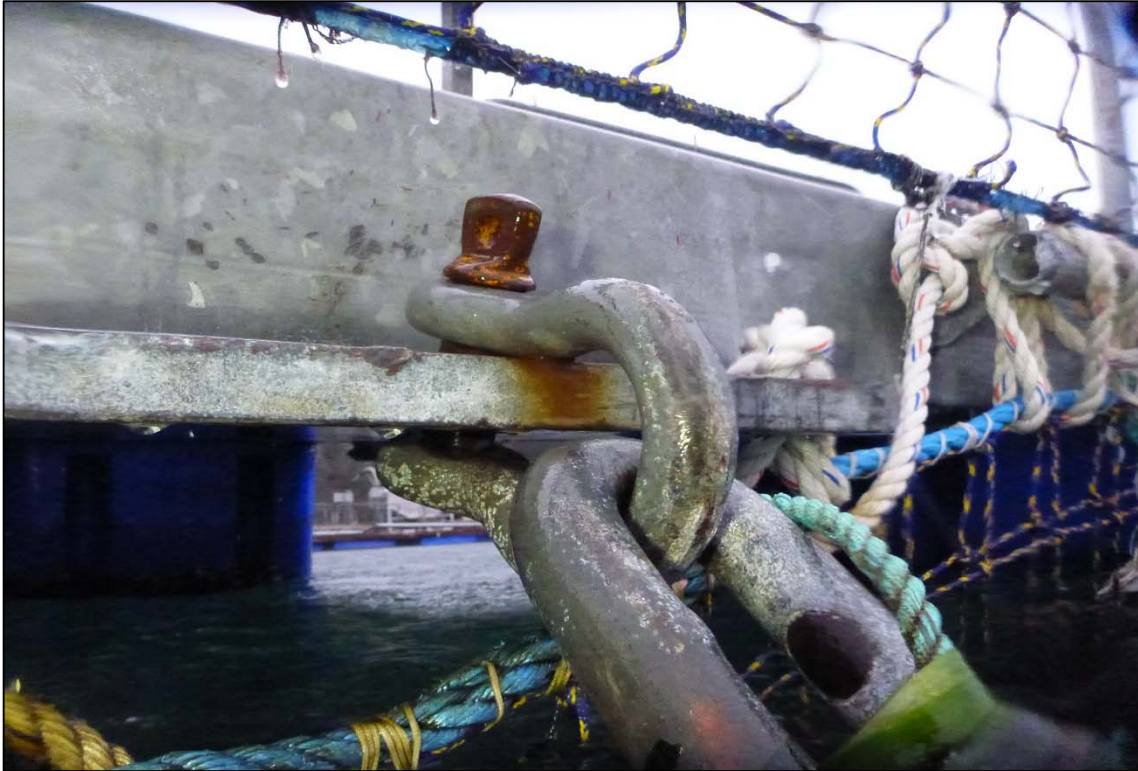
Photograph 45: View of Upper Anchor Chain to Float Connection (Shackle) at Site 3 Anchor Line 10, Looking North.

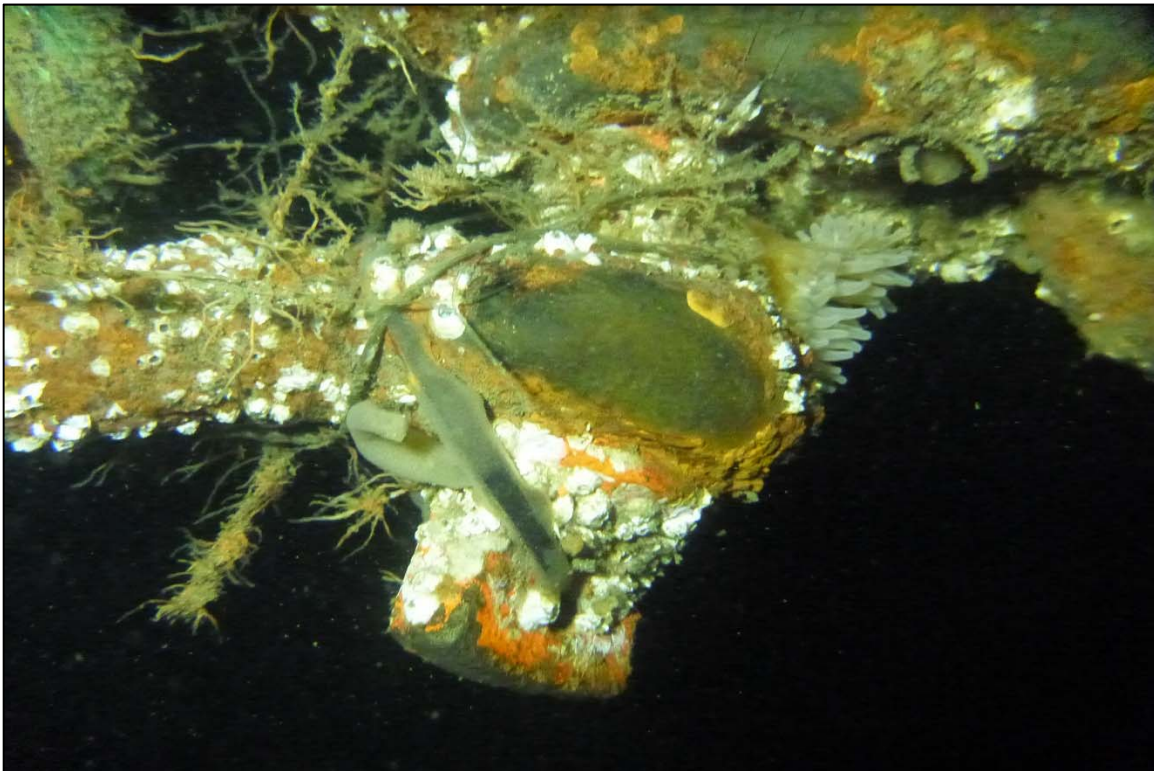
Photograph 46: View of Lower Anchor Chain to Anchor Rope Connection with Safety Zip-Tie at Site 3 Anchor Line 10, Looking Northeast.

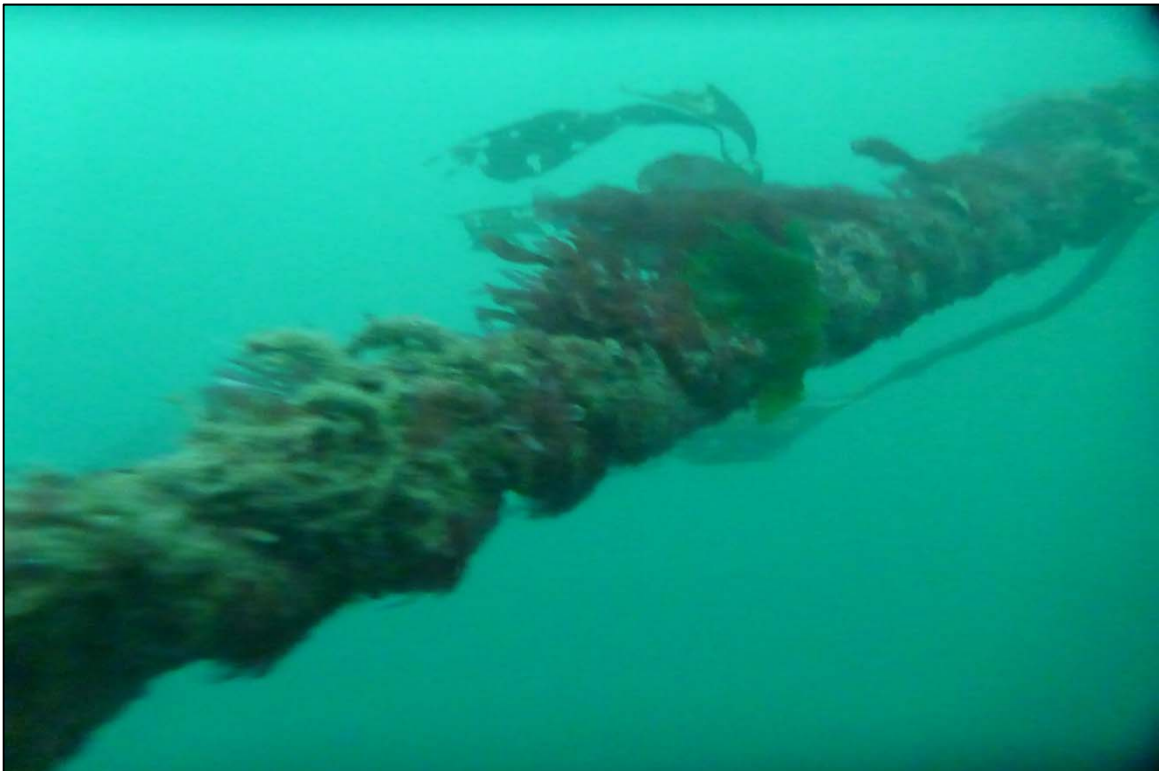
Photograph 48: View of Anchor Rope Heavy Marine Growth at Site 3 Anchor Line 11, Looking North.

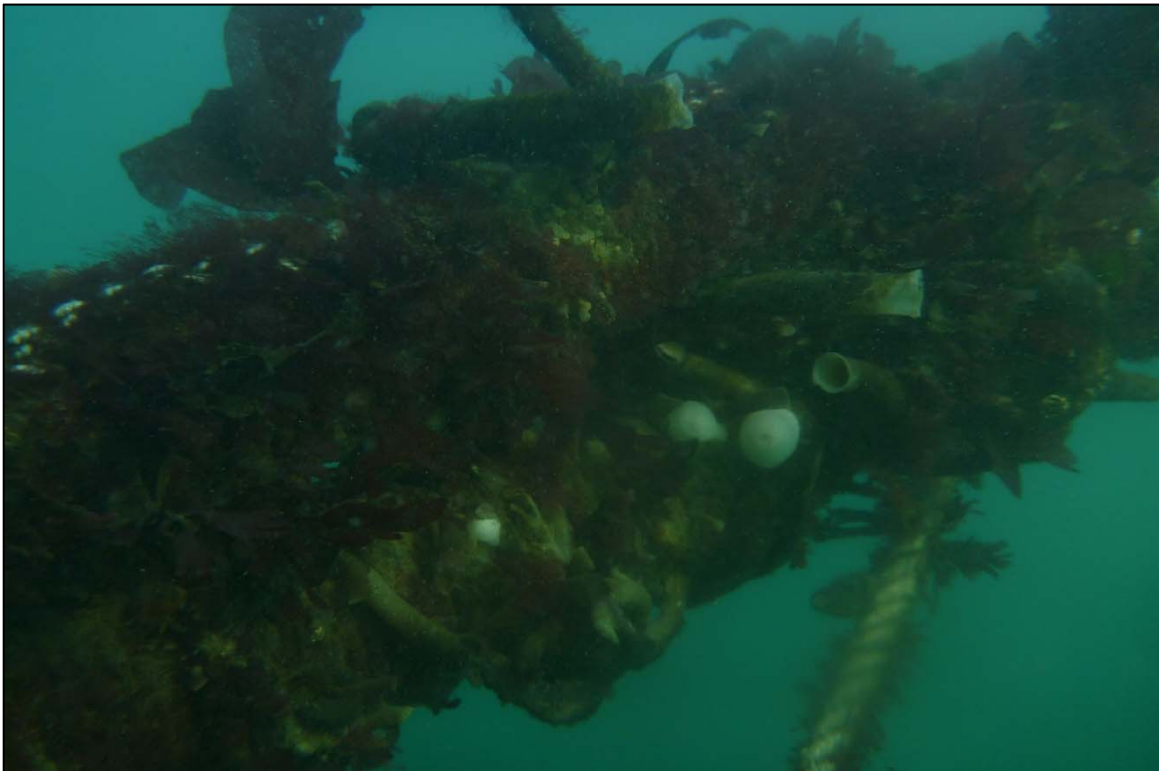
Photograph 64: View of Anchor Rope with Heavy Marine Growth at Site 3 Anchor Line 18, Looking West.

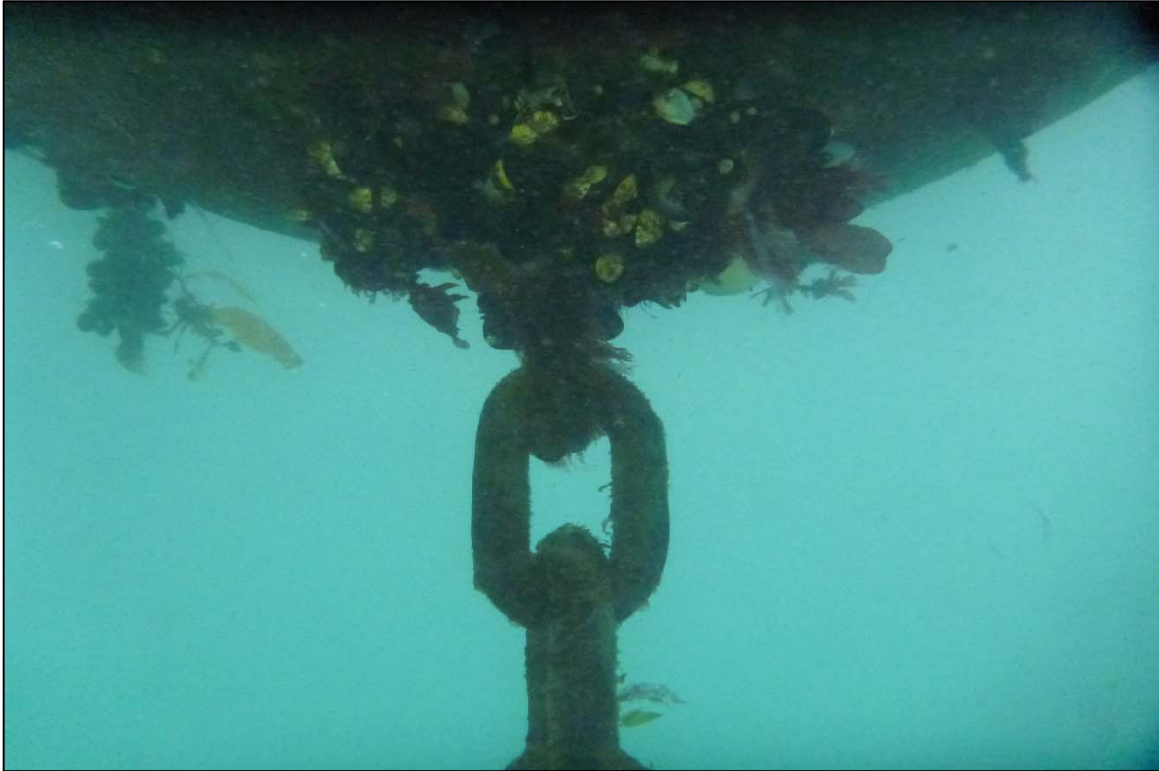
Photograph 71: View of Buoy Connection at Site 3 Anchor Line 21, Looking Northeast.

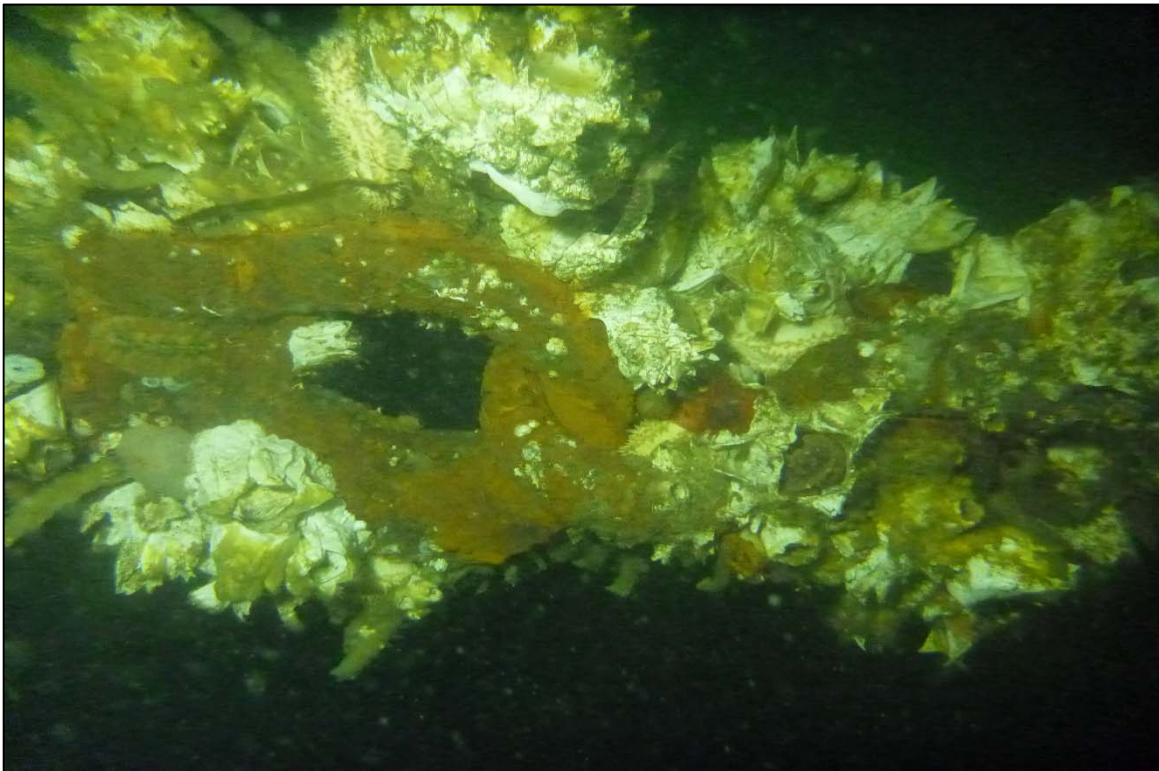
Photograph 72: View of Lower Anchor Chain to Anchor Rope Connection with Heavy Barnacle Growth (Thimble) at Site 3 Anchor Line 21, Looking Northeast.

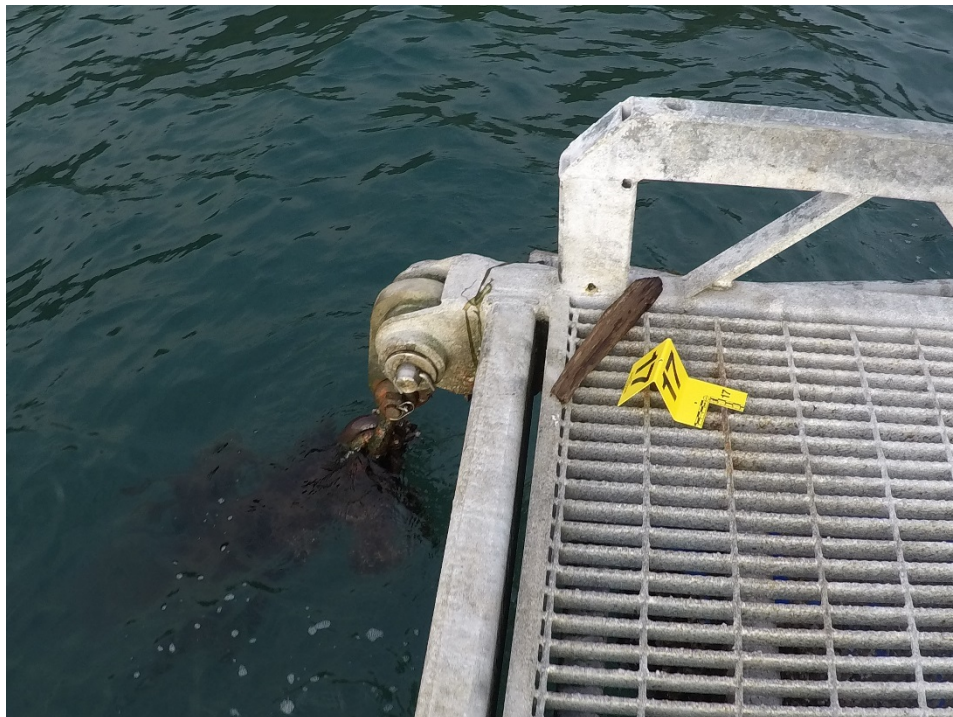
Figure C-14: Cypress Island Net Pen Site 3 – Connection at Anchor Line 17

The ±30 ft long upper anchor chains were typically found to be in satisfactory condition with no structurally significant deterioration. The upper lengths of chain generally exhibited only light to moderate corrosion that had minimal section loss associated with it and just pitting that was typically 1/16 in. deep or less. The below water portions of the upper anchor chains typically exhibited a moderate layer of marine growth, consisting of up to a 1/2 in. thick layer of hard growth covered by 1 in. to 3 in. of softer growth. The upper anchor chains of all of the anchor lines around the net pens system had steel buoys attached to and supporting the upper chain in an apparent effort to relieve some of the downward load on the floating net pens system. The one exception to this was at Anchor Line 2, where the buoy was sunk below water alongside the upper anchor chain, thus exerting a downward load on the anchor line. Typically, the smaller chains used to make the buoy to anchor line chain connections exhibited an extent of corrosion similar to that of the upper anchor line chains, although at Anchor Lines 17 through 19 and 23, there was an estimated 25%

to 50% loss of original section (as little as 3/8 in. link diameter remaining) observed for the smaller buoy chain links due to both corrosion and wear.

In conclusion, the underwater inspection of the Site 3 Cypress Island Fish Net Pens System did not reveal any structurally significant deterioration or other notable deficiencies that would suggest any appreciable reduction in the inherent integrity or stability of the overall system. In that regard, the components inspected below water were typically found to be in sound condition with no indication that an appreciable reduction in the originally intended capacity of a component or connection could be expected. It should again be noted, however, that while the aforementioned deficient buoy attachments do not affect the capacity of the anchor lines per se, if they were to fail, that could disrupt the equilibrium of the overall net pens system, and therefore, consideration should be given to renewing the heavily deteriorated items.
