Port Angeles Primary Atlantic Salmon Net Pens Engineering Assessment

January 29, 2018

Document reference: 391980 | 2 | b

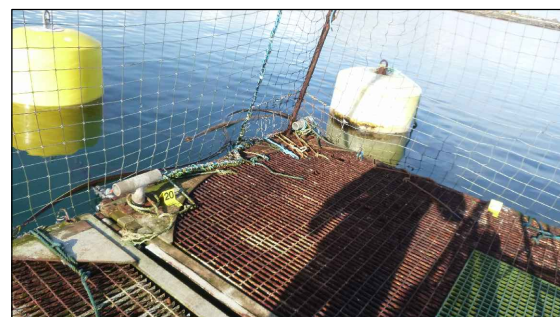
PHOTO 1
TYPICAL CORROSION ON EXTERIOR CORNER WALKWAY GRATING

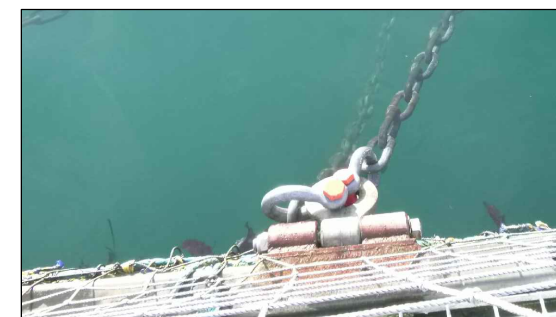
PHOTO 4
IMPROPER ASSEMBLY OF 2 SHACKLES TO ONE PADEYE

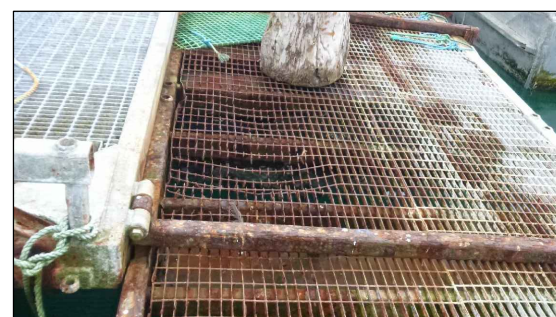
PHOTO 8
SEVERE CORROSION ON BOARDING FLOATS

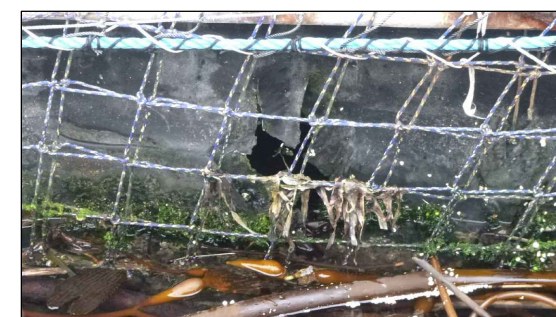
PHOTO 9
DAMAGE TO FLOATING PONTON

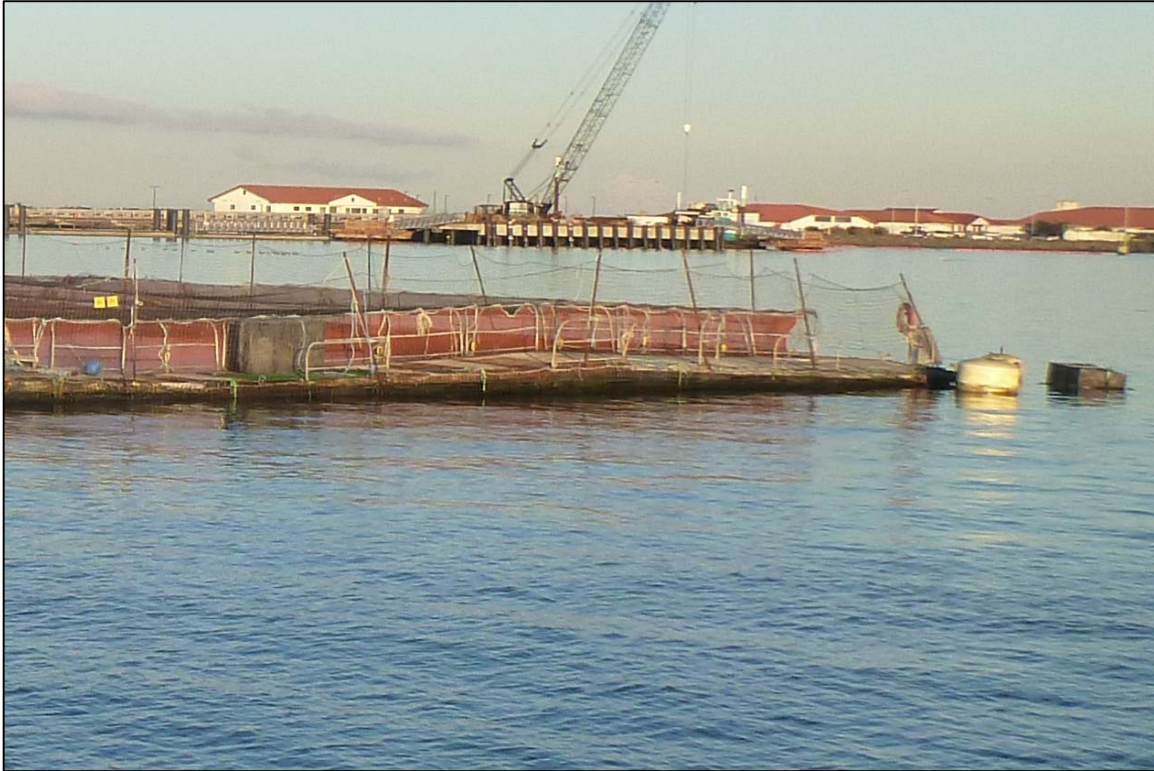
Photograph 11: View of the Depressed Pen Support Float at the Southeast Corner, Looking Northeast.

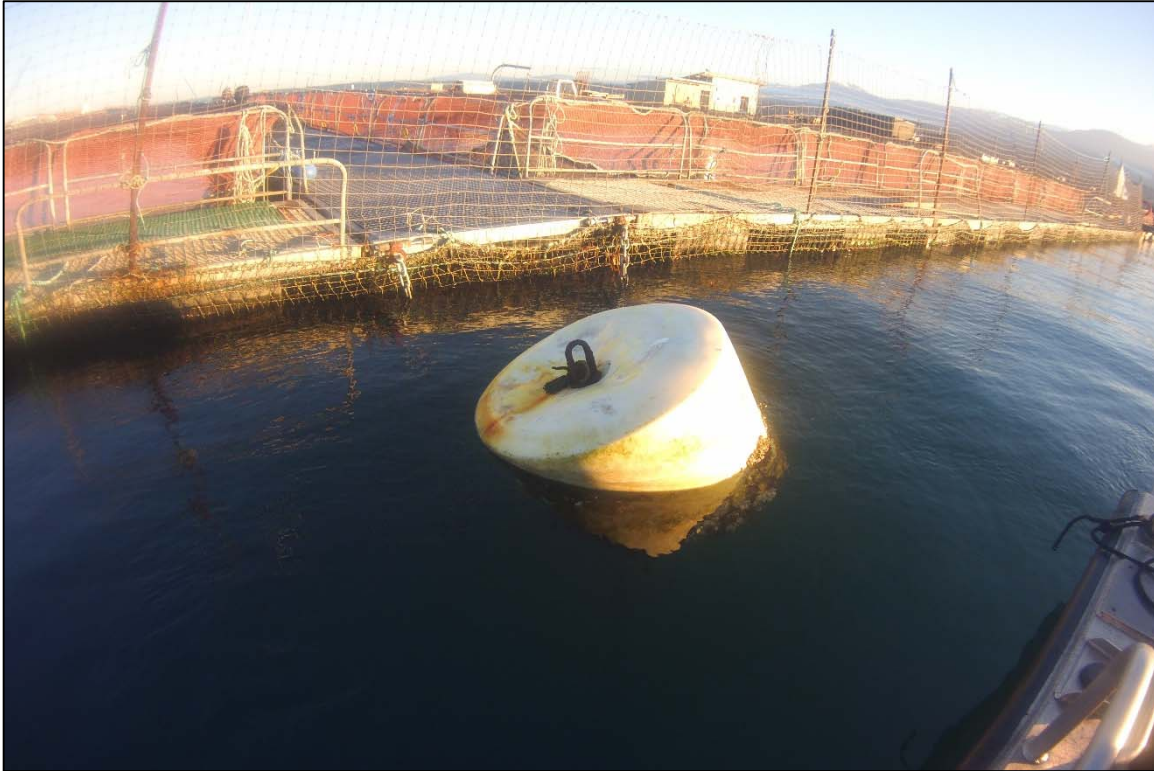
Photograph 13: View of the Depressed Anchor Line Buoy at Anchor Line 20, Looking Southeast.

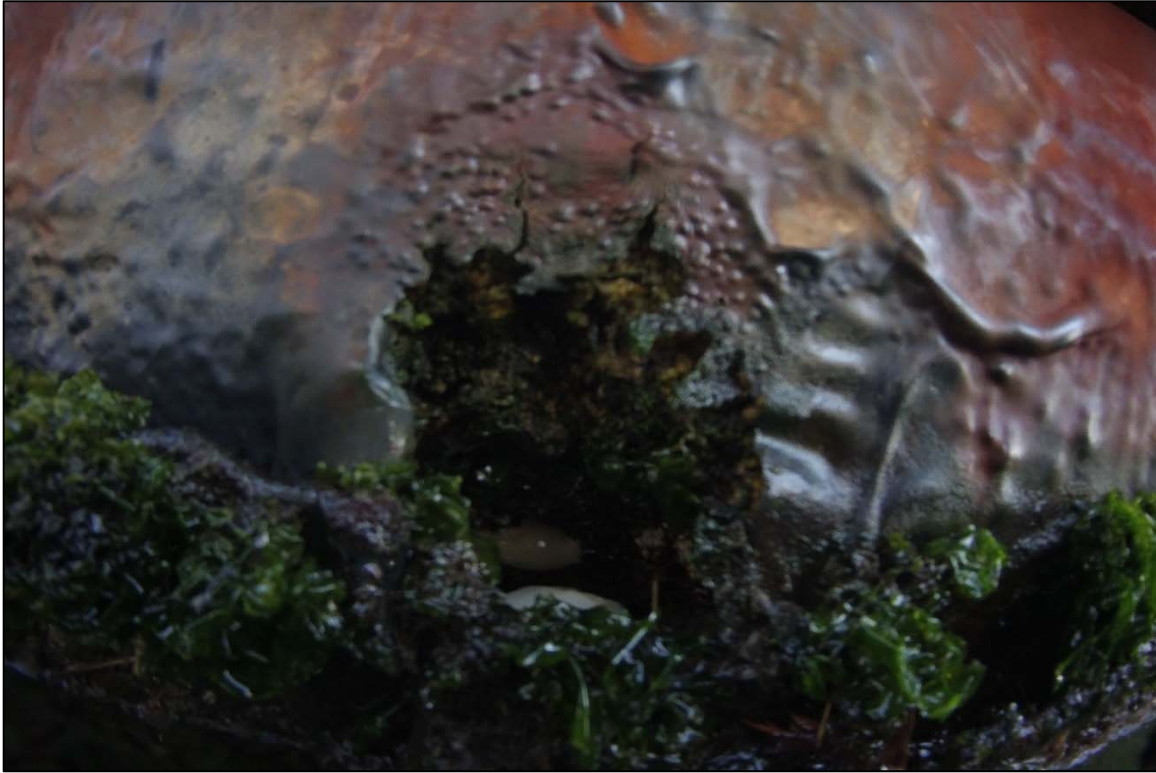
Photograph 17: View of the Heat Damage (Melted Plastic) Float 4 Shown, Looking North.

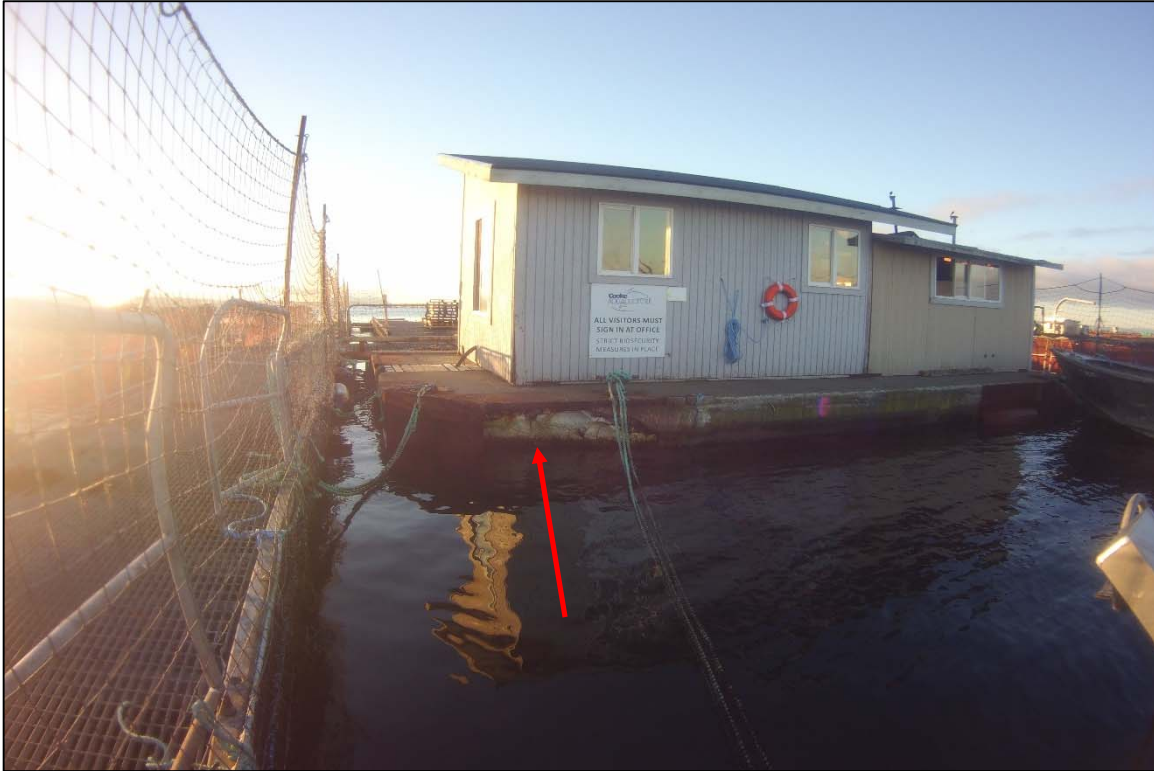
Photograph 21: View of the Storage Buildings Located between Pens 6 and 8 and Area of Deterioration at the Southeast Corner, Looking West.

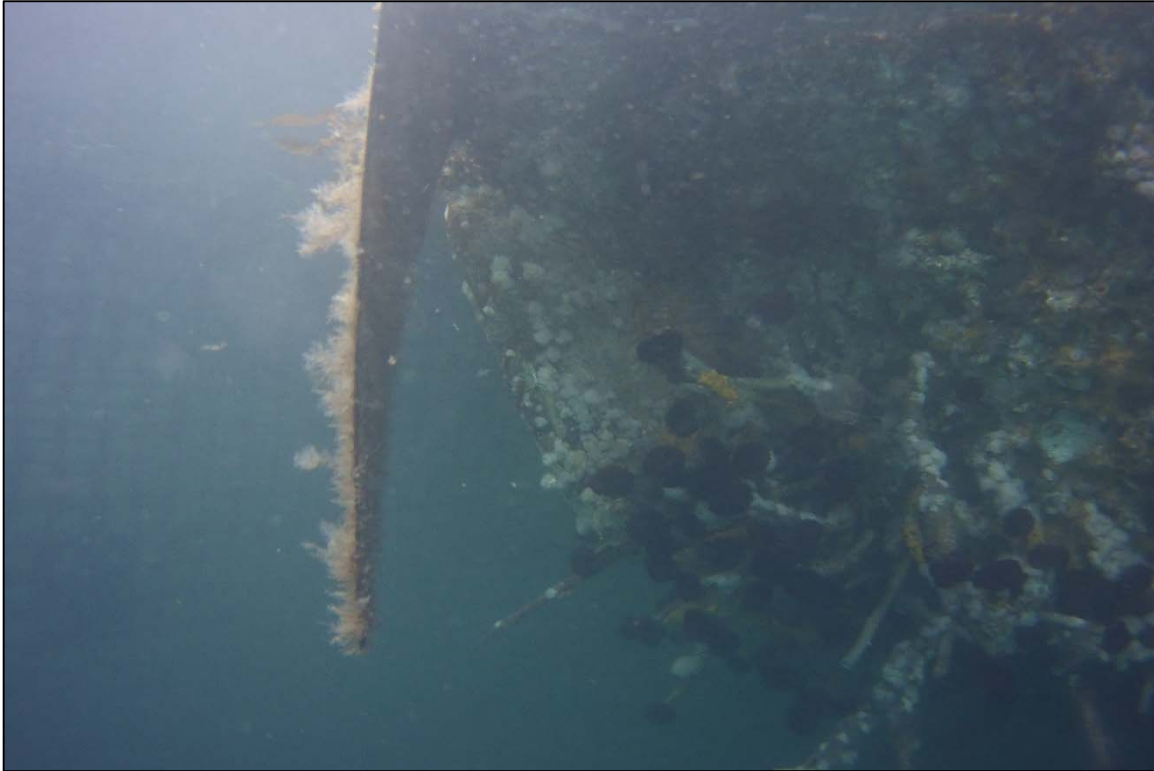
The building support float was constructed of concrete and was typically found to be in fair to poor condition with several areas of significant section loss noted along the east face. The floats typically exhibited up to 2 ft thick marine growth on 100% of the submerged surface areas. The areas of damage along the east face included:

- There was an 8 ft long by 5 ft tall area of missing concrete with exposed reinforcing wire at the southeast corner. The exposed floatation foam had 1 ft penetration at the top and 5 ft penetration at the bottom of the defect.
- Three steel plates were attached to the outside edge of the east face (purpose of plates is unknown). The middle plate had a 2.5 ft long horizontal crack.
- There was an area of missing concrete with exposed reinforcing wire at the northeast corner that extended 6 ft horizontally on the east face and 3 ft horizontally on the north face and was 2 ft tall. The exposed floatation foam had 1 ft penetration throughout the defect.

Photograph 23: View of the Area of Section Loss and Exposed Foam Floatation on the Southeast Corner of the Building Barge Float, Looking South.

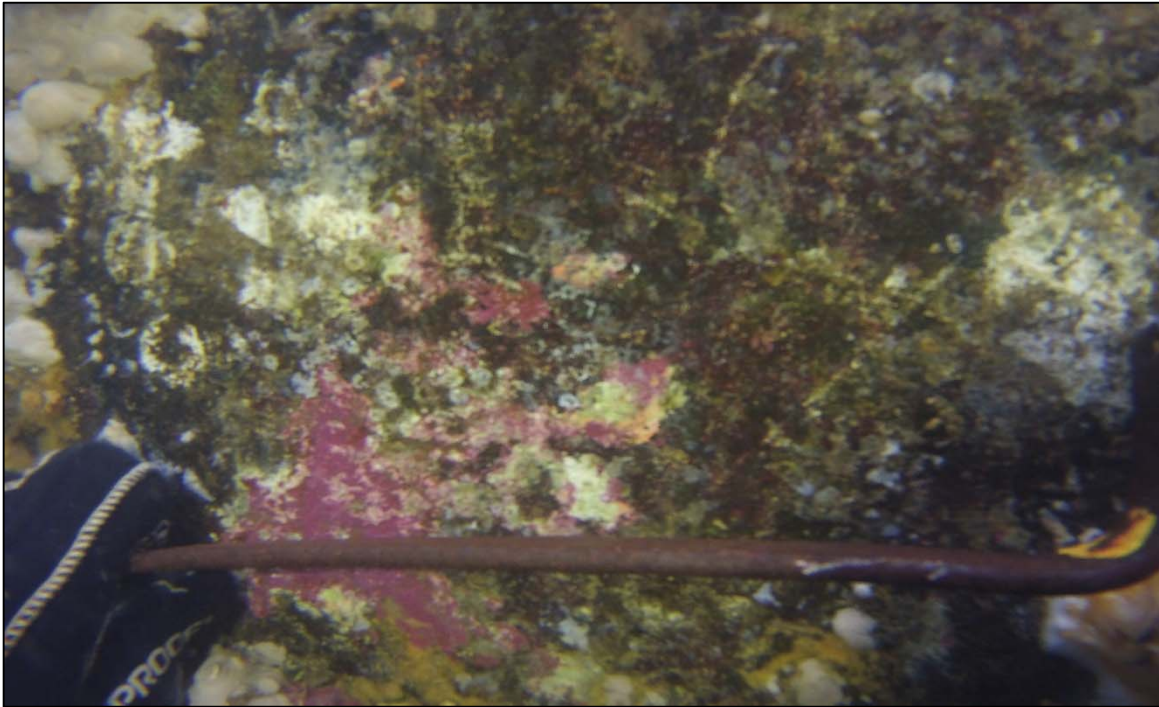
Photograph 25: View of Typical Concrete Condition of the Office Building Barge Float, Looking East.

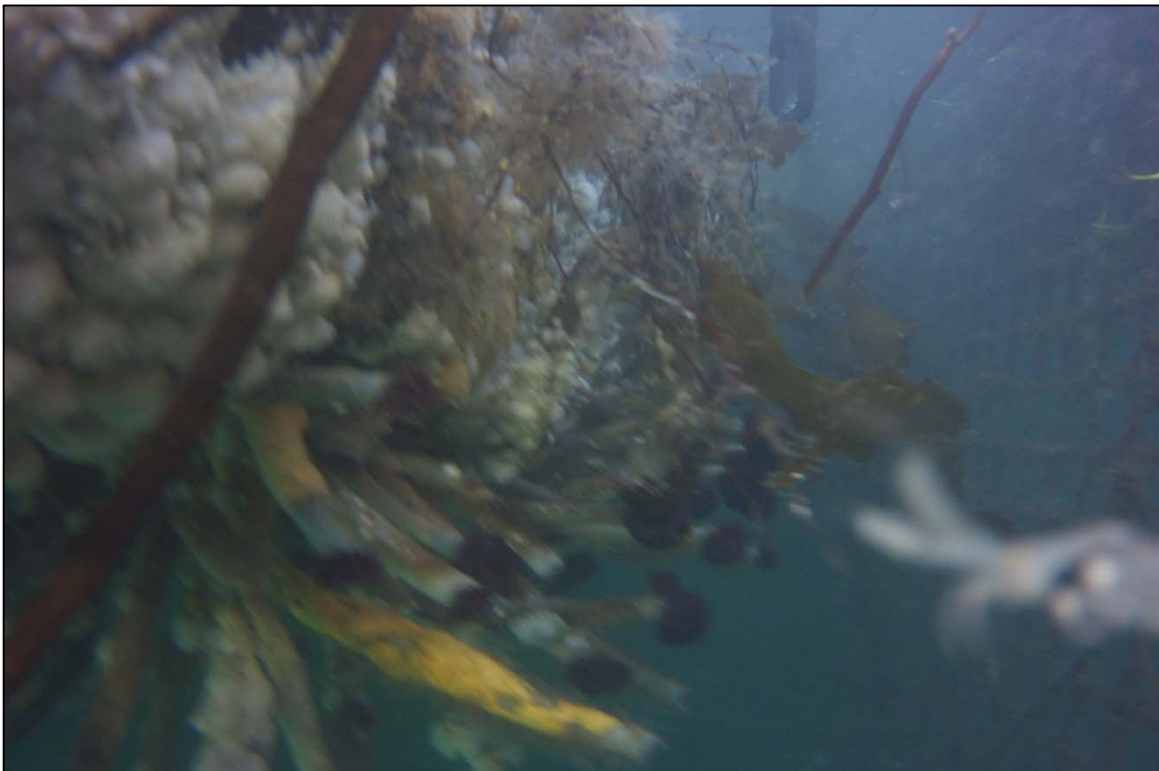
Photograph 26: View of Typical Heavy Marine Growth on the Bottom of the Office Building Barge, Looking West.

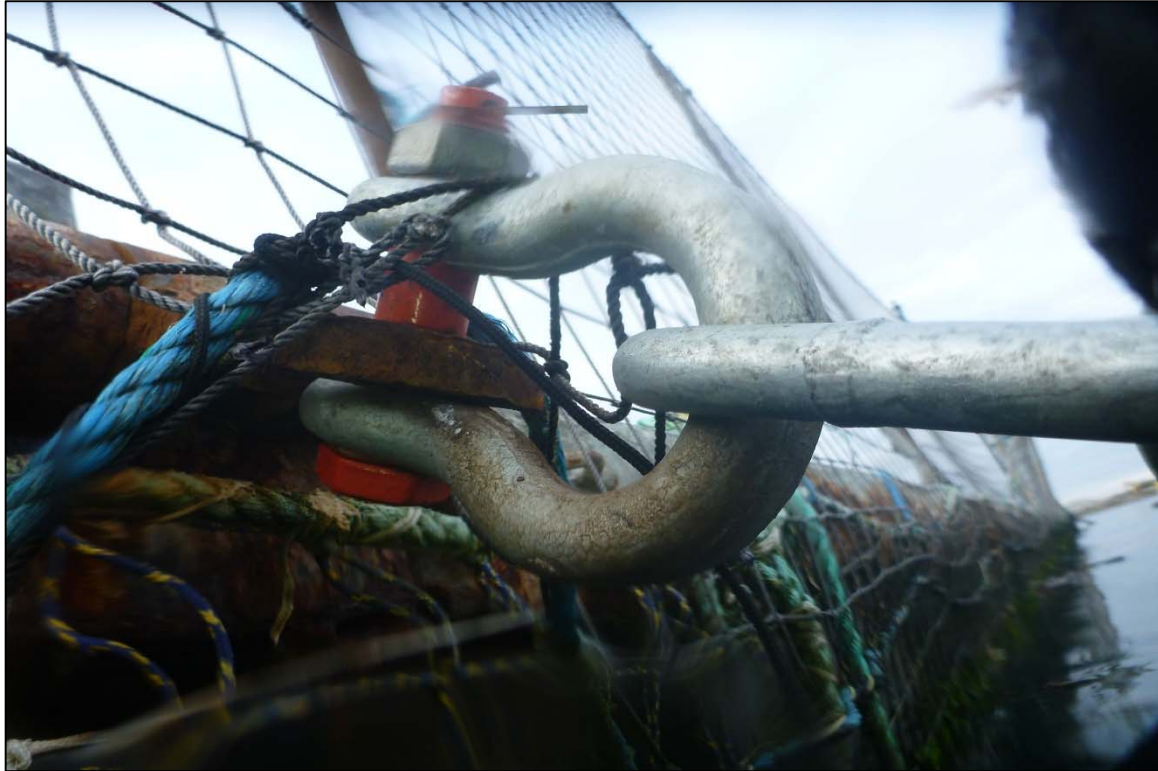
Photograph 27: View of the Upper Pen to Anchor Line Connection (Shackle and Padeye) at Anchor Line 2, Looking West.

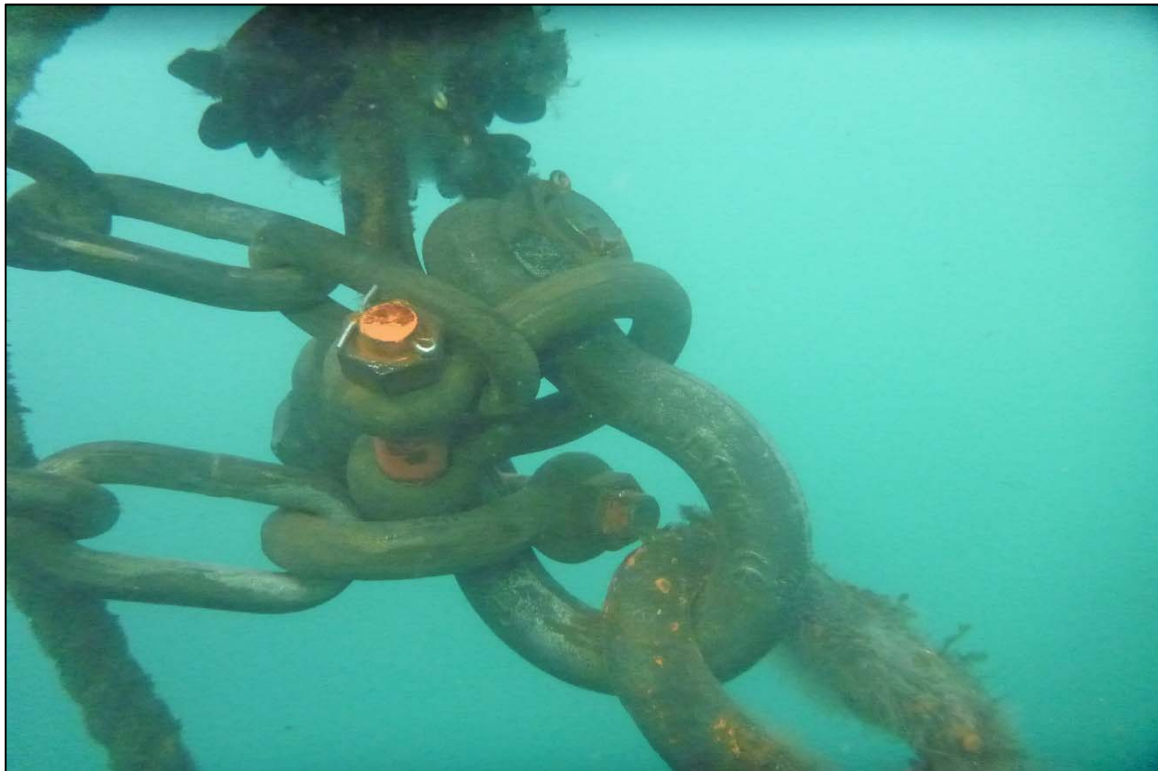
Photograph 28: View of Bridle Chain, Buoy, Anchor Chain Connection (Shackles and Chain) at Anchor 2, Looking South.

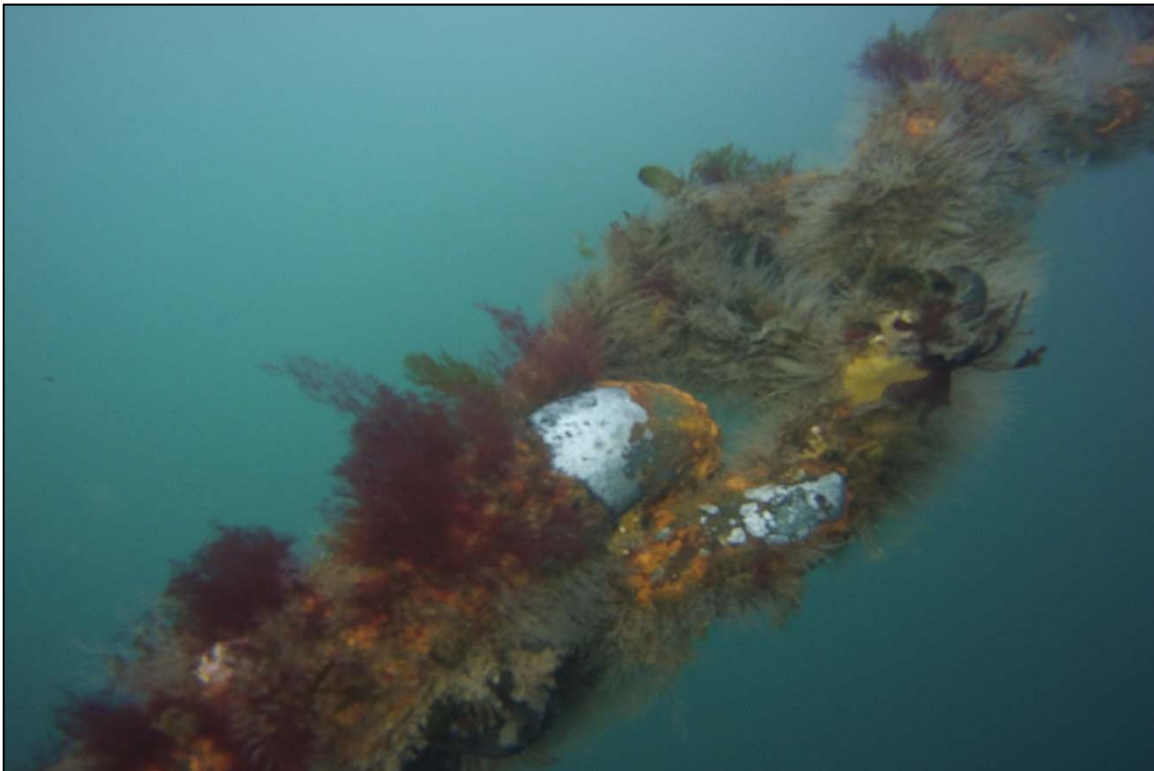
Photograph 30: View of Upper Chain Condition with Heavier Marine Growth at Anchor 8 (Typical), Looking North.

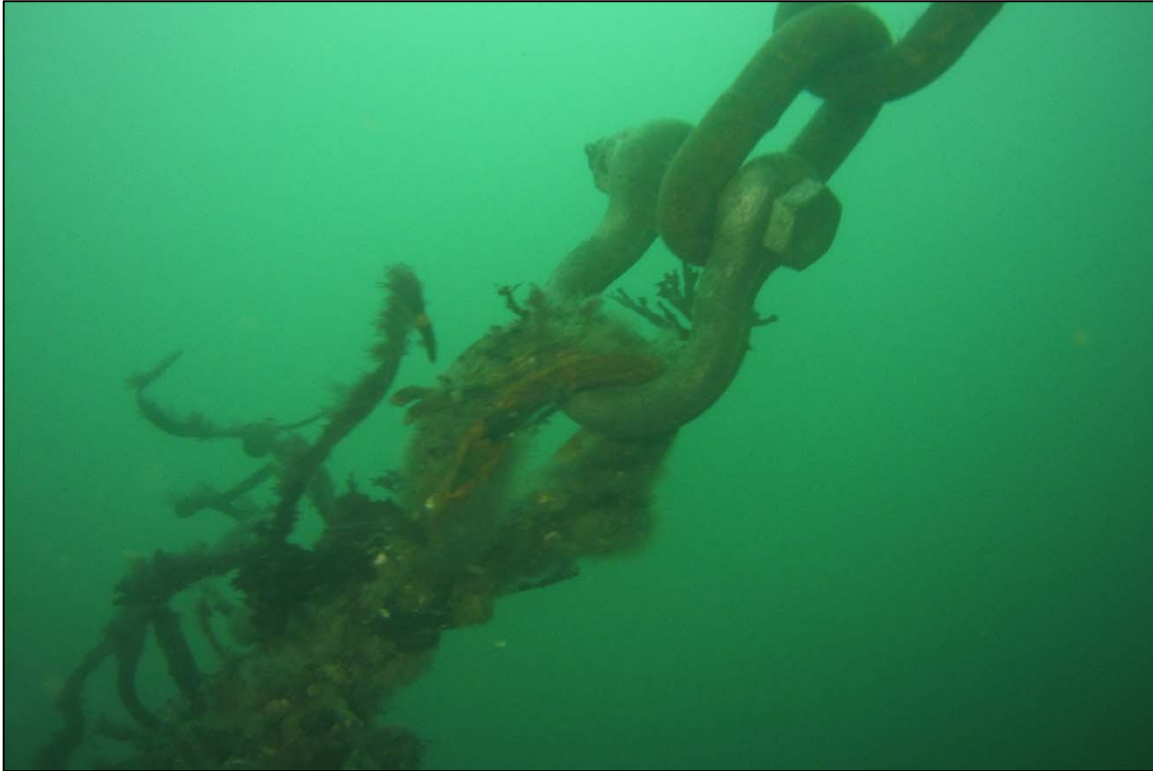
Photograph 31: View of the Upper Rope to Chain Connection at Anchor Line 15 (Typical), Looking South.

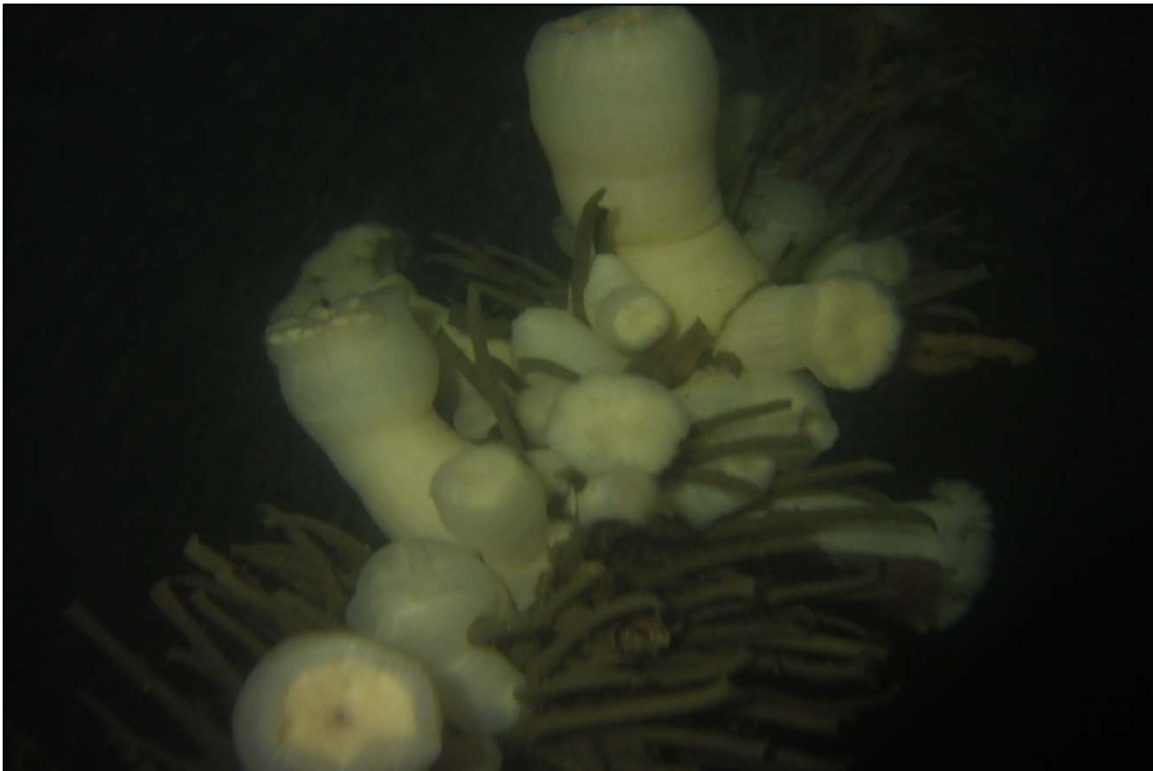
Photograph 32: View of Rope with Heavy Marine Growth at Anchor 8 (Typical), Looking South.

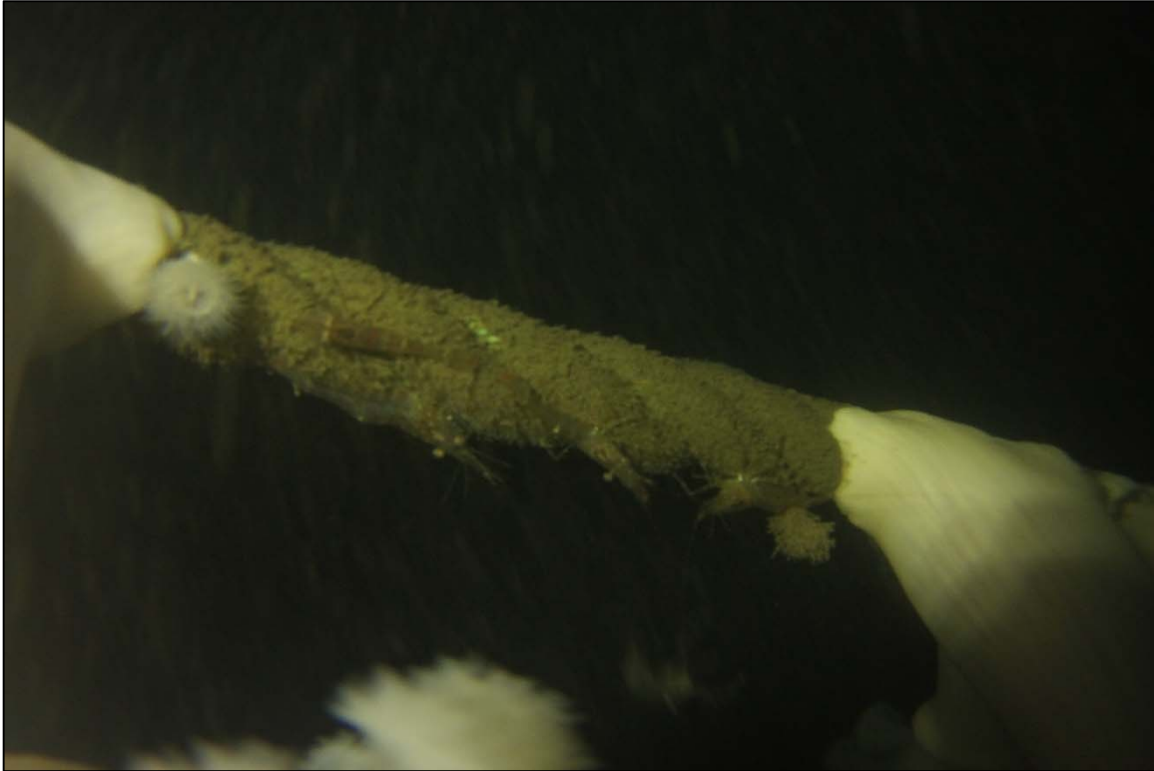
Photograph 33: View of Rope with Minor Marine Growth at Anchor 10 (Typical), Looking South.

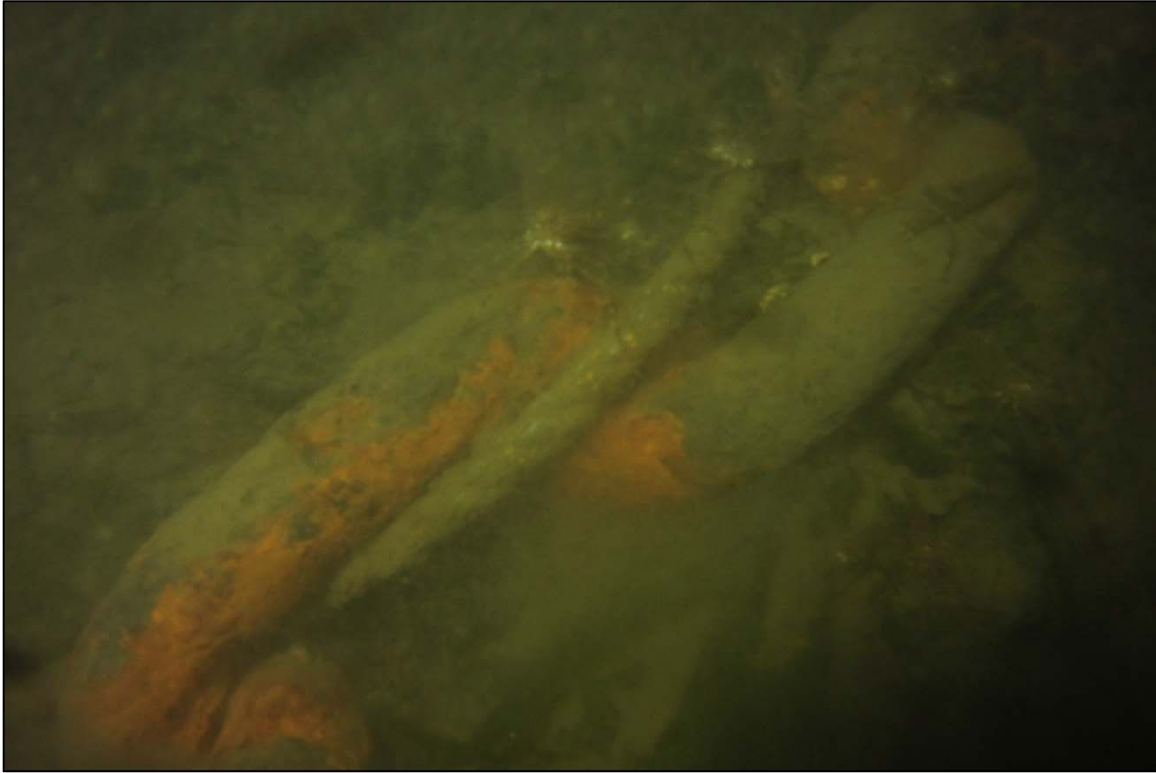
Photograph 35: View of the Anchor Chain on the Channel Bottom at Anchor Line 21 (Typical Observed by Diver), Looking North.

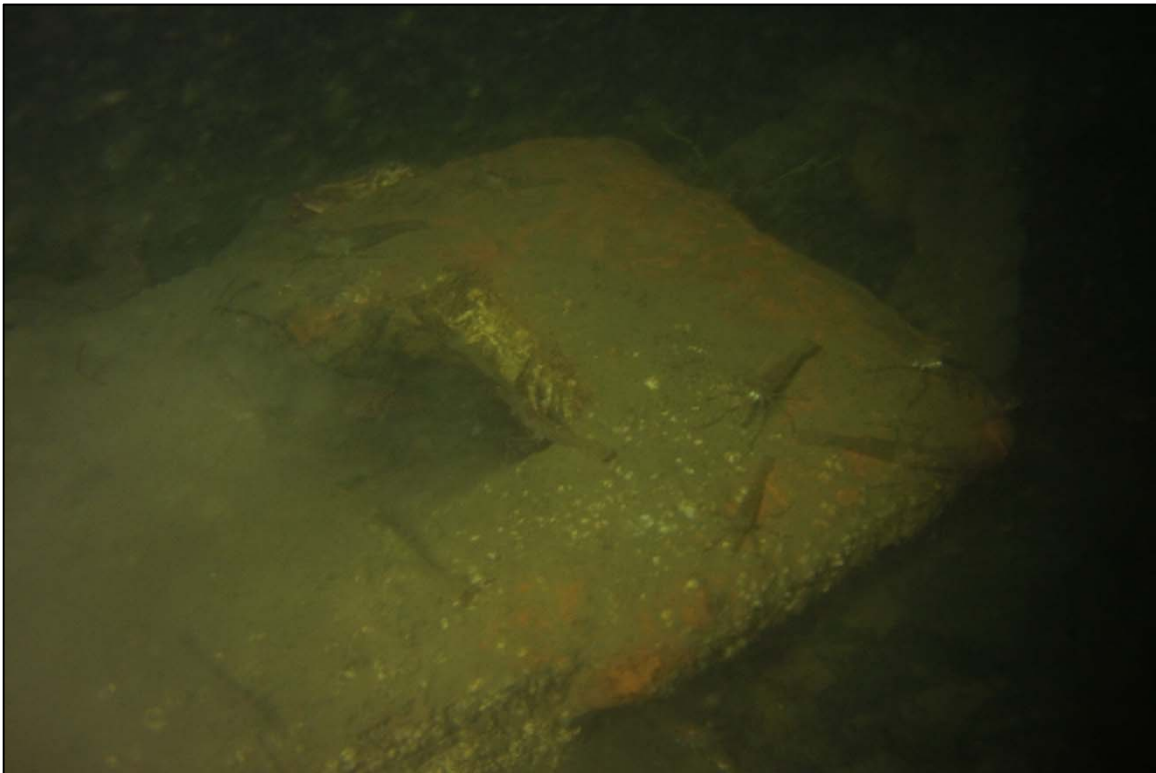
Photograph 36: View of the top of the Anchor at Anchor Line 21 (Typical Observed by Diver), Looking North.

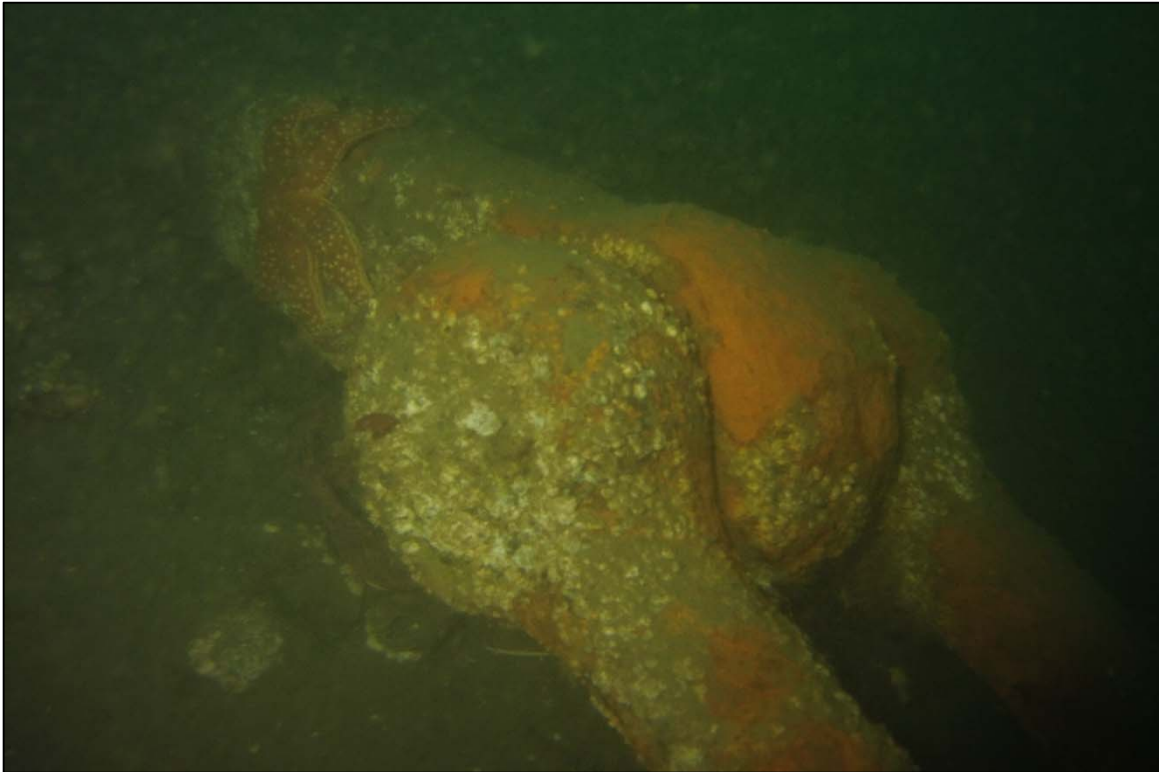
Photograph 36: View of Anchor Stem to Anchor Chain Connection at Anchor 22 (Typical Observed by Diver), Looking Southwest.

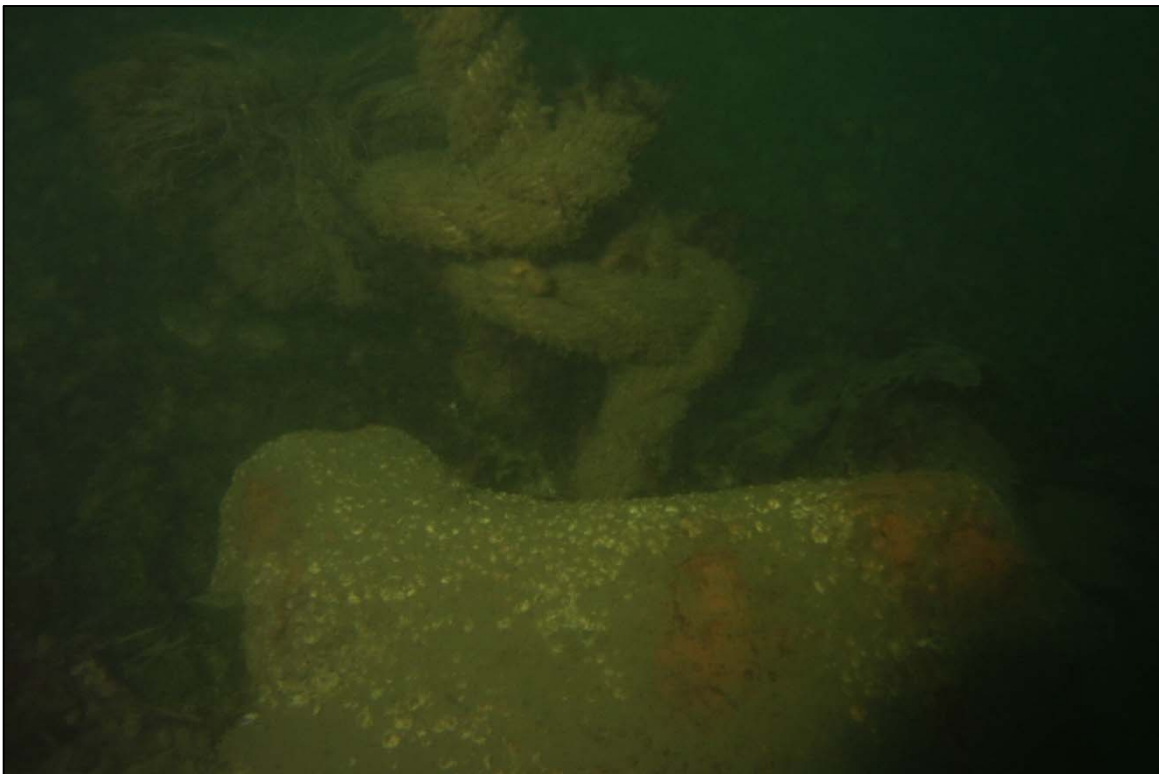
Photograph 38: View of Anchor Head at Anchor 22 (Typical Observed by Diver), Looking South.

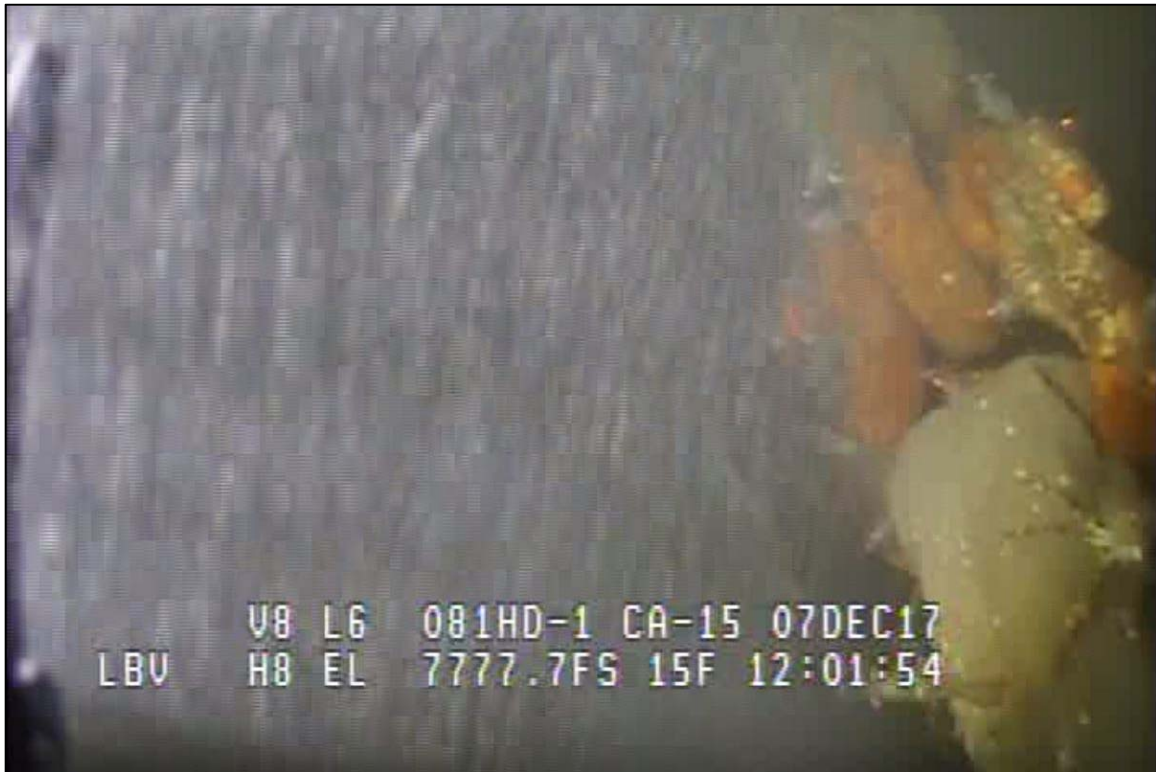
Photograph 39: View of Lower Anchor Chain to Rope Connection at Primary System Anchor Line 4, Looking East.

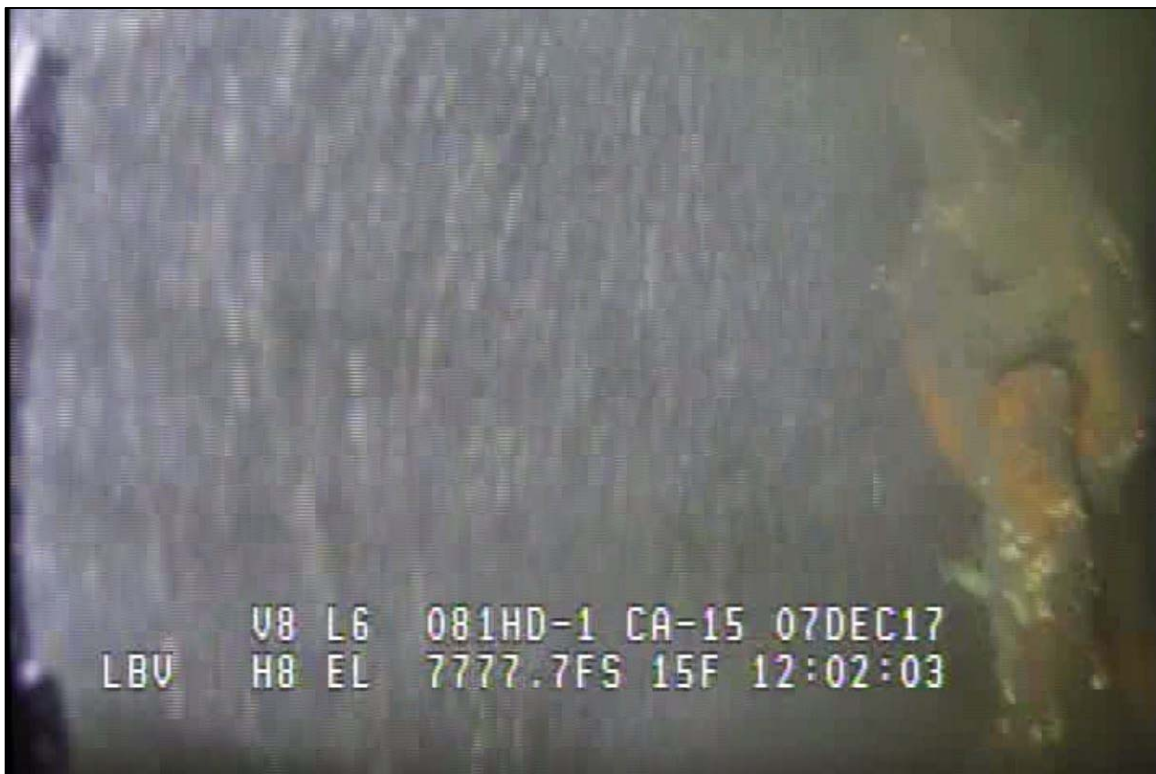
Photograph 40: View of Lower Anchor Chain Condition (Typical) at Primary System Anchor Line 4, Looking East.

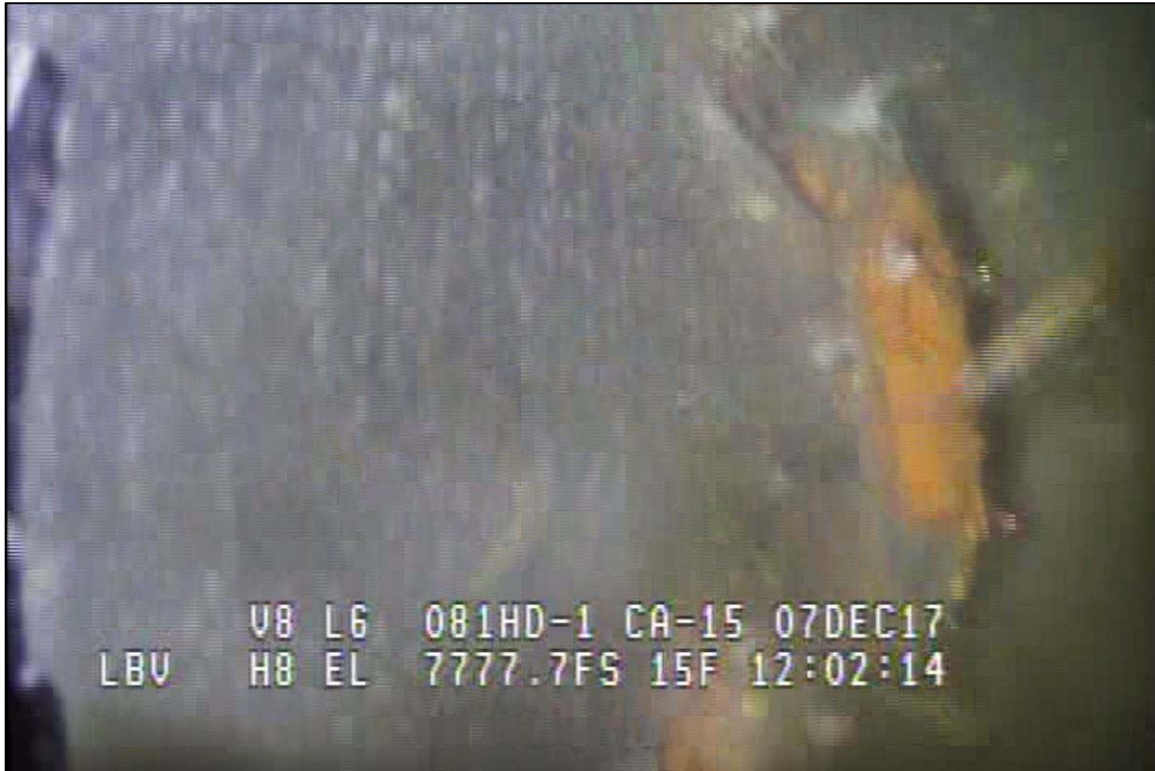
Photograph 41: View of Lower Anchor Chain Embedment in the Channel Bottom at Primary System Anchor Line 4, Looking East.

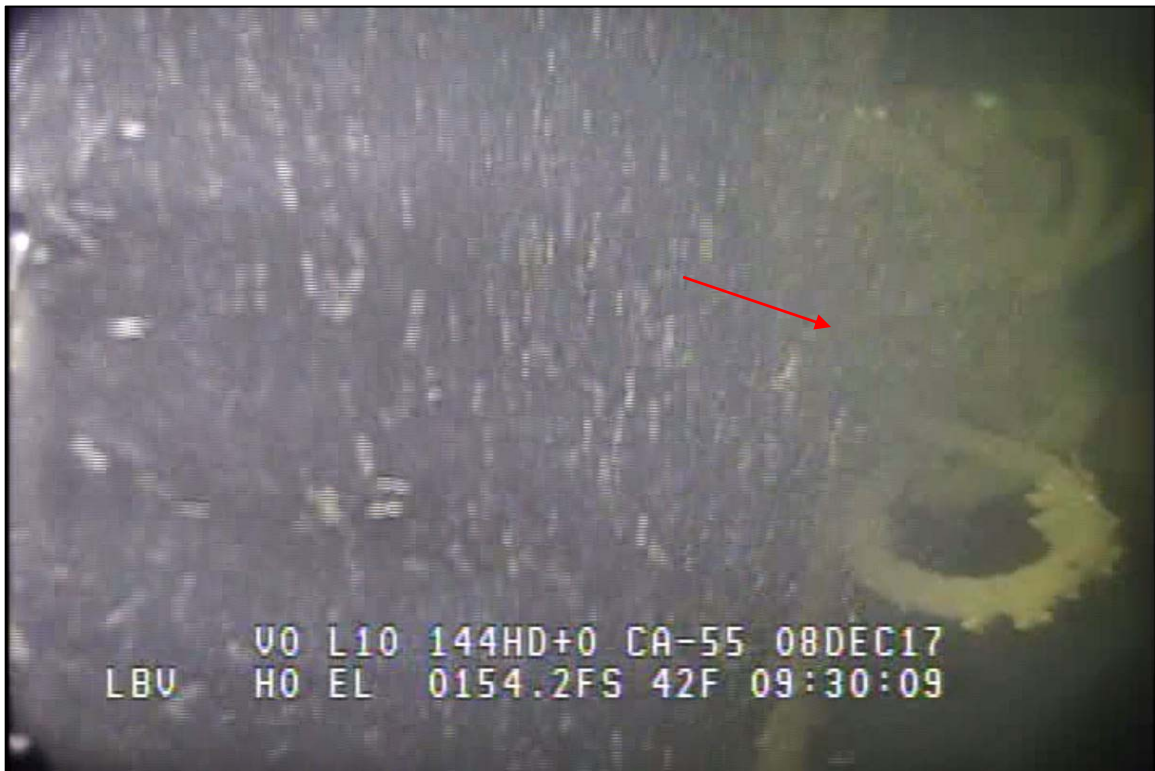
Photograph 42: View of Knots in the Anchor Line Rope at Primary System Anchor Line 10A1, Looking South.

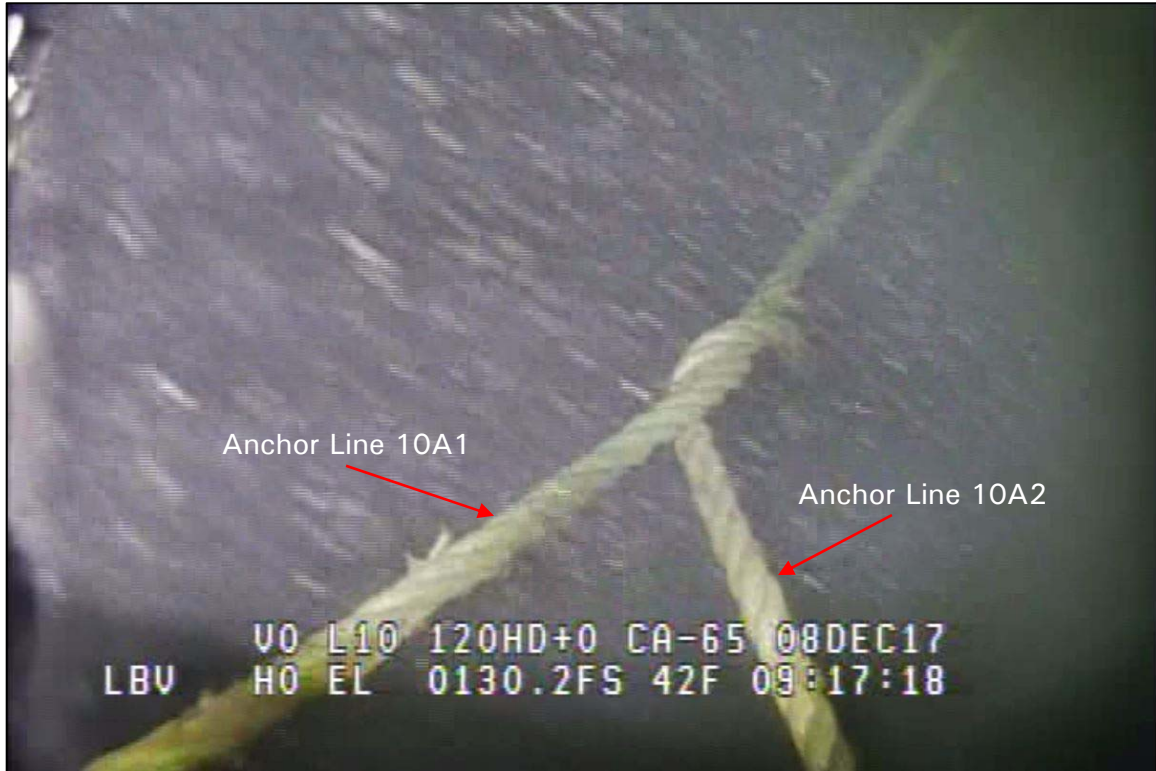
Photograph 43: View of Primary System Anchor Line 10A2 wrapped around Primary System Anchor Line 10A1, Looking South.

wrapped anchor lines condition at the intersection of Anchor Lines 10A1 and 10A2 should be rectified to ensure both anchor lines functioned as intended.

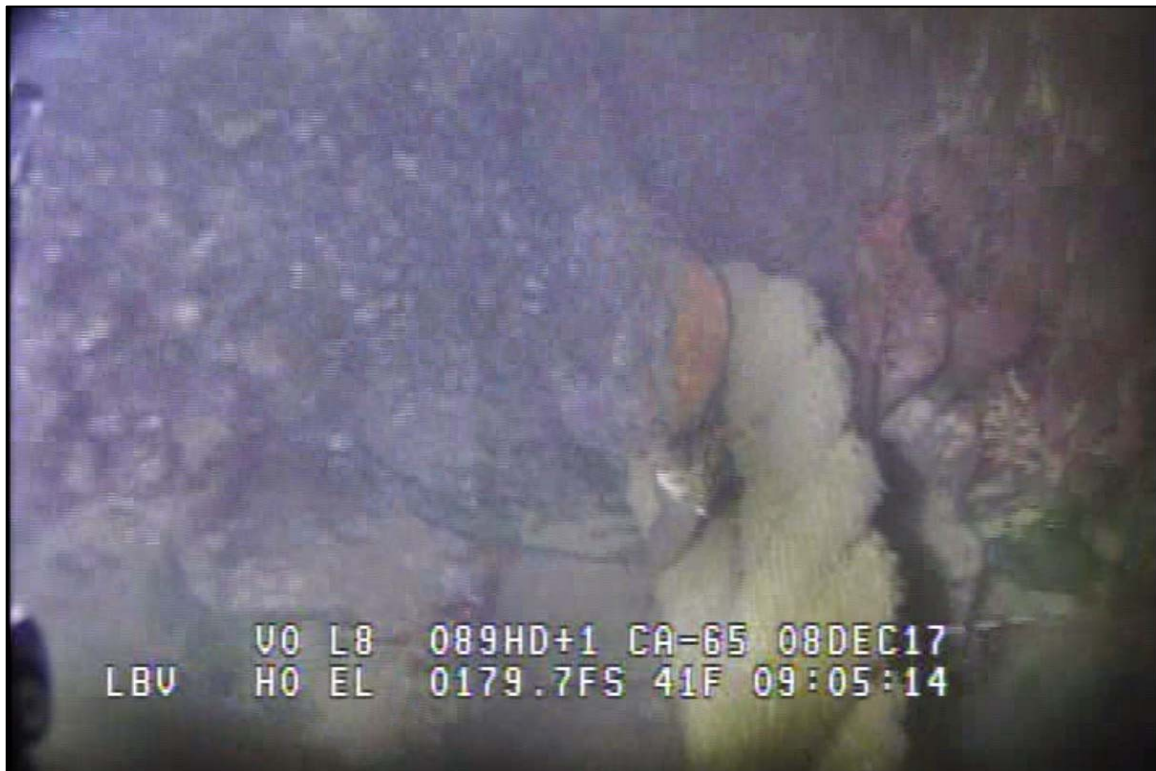
Photograph 44: View of Lower Anchor Chain to Rope Connection (Rope and Shackle) at Primary System Anchor Line 11, Looking South.

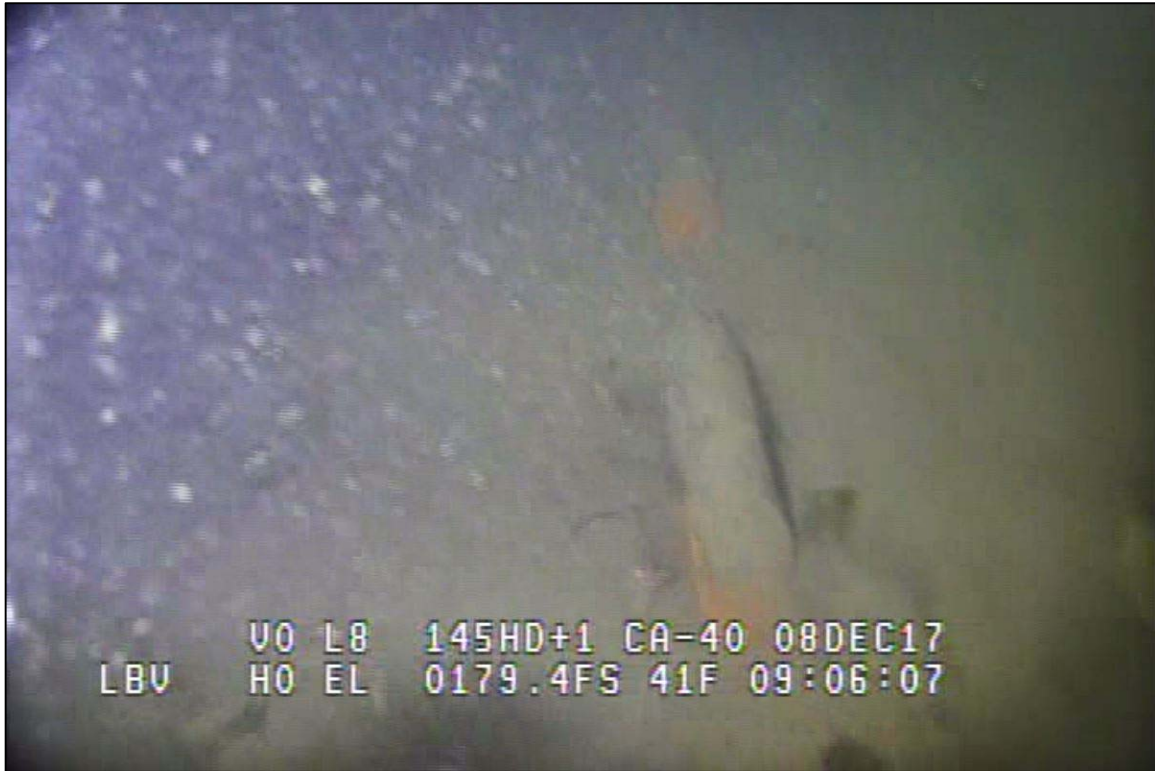
Photograph 45: View of Lower Anchor Chain Embedment in the Channel Bottom at Primary System Anchor Line 11, Looking South.
