Port Angeles Primary Atlantic Salmon Net Pens Engineering Assessment

January 29, 2018

Document reference: 391980 | 2 | b

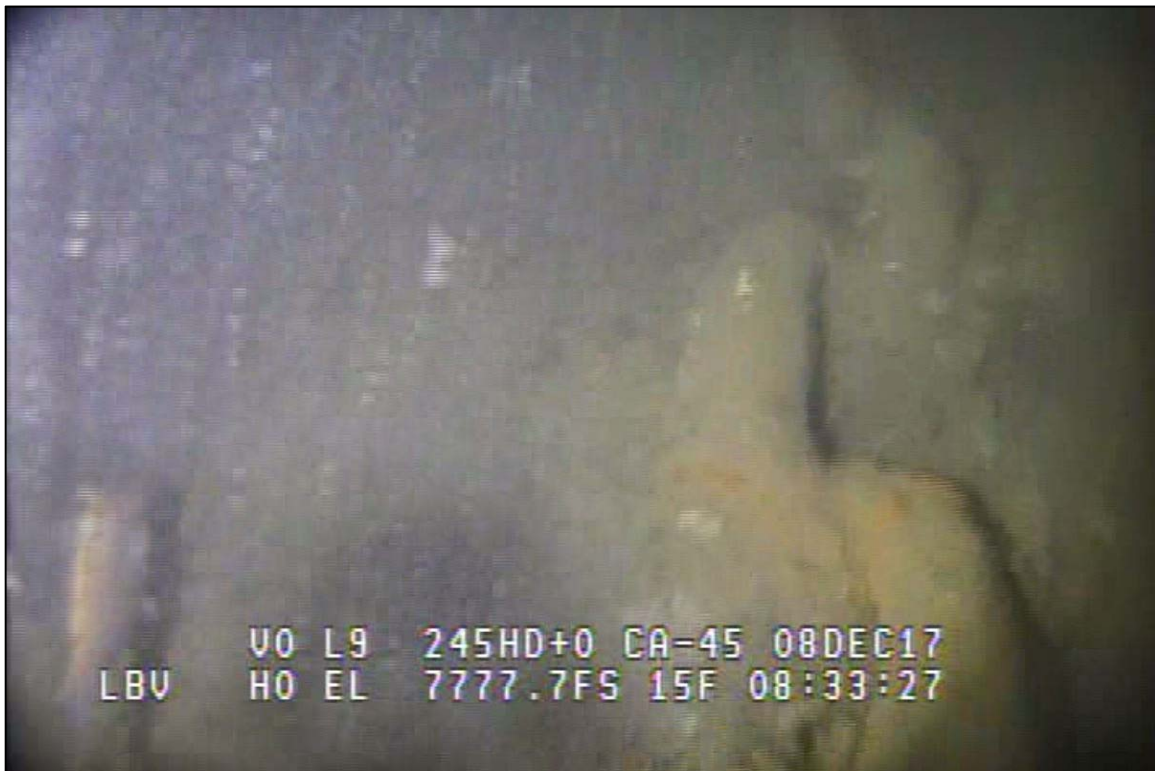
Photograph 46: View of Lower Anchor Chain Condition (Typical) at Primary System Anchor Line 12, Looking West.

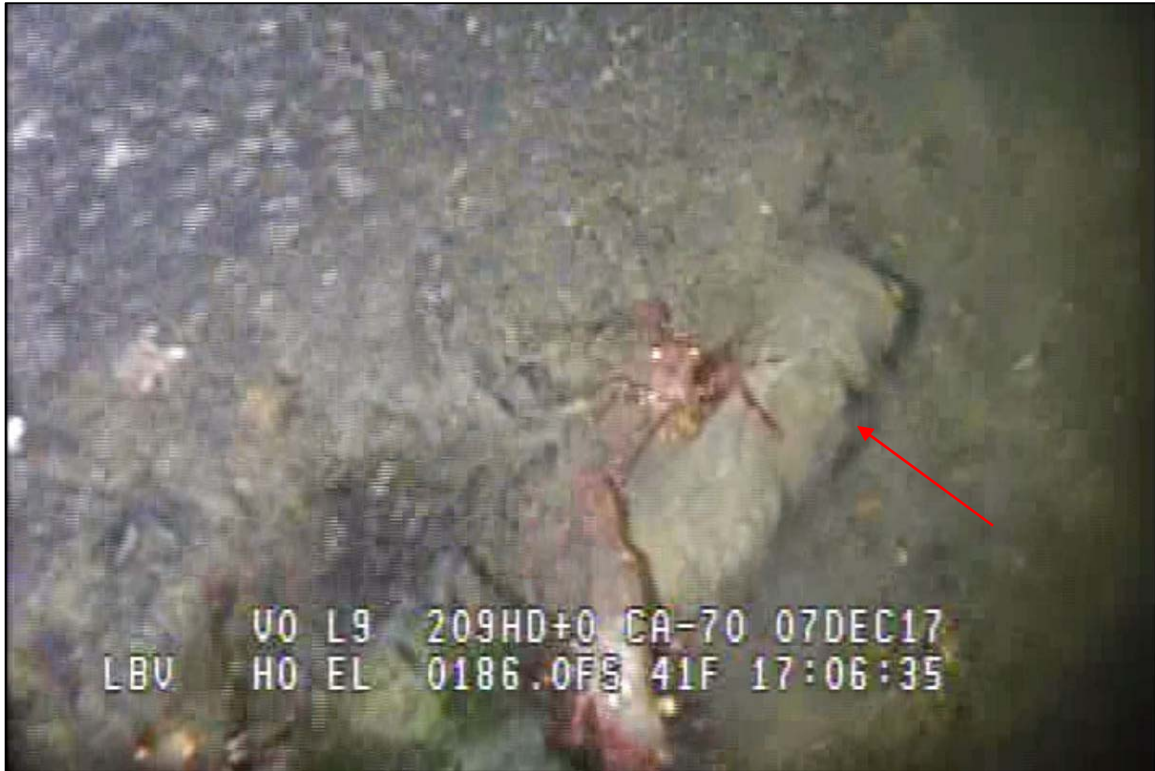
Photograph 47: View of Lower Anchor Chain Embedment in the Channel Bottom at Primary System Anchor Line 13, Looking West.

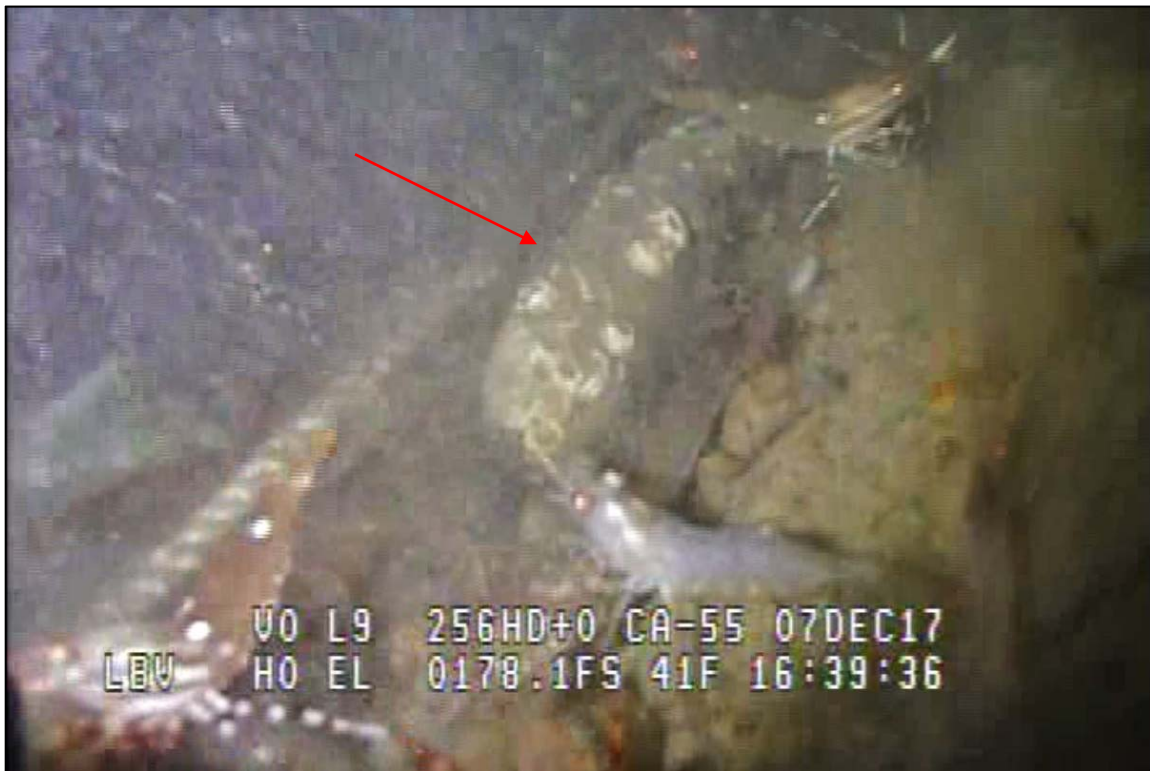
Photograph 52: View of Lower Anchor Chain Embedment in the Channel Bottom at Primary System Anchor Line 14, Looking West.

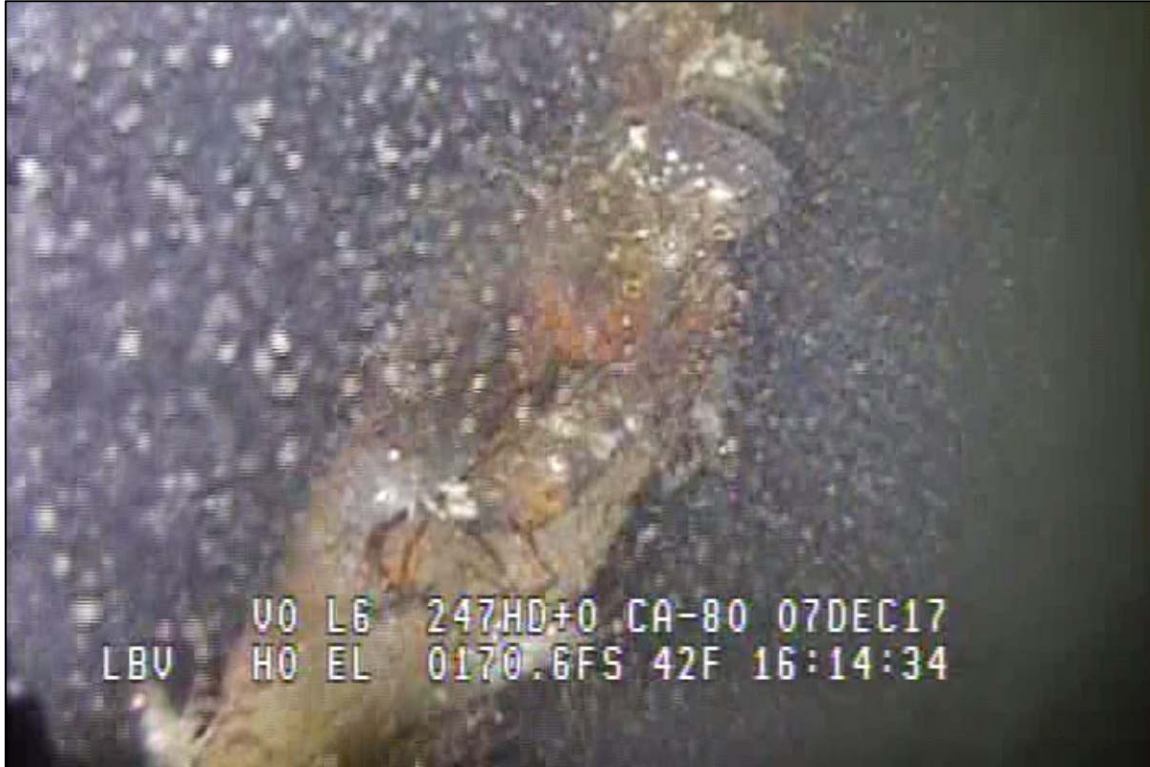
Photograph 53: View of Lower Anchor Chain to Rope Connection (Thimble and Shackle) at Primary System Anchor Line 15, Looking West.

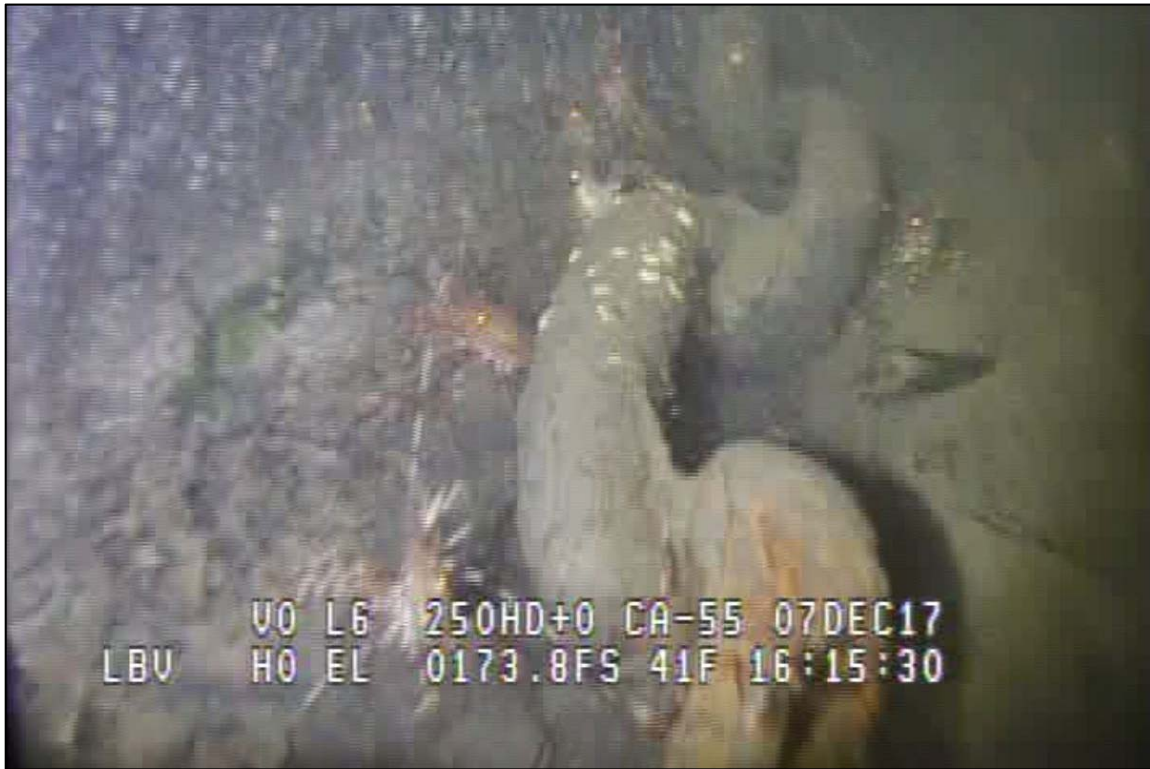
Photograph 54: View of Lower Anchor Chain Condition (Typical) at Primary System Anchor Line 15, Looking West.

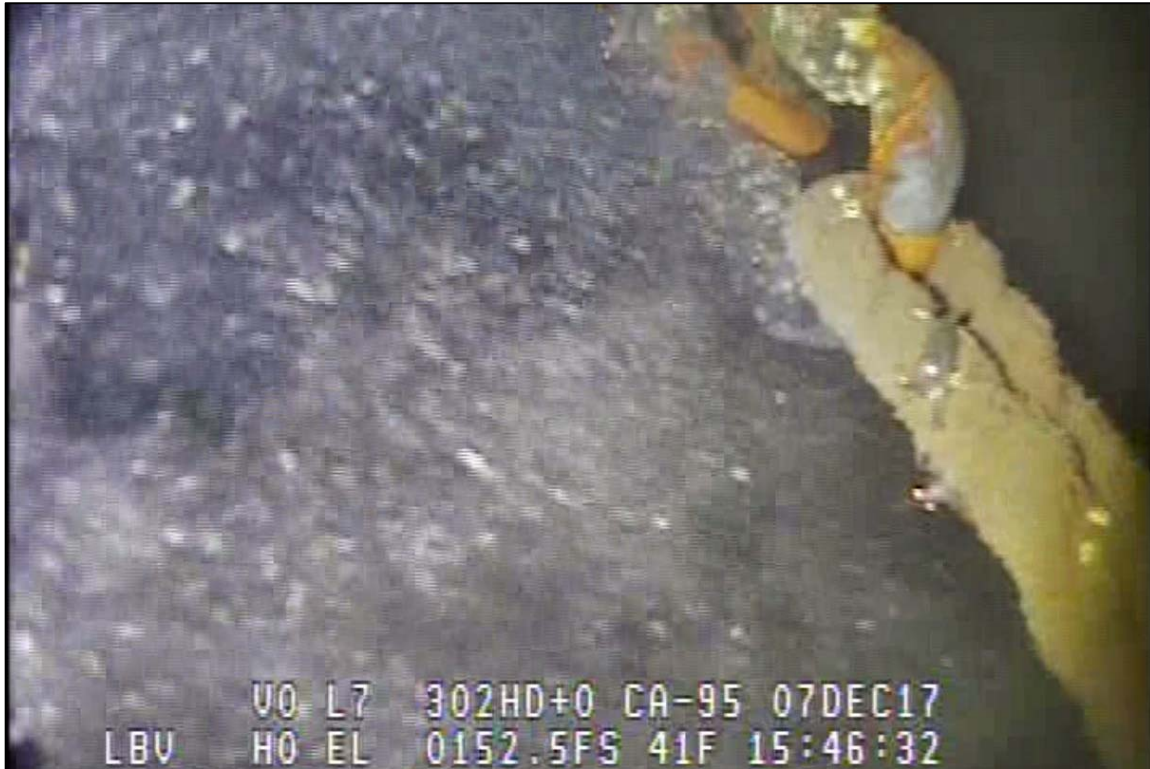
Photograph 55: View of Lower Anchor Chain to Rope Connection (Rope and Shackle) at Primary System Anchor Line 16, Looking West.

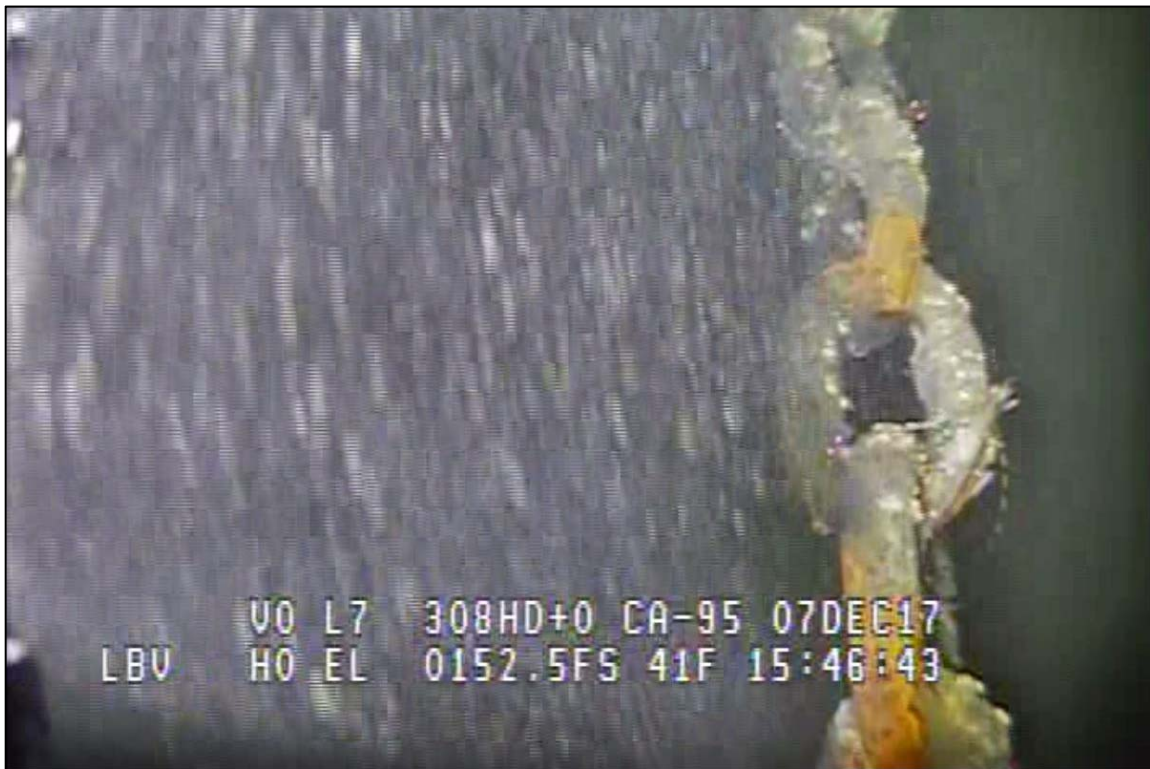
Photograph 56: View of Lower Anchor Chain Condition (Typical) at Primary System Anchor Line 16, Looking West.

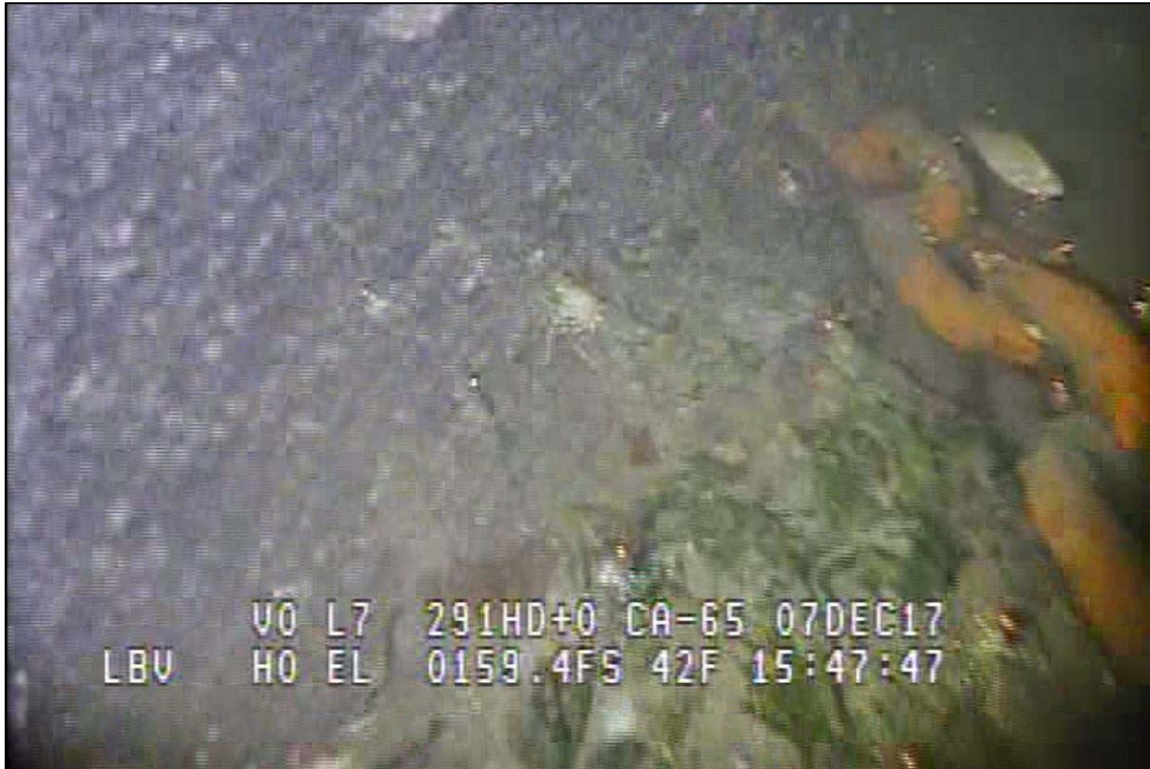
Photograph 57: View of Lower Anchor Chain on Channel Bottom at Primary System Anchor Line 16, Looking West.

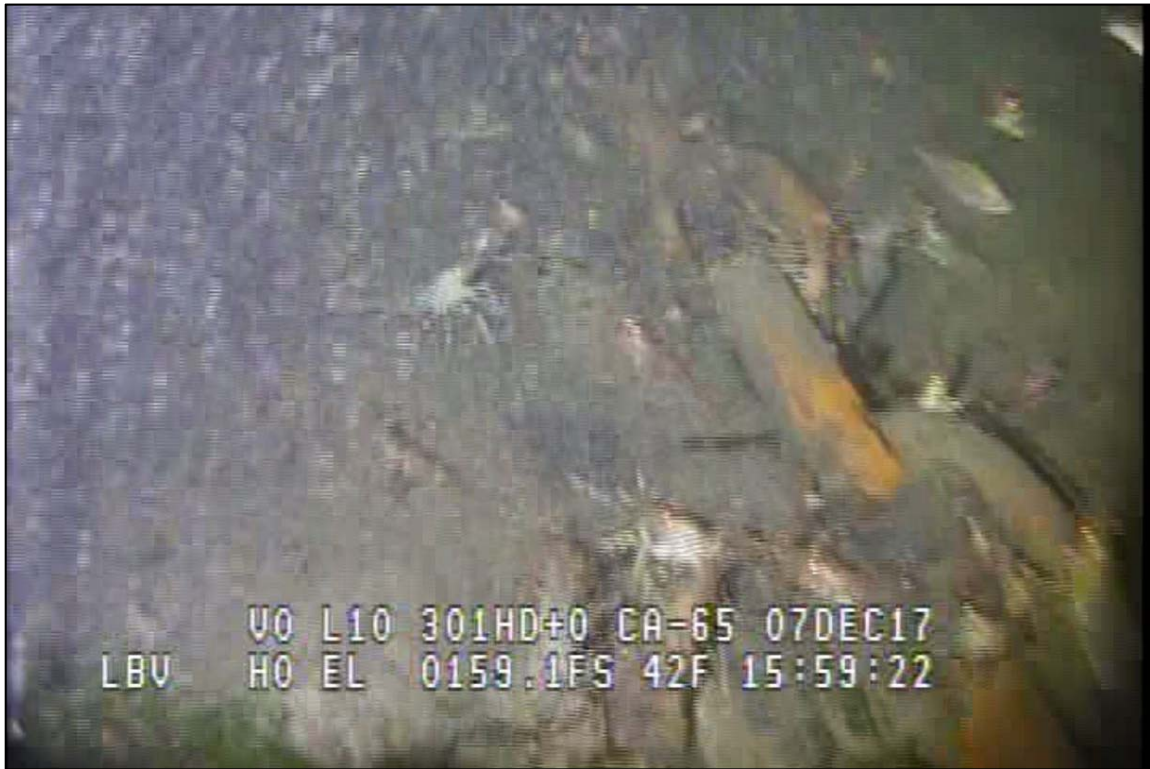
Photograph 59: View of Lower Anchor Chain Embedment in the Channel Bottom at Primary System Anchor Line 16, Looking West.

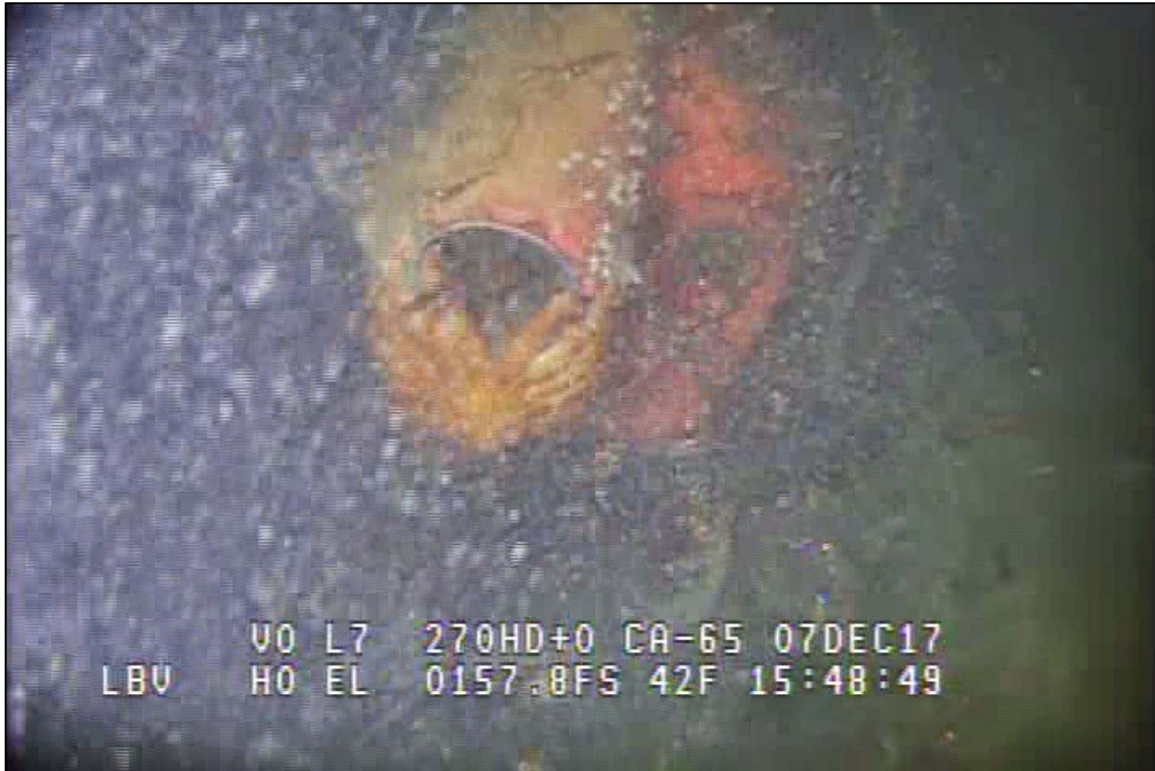
Photograph 60: View of Buoy and Ropes in the Channel Bottom where Lower Anchor Chain is Embedded at Primary System Anchor Line 16, Looking West.

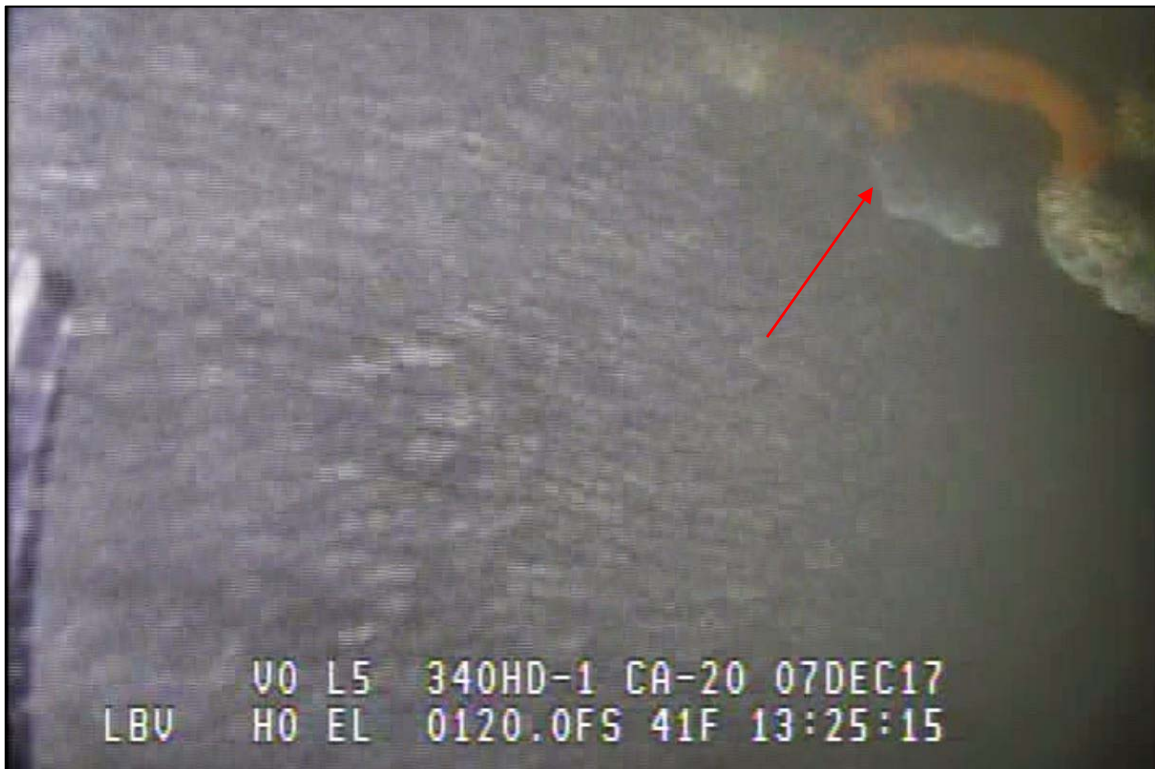
Photograph 61: View of Lower Anchor Chain Condition (Typical) at Primary System Anchor Line 18, Looking West.

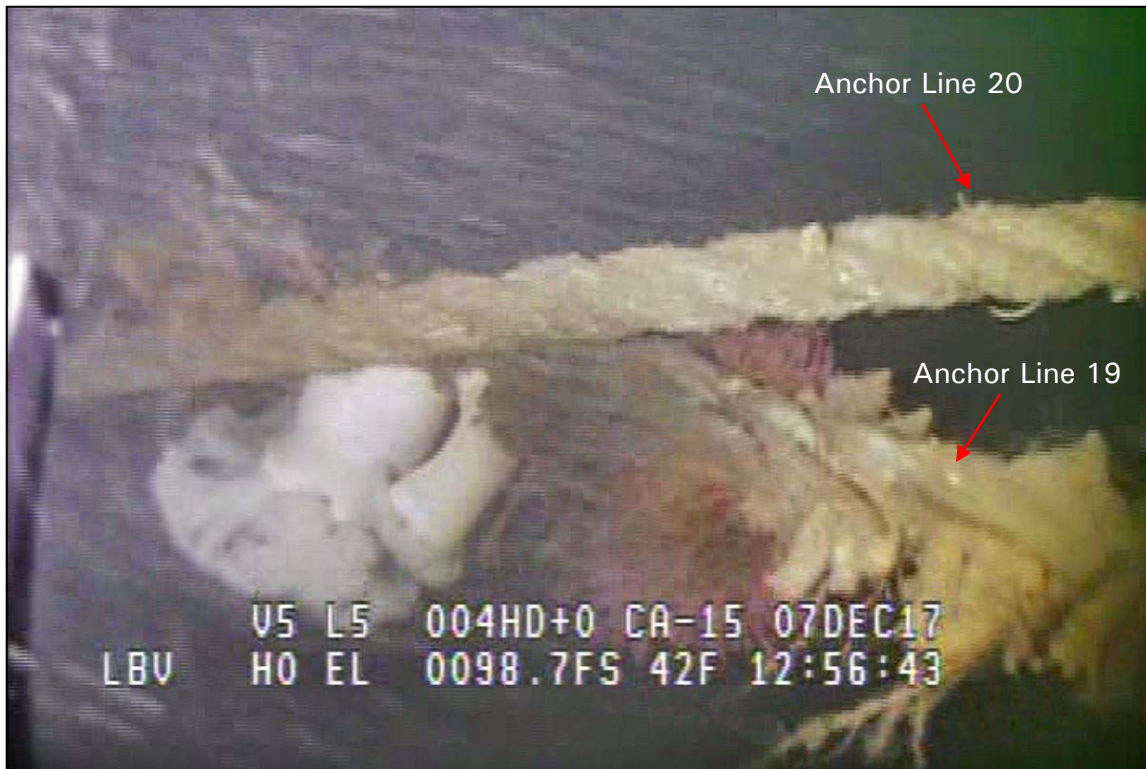
Photograph 62: View of Anchor Line 19 Crossing Below Anchor Line 20, Looking North.

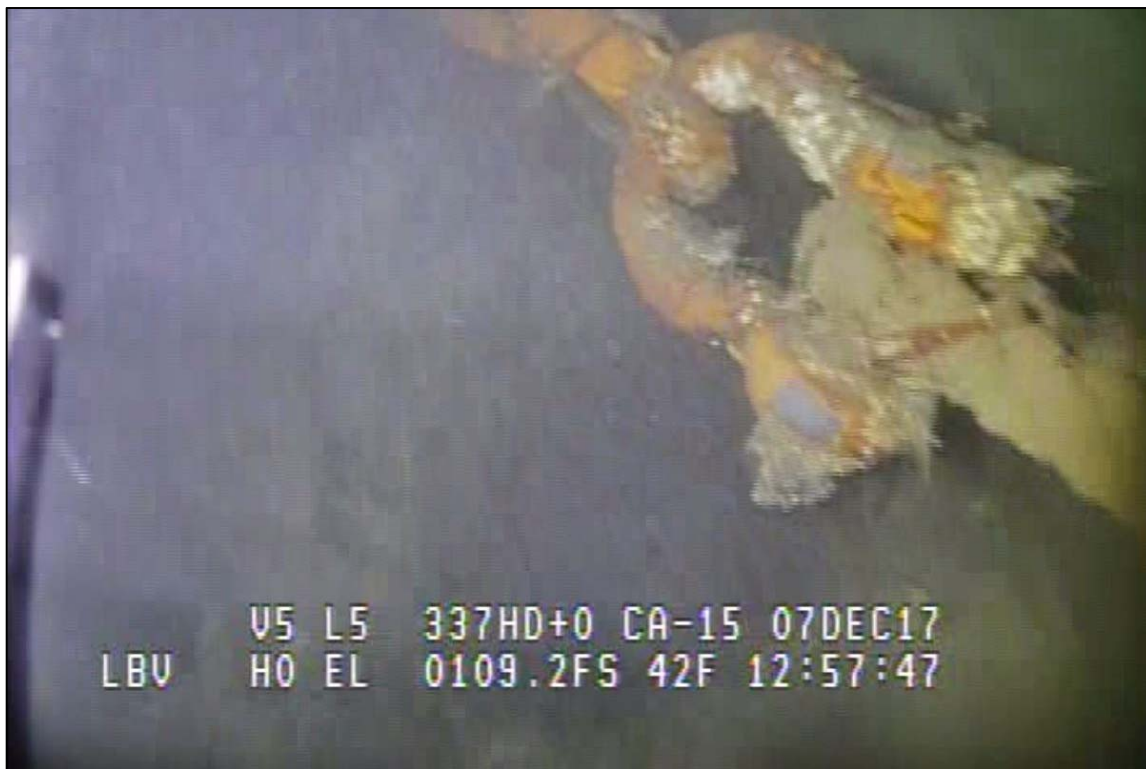
Photograph 63: View of Lower Anchor Chain to Rope Connection (Rope and Shackle) at Primary System Anchor Line 19, Looking Northwest.

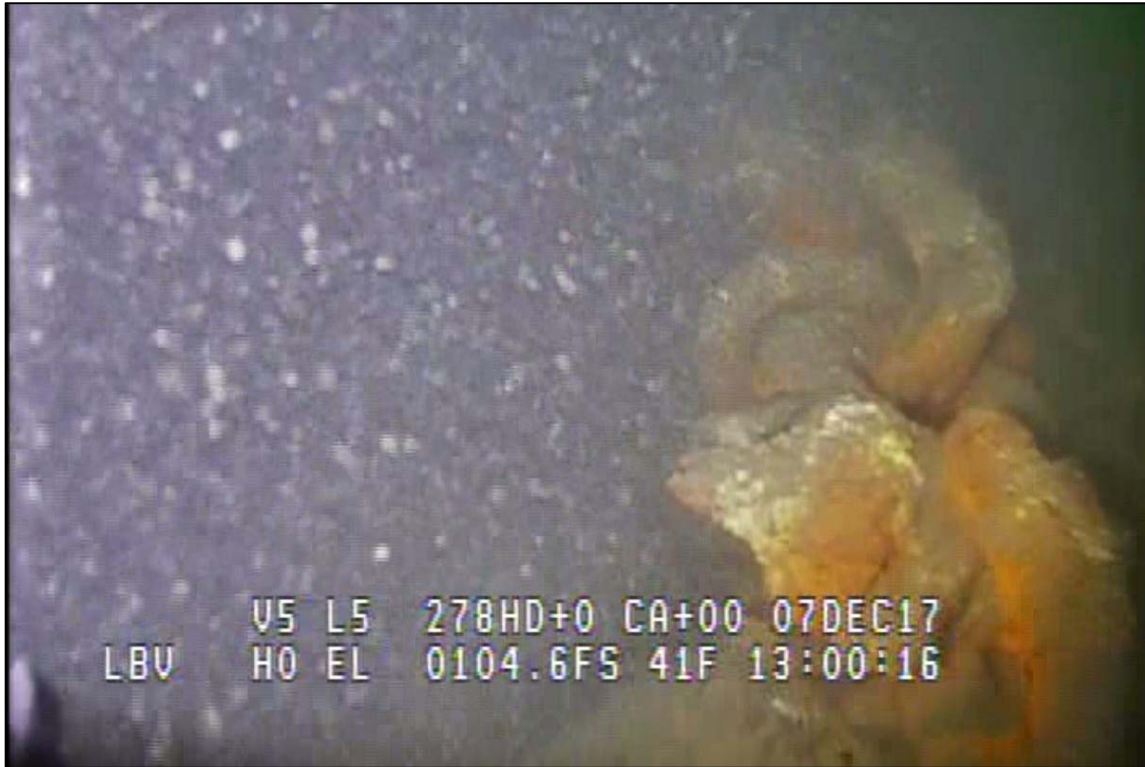
Photograph 66: View of Lower Anchor Chain to Anchor Connection (Shackle) at Primary System Anchor Line 19, Looking West.

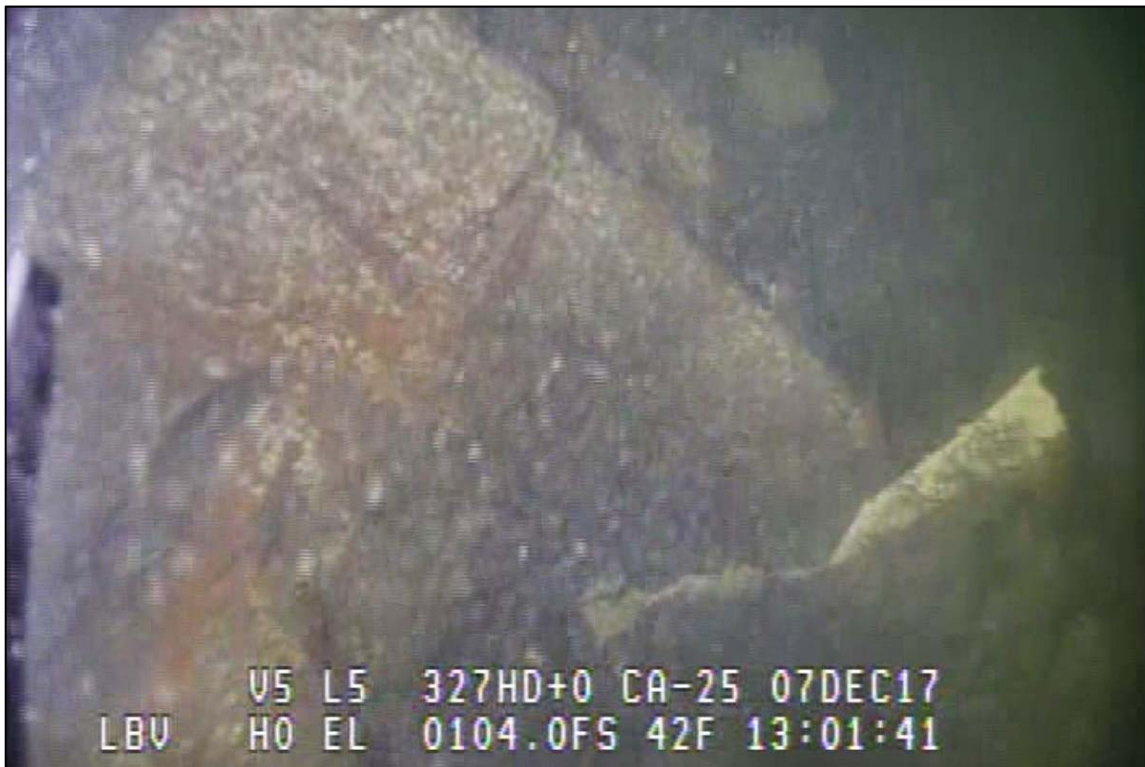
Photograph 67: View of Anchor North Fluke Embedment in the Channel Bottom at Primary System Anchor Line 19, Looking West.

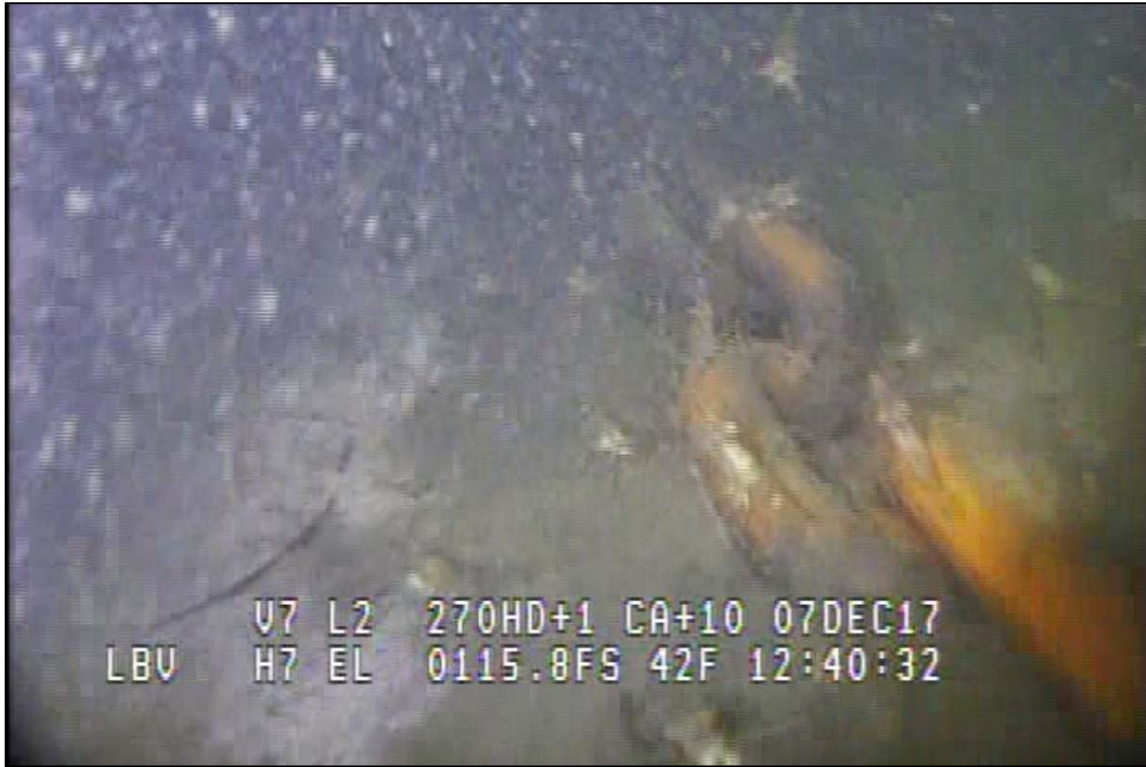
Photograph 69: View of Anchor 20 Crossing Above Anchor Line 19, Looking Southwest.

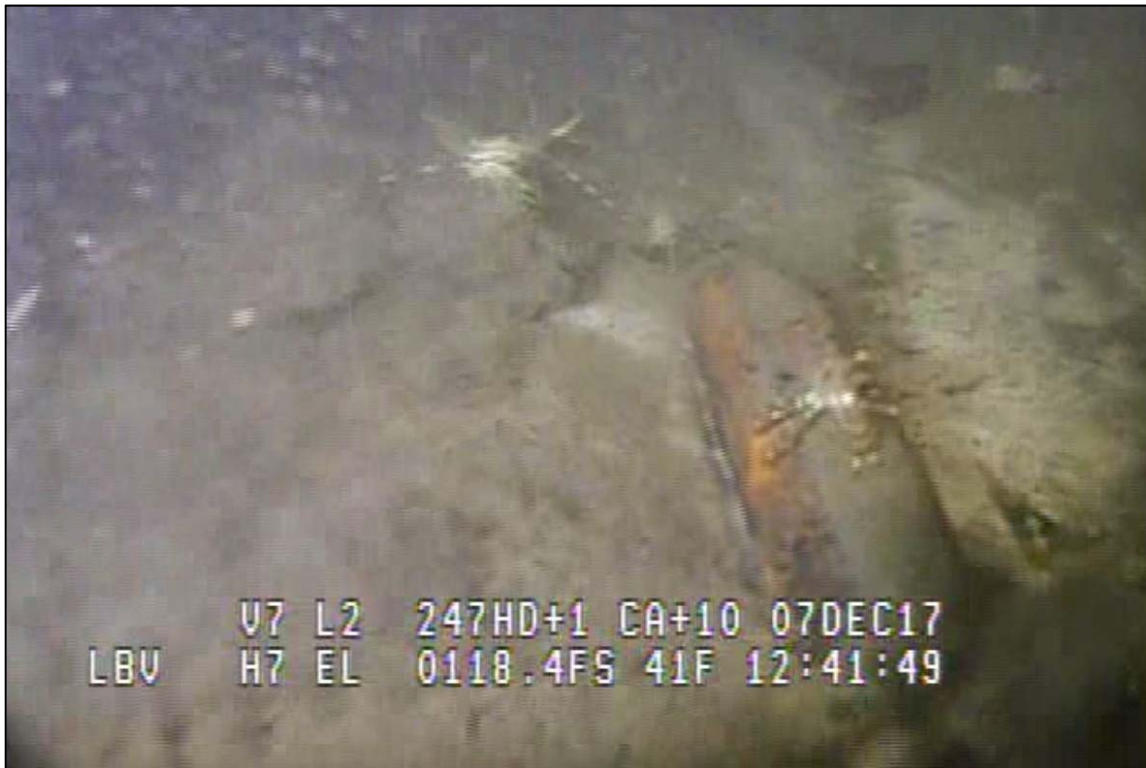
Photograph 70: View of Lower Anchor Chain Condition (Typical) at Primary System Anchor Line 20, Looking Southwest.

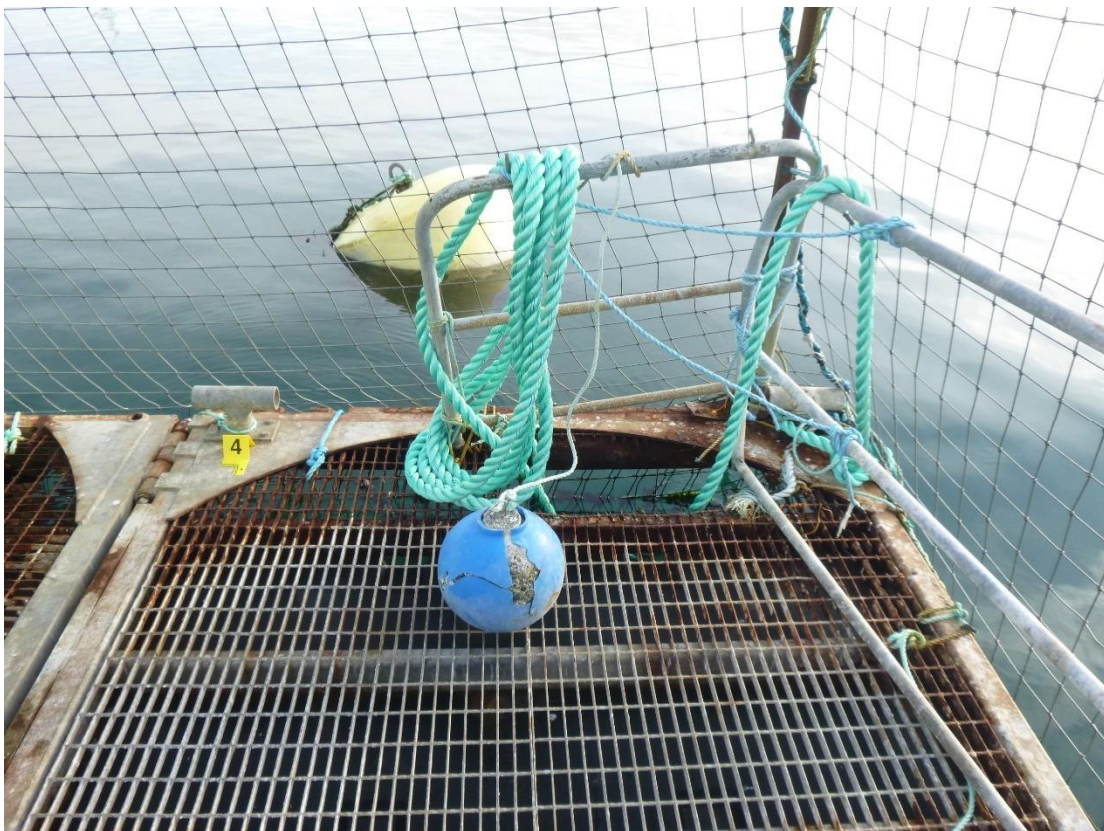
Figure C-11: Anchor 4 Showing Severe Corrosion of Grating in Corner

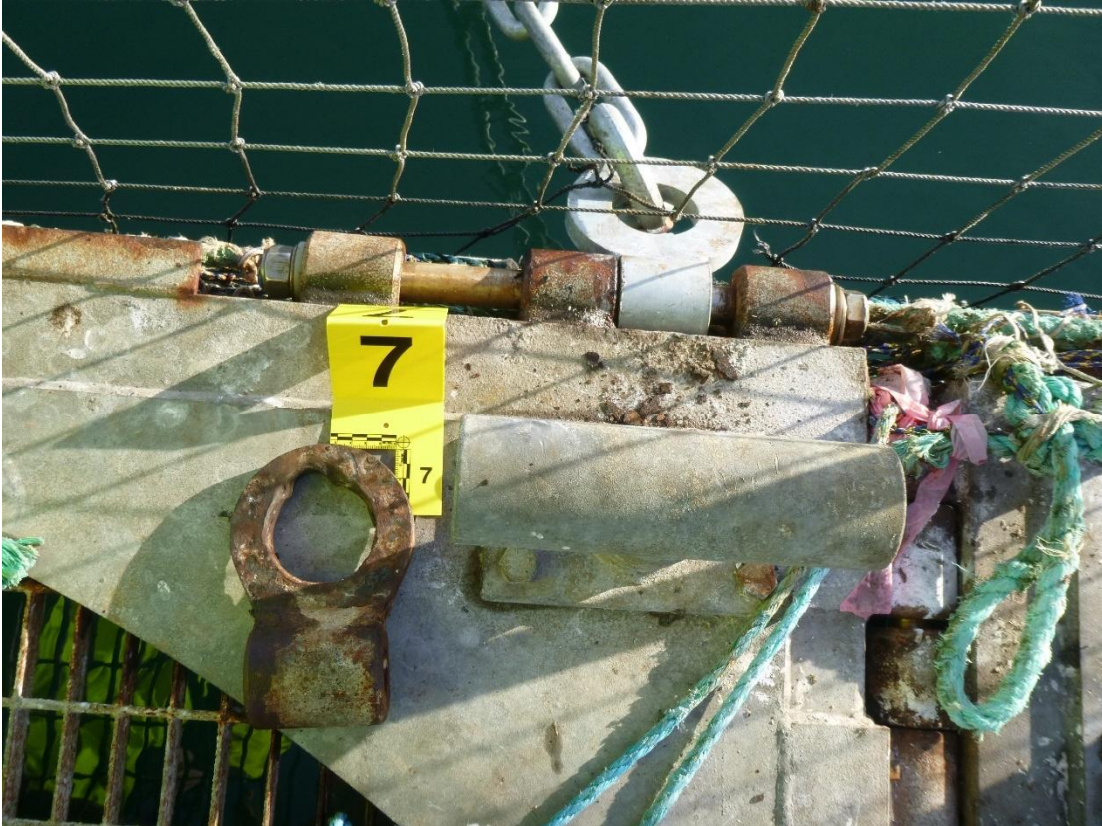
Figure C-22: Anchor 7 New Right Padeye Showing old Padeye

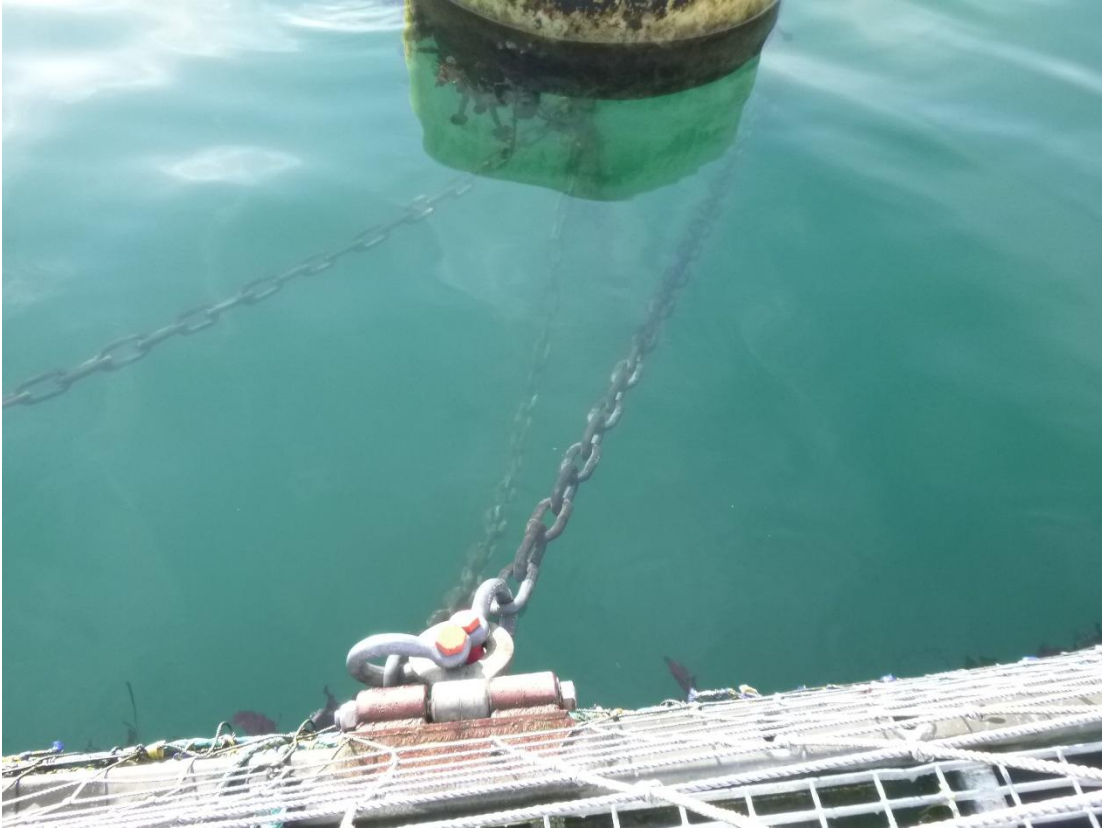
Figure C-30: Anchor 10 and Chain From Additional Unknown Anchor. Note Two Shackles in One Padeye

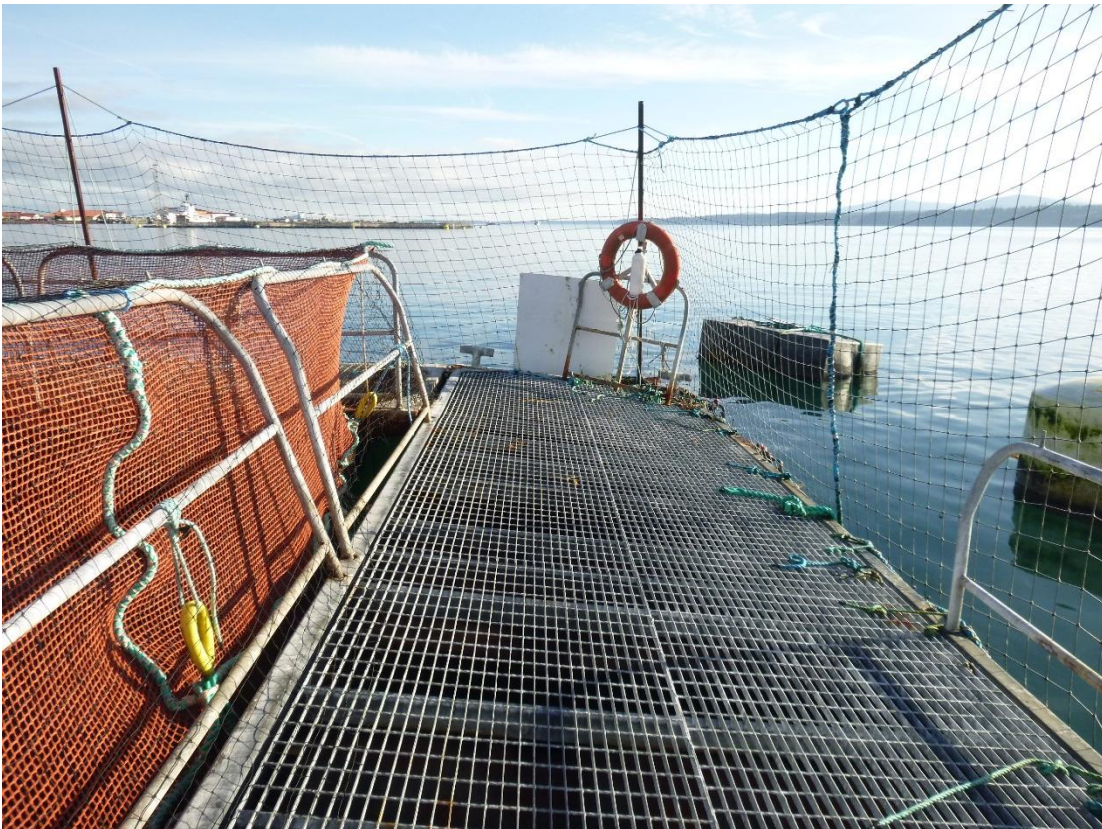
Figure C-31: Showing Sloped Docks Along South Edge of Pen 14 Looking East

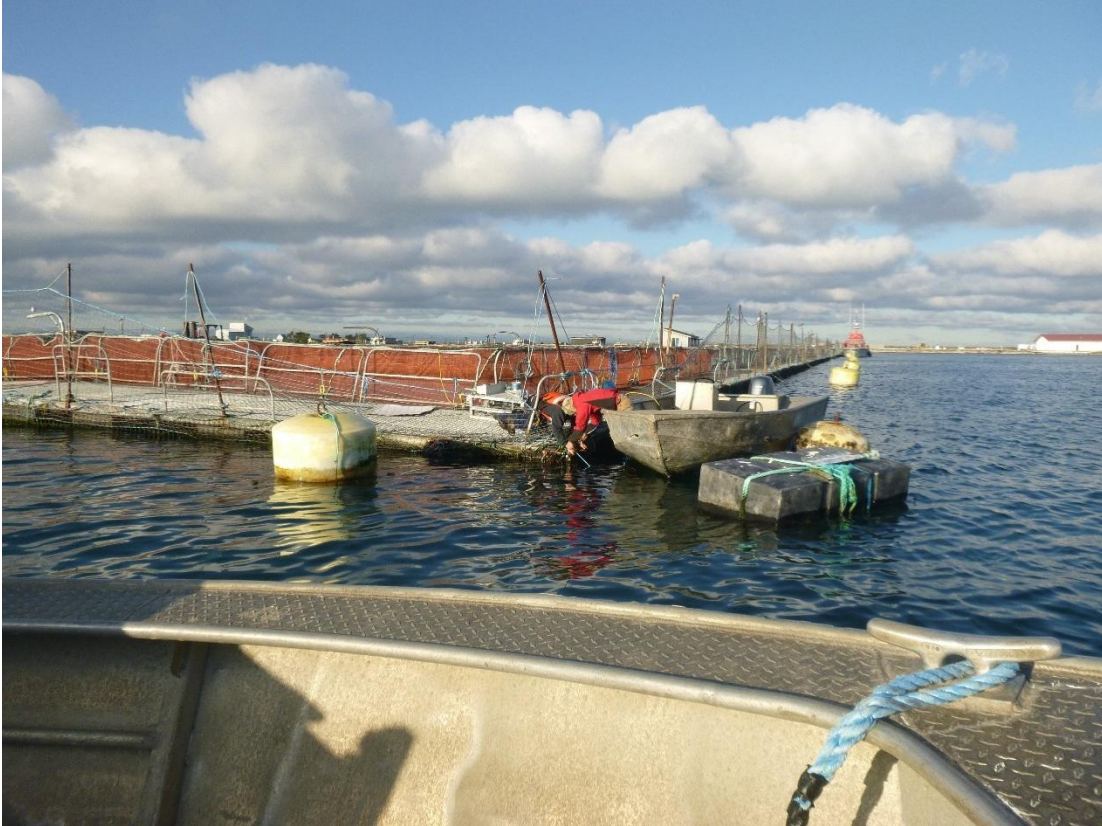
Figure C-32: Showing Sloped Docks Along South Edge of Pen 14 - Looking North

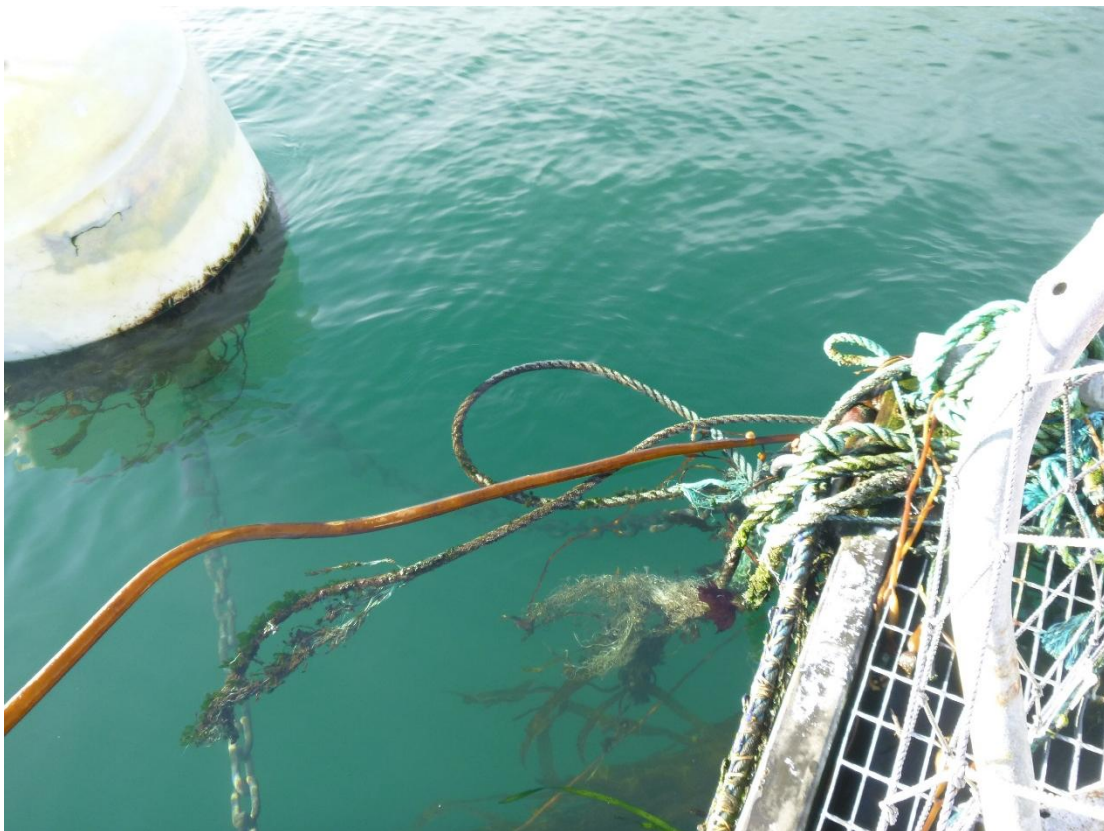
Figure C-37: Anchor 11 Buoy and Bridle Chains Unevenly Loaded

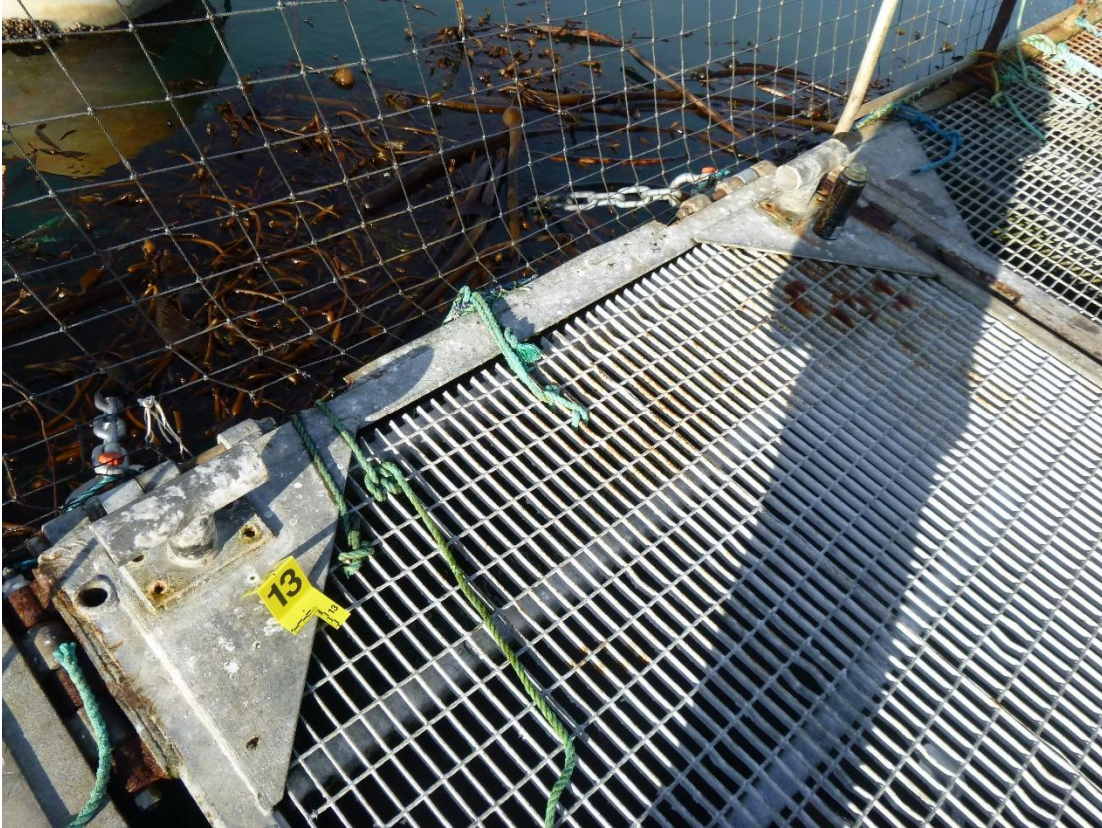
Figure C-42: Anchor 13 Bridle Chains

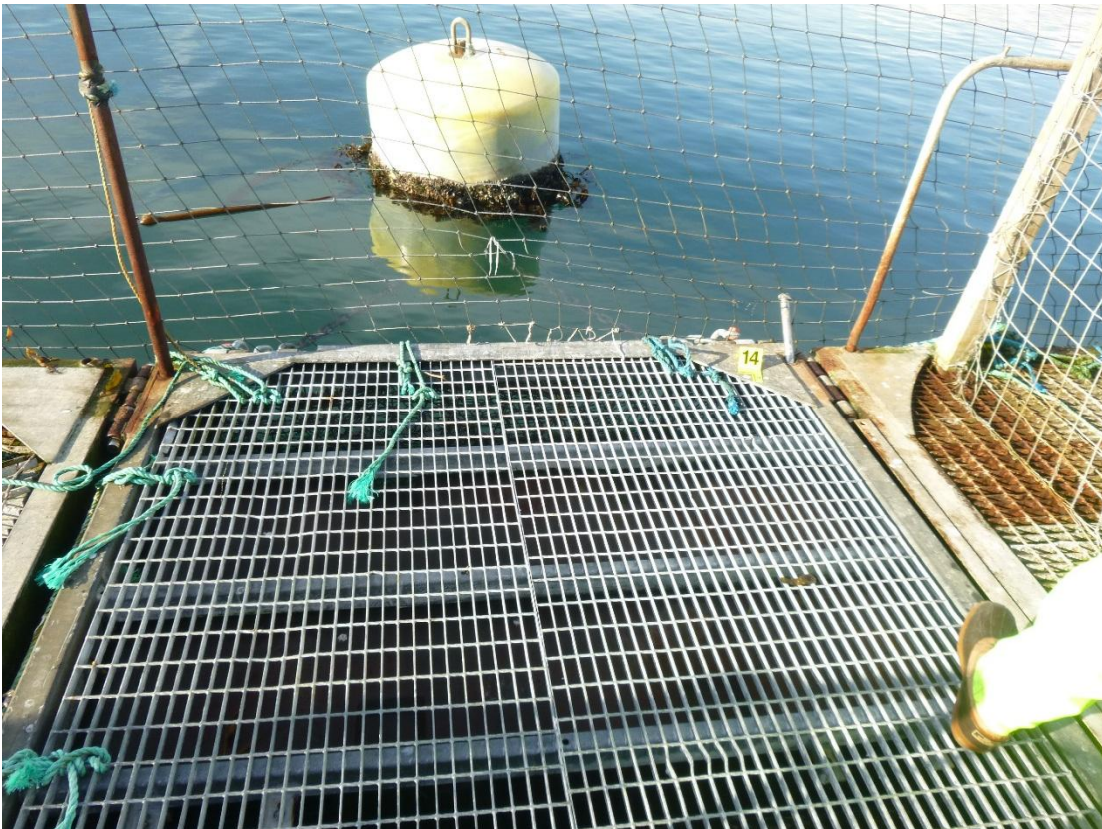
Figure C-43: Anchor 14 (Looking West)
