Port Angeles Primary Atlantic Salmon Net Pens Engineering Assessment

January 29, 2018

Document reference: 391980 | 2 | b

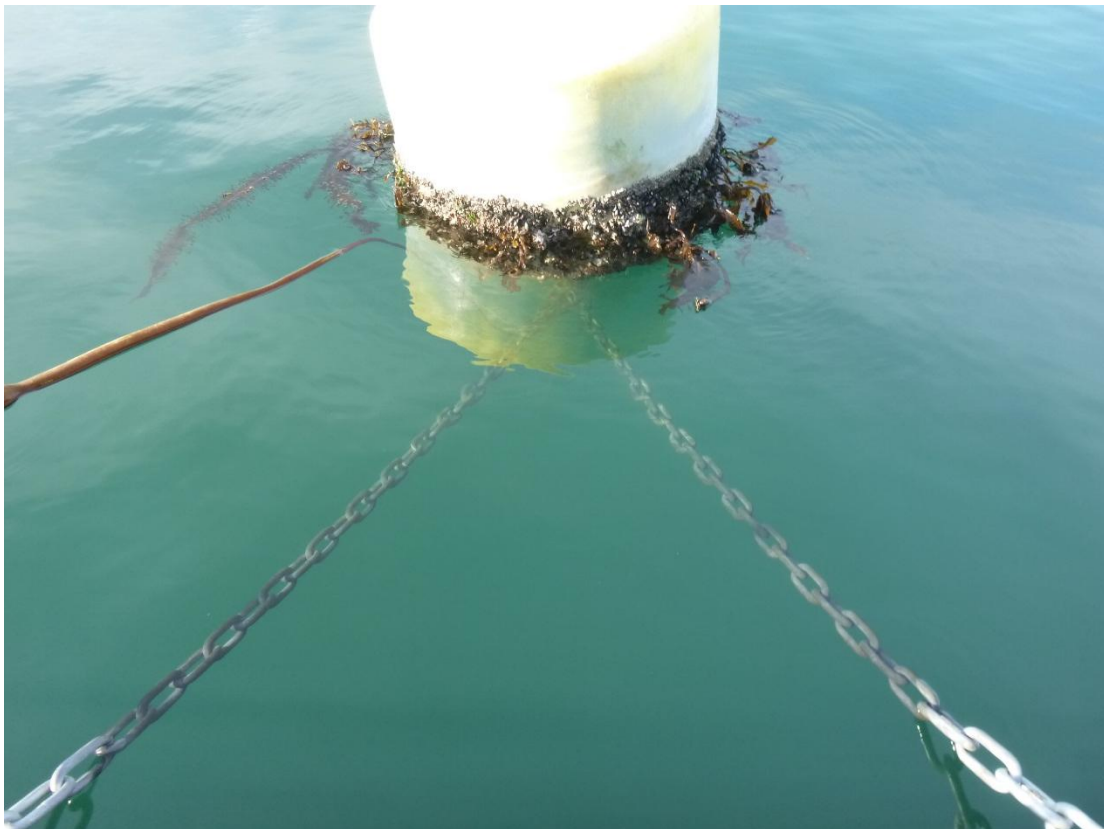
Figure C-45: Anchor 14 Bridle Chains

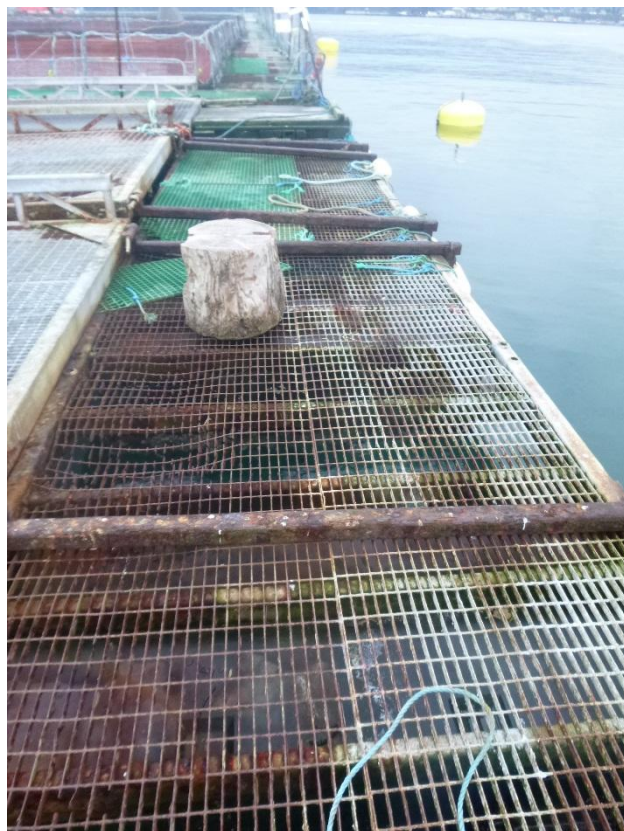
Figure C-53: Floating Dock Boarding Area Looking South

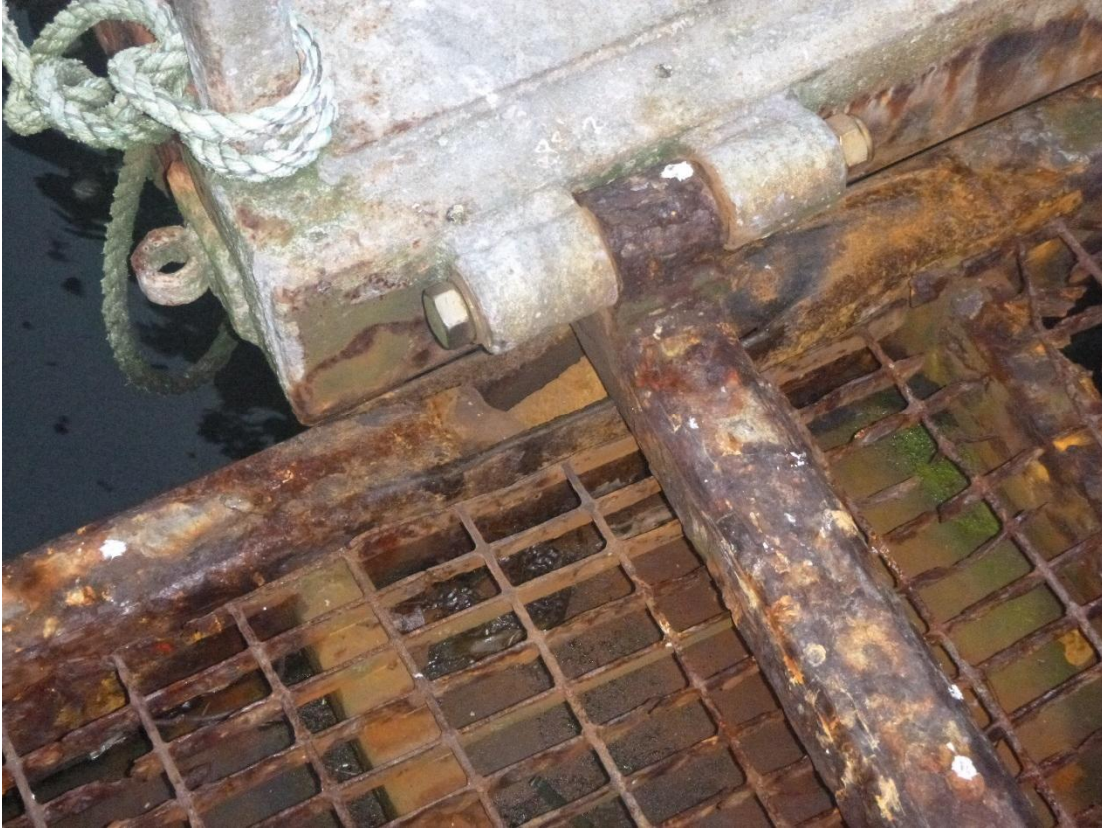
Figure C-54: Floating Dock Boarding Area, Damage to Dock Frame From Arms

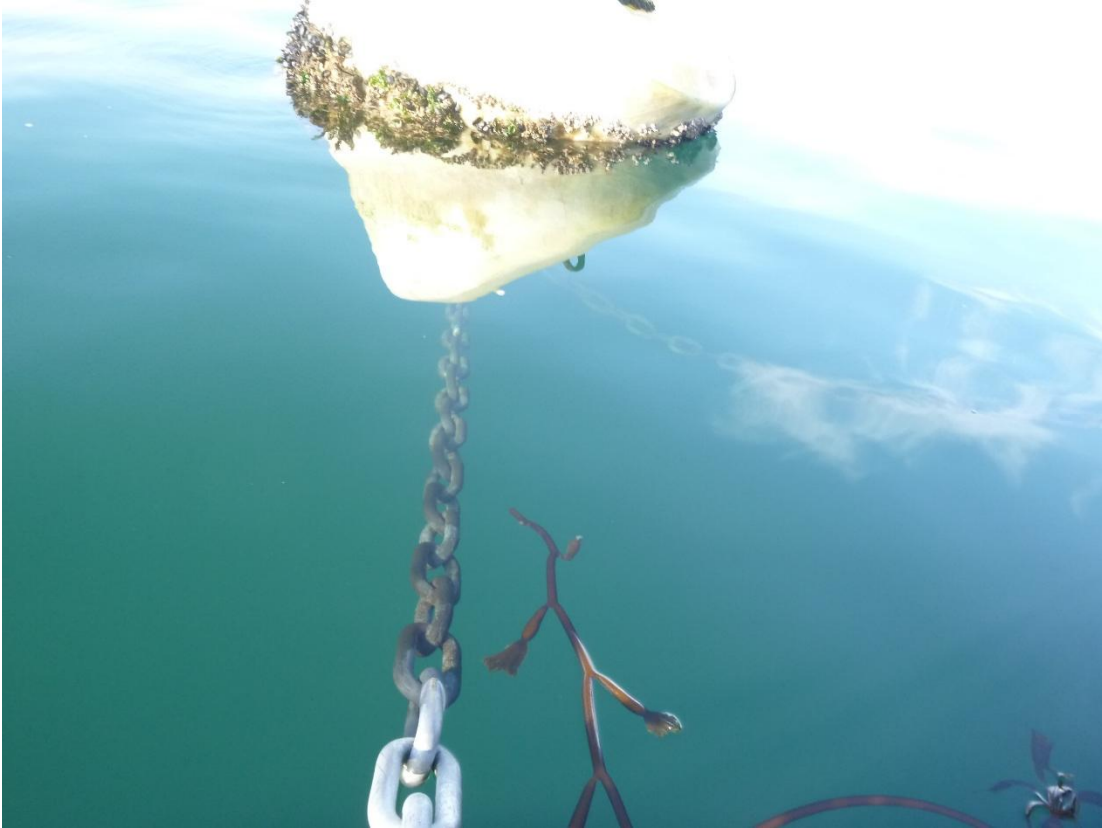
Figure C-62: Anchor 18 Bridle Chain

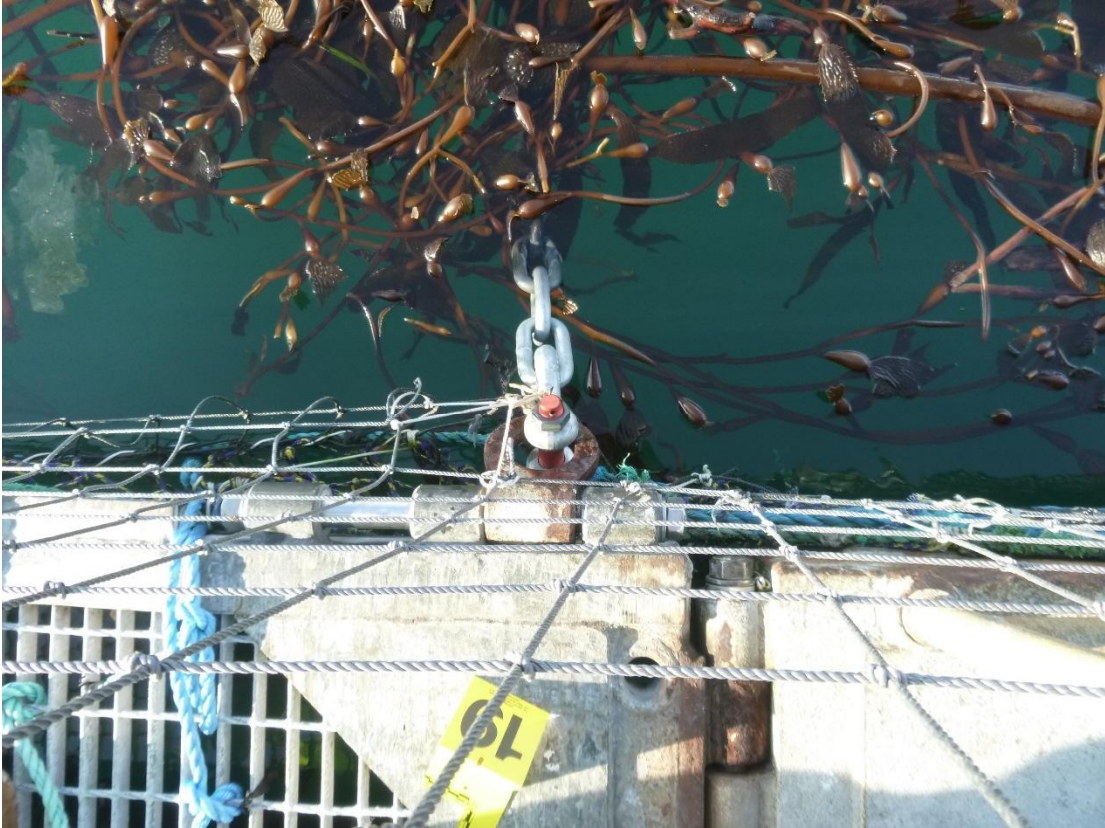
Figure C-64: Anchor 19 Right Padeye and Chain

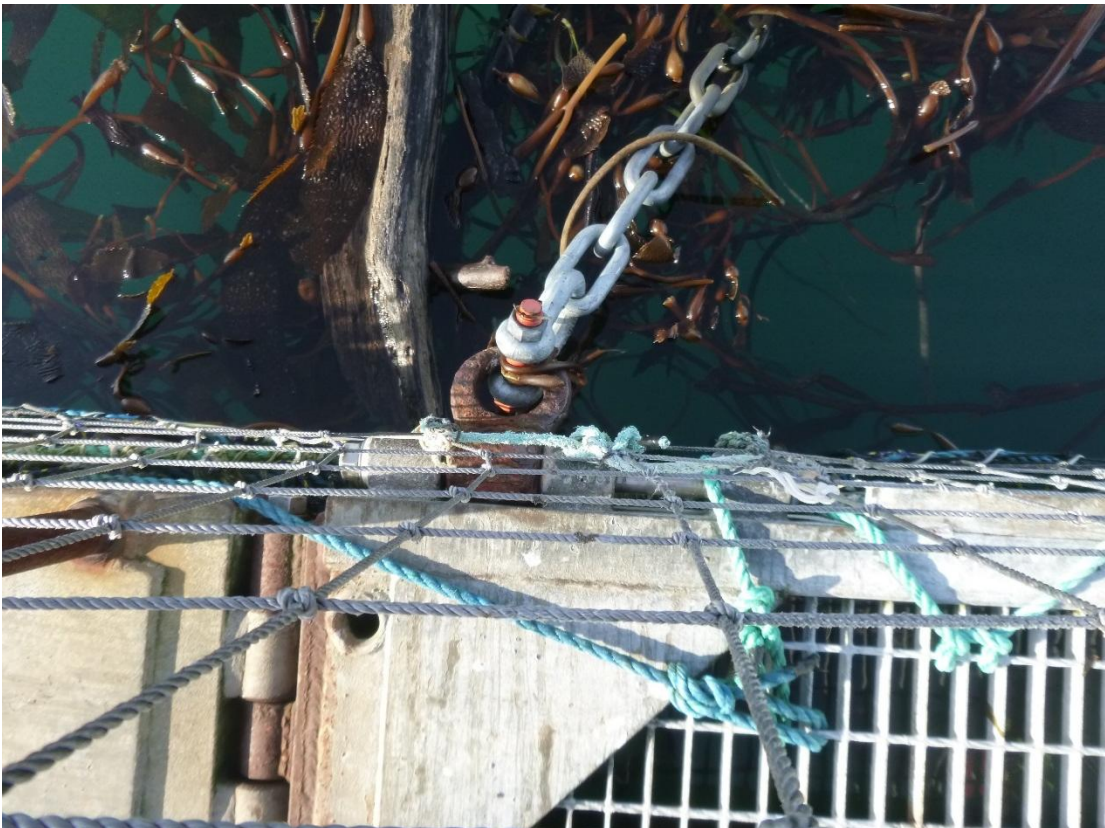
Figure C-65: Anchor 19 Left Padeye and Chain

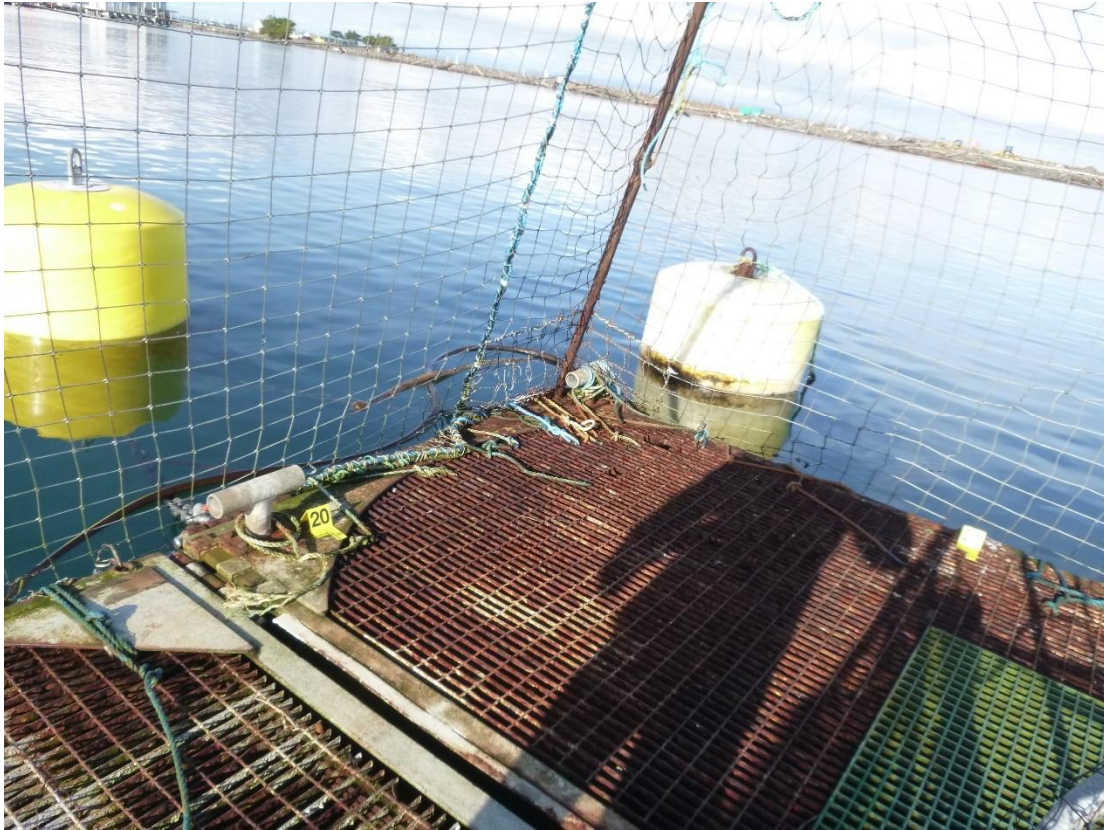
Figure C-66: Anchor 20 and 21 (Looking North West)

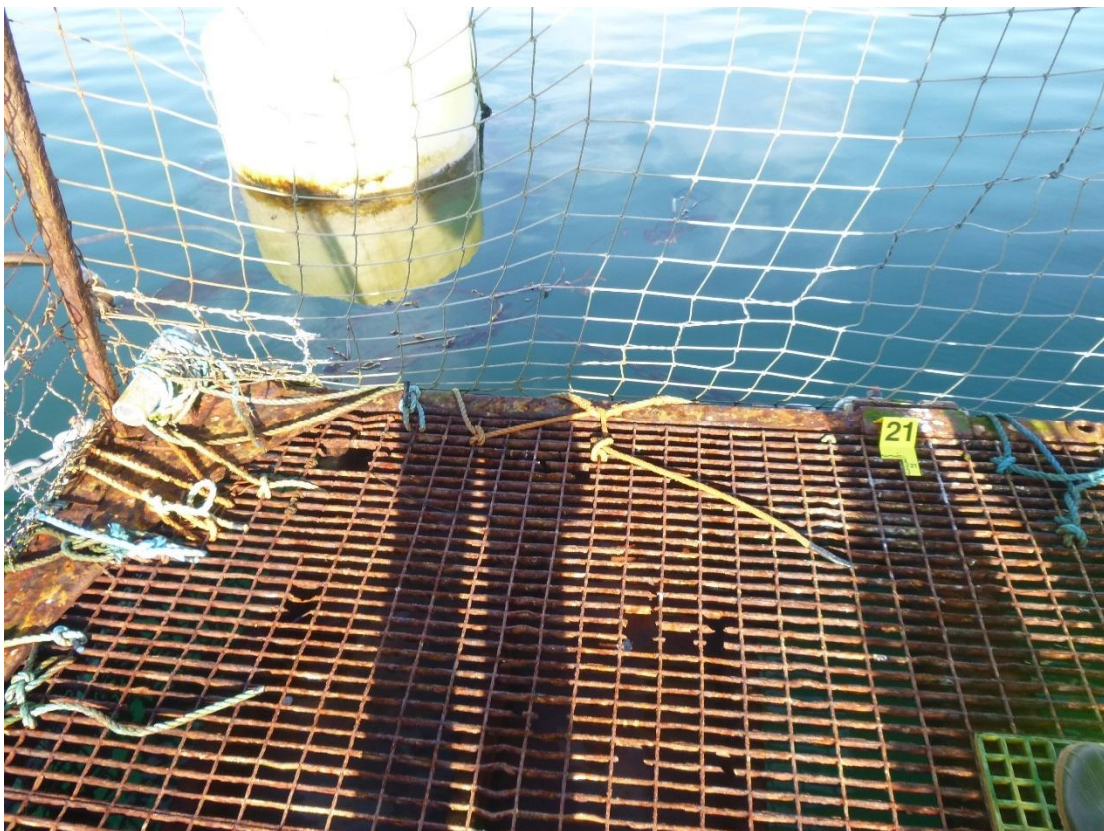
Figure C-69: Anchor 21 Showing Severe Corrosion in Grating

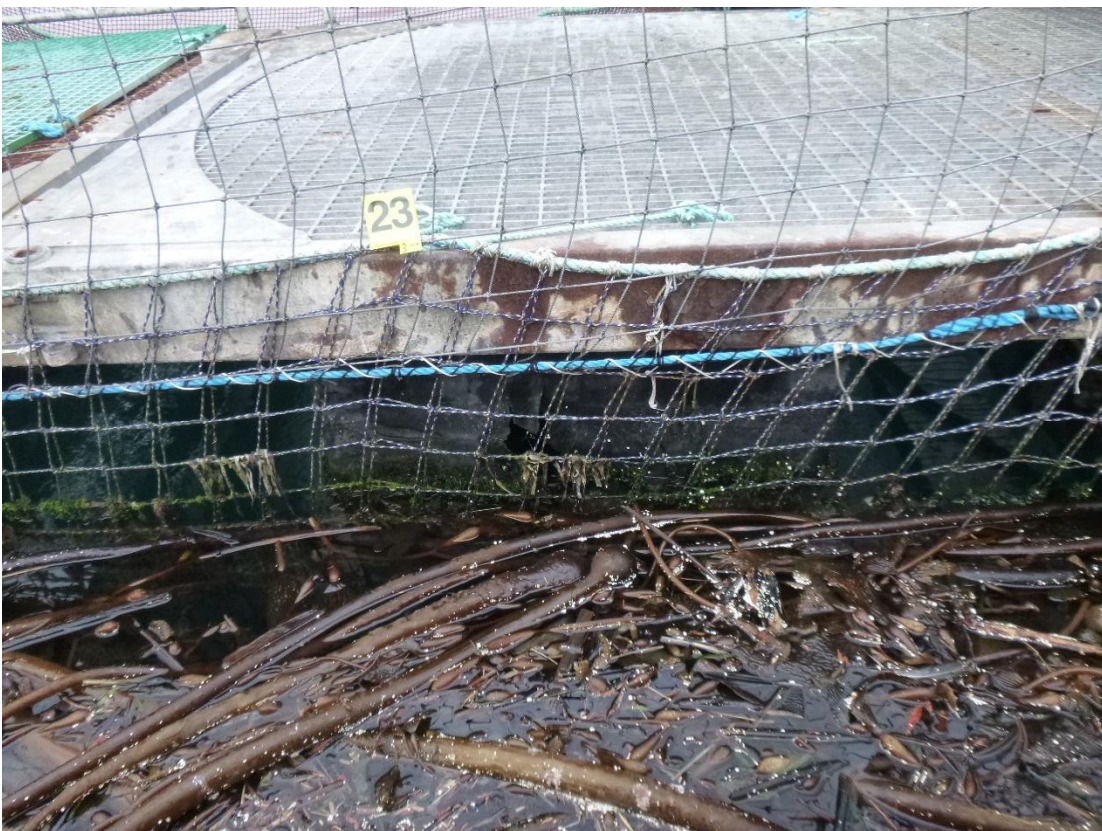
Figure C-75: Location 23 Damaged Pontoon (South Edge of Pen 5)

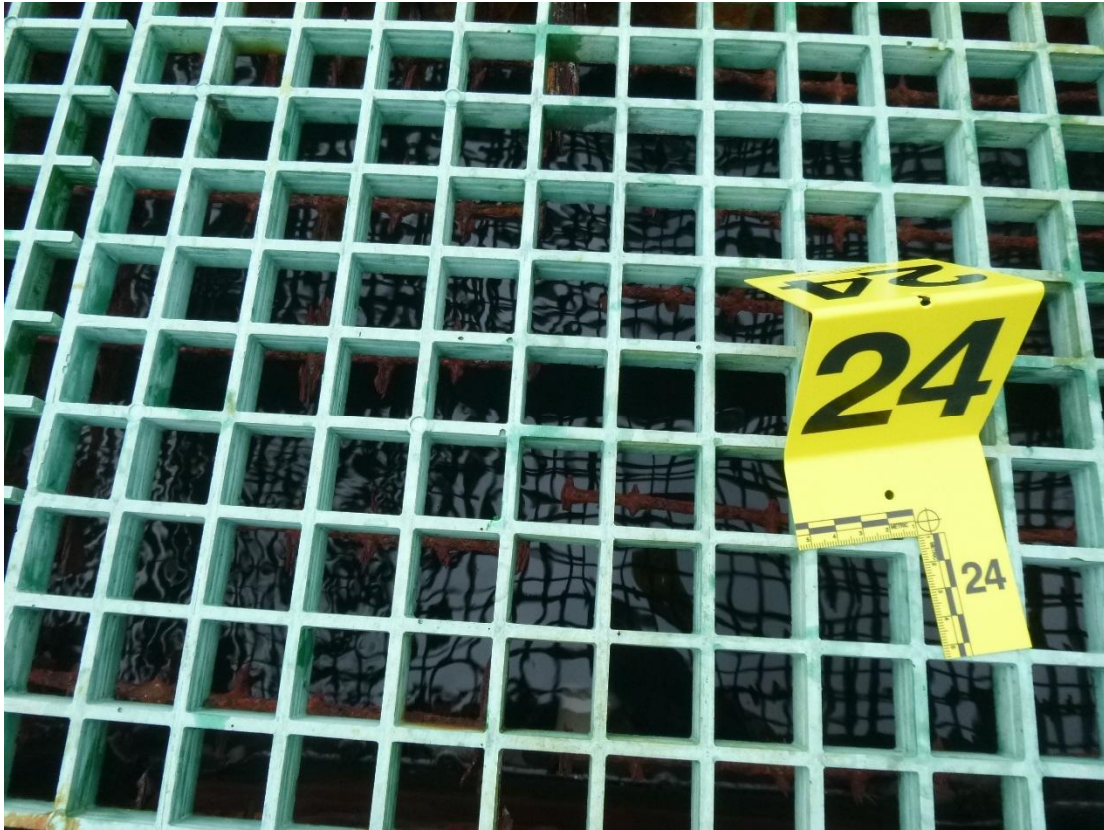
Figure C-78: Fiberglass Mesh Covers Severe Corrosion in Grating

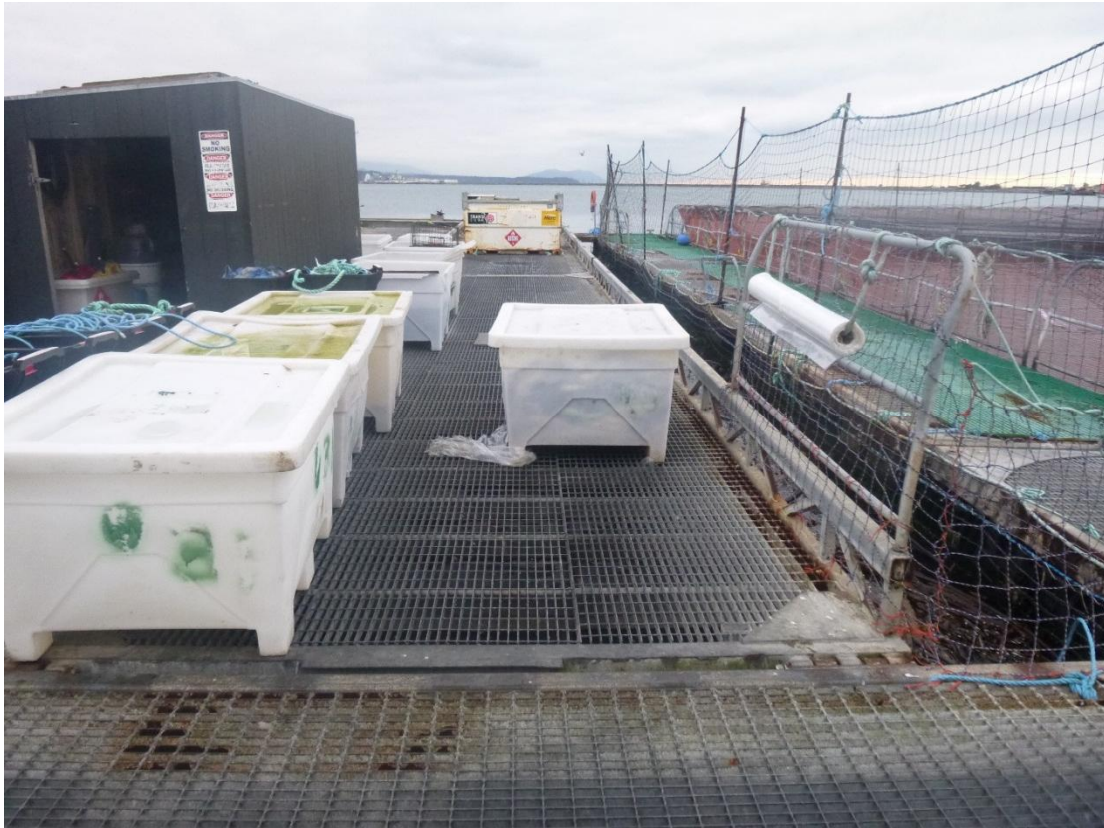
Figure C-82: Boarding Area Between 6 and 8 Pen Sections – North Dock Looking West

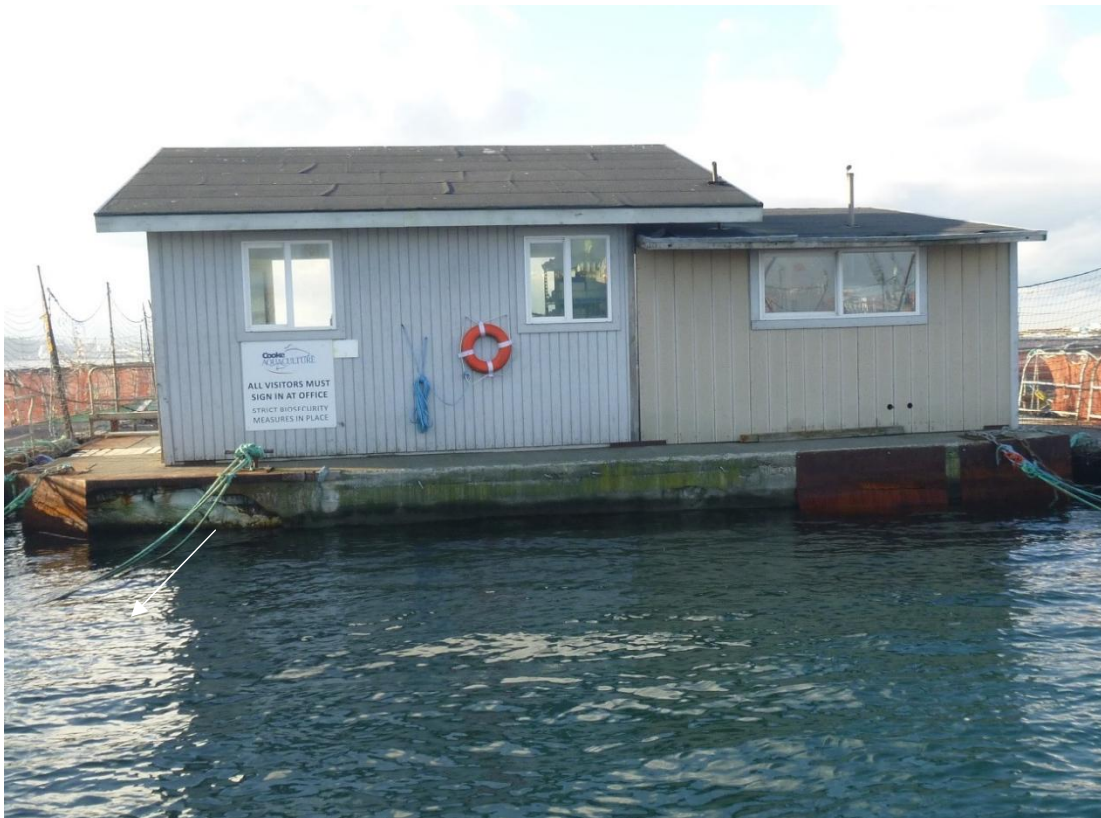
Figure C-84: East face of Office and Gen-set Barge – Looking West

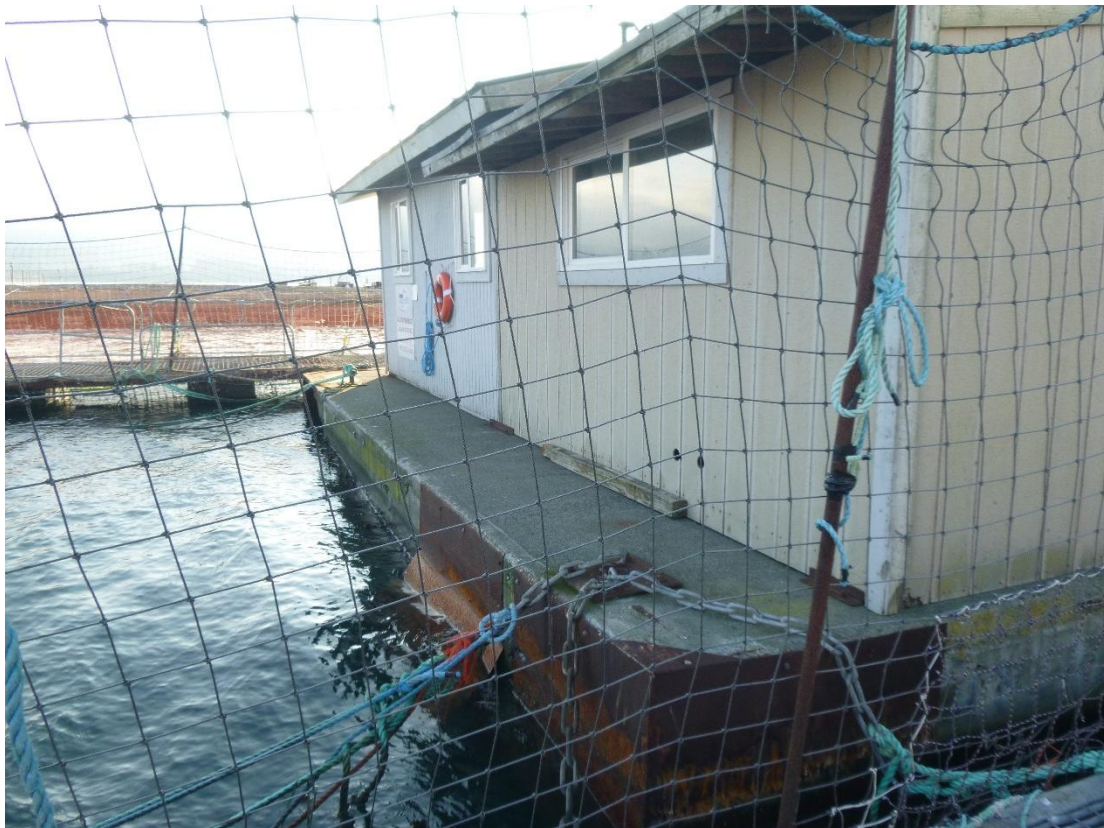
Figure C-85: Northeast Corner of Office and Gen-set Barge – Looking South

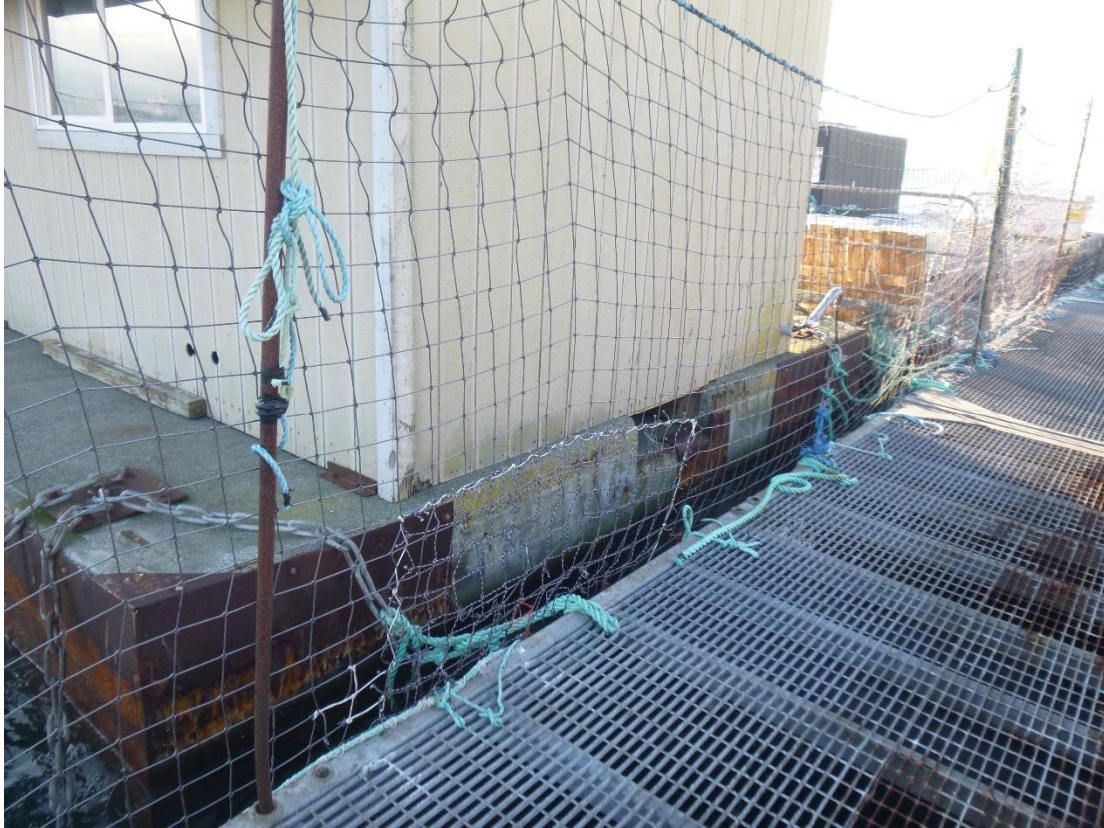
Figure C-86: North Face of Office and Gen-set Barge – Looking Southwest

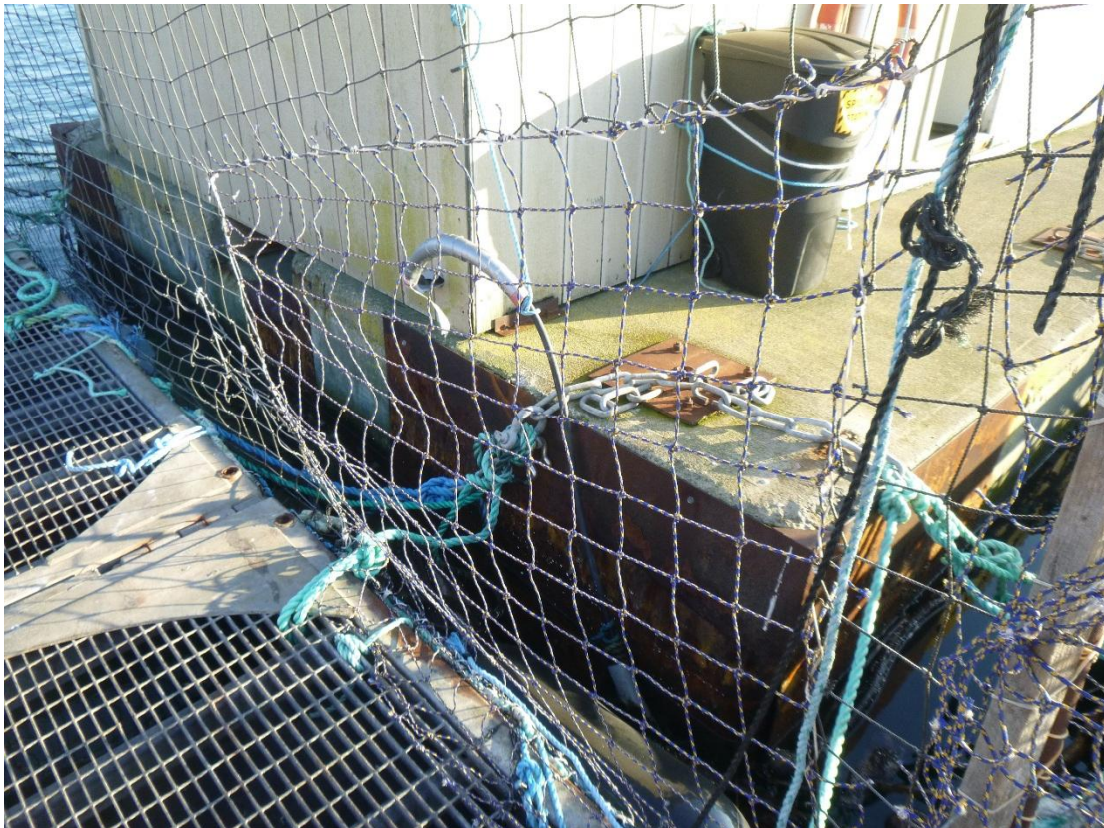
Figure C-87: Northwest Corner of Office and Gen-set Barge – Looking Southeast

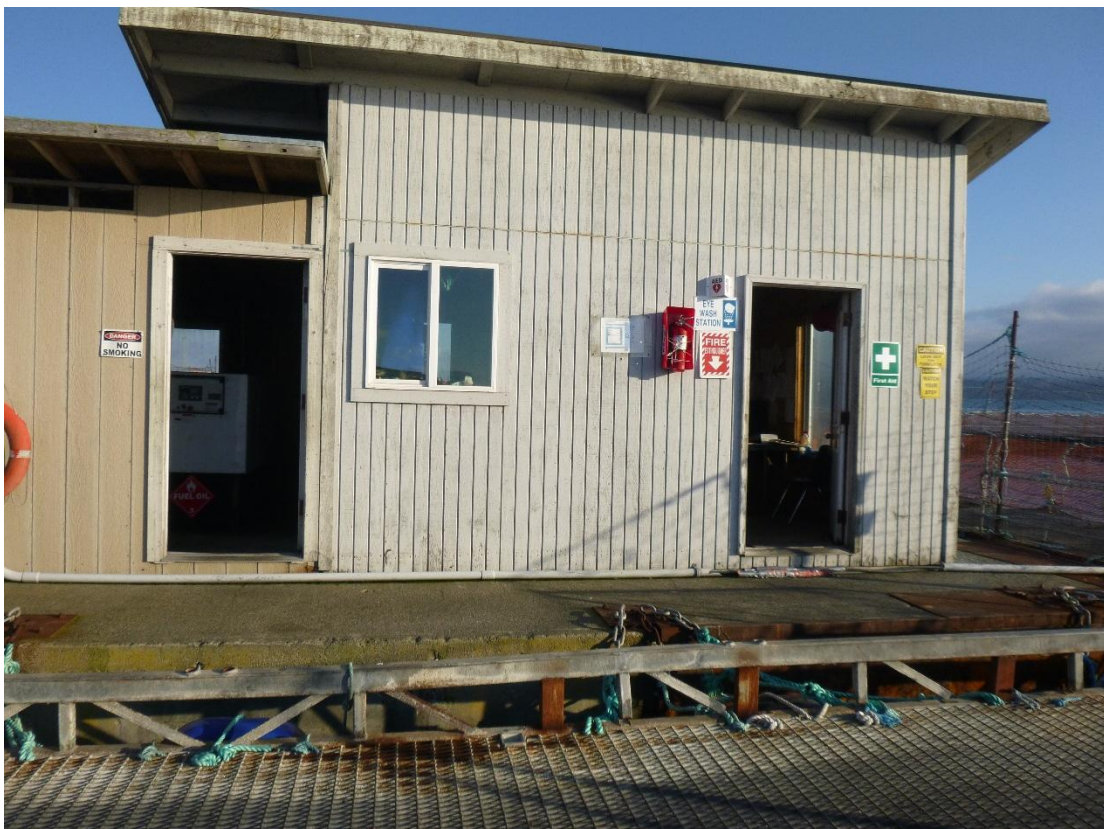
Figure C-89: West Face of Office and Gen-set Barge – Looking East

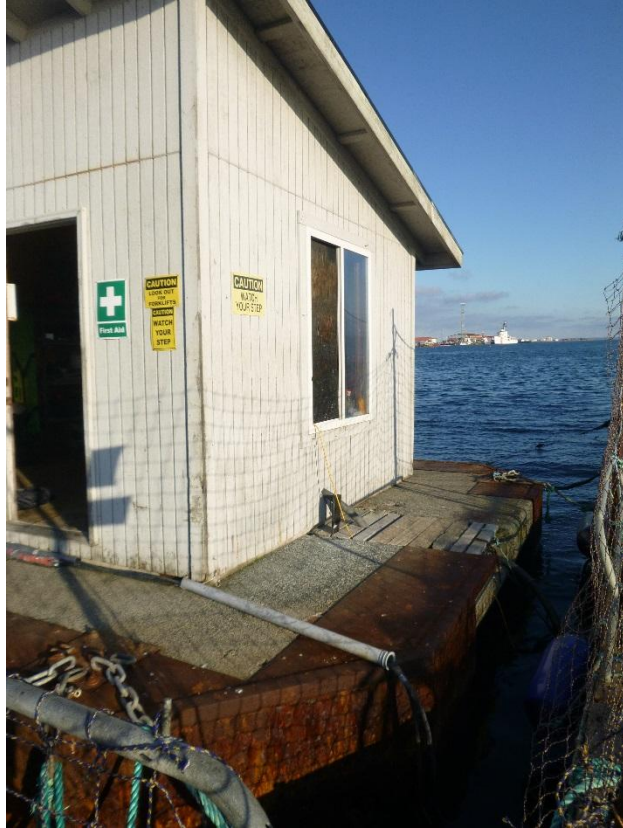
Figure C-90: Southwest Corner of Office and Gen-set Barge – Looking East
