# **Rich Passage Orchard Rocks Atlantic Salmon Net Pens Engineering Assessment**

January 29, 2018

Mott MacDonald  
110 James Street  
Suite 101  
Edmonds WA 98020  
United States of America

State of Washington  
Department of Natural  
Resources  
1111 Washington Street SE  
Olympia Washington 98504

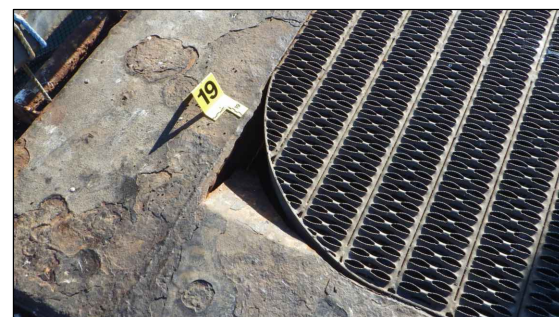
**PHOTO 3**  
 DAMAGE DUE TO CORROSION  
 ON CENTER BRIDGE

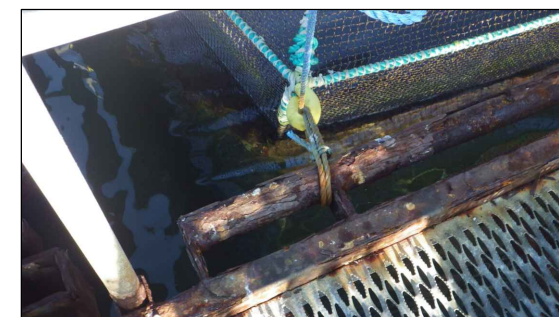
**PHOTO 4**  
 FISH NET CORRODED  
 SUPPORT PIPE

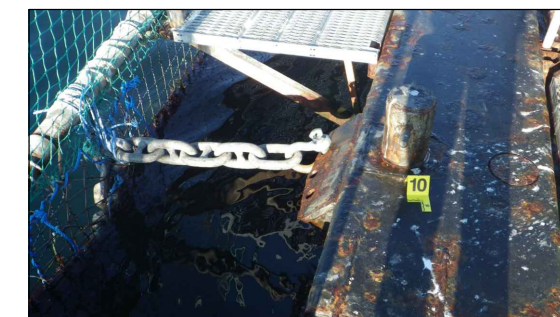
**PHOTO 5**  
 ANCHOR 10/MOORING CHAIN  
 CONNECTED TO PREDATOR PIPE

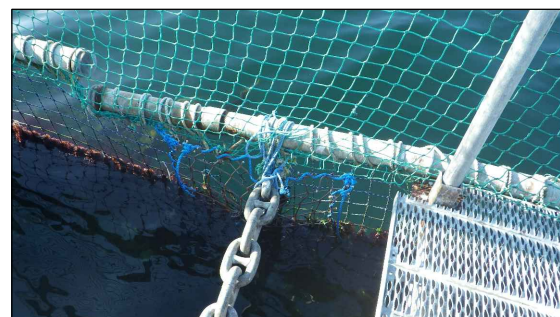
**PHOTO 6**  
 ANCHOR 10 MOORING CHAIN  
 CAUSING BENDING TO  
 PREDATOR NET SUPPORT PIPE

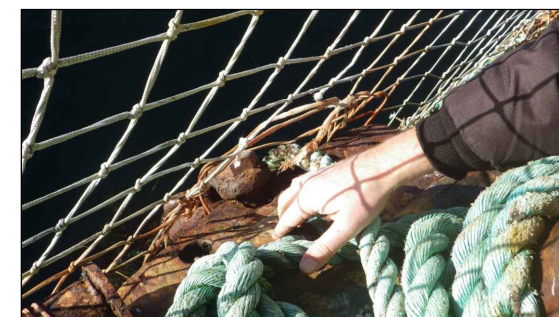
**PHOTO 4**  
CORRODED SHACKLES AND MOORING BRACKET AT ANCHOR 13

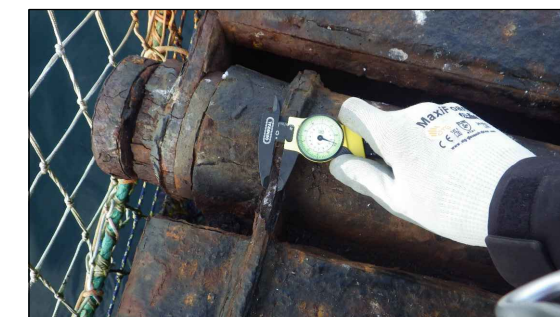
**PHOTO 5**  
PEN HINGE WITH MAJOR CORROSION / 40% LOSS IN SECTION

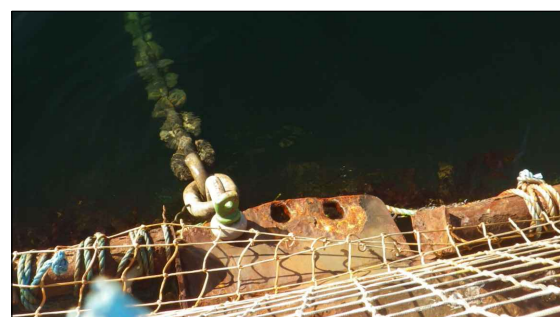
**PHOTO 6**  
NEW SHACKLE AND CHAIN WITH MAJOR CORROSION ON MOORING BRACKET

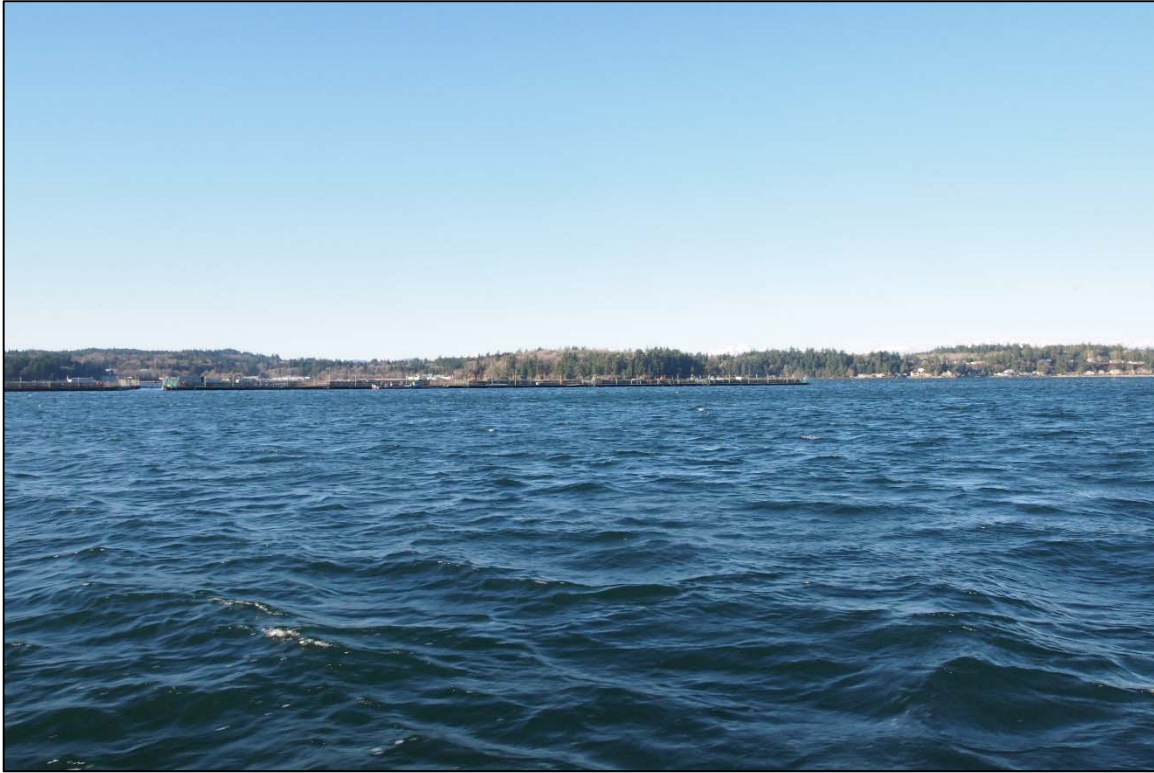
Photograph 1: Overall View of the Orchard Rocks North Fish Net Pens System, Looking West.

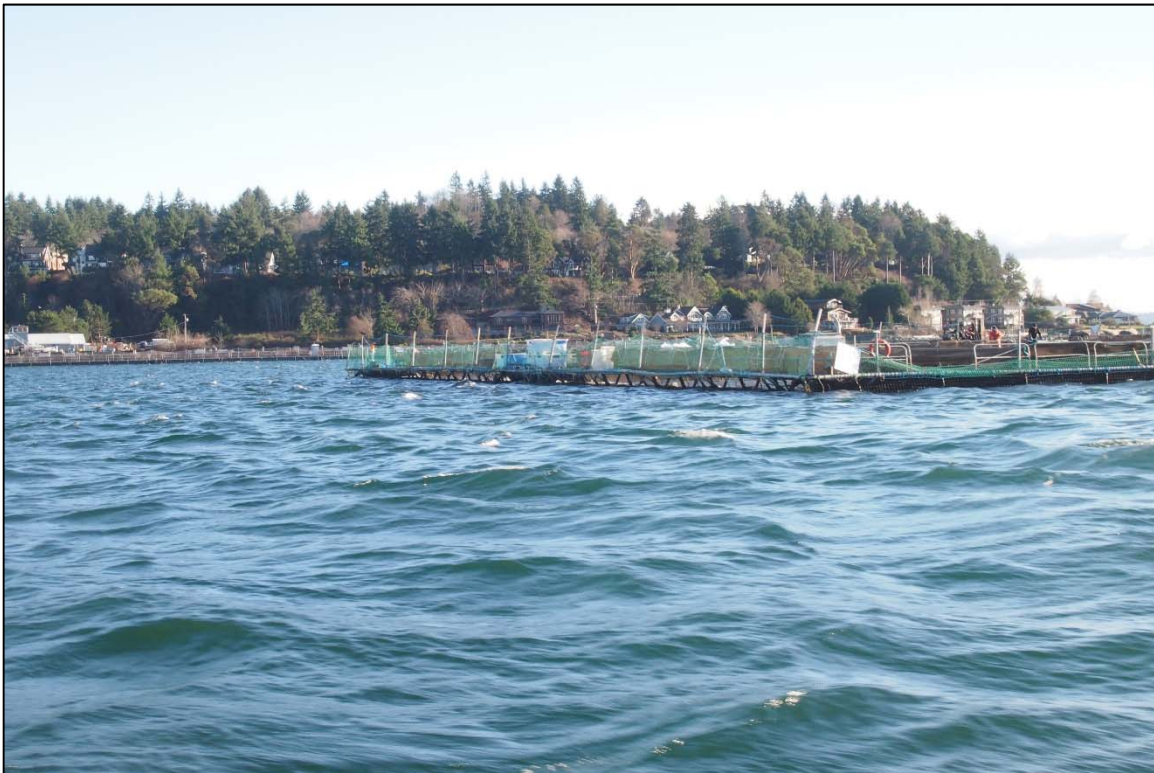
Photograph 2: Overall View of the Orchard Rocks North Fish Net Pens System, Looking East.

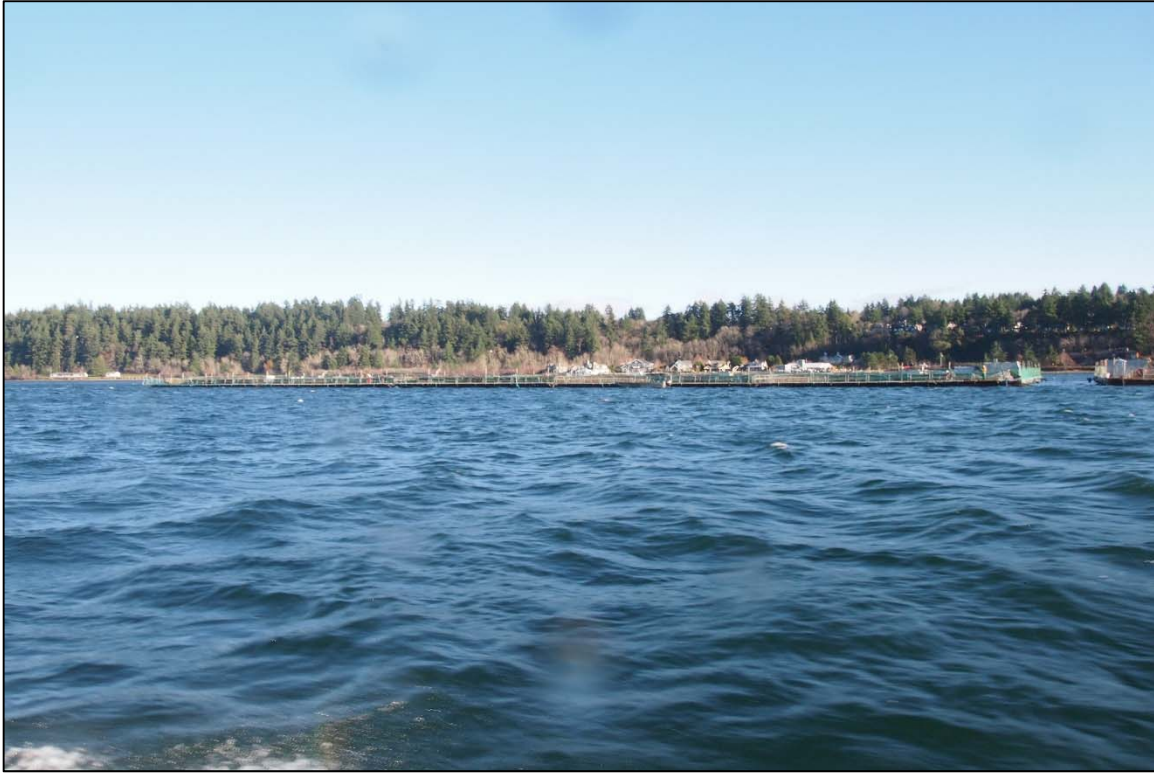
Photograph 3: Overall View of the Orchard Rocks North Fish Net Pens System, Looking East.

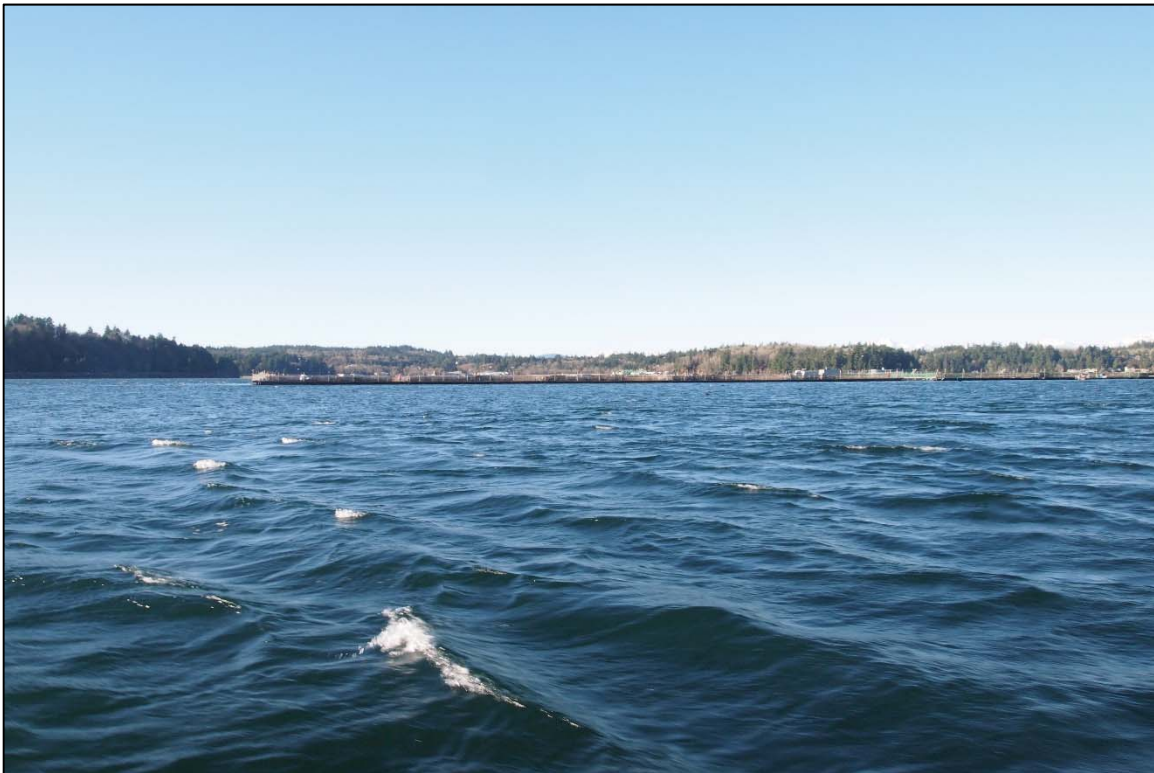
Photograph 4: Overall View of the Orchard Rocks South Fish Net Pens System, Looking West.

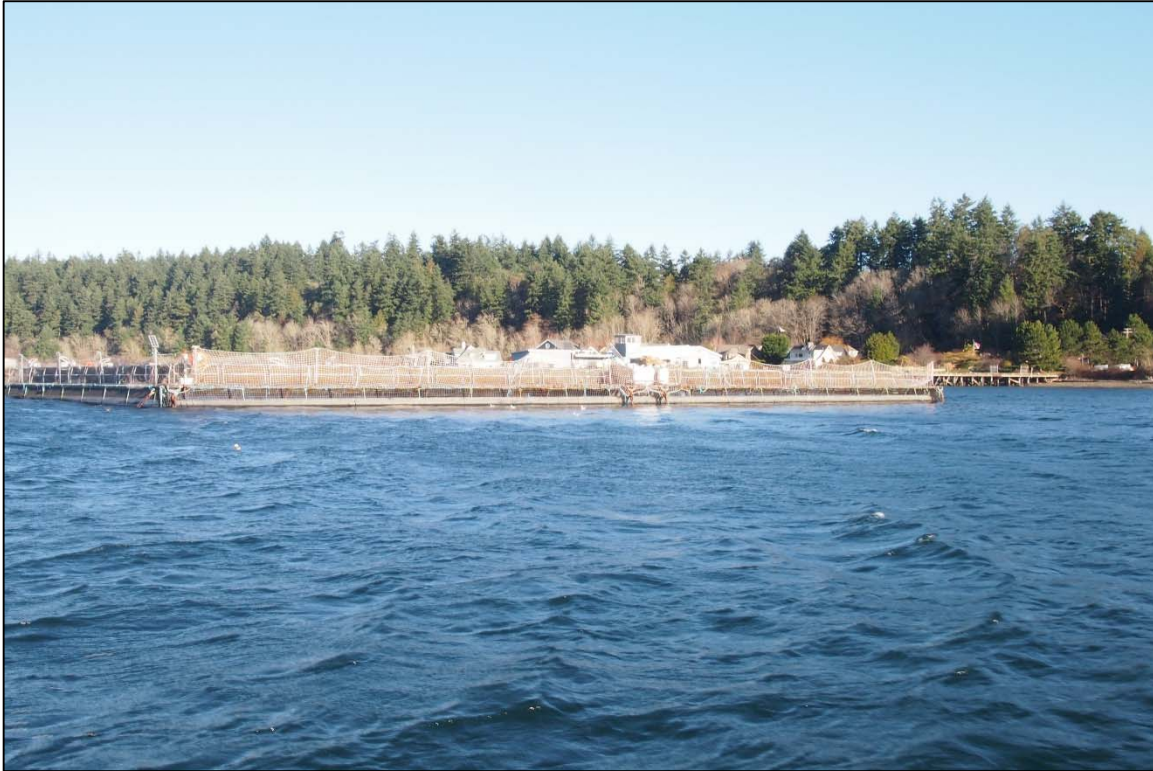
Photograph 5: Overall View of the Orchard Rocks South Fish Net Pens System, Looking Northeast.

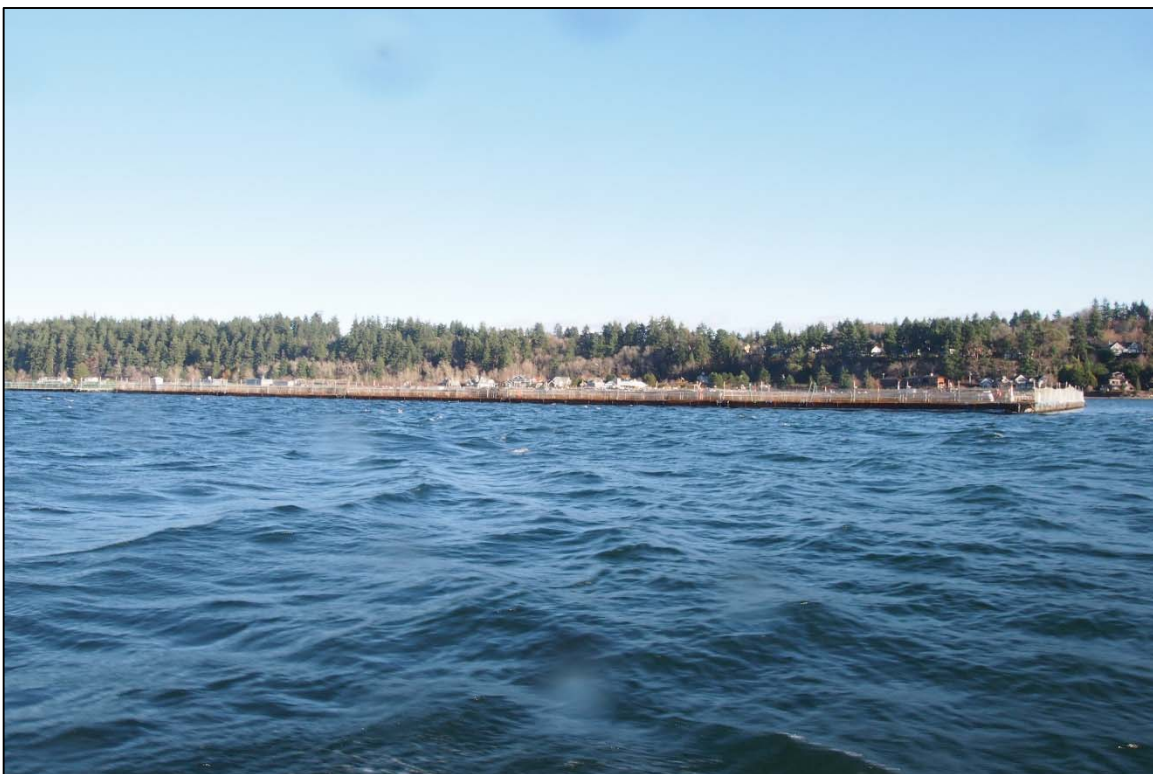
Photograph 6: Overall View of the Orchard Rocks South Fish Net Pens System, Looking East.

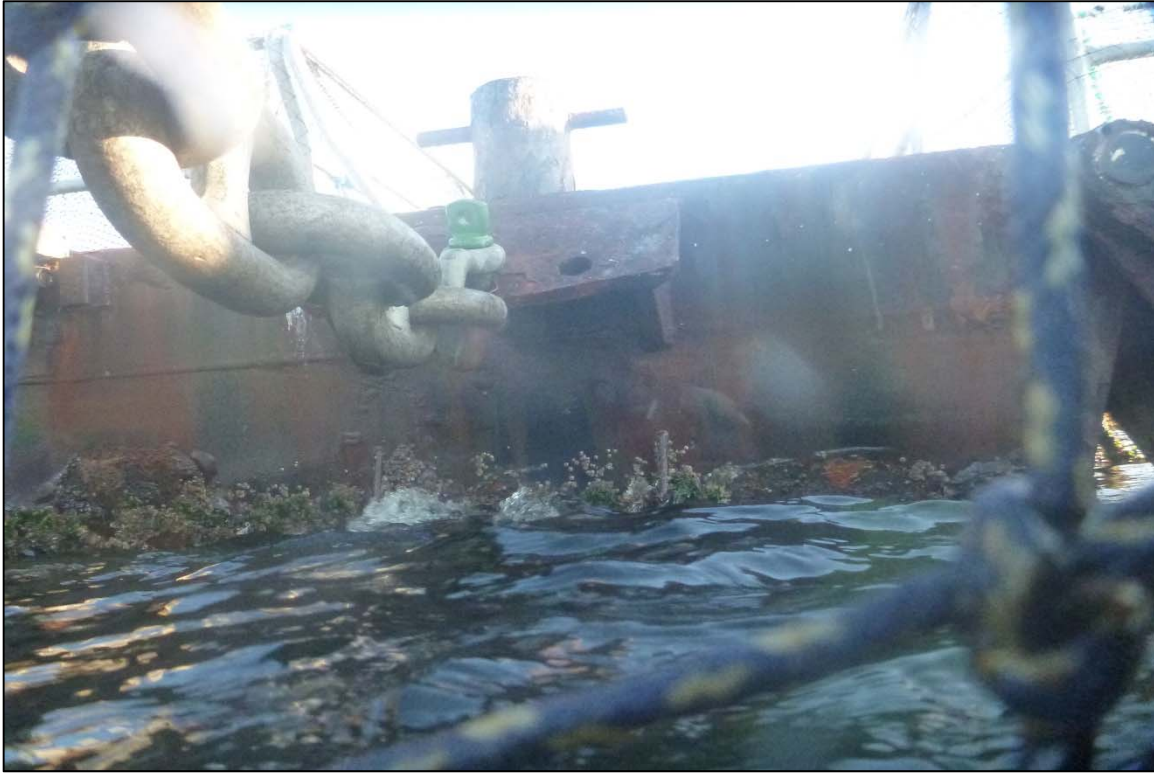
Photograph 11: View of Upper Anchor Chain to Float Connection at Orchard Rocks North Anchor Line 9, Looking East.

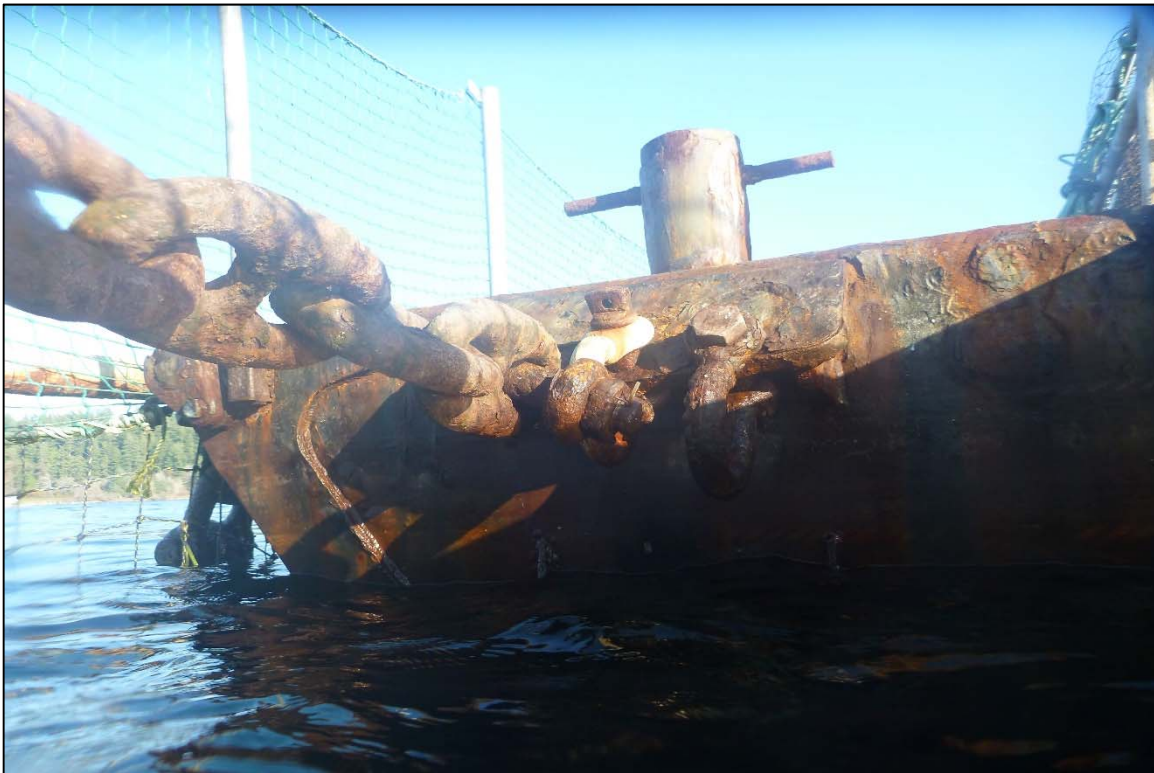
Photograph 12: View of Upper Anchor Chain to Float Connection at Orchard Rocks North Anchor Line 12, Looking East.

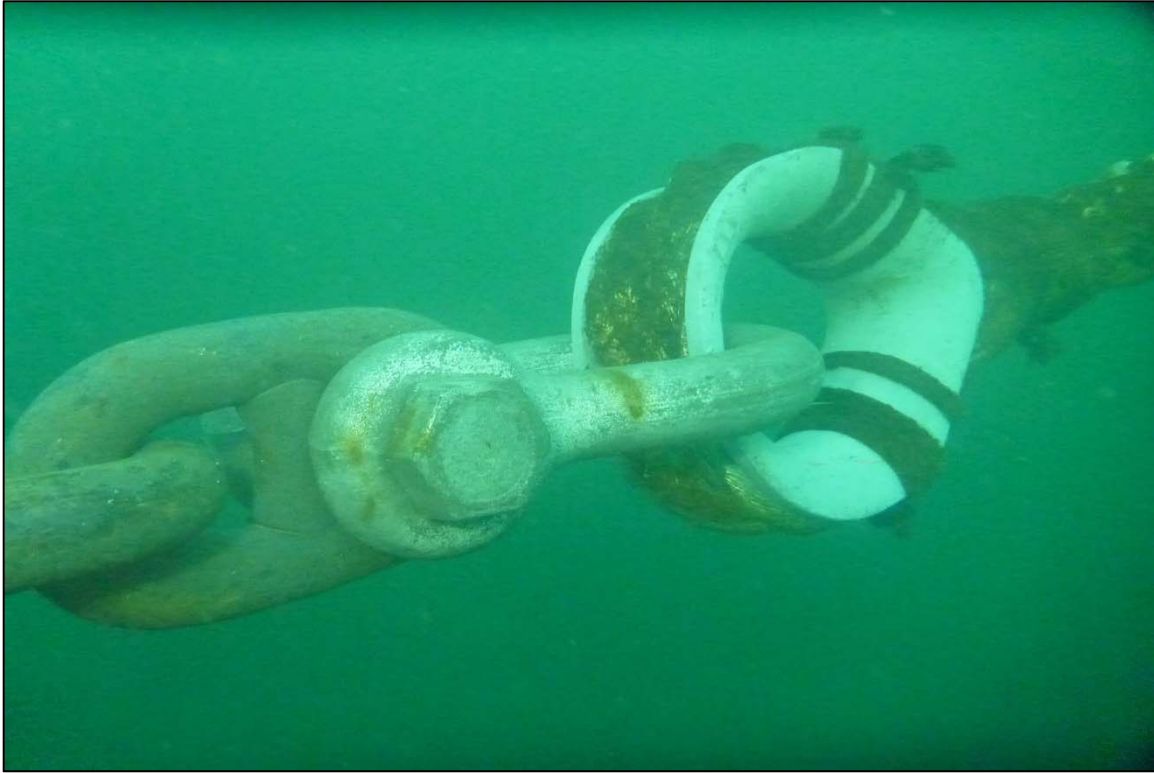
Photograph 13: View of Upper Anchor Chain to Rope Connection (Shackle and Thimble) Orchard Rocks North Anchor Line 1, Looking Northeast.

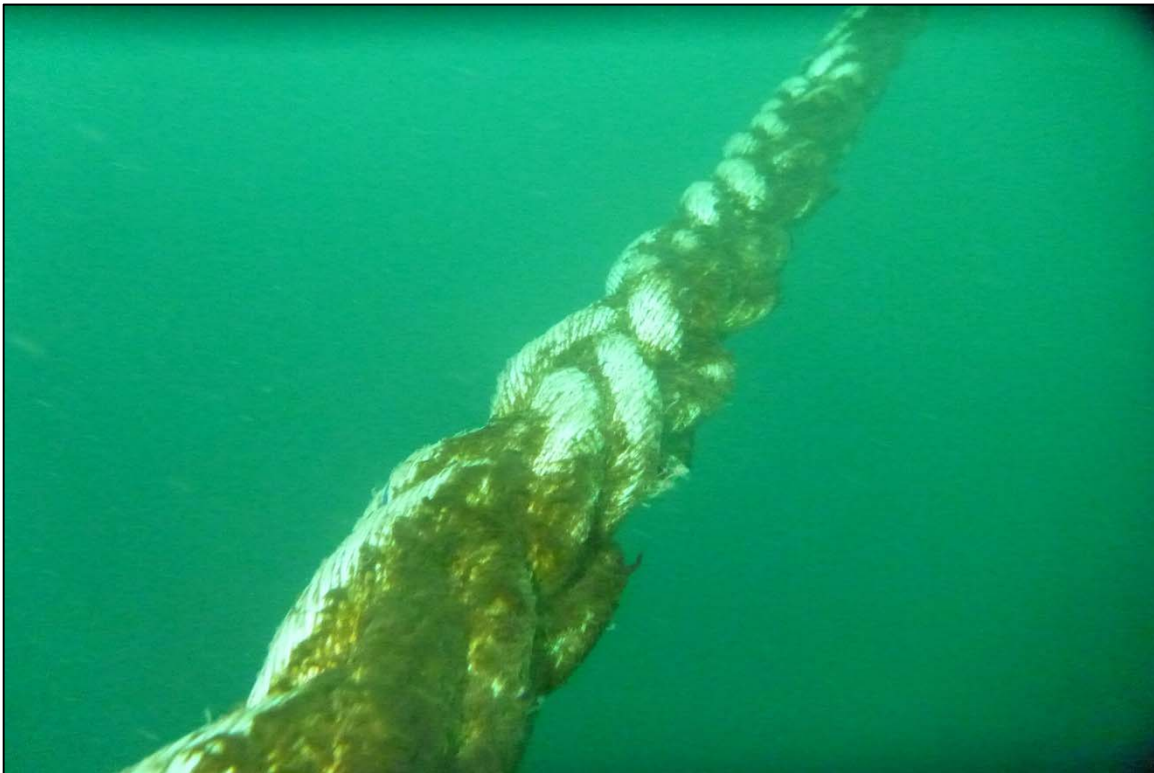
Photograph 14: View of Rope Condition with Light Marine Growth at Orchard Rocks North Anchor Line 1, Looking East.

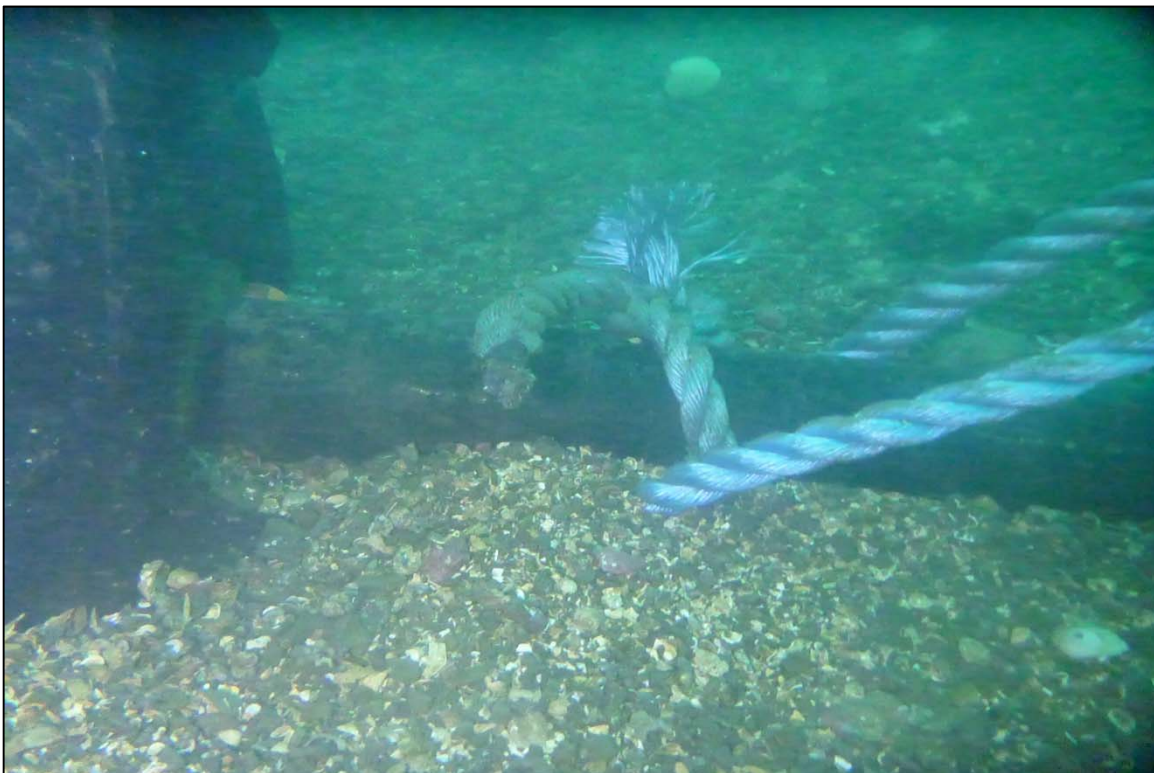
Photograph 16: View of Anchor Fluke Embedment at Orchard Rocks North Anchor Line 1, Looking East.

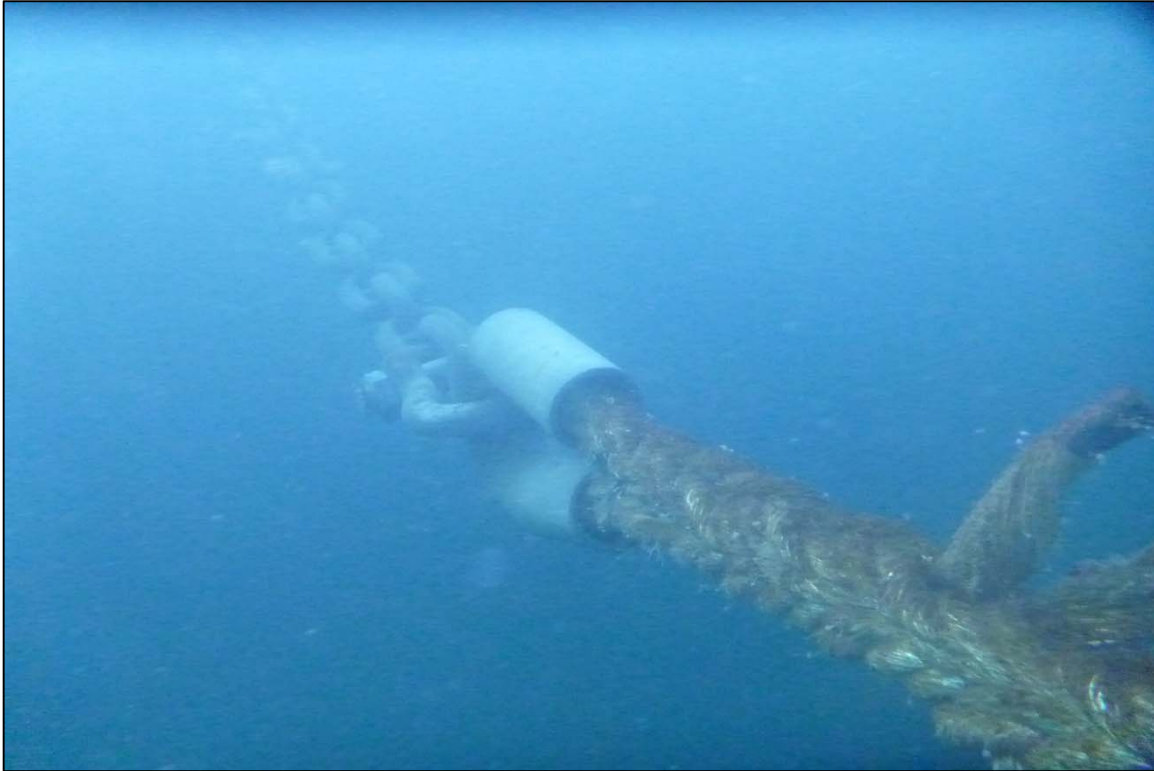
Photograph 17: View of Upper Anchor Chain to Rope Connection (Shackle and Thimble) at Orchard Rocks North Anchor Line 2, Looking West.

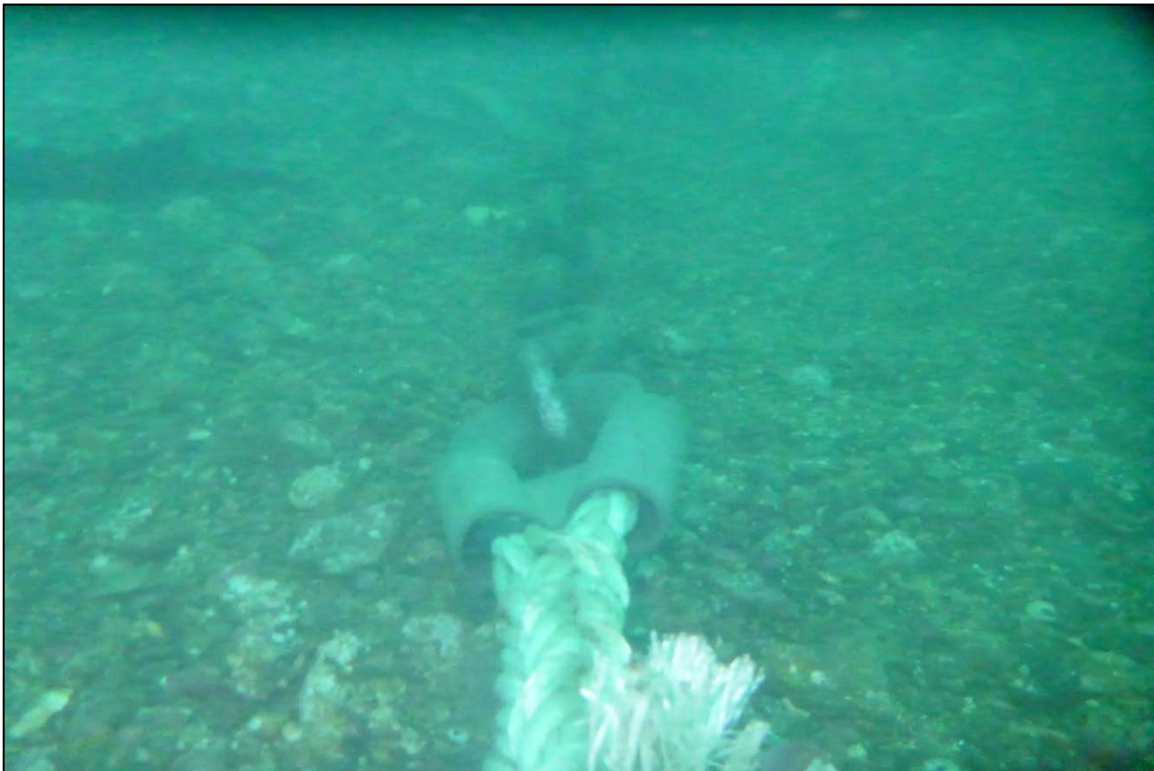
Photograph 18: View of Rope to Lower Anchor Chain Connection (Shackle and Thimble) at Orchard Rocks North Anchor Line 2, Looking East.

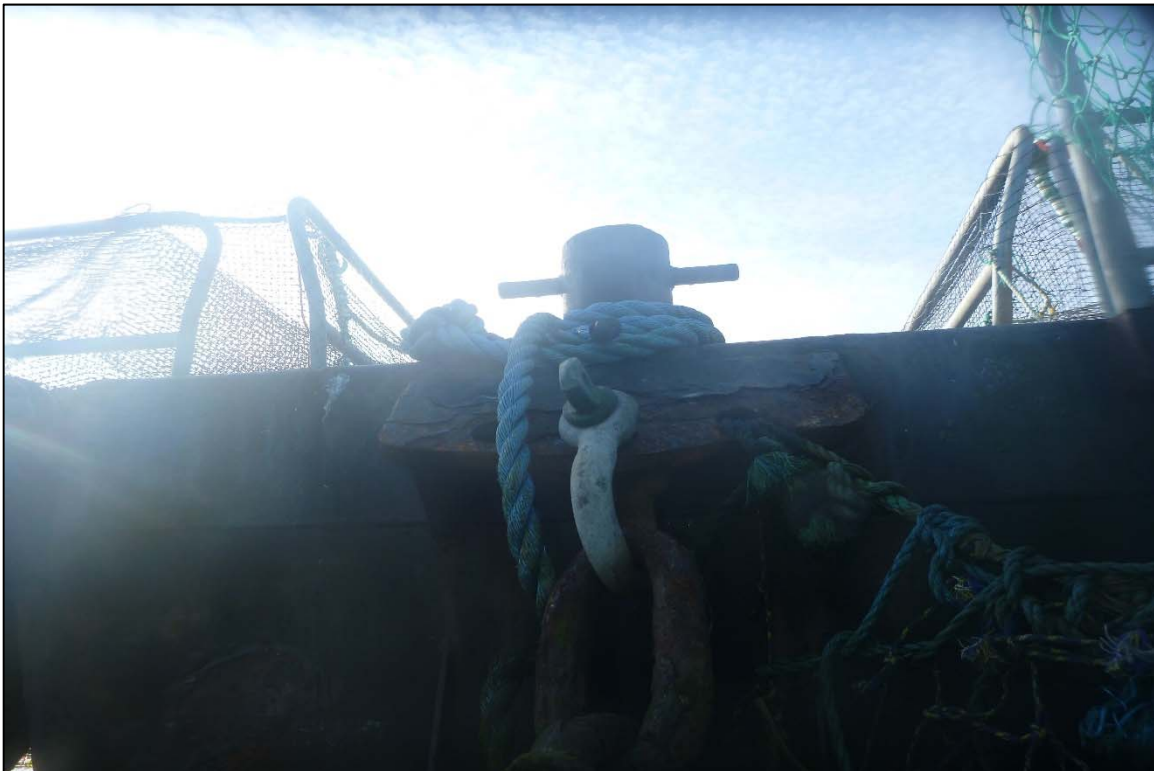
Photograph 20: View of Upper Anchor Chain to Float Connection with Severe Corrosion at Orchard Rocks North Anchor Line 3, Looking West.

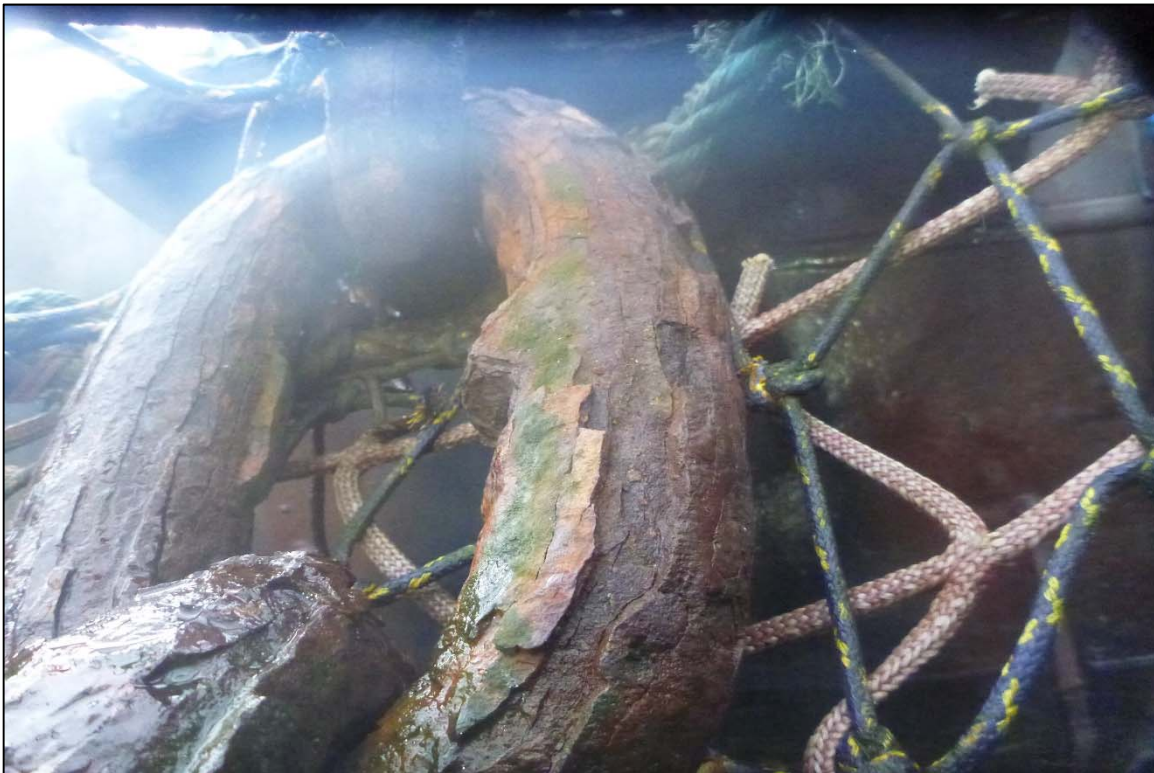
Photograph 24: View of Upper Anchor Chain Condition with Heavy Corrosion and Delamination at Orchard Rocks North Anchor Line 4, Looking West.

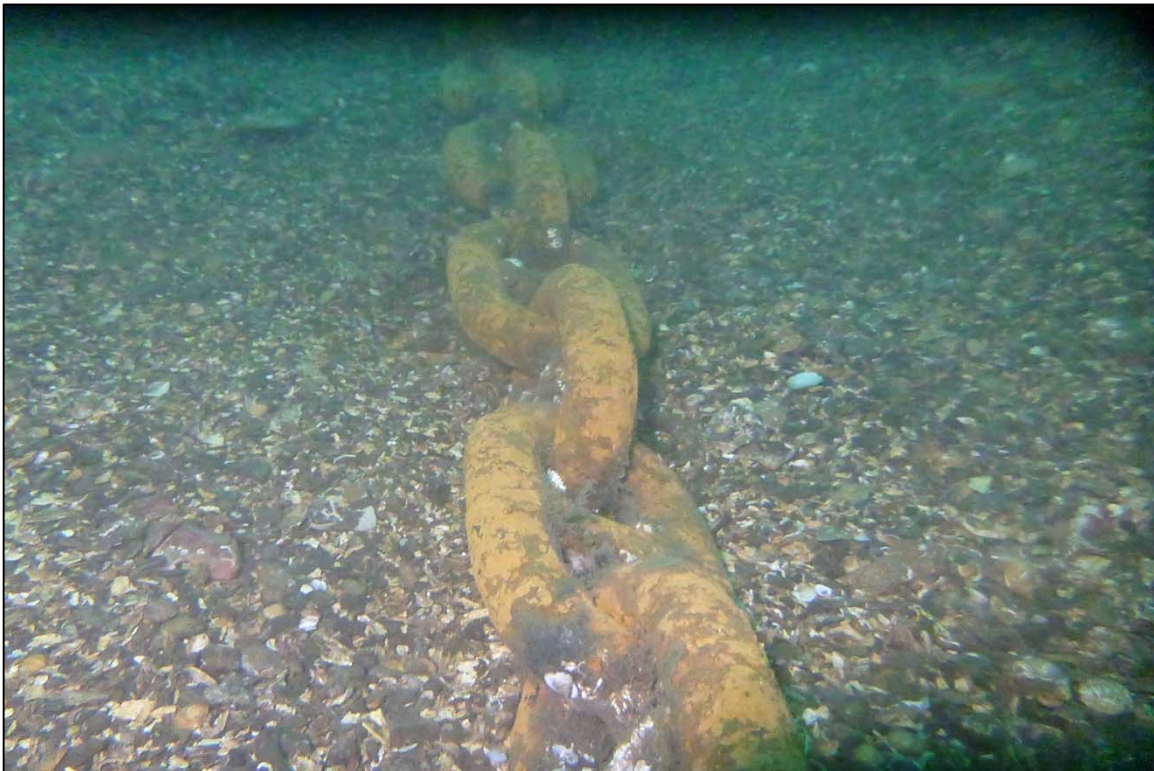
Photograph 28: View of Lower Anchor Chain on the Channel Bottom at Orchard Rocks North Anchor Line 5, Looking East.

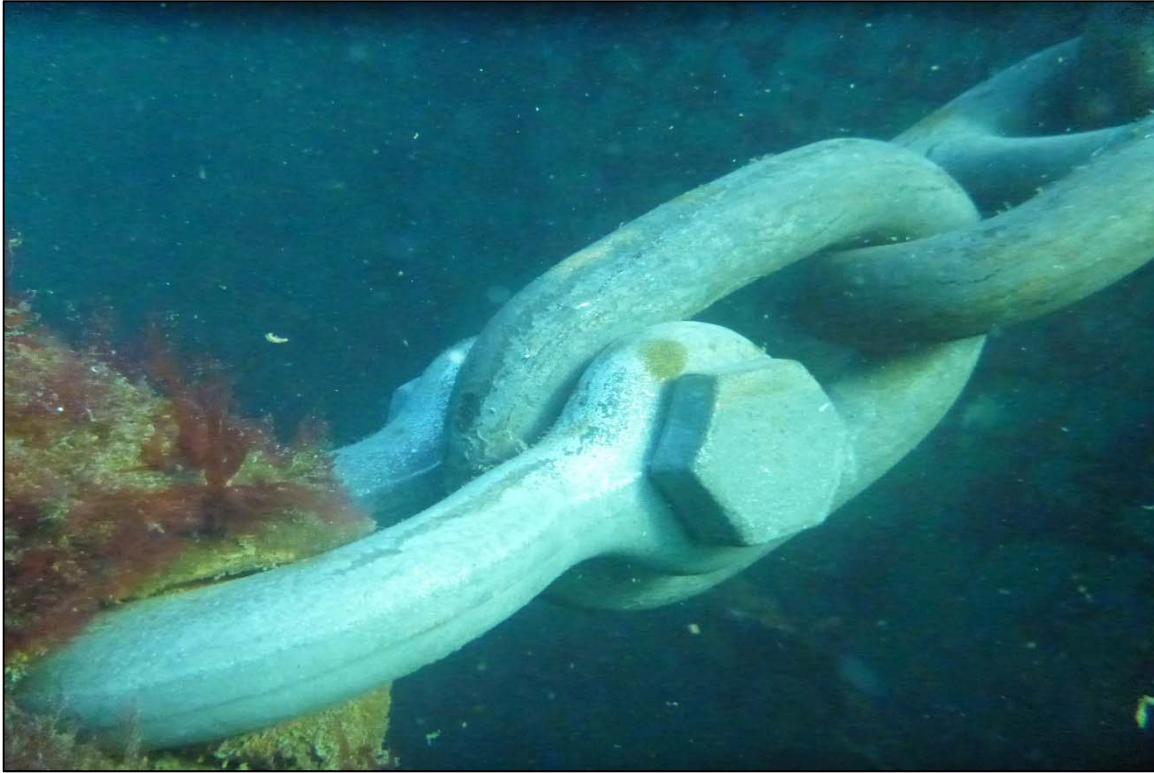
Photograph 29: View of Upper Anchor Chain Condition at Orchard Rocks North Anchor Line 9, Looking North.

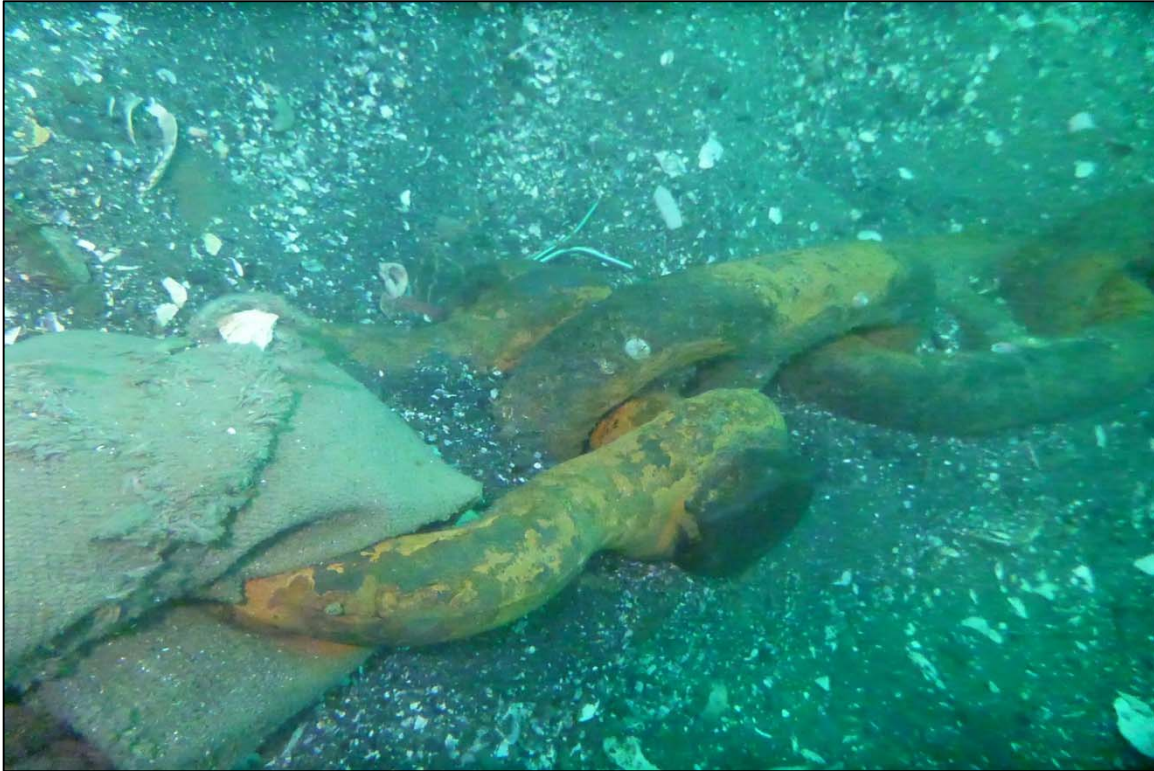
Photograph 31: View of Rope to Lower Anchor Chain Connection (Shackle and Sleeve) at Orchard Rocks North Anchor Line 9, Looking North.

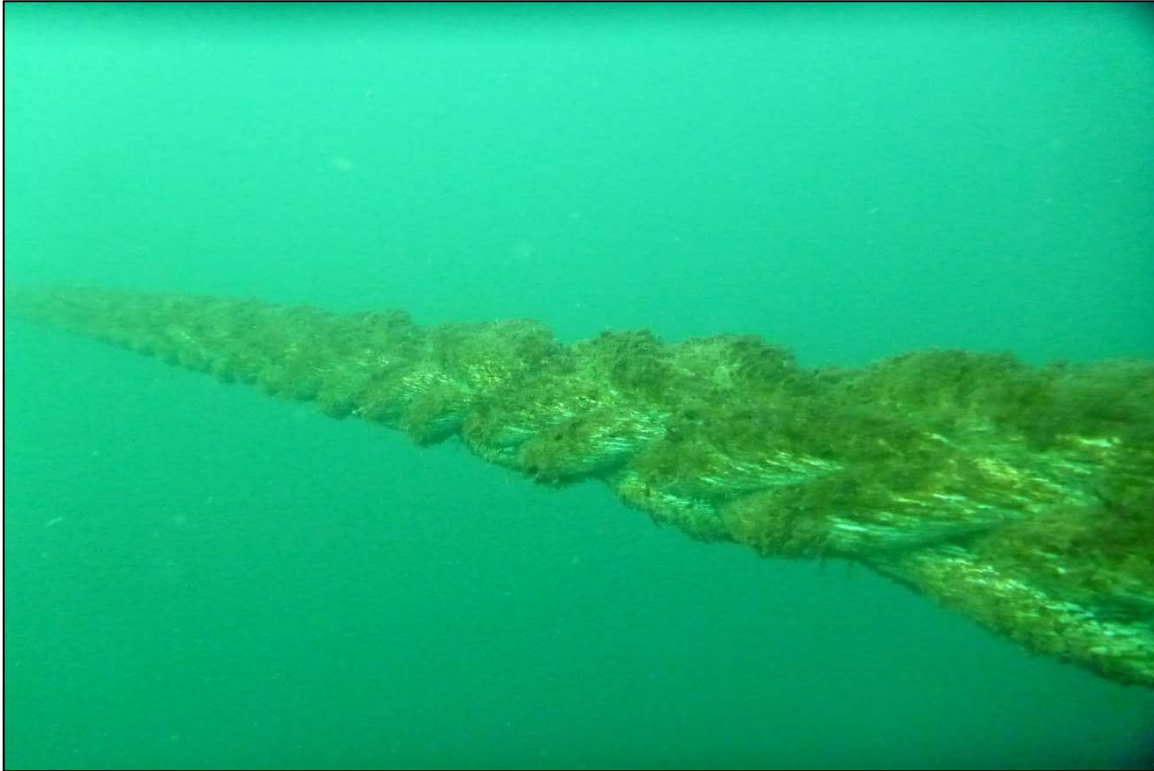
Photograph 33: View of Rope Condition with Light Marine Growth at Orchard Rocks North Anchor Line 10, Looking Northwest.

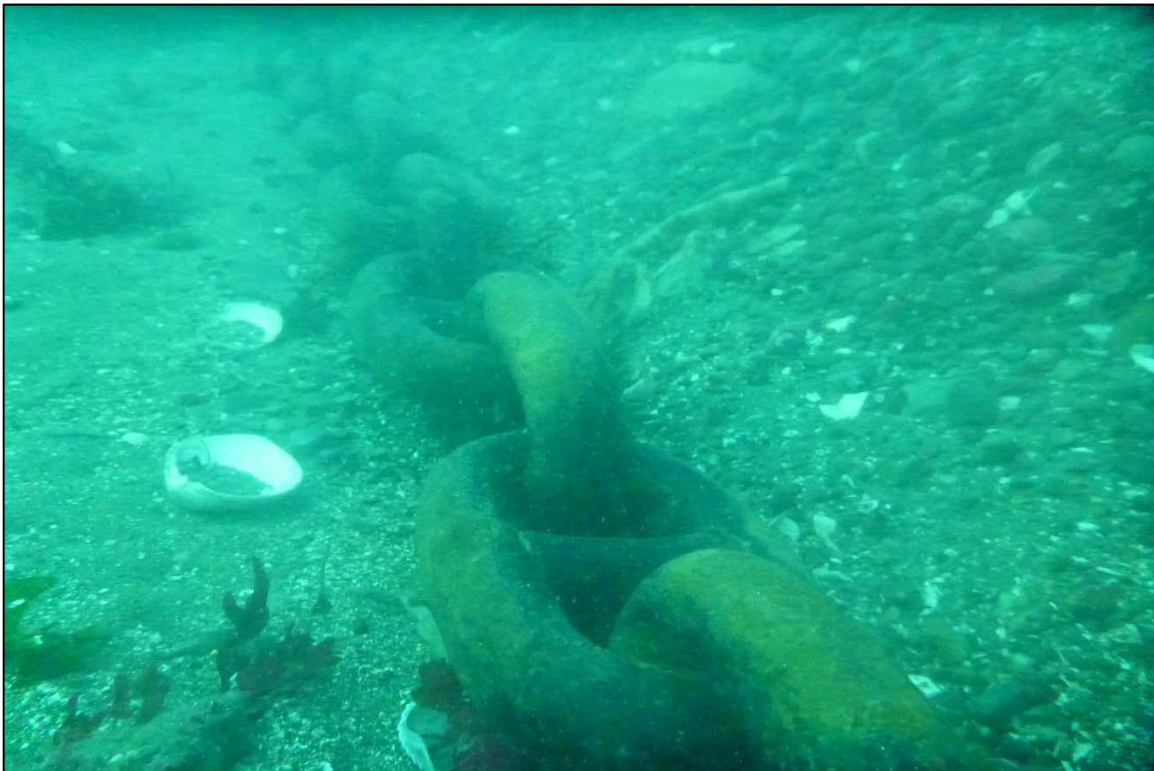
Photograph 34: View of Lower Anchor Chain on Channel Bottom at Orchard Rocks North Anchor Line 10, Looking West.

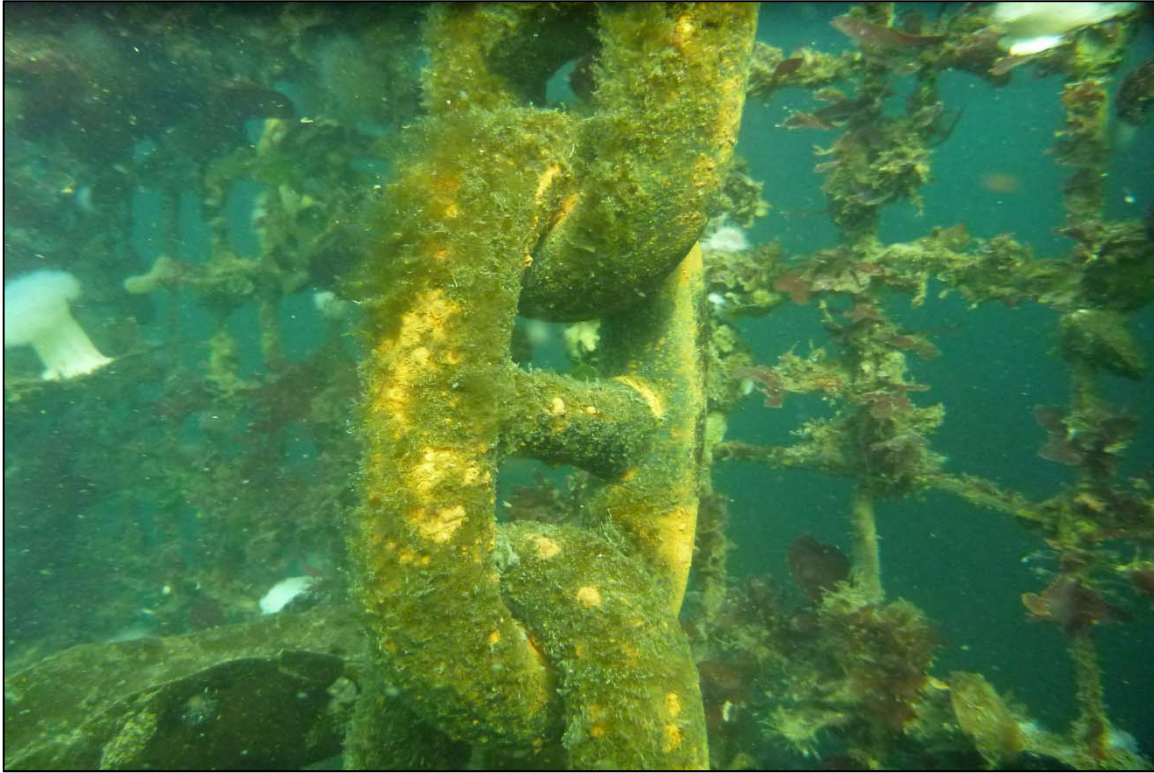
Photograph 35: View of Light Marine Growth on the Upper Anchor Chain at Orchard Rocks North Anchor Line 11, Looking North.

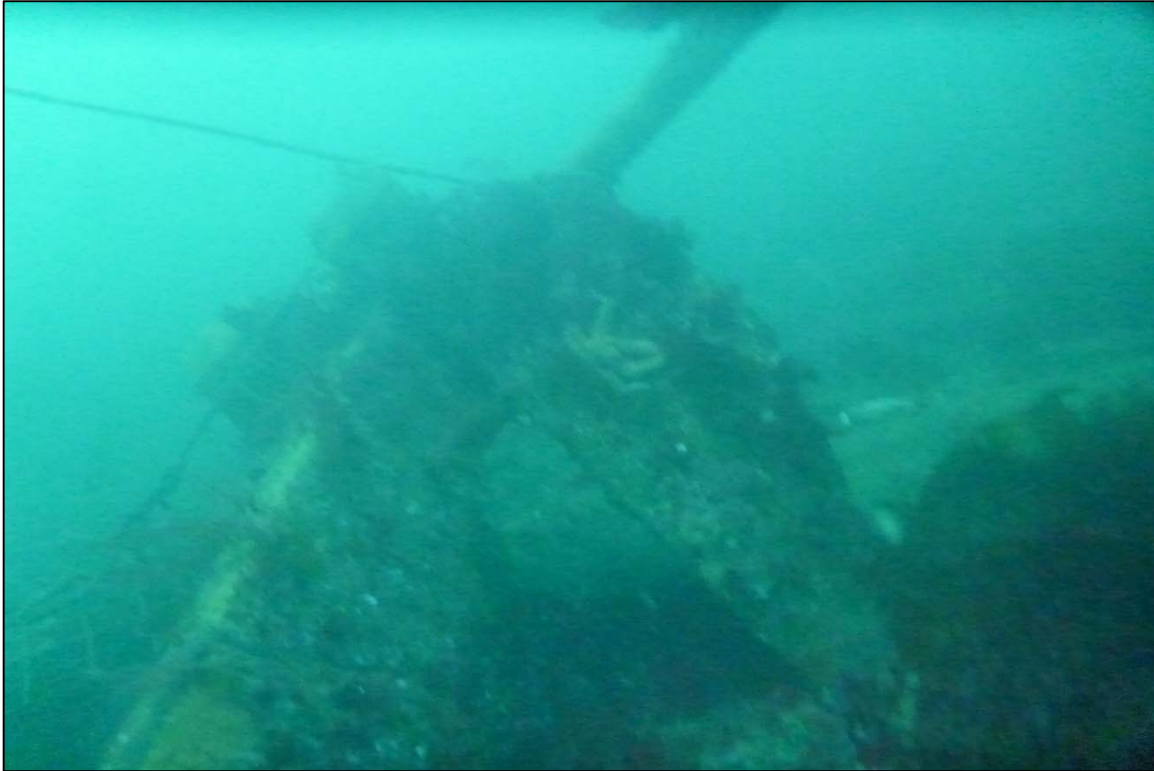
Photograph 37: View of the Anchor on the Channel Bottom at Orchard Rocks North Anchor Line 36, Looking West.

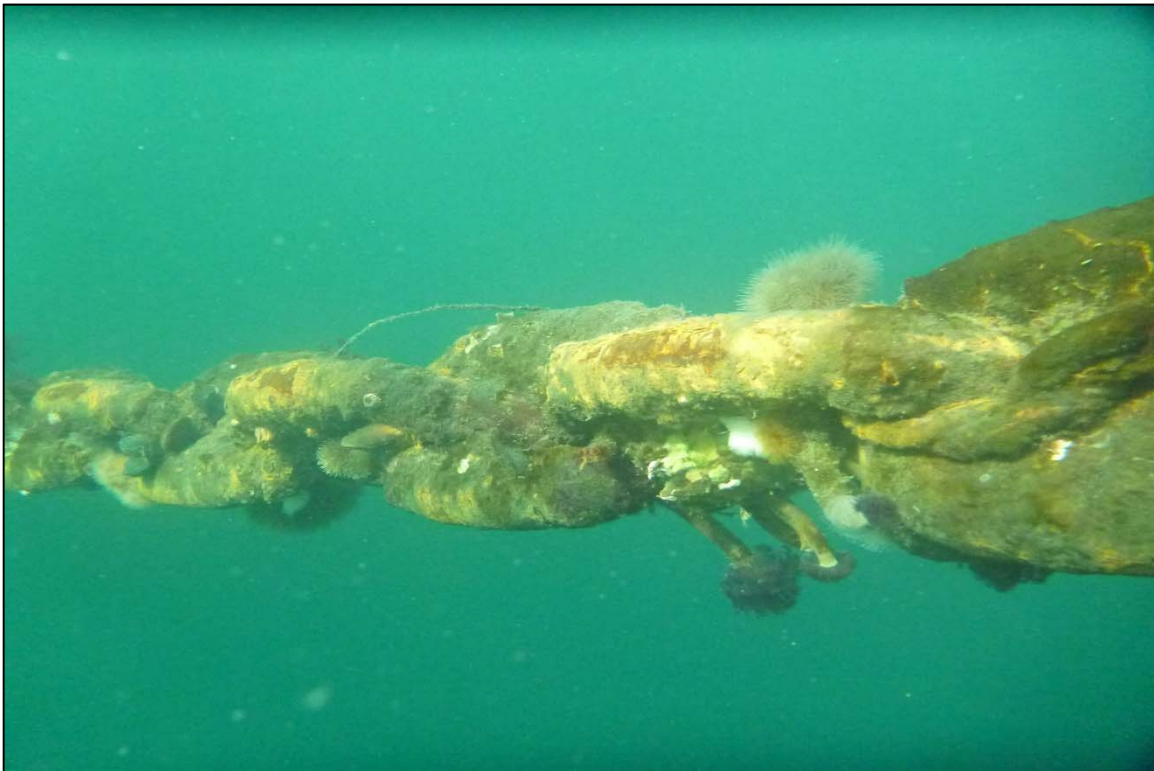
Photograph 38: View of Upper Anchor Chain Condition at Orchard Rocks North Anchor Line 13, Looking East.
