# **Rich Passage Orchard Rocks Atlantic Salmon Net Pens Engineering Assessment**

January 29, 2018

Mott MacDonald  
110 James Street  
Suite 101  
Edmonds WA 98020  
United States of America

State of Washington  
Department of Natural  
Resources  
1111 Washington Street SE  
Olympia Washington 98504

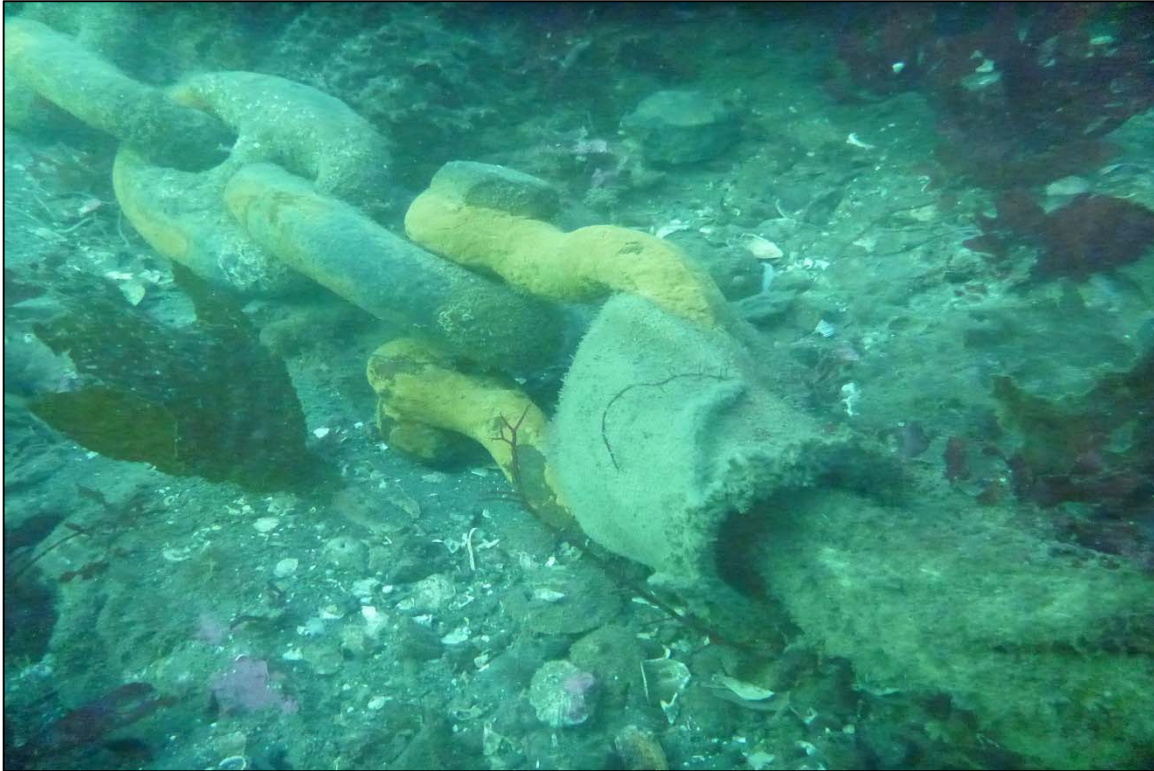
Photograph 39: View of the Rope to Lower Anchor Chain (Shackle and Sleeve) at Orchard Rocks North Anchor Line 12, Looking Northeast.

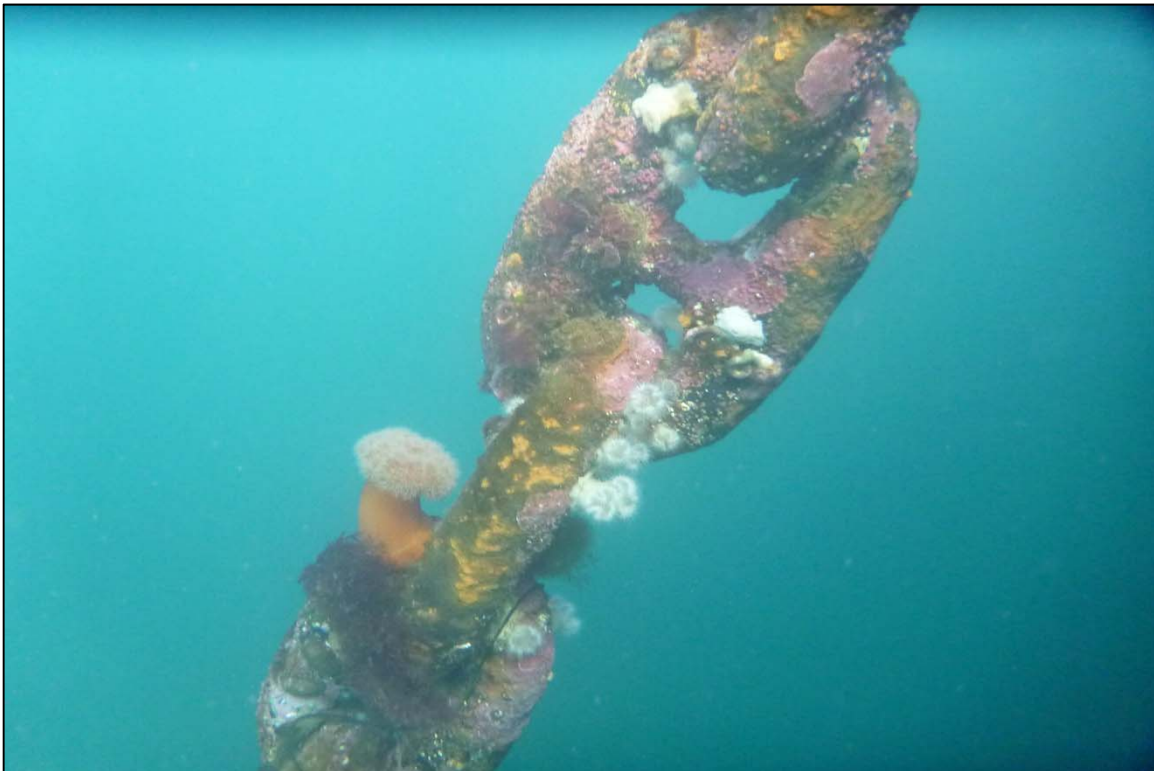
Photograph 40: View of Upper Anchor Chain Condition at Orchard Rocks North Anchor Line 13, Looking East.

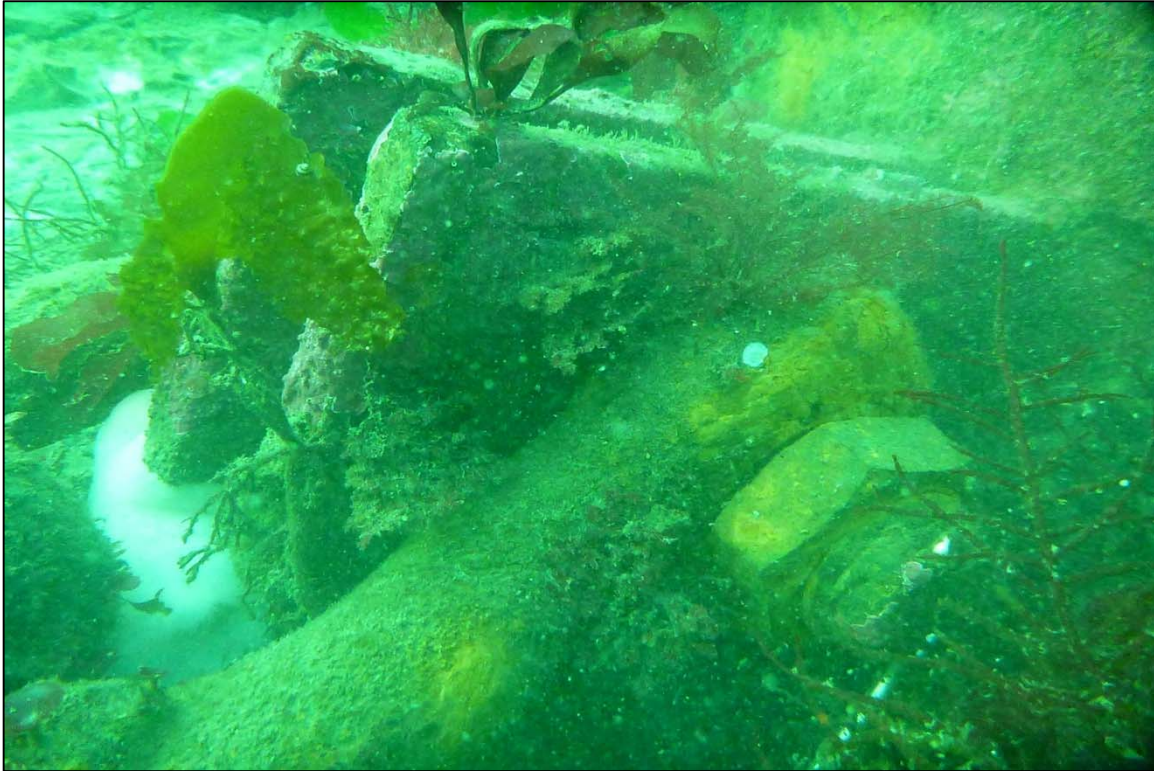
Photograph 41: View of Lower Anchor to Anchor Connection at Orchard Rocks North Anchor Line 13, Looking Northwest.

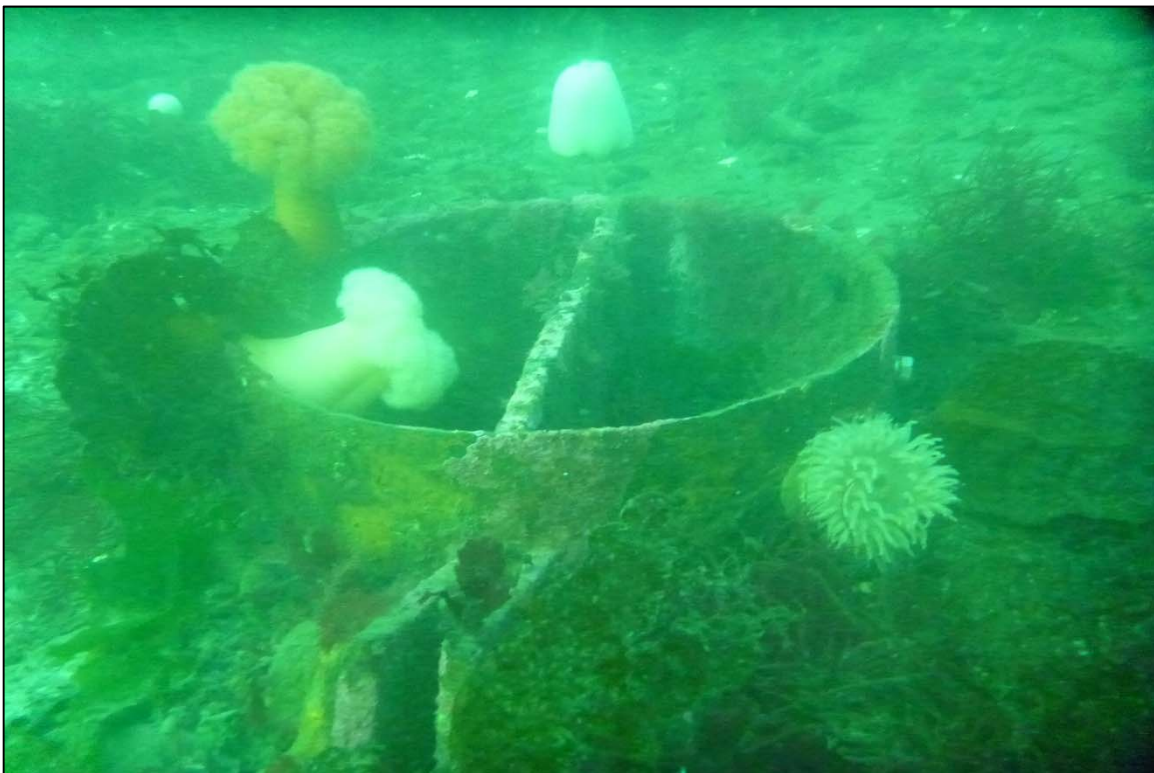
Photograph 42: View of Pipe Anchor Condition at Orchard Rocks North Anchor Line 13, Looking North.

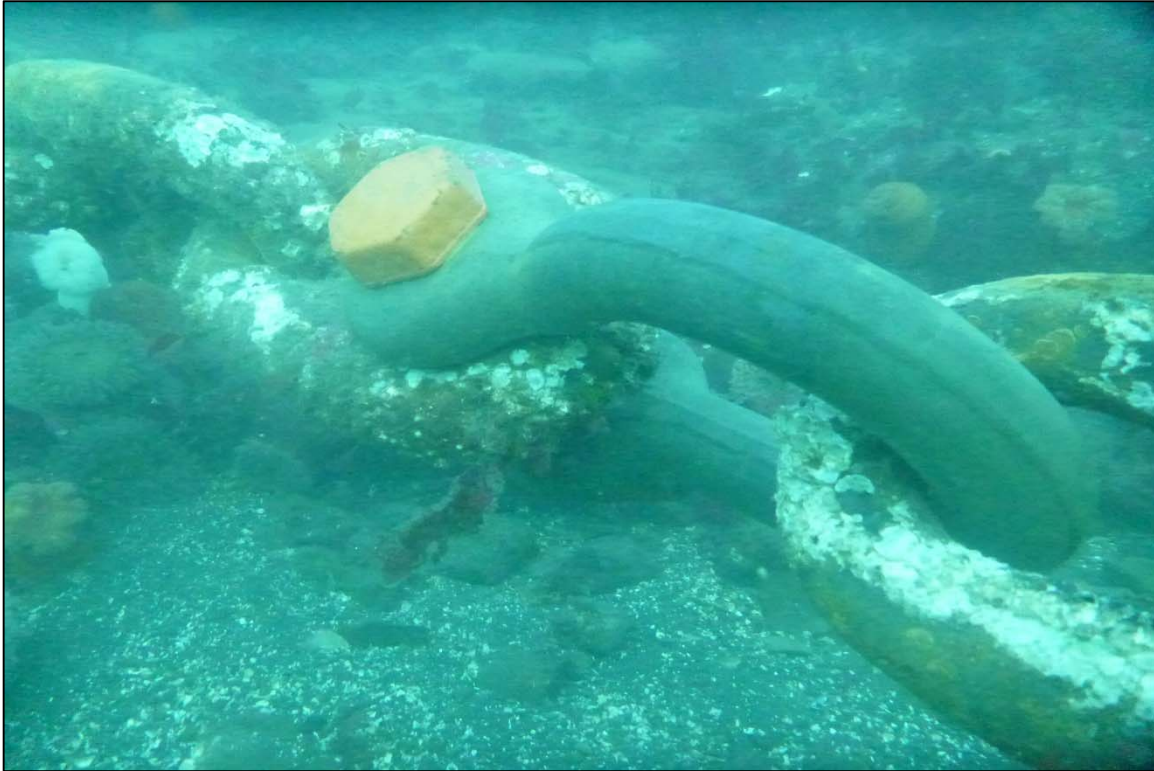
Photograph 43: View of Shackle Connection in the Anchor Chain at Orchard Rocks North Anchor Line 14, Looking Northeast.

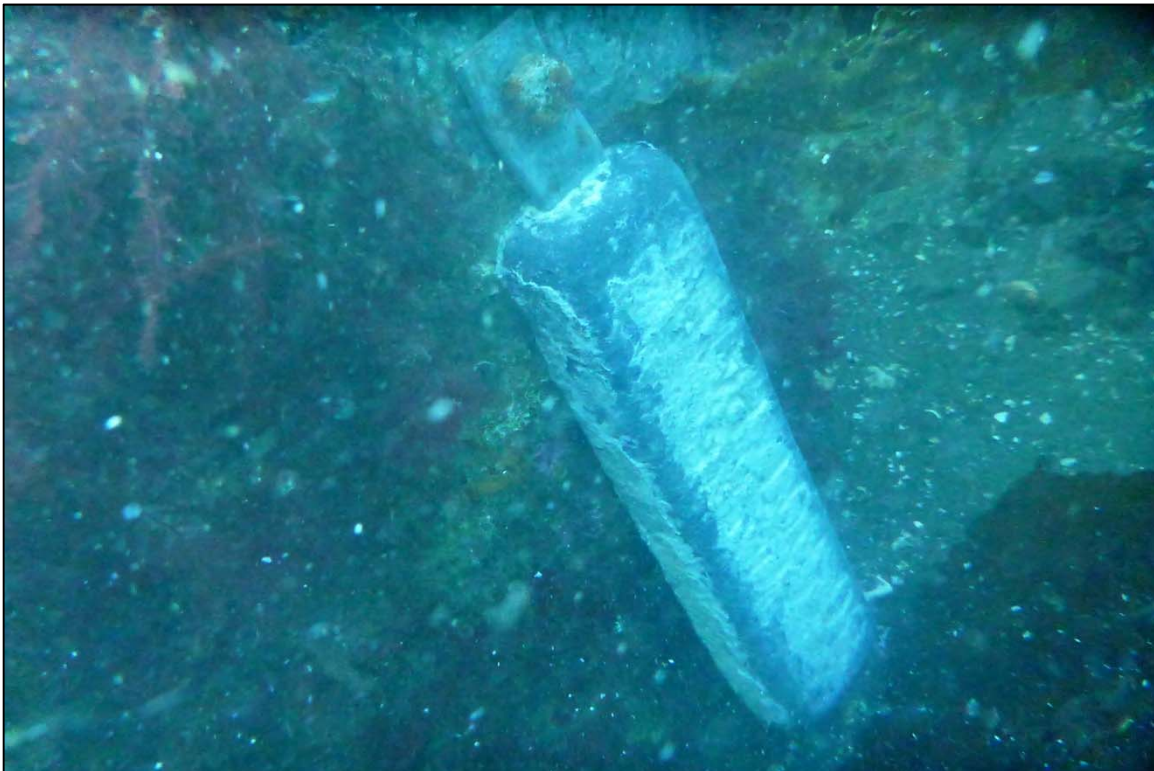
Photograph 44: View of Anode at the Pipe Anchor at Orchard Rocks North Anchor Line 14, Looking West.

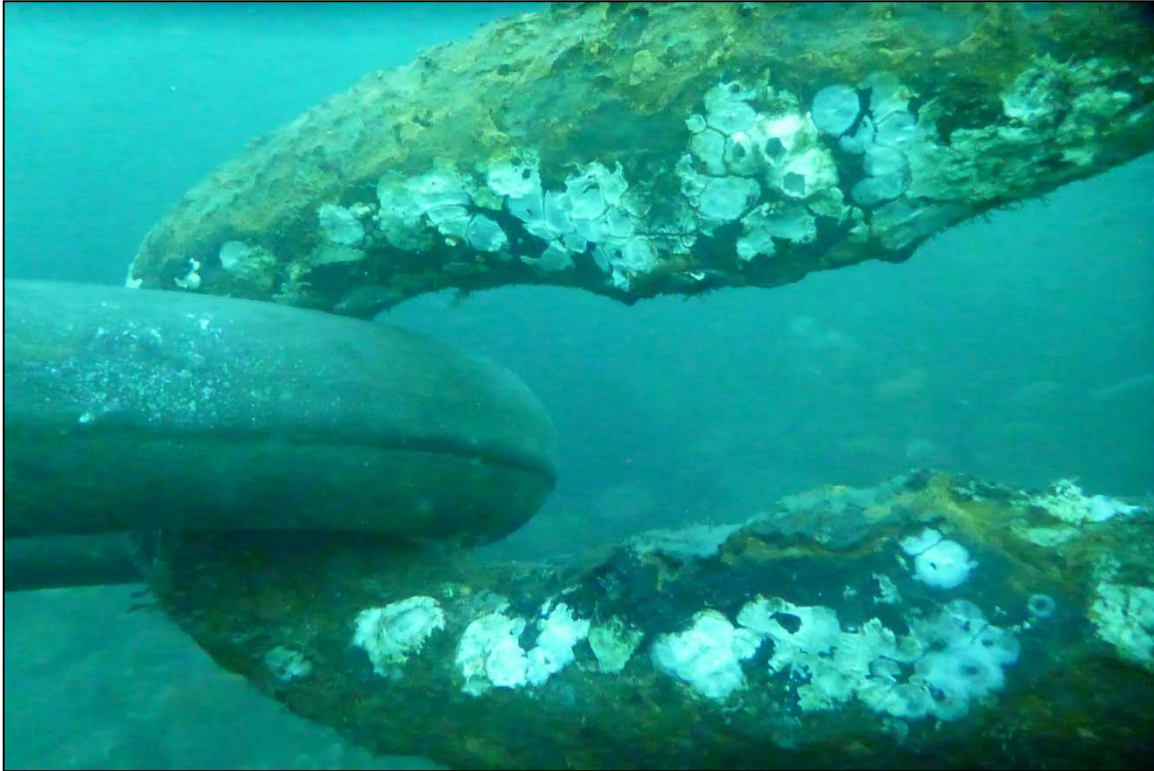
Photograph 45: View of Section Loss and Missing Stud in the Anchor Chain at Orchard Rocks North Anchor Line 15, Looking East.

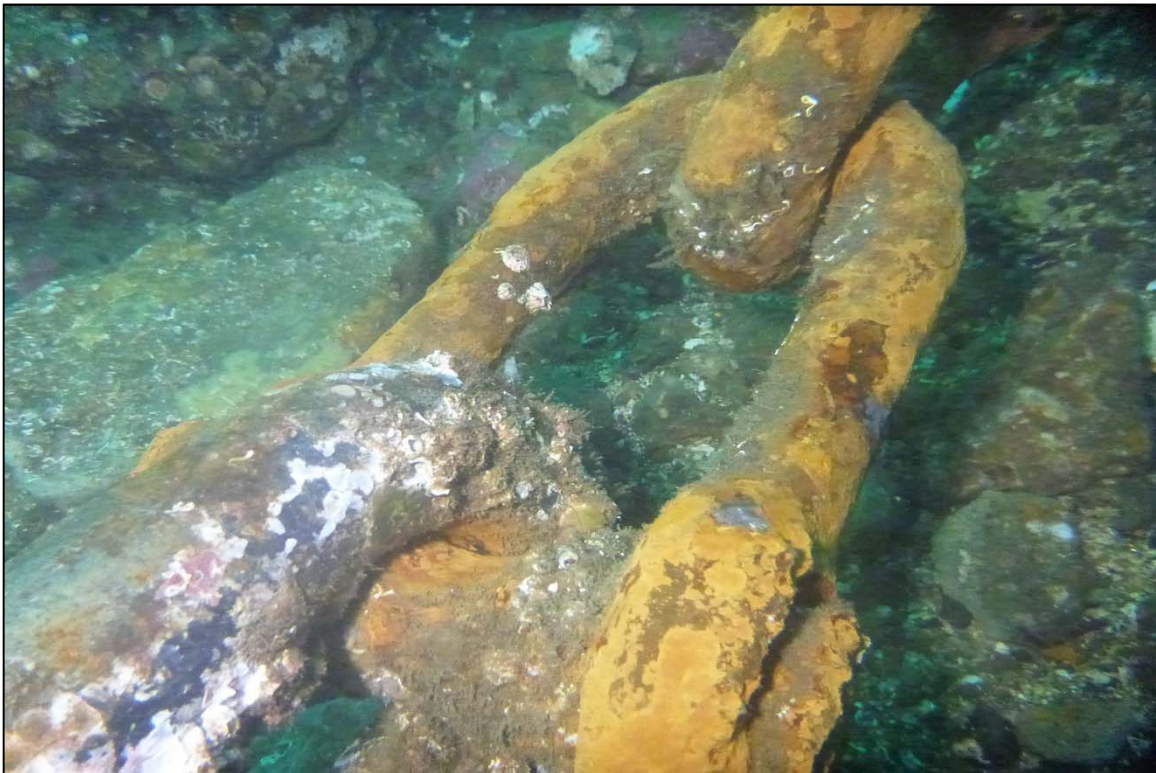
Photograph 48: View of Lower Anchor Shackle with Heavy Corrosion and Section Loss at Orchard Rocks North Anchor Line 16, Looking North.

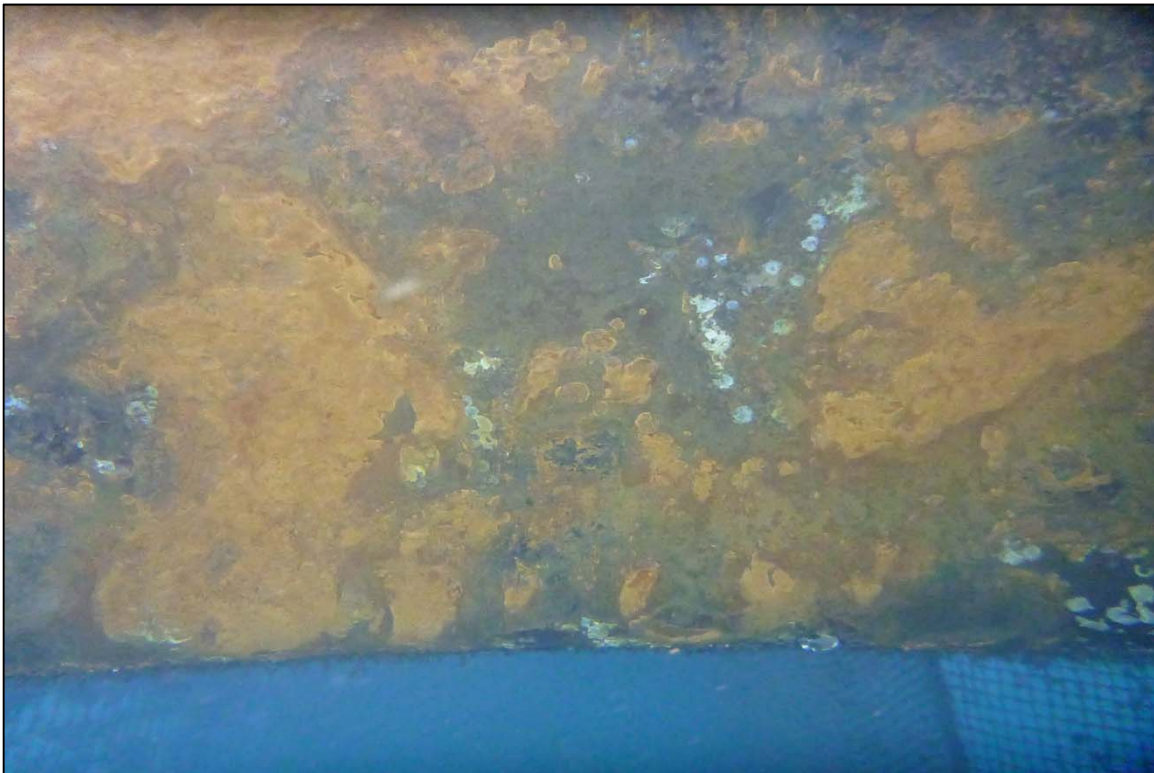
Photograph 50: View of the Steel Pontoon Condition at Orchard Rocks South Fish Net Pens System, Looking South.

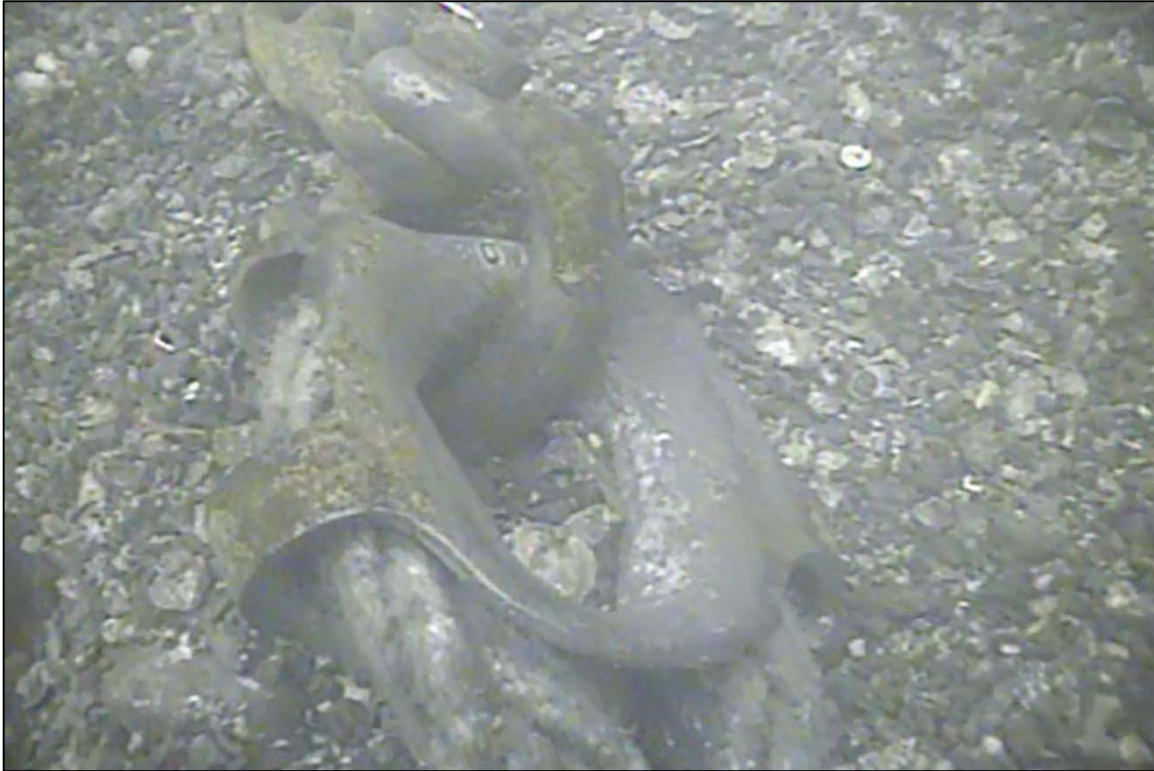
Photograph 54: View of Light Marine Growth on the Rope at Orchard Rocks South Anchor Line 1, Looking South.

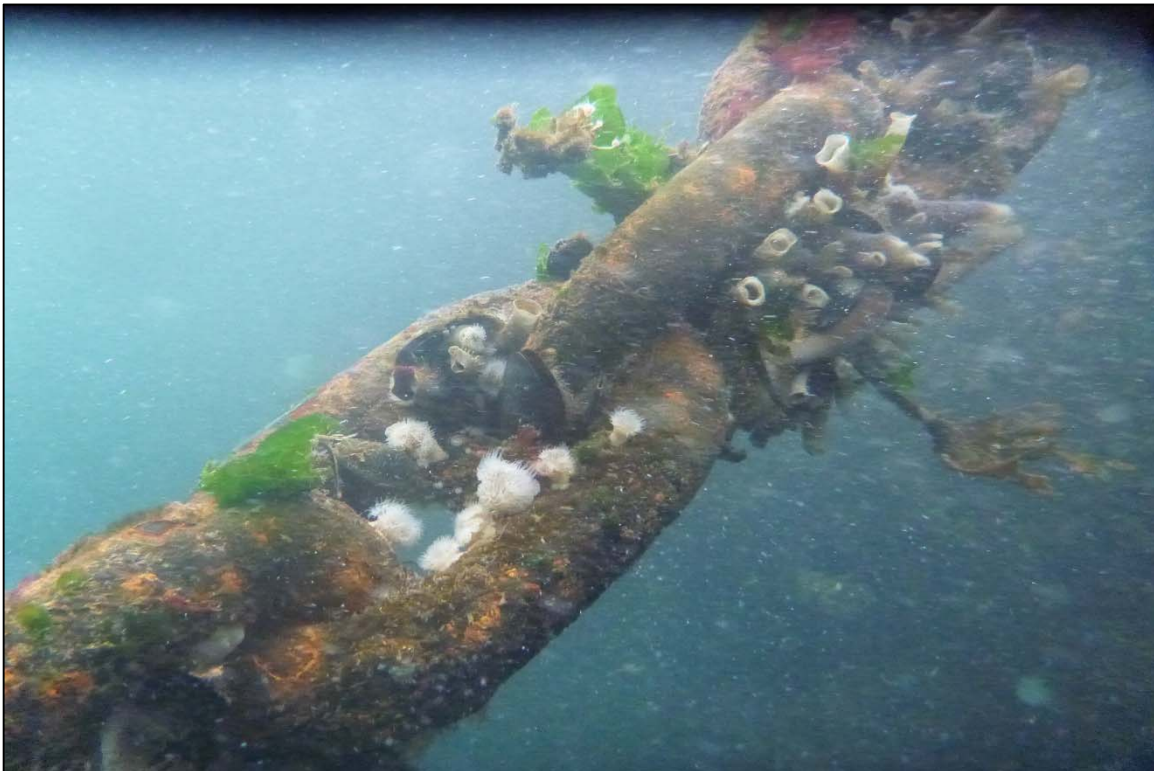
Photograph 55: View of Rope to Lower Anchor Chain Connection (Shackle and Thimble) at Orchard Rocks South Anchor Line 1, Looking East.

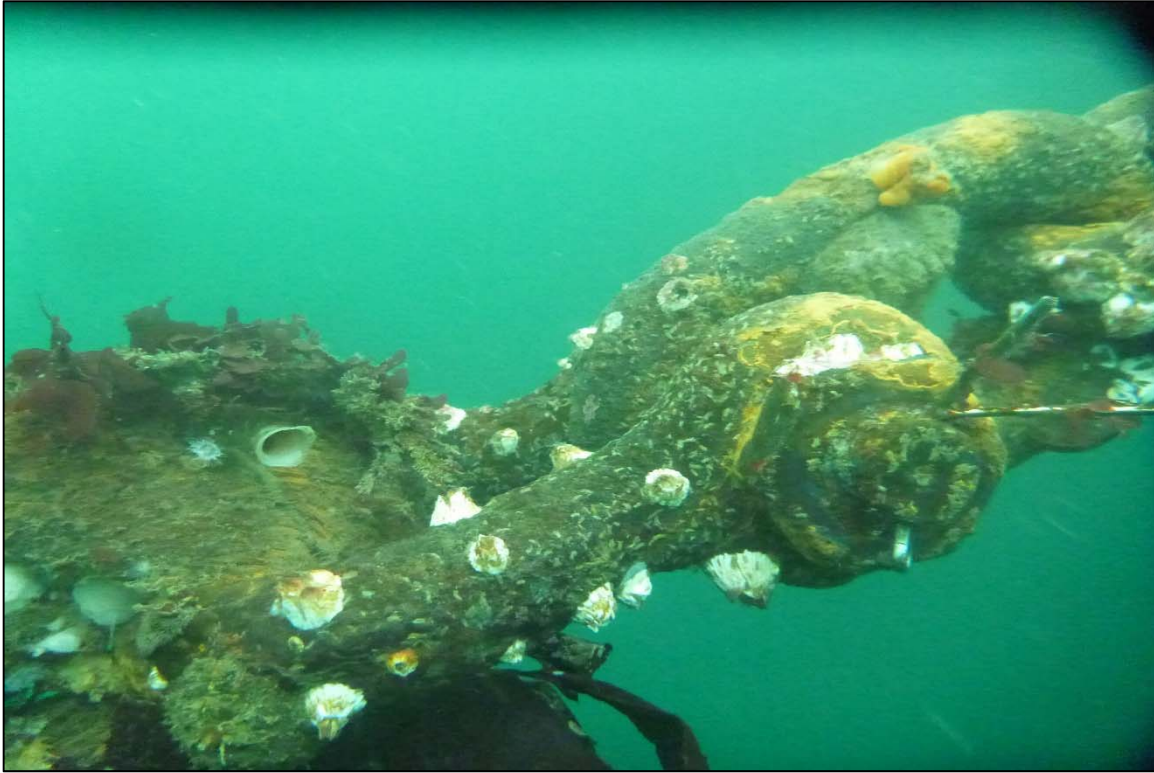
Photograph 56: View of Upper Chain Condition at Orchard Rocks South Anchor Line 2, Looking East.

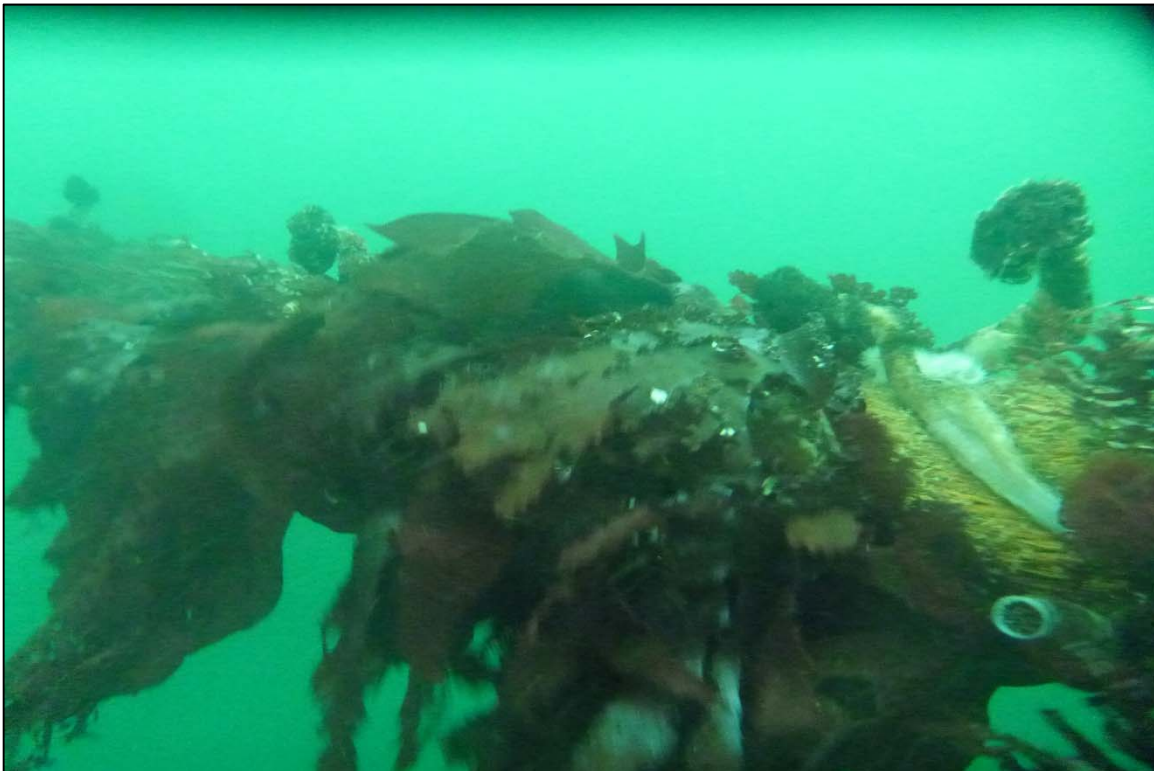
Photograph 57: View of Upper Chain to Rope Connection (Shackle) at Orchard Rocks South Anchor Line 2, Looking South.

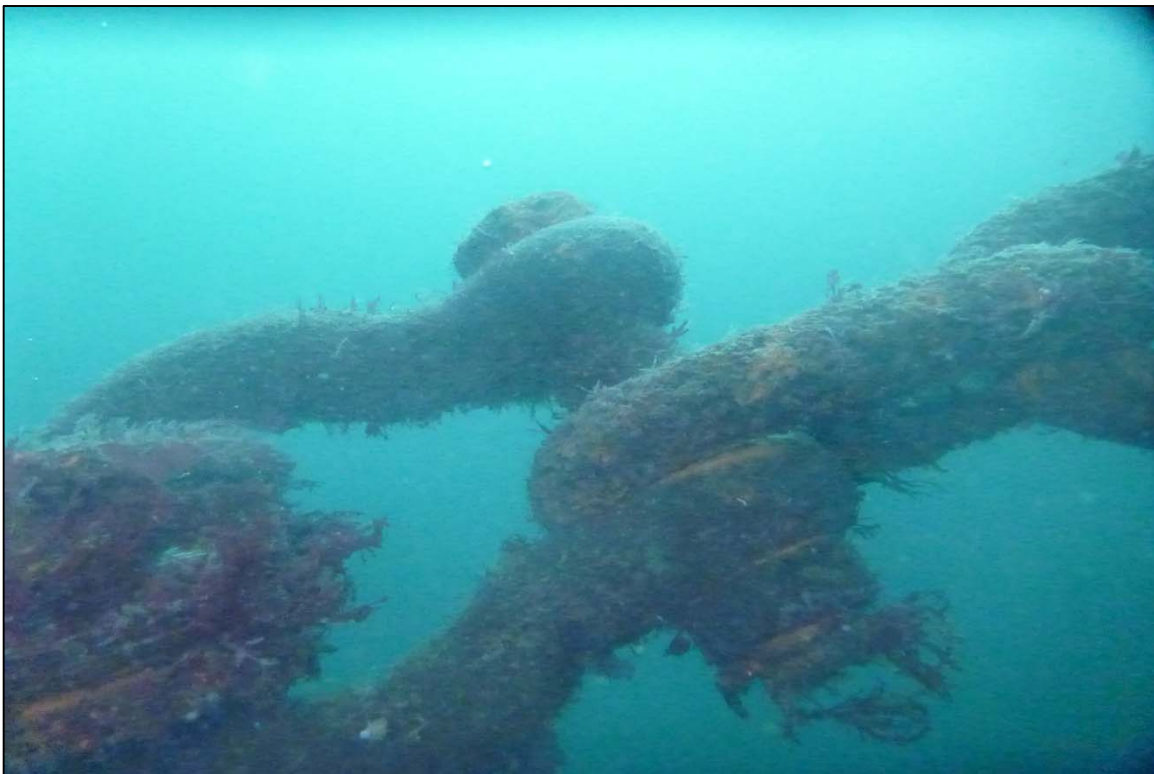
Photograph 63: View of Upper Anchor Chain to Float Connection at Orchard Rocks South Anchor Line 4, Looking West.

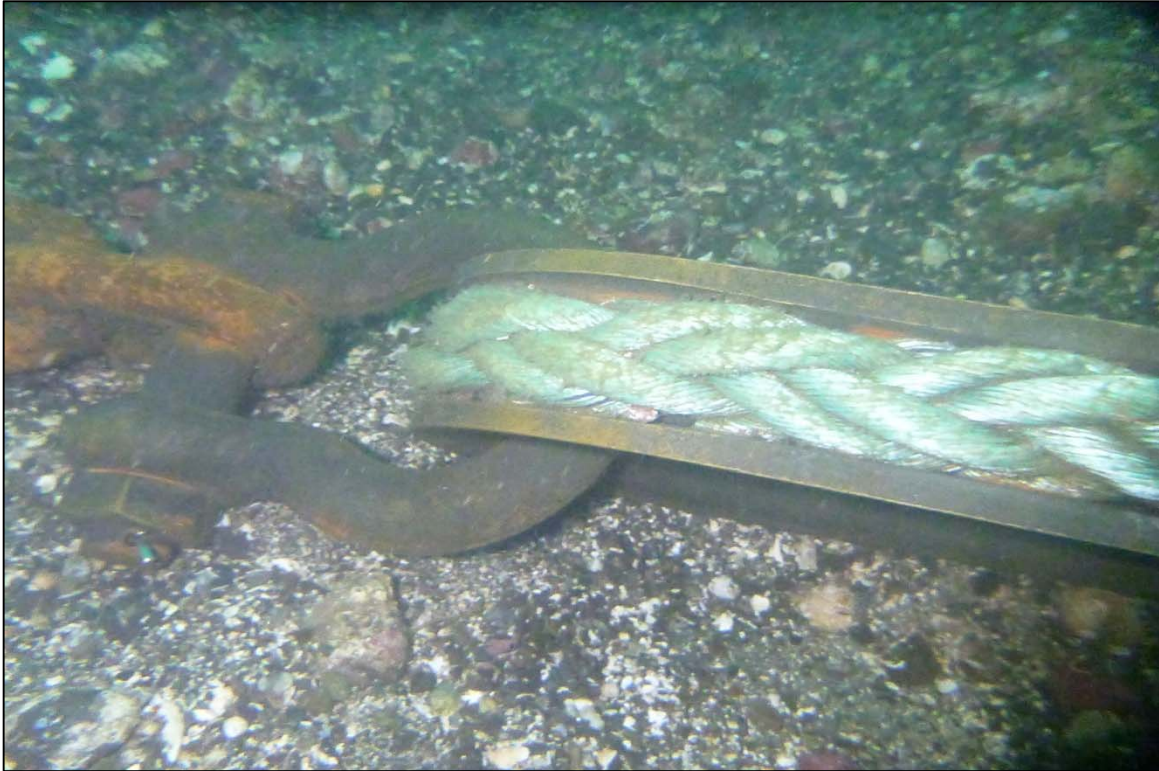
Photograph 64: View of Upper Anchor Chain to Anchor Rope Connection (Shackle) at Orchard Rocks South Anchor Line 4, Looking West.

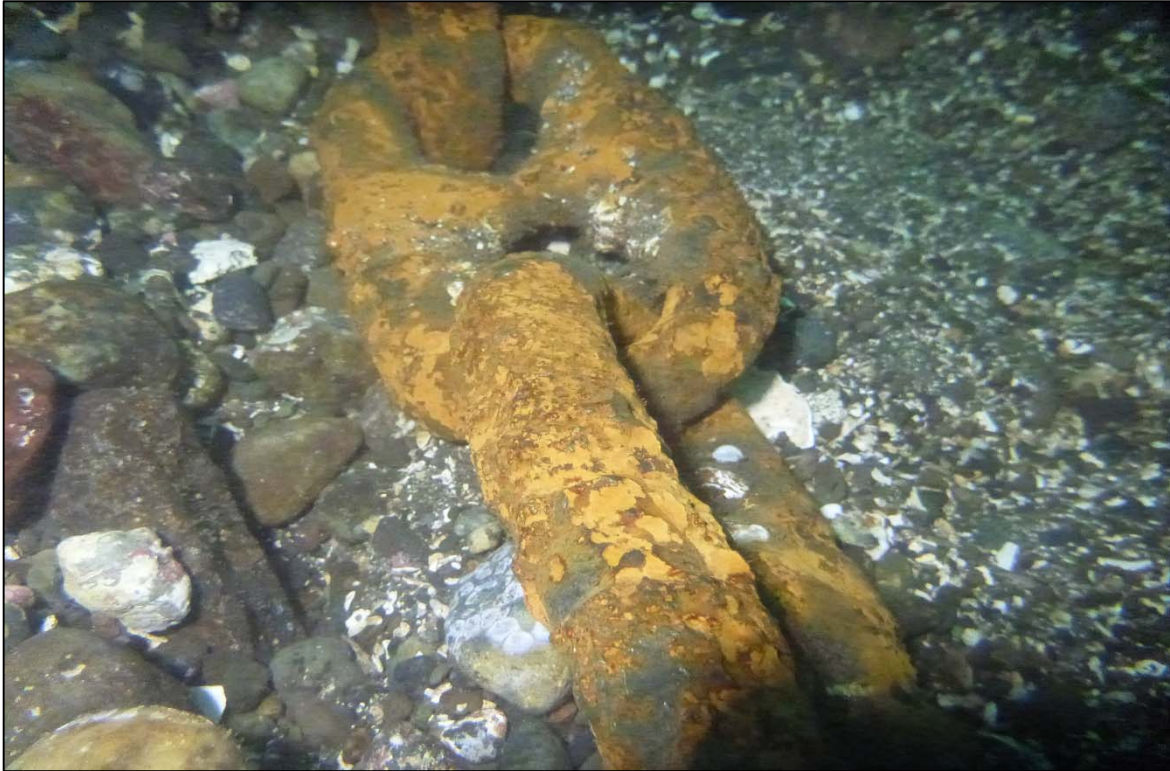
Photograph 66: View of Upper Anchor Chain Moderate Marine Growth at Orchard Rocks South Anchor Line 5, Looking South.

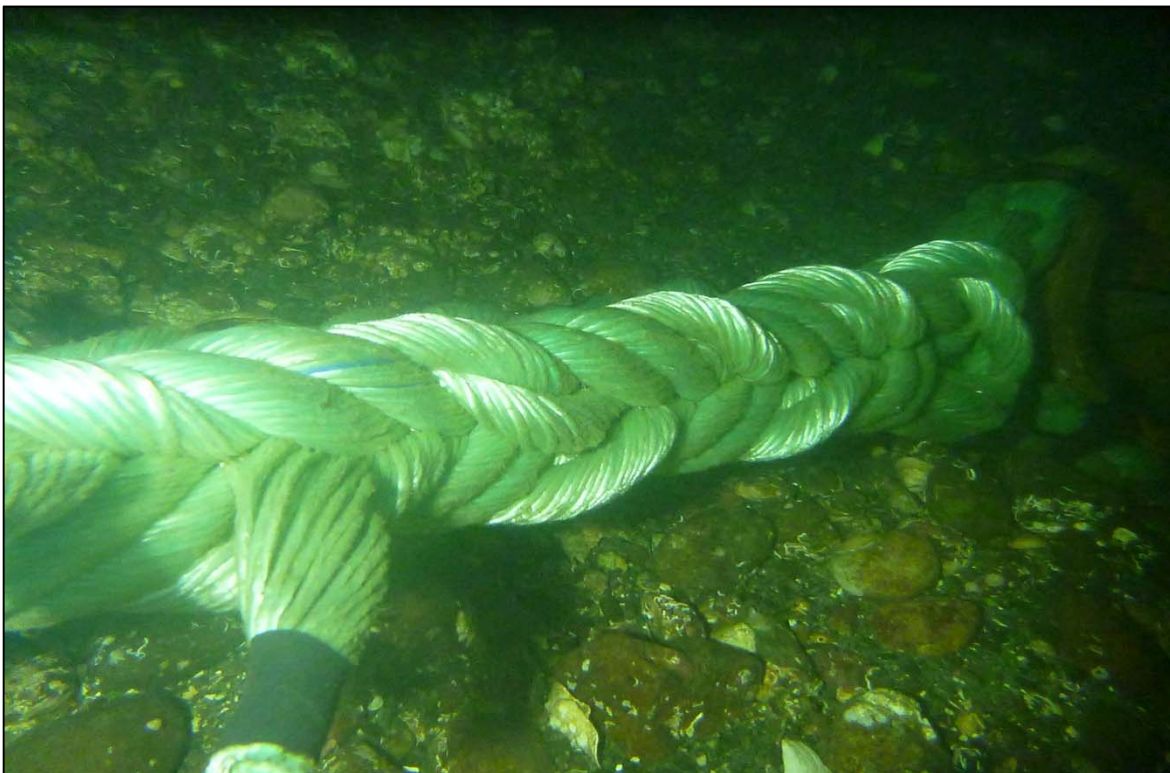
Photograph 69: View of Upper Anchor Chain to Float Connection for Anchor 6 and 6A at Orchard Rocks South Anchor Line 4, Looking West.

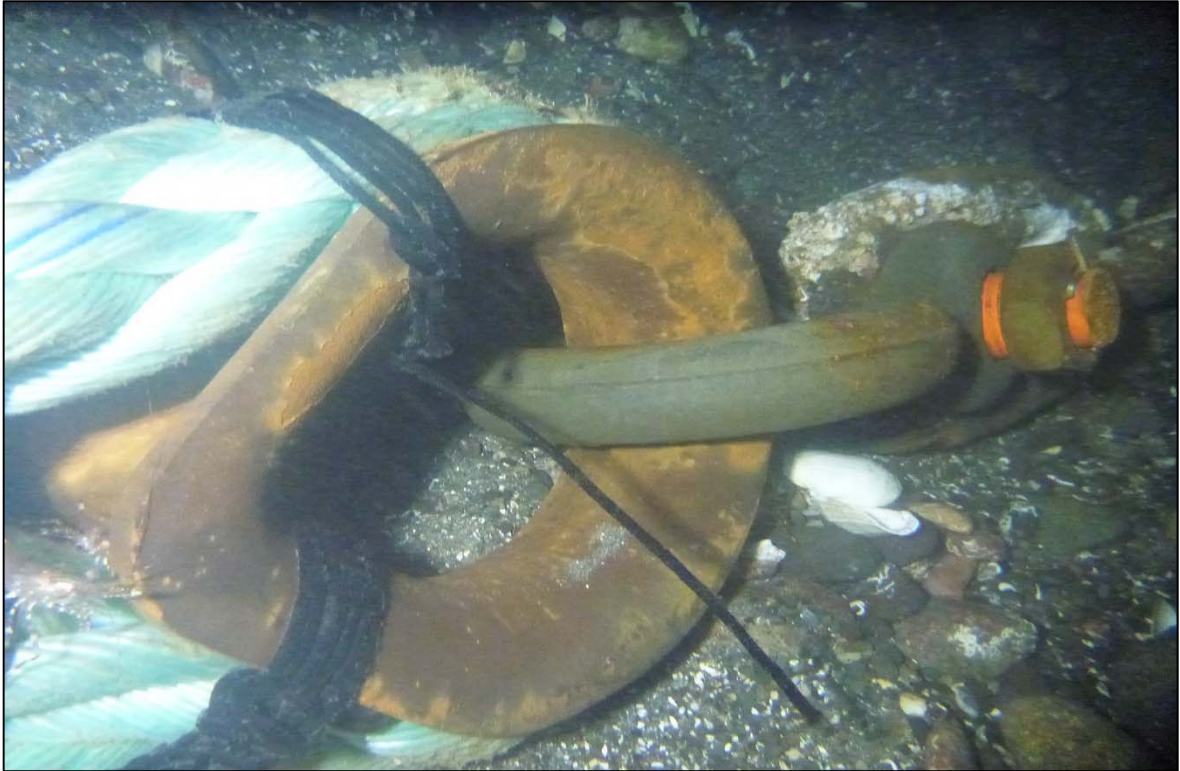
Photograph 70: View of Upper Rope Splice at Orchard Rocks South Anchor Line 6, Looking West.

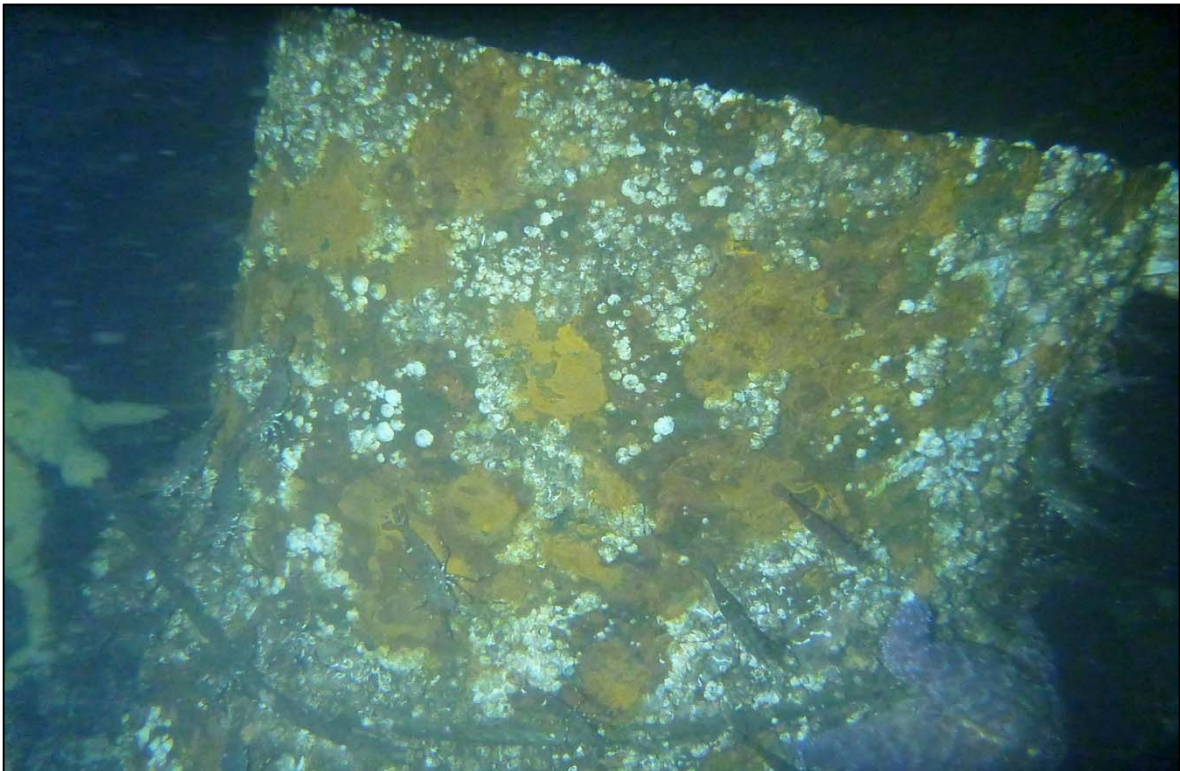
Photograph 71: View of Lower Anchor Chain to Anchor Rope Connection at Orchard Rocks South Anchor Line 6, Looking West.

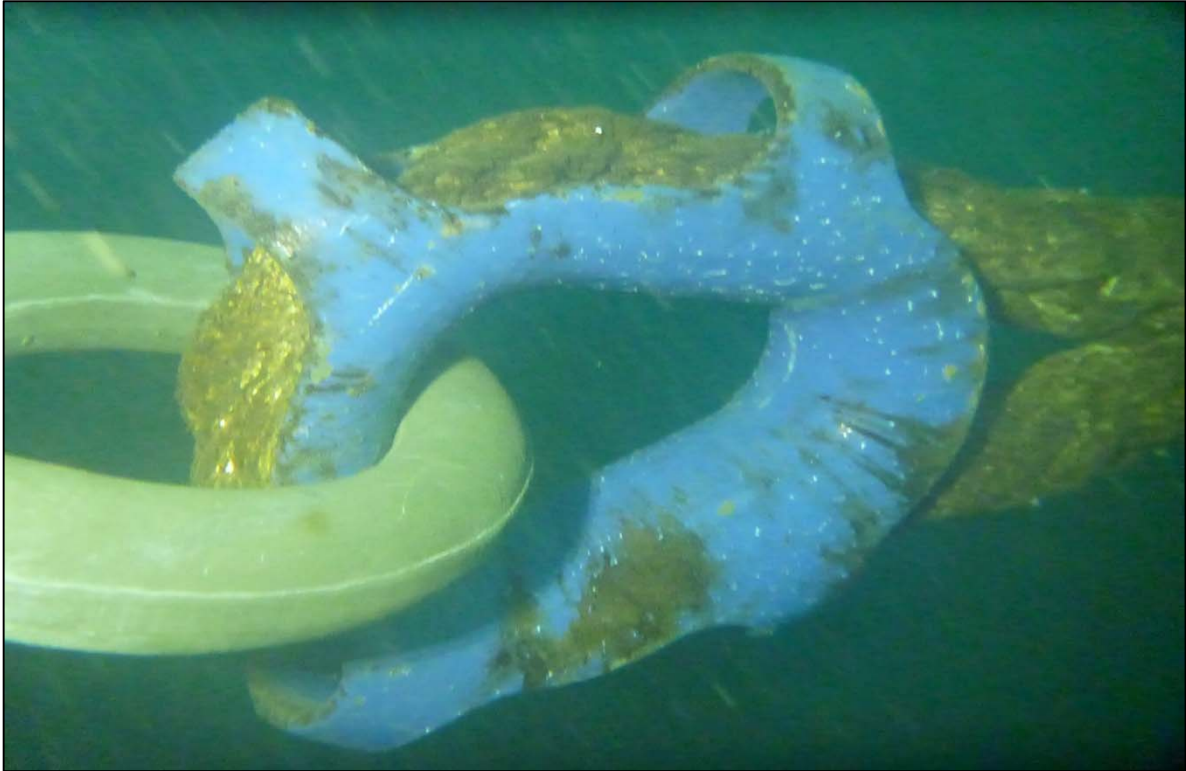
Photograph 72: View of Pipe Anchor at Orchard Rocks South Anchor Line 6, Looking East.

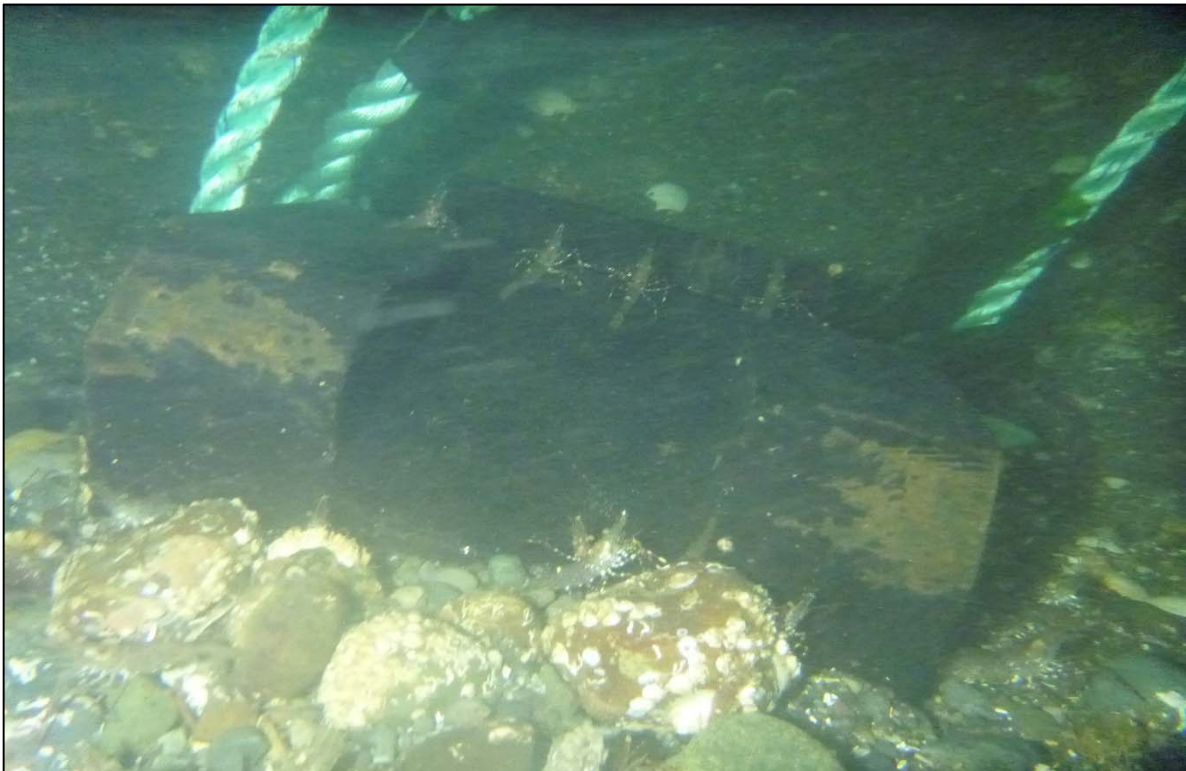
Photograph 73: View of Upper Anchor Chain to Anchor Rope Connection (Thimble and Shackle) at Orchard Rocks South Anchor Line 6A, Looking West.

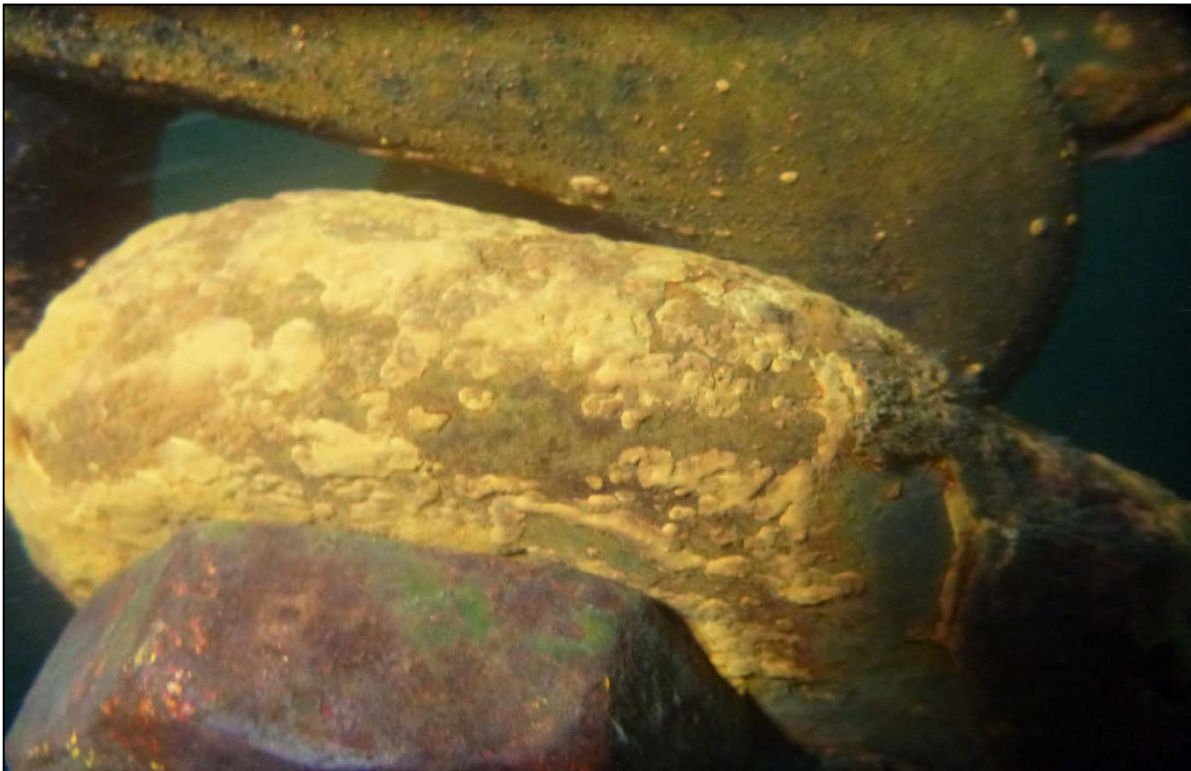
Photograph 75: View of Upper Anchor Chain to Anchor Line Connection (Shackle and Lashing) at Orchard Rocks South Anchor Line 7, Looking South.

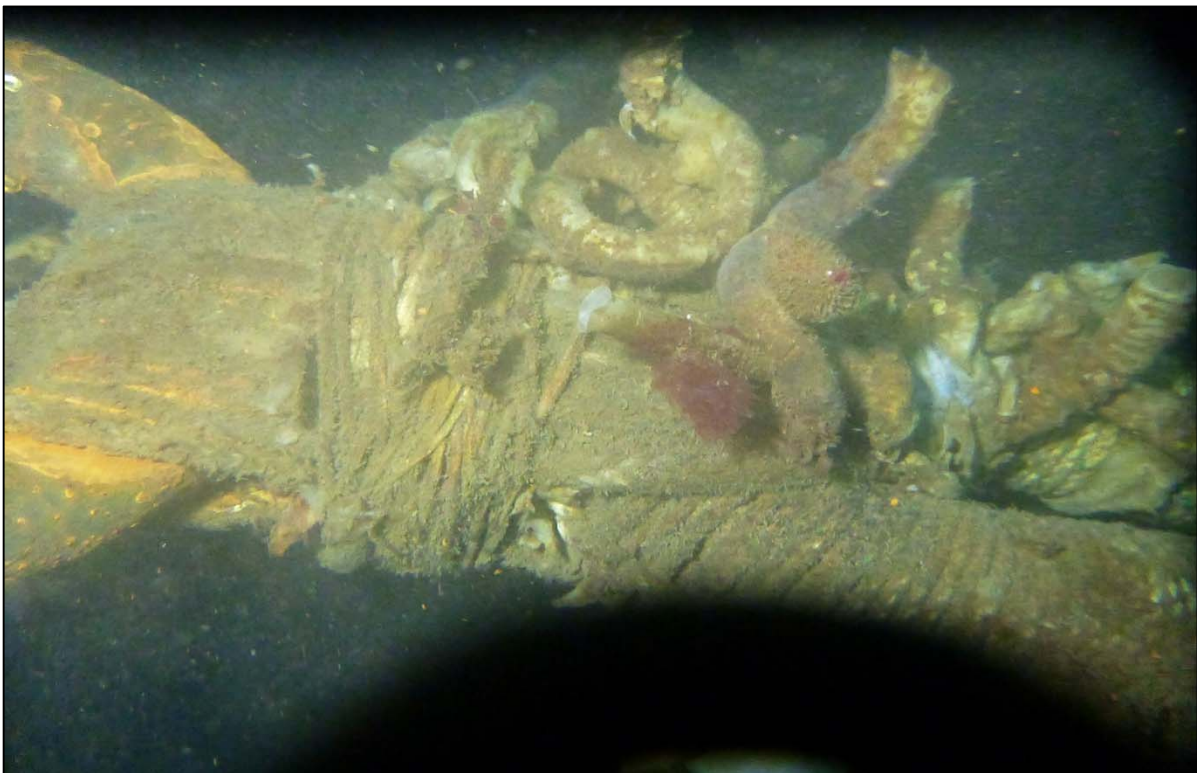
Photograph 77: View of Lower Anchor Chain to Anchor Rope Connection with Lashing at Orchard Rocks South Anchor Line 7, Looking South.

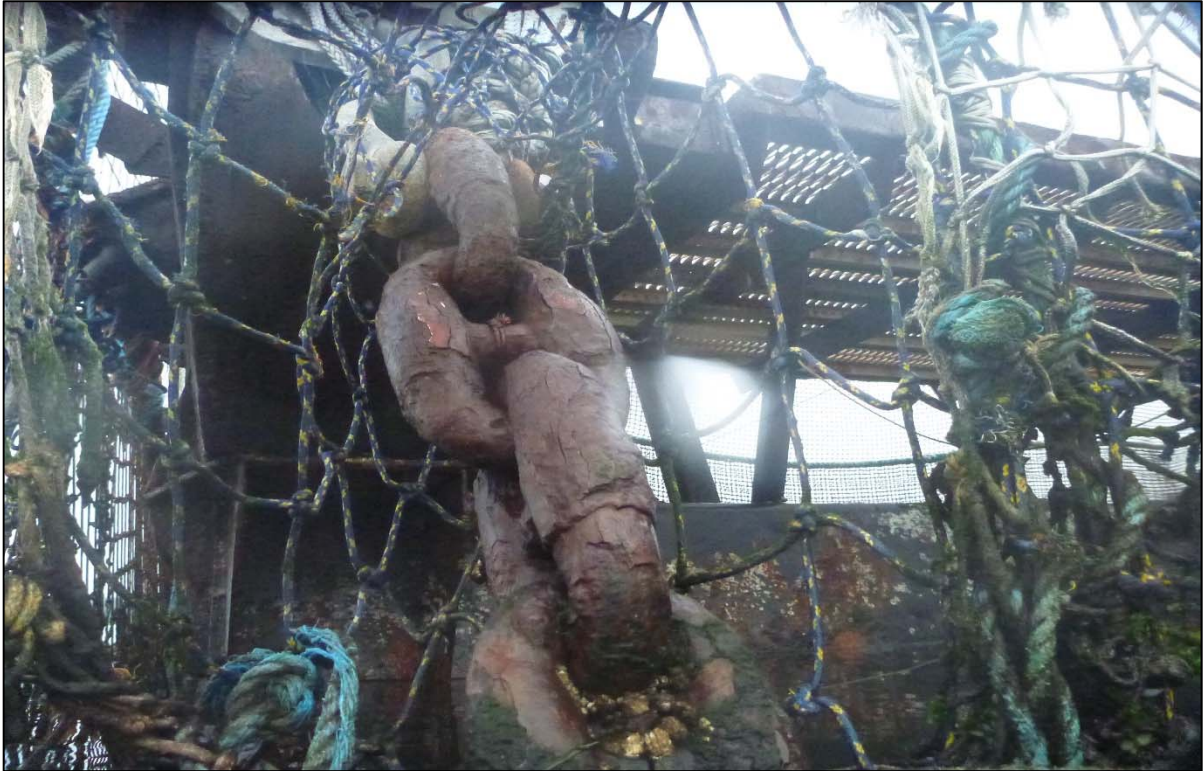
Photograph 78: View of Lower Anchor Chain to Anchor Rope Connection (Lashing) at Orchard Rocks South Anchor Line 8, Looking South.
