# **Rich Passage Orchard Rocks Atlantic Salmon Net Pens Engineering Assessment**

January 29, 2018

Mott MacDonald  
110 James Street  
Suite 101  
Edmonds WA 98020  
United States of America

State of Washington  
Department of Natural  
Resources  
1111 Washington Street SE  
Olympia Washington 98504

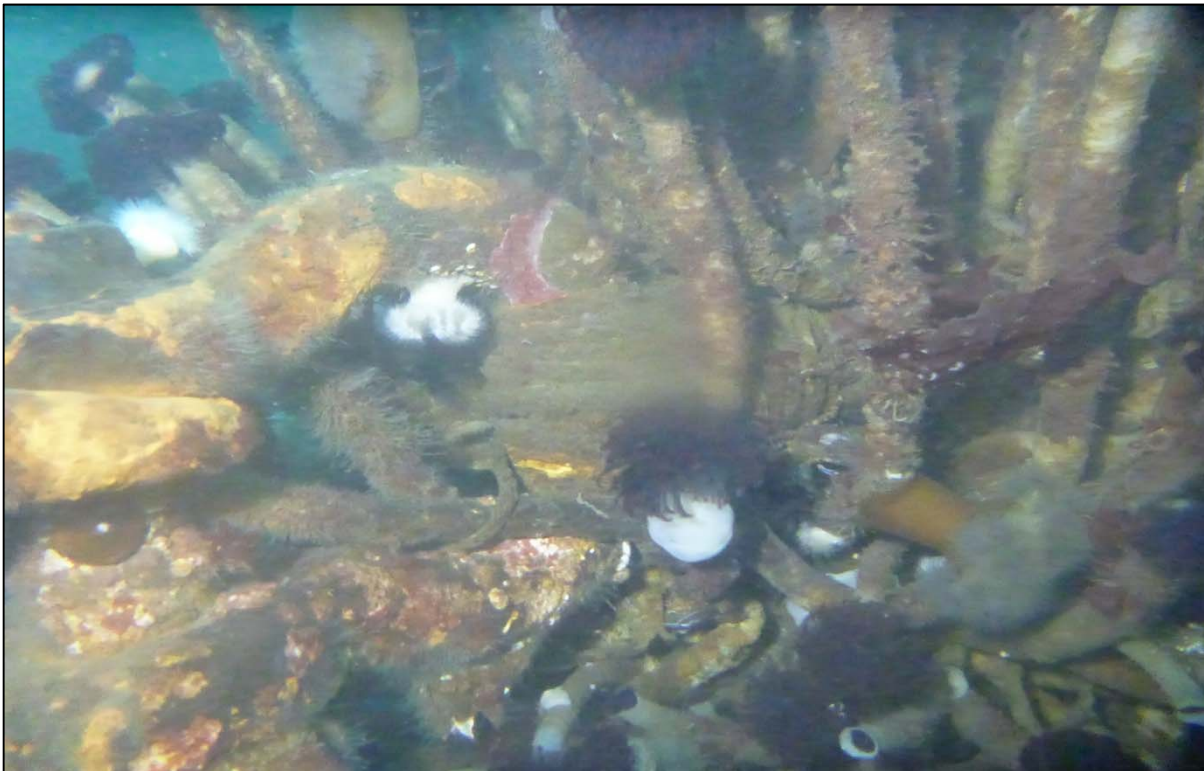
Photograph 79: View of Upper Anchor Chain Connection at Orchard Rocks South Anchor Line 10, Looking South.

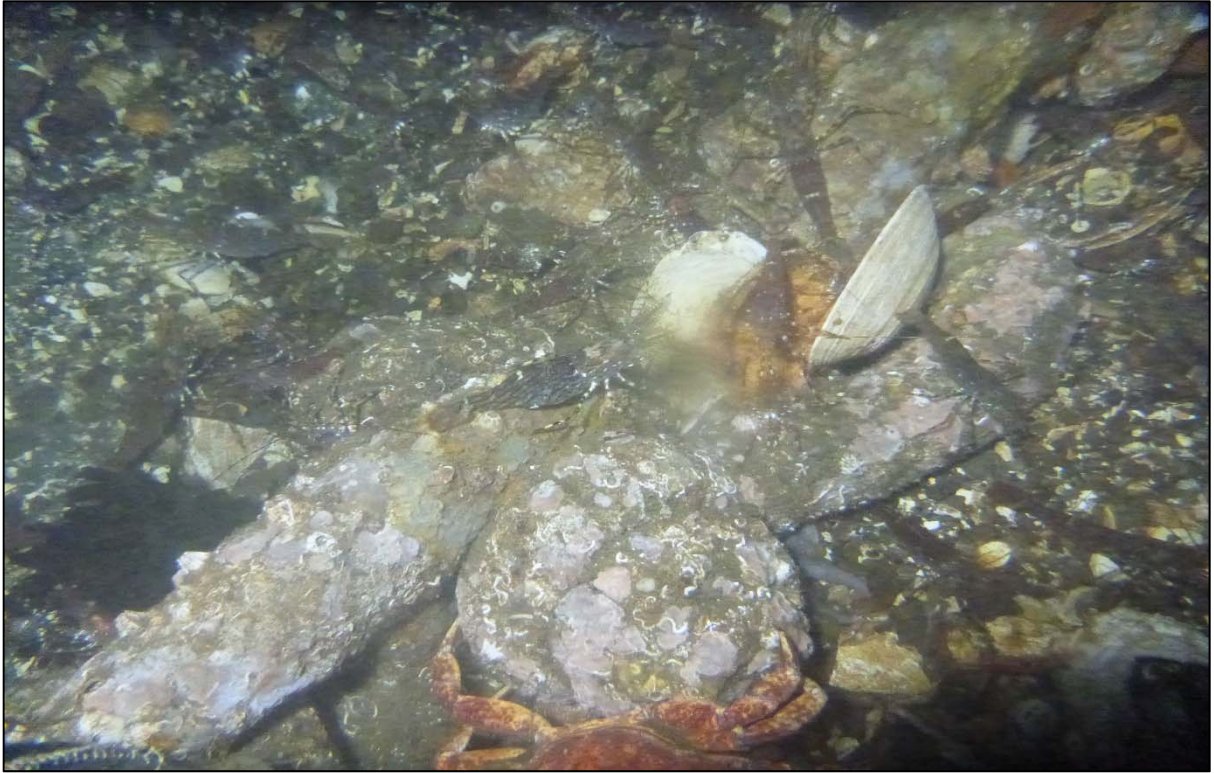
Photograph 80: View of Upper Anchor Chain to Anchor Line Connection (Shackle and Lashing) at Orchard Rocks South Anchor Line 10, Looking South.

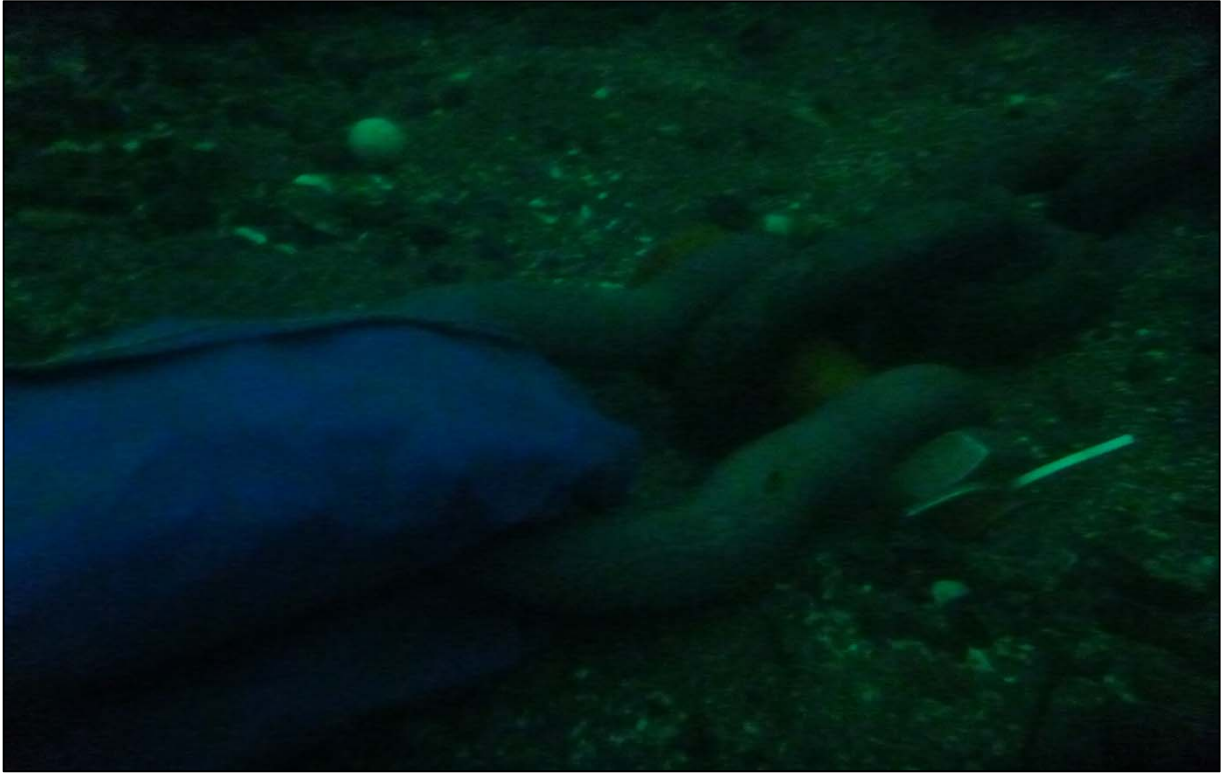
Photograph 82: View of Lower Anchor Rope Splice at Orchard Rocks South Anchor Line 11, Looking South.

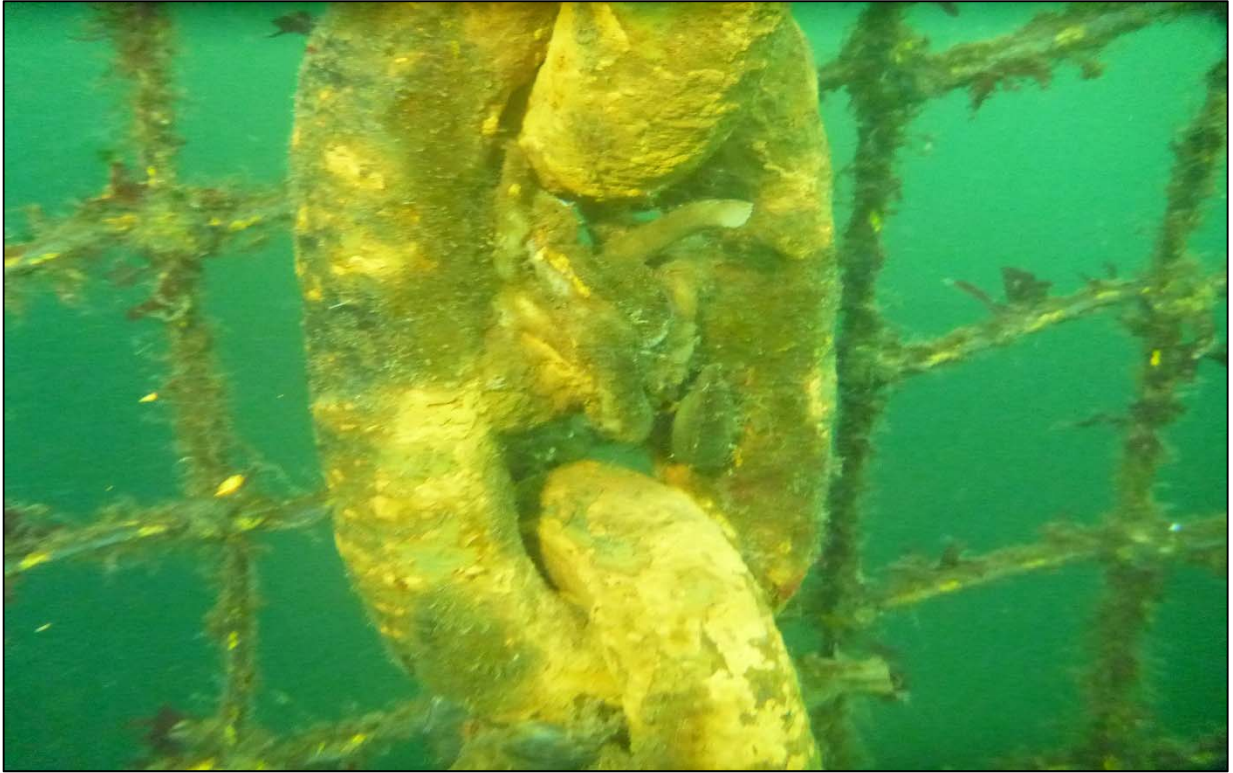
Photograph 84: View of Lower Anchor Chain to Steel Pipe Anchor at Orchard Rocks South Anchor Line 11, Looking South.

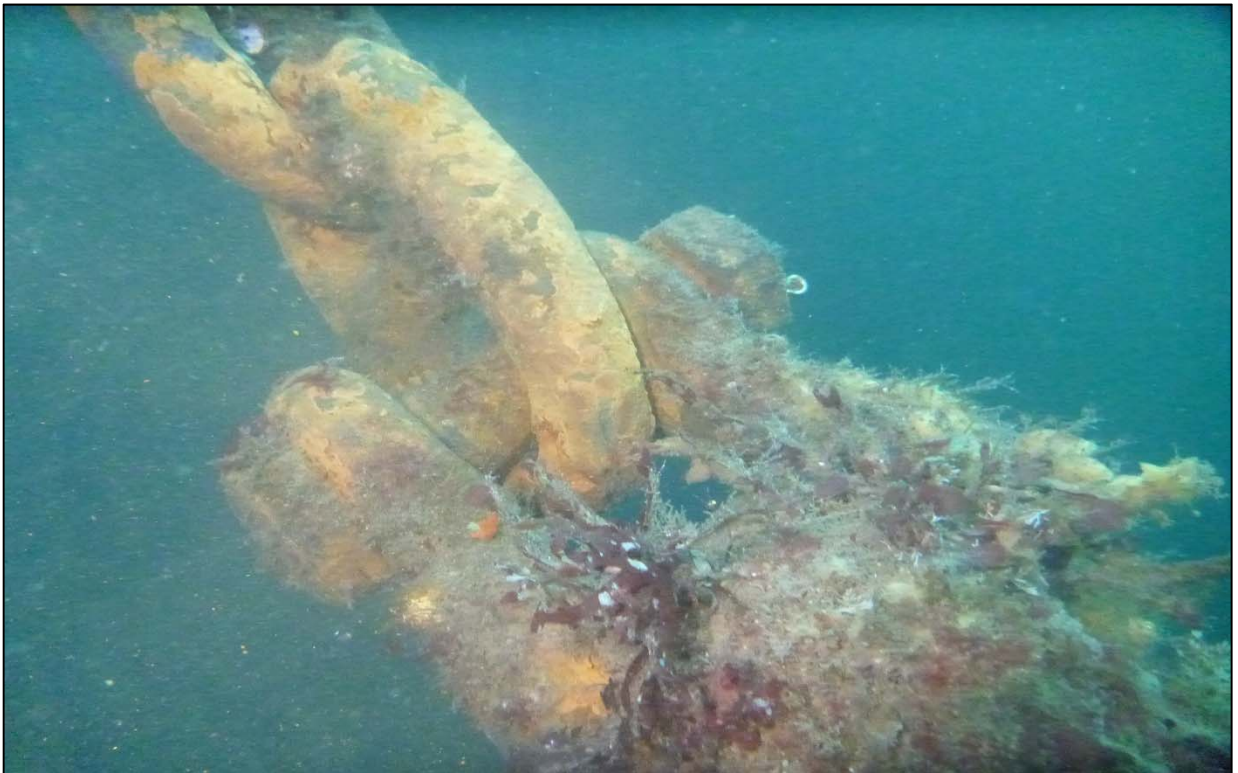
Photograph 85: View of Upper Anchor Chain at Orchard Rocks South Anchor Line 12, Looking East.

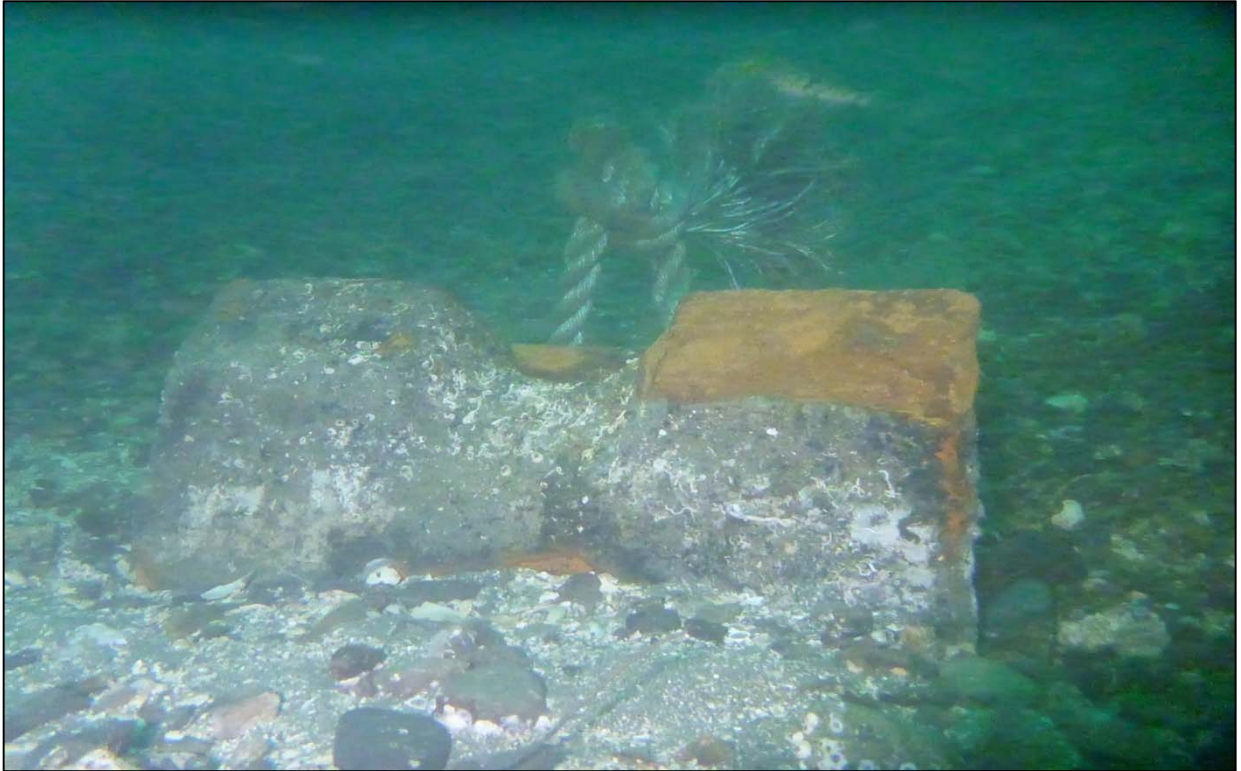
Photograph 86: View of Lower Anchor Chain Shackle at Orchard Rocks South Anchor Line 12, Looking South.

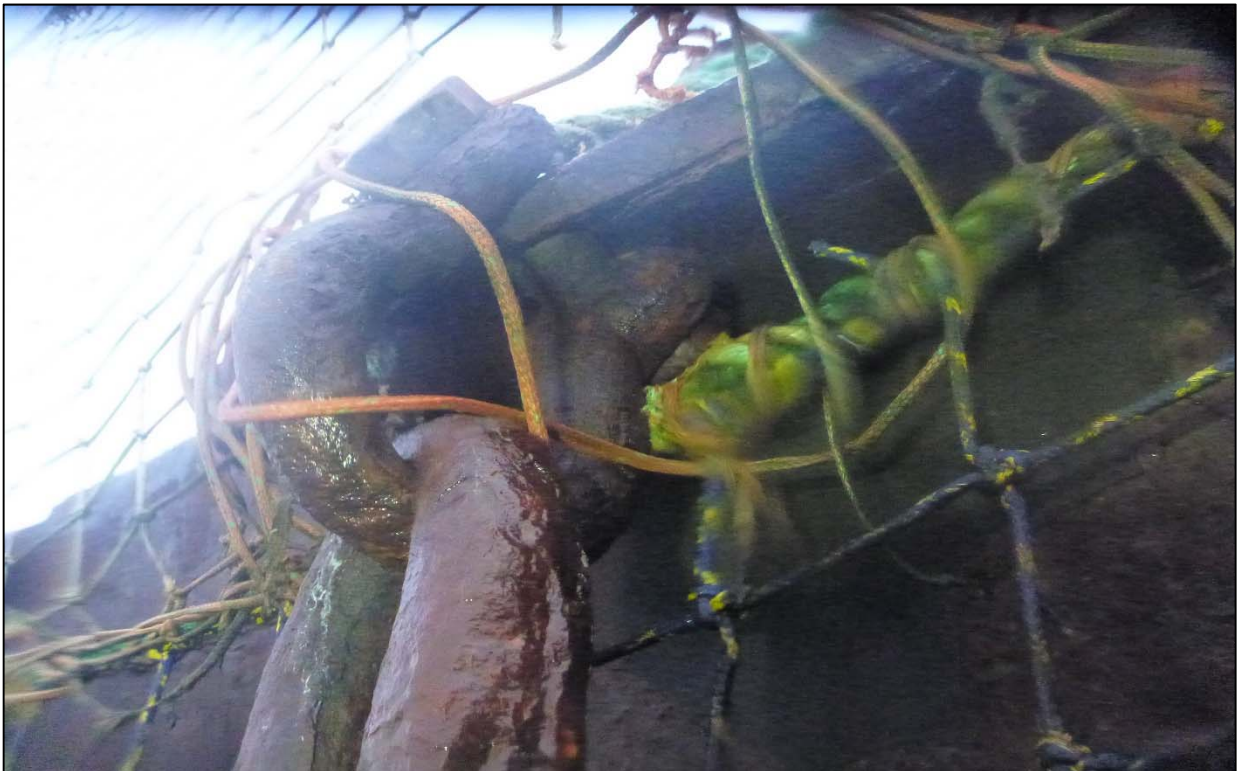
Photograph 87: View of Top of the Danforth Anchor at Orchard Rocks South Anchor Line 12, Looking East.

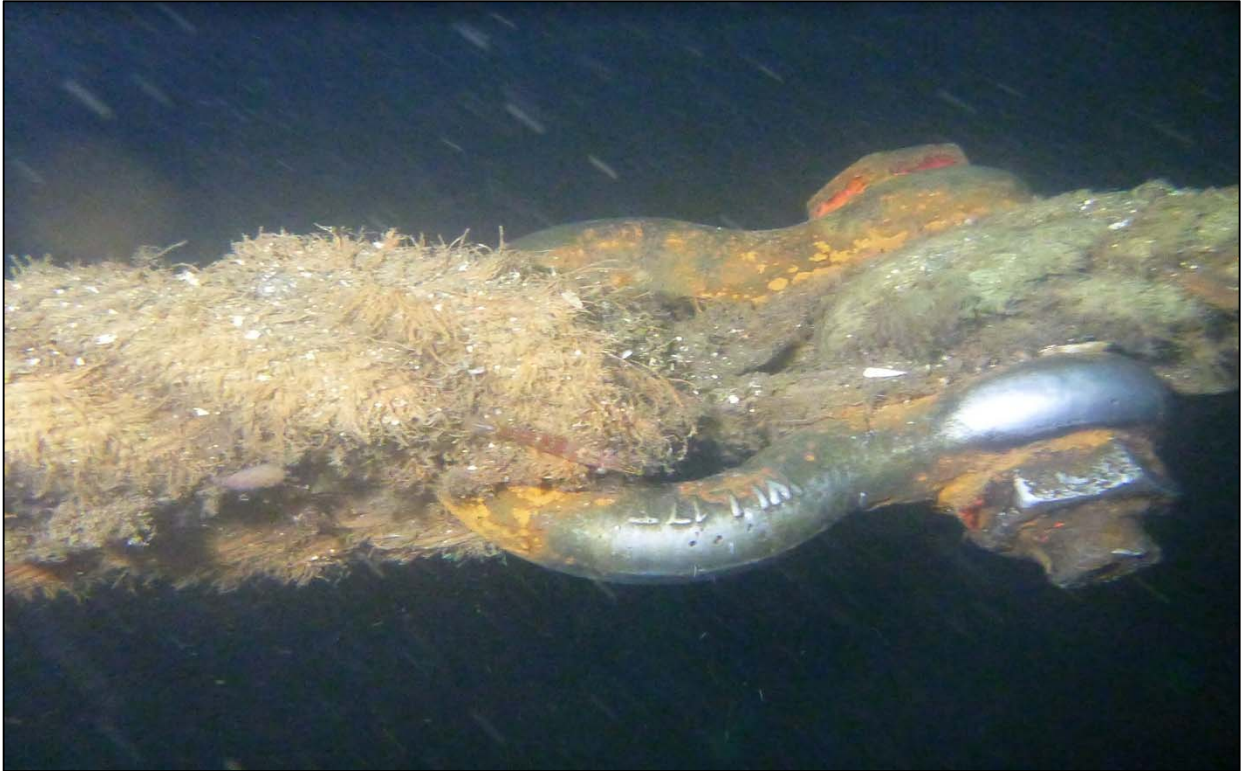
Photograph 88: View of Upper Anchor Chain Connection at Orchard Rocks South Anchor Line 13, Looking North.

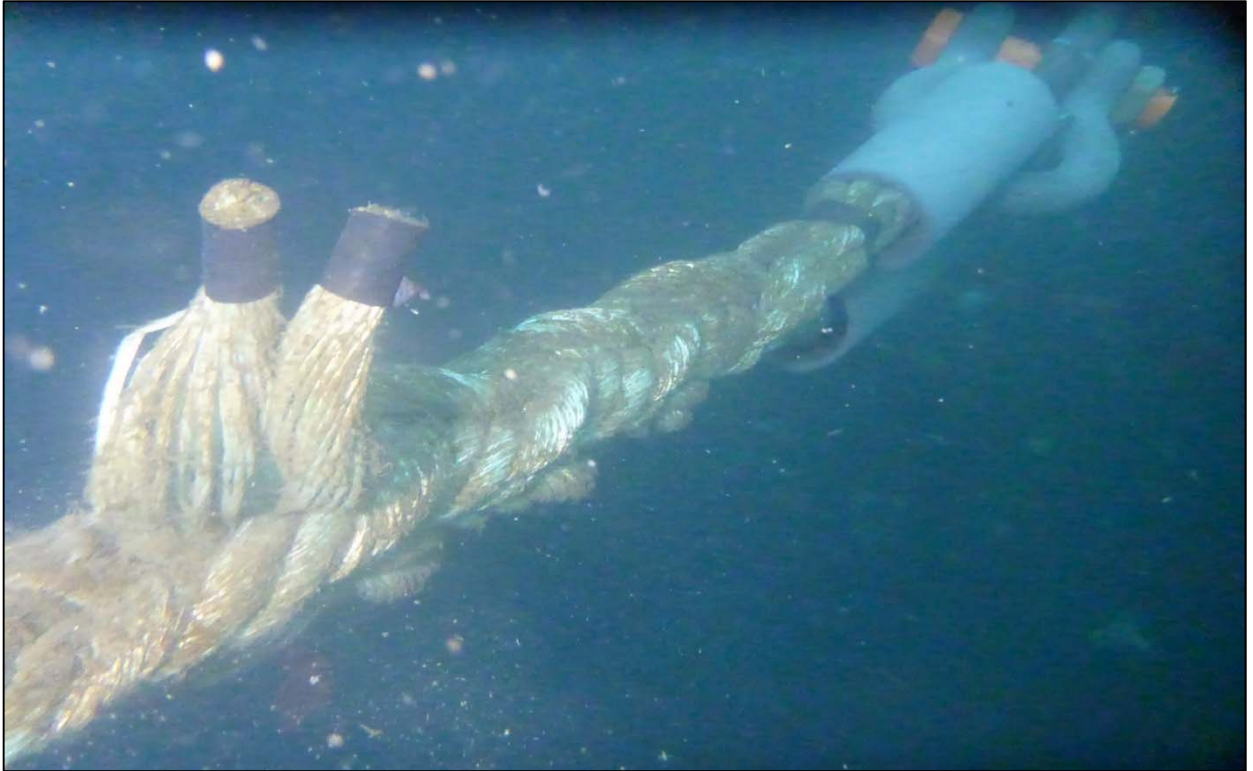
Photograph 90: View of Lower Anchor Chain at Orchard Rocks South Anchor Line 13, Looking South.

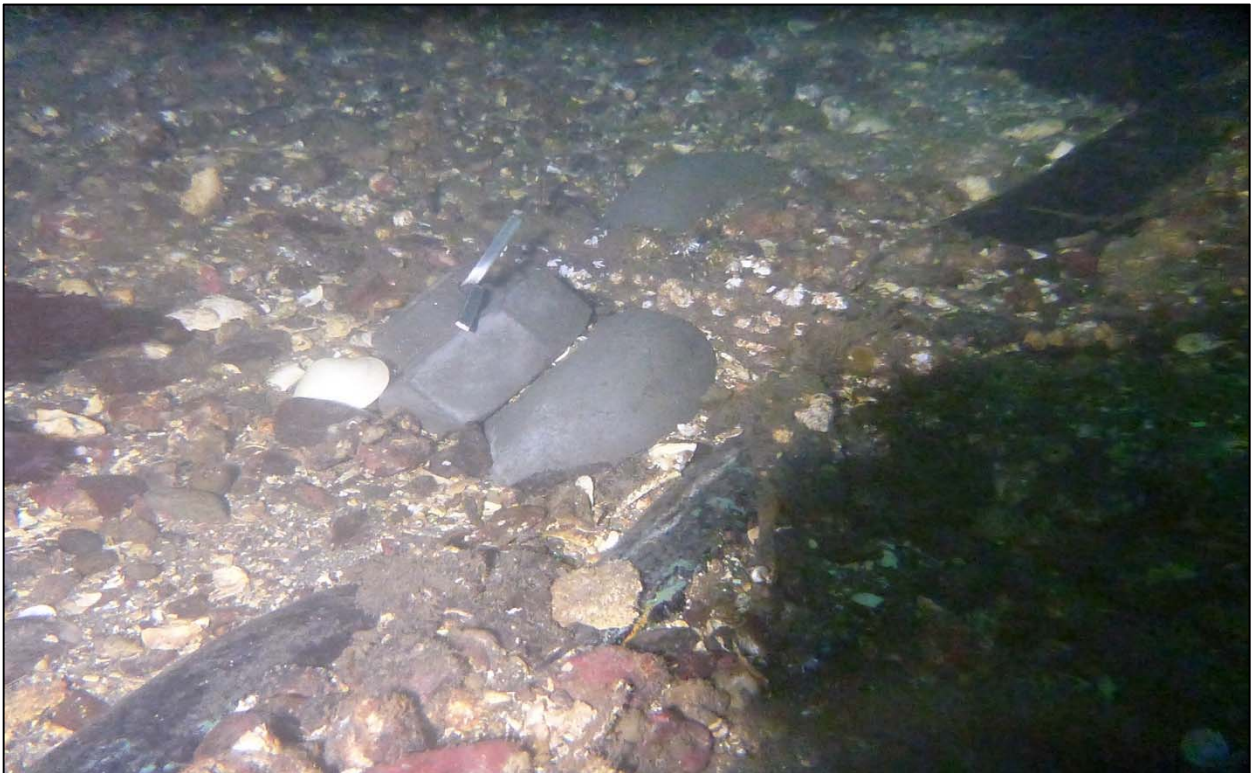
Photograph 91: View of Lower Anchor Chain to Anchor Rope Connection (Shackle and Thimble) at Orchard Rocks South Anchor Line 14, Looking West.

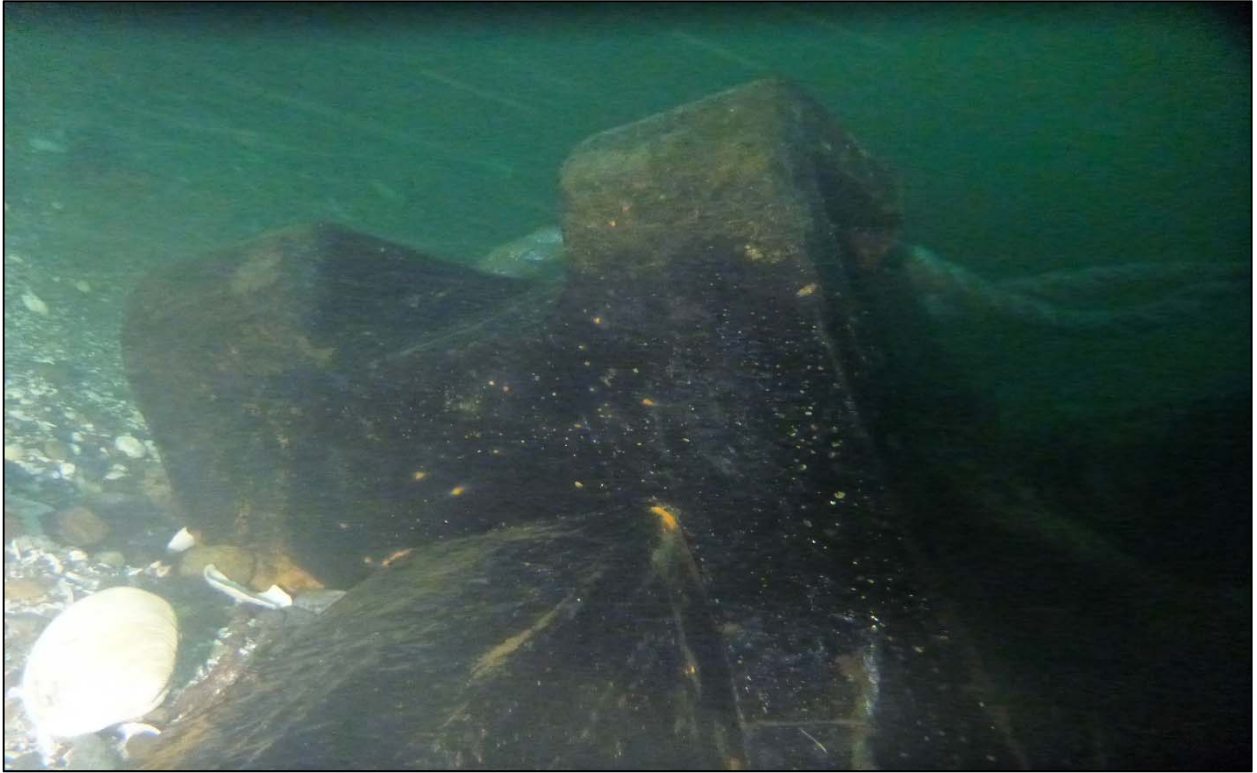
Photograph 92: View of Lower Anchor Chain to Anchor Connection (Shackle) at Orchard Rocks South Anchor Line 14, Looking West.

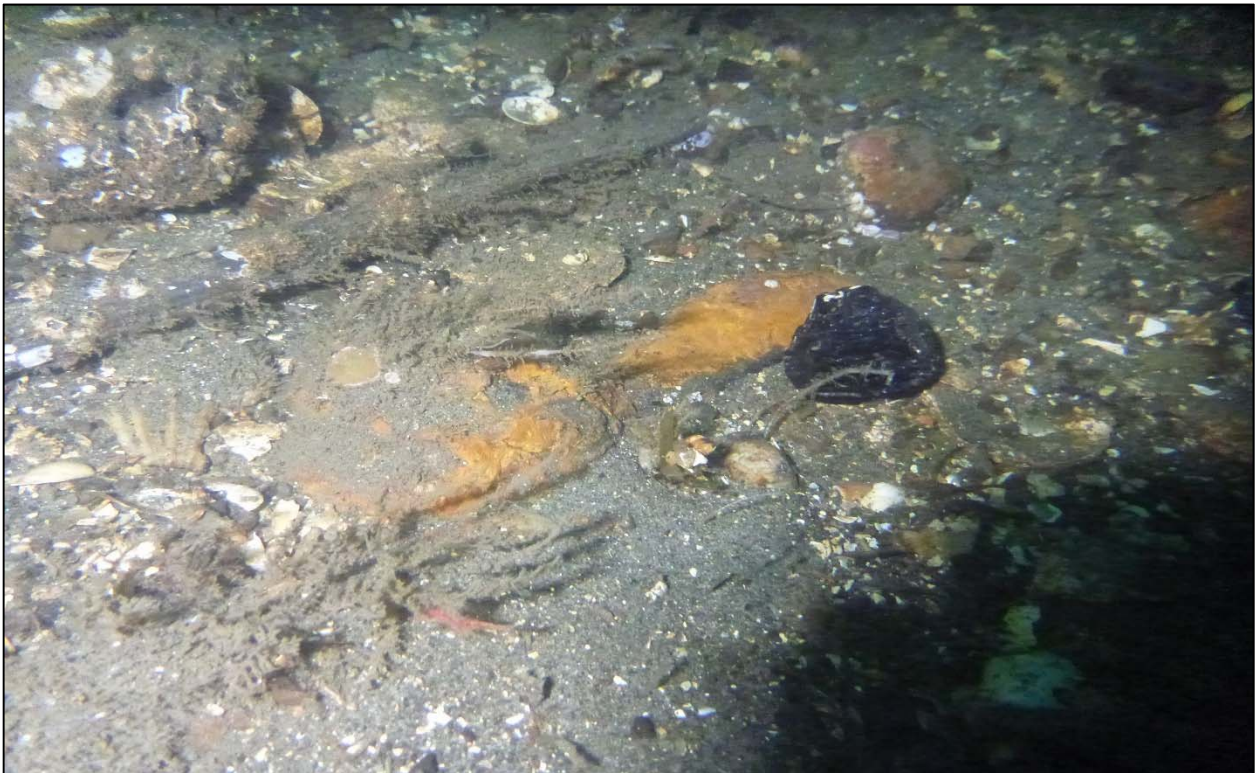
Photograph 93: View of Top of the New Anchor Rope at Orchard Rocks South Anchor Line 14, Looking West.

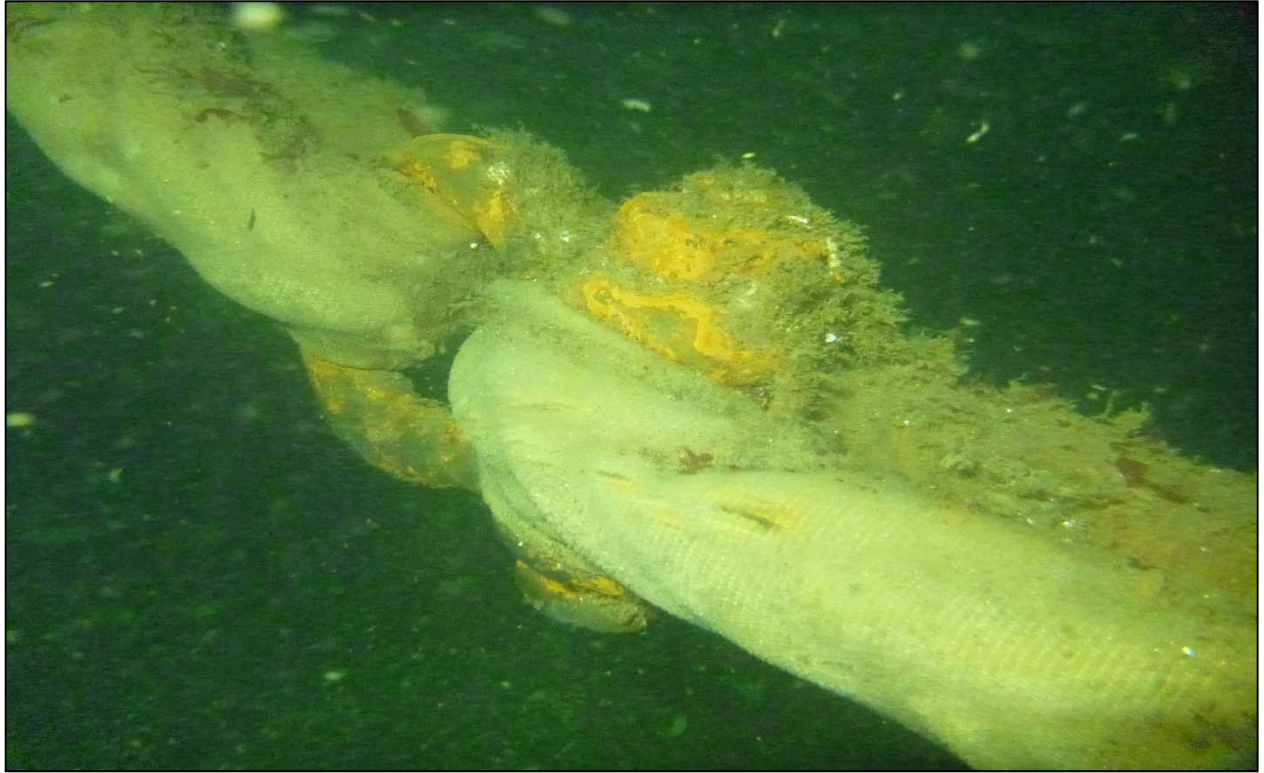
Photograph 94: View of Lower Anchor Chain 90% Buried at Orchard Rocks South Anchor Line 15, Looking South.

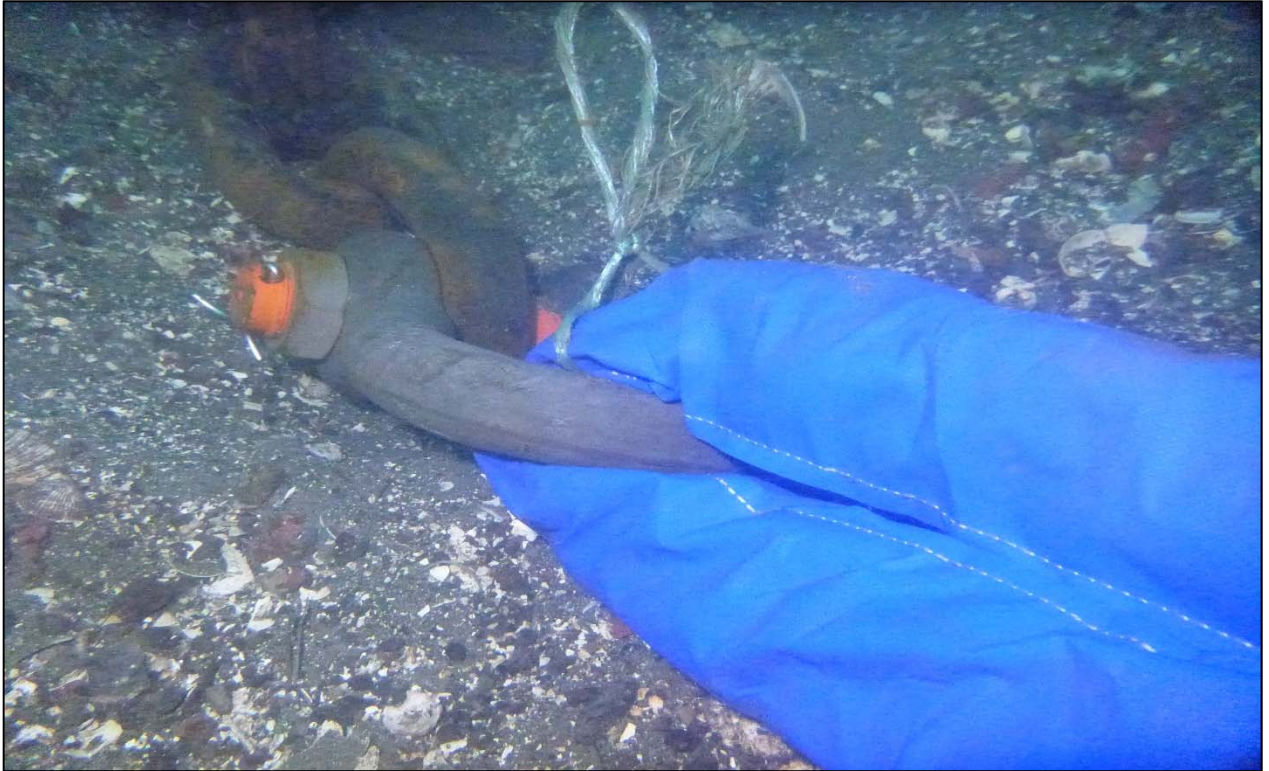
Photograph 96: View of Upper Anchor Chain to Anchor Rope Connection (Shackle and Thimble) at Orchard Rocks South Anchor Line 16, Looking South.

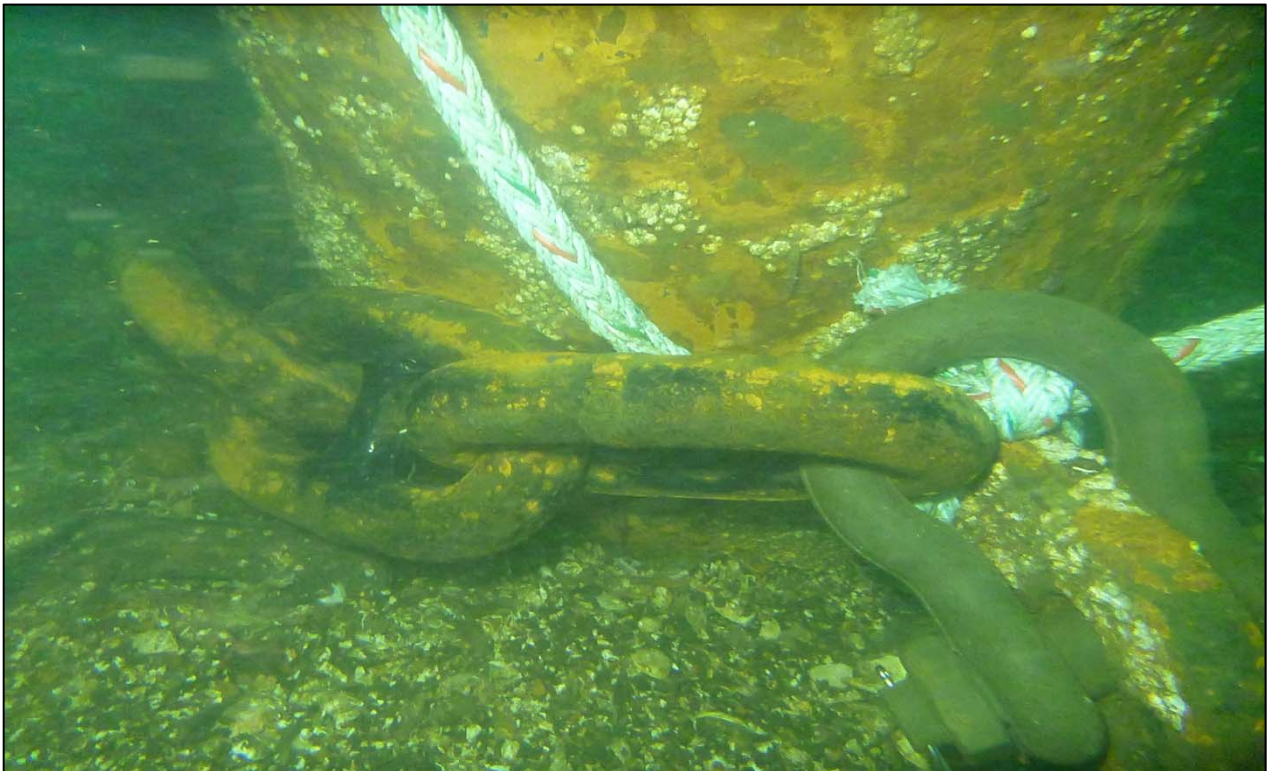
Photograph 97: View of Lower Anchor Chain to Anchor Rope Connection (Shackle and PVC) at Orchard Rocks South Anchor Line 16, Looking North.

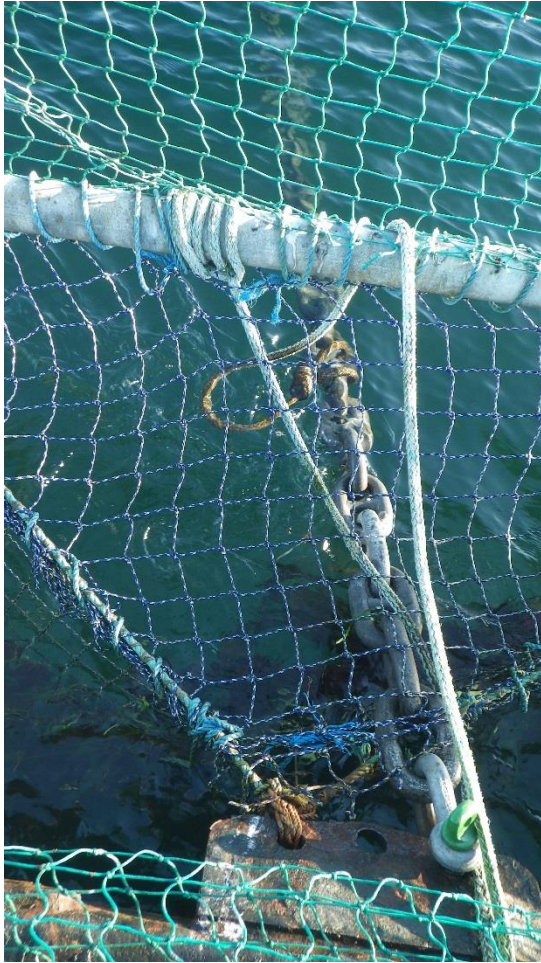
Figure C-6: Anchor #1, NE Corner of the North Net Pen. New shackle and chain.

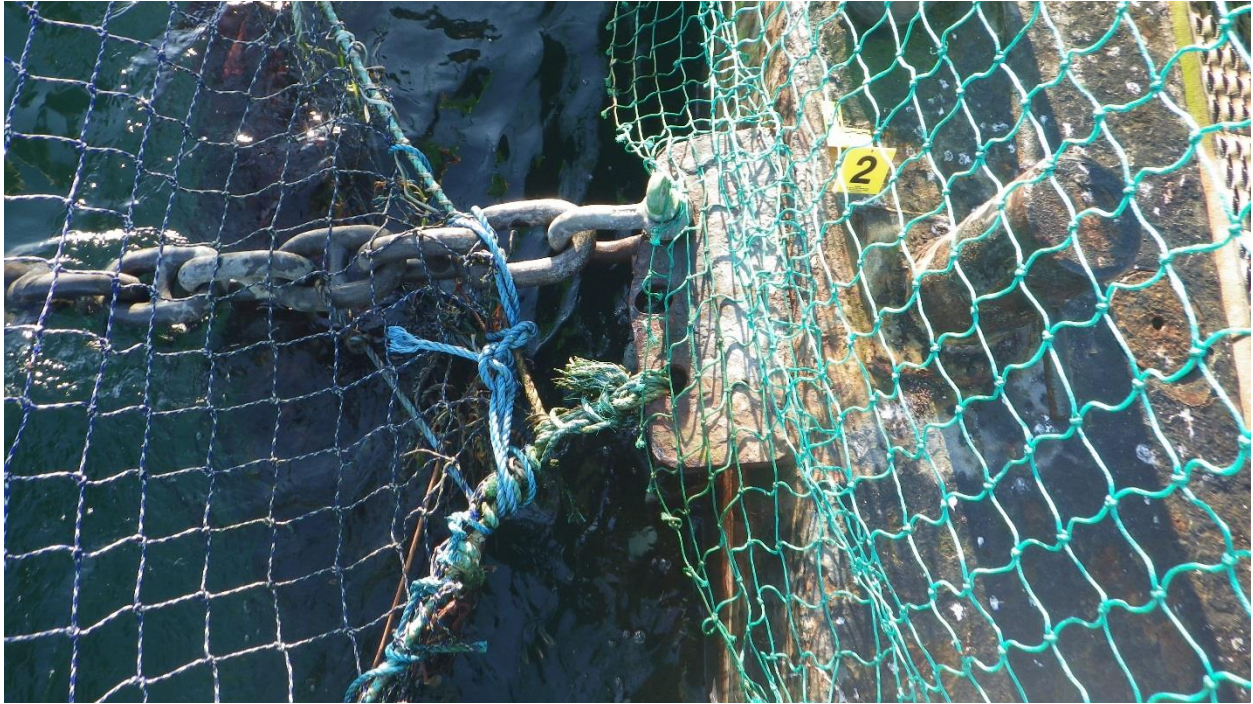
Figure C-8: Anchor #2, East Side of the North Net Pen. New shackle and chain.

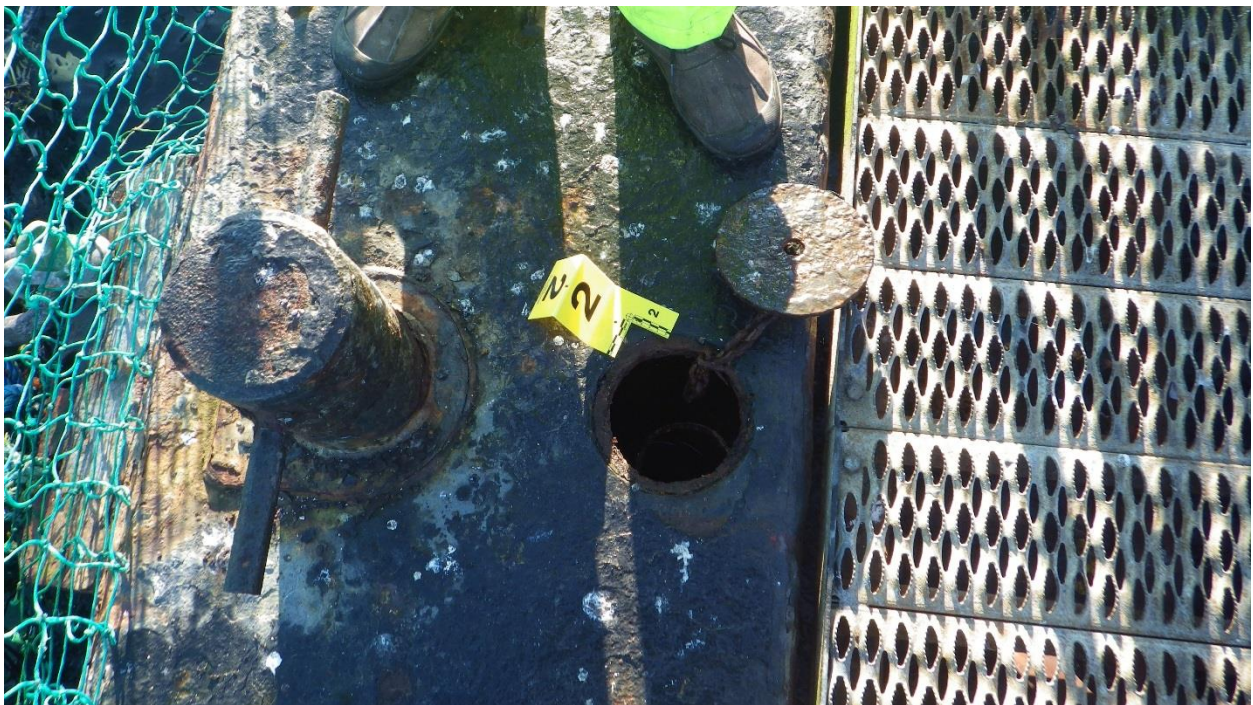
Figure C-9: Anchor #2, East Side of the North Net Pen. Old anchor access port.

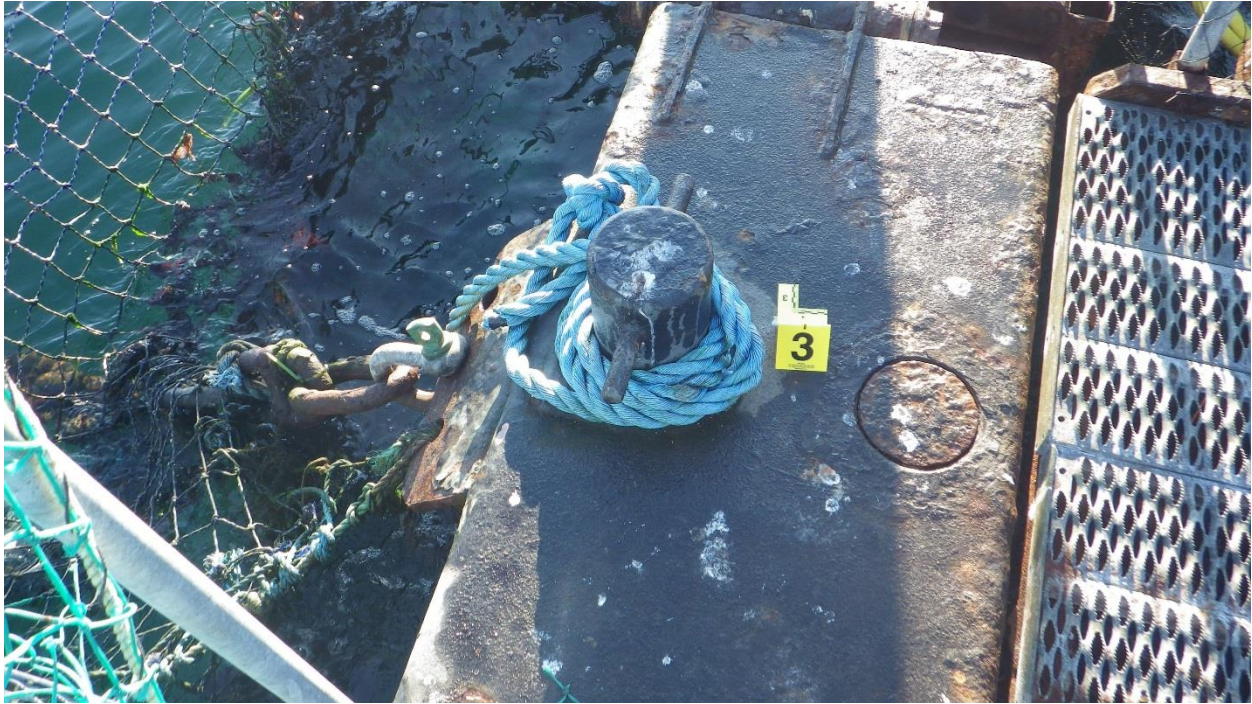
Figure C-10: Anchor #3, East Side of the North Net Pen. New shackle, old chain, moderate corrosion.

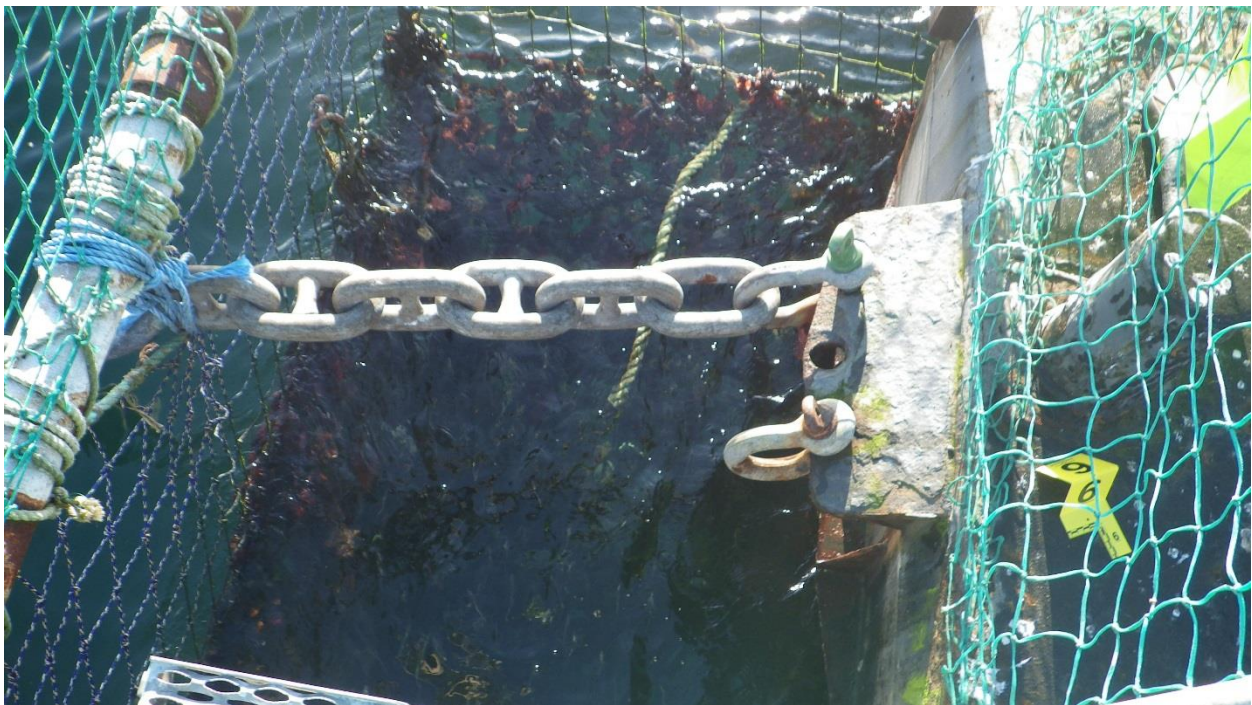
Figure C-15: Anchor #5, East Side of the North Net Pen. Note chain tied to predator support pipe.

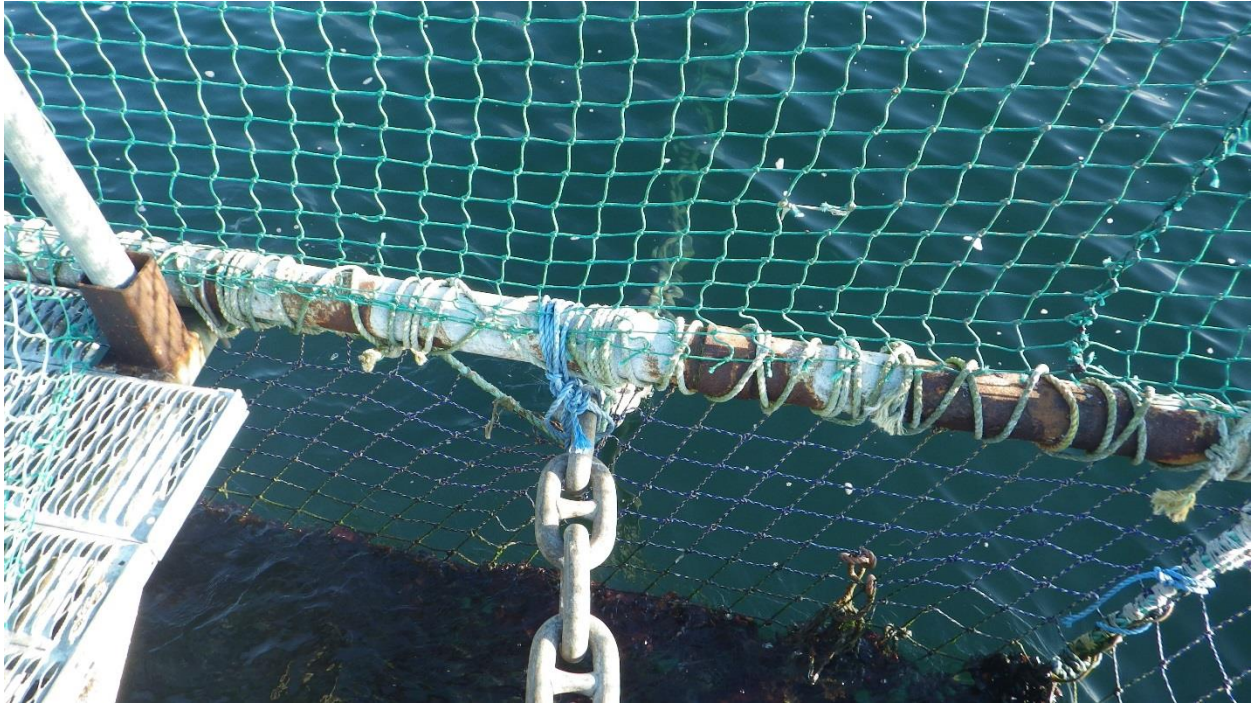
Figure C-16: Anchor #6, SE Corner of the North Net Pen. Chain attached to predator support pipe.

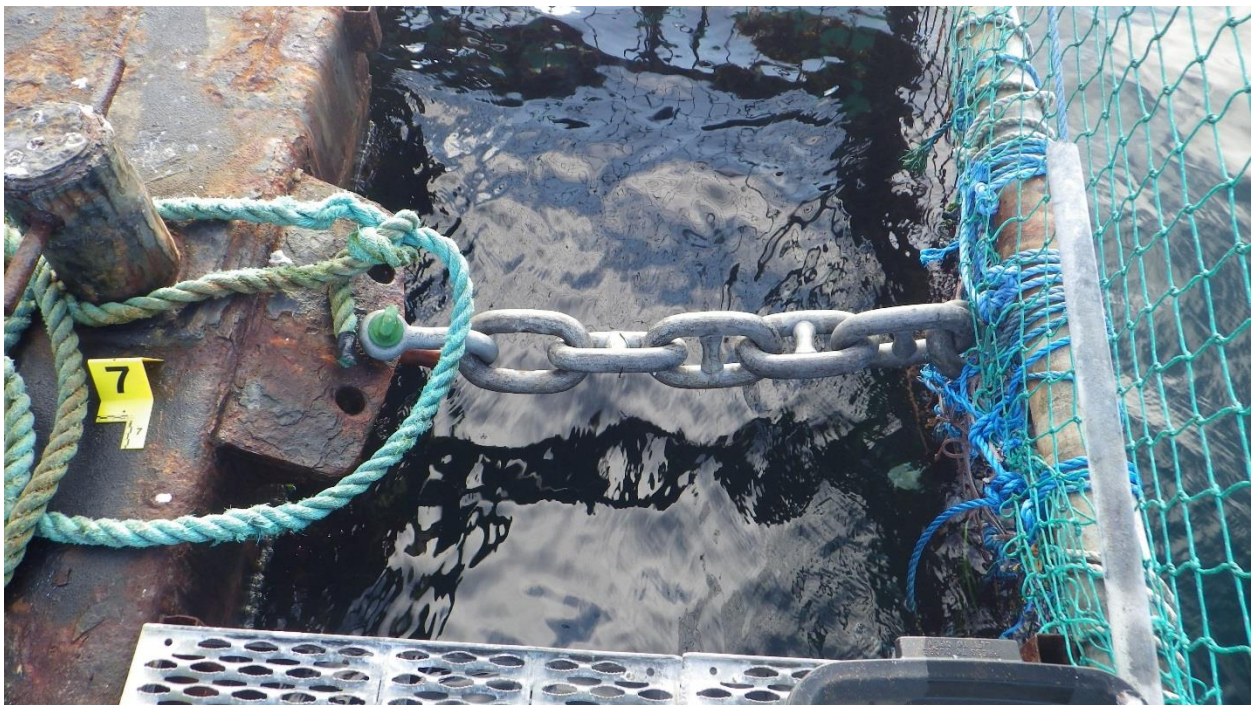
Figure C-17: Anchor #7, SW Corner of the North Net Pen. New shackle and chain. Chain tied to predator support pipe.

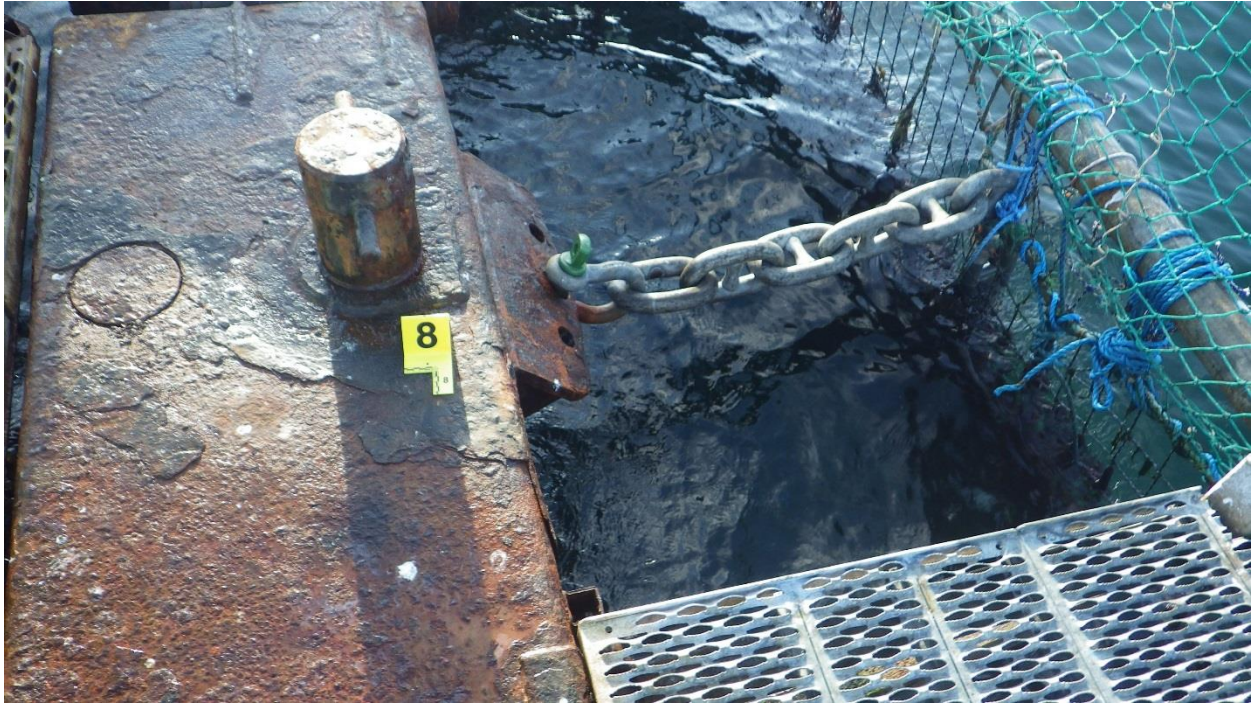
Figure C-18: Anchor #8, West Side of the North Net Pen. New shackle and chain. Chain tied to predator support pipe.

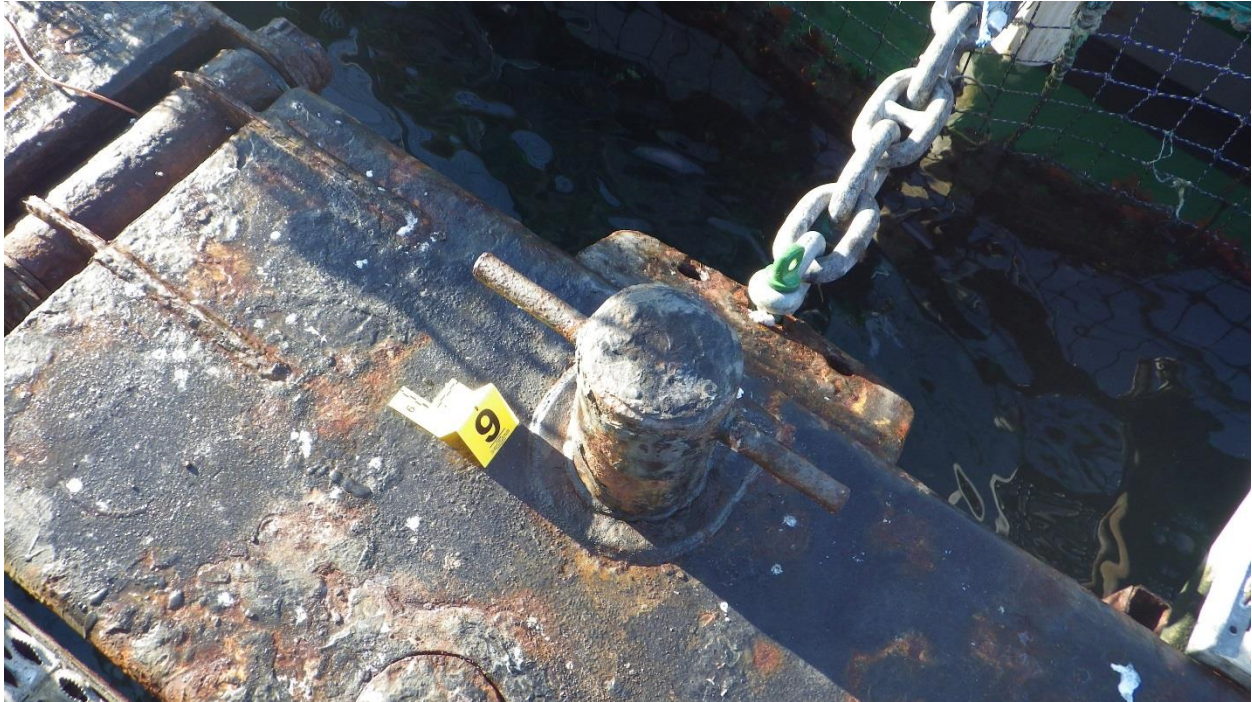
Figure C-20: Anchor #9, West Side of the North Net Pen. New shackle and chain.
