# **Rich Passage Orchard Rocks Atlantic Salmon Net Pens Engineering Assessment**

January 29, 2018

Mott MacDonald  
110 James Street  
Suite 101  
Edmonds WA 98020  
United States of America

State of Washington  
Department of Natural  
Resources  
1111 Washington Street SE  
Olympia Washington 98504

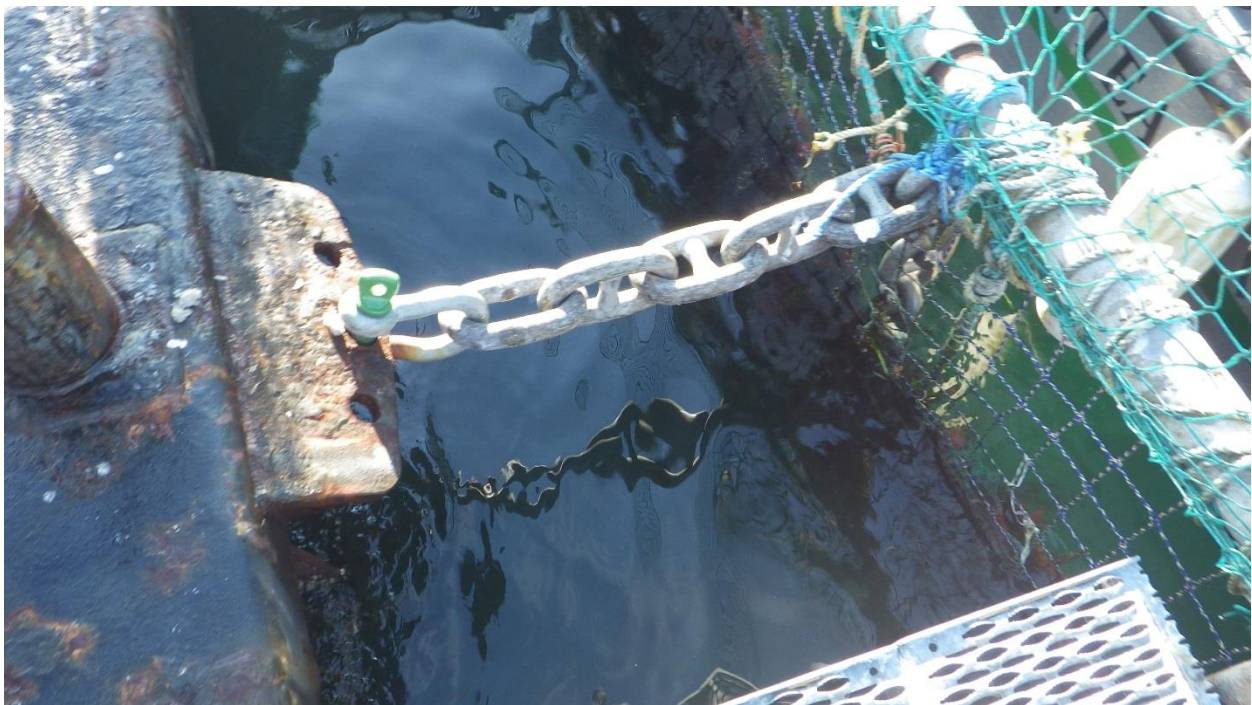
Figure C-21: Anchor #9, West Side of the North Net Pen. Chain tied to predator support pipe.

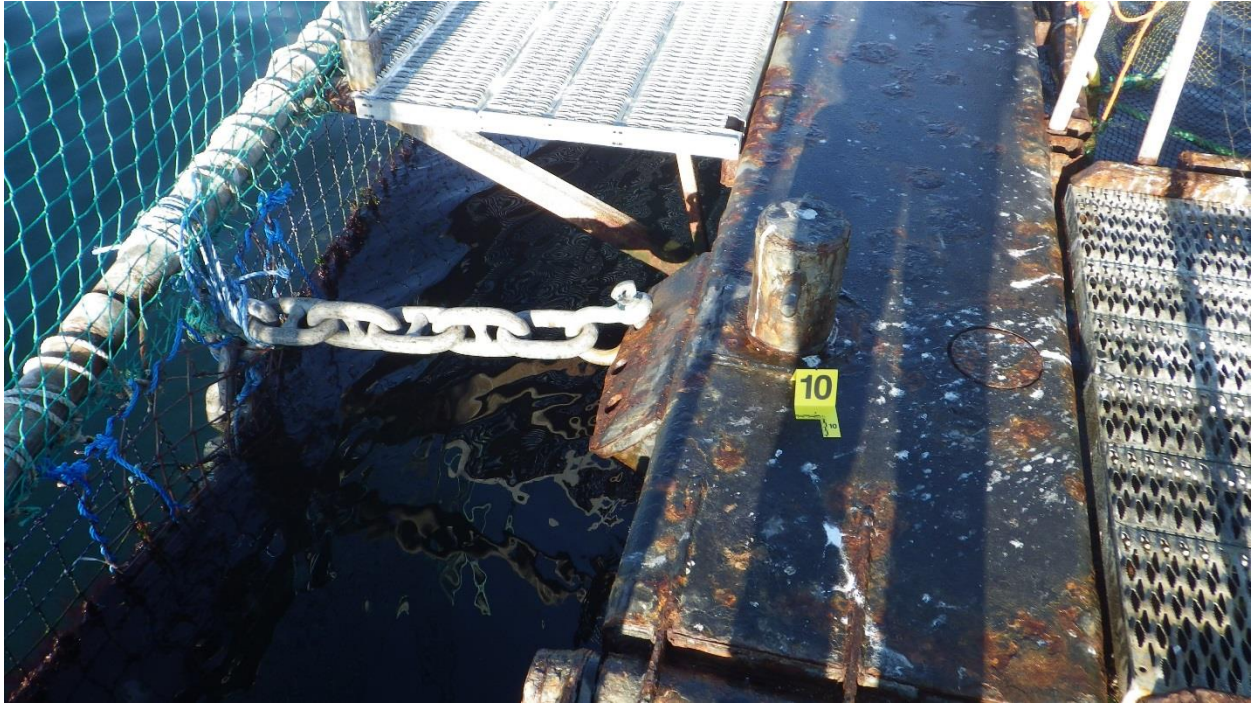
Figure C-22: Anchor #10, West Side of the North Net Pen. New shackle and chain. Chain tied to predator support pipe.

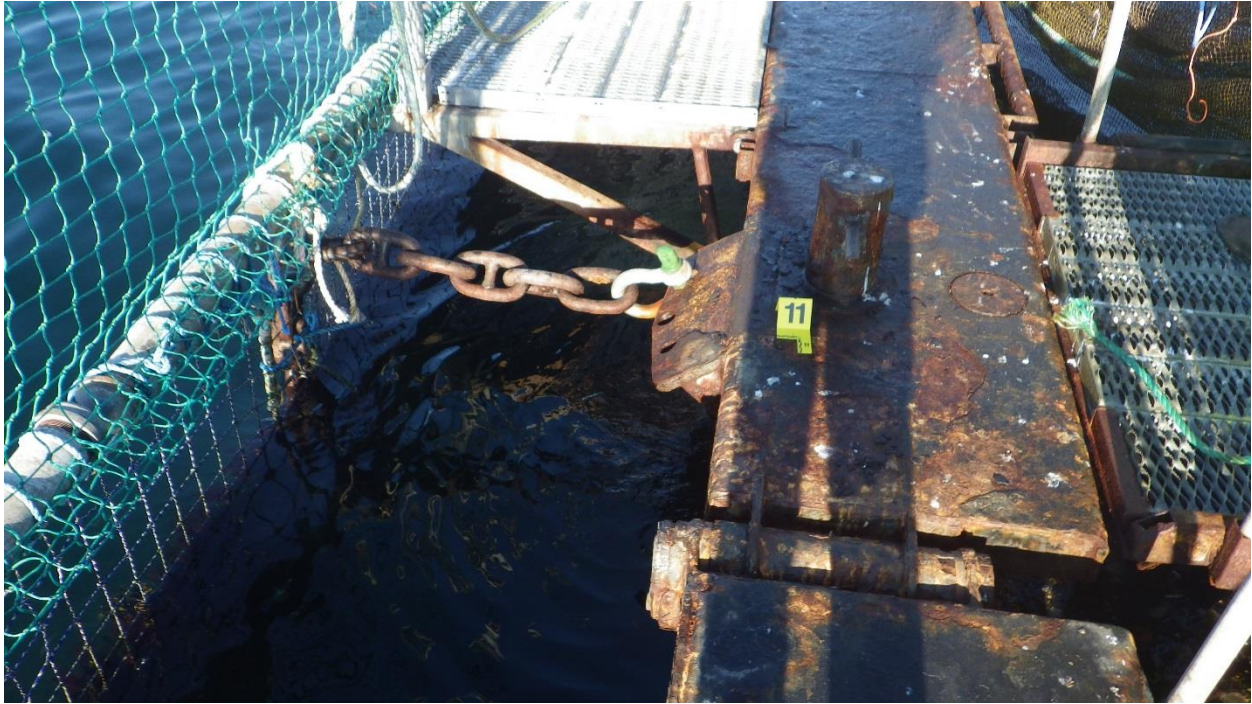
Figure C-24: Anchor #11, West Side of the North Net Pen. New shackle with old chain. Minor corrosion on chain. Chain tied to predator support pipe.

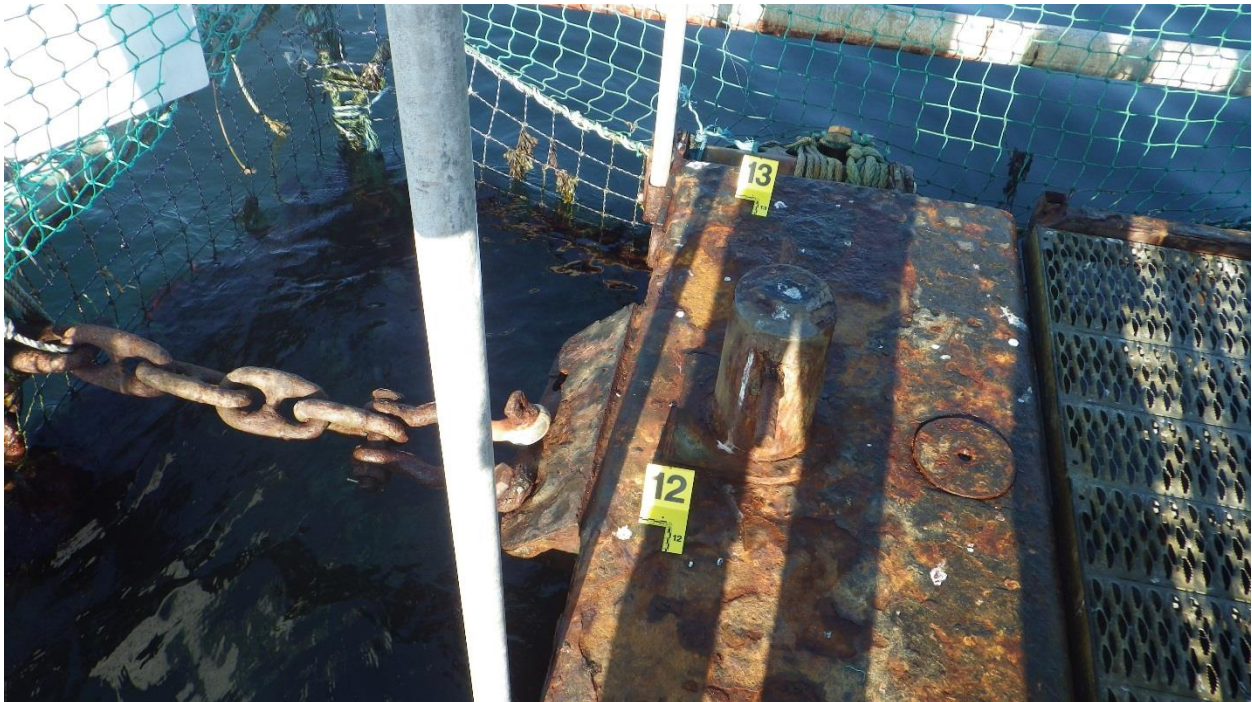
Figure C-25: Anchor #12, NW Corner of the North Net Pen. Moderate corrosion on chain.

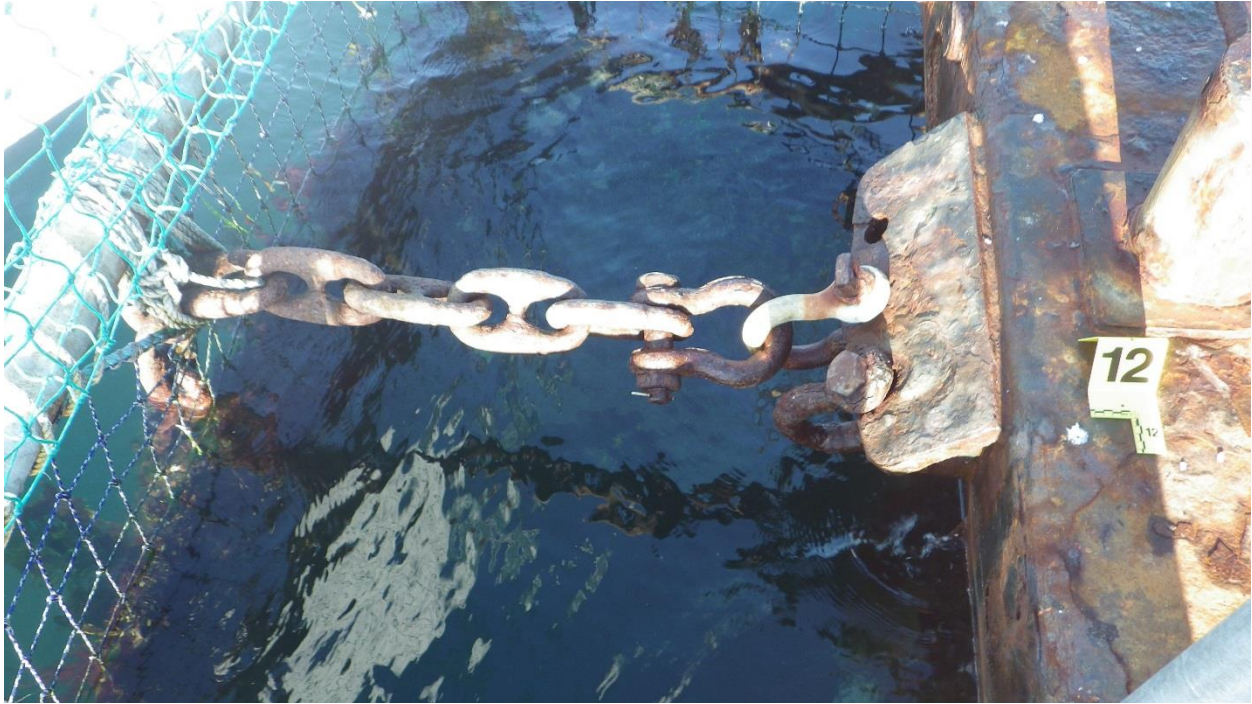
Figure C-26: Anchor #12, NW Corner of the North Net Pen. Chain tied to predator support pipe.

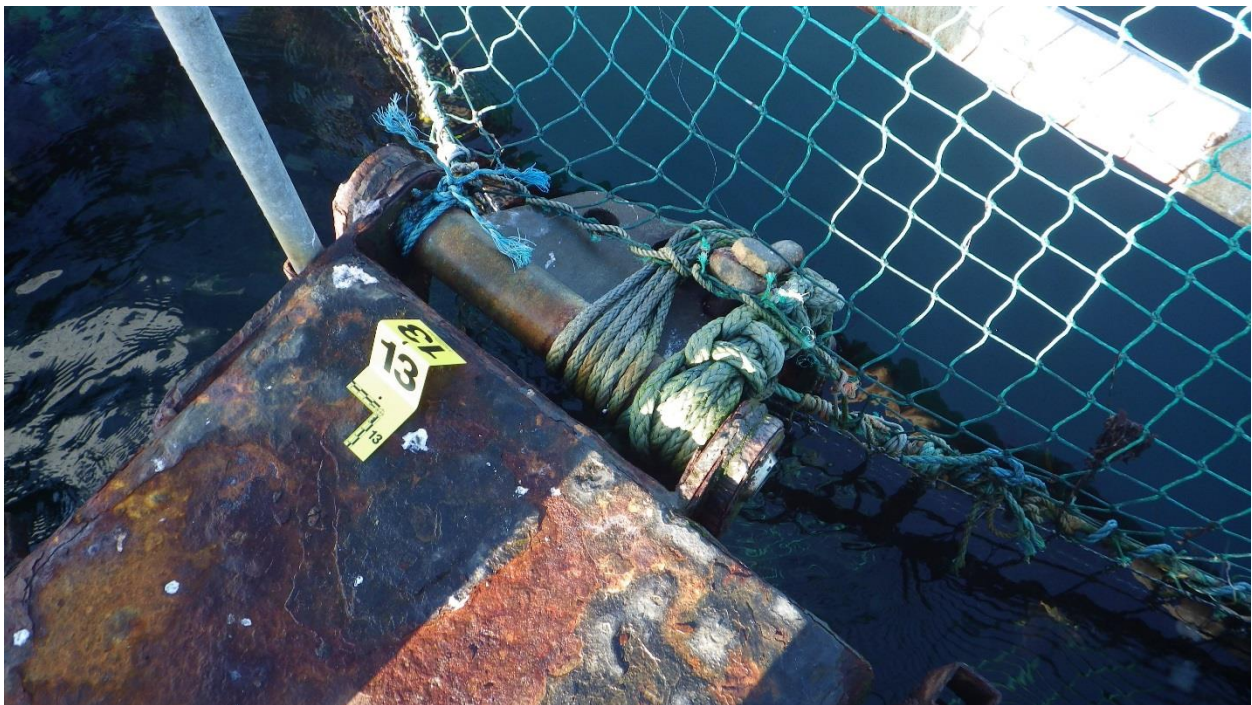
Figure C-27: Anchor #13, NW Corner of the North Net Pen. Hinge appears to be seized.

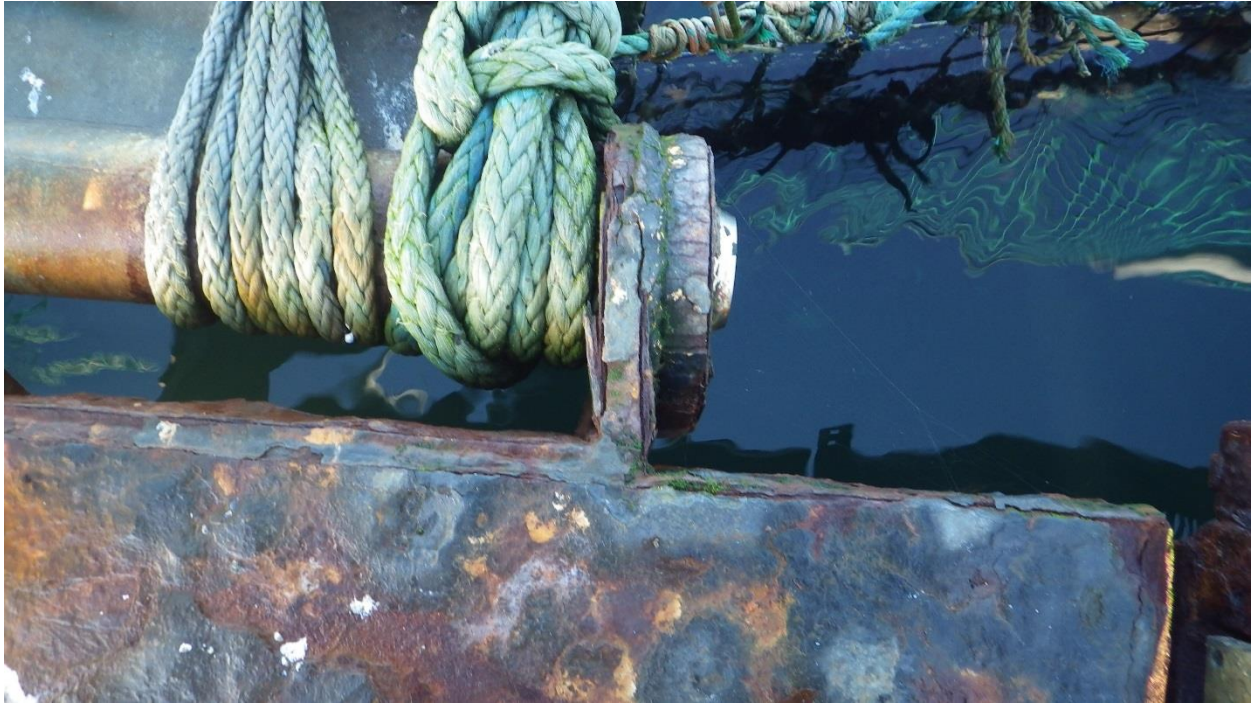
Figure C-28: Anchor #13, NW Corner of the North Net Pen. Moderate corrosion at hinge.

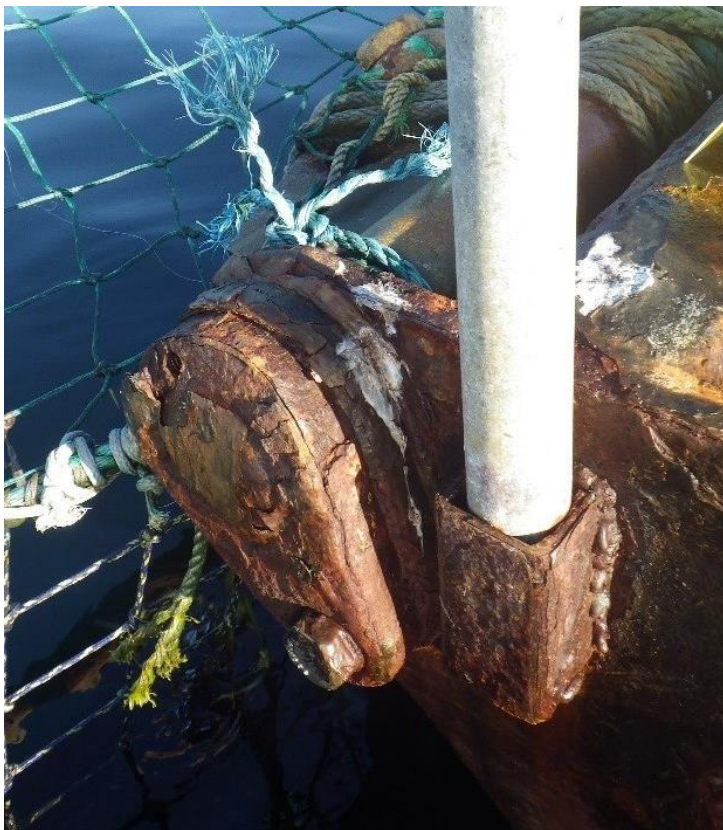
Figure C-29: Anchor #13, NW Corner of the North Net Pen. Moderate or major corrosion at hinge.

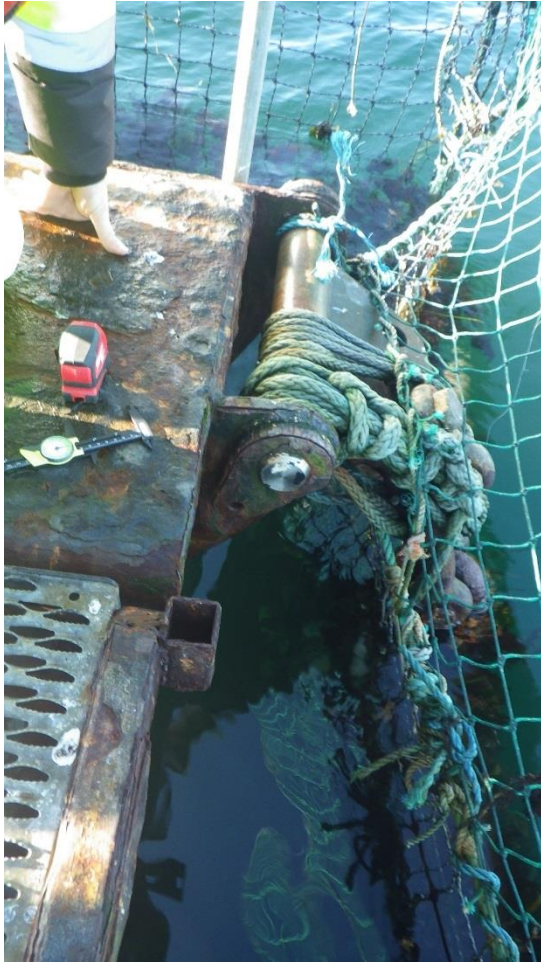
Figure C-30: Anchor #13, NW Corner of the North Net Pen. Hinge at different angle than chain.

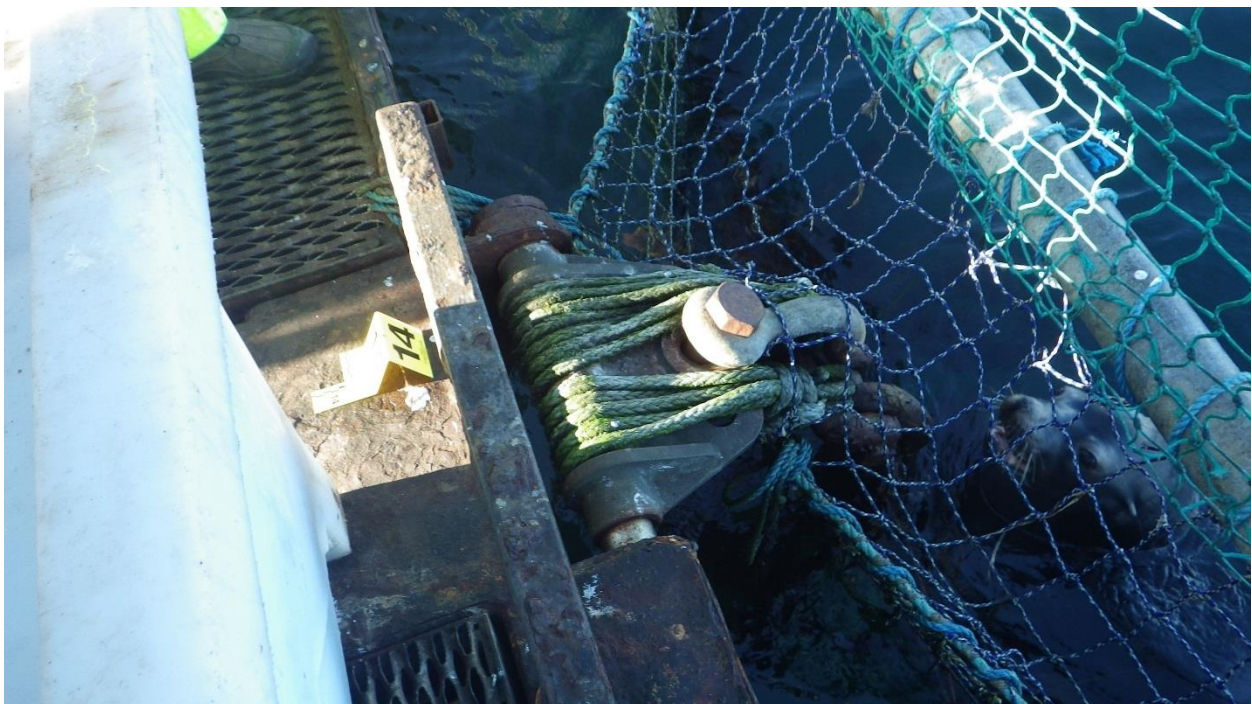
Figure C-31: Anchor #14, North Side of the North Net Pen. Hinge at different angle than chain.

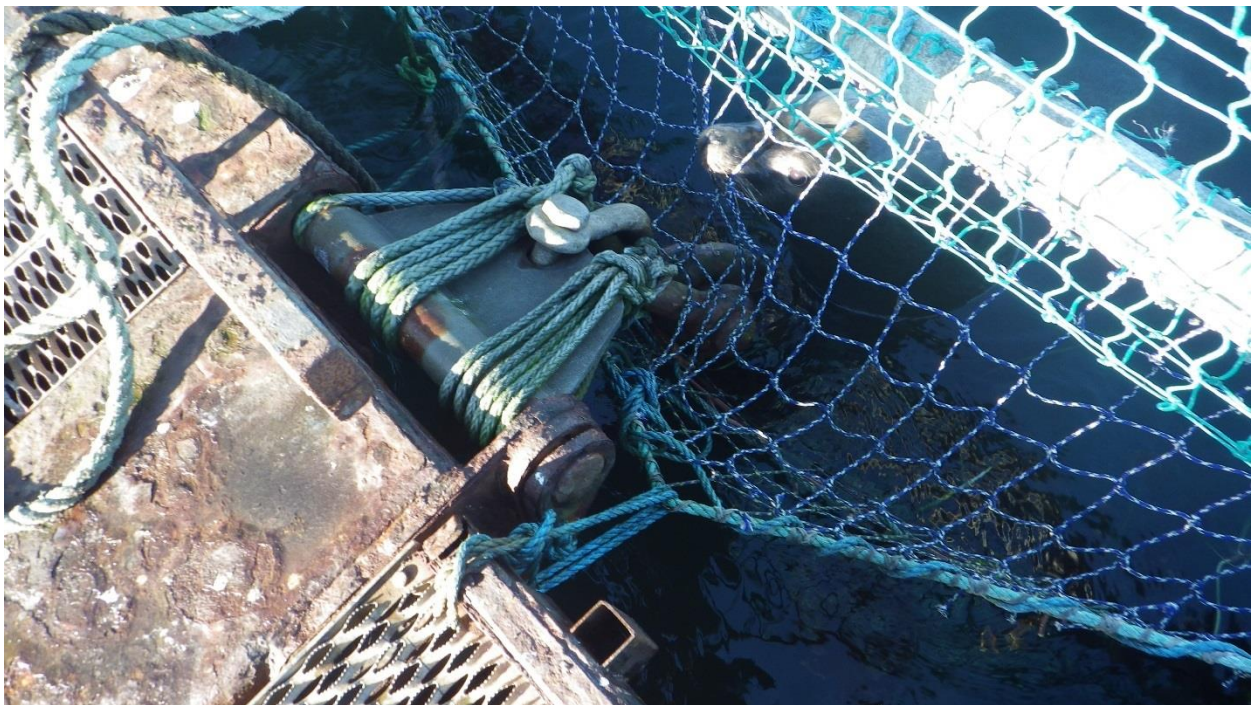
Figure C-33: Anchor #15, North Side of the North Net Pen. Hinge at different angle than chain.

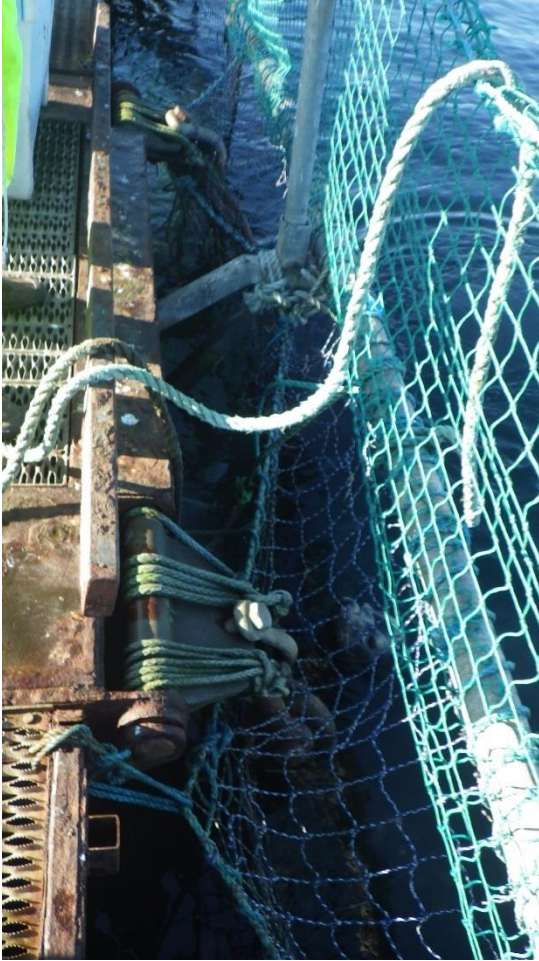
Figure C-34: Anchor #15, North Side of the North Net Pen. Hinge at different angle than chain.

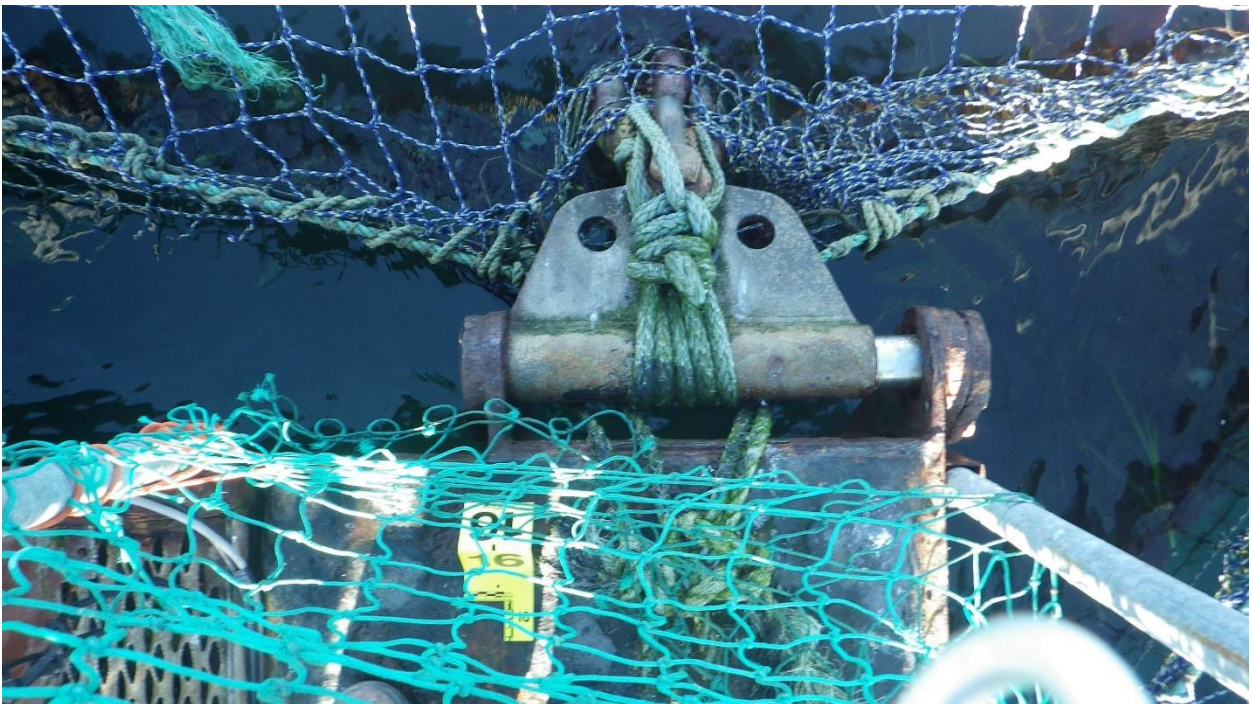
Figure C-35: Anchor #16, NE Corner of the North Net Pen. Hinge at different angle than chain.

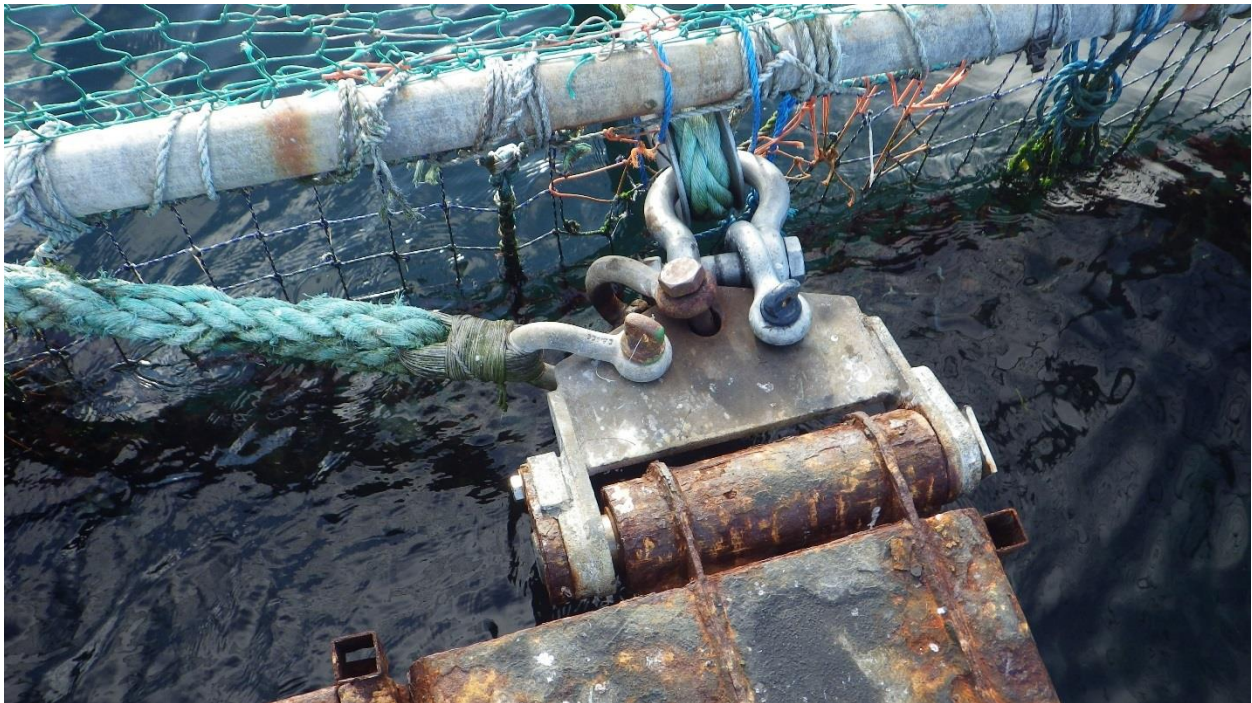
Figure C-37: North West Hinge – Connection of North and South Net Pens. Hinge with moderate corrosion.

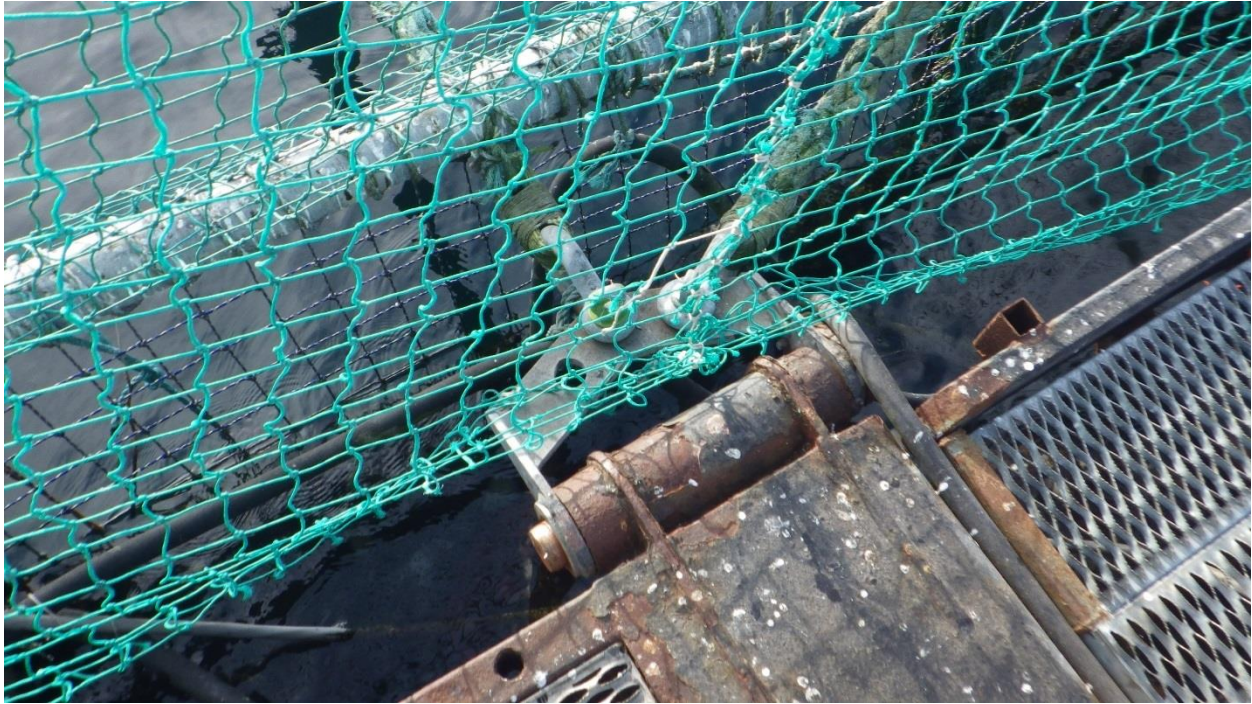
Figure C-38: North West Mid – Interconnection of North and South Net Pens. Hinge with moderate corrosion.

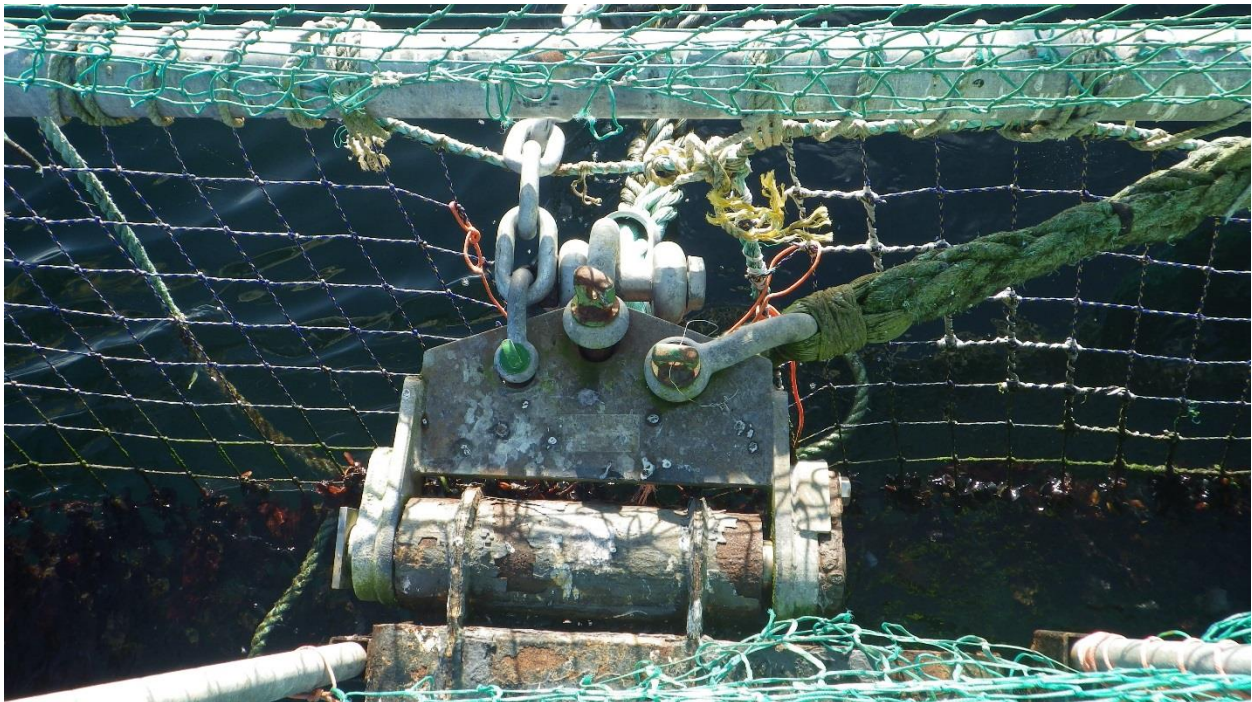
Figure C-39: North East Hinge – Connection of North and South Net Pens. Hinge with moderate corrosion.

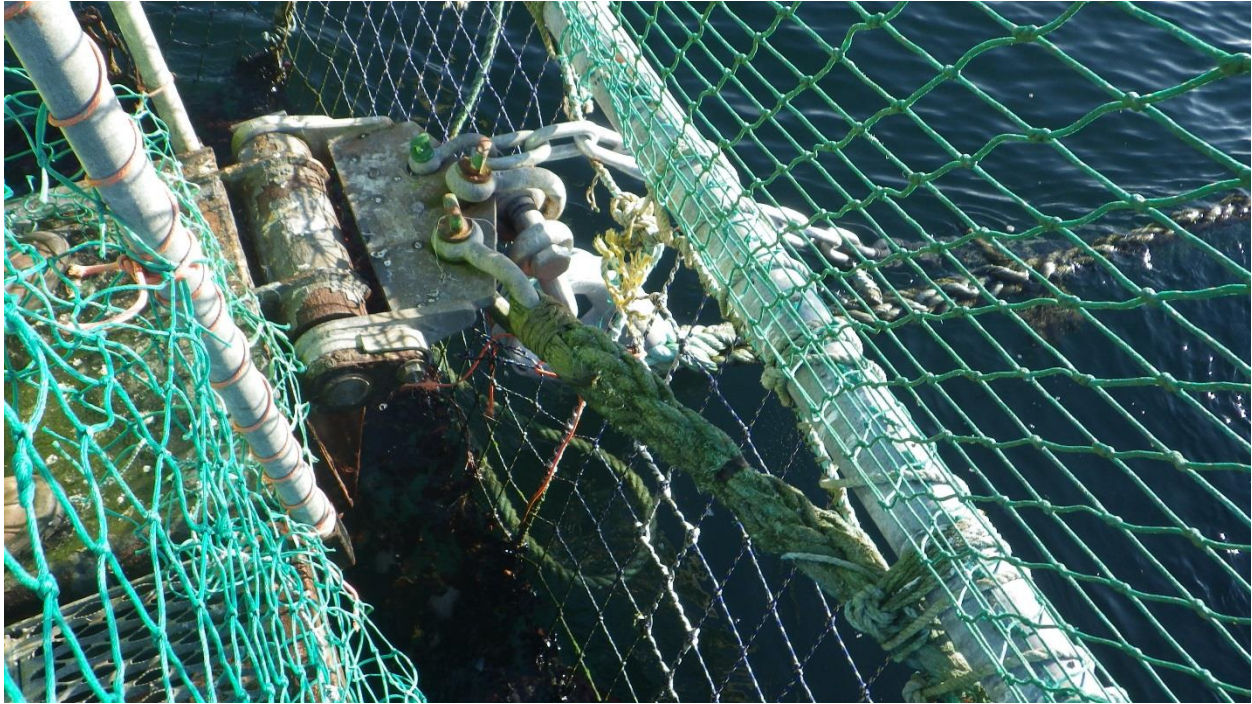
Figure C-40: North East Hinge – Connection of North and South Net Pens. Hinge with moderate corrosion.

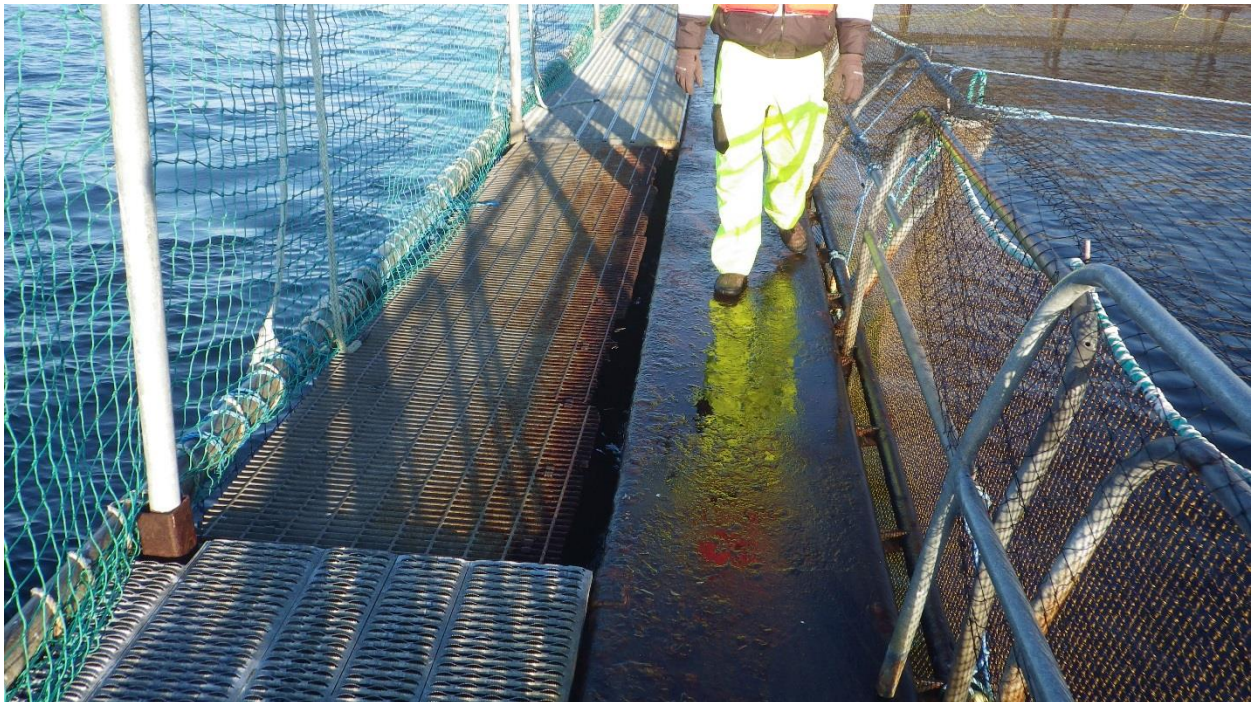
Figure C-41: Old Walkway Grating on west side. Note gap in grating.

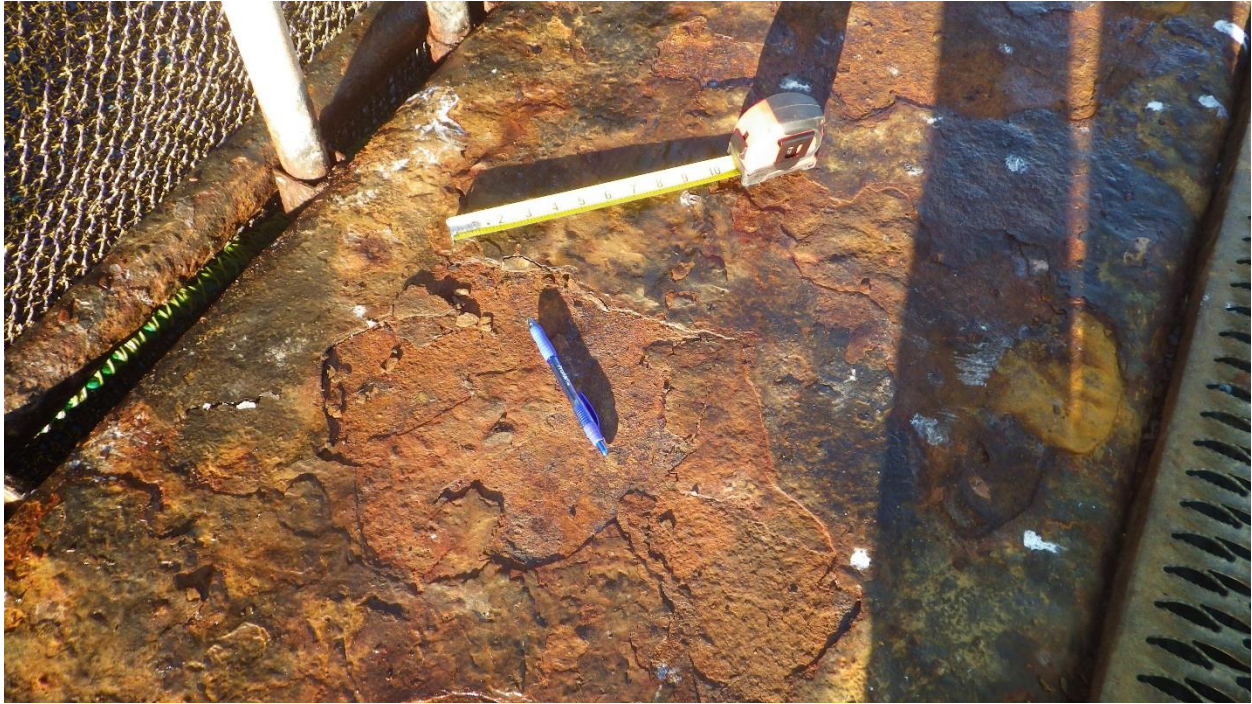
Figure C-42: Rusted Outer Steel Frame on North East side walkway. Moderate to major corrosion.

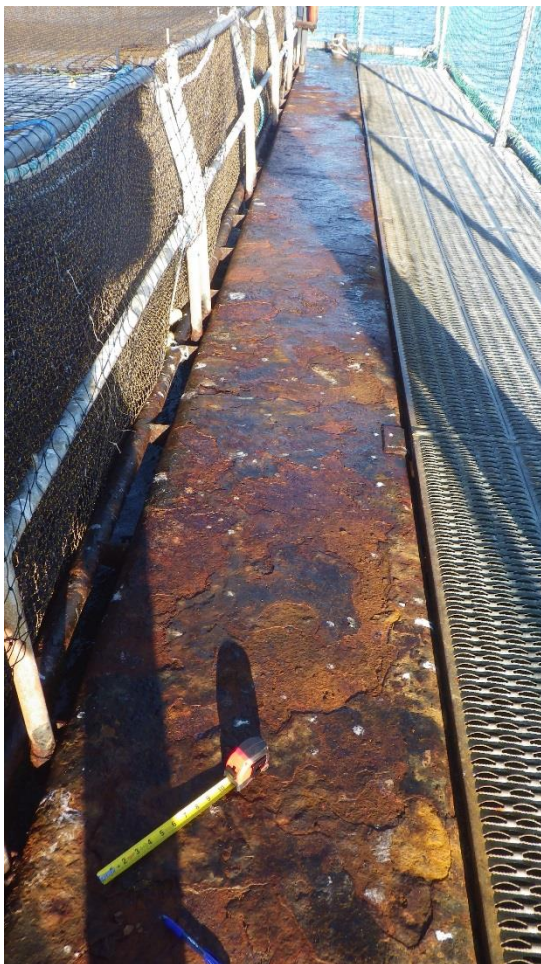
Figure C-43: Rusted Outer Steel Frame on North East side walkway. Moderate to major corrosion.

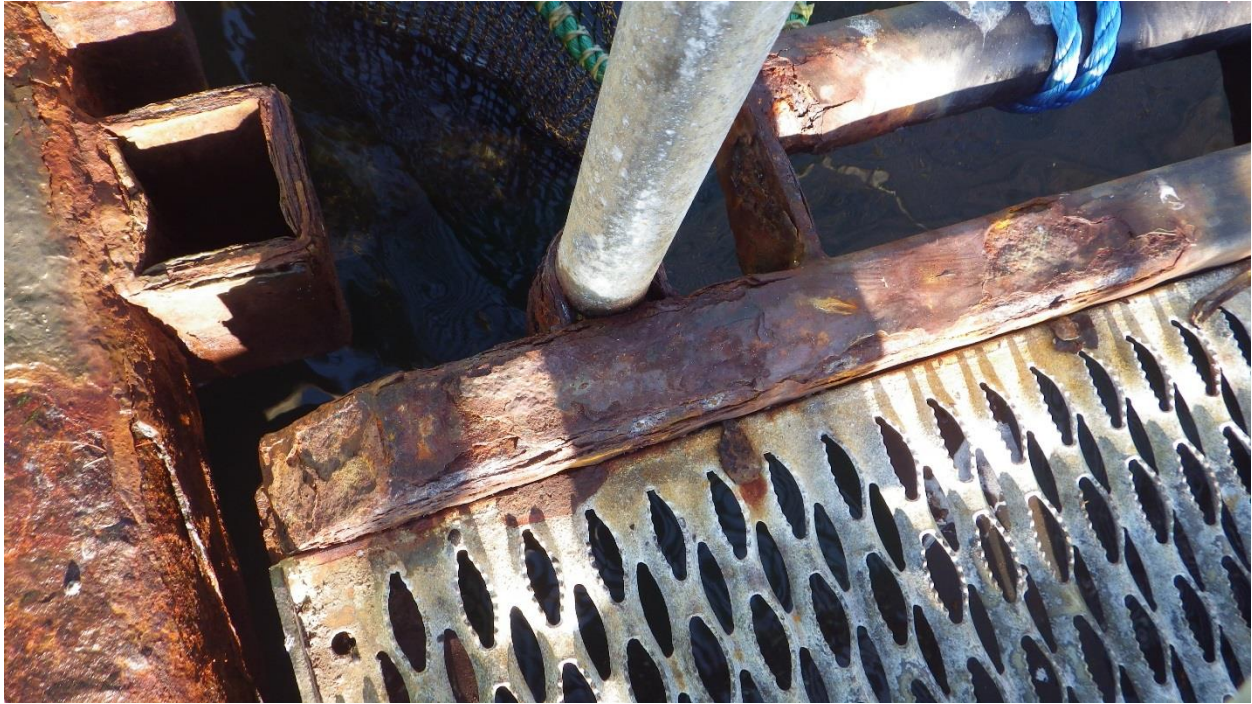
Figure C-48: Rusted Handrail Bracket and Structural Framing. Major corrosion.

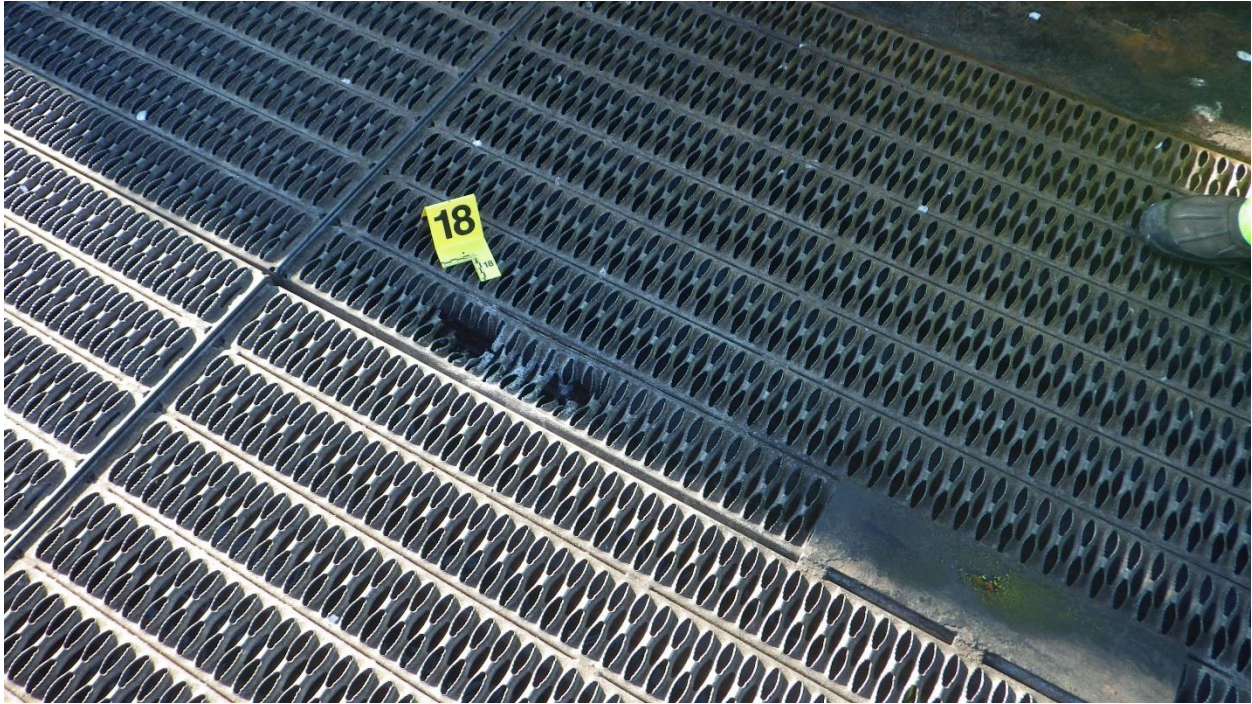
Figure C-52: Damaged Grating Panel at Center Bridge.

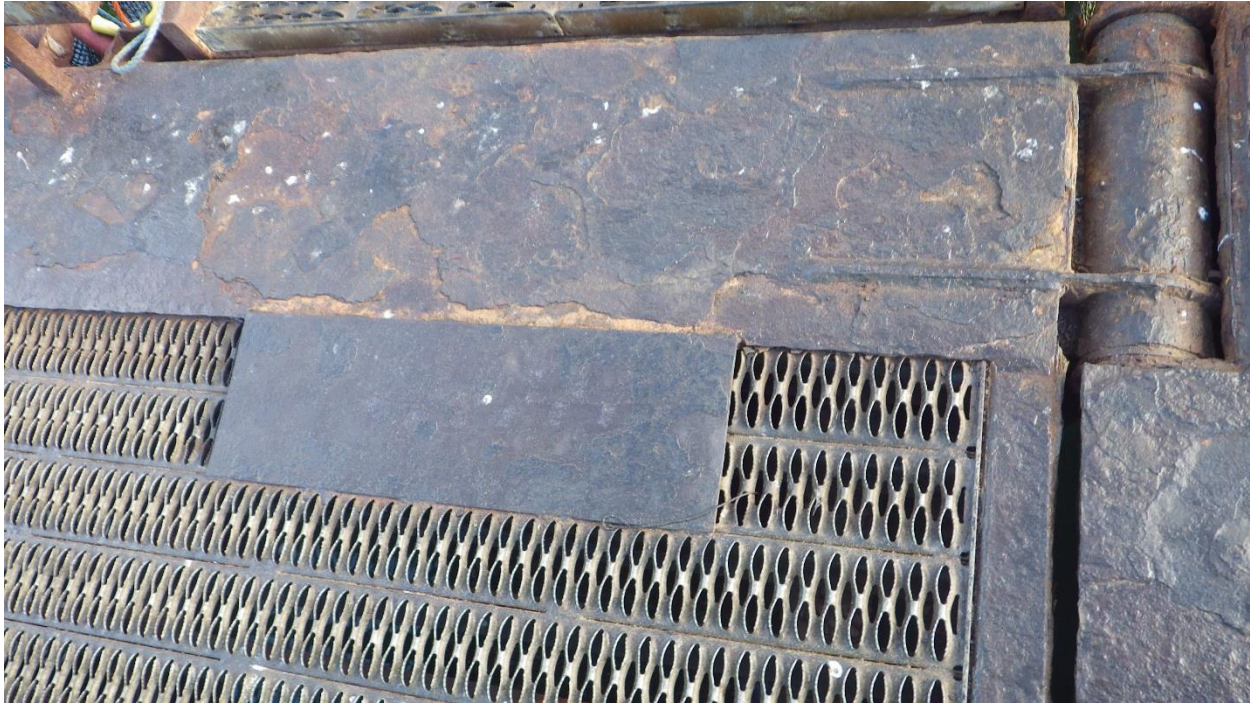
Figure C-54: Steel Plates Welded on Top of Rusted Grating. Moderate corrosion.

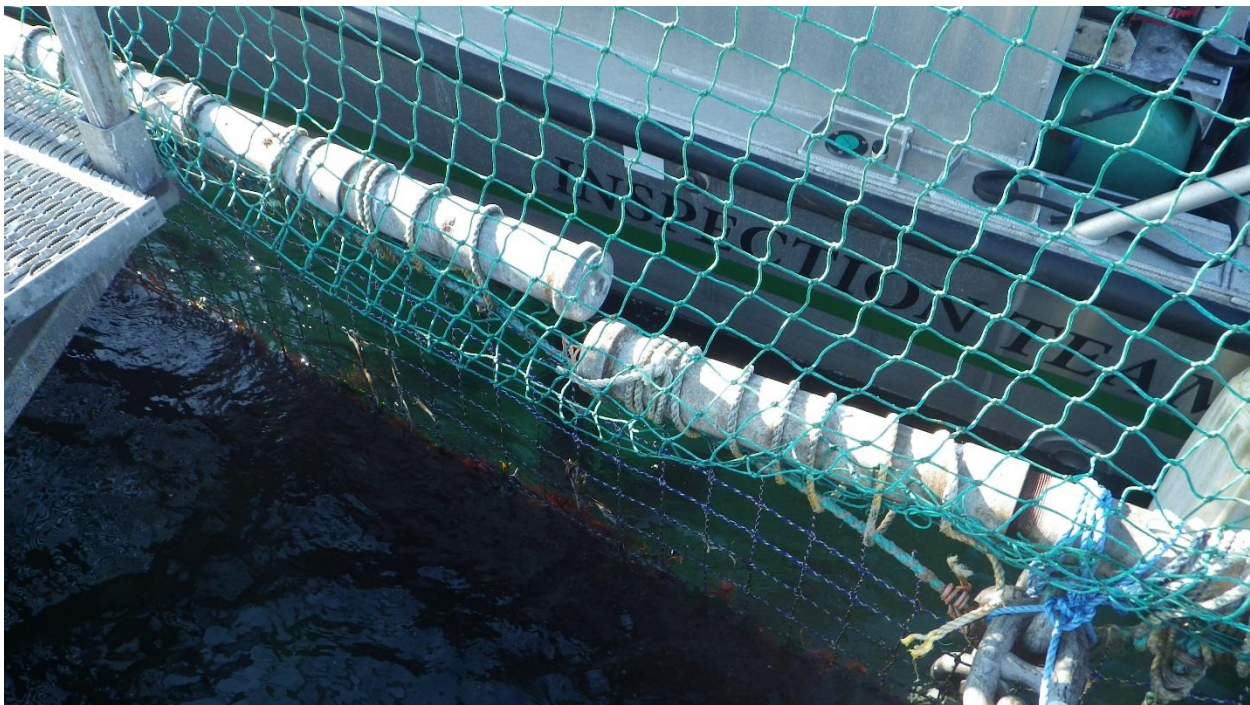
Figure C-55: Near Anchor 10, Discontinuous Predator Net Railing – Bent due chain connection load.

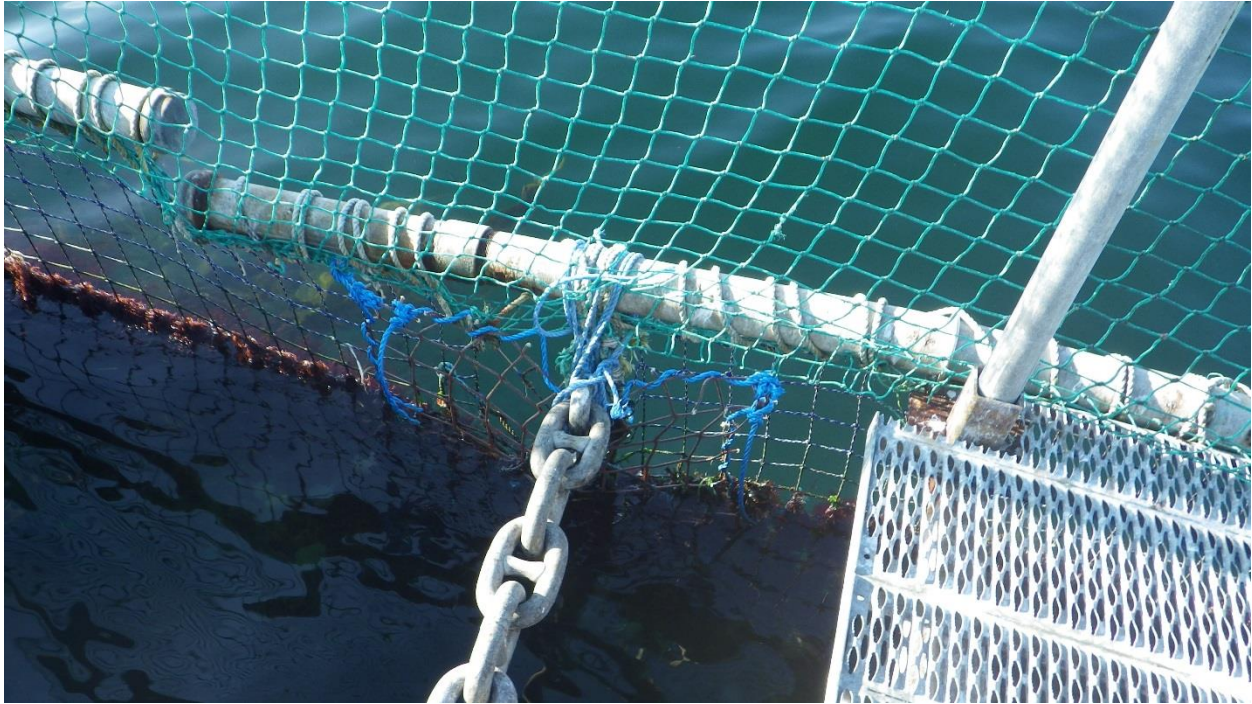
Figure C-56: Near Anchor 10, Discontinuous Predator Net Railing – Bent due chain connection load.

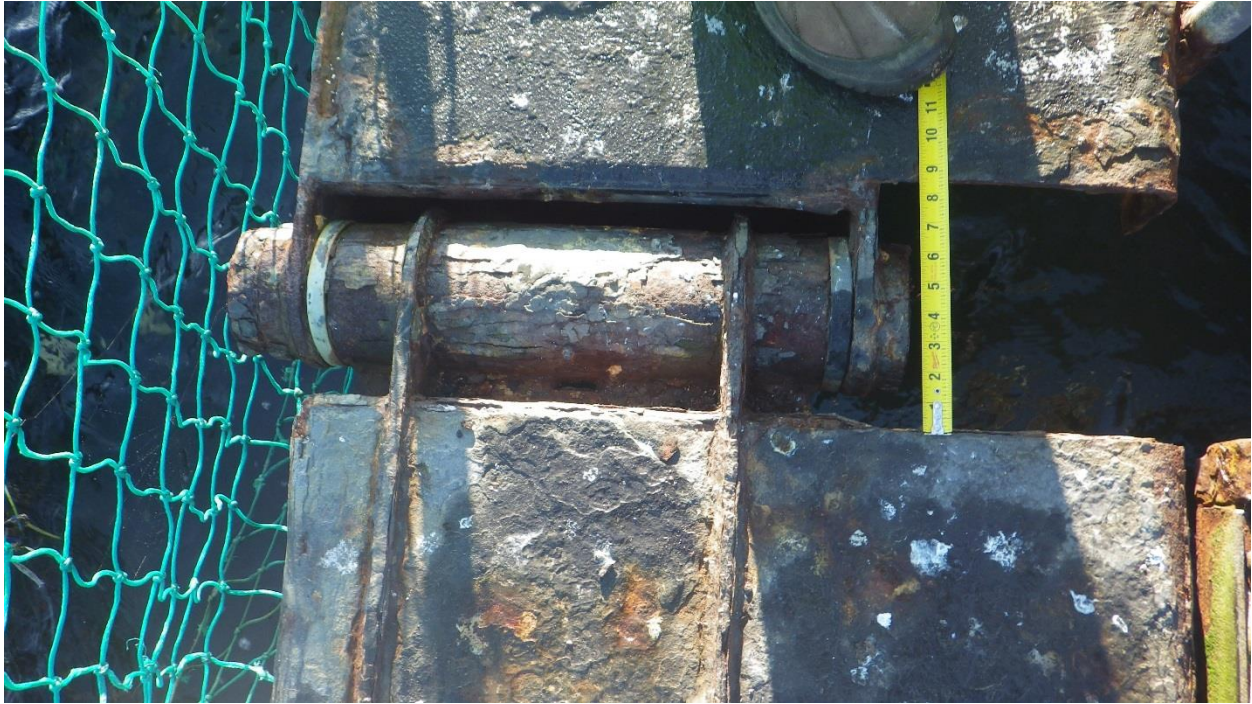
Figure C-58: Rusted Hinge between anchors 2 and 3. Major corrosion.

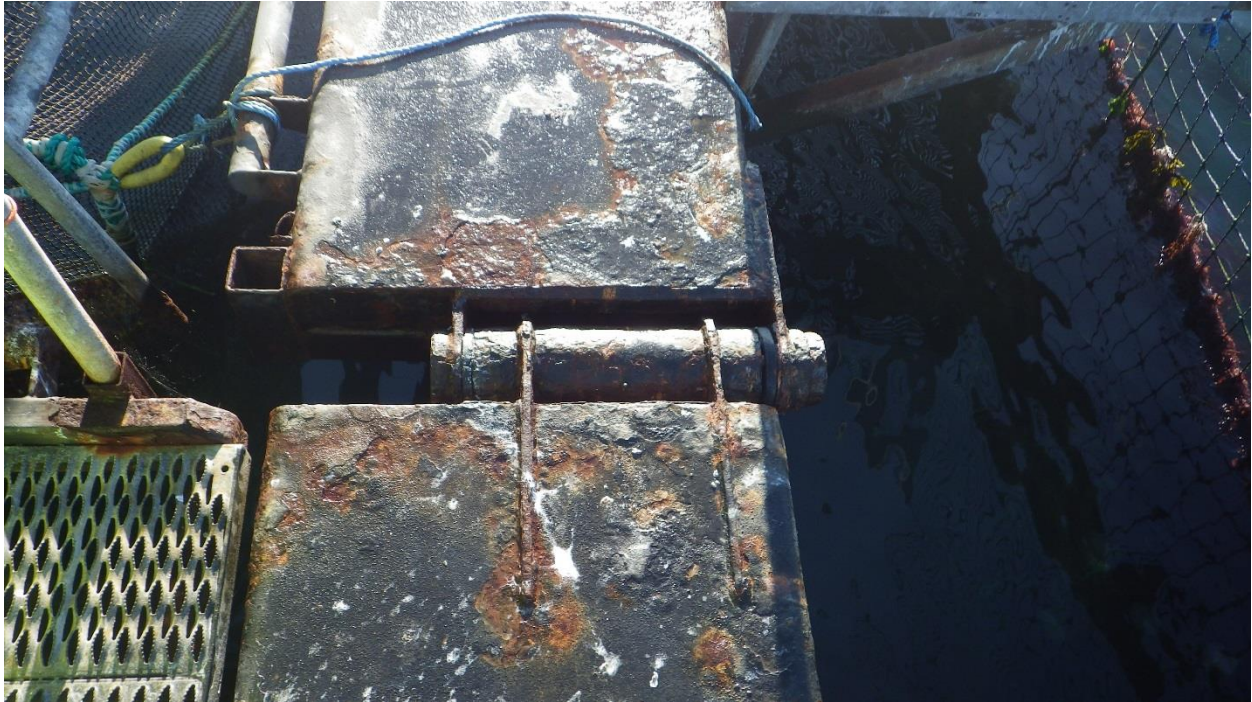
Figure C-60: Rusted Hinge between anchors 9 and 10. Moderate corrosion.
