# **Rich Passage Orchard Rocks Atlantic Salmon Net Pens Engineering Assessment**

January 29, 2018

Mott MacDonald  
110 James Street  
Suite 101  
Edmonds WA 98020  
United States of America

State of Washington  
Department of Natural  
Resources  
1111 Washington Street SE  
Olympia Washington 98504

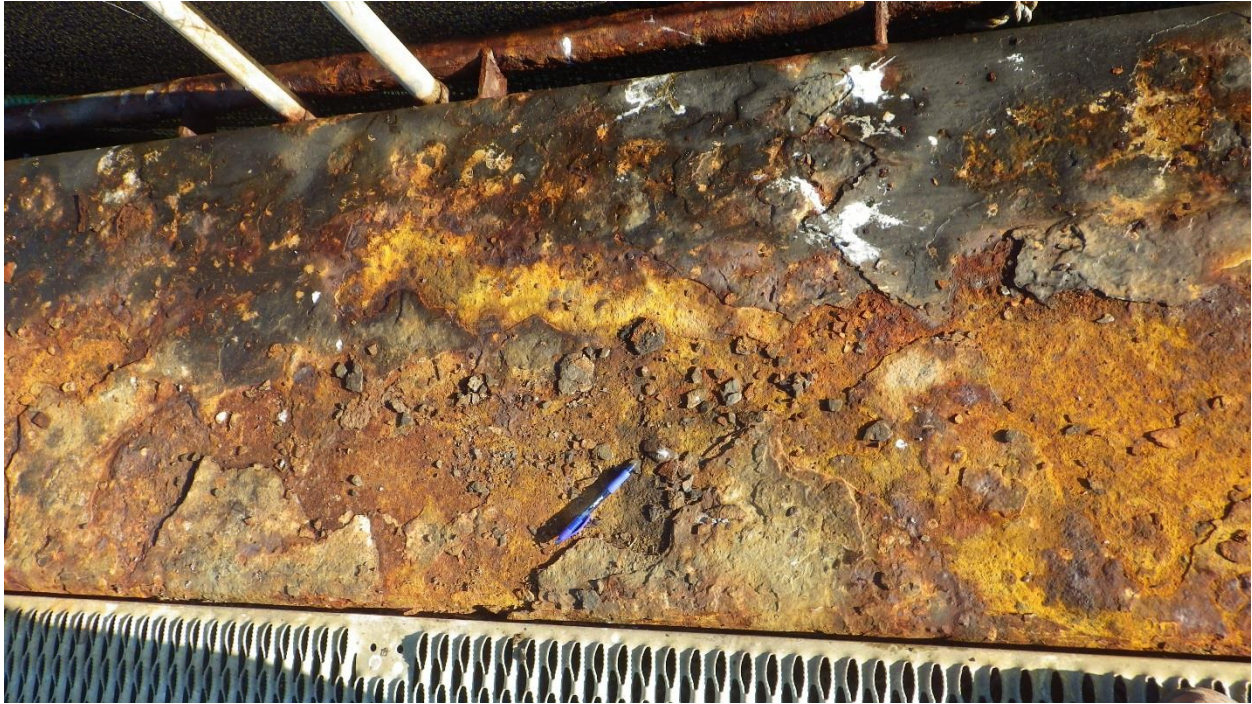
Figure C-62: Rusted walkway between anchors 11 and 12. Major corrosion.

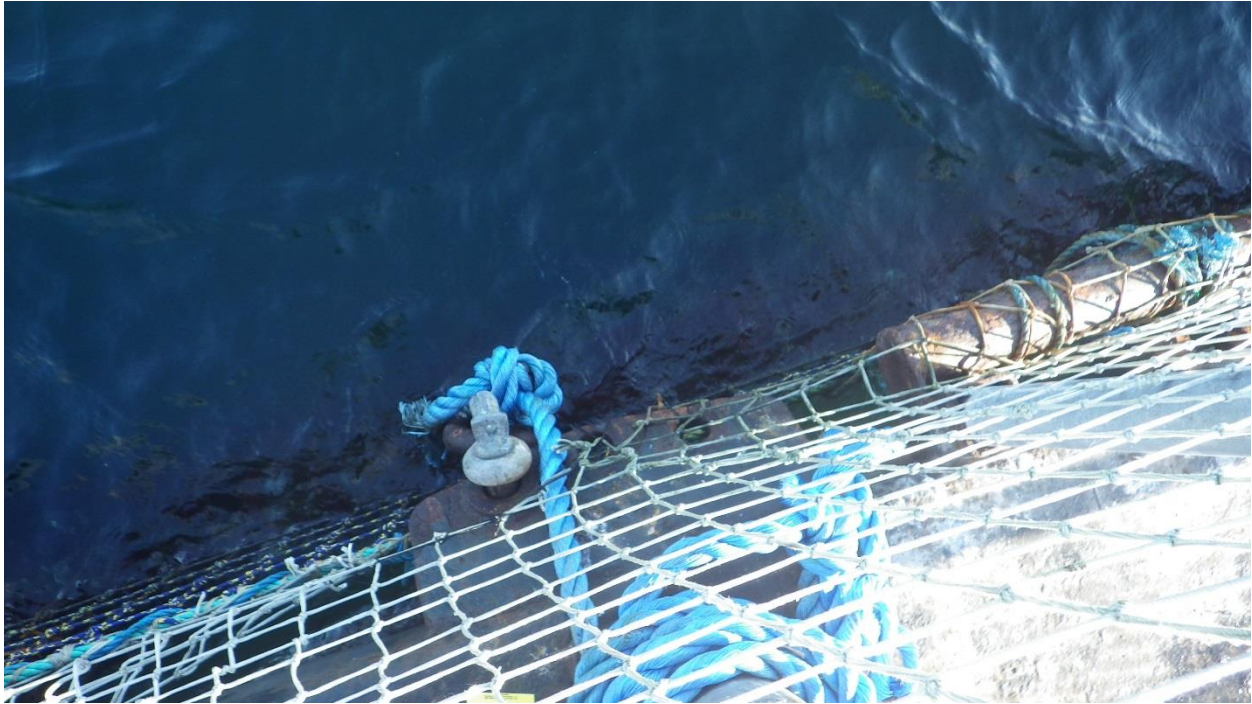
Figure D-7: Anchor #2, East Side of the South Net Pen. Newer shackle, old chain.

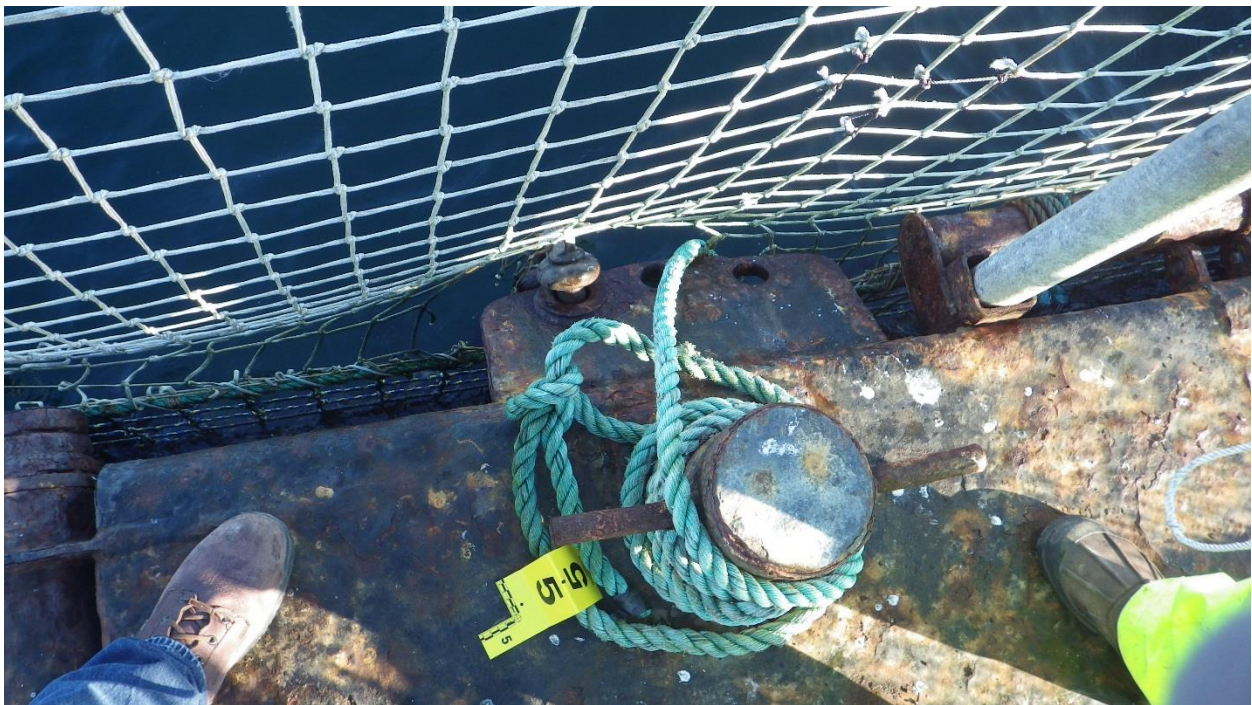
Figure D-14: Anchor #5, East Side of the South Net Pen. Mooring bracket hole reinforced.

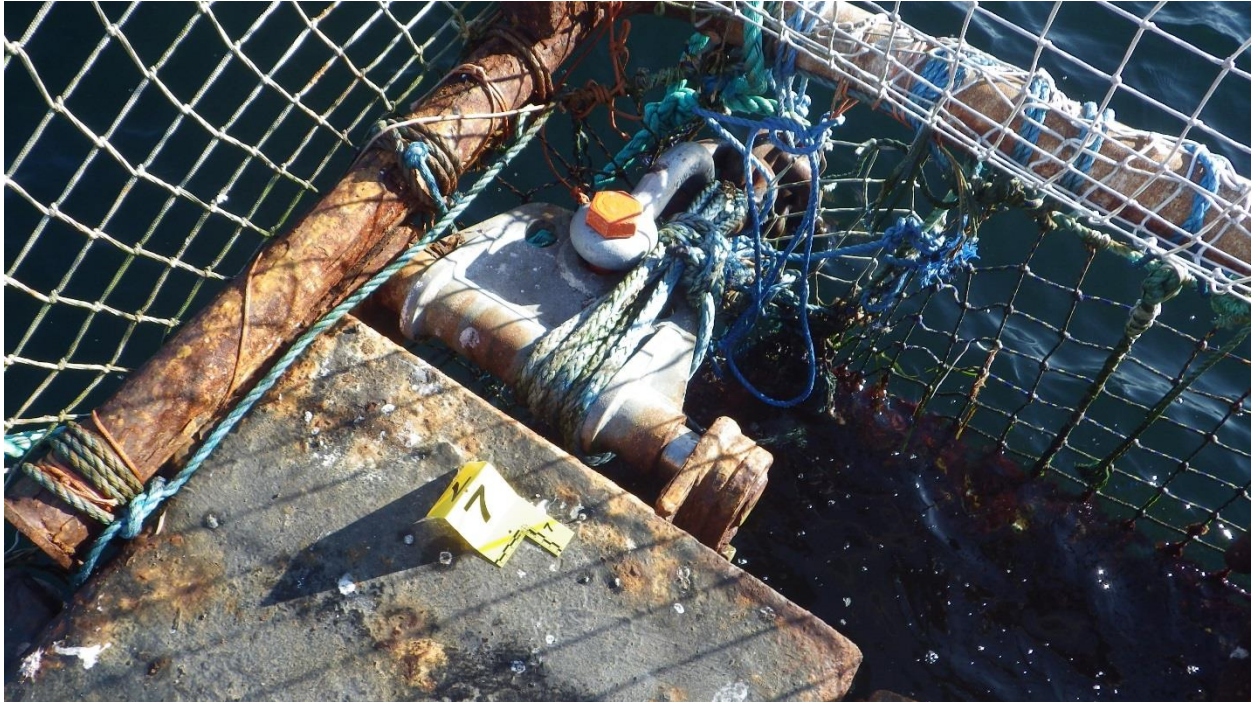
Figure D-17: Anchor #7, SE Corner of the South Net Pen. Hinge with minor to moderate corrosion.

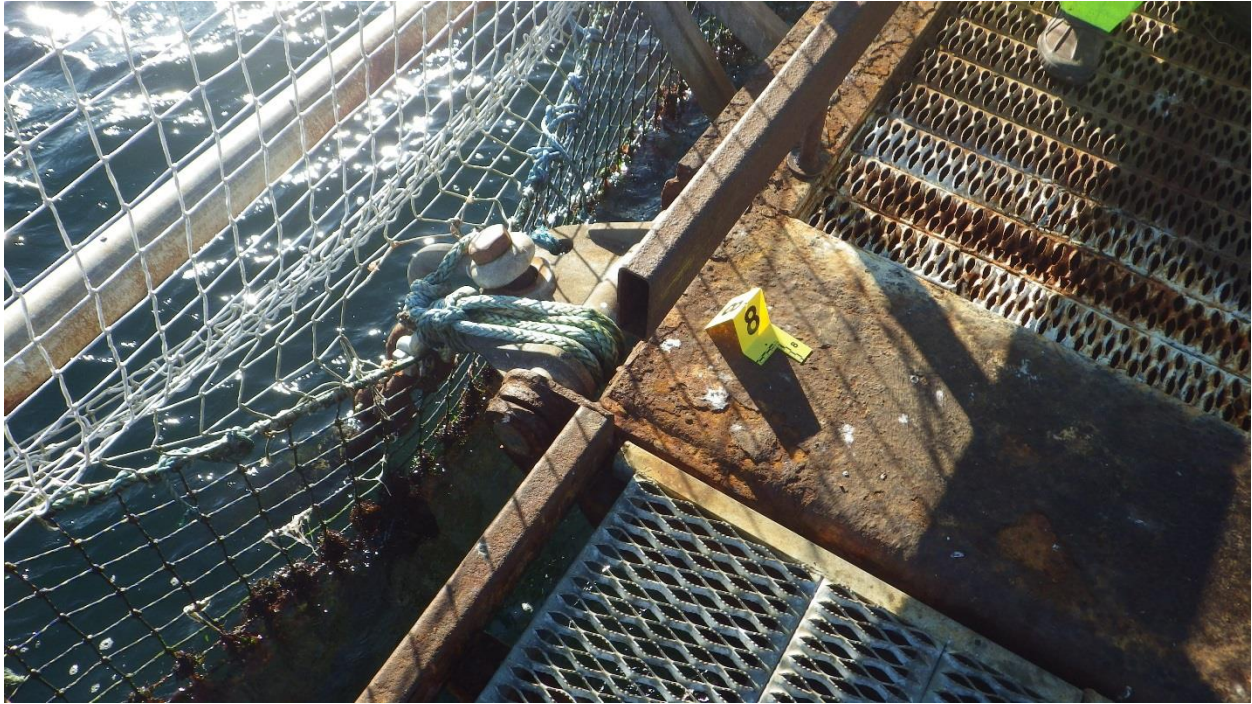
Figure D-19: Anchor #8, South Side of the South Net Pen. Hinge with moderate corrosion.

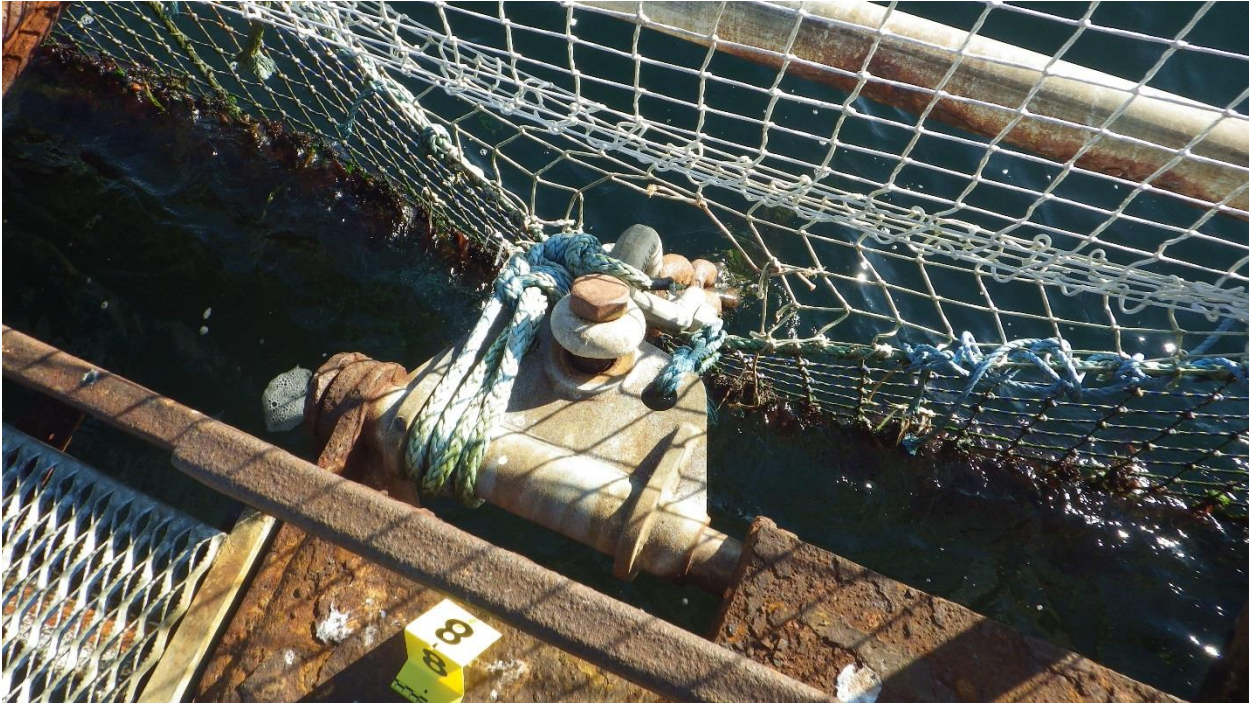
Figure D-21: Anchor #8, South Side of the South Net Pen. Hinge with moderate corrosion.

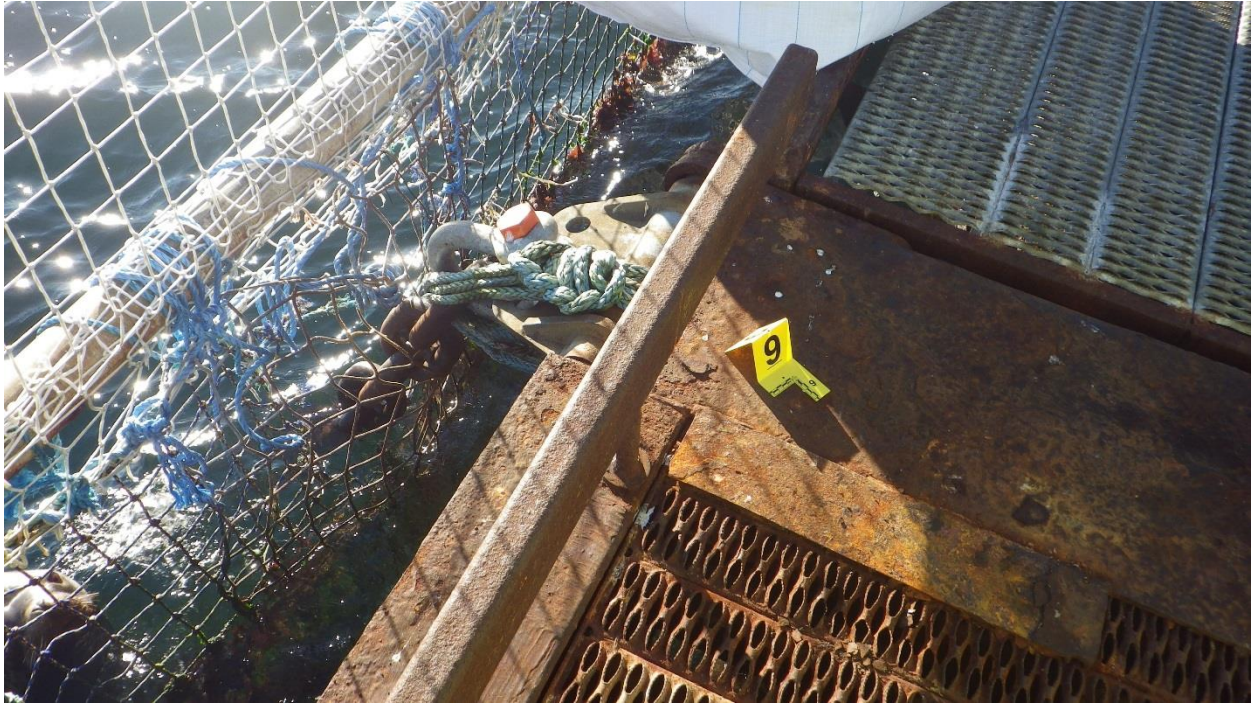
Figure D-23: Anchor #9, South Side of the South Net Pen. Hinge with moderate corrosion.

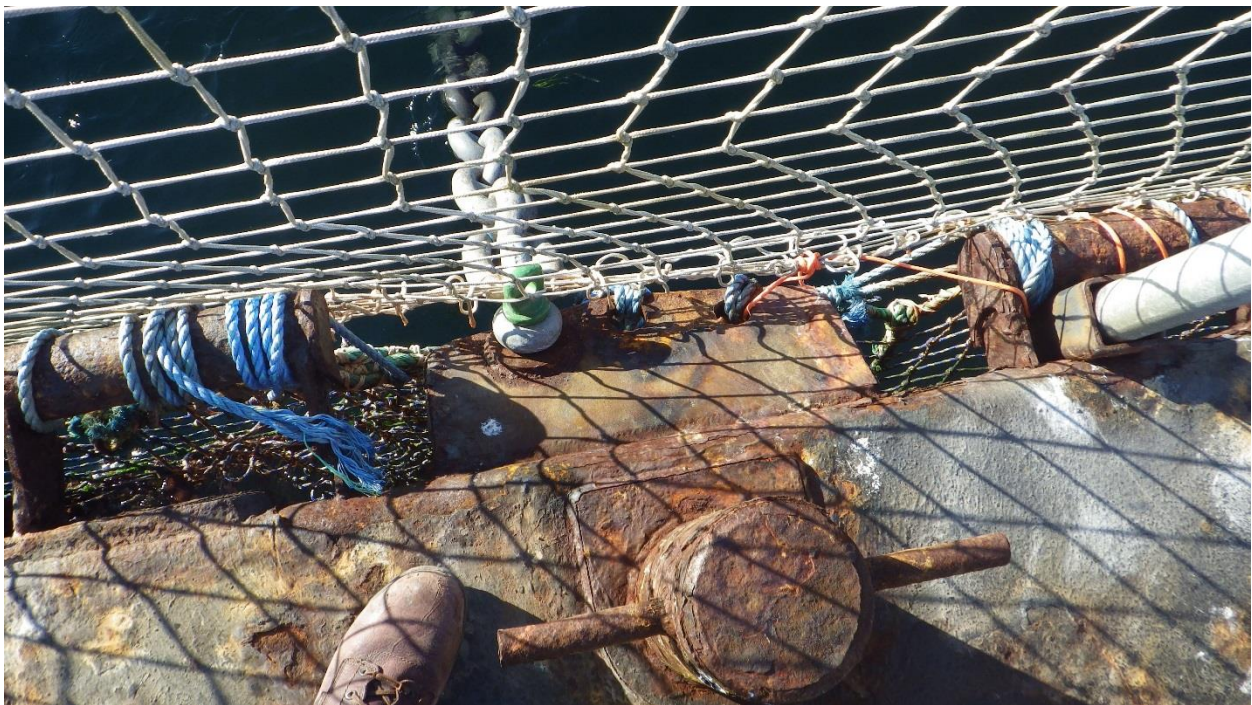
Figure D-28: Anchor #11, SW Corner of the South Net Pen. Reinforced hole on mooring bracket.

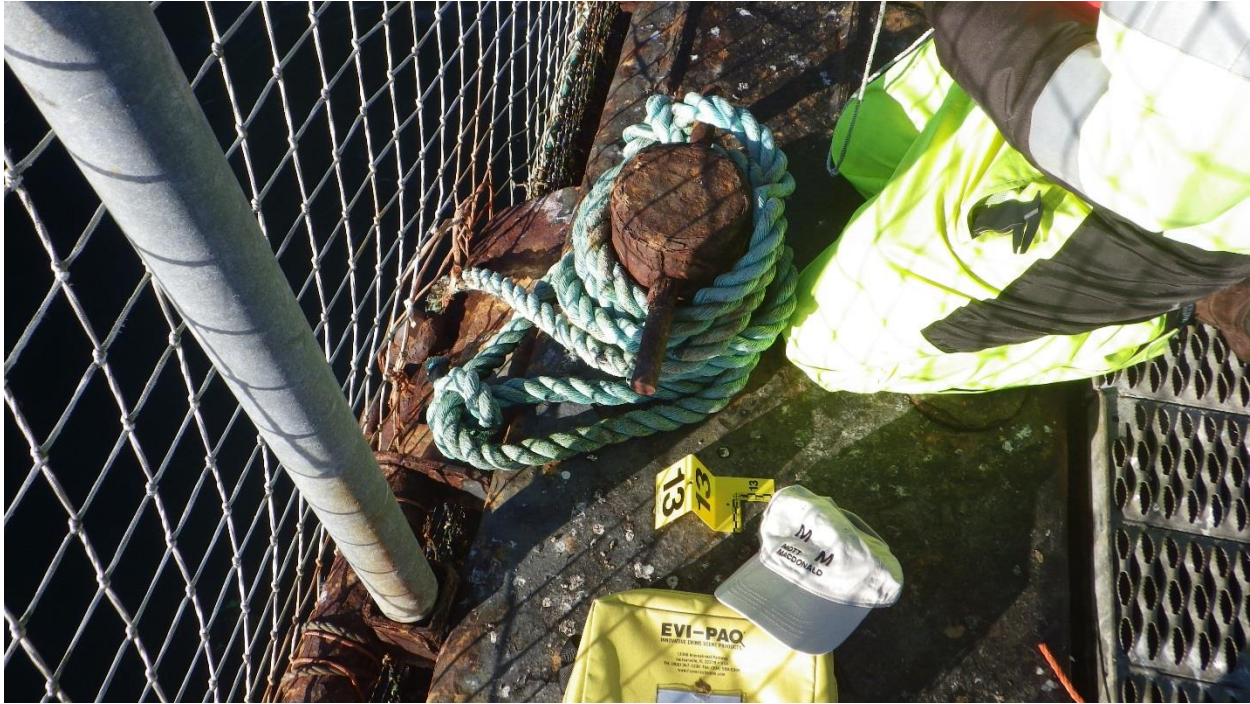
Figure D-31: Anchor #13, West Side of the South Net Pen. Moderate corrosion on shackle.

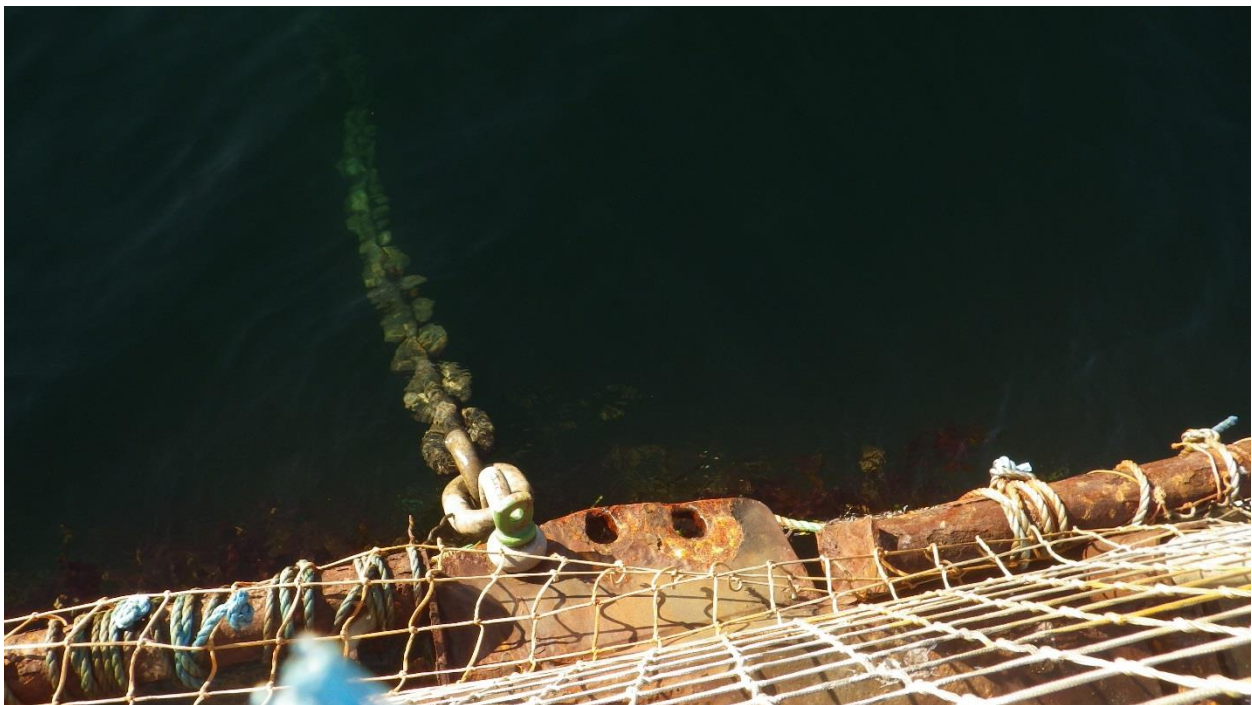
Figure D-37: Anchor #16, West Side of the South Net Pen, with new shackle and chain.

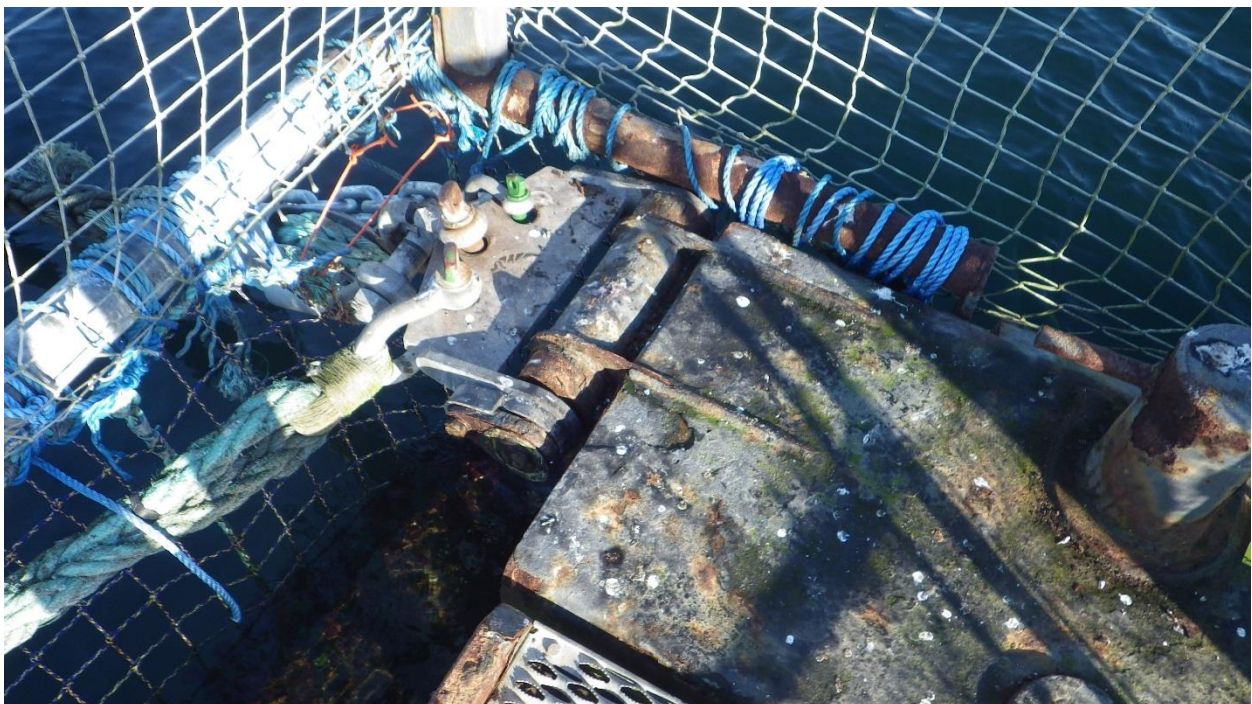
Figure D-39: South East Hinge connected to North pen with moderate corrosion.

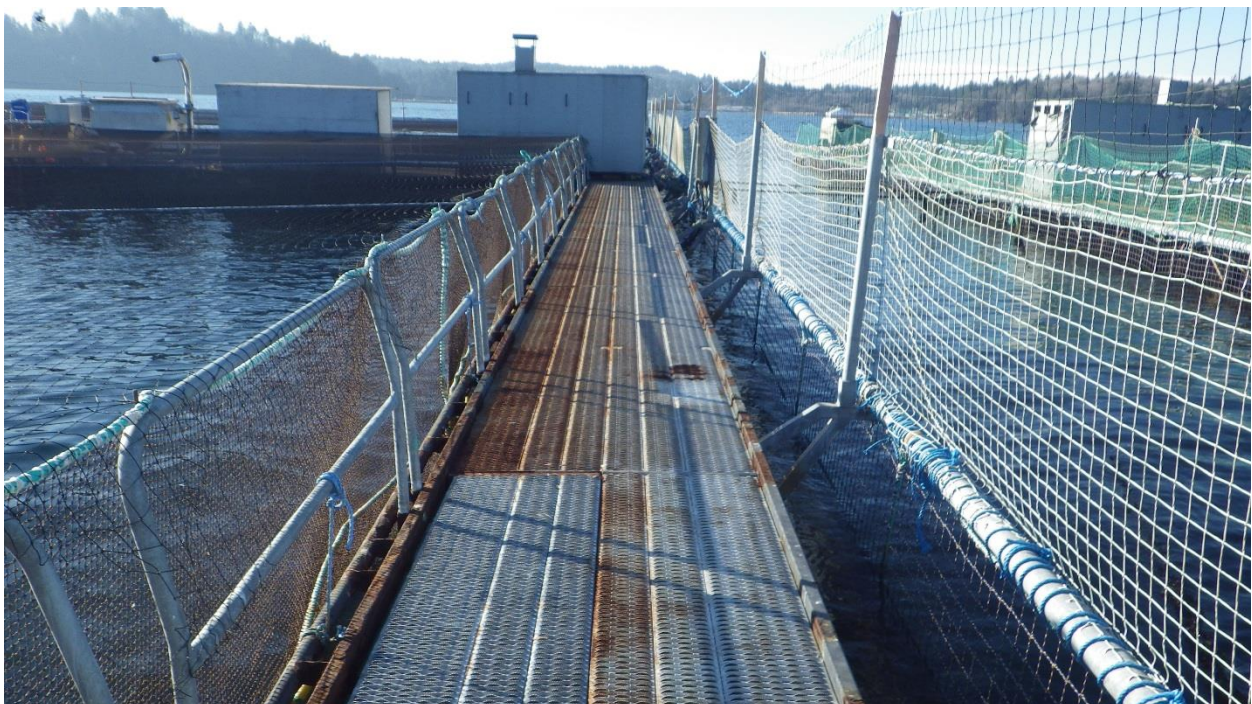
Figure D-49: Steel Framing Walkway. Note that Grating is Absent.

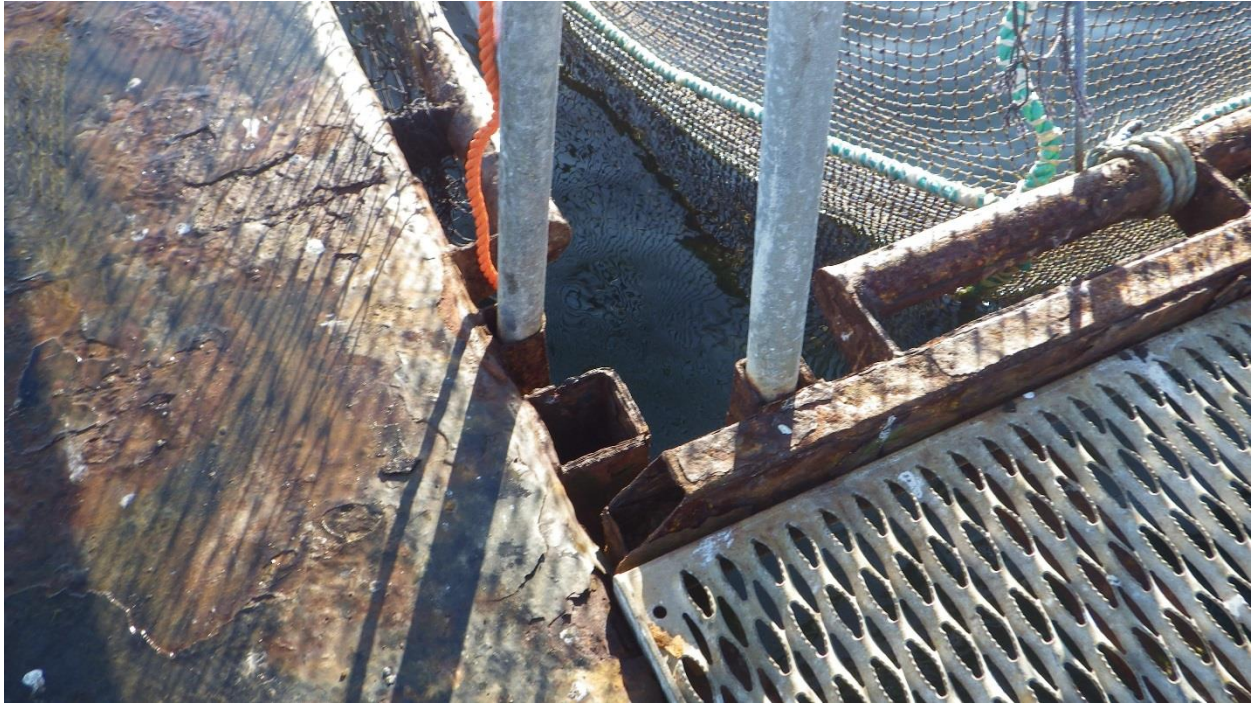
Figure D-50: Rusted Grated Walkway and Center Bridge and staff shed.

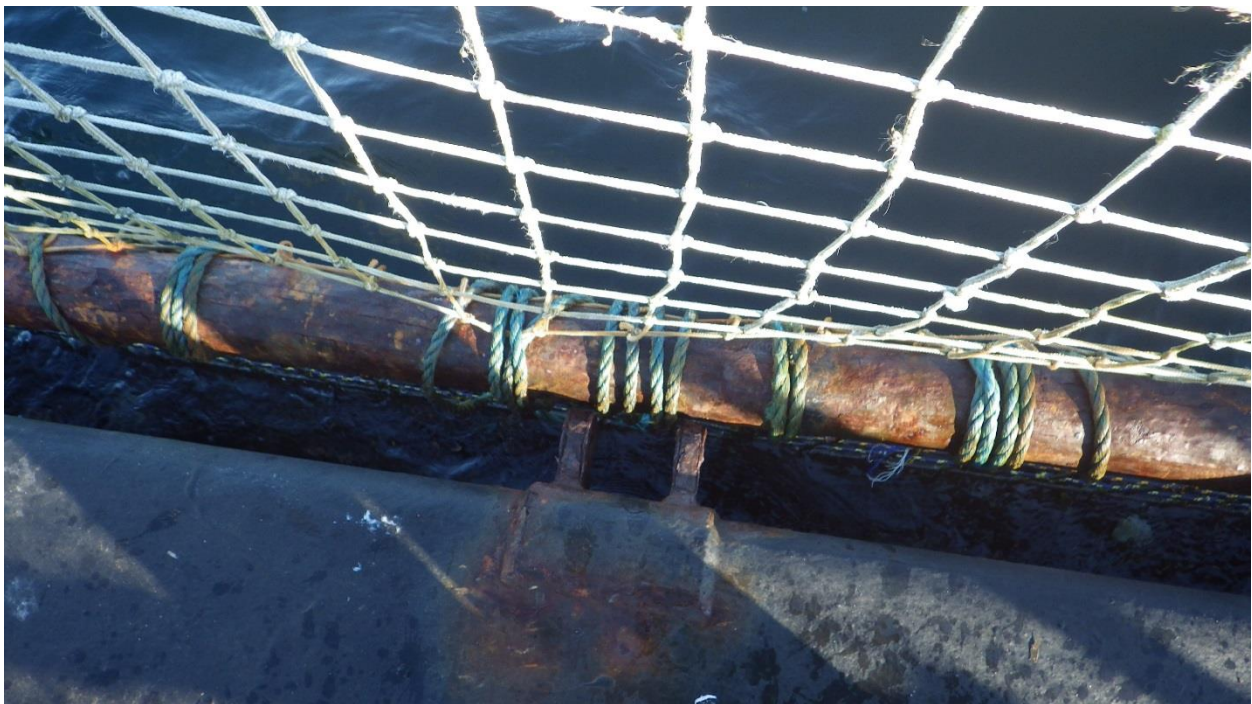
Figure D-51: Rusted Steel Framing, Handrail Brackets, and Net Pen Support Railings, moderate to major corrosion.

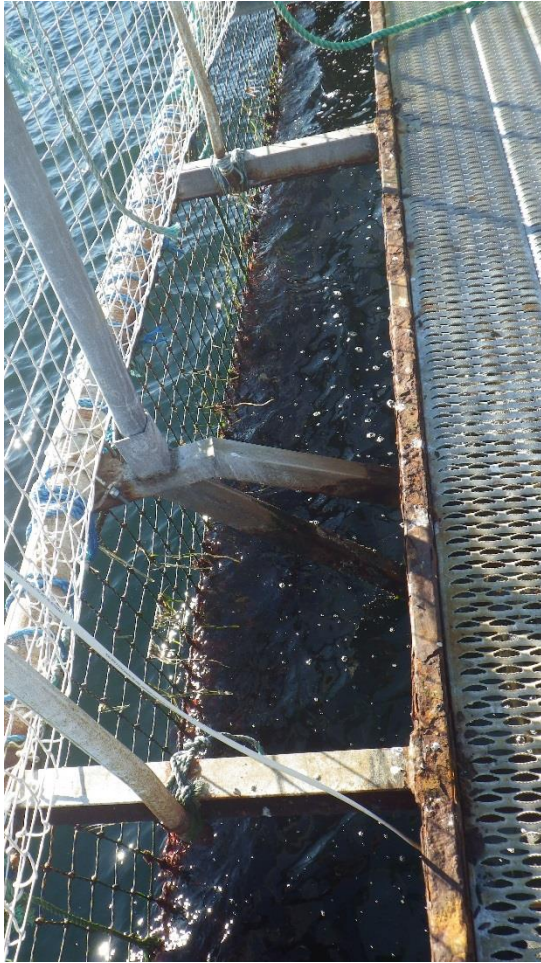
Figure D-52: Rusted Predator Net Support Railing with moderate corrosion.

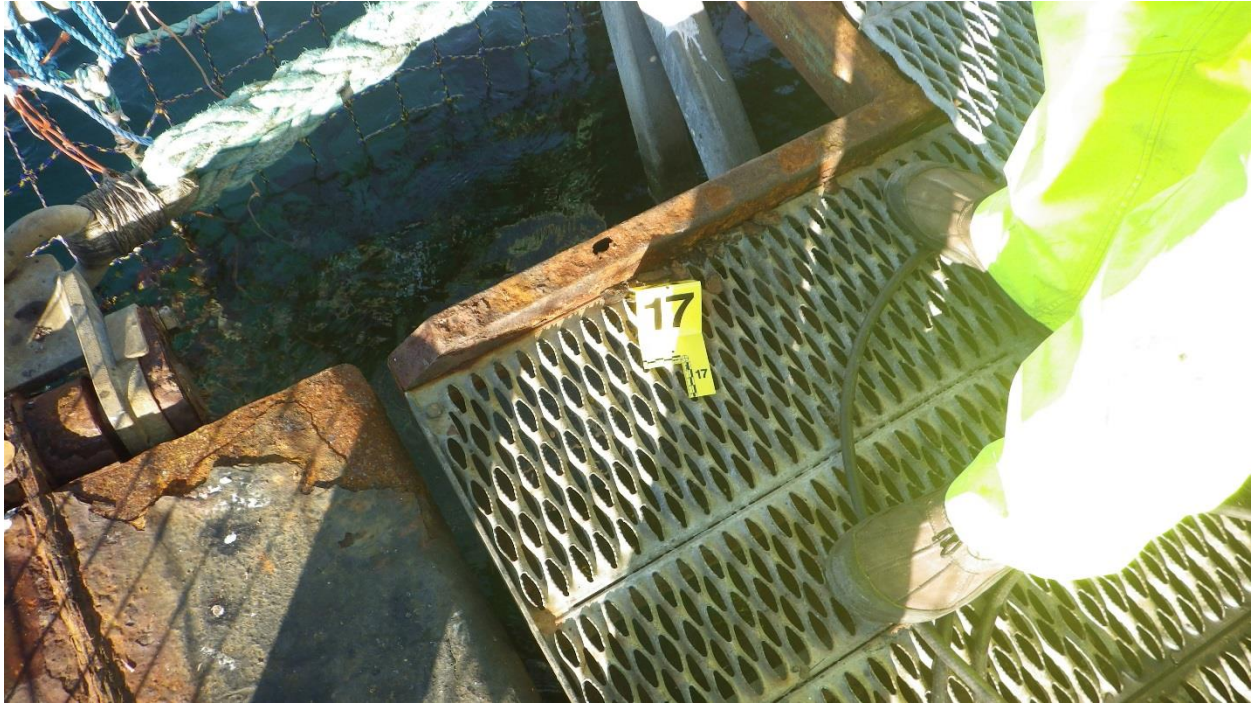
Figure D-56: Rusted Steel Framing, Handrail Brackets, and Net Pen Support Railings with moderate to major corrosion.

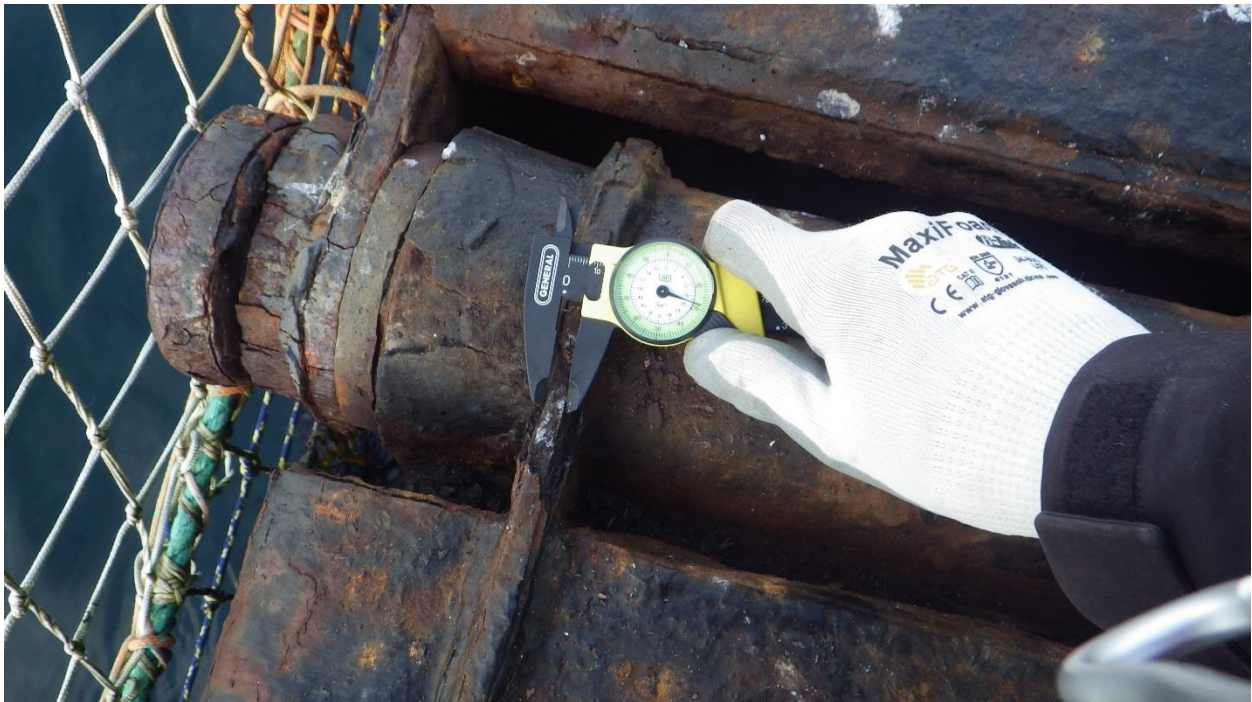
Figure D-57: Rusted Steel Framing, Hole in Framing Member with total section loss, major to severe corrosion.

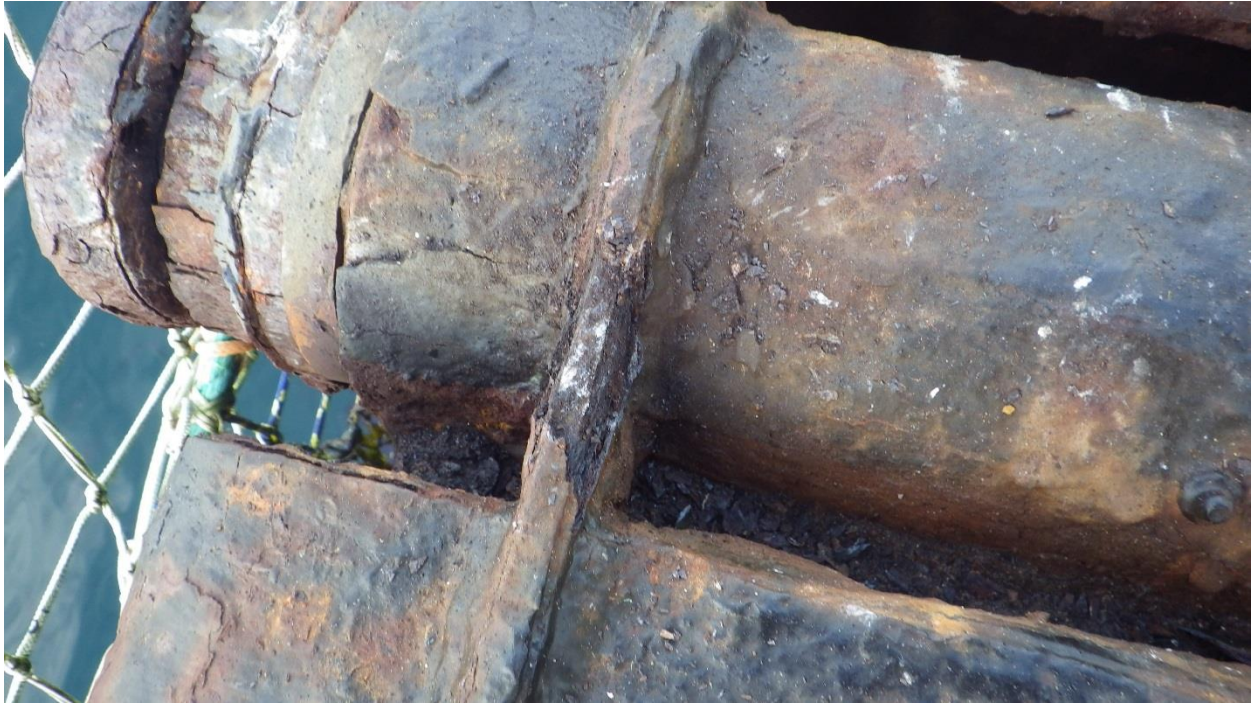
Figure D-58: Rusted Hinge Connection, Major Corrosion, Reduced Section of 40%.
