ROANOKE PARKS AND RECREATION  
EUREKA PARK RECREATION CENTER  
**FEASIBILITY STUDY**

SPECTRUM DESIGN P.C.  
Plaza Suite 1  
10 Church Avenue SE  
Roanoke, VA 24011-2104  
540.342.6001 PH | 540.342.6055 FAX  
[www.spectrumpc.com](http://www.spectrumpc.com)

AUGUST 4, 2017  
PROJECT NO. 16100

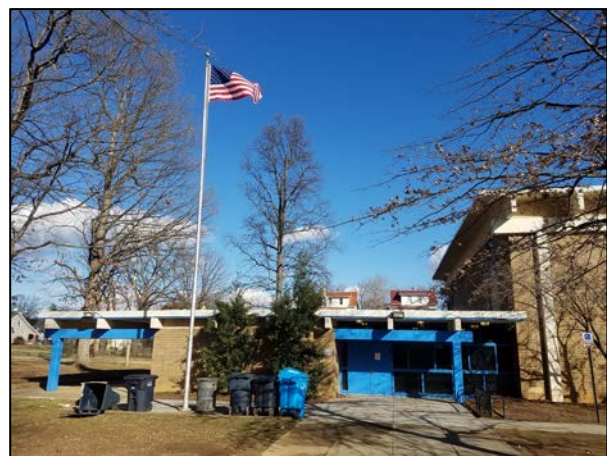
The flag pole appears to be in proper working conditions and does not require maintenance. If building elements are added that protrude in the direction of the flag pole, a new pole location should be considered.

Flag Pole

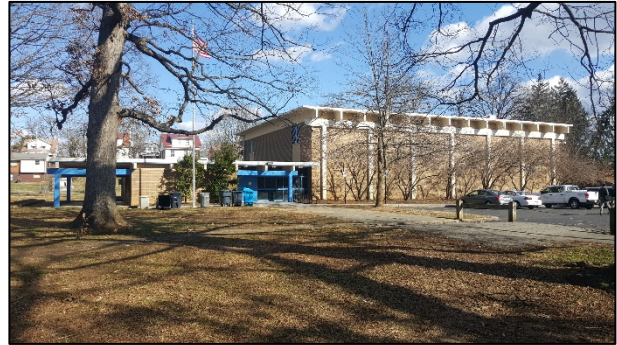
The office/program area of Eureka Park Recreation Center is a multi-wythe masonry building with concrete block masonry interior and brick veneer. It does not appear that the building is cavity wall construction. The masonry is in good condition, with limited areas of damage from graffiti.

Exterior Masonry Walls

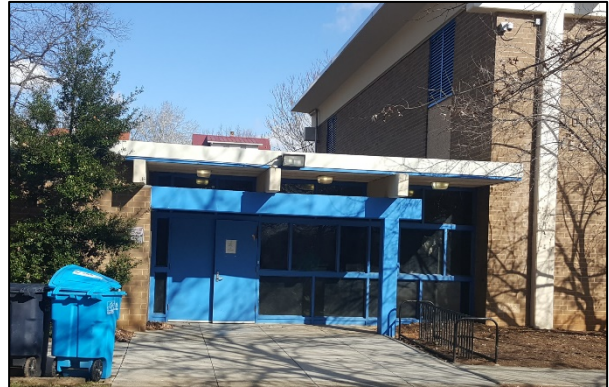
Main Entrance

**Recommendation:** Reconfigure the entrance to provide a secure entrance vestibule. The new entrance should be constructed with modern thermally broken frames and insulated glass. Increase the amount of insulation on the roof during the next roof-replacement.

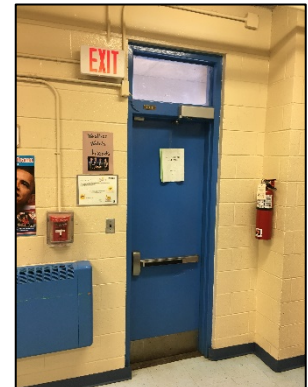
Exterior doors and frames are hollow metal. Doors have panic hardware on the inside to allow egress. Some metal sweeps at the bottom of the doors are damaged on many

Exterior Doors

exterior doors. Paint is fading and damaged on many exterior surfaces.

**Recommendation:** Repaint all exterior doors and replace damaged sweeps.

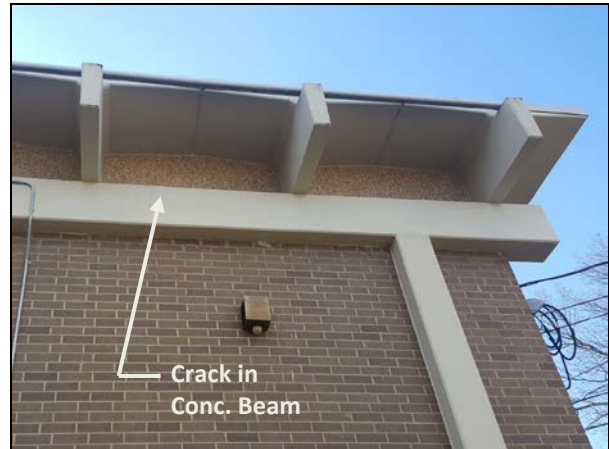
The building's concrete frames are expressed on the exterior of the building. At the gymnasium, the fascia is infilled with pebble finish precast panels. The panels appears to be in good condition with no signs of damage. The overhangs on the gymnasium are the exposed concrete T-beams with no soffit panels. The concrete structure appears in generally good condition where it is exposed. One crack in the concrete structure was seen in the concrete beam in the last span on the northwest corner of the north face of the building. The crack appears small, but should be monitored.

Concrete Beams & Soffit at Gymnasium

**Recommendation:** Monitor one crack in the roof beam located on the northwest corner of the building. Consult a Structural Engineer for repair if the depth or width of the crack grows.

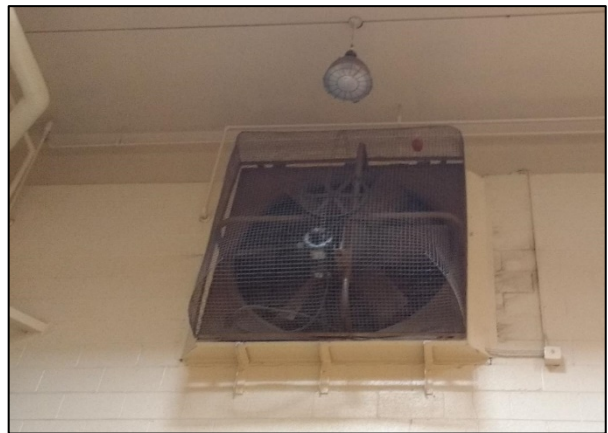
Two large, approximately 60"-diameter propeller fans, now nonoperational, are located high in the wall and were likely used for cross-flow cooling in conjunction with operable louvers on the opposing wall, prior to the addition of mechanical cooling.

Wall Propeller Fan (typ. of 2)

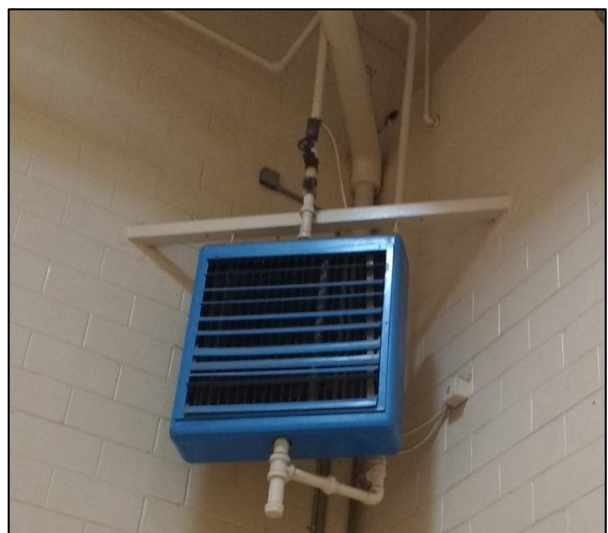
Four large heating water unit heaters, located in each gym corner, provide heating during winter. Each unit heater is controlled by a nearby wall-mounted thermostat and pipe-mounted aquastat that energize the unit heater fan as needed.

Hot Water Unit Heater (Typ. of 4)

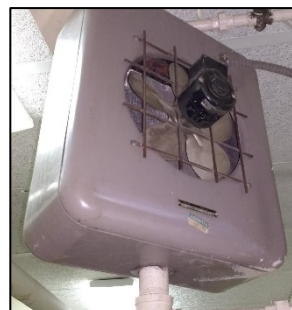
Supplemental heat is provided in each restroom by a ceiling-mounted, hot water unit heater, likely original to the building. One exhaust fan, located in the water heater closet and controlled via manual switch, pulls exhaust from each restroom.

Toilet unit heater

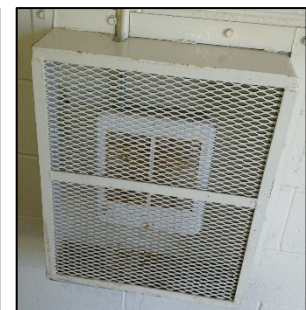
In the stand-alone ballfield restrooms, each room is heated by a small electric wall unit heater with security grating. No other exhaust or ventilation was observed.

Toilet wall heater

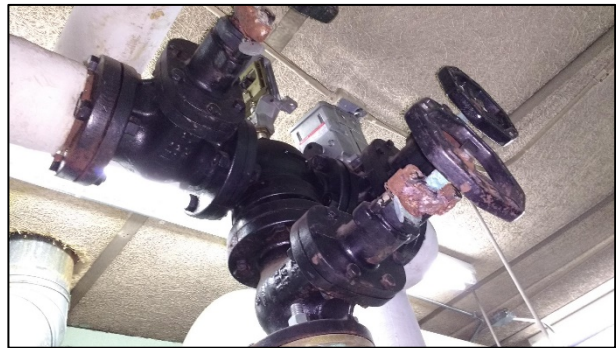
A three-way mixing valve provides boiler protection; it is unclear whether mixing valve actuators are functional.

Boiler Mixing Valve

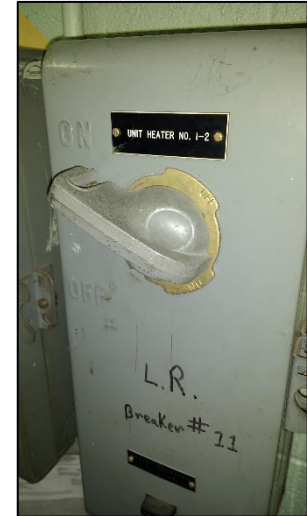
The main service also includes seven original vintage (1965) breakers for the unit heaters, fans, and pumps, as well as an additional, modern 230V subpanel. The service equipment and all of the main distribution equipment in the main electrical room, with the exception of the original breakers, appear to be in good to excellent condition.

Original Breaker

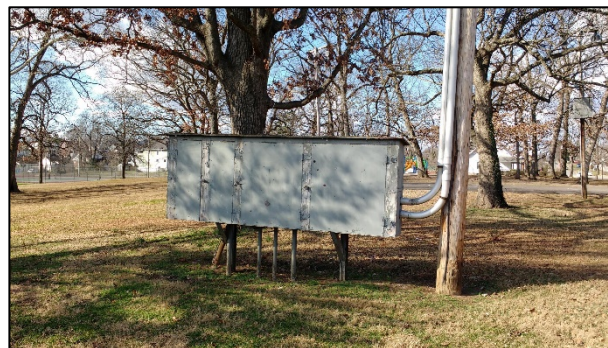
Exterior ballfield lighting is fed by an overhead AEP pole-mounted transformer to a meter and wooden enclosure south of the gym. Feeders route from a CT cabinet to pole-mounted lights through underground conduit. The restroom building is fed by underground service to a 240/120-V, single-phase meter mounted on the side of the building.

Ballfield Lighting Cabinet

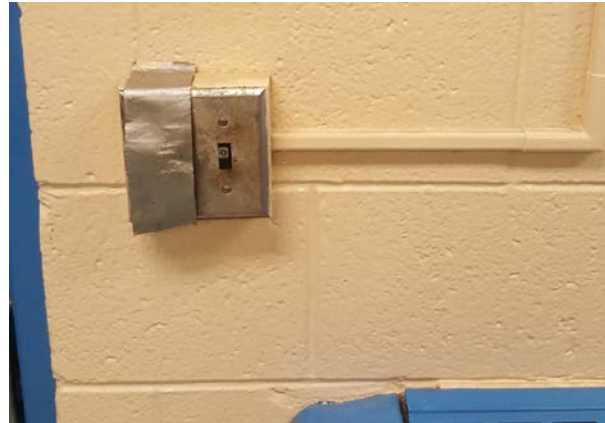
Typical Light Switch and Wiring

**Recommendation:** Replace the older T12 fixtures.

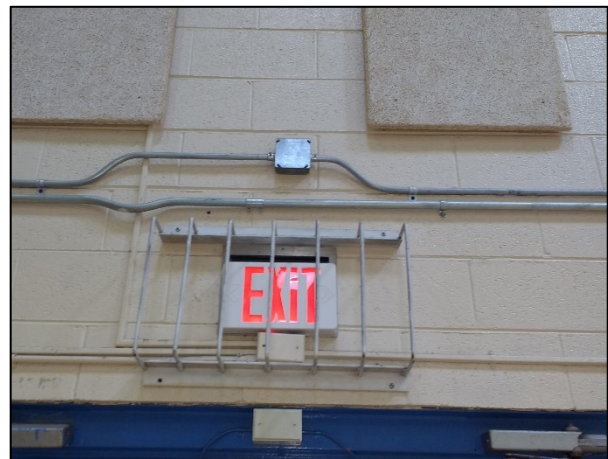
Overall emergency systems appear to be in good working order and good condition.

Exit sign

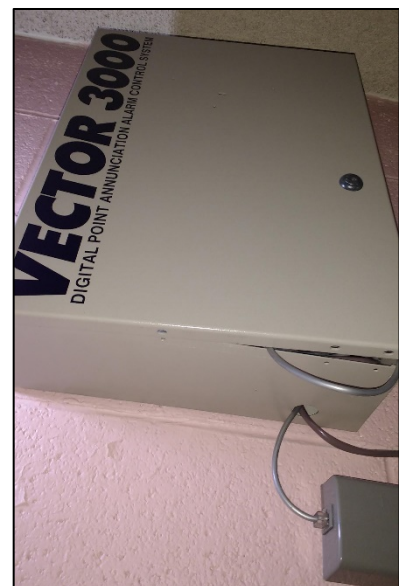
The building is equipped with an older digital point annunciation Vector 3000 series fire alarm system. This model appears to be no longer made, and may present obsolescence issues as parts and support are needed in the future.

Fire Alarm Panel

There are no recommendations in the Fire Alarm area as a result of this survey.
