U.S. Department of Transportation
Federal Highway Administration

Subject: **ACTION:** Roadside Safety Hardware

Date: MAY 26 2015

Selection, Installation and Maintenance of W-Beam Guardrail End Terminals

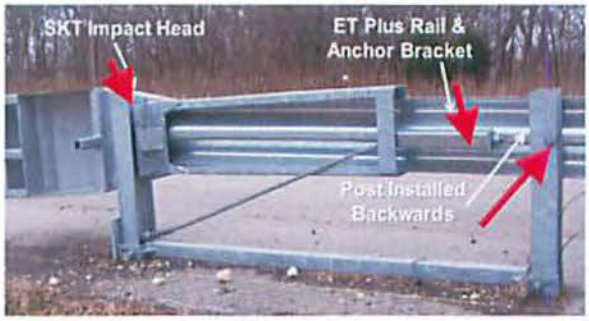
Mismatched Parts

Material and Storage Requirements: The photo shows an in-service installation using components from two different systems. This is likely due to improper maintenance decisions being made after an impact. Parts from one system to another system are not interchangeable unless specified by the manufacturer.
