El Vado Dam – Safety of Dams Modification Project Draft Environmental Assessment

**Middle Rio Grande Project, New Mexico
Interior Region 7 – Upper Colorado Basin**

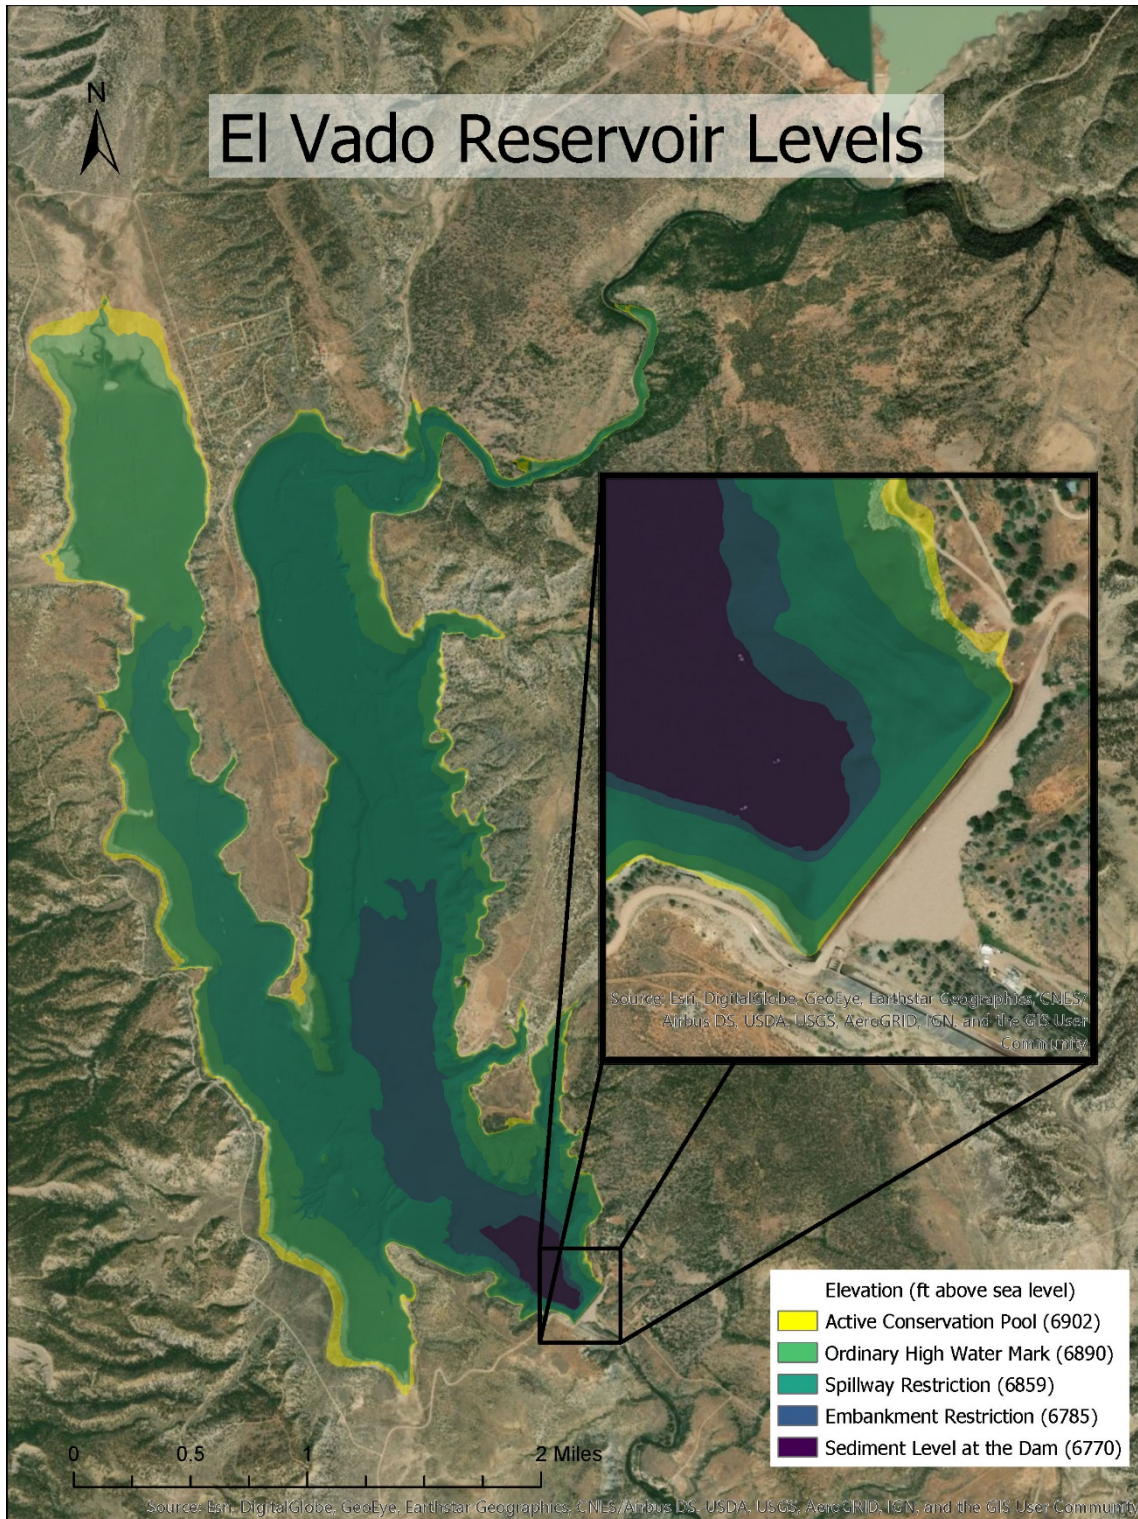
Figure 1 Proposed reservoir elevations for El Vado Dam SOD Modification Project

- A. Restrict the reservoir elevation to 6785, a storage volume of 2,422 ac-ft, for an estimated period of seven to eight months during construction of the seepage reduction modifications. The pool of water would extend about 1 mile upstream of the dam as shown on Figure 1. This restriction would affect one irrigation season. Based on the reservoir level at the end of the prior irrigation season and the storage level during fall/winter, the reservoir will begin to be lowered early in the year to get the elevation to 6785 by May 1st.

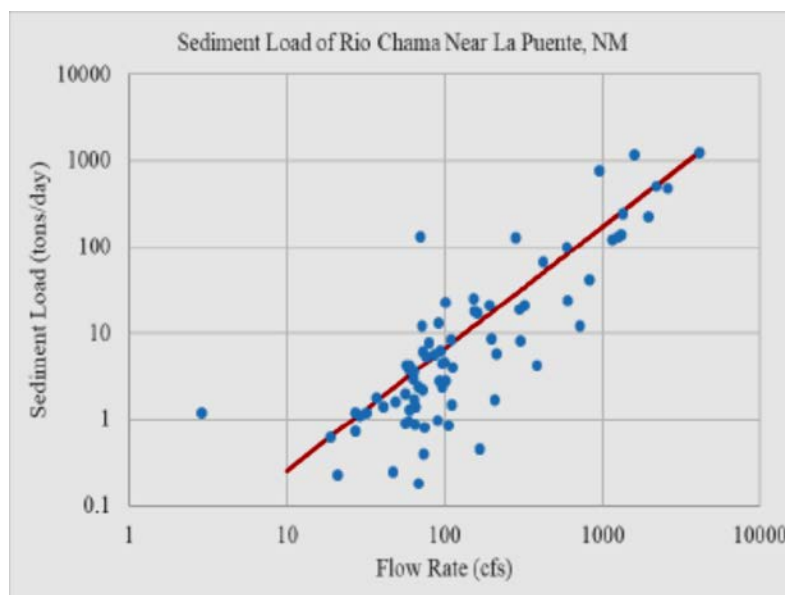
Figure 4 Suspended sediment concentration versus discharge collected at USGS gage 08284100 at Rio Chama near La Puente NM

Second, a sediment transport modeling study was performed to better understand the potential for reservoir sediments to be eroded and carried through the outlet works feature(s) while the reservoir is drawn down for the planned construction activities. A multibeam SONAR bathymetry survey was completed in the spring of 2018 to understand the current sediment levels in the reservoir. Flow data at the U.S. Geological Survey (USGS) gage 08284100 at Rio Chama near La Puente, NM were selected to represent low, medium, and high flow conditions. Incoming sediment loads of fine particles were developed from suspended sediment load and gradations collected at USGS gage 08284100 at Rio Chama near La Puente, NM. Incoming sediment loads and gradations of sand and gravel were estimated by calculating sediment transport capacity in the river leading to the reservoir. Bed material data collected by Bio-West were used as the initial bed gradations. Three scenarios were simulated in the analysis: 1) reservoir drawdown to the lowest current outlet works sill elevation (empty dead pool reservoir elevation 6770), 2) reservoir drawdown and then maintained with an approximately 5-foot deep pool of water at elevation 6775 behind a coffer dam also serving as a sediment collection pond, and 3) reservoir drawdown to elevation 6785 and maintained at this level with the existing river outlet (Proposed Action Alternative). The reservoir has reached this approximate elevation about 20 times since the dam was originally built.
