Recommendations for Cordoning Earthquake-Damaged Buildings

FEMA P-2055-2 / September 2023

Prepared by
APPLIED TECHNOLOGY COUNCIL
201 Redwood Shores Parkway, Suite 240
Redwood City, California 94065
www.ATCouncil.org

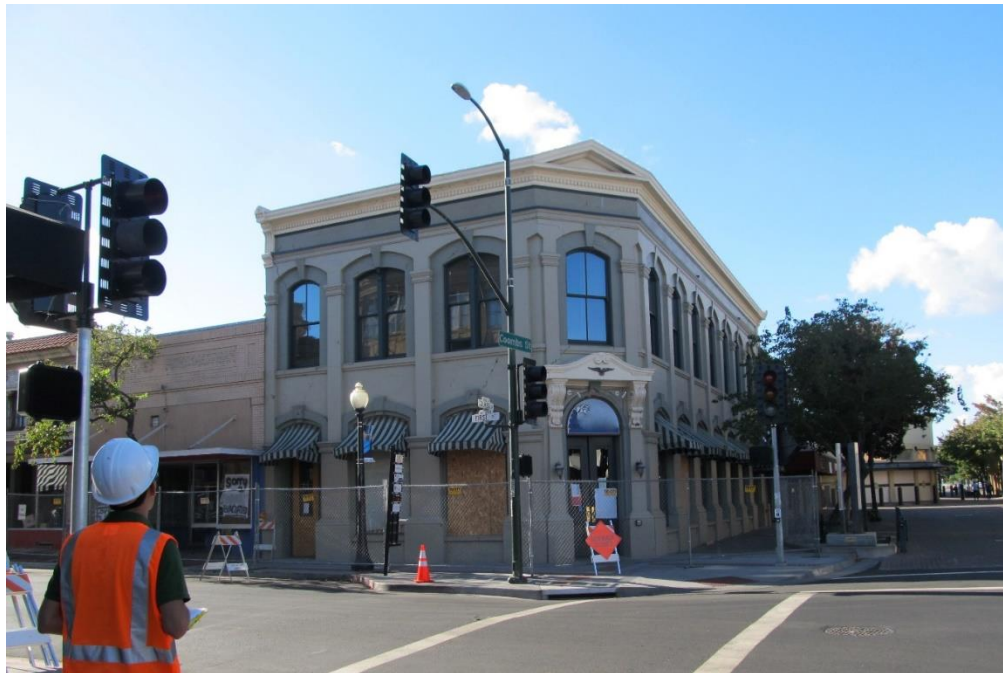
Figure 2-3 A URM building with in UNSAFE placard with a very narrow cordon around it. (FEMA P-1024 Figure 12-1).

FEMA P-1024, *Performance of Buildings and Nonstructural Components in the 2014 South Napa Earthquake* (FEMA, 2015) documents the use of cordons and barricades immediately after the event and their transition to longer-term barricades. Chapter 12 of the report includes observations of initial barricades that were inadequately spaced from damaged buildings. For example, the building shown in Figure 2-3 is an unreinforced masonry (URM) building with an UNSAFE placard and significantly damaged masonry façades; however, the fence is located only several feet from the building, while the street remained fully operational.

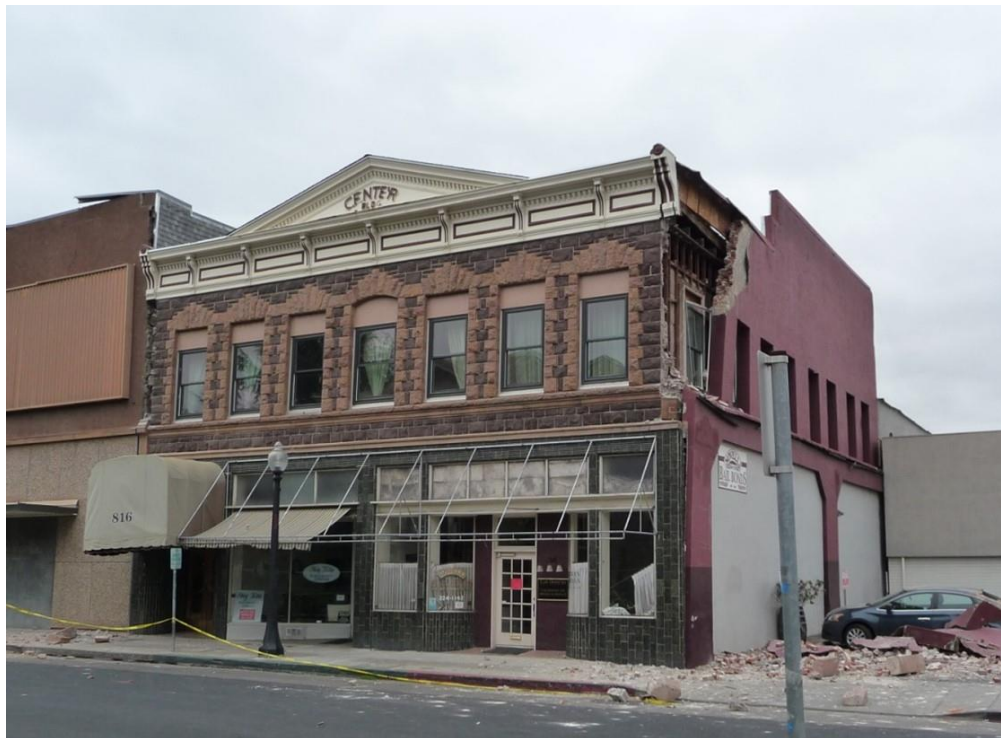
Figure 2-4 Failure of URM south wall of URM building posted UNSAFE (FEMA P-1024 Figure 4-49, photo by Marko Schotanus).

FEMA P-1024 also documents the impact of debris from a damaged unretrofitted URM building on adjacent structures. The building shown in Figure 2-4 was posted UNSAFE; the masonry wall on the south side of the building (right side of the figure) separated from the structure and portions of it fell into the neighboring parking lot, striking an unoccupied, parked car. In addition, stones fell off the back of the building into the alleyway that separates the building from several retrofitted URM. As a result, four of the neighboring buildings were also posted UNSAFE due to the risk of collapsing masonry walls striking the buildings. The surrounding buildings were subsequently posted INSPECTED following the erection of wood barriers (Figure 2-5), allowing the occupants, in this case businesses, to resume operations.

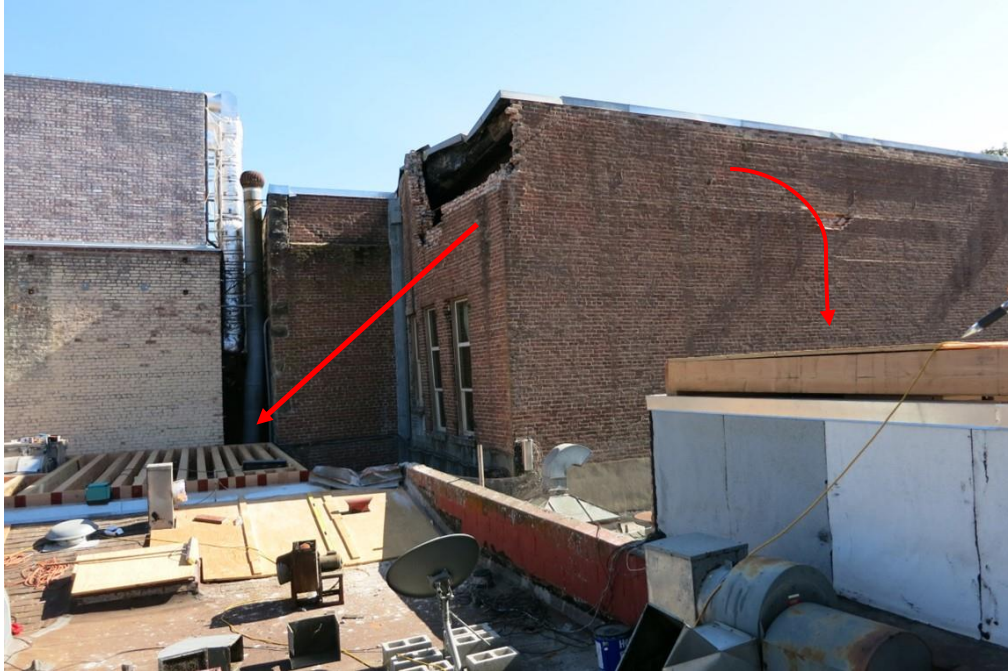
Figure 2-5 Protective barrier constructed over the rooftops of buildings to protect from falling brick. (FEMA P-1024, Figure 12-7)

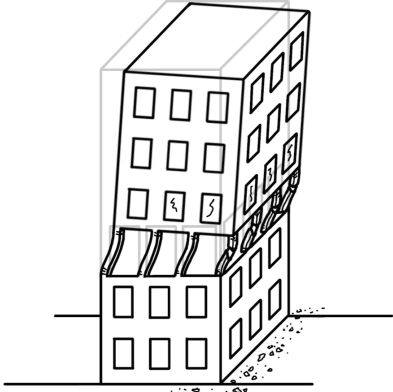
<p>Visible monolithic lean; core and façade damage See Section 3.2.1: Monolithic Overturning</p>

<p>45-degree circular wedge area, oriented along azimuth of tilt, with cordon distance D, where: w = building width D = height of building above hinge point</p>
<p>Frame (steel, concrete, wood)</p>

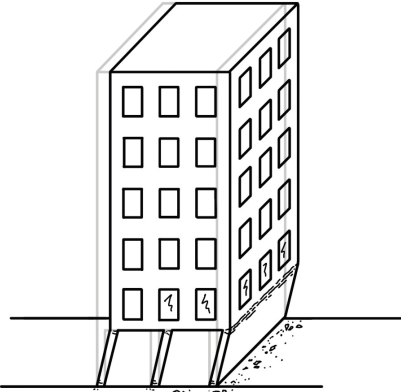
<p>Story mechanism: Progressive collapse unlikely per engineering evaluation See Section 3.2.2: Story Mechanism</p>

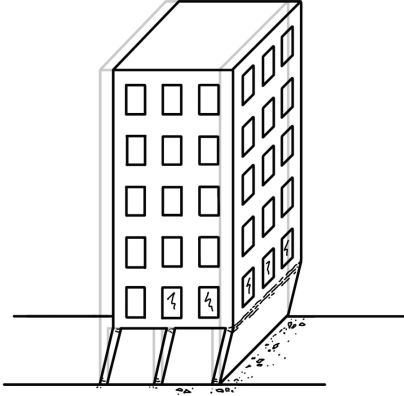
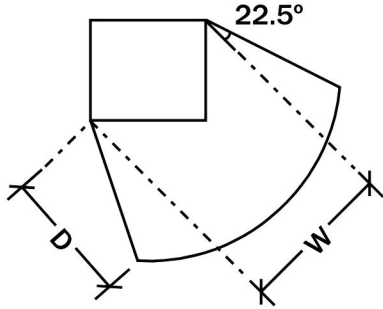
<p>Sideways mechanism: Progressive collapse mechanism likely per engineering evaluation See Section 3.2.2: Story Mechanism</p>

<p>45-degree circular wedge area, oriented along azimuth of tilt, with cordon distance D, where: $D = \text{height of building}$</p>
<p>Frame (steel, concrete, wood)</p>

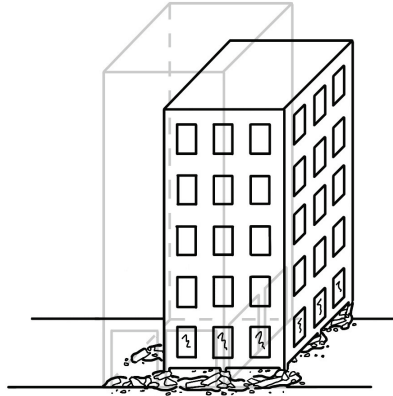
<p>Story mechanism: Stable See Section 3.2.2: Story Mechanism</p>

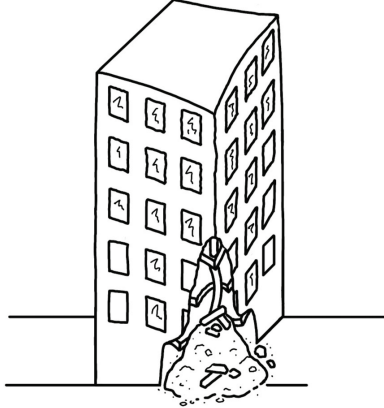
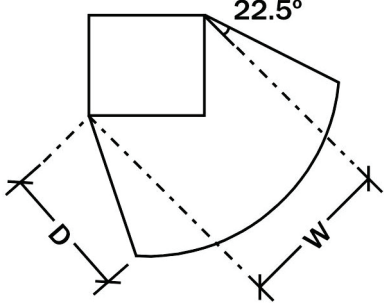
<p>Torsional damage See Section 3.2.3 Torsion</p>

<p>45-degree circular wedge area, oriented along azimuth of tilt, with a cordon distance D, where:</p> <ul style="list-style-type: none"> w = width of building measured from opposing corners D = height of building above hinge point
<p>Concrete flat slab with weak slab-column connections</p>

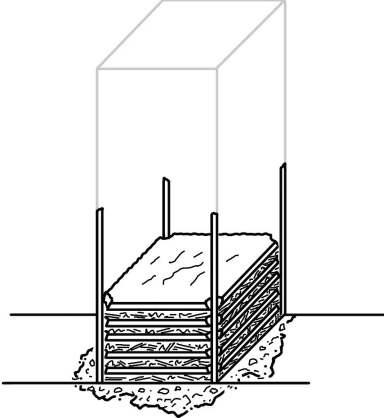
<p>Pancake collapse, slabs collapsed; columns, walls, and/or core unbraced; monolithic overturning of remaining vertical elements See Section 3.2.4 Pancake</p>

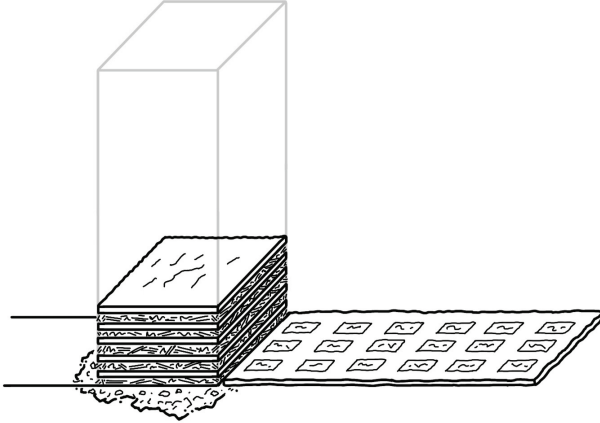
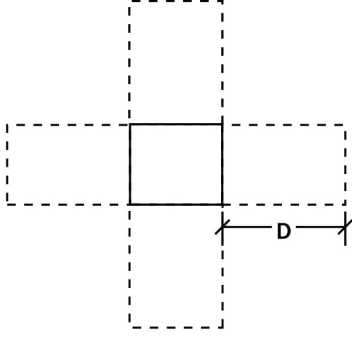
<p>Damage to connection between horizontal diaphragms and perimeter wall panels See Section 3.2.5 Wall Fall</p>

<p>Rectangular area extending from each affected wall distance D, where: D = height of wall panels</p>
<p>Masonry walls</p>

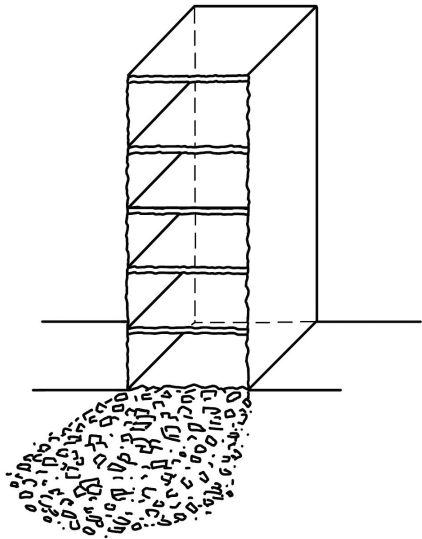
<p>Damage to connection between horizontal diaphragms and masonry façade See Section 3.2.5 Wall Fall</p>

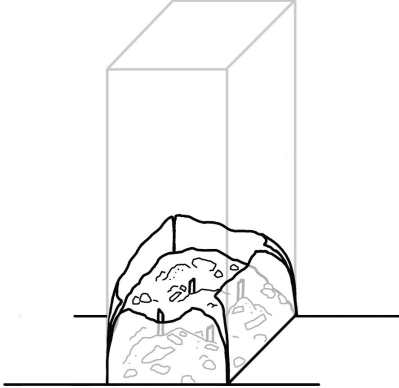
<p>Interior column failures with inward perimeter structure tilt See Section 3.2.6 Implosion</p>

<p>Minimal collapse shadow</p>
<p>Non-engineered masonry, adobe, concrete block, or precast buildings</p>

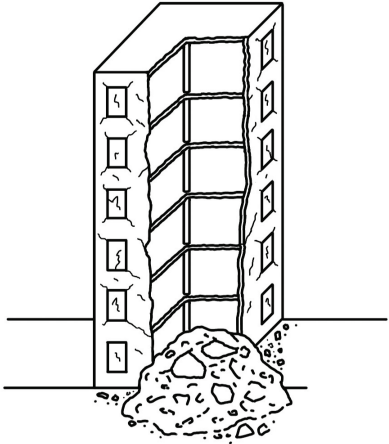
<p>Partial collapse of the building as a rubble pile, or wide spread damage on most vertical supporting members See Section 3.2.7 Rubble Pile</p>

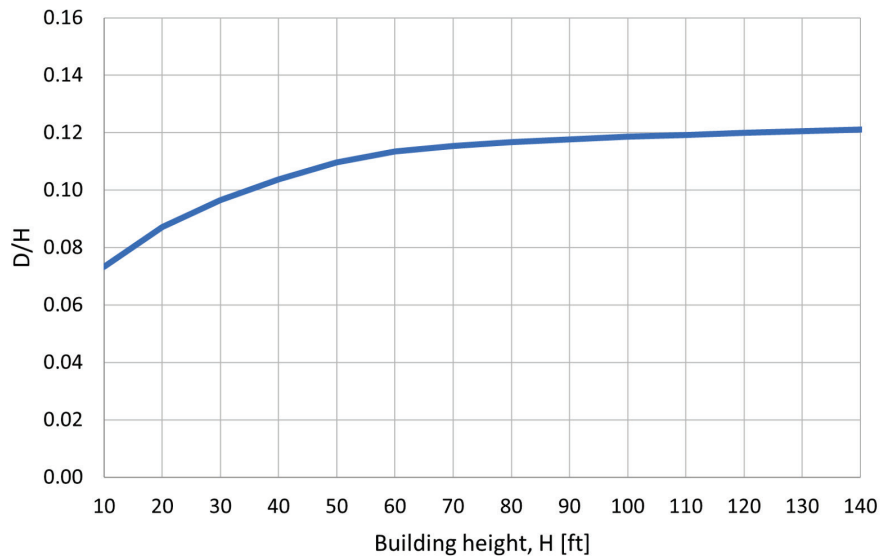
Figure 3-3 Determination of debris shadow as a function of building height.

Figure 3-3 presents an estimate of the maximum horizontal distance for determining falling debris shadow from the building, R , as a function of building height, H , determined based on the following: The initial horizontal velocity is approximated as the peak floor acceleration divided by the natural

frequency of the first mode of the building, both determined in accordance with ASCE/SEI 7-22. For example, for a building with $H = 100$ ft, the debris shadow distance, D , is recommended as 12 ft.

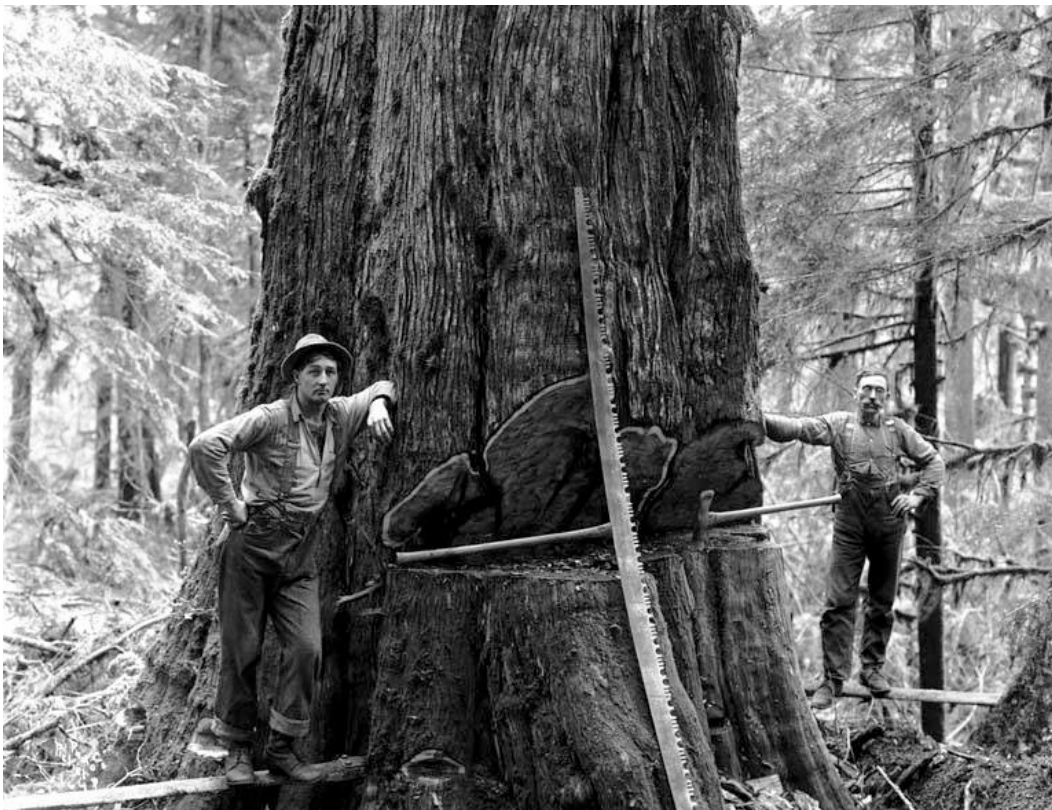
Figure 3-4 Tree notched to define direction of fall (image from public domain).

The monolithic overturning collapse mode is best illustrated by the felling of a tree (Figure 3-4): the trunk of a tree is notched facing the direction of the intended fall (thereby removing compressive strength on that side of the tree) while the back side of the tree is crosscut (thereby removing tensile strength on the backside of the tree). These cuts effectively create a hinge at the base of the tree, allowing the force of gravity to topple the tree. The collapse shadow of the tree is equivalent to the solar shadow of a tree with the sun 45 degrees above the horizon; i.e., the shadow has the width and height of the tree centered on the stump and oriented at the azimuth defined by the location of the undercut.

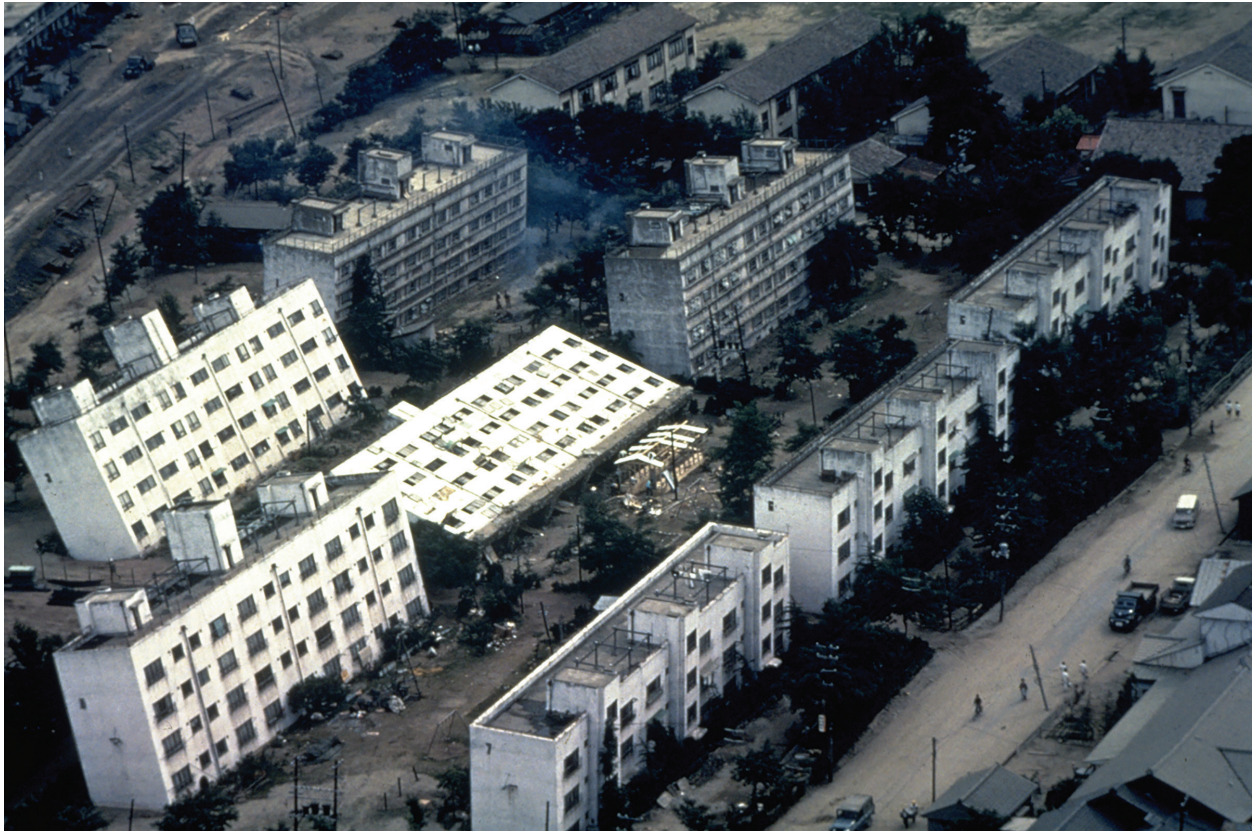
Figure 3-5 Tilting of apartment buildings due to liquefaction in 1964 Niigata Japan earthquake (Photo Credit: NISEE).

- Tilting of apartment buildings due to liquefaction in 1964 Niigata Japan earthquake (Figure 3-5)
- One of the five towers of the Piño Suarez building collapsed in the 1985 Mexico City Earthquake as a result of column buckling in the fourth story, crushing an adjacent tower (Figure 3-6)

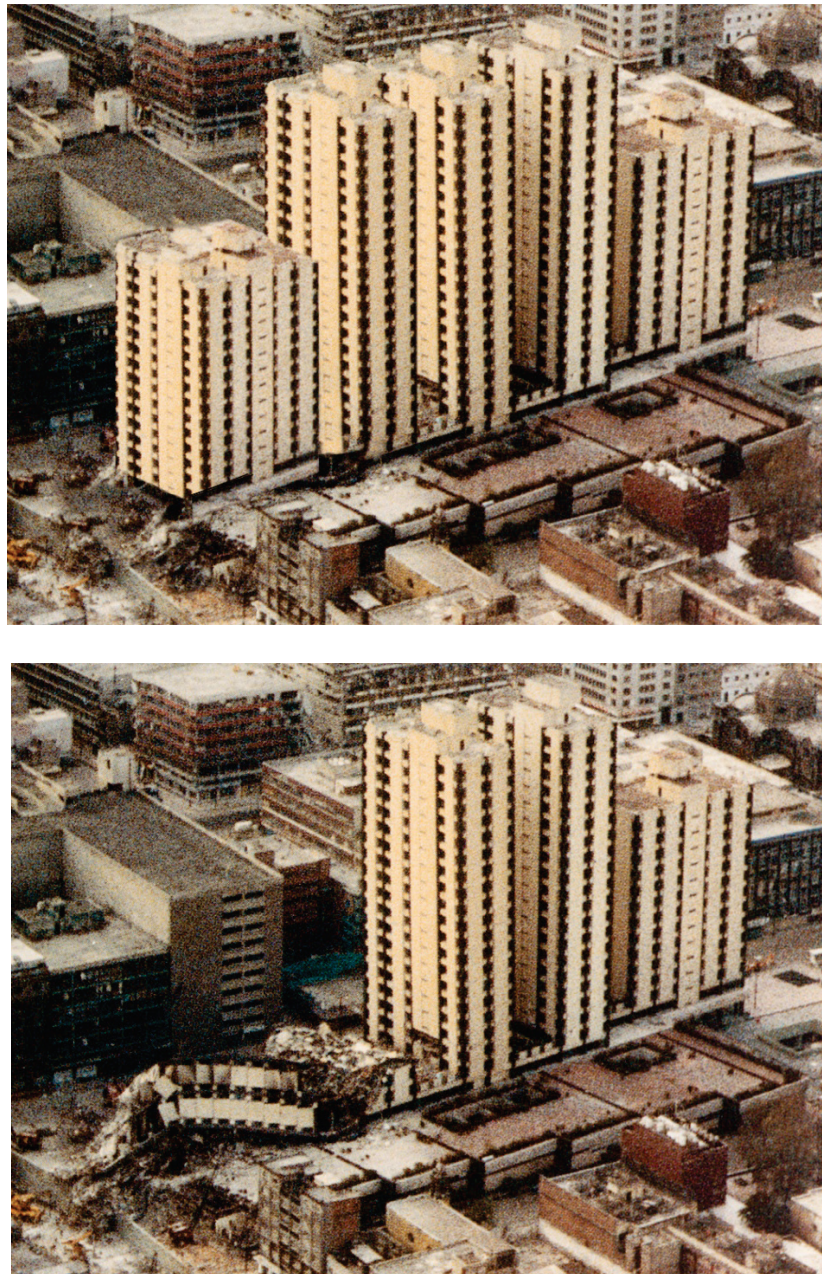
Figure 3-6 Piño Suarez towers before and after the 1985 Mexico City Earthquake (from *Reports on the Damage Investigation of the 1985 Mexico Earthquake*, Architectural Institute of Japan, 1987; upper image photoshopped by Exponent to include all five original towers).

All of the monolithic overturning collapses identified in the literature review occurred during the main shock; literature review conducted did not identify buildings that collapsed monolithically in an aftershock. This is not surprising – if a structure survives the dynamic forces of the main shock and forces associated with partial collapse, without toppling, the damaged structure has established a stable equilibrium during the main shock. Further damage and movement will likely require forces comparable to those of the main shock. Therefore, buildings that survive the main shock without residual lean are highly unlikely to sustain a monolithic overturning failure in an aftershock. The Piño Suarez building (Figure 3-6), consisting of three identical 22-story towers, provides an excellent case study (albeit for a single earthquake). During the main shock, one of the three 22-story towers

collapsed, while the remaining two towers sustained similar column buckling and resulting visible residual lean; however, the two remaining towers did not collapse in the aftershocks.

An example of a cascading collapse occurred at the Piño Suarez complex (Mexico City, Mexico 1985) (Figure 3-6) where a 22-story tower collapsed onto an adjacent 15-story building, causing its collapse. If the first tower to collapse had been located at the other end of the line of towers, all three towers may have collapsed.

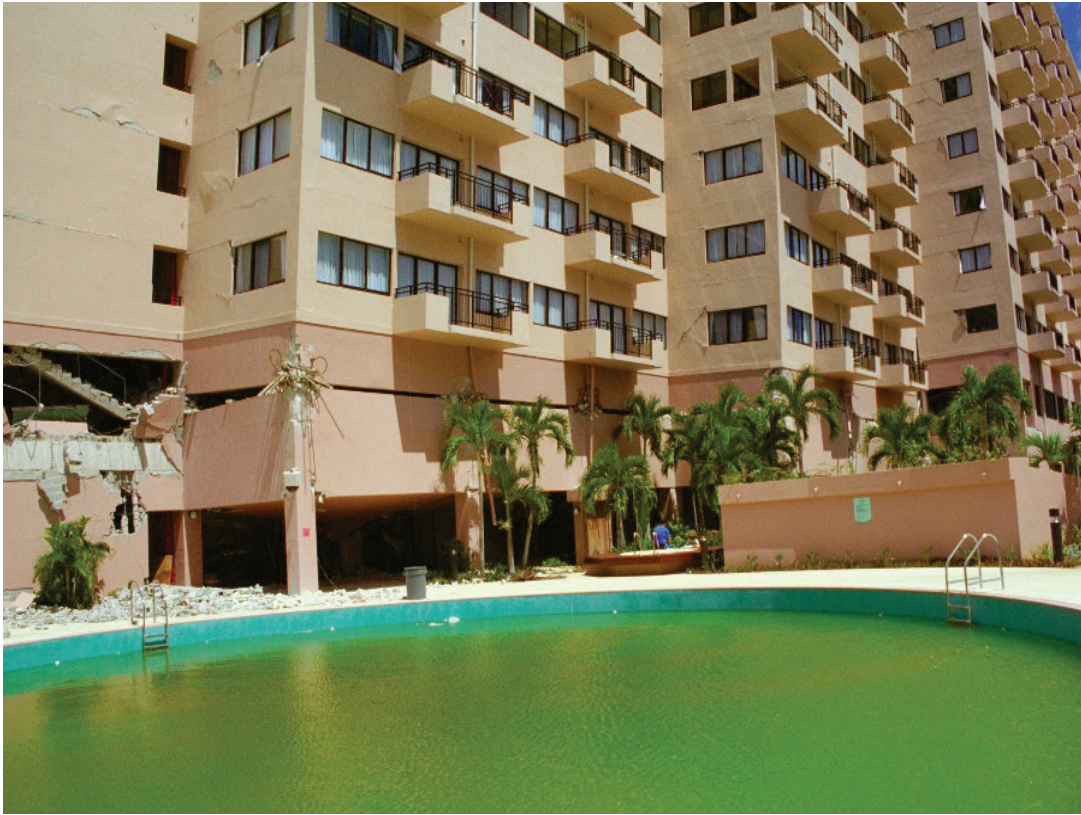
Figure 3-7 Partial collapse of Royal Palm Resort in 1993 Guam Earthquake due to shear failure of captive columns in soft story. Note undamaged adjacent structure along right edge of photo (Exponent/Luth).

- One wing of the Royal Palm Resort partially collapsed in the 1993 Guam Earthquake due to shear failure of second story columns along the front face resulting in significant residual lean (Figure 3-7)
- The Weiguan Jinlong Building overturned during the 2016 Southern Taiwan Earthquake (Figure 3-8)
- Multiple residential buildings in Gölbaşı (Türkiye) were affected by liquefaction after the 2023 Kahramanmaraş earthquake sequence (Figure 3-9)

- The degree of residual lean – P-delta forces increase with increasing residual lean.
- The nature and extent of damage that caused the residual lean.
- The stability of the damaged structure:
 - whether it has come to rest in a stable configuration, such as the Royal Palm Resort (Figure 3-7)
 - whether the angle of tilt increases during aftershocks or remains stable
 - whether the leaning portion of the building has sufficient structural integrity to remain intact as it topples
- The probability of a damaging aftershock, which decreases with time.

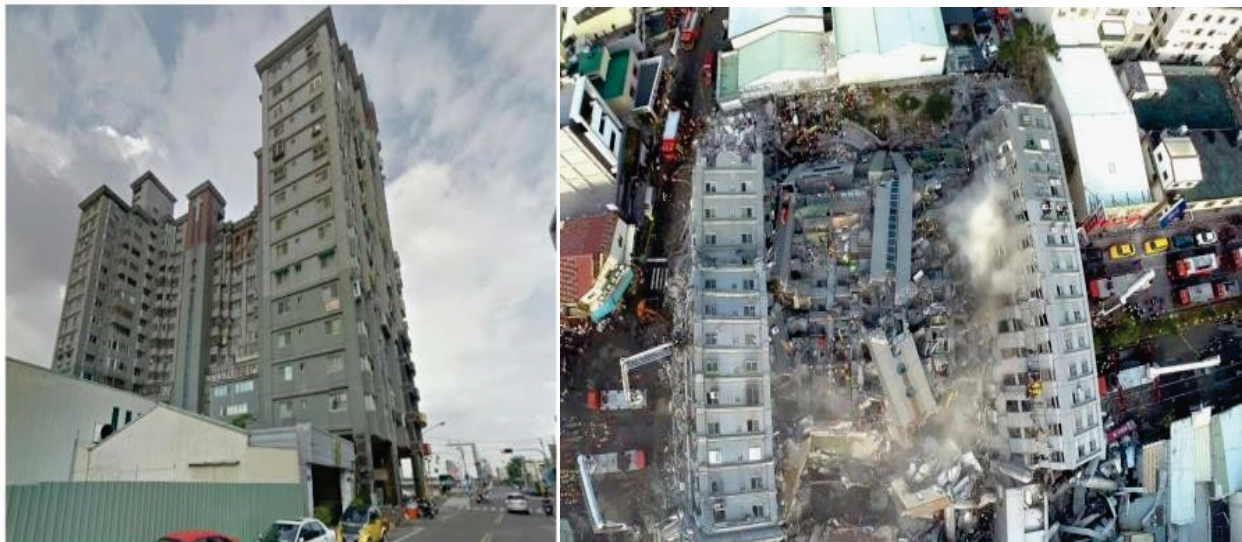
Figure 4: Pre-Collapse photo West Side (Source: google maps)

Figure 3-8 Weiguan Jinlong building before and after the 2016 Southern Taiwan Earthquake (before: from Zaldivar et al.; after: from Xinhua via SCMP).

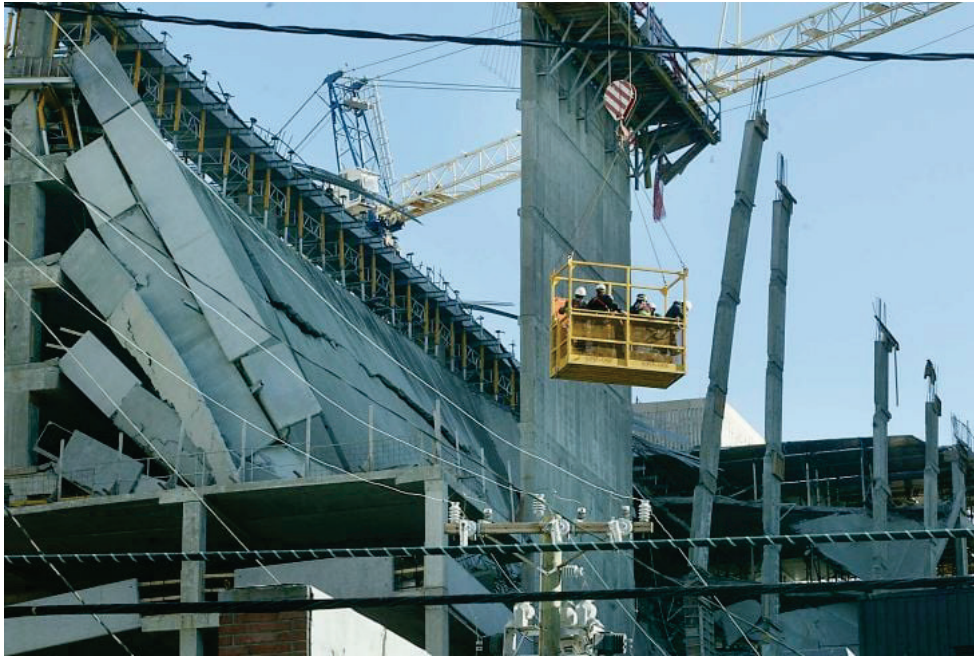
Figure 3-10 Laterally unsupported columns and shear wall following partial collapse of Tropicana Casino parking garage during construction in Atlantic City, New Jersey, 2003.

The same rationale applies to portions of buildings that may fall as rigid bodies, such as reinforced columns and shear walls protruding from partial collapses as shown in Figure 3-10, as well as reinforced chimneys.

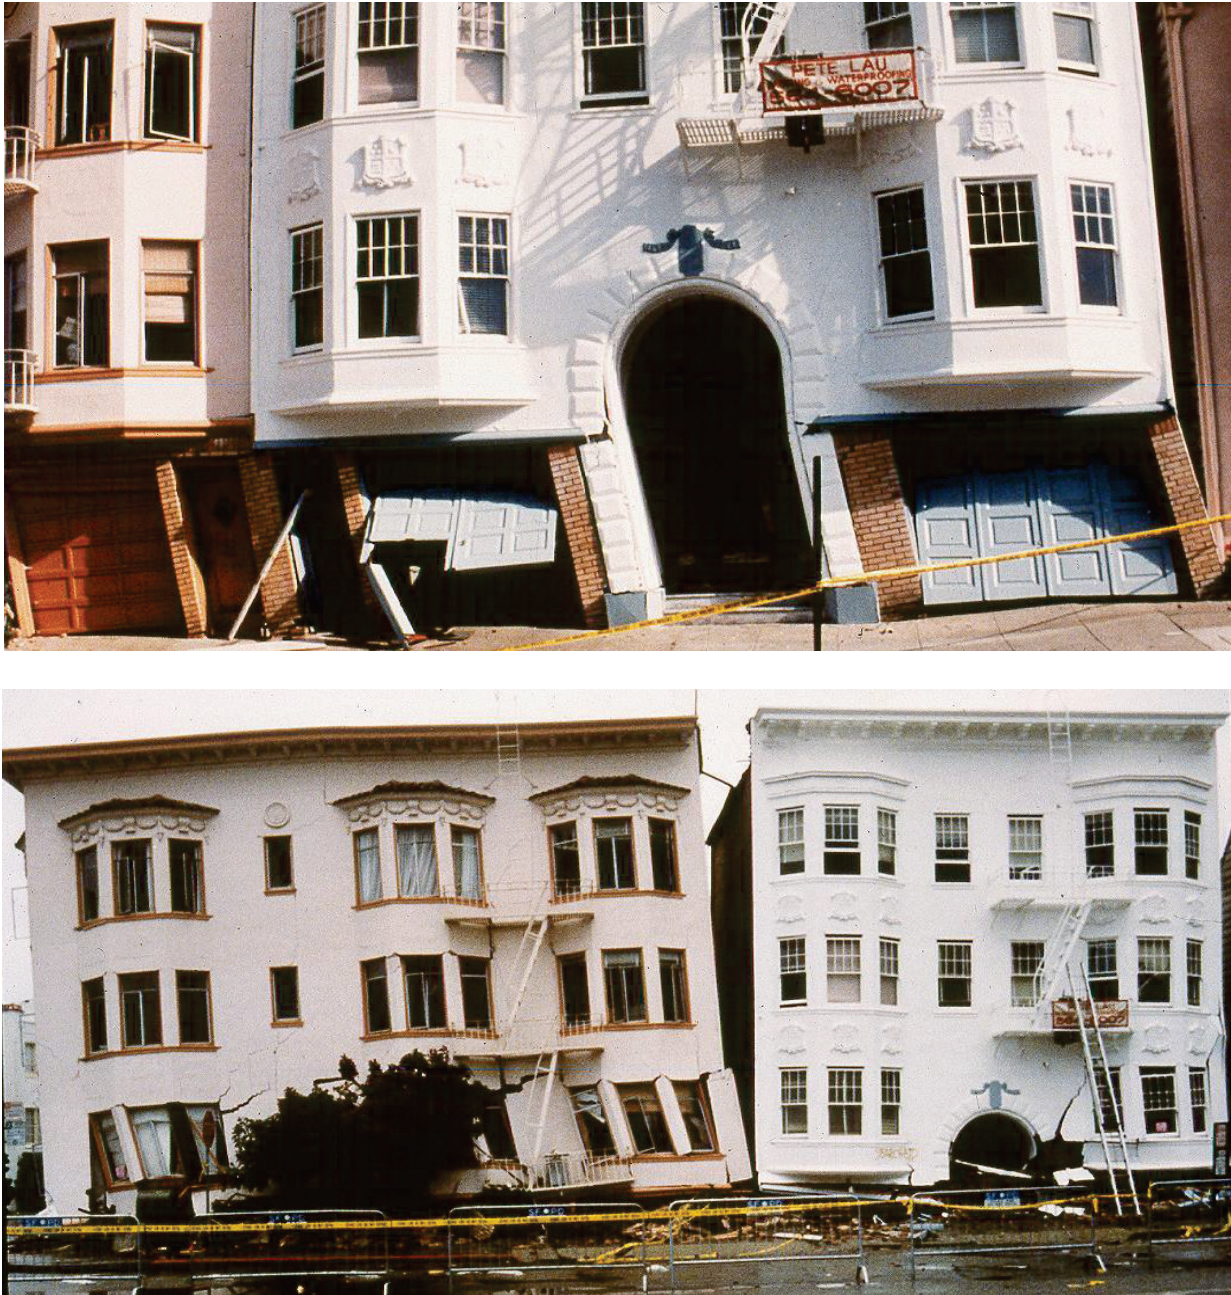
Figure 3-13 San Francisco soft story collapse showing leaning story after main shock (upper photo) and story collapse in aftershock (lower photo). Image from ATC-20 training materials.

The sidesway collapse mode is characterized by the leaning/tilting of all columns in a single story. A story mechanism may occur in any story, but most commonly occurs in the first story, where the lateral strength/stiffness of that story is less than the stories above; i.e., a weak or soft story. This was particularly observed in the Marina District of San Francisco following the 1989 Loma Prieta Earthquake, as illustrated in Figure 3-13.

If there are multiple weak or soft stories in a building, a cascading story collapse can occur where each weak or soft story collapses one story further away from its original position than the weak or soft story below. As shown in Figure 3-13, the second story of the building to the left is leaning and could be vulnerable to collapse in an aftershock. It is this type of potential cascading collapse that poses the greatest threat and should receive a detailed engineering evaluation to inform cordoning decisions. It is important to note that the vast majority of weak or soft story collapses occur during the main shock.

- Many low-rise, wood frame apartment buildings in the Marina District of San Francisco, California with garages in the first story were damaged in the 1989 Loma Prieta Earthquake (Figure 3-13). Some collapsed into the street in a stable configuration. Some buildings sustained residual lean, two of which collapsed in an aftershock (Figure 3-13), this is the only instance of aftershock-induced weak or soft story collapse that was identified in the literature review. Buildings that did not collapse were temporarily braced against further movement and subsequently repaired.

Most commonly, the seismic damage in buildings of this collapse type is concentrated in the weak or soft story, leaving the remaining stories relatively unscathed (such as the white building in Figure 3-13). In such a case, if collapse does occur, the remaining portion of the structure apart from the weak or soft story generally comes to rest in a stable, relatively undamaged condition, as shown in Figures 3-14 and 3-15. A building with a collapsed weak or soft story (such as the white building in Figure 3-13) is arguably more stable than the undamaged building in its original state. This is because the “fatal flaw” – the weak or soft story, has been eliminated, leaving the remaining portion of the building potentially more stable (due to removal of irregularities) than the original building

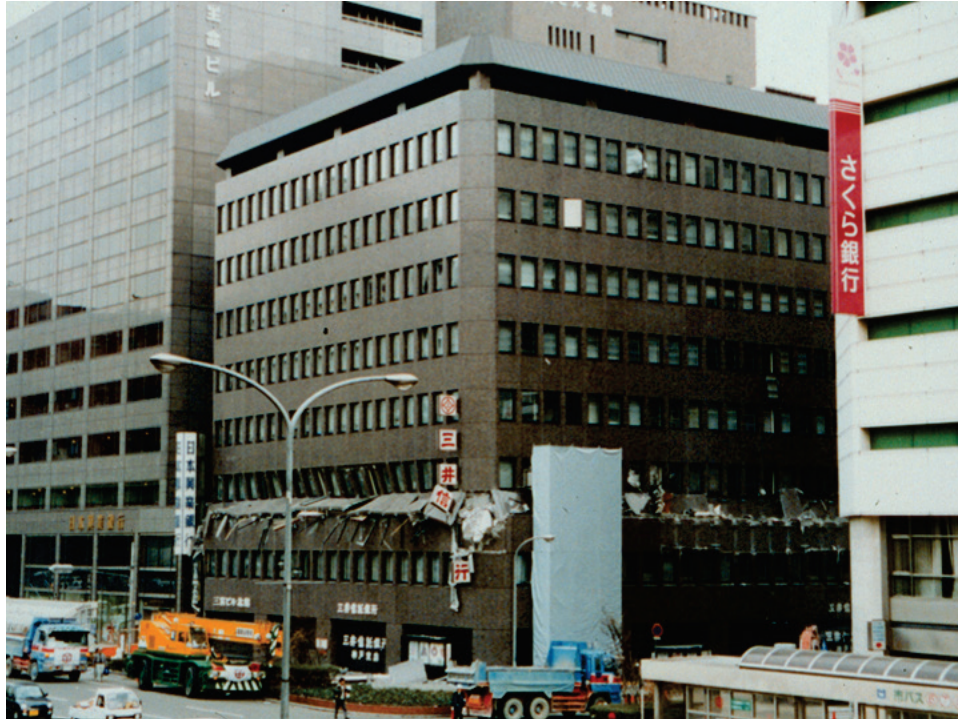
Figure 3-14 Third story collapse of 10-story office building in 1995 Kobe Earthquake in Japan (Source: Exponent/Osteraas).

- Weak or soft story collapses occurred in the mid-stories of several buildings in the 1995 Kobe Earthquake (Japan), as shown in Figures 3-14 and 3-15.

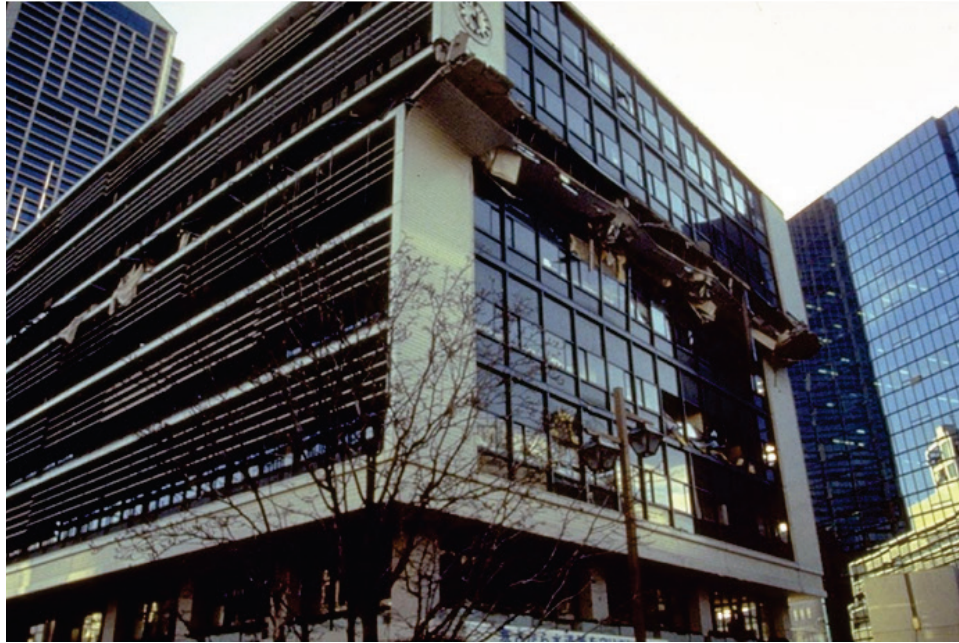
Figure 3-15 Sixth story collapse of 8-story Kobe City Hall Annex building in 1995 Kobe Earthquake in Japan (Source: EERI Slides on the Hyogo-Ken Nanbu (Kobe) Earthquake of January 17, 1995).

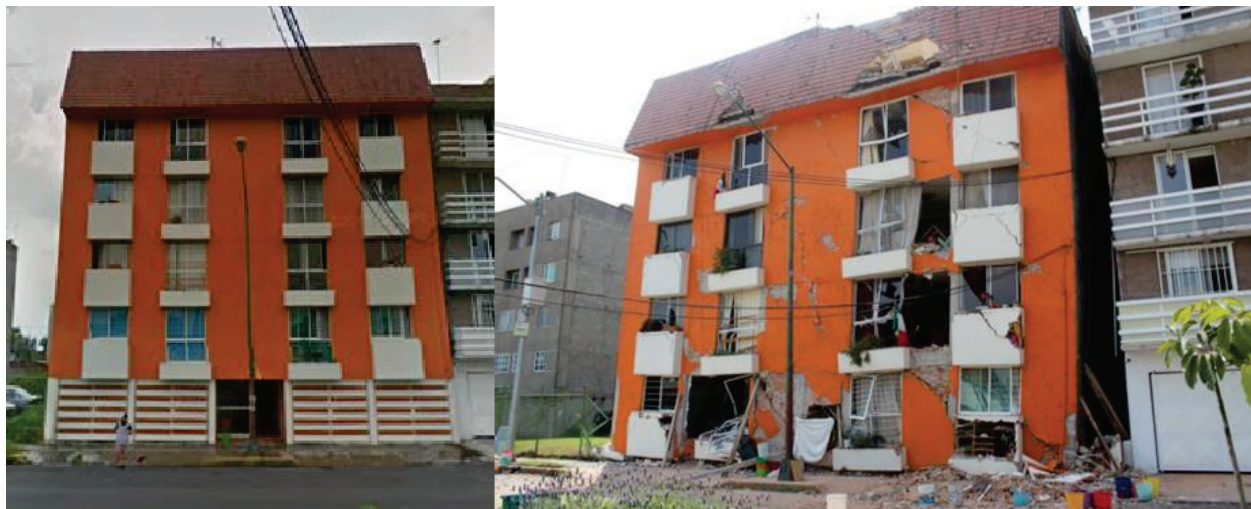
Figure 3-16 Residential building before and after 2017 Puebla-Morelos Earthquake (Galvis et al. 2021).

- The first story of several buildings in Mexico City, Mexico collapsed after the 2017 Puebla-Morelos Earthquake, leaving the remaining portions of the buildings stable (albeit extensively damaged) against further collapse, as shown in the example of Figure 3-16. For the buildings identified in the literature review, the collapse shadow was well defined as a rectangle with a length equal to the height of the weak or soft story and width equal to the building width along the “front” side of the building. For buildings with potential cascading story failures, the length of the collapse shadow could extend to a length equal to the height of the building above the weak or soft story.

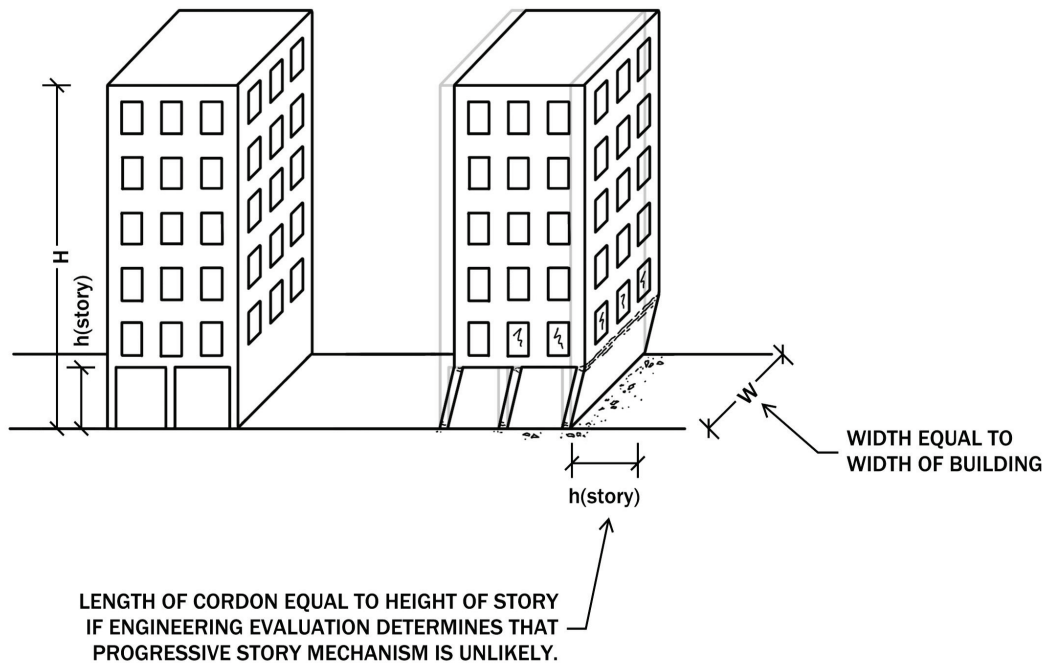
Figure 3-17 Illustration of story mechanism collapse mode.

building and length (measured from the front face of the building) equal to the height of the building above the floor of the weak or soft story would be prudent. Figure 3-17 illustrates the potential collapse mode.

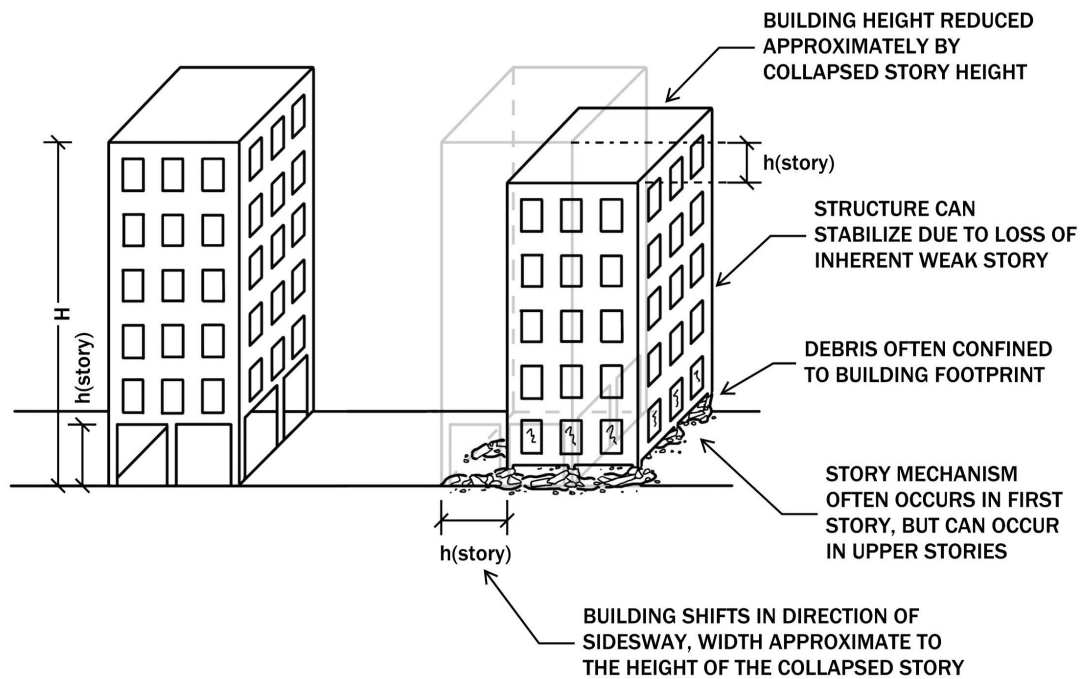
Figure 3-20 Illustration of story mechanism collapse mode for stable condition.

If the collapse occurs only in a weak story with no visible story lean for the structure remaining above, minimal cordon is necessary. Figure 3-20 illustrates the potential collapse mode and Figure 3-21 presents a plan view of the collapse shadow.

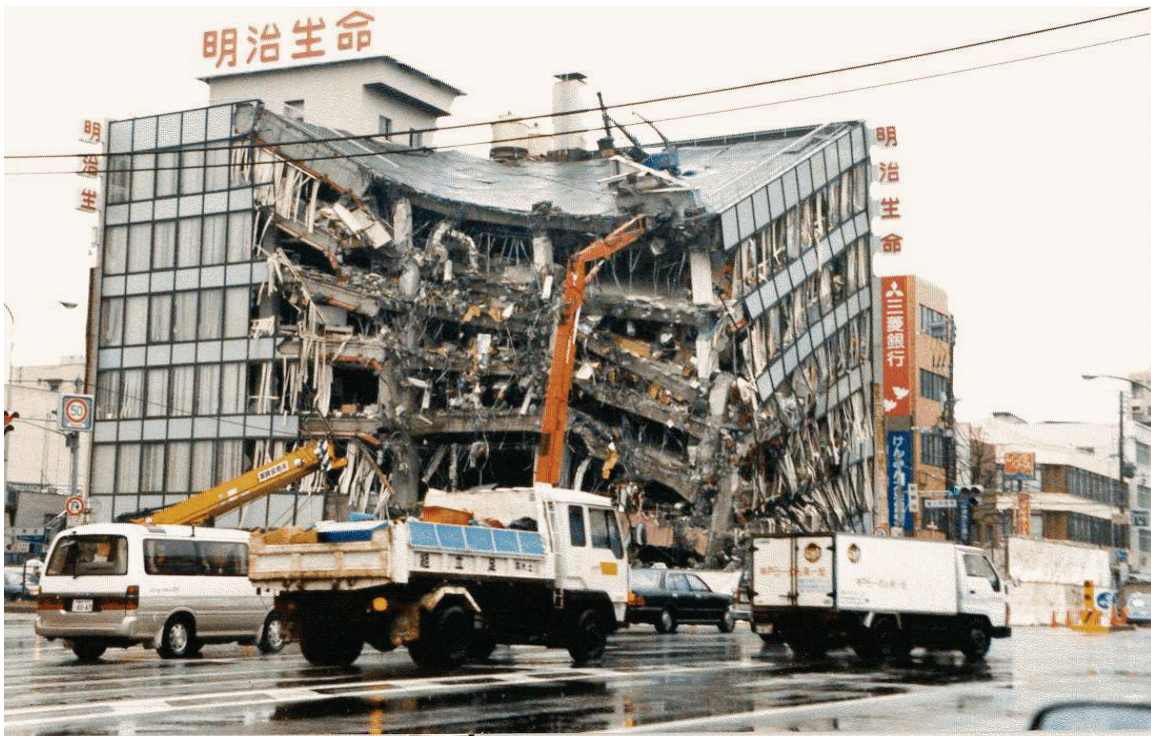
Figure 3-22 Corner building collapse in 1995 Kobe Earthquake in Japan (Exponent/Osteraas).

This collapse mode caused many partial collapses of corner buildings in the 1995 Kobe Earthquake in Japan (Figure 3-22) and in the 2010 Maule Earthquake in Chile (Figure 3-22).

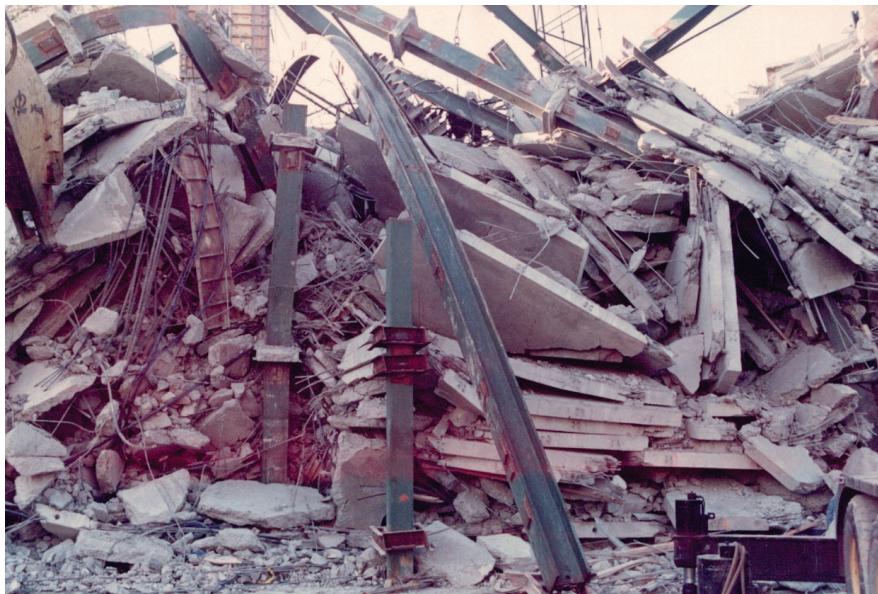
Figure 3-27 L'Ambiance Plaza collapse during construction, Bridgeport, Connecticut, 1987 (Exponent/Peraza).

- Macy's department store floor collapse in the 1994 Northridge Earthquake (Figure 3-26)
- Collapse of L'ambiance Plaza in Bridgeport, Connecticut in 1987 (Figure 3-27). Note, this collapse occurred during the construction of the building.

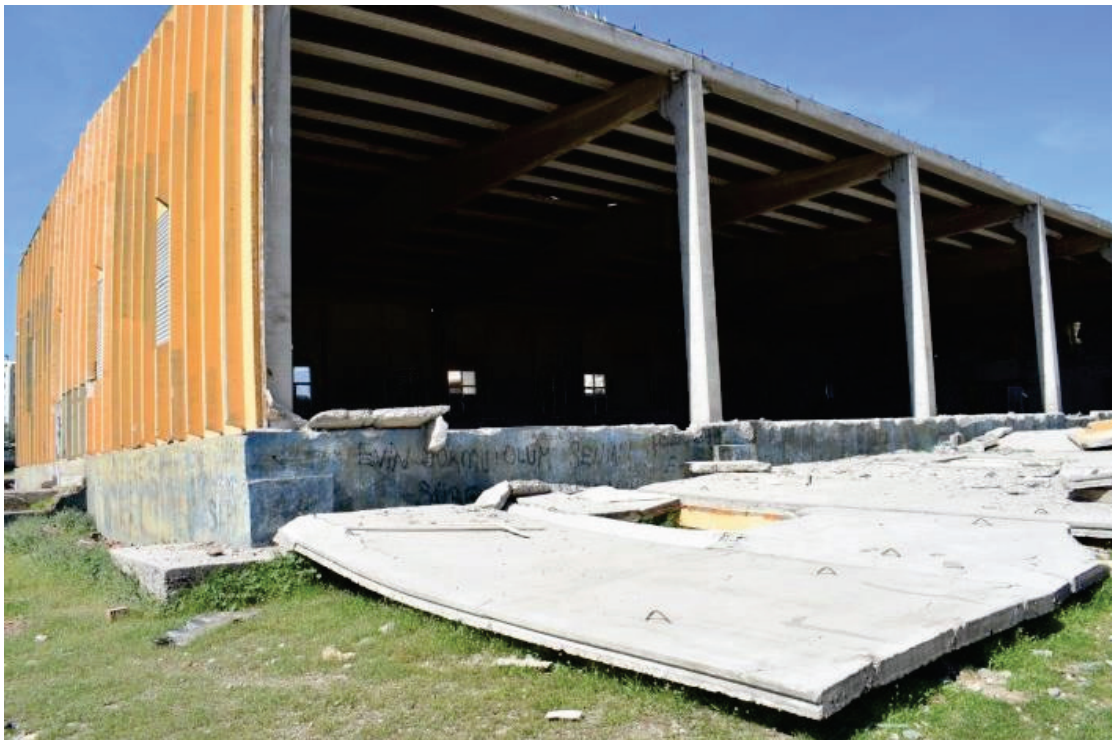
Figure 3-30 Warehouse in Kahramanmaraş after the 2023 Kahramanmaraş Earthquake (Türkiye). (Photo Credit: Thornton Tomasetti/Galvis).

The tilt-down collapse mode derives its name from the tilt-up construction process, where reinforced concrete panels are cast horizontally on the building floor slab then tilted up into position around the building perimeter. The walls have a mutually beneficial relationship with the upper floors and roof diaphragm: the walls carry the gravity loads and in-plane seismic loads from the floors and roof, while the floors and roof hold the wall panels in a vertical position out of plane. When the connection between the walls and roof/floors is lost, the wall panels fall away from the building and the roof/floors collapse (Figures 3-30 and 3-31).

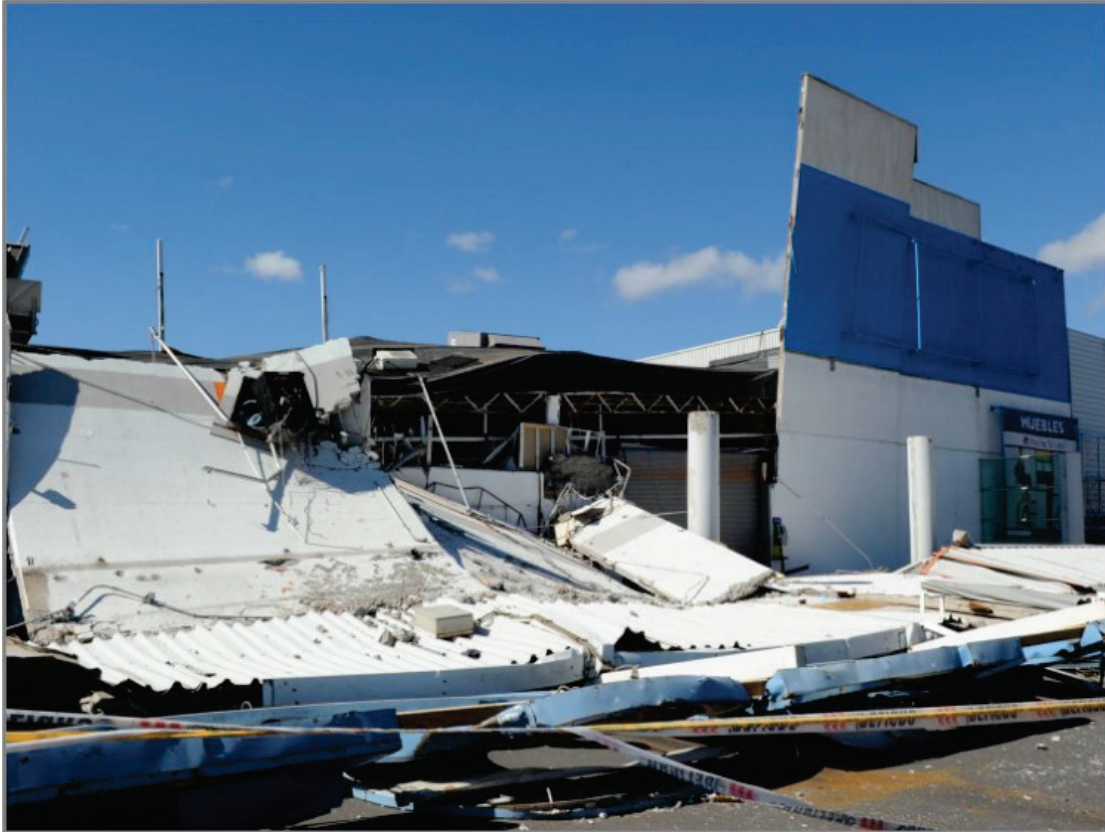
Figure 3-31 Collapse of tilt-up walls in the 2010 Maule, Chile Earthquake (ATC-20 training slides).

Tilt-up construction is only used for low-rise buildings (1-4 stories). The collapse shadow of buildings with tilt-up wall panels is always a rectangle perpendicular to the building wall, with length equal to the panel height, starting at the face of the building, and width equal to the width of the collapsed wall
