Recommendations for Cordoning Earthquake-Damaged Buildings

FEMA P-2055-2 / September 2023

Prepared by
APPLIED TECHNOLOGY COUNCIL
201 Redwood Shores Parkway, Suite 240
Redwood City, California 94065
www.ATCouncil.org

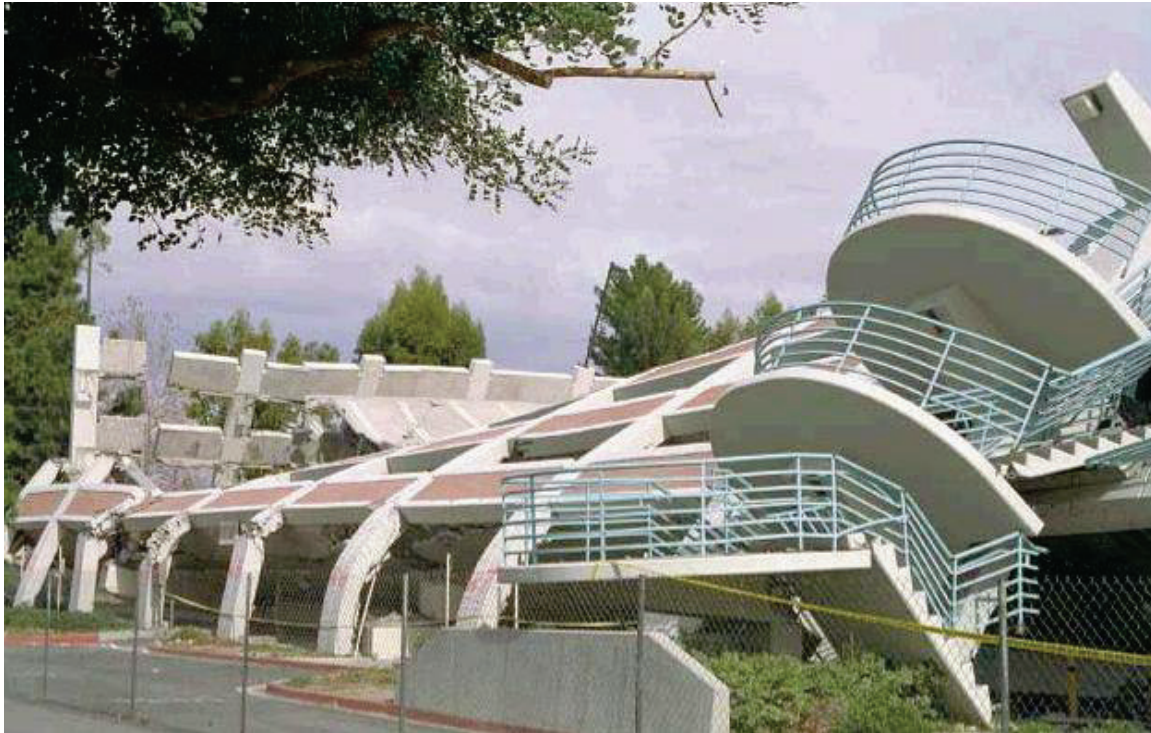
Figure 3-36 Parking garage damage at Northridge CSU in the 1994 Northridge Earthquake (Exponent/Shusto).

- Northridge Campus parking garage collapsed in the 1994 Northridge Earthquake (Figure 3-36)

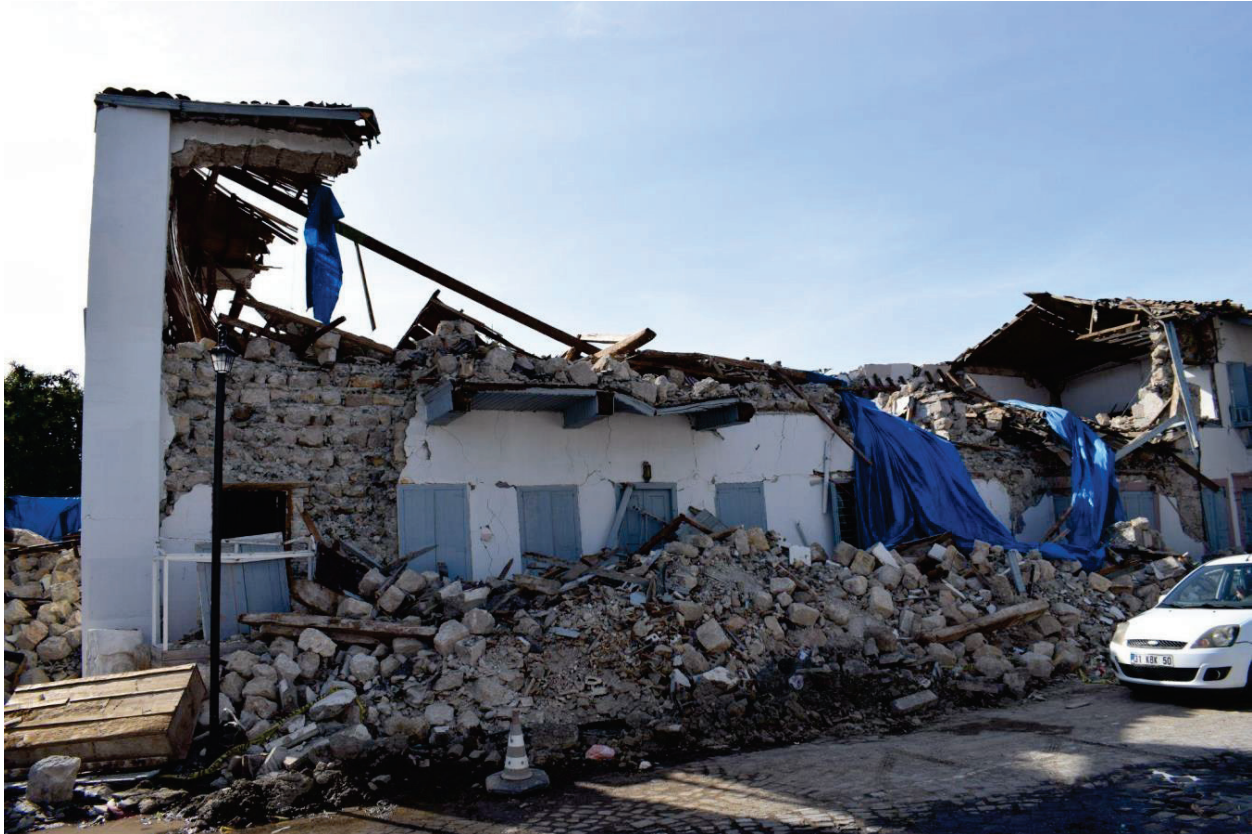
Figure 3-39 Adobe dwelling in Arsuz after the 2023 Kahramanmaraş Earthquake (Türkiye) (Photo Credit: Thornton Tomasetti/Galvis).

Buildings that are weak and poorly intra-connected, such as adobe, unreinforced masonry, and precast concrete, have little capacity to resist lateral loads caused by ground shaking or P-delta effects associated with tilting of a damaged building. Once cracks develop in the masonry or adobe or when precast members slip off their supports, there is no secondary load path to hold the components together. Thus, weak and poorly intra-connected buildings generally collapse into a rubble pile (Figure 3-39) that does not extend significantly beyond the building's footprint.

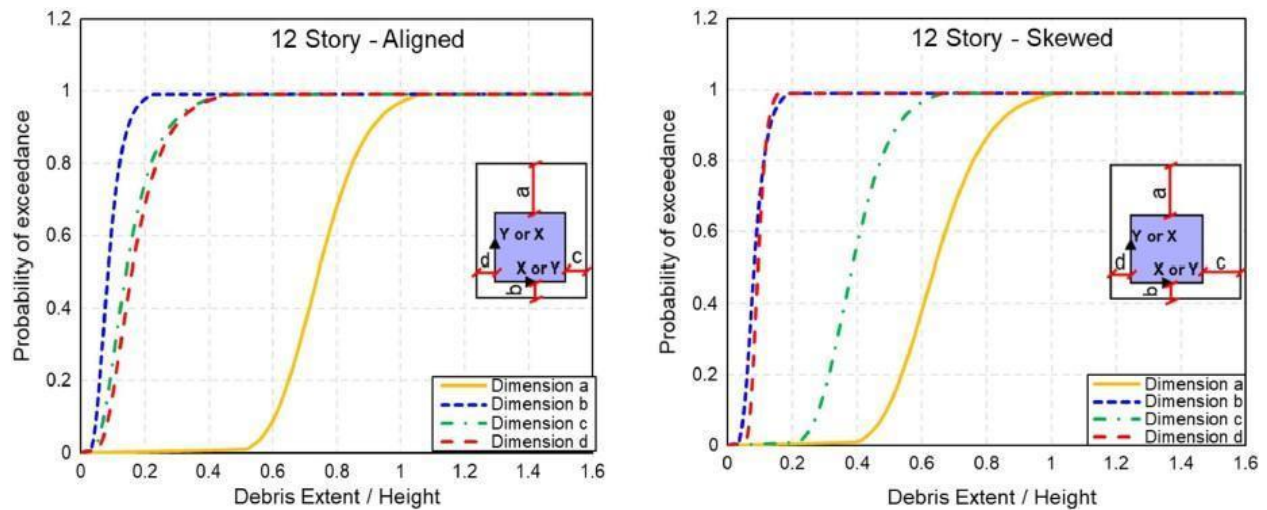
Figure A-4 Fitted lognormal cumulative density functions of the debris extent of 12-story buildings with different collapse modes (Sediek et al., 2021).

Results show that, for the buildings simulated, the 90th percentile of the largest debris extension is approximately 80% of the building height depending on the collapse mode (Figure A-4). The debris

are heavily concentrated in one direction for aligned collapse modes since the debris extension in the dominant direction is approximately three times larger than the debris extension in all other directions. For skewed collapse modes, the debris in the next largest direction is about 2/3 of that of the dominant direction. Aligned collapse modes were found to be more common in low-rise buildings (<4 stories) while skewed collapse modes are more common in taller buildings (8-12 stories). In all cases, the 90th percentile extent of the debris field as a fraction of building height was less than the building height, h_b , and decreased with increasing building height. The extent of the debris field on the “back” side (i.e., the side opposite the azimuth of the fall shadow) was approximately $0.2h_b$. The extent of the debris field on the sides of the building was approximately $0.4 h_b$.

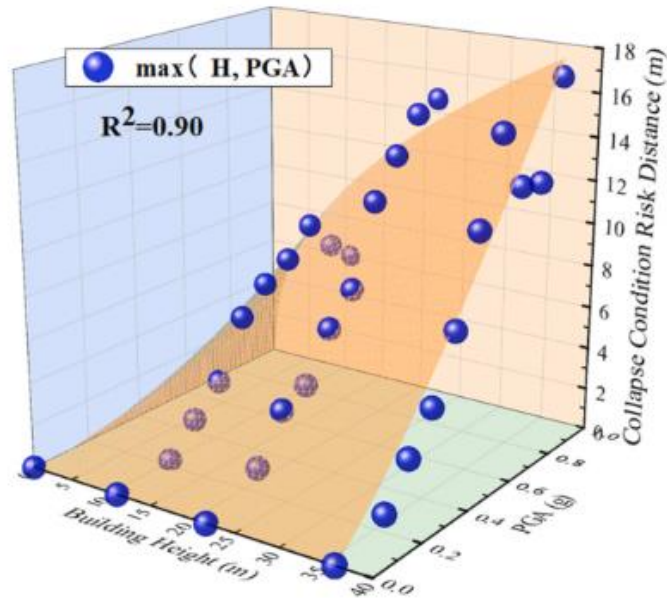
Figure A-5 Debris extent distribution for modern reinforced concrete frames per He et al. (2023)

He et al. (2023) studied debris extent of regular modern reinforced concrete structures with 3, 4, and 10 stories and a rectangular footprint of 16.8m by 12.9m (55 ft by 42 ft). The study used finite element simulations in Abaqus for each building using 22 ground motions capable of producing collapse. The structural model was calibrated with previous laboratory testing of a three-story frame. The authors found that the maximum debris extent is a function of the building height and the peak ground acceleration of the ground motion as shown in Figure A-5. The results of the simulations indicate that the maximum debris extent is approximately 2/3 of the building height for strong ground motions. The authors showed that their results are aligned with estimations from simplified equations from previous studies (Argyroudis et al., 2015).

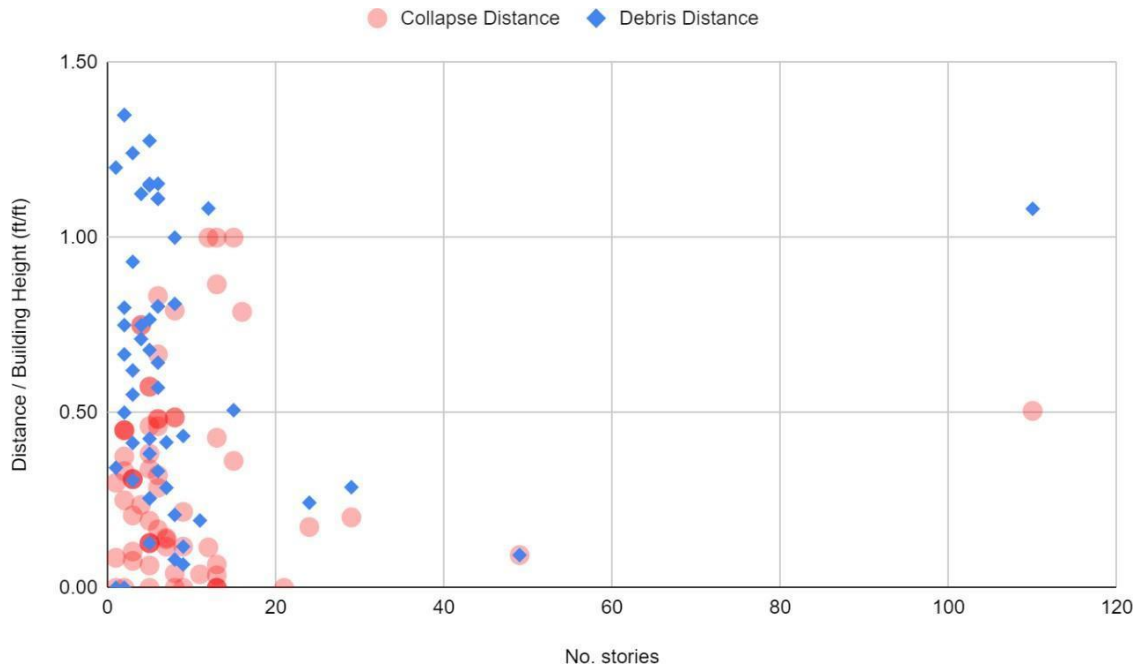
Figure A-7 Scatter plot of collapse and the debris distance normalized by the building height versus the number of stories of the buildings in the database.

Figure A-7 shows the ratio of collapse distance and debris distance normalized by building height versus the number of stories of the buildings. All the buildings in the database had a collapse distance less than or equal to the building height, and the vast majority of cases had collapse distance less than 0.5 times the building height. The debris distance was less than 1.5 times the building height in all cases, and less than 1 times the building height in most cases. Worth noting is that debris distance includes consideration of smaller elements that although dangerous, have a much lower chance of causing injuries, fatalities or damage to surrounding buildings compared to bigger structural elements within the collapse distance.
