**PAVEMENT TECHNOLOGY ADVISORY
- MATERIAL SAMPLING AND TESTING OF
EXISTING HOT-MIX ASPHALT PAVEMENTS-
PTA-T5**

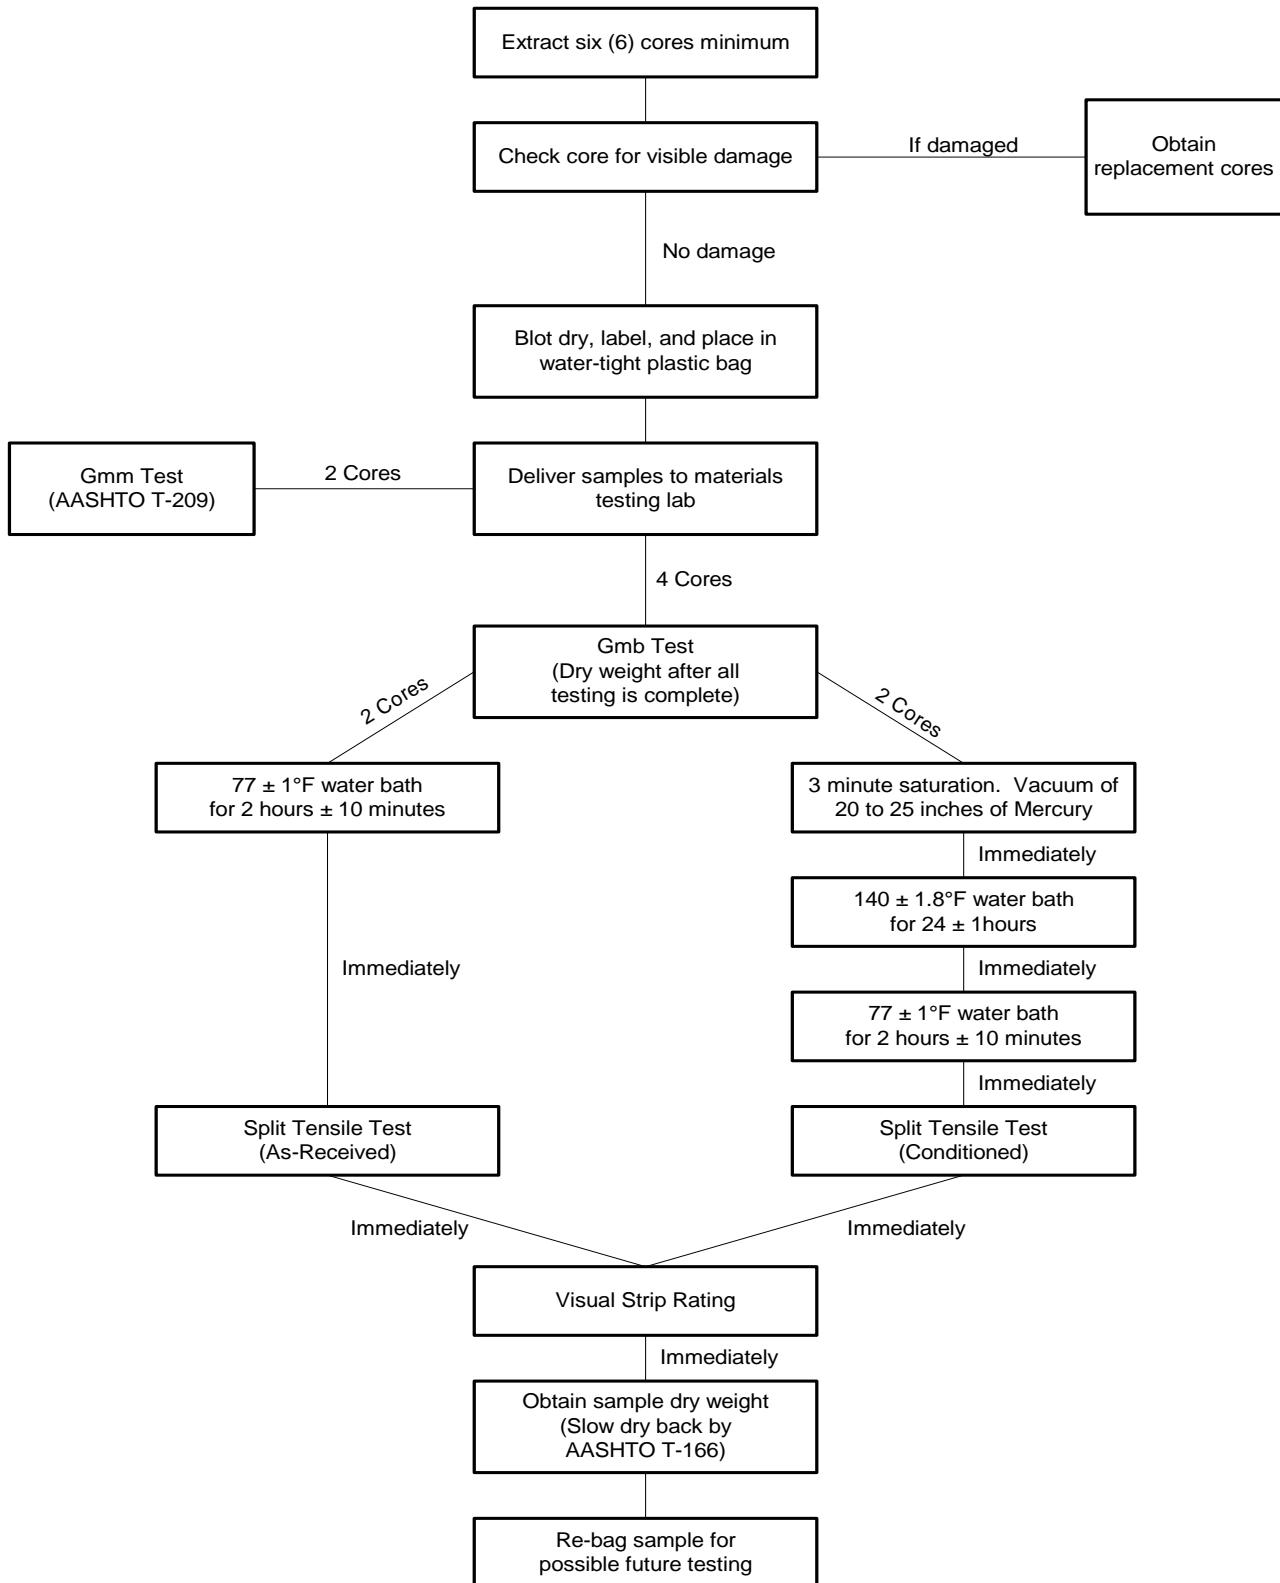
Material Testing Flow Chart

(Procedures for cores taken from existing pavements only)

Lab testing is performed within three days of the field sampling. The cores are separated into component layers by sawing, or by freezing and splitting. The percent density, split tensile strength, and the extent of stripping in the specimens are determined. A flow chart indicating the specific order and methods of testing is included at the end of this document.
