Truck Driver Poisoned by Carbon Monoxide in Cab

REPORT #: 71-254-2024s

INDUSTRY: General freight trucking

EVENT TYPE: Carbon monoxide poisoning

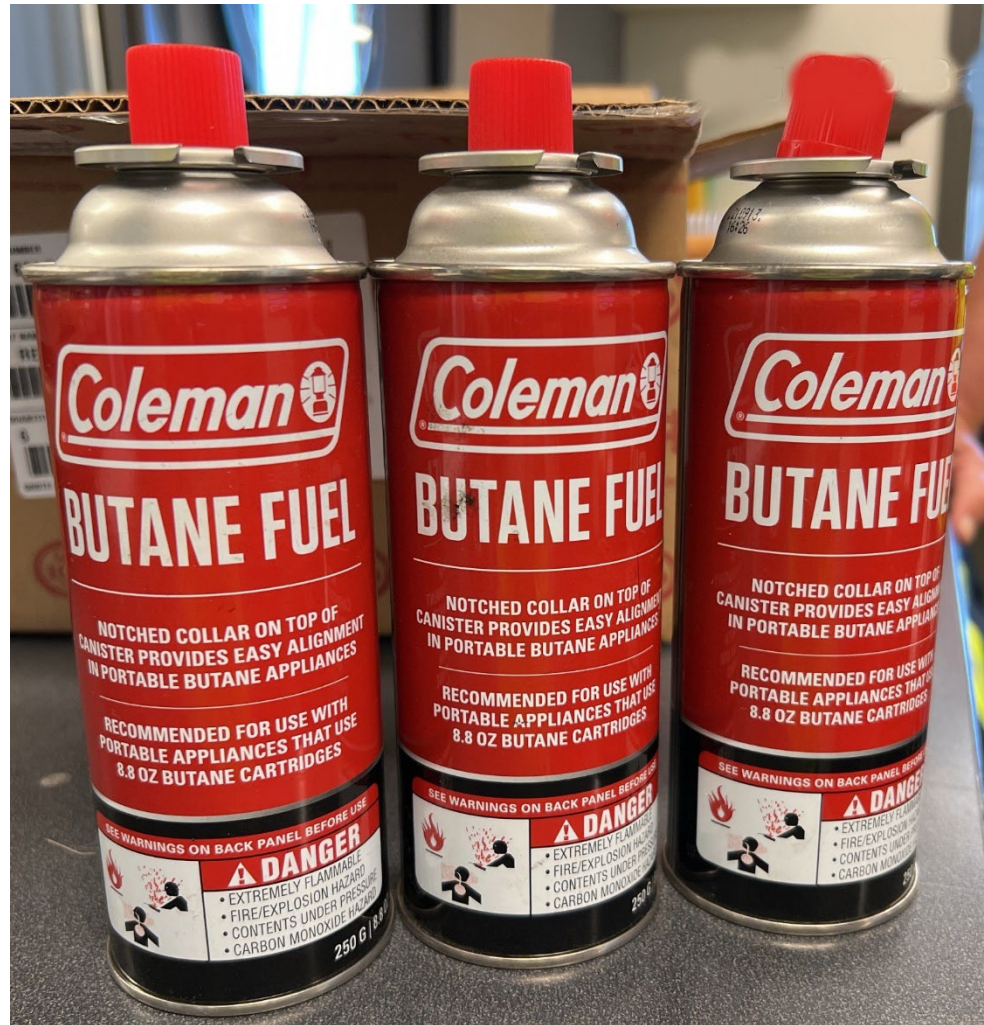
- The driver was most likely poisoned by CO from a single-burner butane cooking stove found in the truck.
- The sleeper had a bunk heater with a small diesel-powered blower motor. Air monitoring in the sleeper and near the heater's exhaust while it was running did not show any significant amount of CO.
- No exhaust leaks were detected in the truck's engine or undercarriage area.

Photo 2. Butane cooking stove fuel canisters found in truck.

- Develop and enforce clearly written accident prevention program (APP) policies for CO poisoning prevention. Policies should:
 - Prohibit use of butane, propane, and other fuel-burning cooking stoves and space heaters inside cabs, sleepers, and trailers. Fuel canisters can produce CO, a colorless, odorless, and tasteless toxic gas that can quickly, and without warning, cause brain and heart damage, unconsciousness, and suffocation.
