Case Studies of Natural Shoreline Infrastructure in Coastal California

A COMPONENT OF IDENTIFICATION OF NATURAL INFRASTRUCTURE OPTIONS FOR ADAPTING TO SEA LEVEL RISE

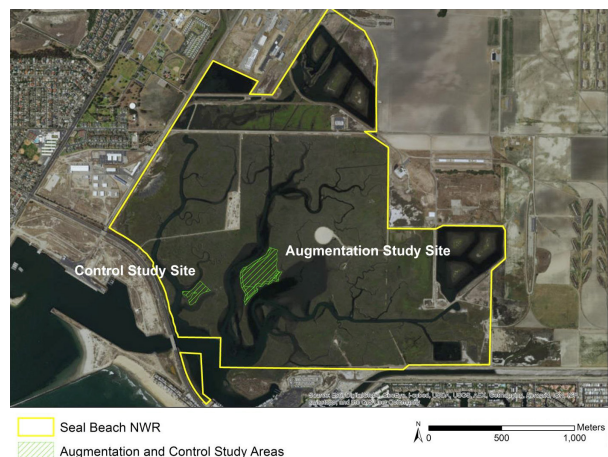
▼ **Figure 1:** Study site map showing augmentation and control areas. Image credit: USGS.

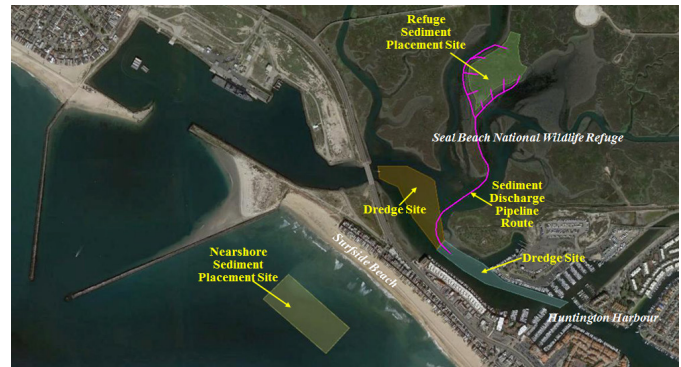
▲ **Figure 4:** Pipeline route from dredge site to augmentation site at the Refuge. The Nearshore Sediment Placement site was used in the larger dredging project and not the Seal Beach project.

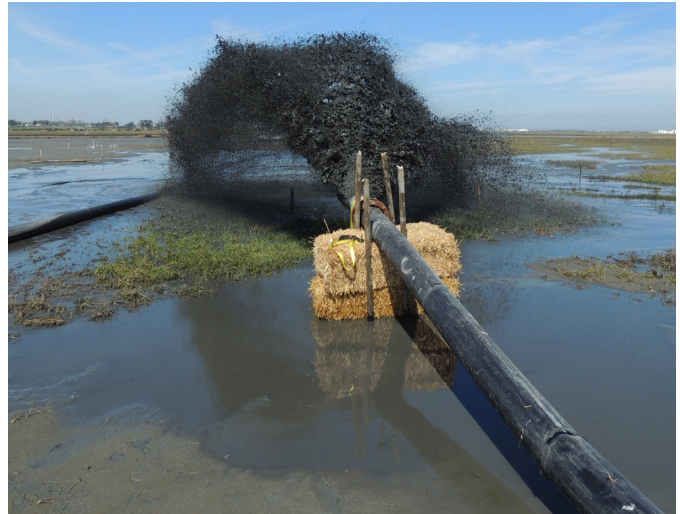
▲ **Figure 5:** 'Rainbow' spray of sediment onto the augmentation site. Photo credit: Rick Nye.

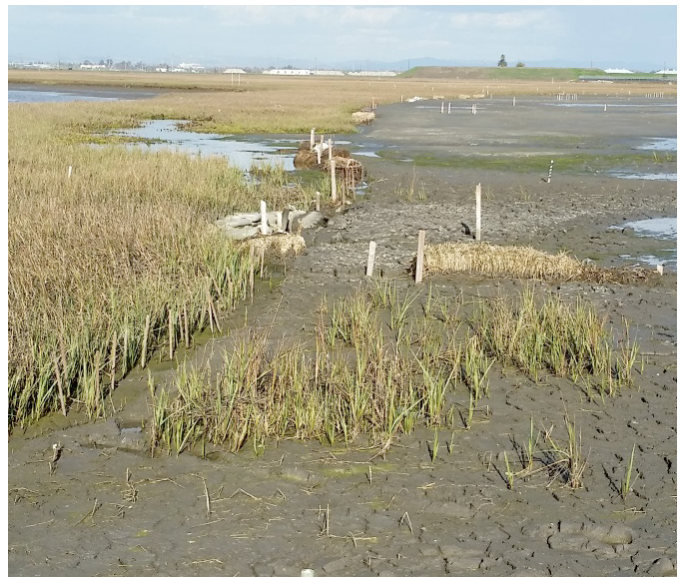
▲ **Figure 6:** Cordgrass growing in augmentation site, January 2017. Photo credit: Chase Freeman.

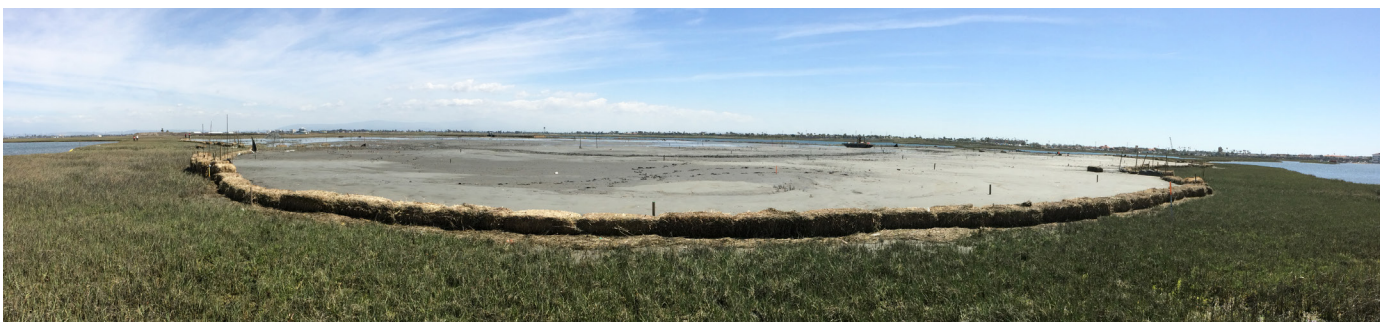
▼ **Figure 7:** Augmentation site after completion of sediment augmentation. Photo credit: Kirk Gilligan, USFWS.

of sediment in total. (Figure 7) The hay bales worked well to contain sediment except in places near channels where scouring was observed and additional measures were taken to contain sediment using sand bags, and geotextile fabric. An air horn and cracker shells were used to encourage birds to leave the spray zone, however they tended to return to forage on invertebrates in the sediment slurry and were not harmed. The last day of sediment application was April 4, 2016, although there was a considerable amount of garbage transferred along with the dredge spoils, which needed to be cleaned up. Post-construction monitoring began on June 1, 2016.

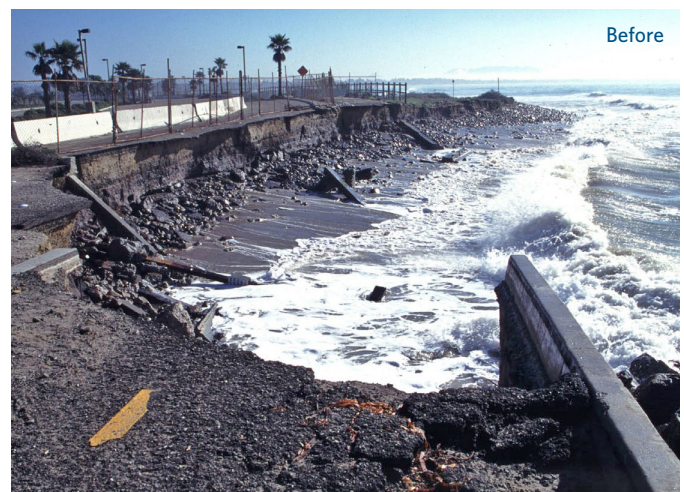
▲ **Figure 9:** Project site before landward realignment of built infrastructure and restoration of the dunes and beach. The bike path and parking lot were built on fill in 1989 and eroded within 2 years. Photo credit: Paul Jenkin.

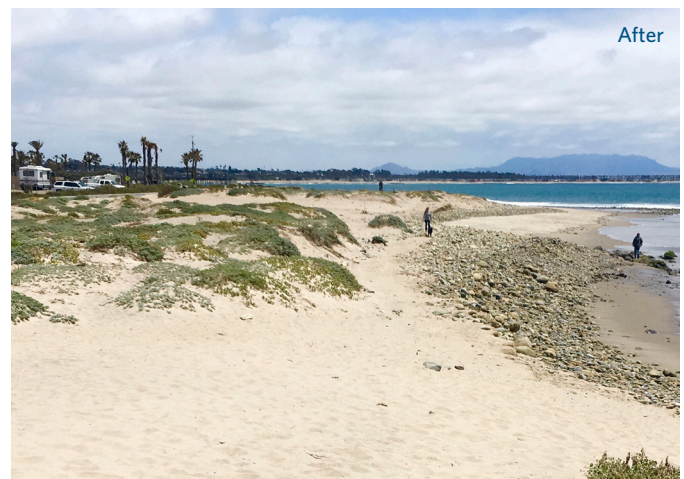
▲ **Figure 10:** Project site after managed retreat and restoration of natural processes. May 2016. Photo credit: Paul Jenkin.

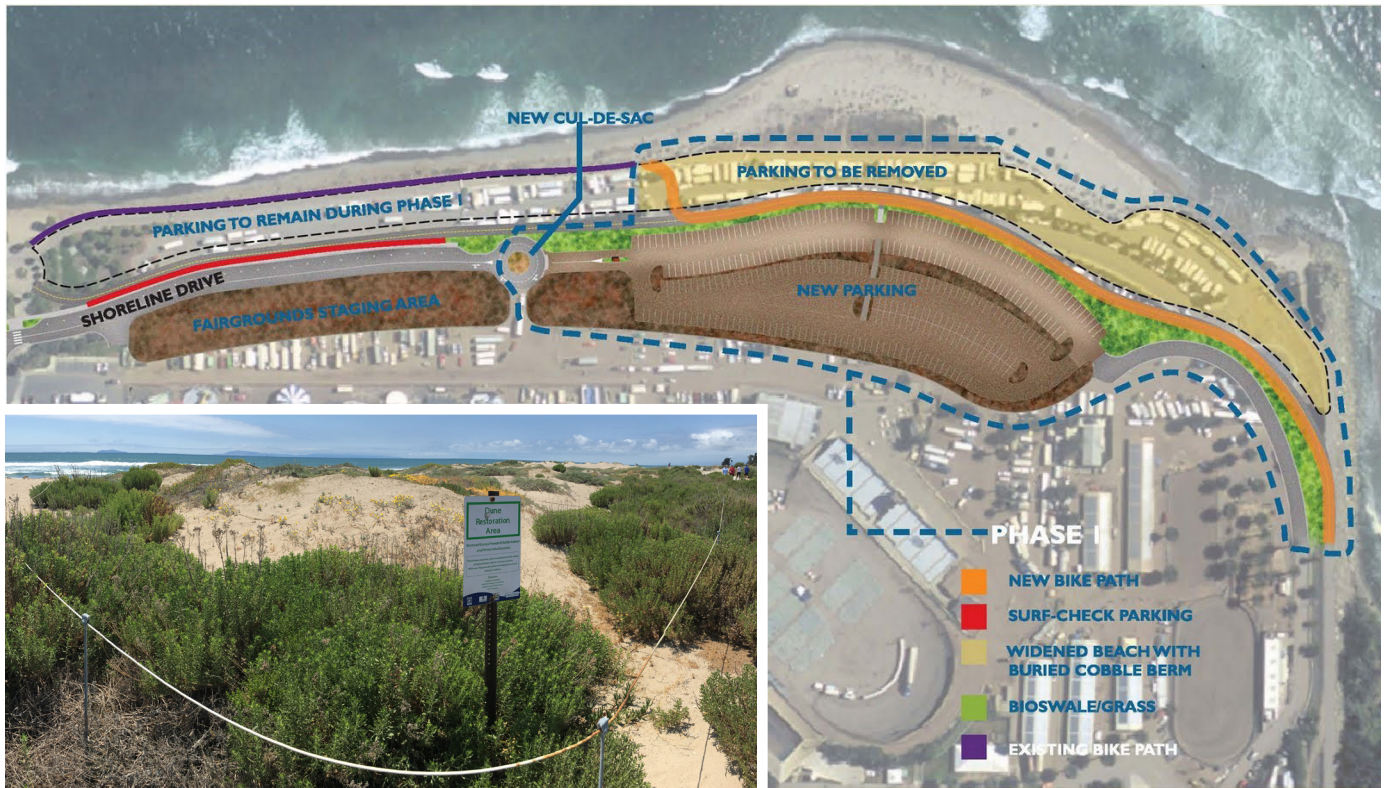
▲ **Figure 11:** A schematic showing the revised design to accommodate phasing due to budget constraints. Phase 1 (blue dashed lines) was constructed 2010-2012. The remainder of the project, called Phase 2 (highlighted shore areas to the left of Phase 1), has not been constructed. 2009. Image credit: City of Ventura, RRM and PWA. Inset Photo: Restored vegetated dunes in the area labeled as 'parking to be removed' in the design schematic. Photo credit: Paul Jenkin.

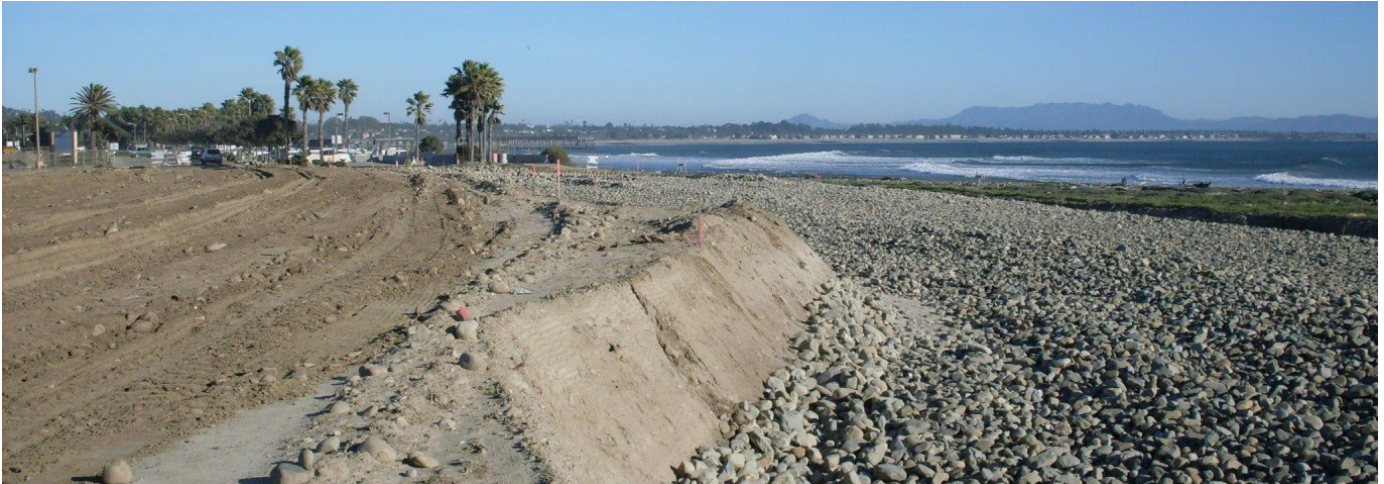
▲ **Figure 13:** After the eroded parking lot and bike path were excavated, cobble was imported and covered with sand to restore the cobble beach. 2011. Photo credit: City of Ventura.

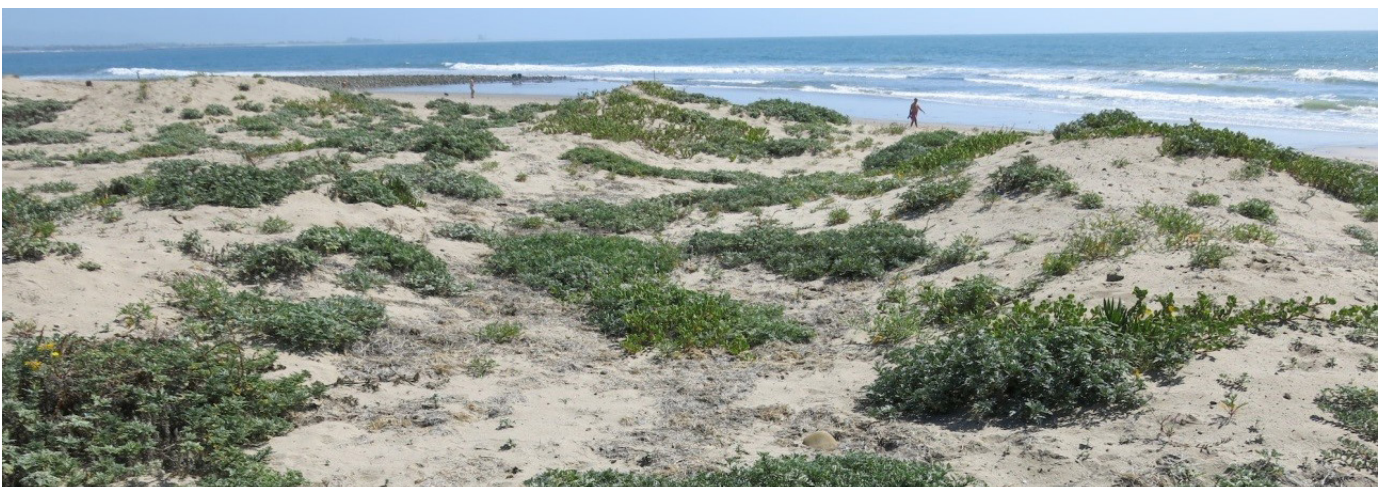
▲ **Figure 15:** Successful construction and vegetation of dunes, 2014. Photo credit: Louis White.

The areas of the beach backed by dunes have vegetated quickly and performed the job of protecting the space behind them from flooding during large storms. (Figure 15) Of interest, during high wave conditions in the 2015-2016 winter while other shore areas were damaged, no damage was experienced at the Surfers' Point Retreat project, and wave runup was documented to reach the bike path only where dunes were absent, in the area left flat to facilitate kite surfer activity (ESA 2016). In contrast, significant damages occurred elsewhere in the region due to these storms, including damage

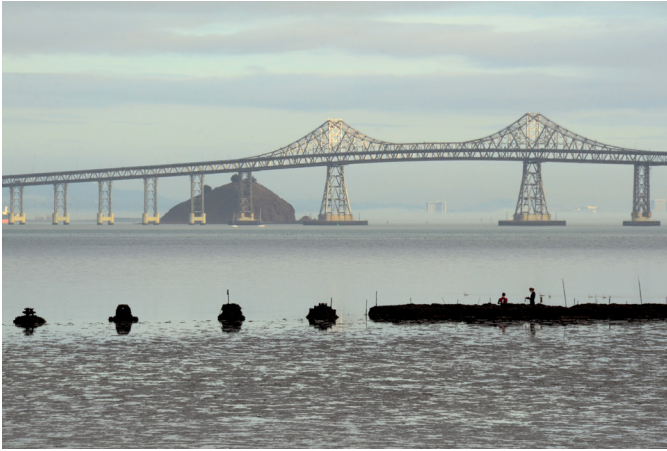
▲ **Figure 17:** Mounds of Pacific oyster half shell and baycrete structures off the San Rafael shoreline in San Francisco Bay. Photo credit: Sally Rae Kimmel.

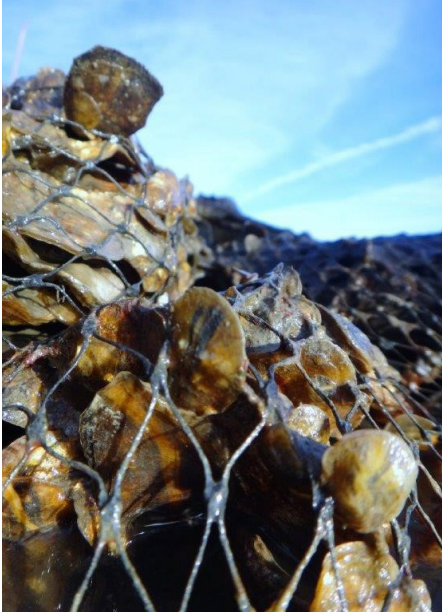
▲ **Figure 21:** Olympia oysters readily recruited to bags of clean Pacific oyster half shell. Photo credit: Stephanie Kiriakopolos.

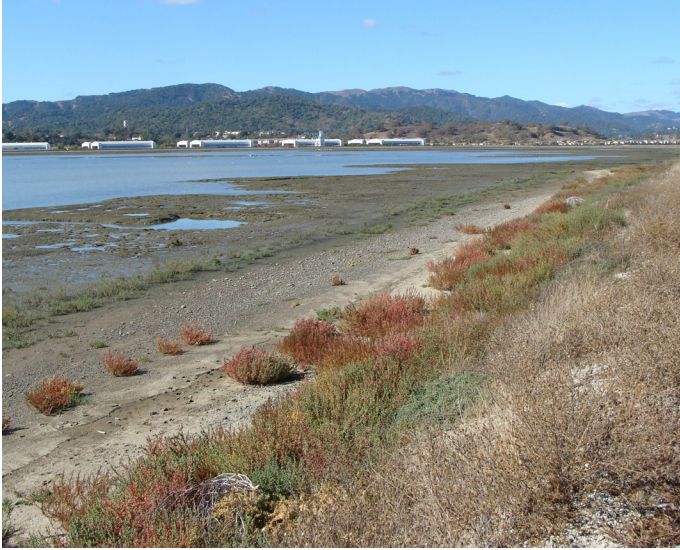
▲ **Figure 29:** The habitat-friendly levee bench on the north side of the project after 1.5 years has vegetated and resisted erosion although it has settled more than expected and may require additional sediment placement. Photo credit: Damien Kunz.

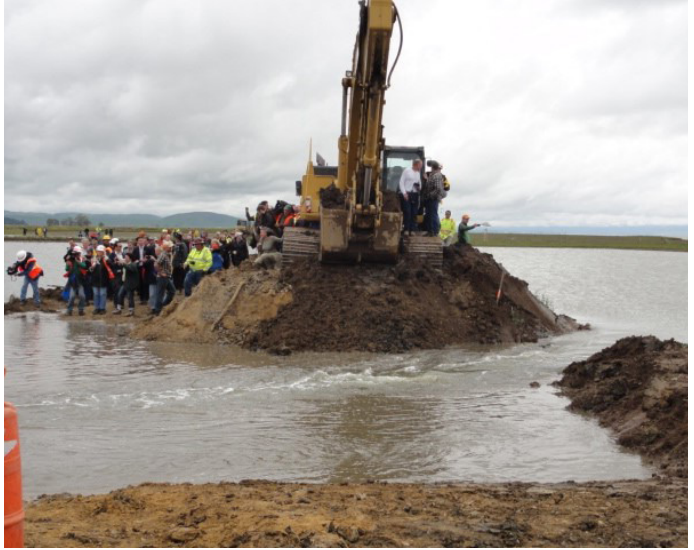
▲ **Figure 32:** Bayward levee was breached to restore site to full tidal action on April 25, 2014. Photo credit: USACE.

On April 25, 2014 the bayside levee was breached, restoring tidal action to the site and supporting natural sediment accretion, colonization of marsh vegetation, and use of the site by invertebrates, birds, and fish. (Figure 32) The USACE leads an adaptive management and monitoring plan and group. The nursery manager performs vegetation monitoring; bird, fish, invertebrate, sediment, wind conditions, and water drainage are monitored by ESA; and structural performance of the perimeter levee is monitored by USACE. The site is expected to reach full maturity between 2030 and 2050, although factors such as sea level rise and low levels of natural sediment accretion could delay or prevent the site from becoming fully restored.

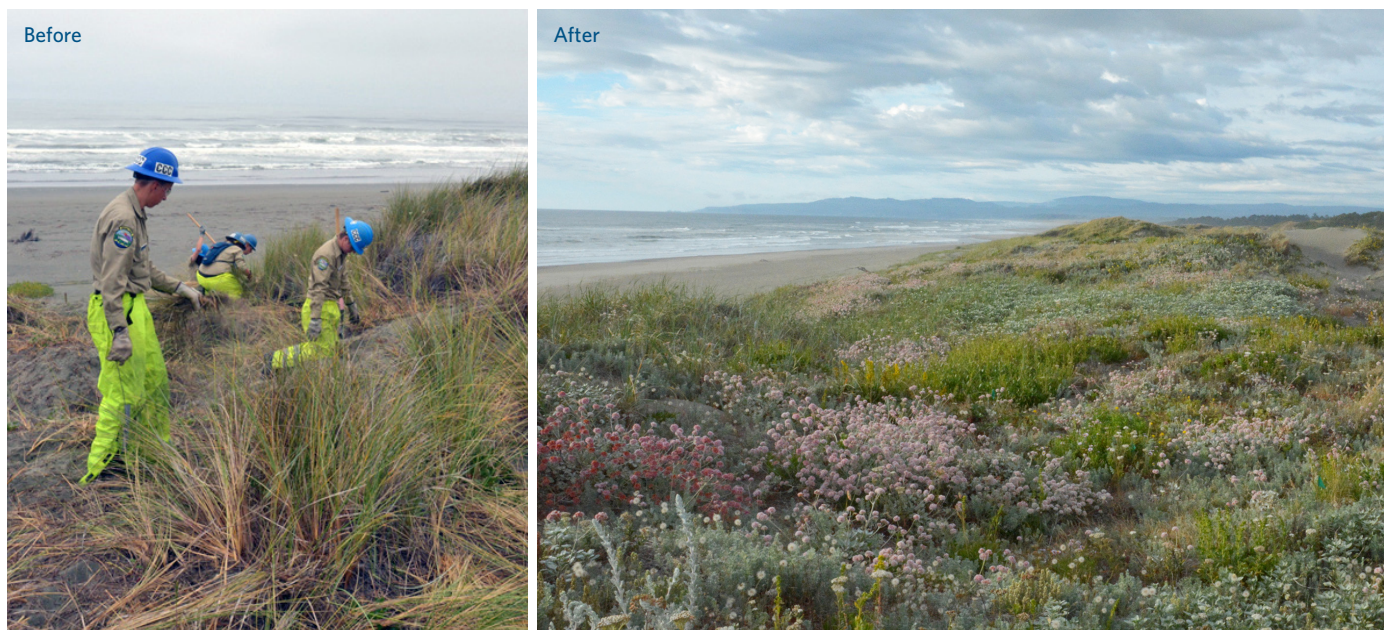
▼ **Figure 33:** European beachgrass being removed from dunes (left) to allow native vegetation and natural dynamics to return (right). Photo credit: Andrea Pickart.

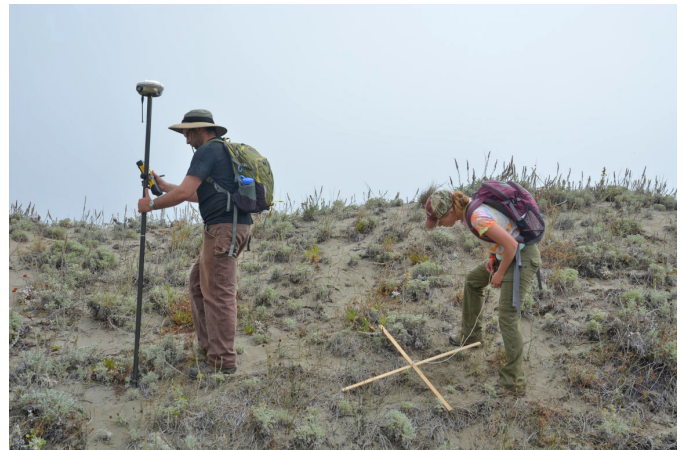
▲ **Figure 35:** Vegetation and RTK-GPS elevation surveys. Photo credit: Andrea Pickart.
