Prepared for:
HRP Potomac, LLC
c/o Hilco Redevelopment Partners
Boston, Massachusetts

Prepared By:
Ramboll Americas Engineering Solutions, Inc.
Arlington, Virginia

REMEDIAL ACTION PLAN (RAP)

1400 NORTH ROYAL STREET, ALEXANDRIA, VIRGINIA

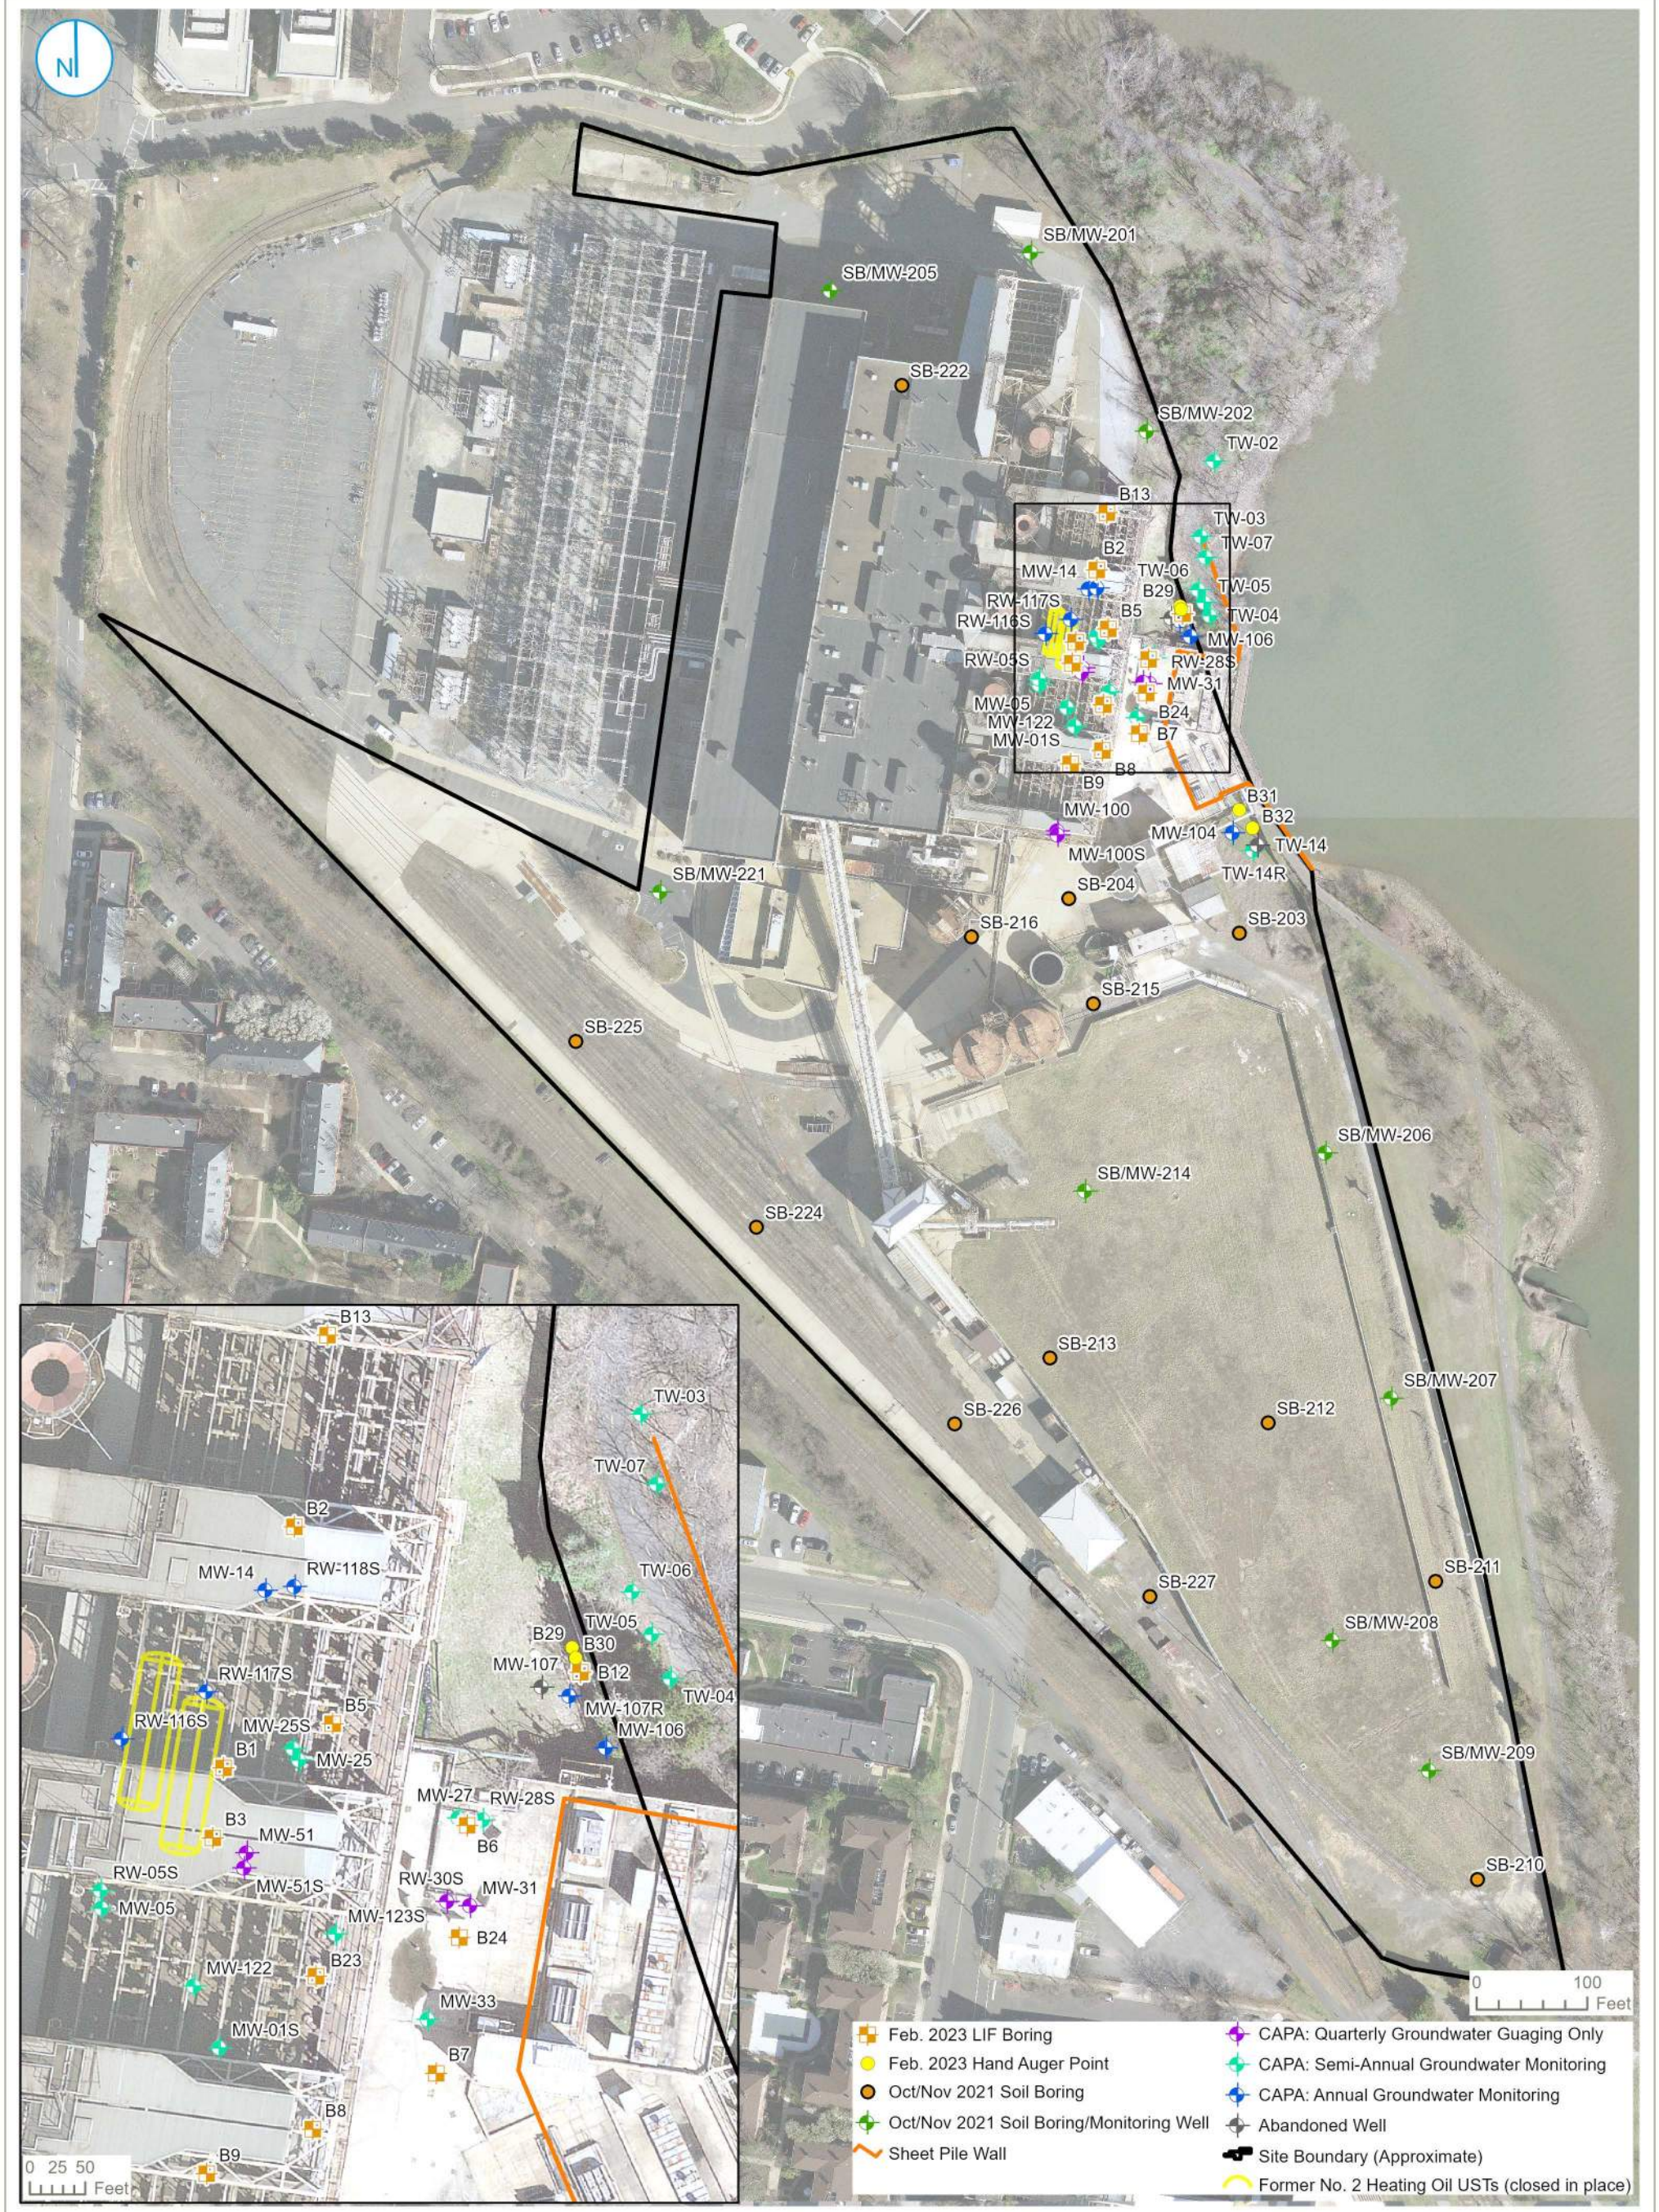
FIGURE 3

This figure depicts sample locations advanced and/or utilized by Ramboll during site characterization and corrective action monitoring field events at the site. Additional sample points have been advanced by prior consultants that are not depicted herein, which can be found in historic site reports. Ramboll notes that available aerial imagery is slightly oblique over this site, causing building structures to tilt slightly northward from the principal viewing point. No sample locations (i.e., SB-222) have been advanced inside building structures; all locations depicted are based on survey data.

RAMBOLL HISTORIC SAMPLING LOCATIONS

The nature and extent of impacts at the Site by chemicals of concern (COCs) is summarized below. Ramboll anticipates further evaluation will be conducted in conjunction with future Site redevelopment activities to gather more detailed information to assist in decision making. During preliminary Site characterization investigation activities, exceedances of potentially applicable VDEQ screening levels were identified in Site soil and groundwater (see **Figure 3** for an overview of sample locations).

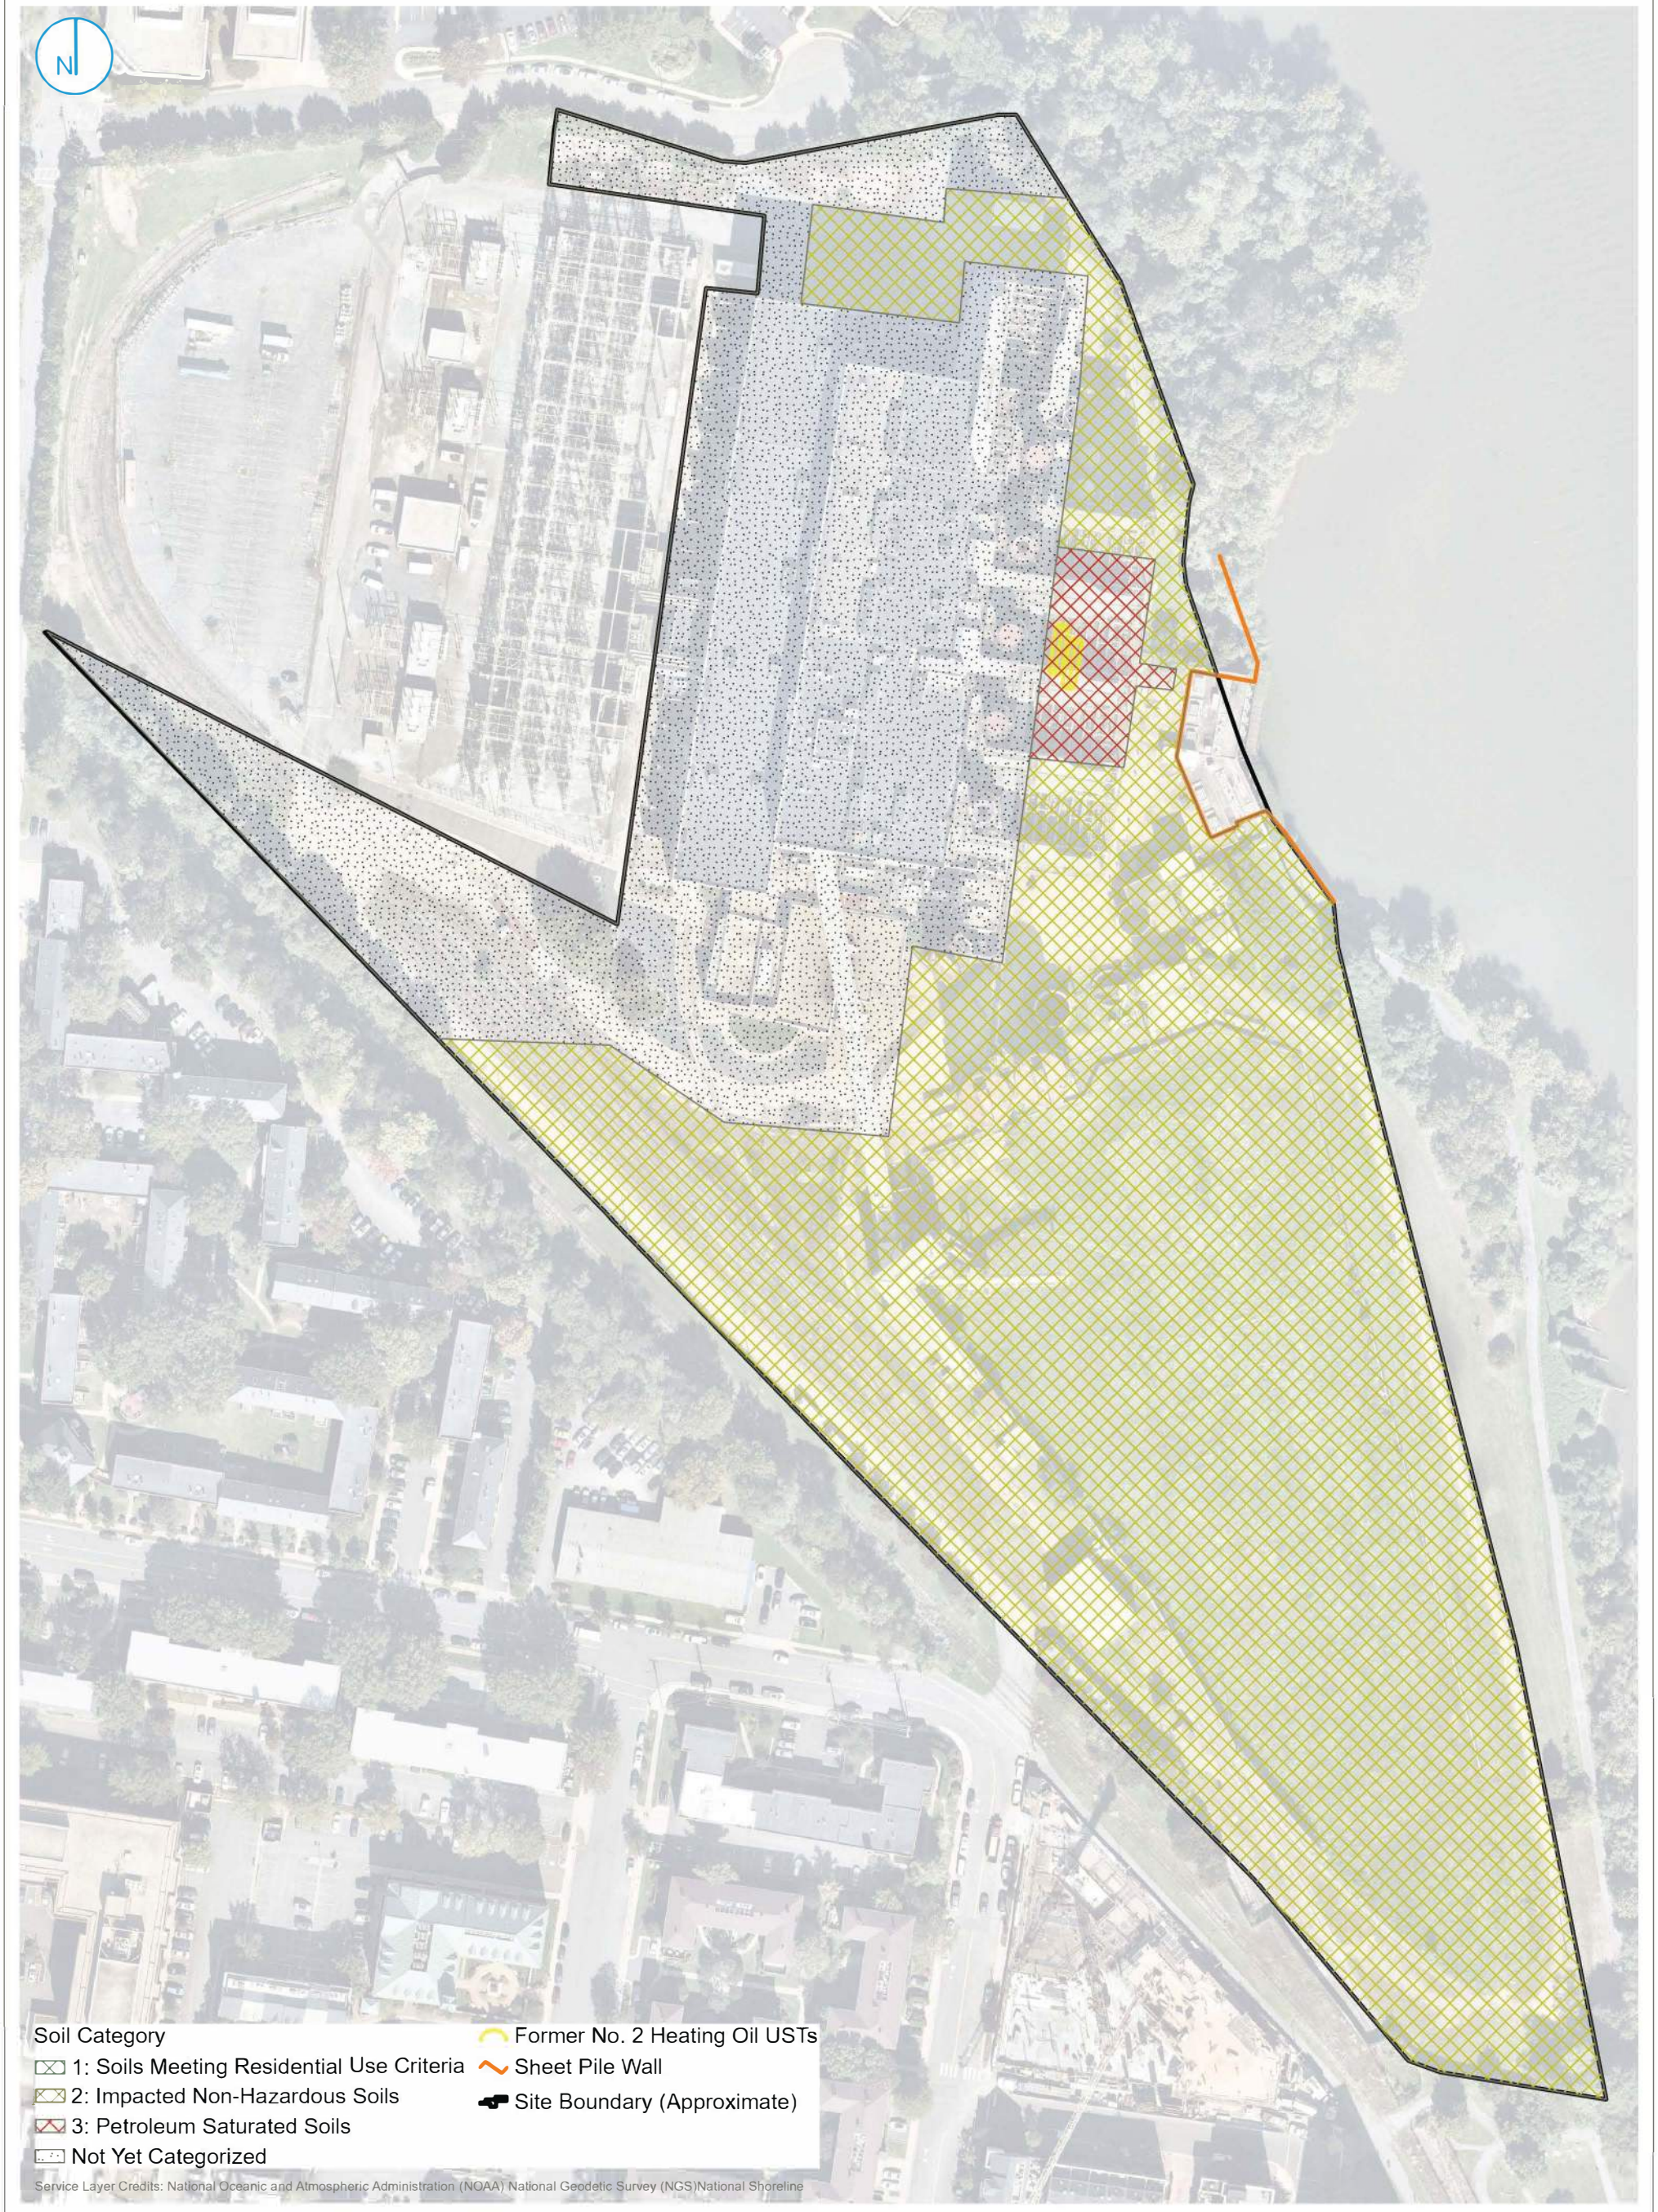
The maximum anticipated areal extent of each soil Category is depicted herein based on multiple lines of evidence. This is a preliminary, conservative estimate, therefore no Category 1 soils are depicted. It is anticipated that additional pre-development and pre-excavation soil characterization sampling will be completed to assist in the preparation of a Soil Excavation Plan, which will provide further horizontal and vertical delineation of the extent of each soil Category. Once additional sampling is completed, soil Categories will be reviewed and updated, and revised versions of this figure will be prepared in conjunction with the Contractor.

As outlined in the SGMP, it is anticipated that soils outside the petroleum-impacted area that may be reused on site will be segregated into two categories: Category 1: Soils Meeting Residential Use Criteria and Category 2: Impacted Non-Hazardous Soils.

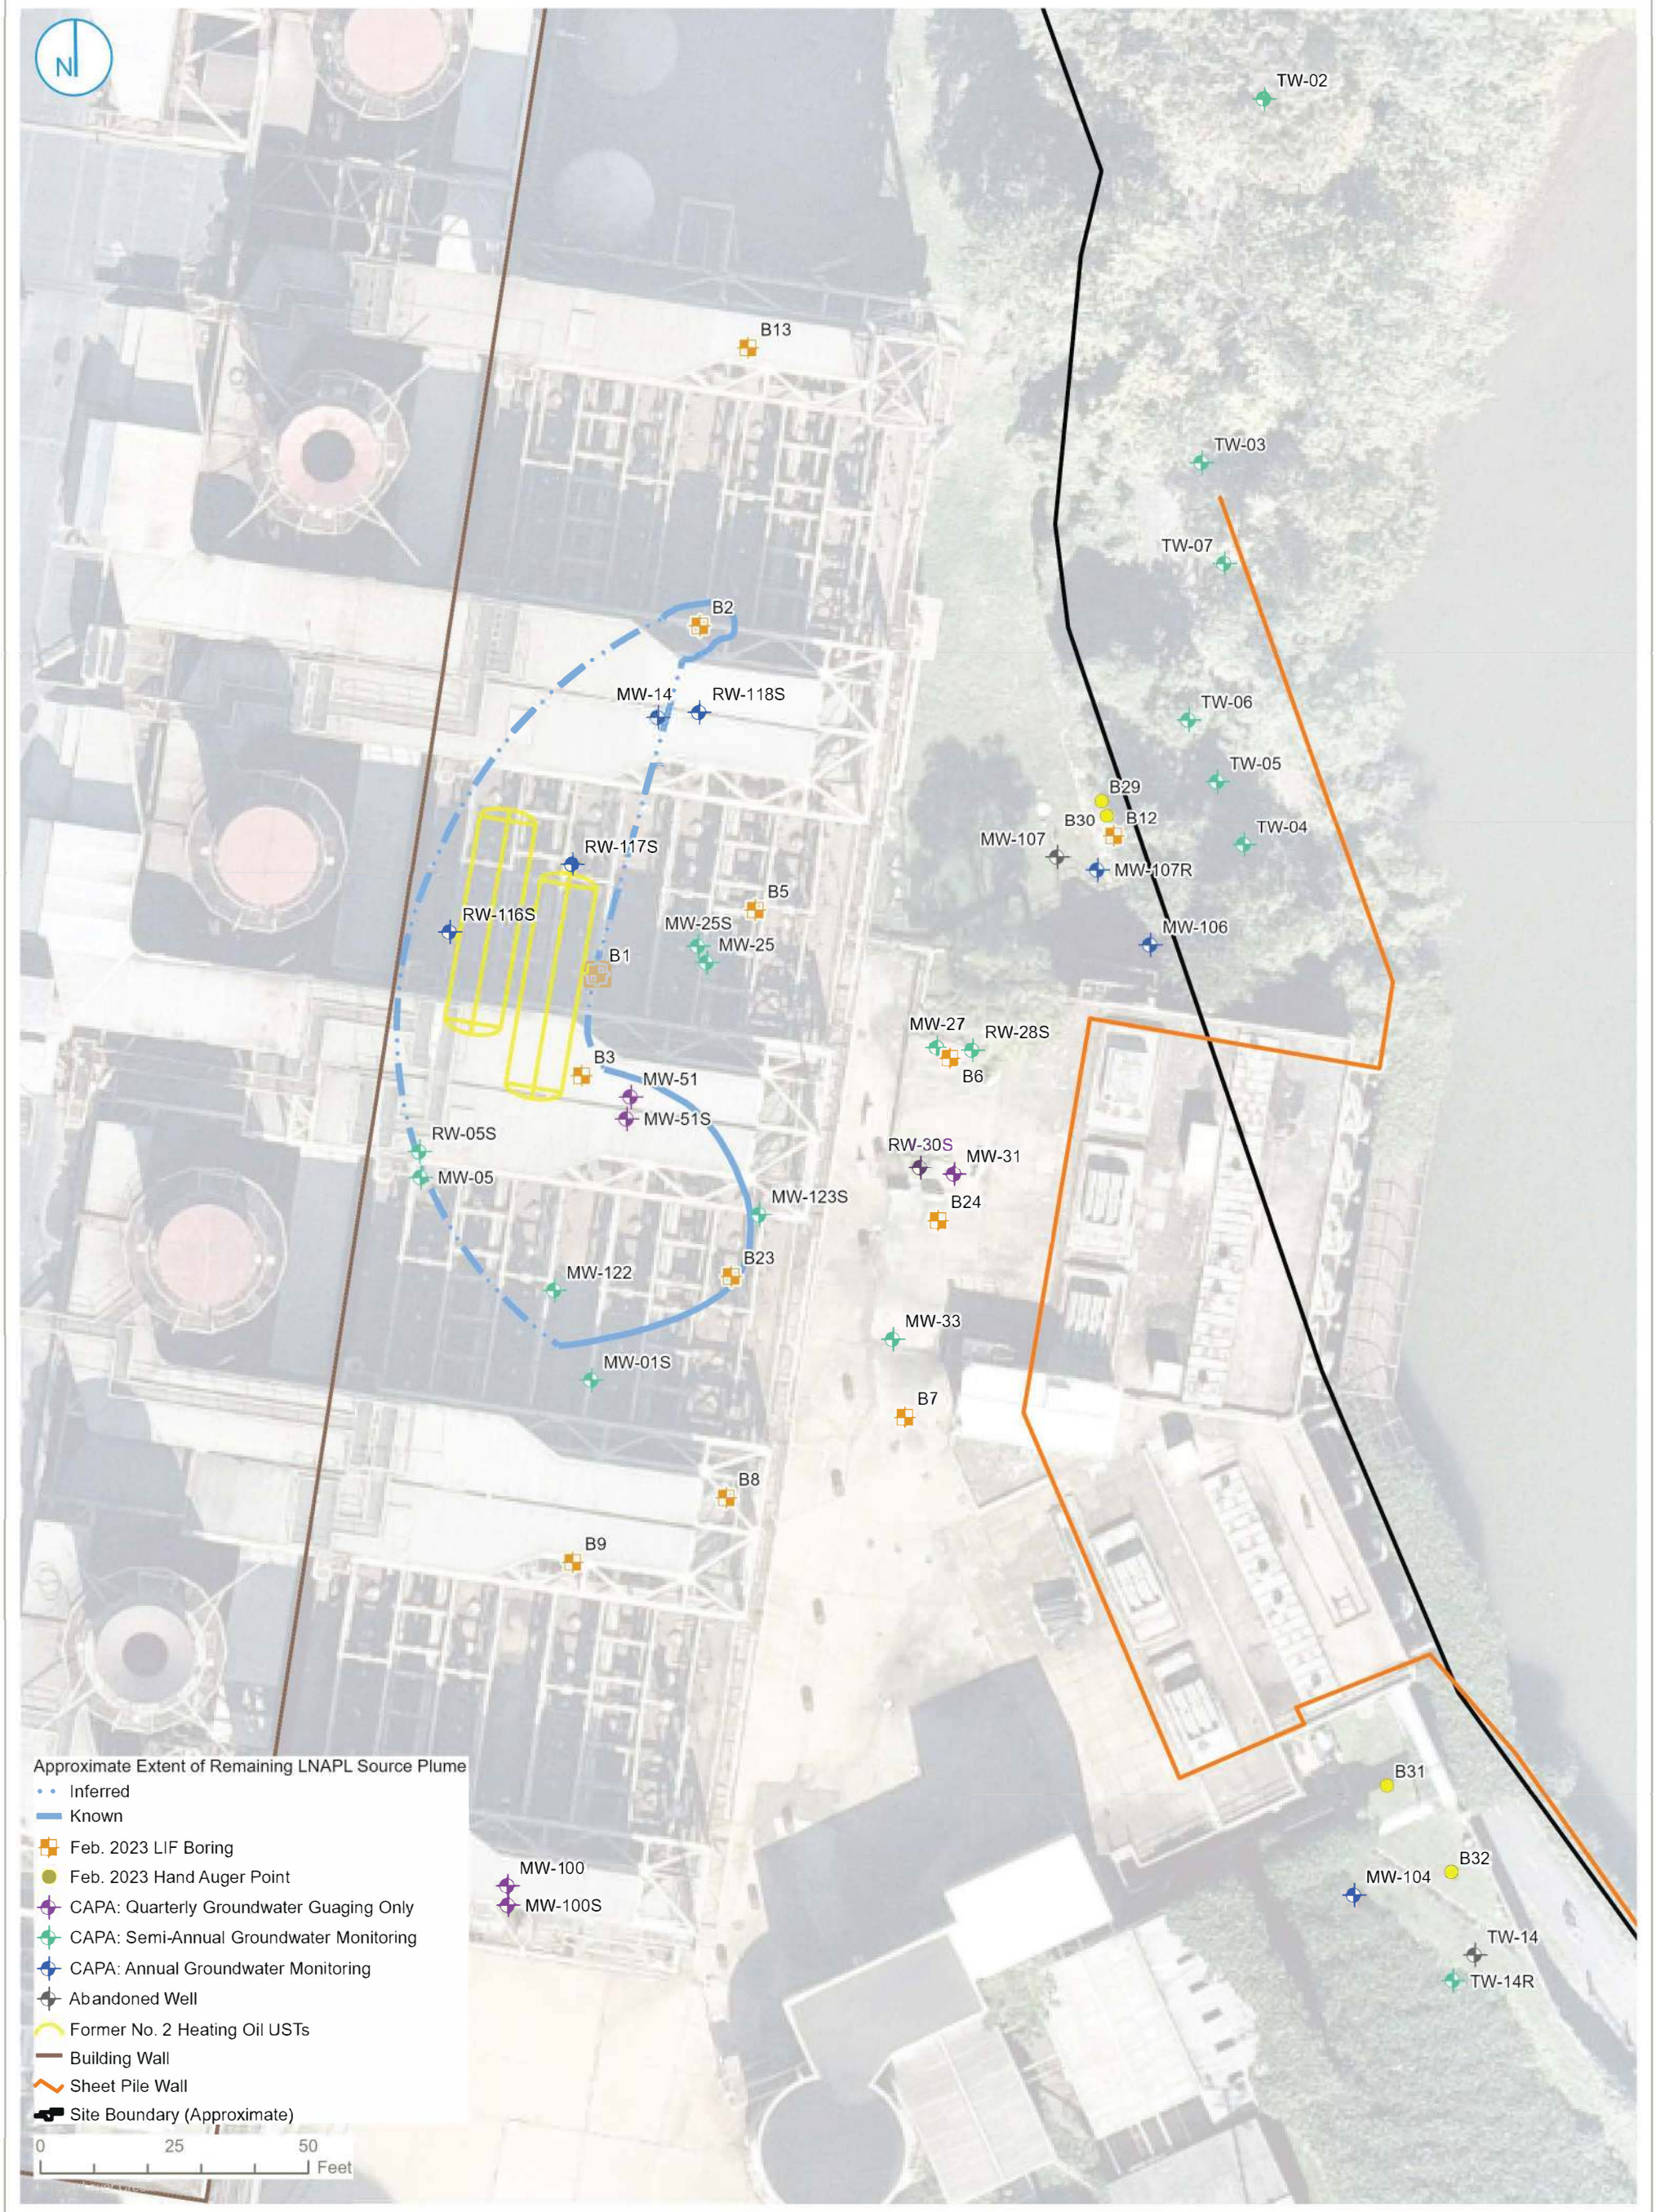
FIGURE 6

**APPROXIMATE EXTENT OF REMAINING LNAPL
BASED ON MULTIPLE LINES OF EVIDENCE**

Based on studies completed to date and lines of evidence including historic concentration data and gauging of LNAPL in monitoring wells, the estimated remaining residual LNAPL appears to be largely immobile with the exception of limited mobility in the immediate vicinity of the former tanks, which were abandoned in place. The anticipated approximate extent of remaining petroleum-LNAPL at the site, based on multiple lines of evidence is depicted on **Figure 6**. Additional evidence supporting LNAPL stability includes recorded %RE from LIF borings; high LNAPL viscosity (4.49 to 4.98 centistokes or 3.91 to 4.35 centipoise), specific density (mean of 0.9280 grams per cubic centimeter [g/cc]; range of 0.8497 g/cc to 0.9990 g/cc), and a transmissivity (0.10 square feet per day [ft²/d]) at the low end of the practical range of recoverability (0.1 ft²/d to 0.8 ft²/d)³. Smaller pore spaces resulting from finer grained soil and the presence of a thicker smear zone also inhibit the mobility of the LNAPL due to the greater interstitial pressures associated with fine-grained sediment and the reduction in oil saturation that occurs within a smear zone.

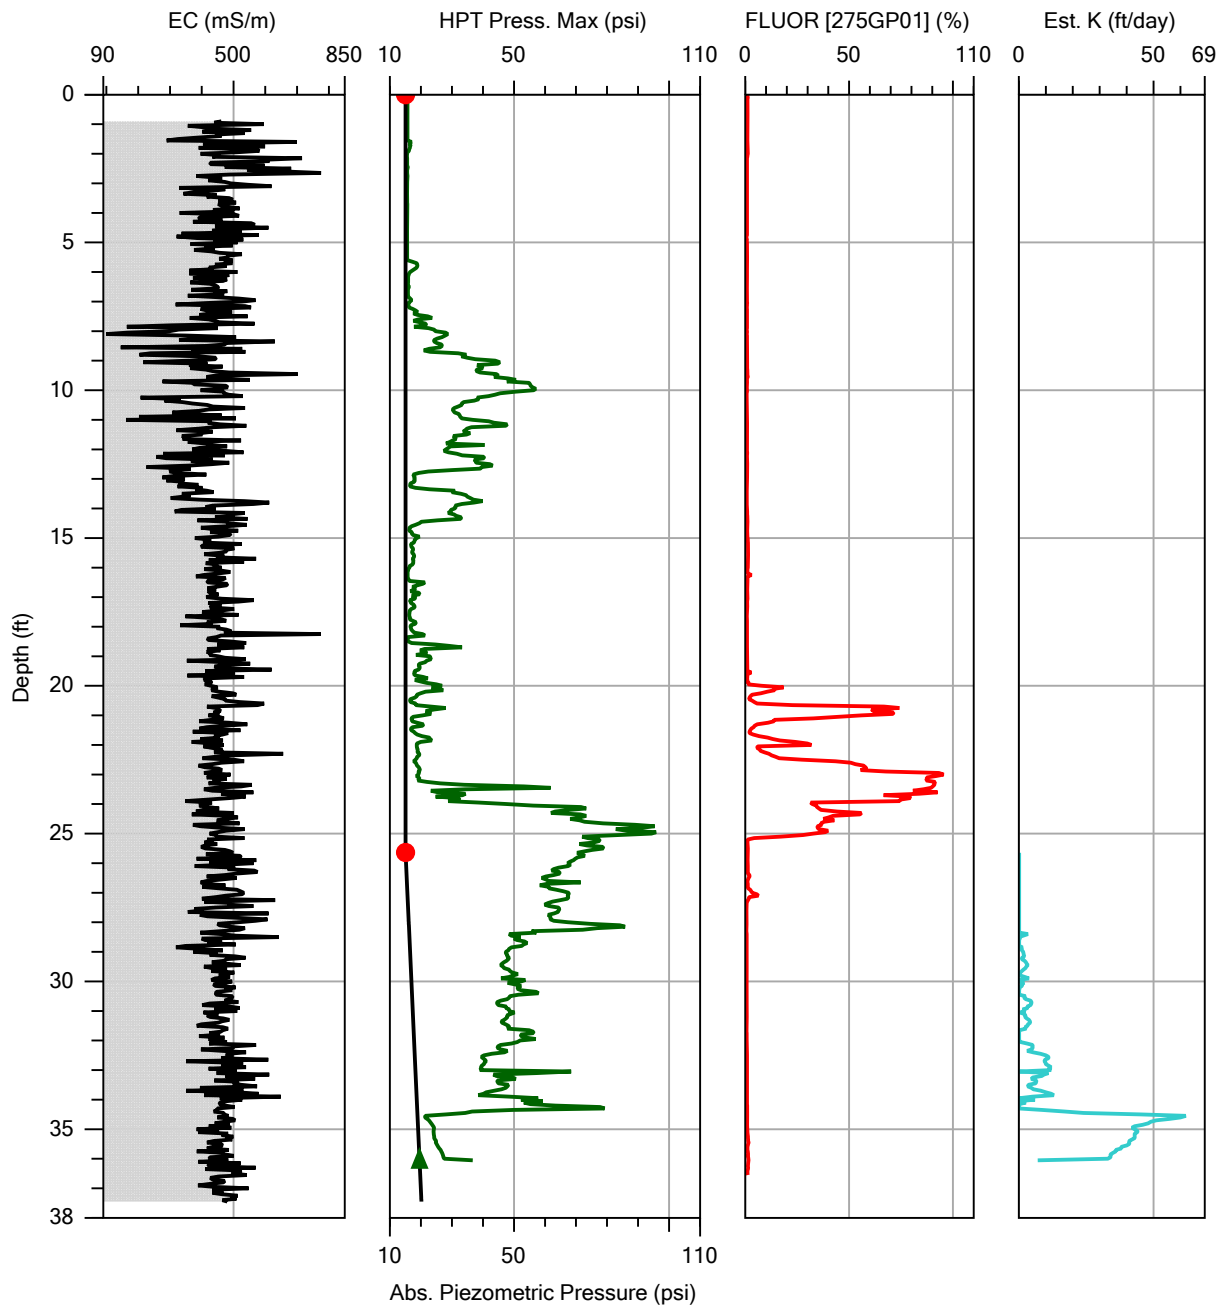
DEPTH:
23.00 ft

Company: Cascade Remediation Services	Operator: C Dixon	File: B03.OIHP
Project ID: HRP: Former PRGS	Client: Ramboll	Date: 02/08/23
		Location: Alexandria, VA

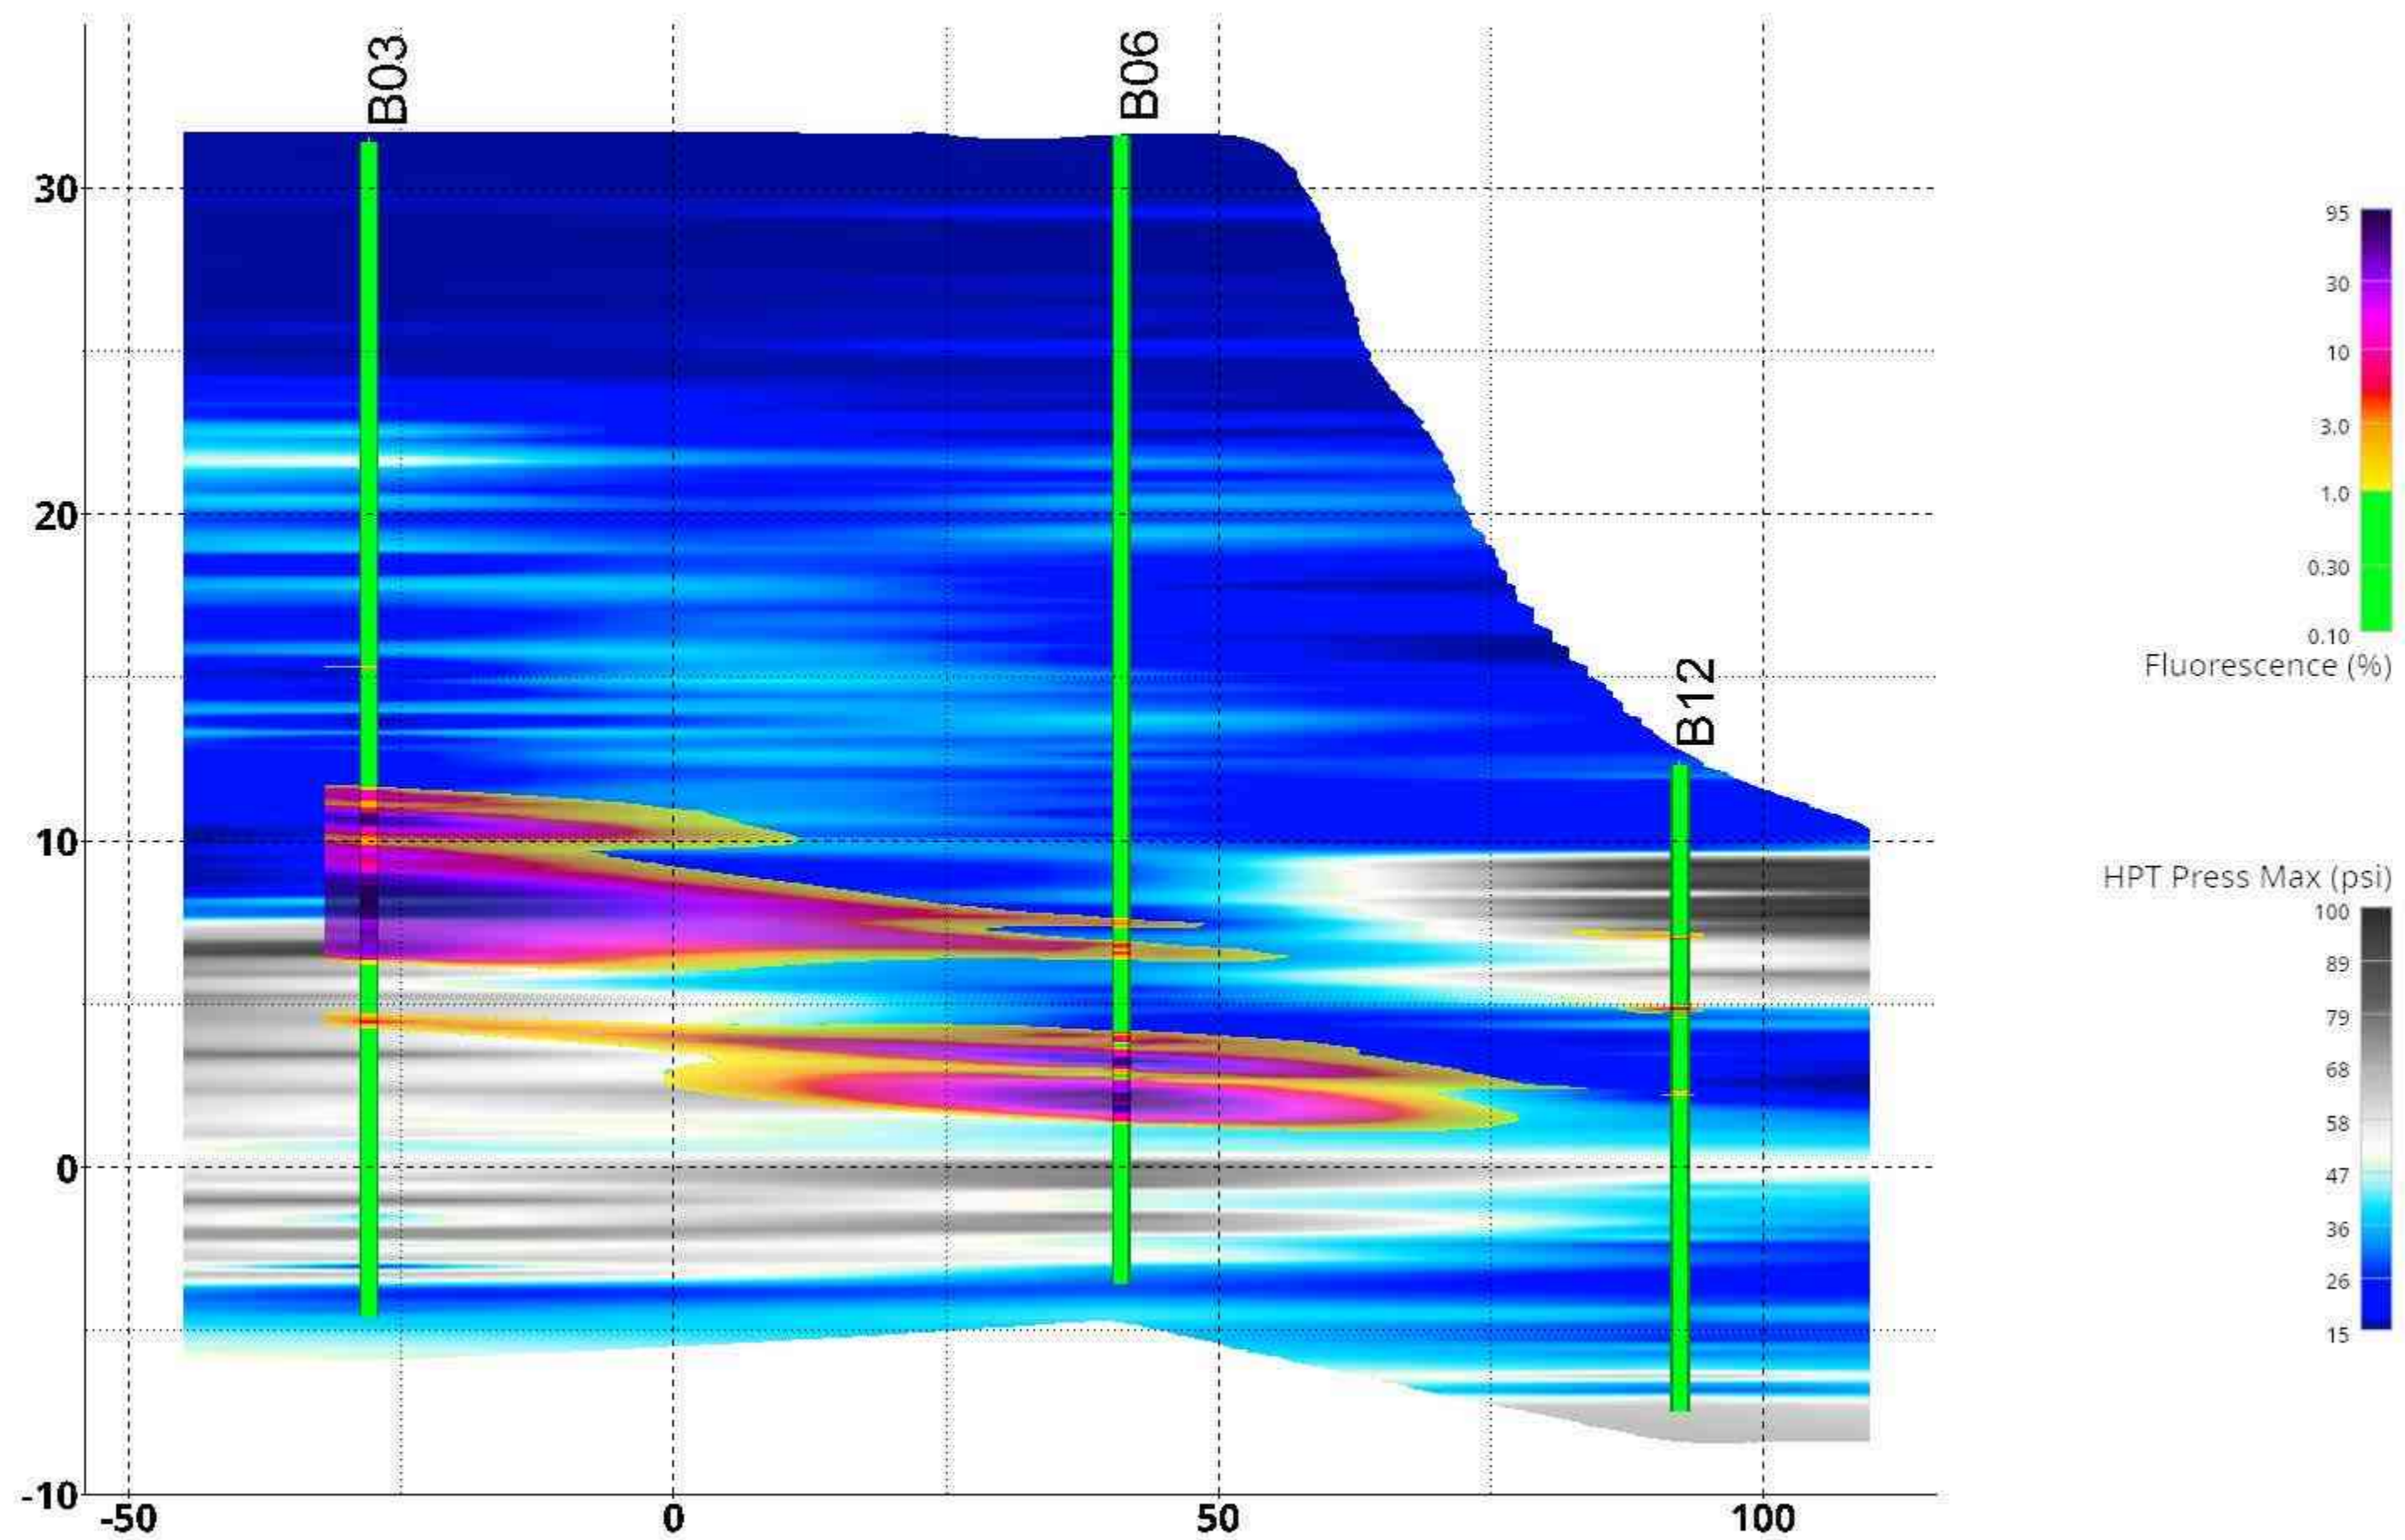
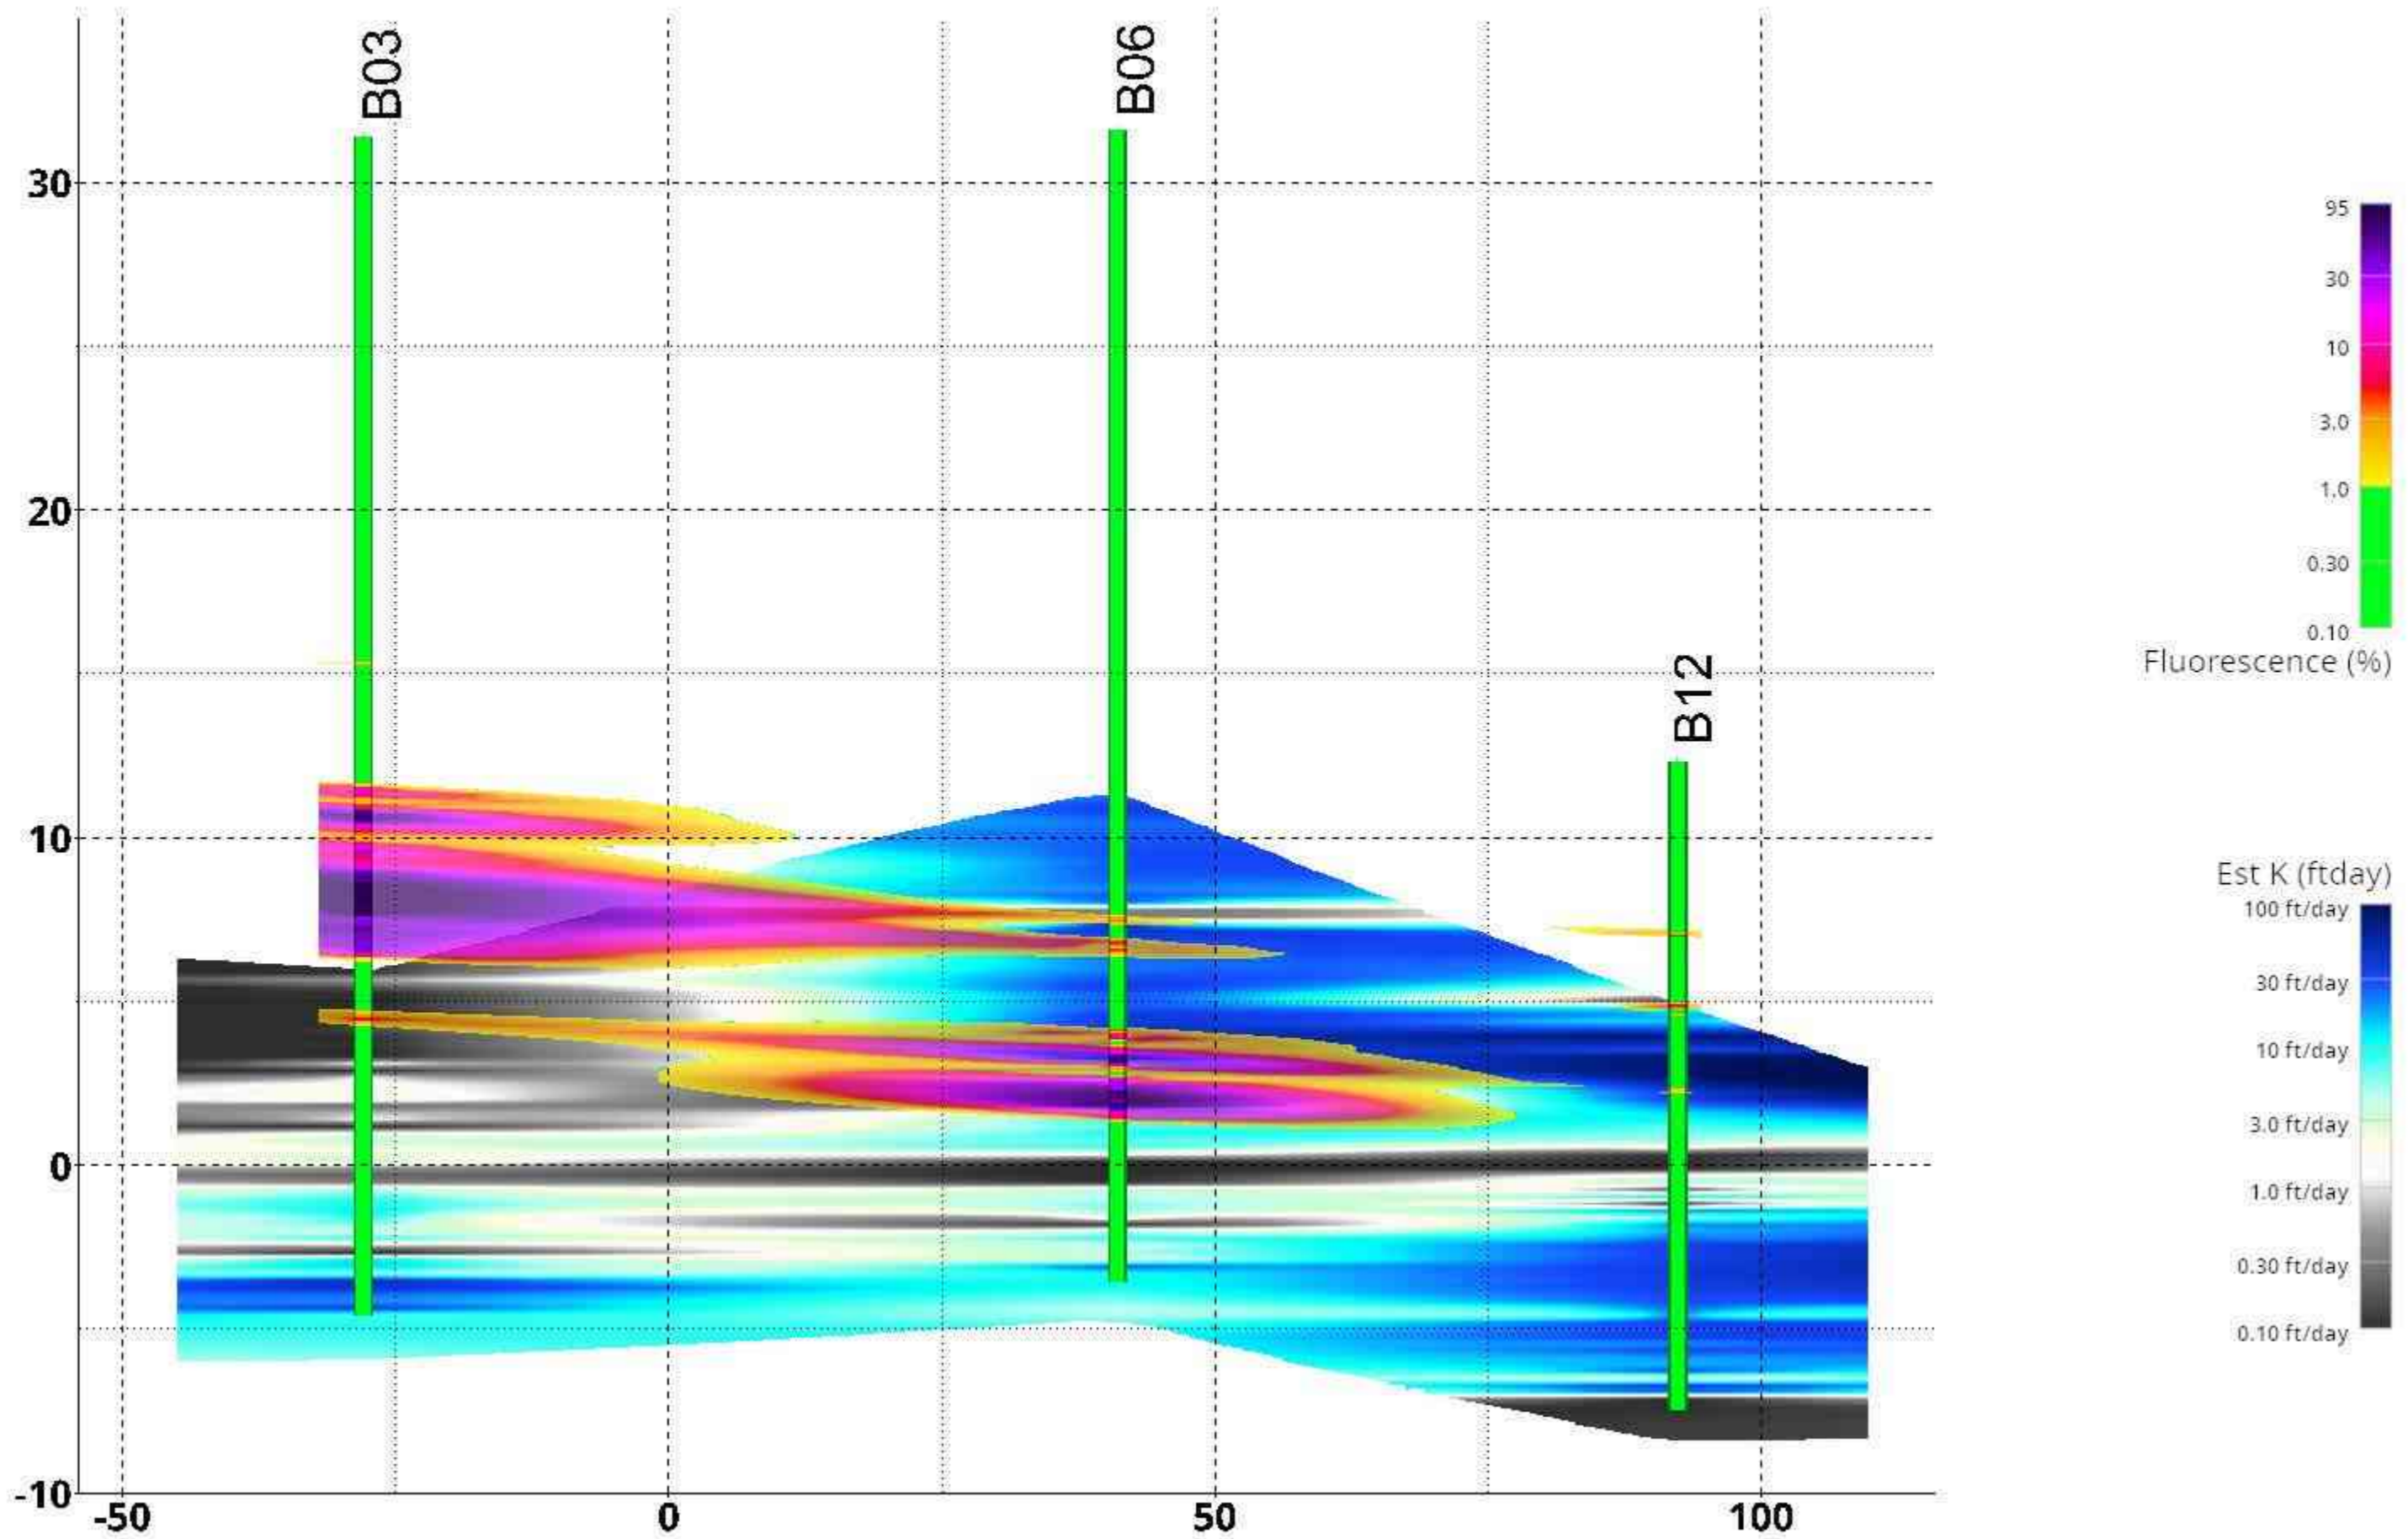
West - B Ft AMSL

East - B'

The Cascade model used to generate the cross sections (**Attachment B**) and footprints (**Attachment C**) does not include previously collected site-specific data. This model only presents the results of the February 2023 LIF investigation; it does not include site-specific geology, historical well observations, dense subsurface utility networks, building footings, the sheet pile wall, and certain other bounding conditions. As such, caution should be taken when viewing the cross sections and footprint images. Additionally, due to dense subsurface utilities and overhead obstructions, data could not be obtained in the direct vicinity of the former UST basin nor between LIF points shown, thus some data gaps exist in the modelled residual LNAPL plume footprints.
